REPORT OF MUNICIPAL SEPARATE STORM SEWER SYSTEM (MS4) INSPECTION  
AT

**City of Wichita**

NPDES Permit KS0091049  
Kansas Permit Number: M-AR94-SO01

February 6 through 10, 2023

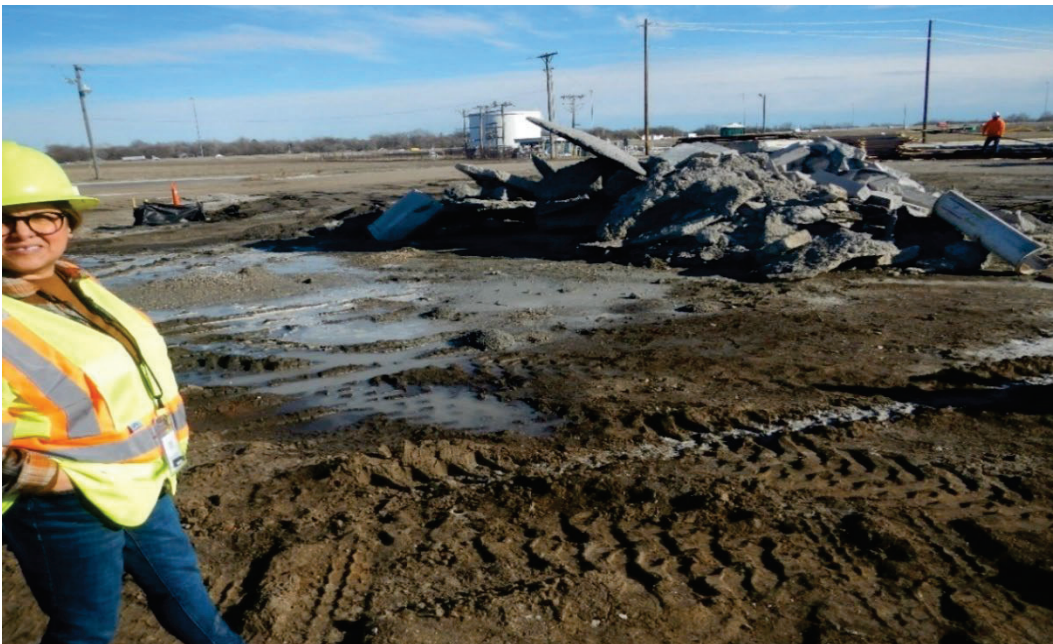
- a. *ICT21 Industrial District Site* (Attachment 9, photos 15-23): We drove by this site while we were making a nearby site visit, I observed and pointed out to Mr. Hall two concrete trucks washing out onto the ground near the site entrance and excess concrete from the two trucks was visible on the ground from the road (NPDES PART I.c.4.c). I asked Mr. Mark to enter the site and investigate the incident. We entered the site. The site had never been inspected by the City, but it was inspected by KDHE. The site has multiple permits and construction phases. The site implementation of the SWPPP was poor; inadequate BMPs were apparent, illegal concrete washout practices were very visible as shown in photo 22 below, and inadequate controls of at least four stormwater inlets were also visible.

**Photo 22, Illegal concrete washout practices at the Wichita Industrial District.**

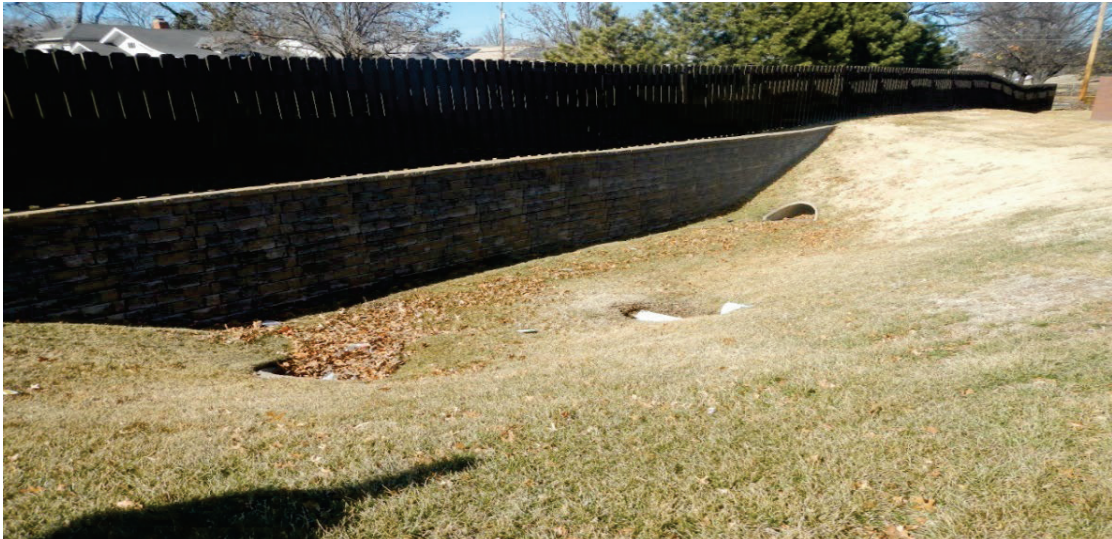
- b. *QuikTrip at 625 Hillside Street (photo 4)*: this is a dry detention basin that was approved by the City Engineer and is one of the BMPs that required to submit a biennial certification.
- c. On site I pointed out significant erosion at the discharge pipe from the QuikTrip; there is a hole at the discharge pipe that is a few feet wide and a couple feet deep; the basin floor is higher than the invert of the inlet and outlets pipes (these pipes flow across the basin and are perpendicular to the eroded discharge pipe). It appears likely the basin was sedimented in during construction and was never excavated to the design specification (should be flat, but is mounded) as shown in photo 4 below.

**Photo 4, Dry detention basin at QuikTrip as a post-construction BMP.**

I asked if the engineering firm that wrote the recertification identified the issues that we identified. City personnel indicated that they would have to review the submitted biennial certification.

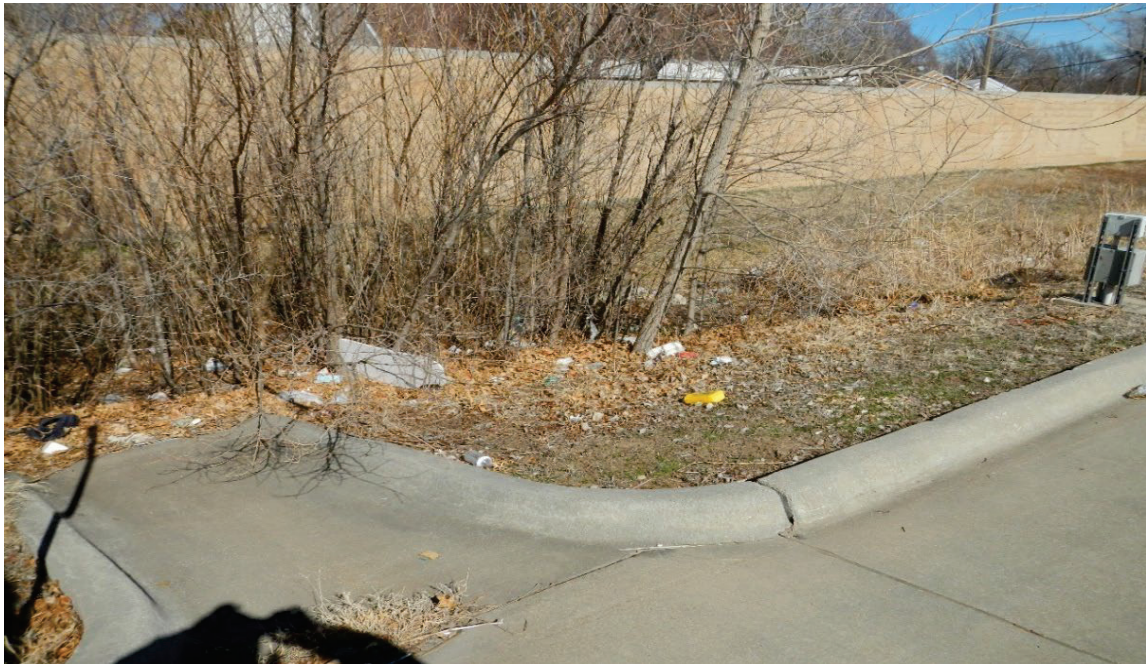
- d. *Old Walmart (photos 6-9)*: the dry detention basin was severely degraded. I pointed out the significant accumulation of debris and trash, overgrowth of weeds, including volunteer trees. At the inlet there were trees approximately three to six inches in diameter throughout the basin floor. The site appeared to be neglected, not cleaned and not maintained for an extended period of time as shown in photo 6 below. I also asked if the engineering firm that wrote the recertification identified the issues we noted. City personnel indicated that they would have to review the submitted biennial certification.

**Photo 6, Dry detention basin at the Old Walmart as a post-construction BMP.**

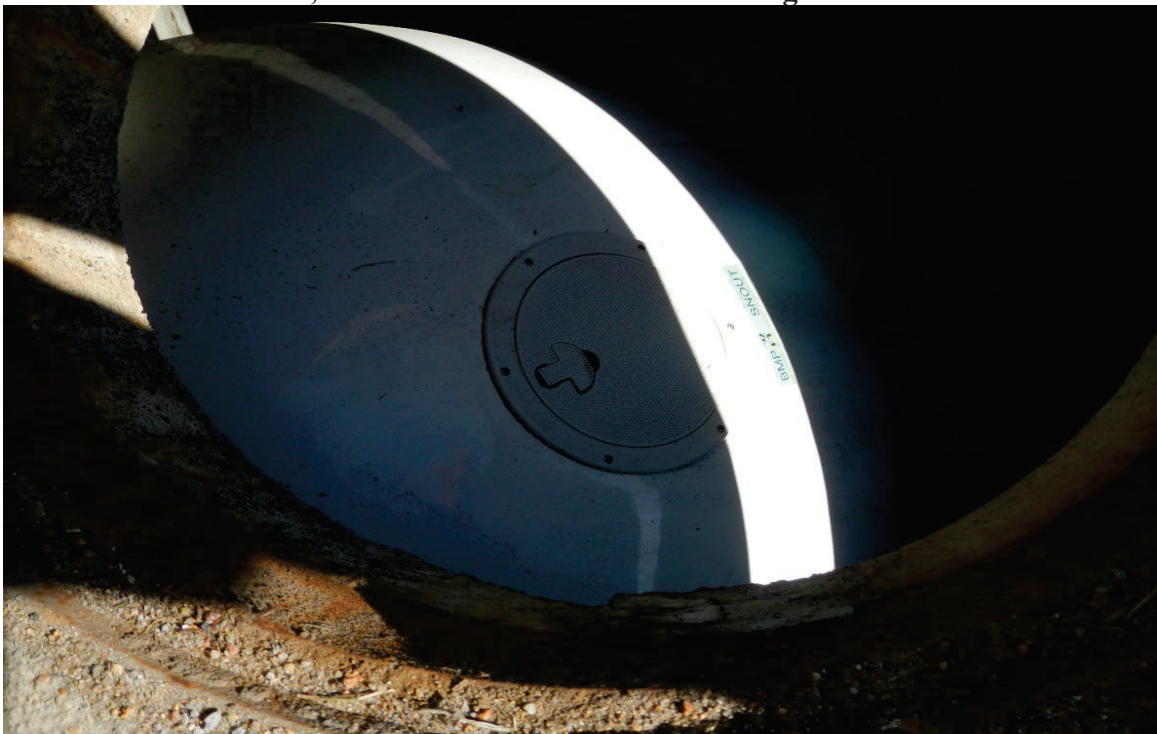
- e. *Snouts*: as mentioned above, snouts are a common sediment reduction BMP used by the City within the MS4. There are approximately 100 snouts around the City. We visually observed the MS4's largest Snout located at Crestview Lakes (72" diameter) as shown in photo 14 below. We also looked at one snout located at the Central Maintenance Facility (CMF) (photo 33). Snouts are maintained by the Stormwater Utility maintenance crews that use a vac truck to clean them every 3 months. Crews collect sludge, debris, sediment,

and trash from the snouts and haul it to a landfill where it is dewatered and then used by the landfill as cover.

**Photo 14, 72-inch Snout. Wichita's MS4 largest snout**

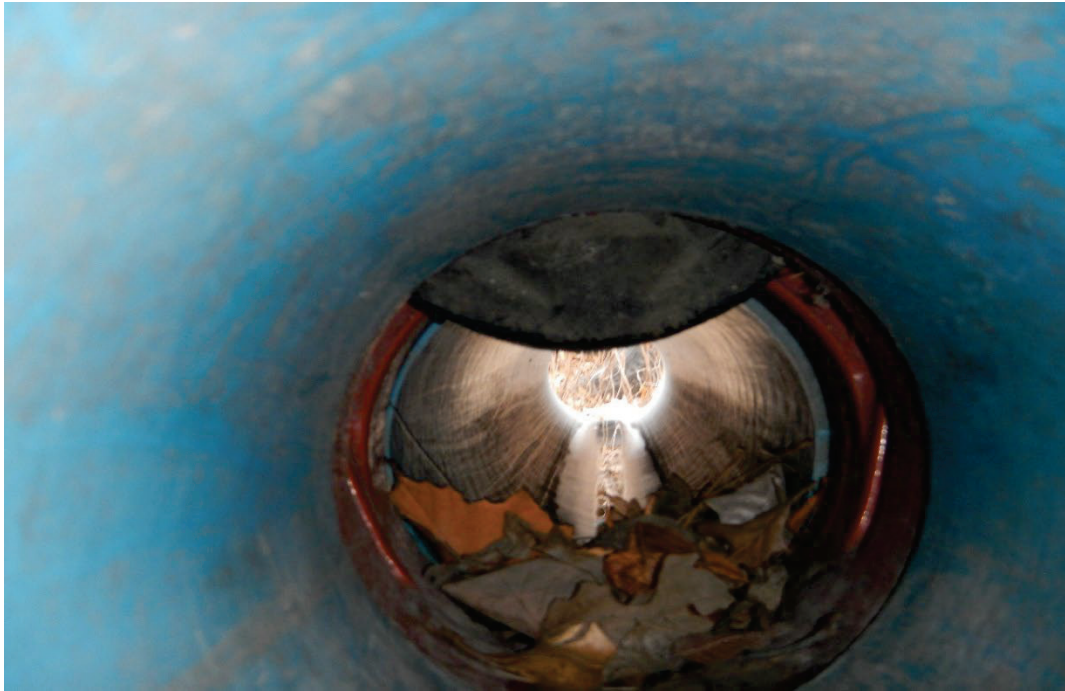
During the walkthrough of the site, I pointed out to site personnel that the north containment which had significant deposits of wet petroleum residue (photos 26) with an outlet pipe to discharge to the west of the site. This containment receives surface runoff from the nearby fueling station and parking area. The valve of the discharge pipe (photo 25) was fully open, and the pipe had fluid inside of it discharged into the MS4.

**Photo 25, inside the containment pipe discharging into the MS4.**

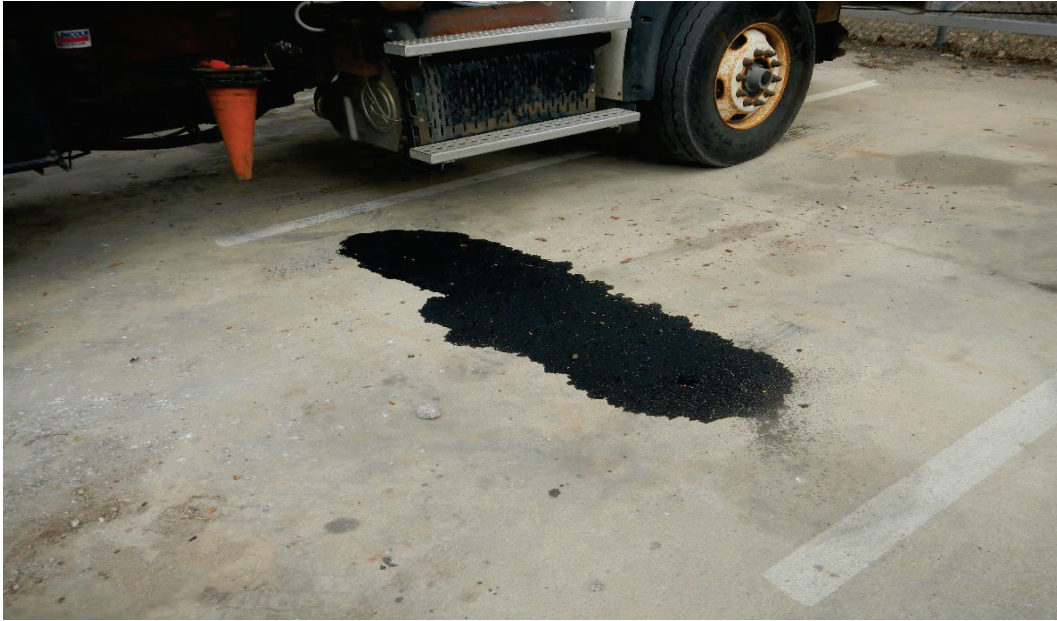
We also observed significant ground dislocation near the street sweeping bin (photo 27) and significant ground dislocation from a leaky vehicle and stored equipment (photos 28, 35, 36), improper outdoor storage of batteries (photo 32), and oil sheen in the stormwater inlets (photos 33 and 37) where the snout was completely discolored. We also observed evidence of oils entering the stormwater inlet (photo 34).

**Photo 36, Significant Spill near stormwater inlet at the CMF**

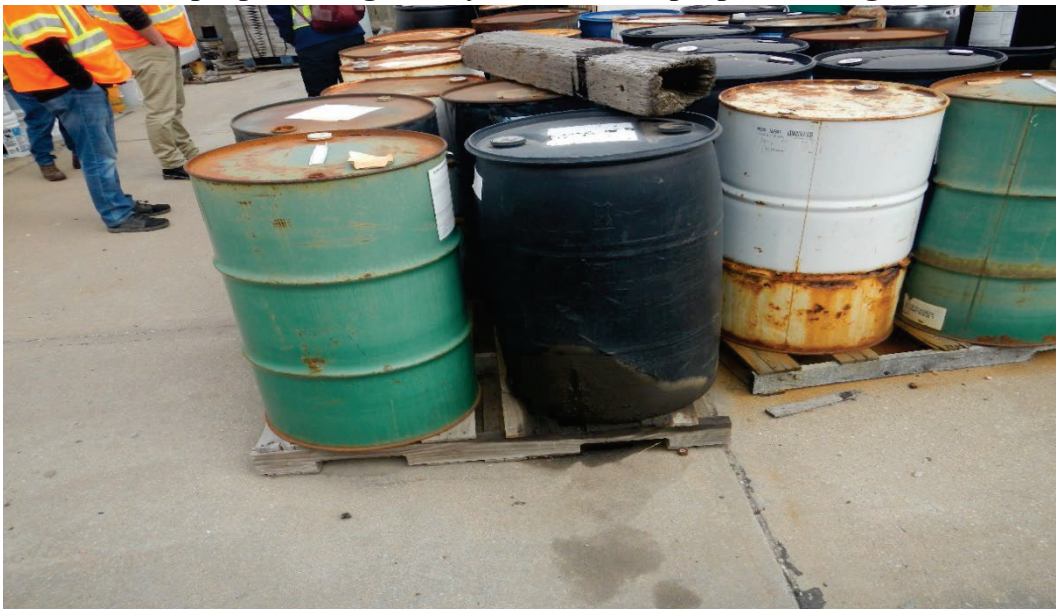
The area near the Street Maintenance Building within the CMF complex was full of improperly stored drums (photo 39-41) with evidence of leaky drums, improper labeling of drums, and lack of secondary containment.

**Photo 41, improper storage, leaky drum and improper labeling of drums.**
