## **RCRA Inspection Report**

Nucor Steel Darlington  
300 Steel Mill Road  
Darlington, Darlington County, South Carolina 29540

February 1, 2023

# Nucor Steel Darlington RCRA CEI Photographs

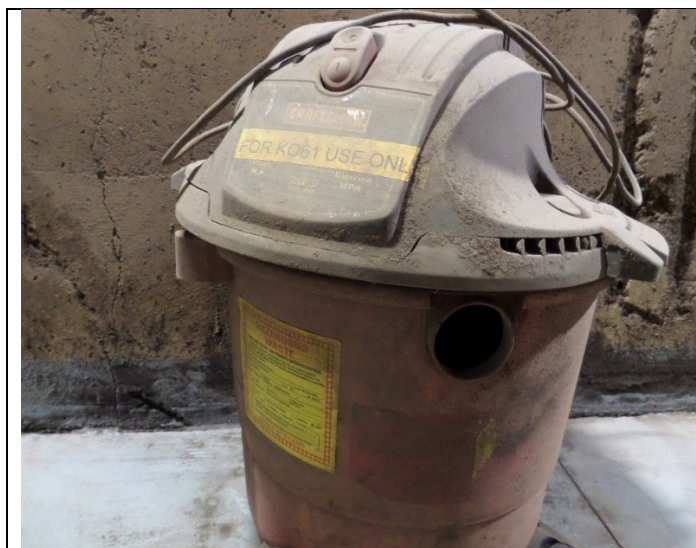
The inspectors observed one 30-gallon vacuum accumulating K061 dust in the SAA. When the vacuum becomes full of dust, it is transferred to the Decon Box. The inspectors observed the container was in good condition, labeled with the words “hazardous waste” and marked with a toxic hazard indicator. The inspectors observed the vacuum cover was not closed and the inlet port was not closed (Photograph 3). Nucor representatives closed the vacuum cover and inlet port (Photograph 4).

**Pursuant to S.C. Code Ann. Regs. 61-79.262.15(a)(4) [40 C.F.R. § 262.15(a)(4)], which is a condition of the SAA Permit Exemption, a generator is required to keep containers of hazardous waste closed at all times during accumulation, except when adding, removing, or consolidating waste; or when temporary venting of a container is necessary for the proper operation of equipment, or to prevent dangerous situations, such as build-up of extreme pressure.**

Baghouse #2 Basement SAA. Observed the vacuum was not kept closed. Photograph 3 taken at 10:57 a.m.

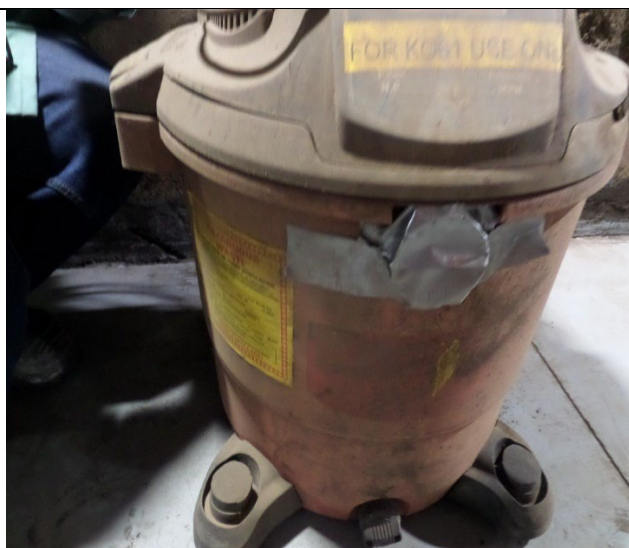
Baghouse #2 Basement SAA. Observed Nucor representatives closed the vacuum. Photograph 4 taken at 10:59 a.m.

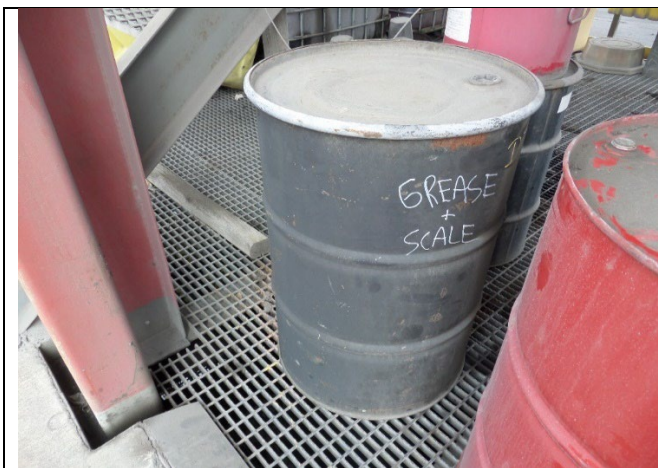
The used oil storage area is constructed with a concrete pad, stairs leading to a platform and a metal roof. The area is identified with the sign “used oil recycling area”. The inspectors observed eight 55-gallon containers of used oil that were closed and labeled with words “used oil”. The inspectors observed two 55-gallon containers of refrigerant and oil and one 55-gallon container of grease and scale, closed and with labels (Photograph 5).

Used Oil Storage Area. Observed a 55-gallon container of grease and scale. Photograph 5 taken at 11:16 a.m.

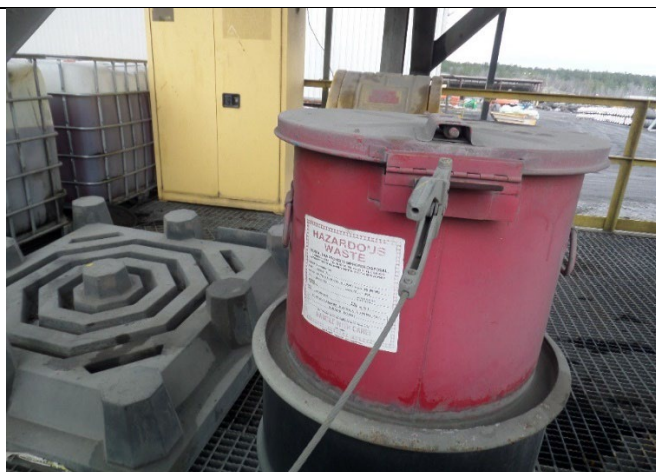
The inspectors observed one 35-gallon SAA container accumulating waste solvent (xylene) that was closed, labeled with the words “hazardous waste” and labeled with a hazard indicator (Photograph 6).

Used Oil Storage Area. Observed a 35-gallon SAA container. Photograph 6 taken at 11:18 a.m.

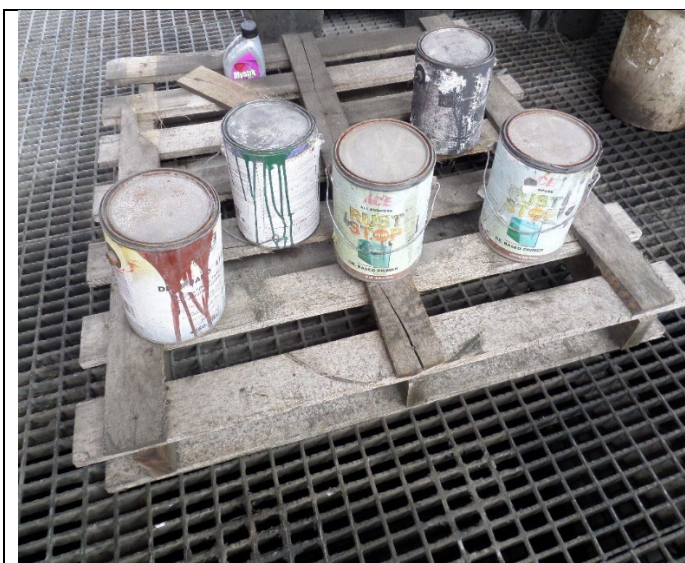
The inspectors observed five one-gallon containers of “ACE All Purpose” and “DEV Guard 4160” oil-based paint and oil-based primer on a wood pallet. The paint did not appear to be useable. The containers were closed and in good condition (Photograph 7).

**Pursuant to S.C. Code Ann. Regs. 61-79.262.15(a)(5)(i) [40 C.F.R. § 262.15(a)(5)(i)], which is a condition of the SAA Permit Exemption, a generator must mark or label its container with the following: (i) The words “Hazardous Waste”**

**Pursuant to S.C. Code Ann. Regs. 61-79.262.15(a)(5)(ii) [40 C.F.R. § 262.15(a)(5)(ii)], which is a condition of the SAA Permit Exemption, must mark or label its containers with an indication of the hazards of the contents (examples include, but are not limited to, the applicable hazardous waste characteristic(s) (i.e., ignitable, corrosive, reactive, toxic); hazard communication consistent with the Department of Transportation requirements at 49 CFR part 172 subpart E (labeling) or subpart F (placarding); a hazard statement or pictogram consistent with the Occupational Safety and Health Administration Hazard Communication Standard at 29 CFR 1910.1200; or a chemical hazard label consistent with the National Fire Protection Association code 704).**

Used Oil Storage Area. Observed five one-gallon containers of paint. Photograph 7 taken at 11:24 a.m.

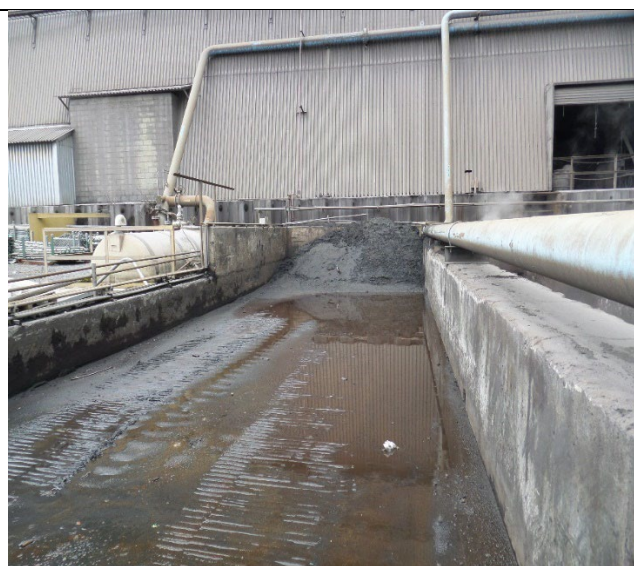
Dirty water containing casting scale is discharged to an on-site concrete settling basin. The non-hazardous waste scale is generated from the casting operation. The scale is settled in the basin and then removed with a front-end loader to a sloped concrete pad and dewatered by gravity and evaporation (Photograph 8). Dewatered scale is stored in the outdoor central accumulation area. The scale is sold to a concrete company as a product. Hazardous waste was not observed in this area at the time of the inspection.

Documentation that would support the determination that the waste discharged to the Caster Dirty Water Settling Basin is not a hazardous waste, was not available at the time of the inspection.

**Pursuant to S.C. Code Ann. Regs. 61-79.262.11(f) [40 C.F.R. § 262.11(f)], an LQG must maintain records supporting its hazardous waste determinations. These records must comprise the generator’s knowledge of the waste and support the generator’s determination, as described at paragraphs (c) and (d) of this section.**

Caster Dirty Water Settling Basin. Observed a pile of cast scale. Photograph 8 taken at 11:40 a.m.

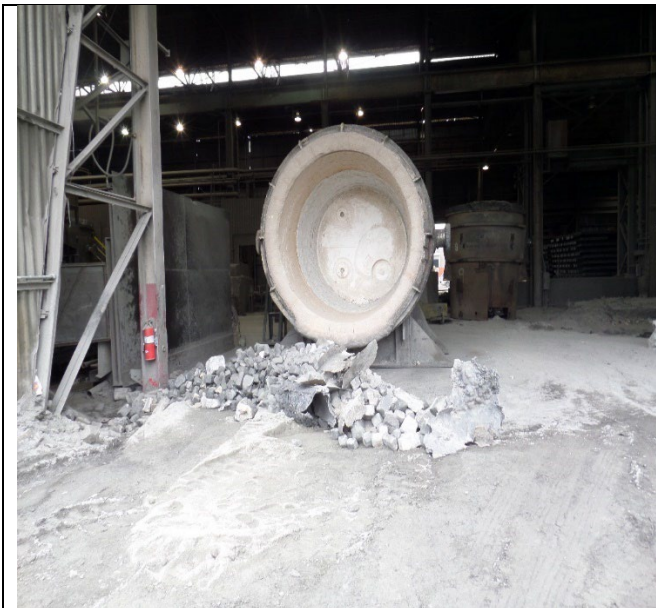
The inspectors observed non-hazardous waste refractory brick and slag on the floor from the refurbishment of a Ladle (Photograph 9).

Refractory Area. Observed refractory brick and slag. Photograph 9 taken at 12:07 p.m.

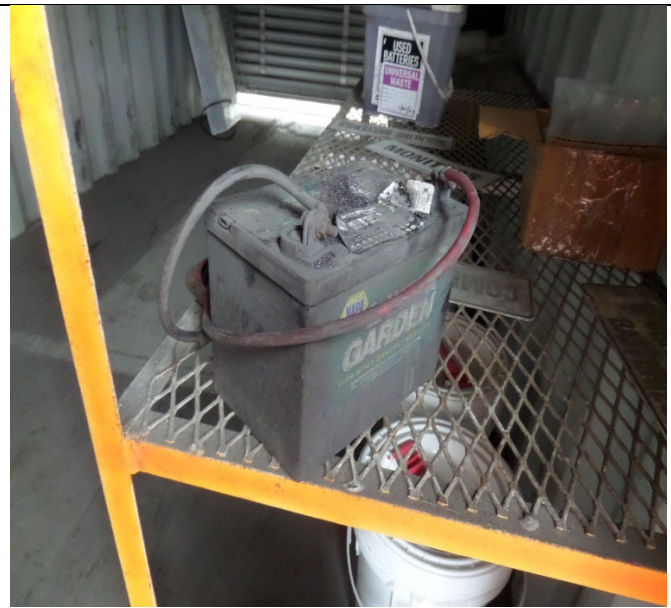
In the universal waste battery bay, the inspectors observed one lead acid battery on a shelf in good condition (Photograph 10). The inspectors observed a 5-gallon container of batteries, closed, labeled with the words “universal waste” and marked with the date January 3, 2023.

Universal Waste Storage Shed, Battery Bay. Observed a lead acid battery. Photograph 10 taken at 12:12 p.m.

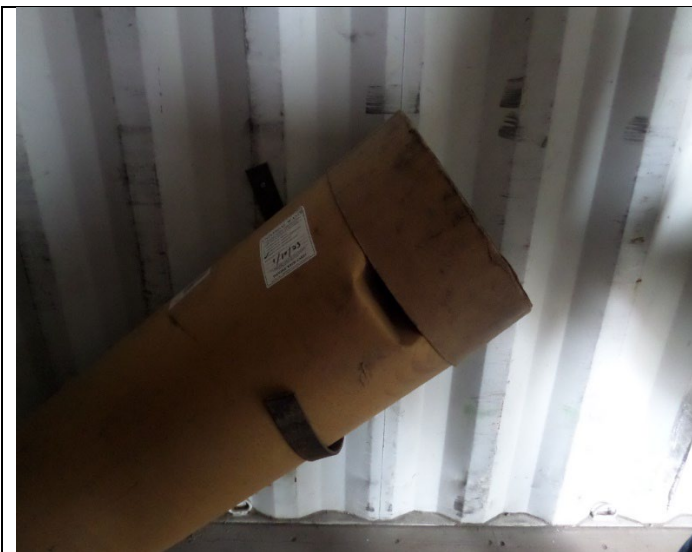
In the universal waste lamp bay, the inspectors observed one container of HID lamps dated November 5, 2022, one container of lamps dated October 6, 2022, one eight-foot lamp container dated September 2, 2022, one eight-foot lamp container dated December 13, 2022, and one four-foot lamp container dated January 10, 2023. The containers were in good condition and labeled with words “universal waste”. The inspectors observed the lid for the one four-foot lamp container was not closed (Photograph 11). Nucor representatives closed the container (Photograph 12).

**Pursuant to S.C. Code Ann. Regs. 61-79.273.13(d)(1) [40 C.F.R. § 273.13(d)(1)], a SQHUW must contain any lamp in containers or packages that are structurally sound, adequate to prevent breakage, and compatible with the contents of the lamps. Such containers and packages must remain closed and must lack evidence of leakage, spillage or damage that could cause leakage under reasonably foreseeable conditions.**

Universal Waste Storage Shed, Lamp Bay. Observed the container of UW lamps was not kept closed. Photograph 11 taken at 12:19 p.m.

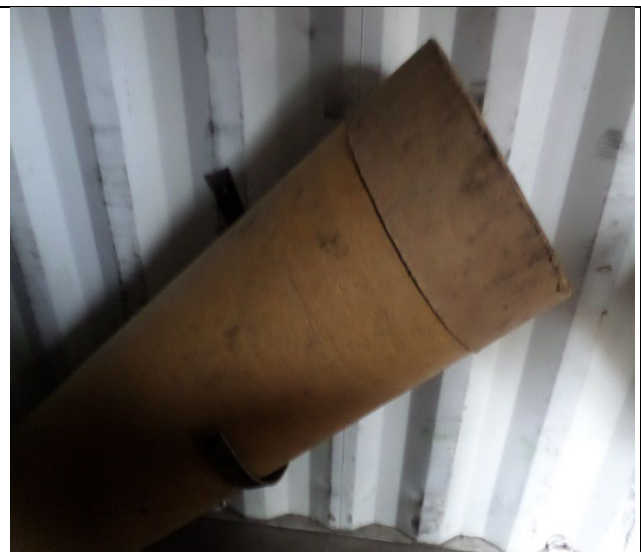
Universal Waste Storage Shed, Lamp Bay. Observed Nucor representatives closed the container. Photograph 12 taken at 12:19 p.m.

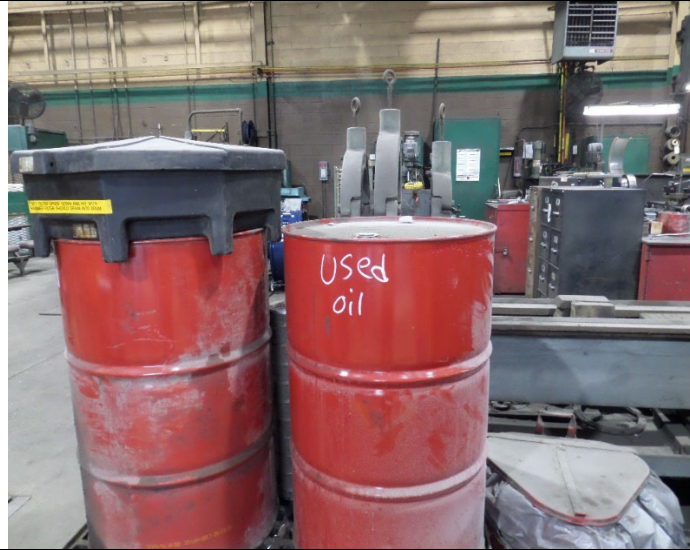
The inspectors observed two 55-gallon containers accumulating used oil. The inspectors observed the containers were labeled with the words “used oil”. The inspectors observed the bung cap for one 55-gallon container of used oil was not closed. Nucor representatives closed the container (Photograph 13).

Daylight Maintenance. Observed open container of used oil. Nucor representatives closed the container. Photograph 13 taken at 12:41 p.m.

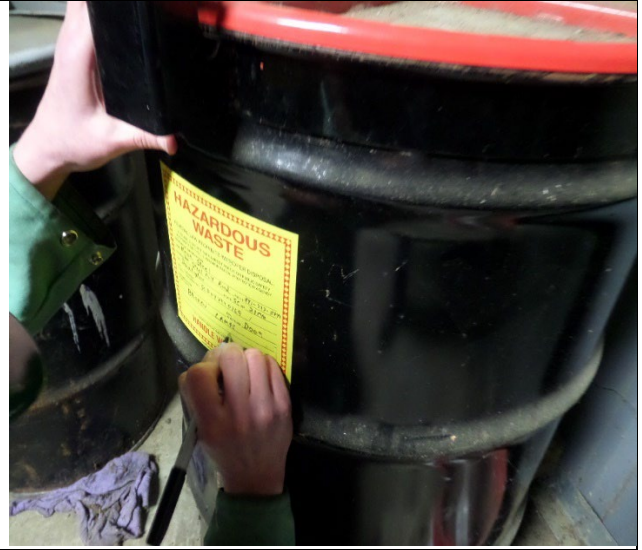
The inspectors observed one 55-gallon container accumulating broken lamps generated in various areas of the Cold Finishing Building. The container was closed, in good condition and labeled with the words “hazardous waste”. The container was not marked or labeled with a hazard indicator. The container was accumulating hazardous waste from various generation points and was not marked with a date (Photograph 14). Nucor representatives marked the container with a hazard indicator.

**Pursuant to S.C. Code Ann. Regs. 61-79.262.17(a)(5)(i)(B) [40 C.F.R. § 262.17(a)(5)(i)(B)], which is a condition of the LQG Permit Exemption, a generator is required to mark or label containers with an indication of the hazards of the contents.**

**Pursuant to S.C. Code Ann. Regs. 61-79.262.17(a)(5)(i)(C) [40 C.F.R. § 262.17(a)(5)(i)(C)], which is a condition of the LQG Permit Exemption, a generator is required to mark or label containers with the date upon which each period of accumulation begins clearly visible for inspection on each container.**

Cold Finishing Building - Universal Waste Storage Room. Observed the container was not marked or labeled with a hazard indicator. Nucor representatives marked the container with a hazard indicator. Photograph 14 taken at 1:20 p.m.

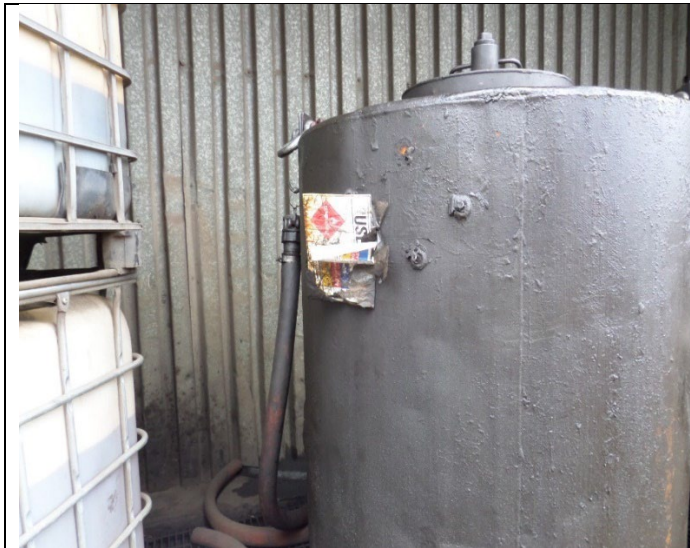
Used oil is accumulated in containers on a metal grate platform over a concrete containment sump. The inspectors observed one 300-gallon container on the metal platform and one 100-gallon container on a metal stand accumulating used oil. The inspectors observed the 300-gallon container of used oil was not clearly marked or labeled with the words “used oil”. The used oil label on the container was hidden from being clearly read due to other labels. Nucor representatives arranged the label so that it could be clearly read (Photographs 15 and 16).

Cold Finishing Building - Used Oil Storage. Observed 300-gallon used oil container not marked or labeled clearly with the words used oil. Photograph 15 taken at 1:42 p.m.

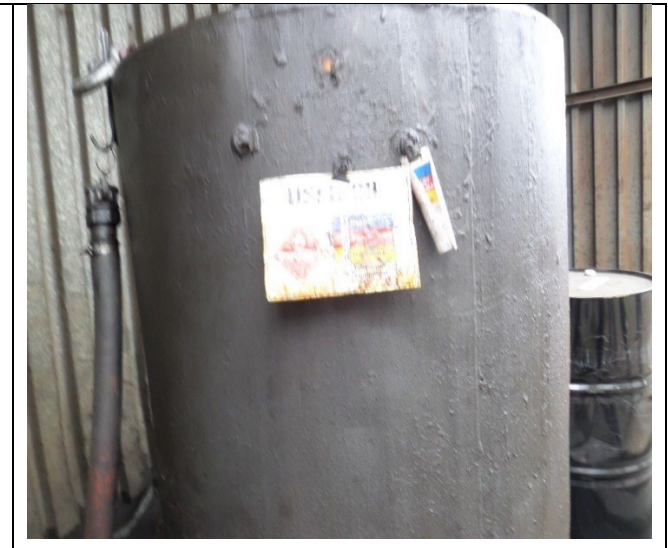
Cold Finishing Building - Used Oil Storage. Observed Nucor representatives clearly label the container with the words used oil. Photograph 16 taken at 1:44 p.m.

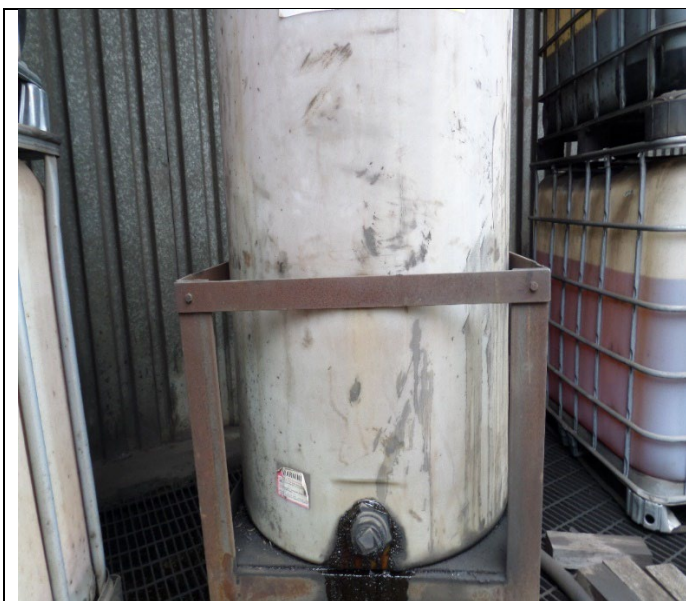
The inspectors observed used oil released to the concrete containment sump. The inspectors observed used oil staining on the 100-gallon container and bottom valve and on the grated platform beneath the 100-gallon container’s bottom valve (Photographs 17, 18 and 19).

Cold Finishing Building - Used Oil Storage. Observed used oil on the bottom of 100-gallon container, the stand and around the valve. Photograph 17 taken at 1:45 p.m.

- (1) Stop the release;
- (2) Contain the released used oil;
- (3) Clean up and manage properly the released used oil and other materials; and
- (4) If necessary, repair or replace any leaking used oil storage containers or tanks prior to returning them to service.

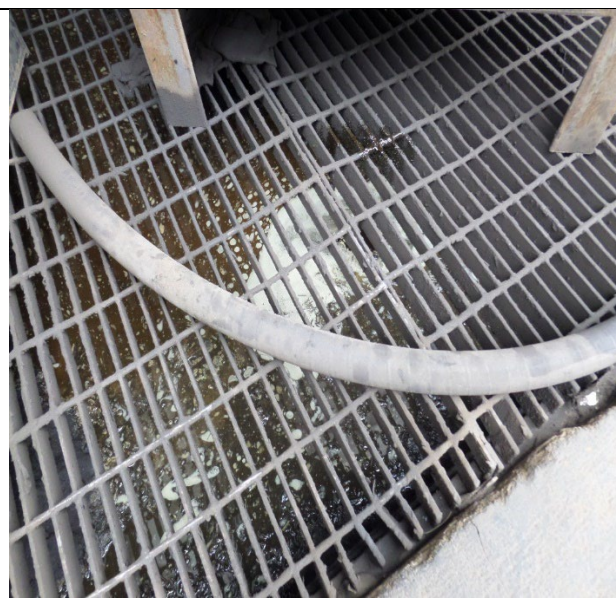
Cold Finishing Building - Used Oil Storage. Observed used oil in containment sump and on the grated platform under 100-gallon container. Photograph 18 taken at 1:45 p.m.

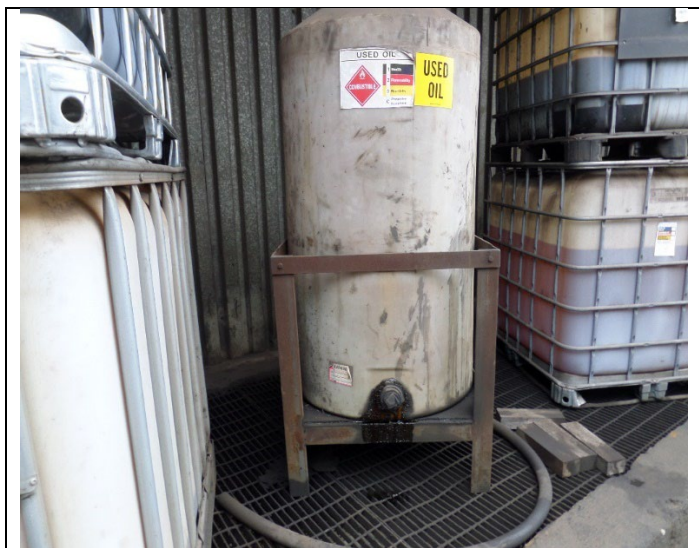
Cold Finishing Building - Used Oil Storage. Observed used oil on the bottom of 100-gallon container, the stand and around the valve. Photograph 19 taken at 1:46 p.m.
