DOCUMENT DESCRIPTION: Investigation of Asbestos Fiber Release During Discharge of Remington Shotgun Shells

**Report of Results: MVA13129**

**Investigation of Asbestos Fiber Release During  
Discharge of Remington Shotgun Shells**

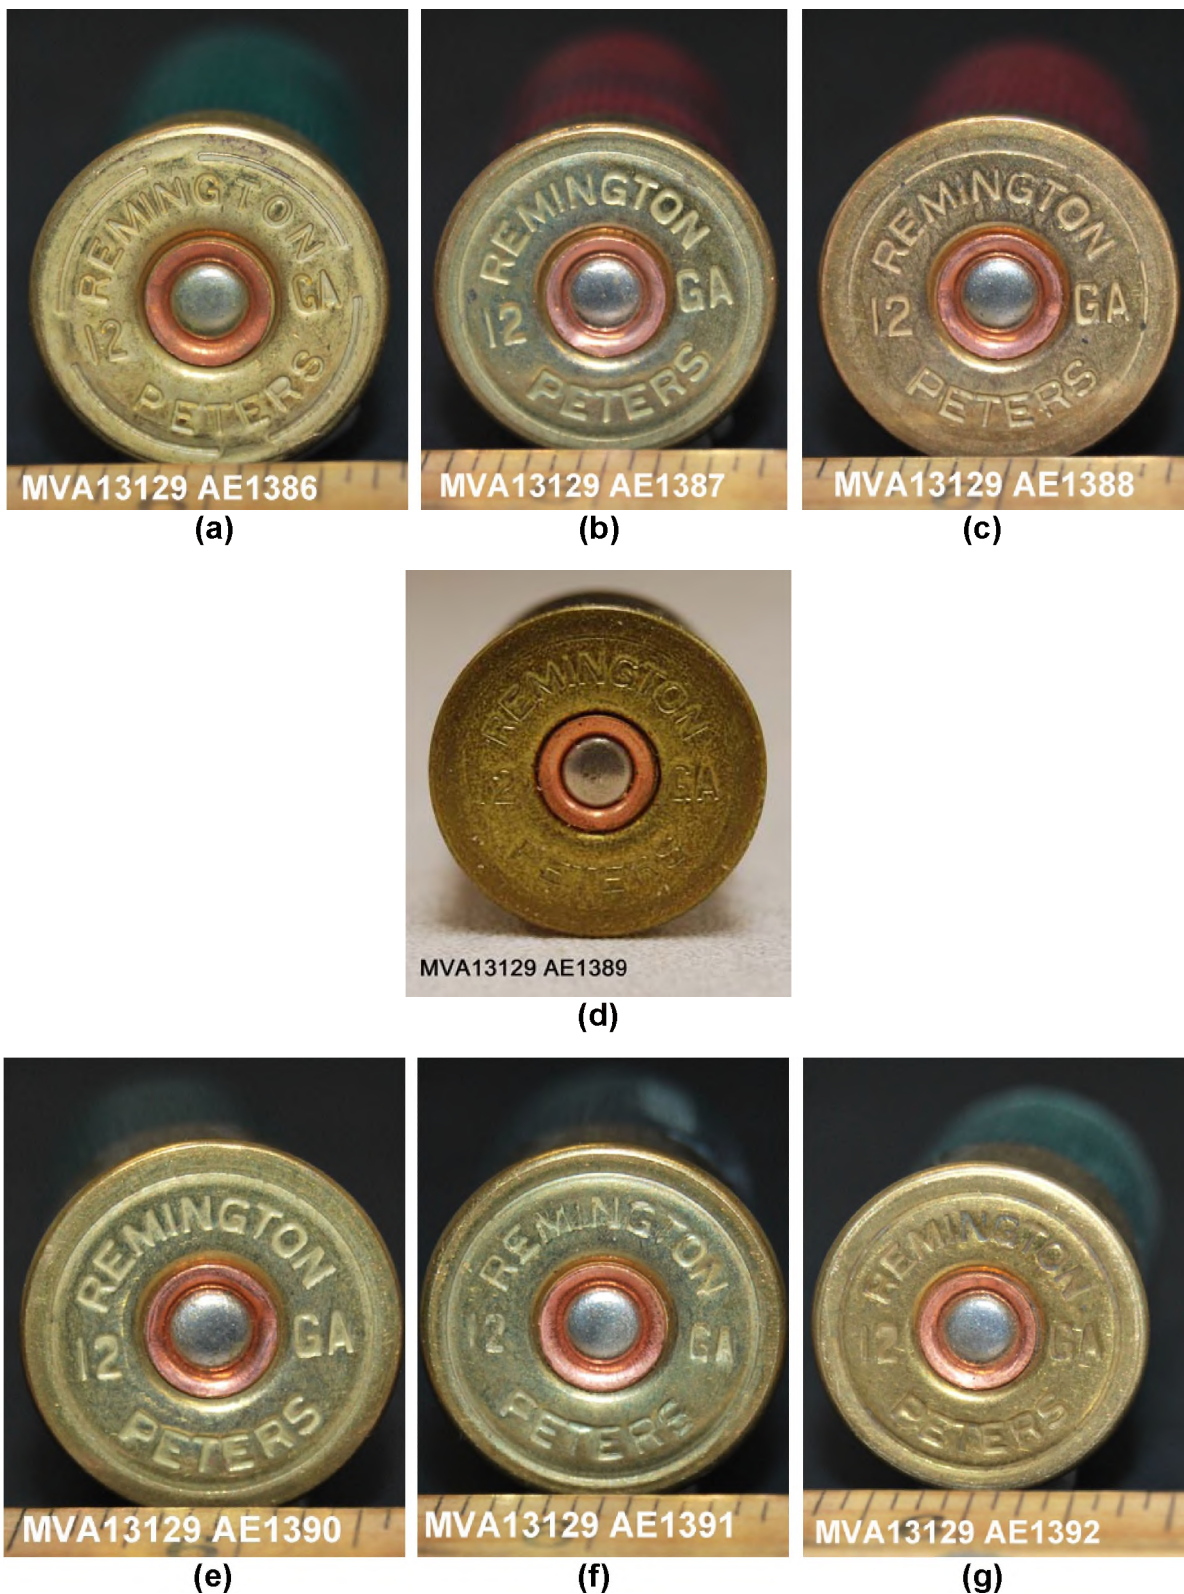
**Figure 8.** Representative photos of metal base and primer for each style of Remington 12 gauge shotgun shells, samples (a) AE1386, (b) AE1387, (c) AE1388, (d) AE1389, (e) AE1390, (f) AE1391, (g) AE1392. Photograph (d) of AE1389 taken under different lighting conditions. AE1389 metal base appears consistent with other shells when viewed side-by-side.

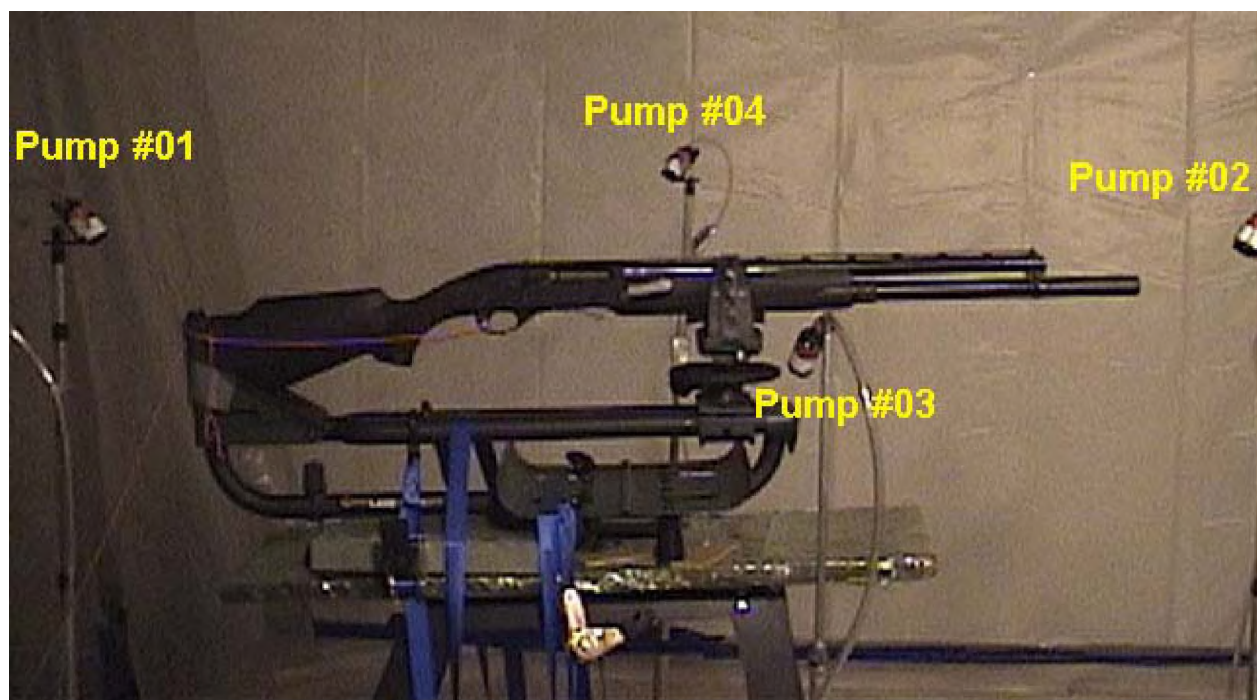
**Figure 9.** Still image extracted from video and annotated to illustrate the location of the air samples connected to Pumps #01 through #04. Air samples collected via Pump #05 were located outside of the containment area and not pictured.

Five stationary air sampling pumps were utilized to collect air samples before and during the experiments. Four of the pumps were used to collect air samples at different locations within the study chamber, as shown in Figure 9. Air samples collected using Pump #01 were positioned within the breathing zone of a theoretical shooter (no shooter was present in the study chamber during firearm discharge), approximately 24" behind the shell ejector port. Air samples collected using Pump #02 were positioned 12" from the

muzzle exhaust (end of the barrel) and 36" downrange from the shell ejector port. Air samples collected using Pump #03 were positioned approximately 12" from the shell ejector port. Air samples collected using Pump #04 were set-up to replicate the position of a bystander standing three feet from the shooter. Air samples collected using Pump #05 were positioned outside of the containment within a few feet of the study chamber entry. After the experiments were conducted, the flow rate of Pump #03 had fallen outside of the acceptance range, so the results for those air samples are reported as a range based on the minimum and maximum flow rates recorded instead of an average flow rate.

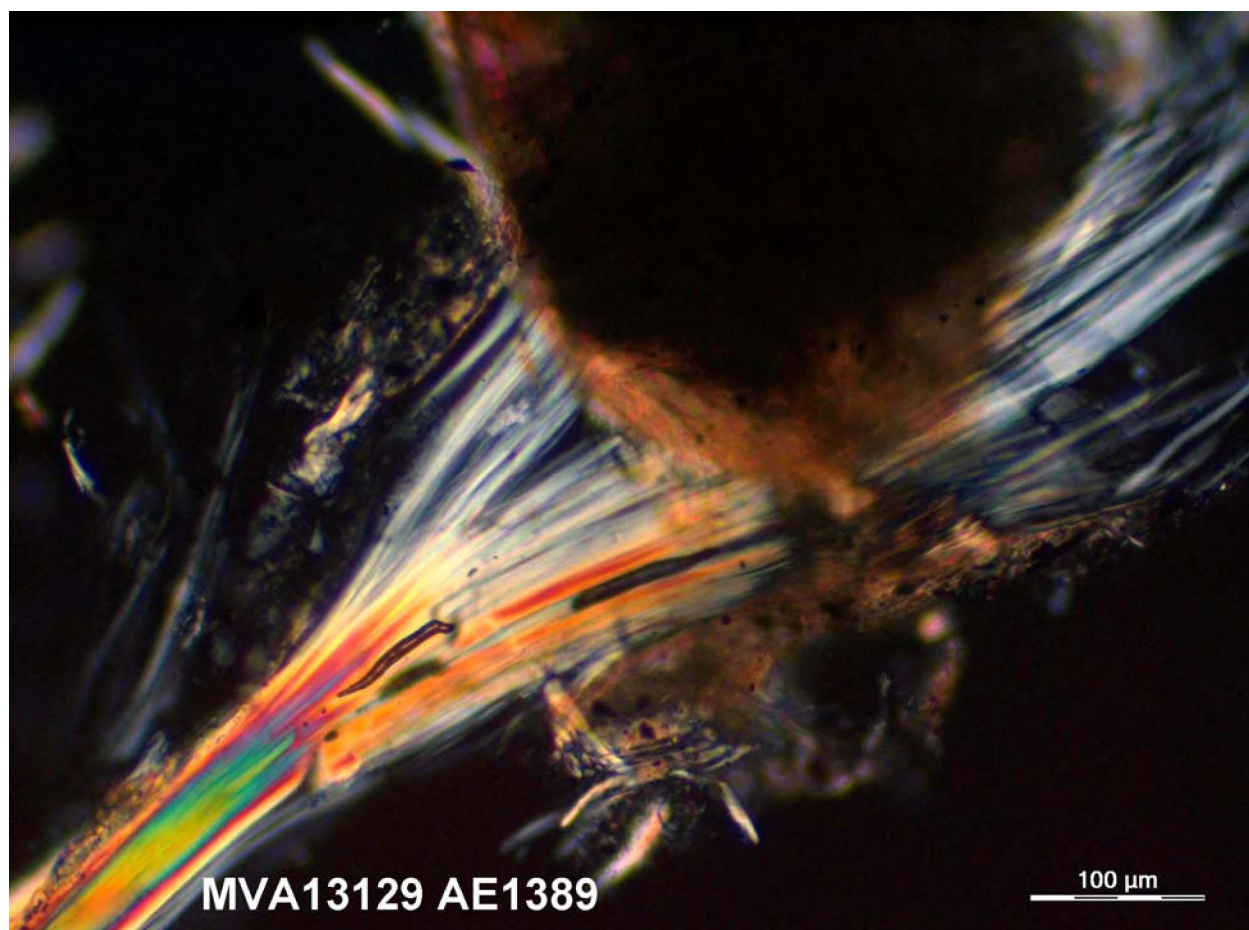
**Figure 21.** PLM image of chrysotile asbestos fibers and bundles from basewad, sample AE1389.

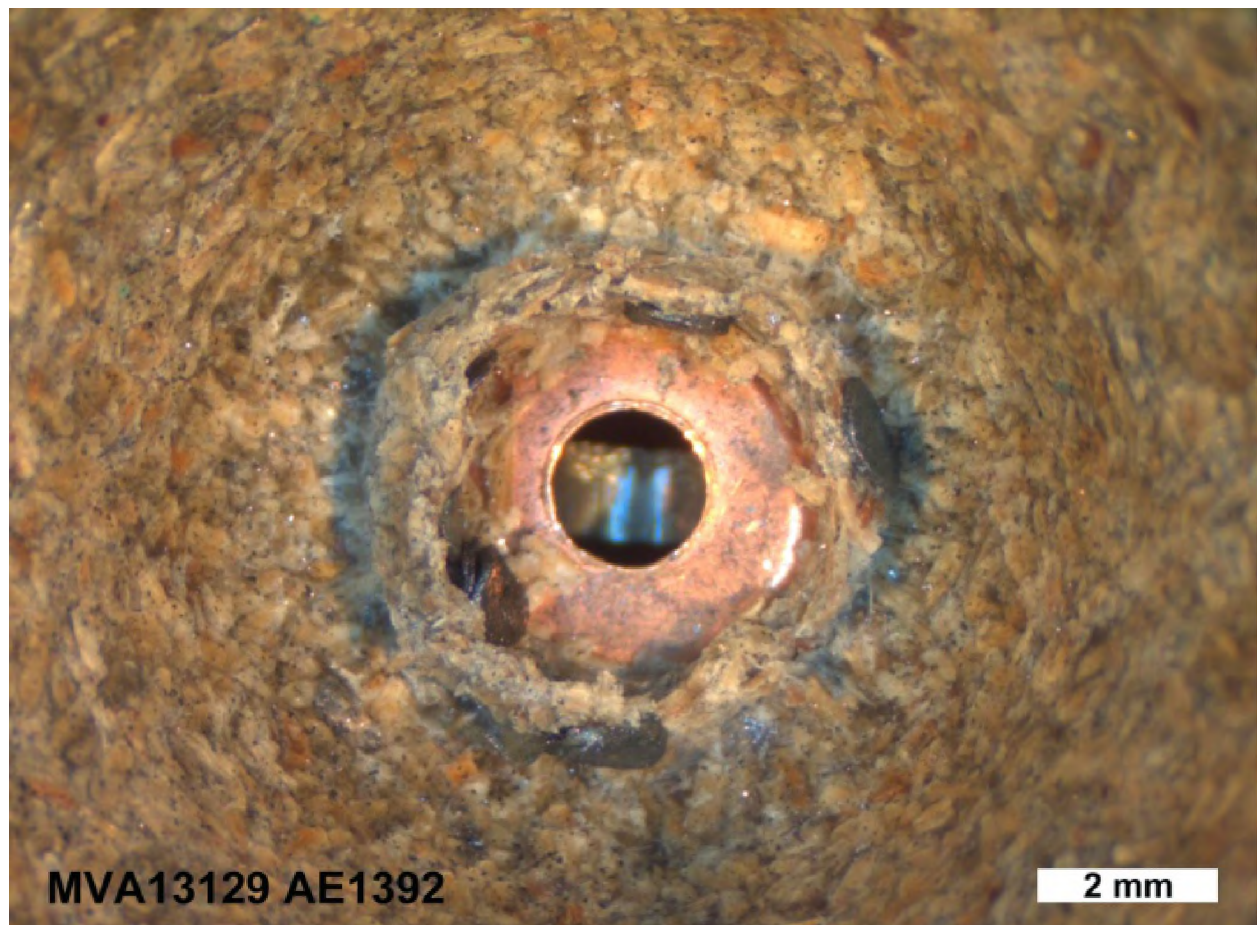
**Figure 29.** Stereomicroscope image of basewad in sample AE1392.

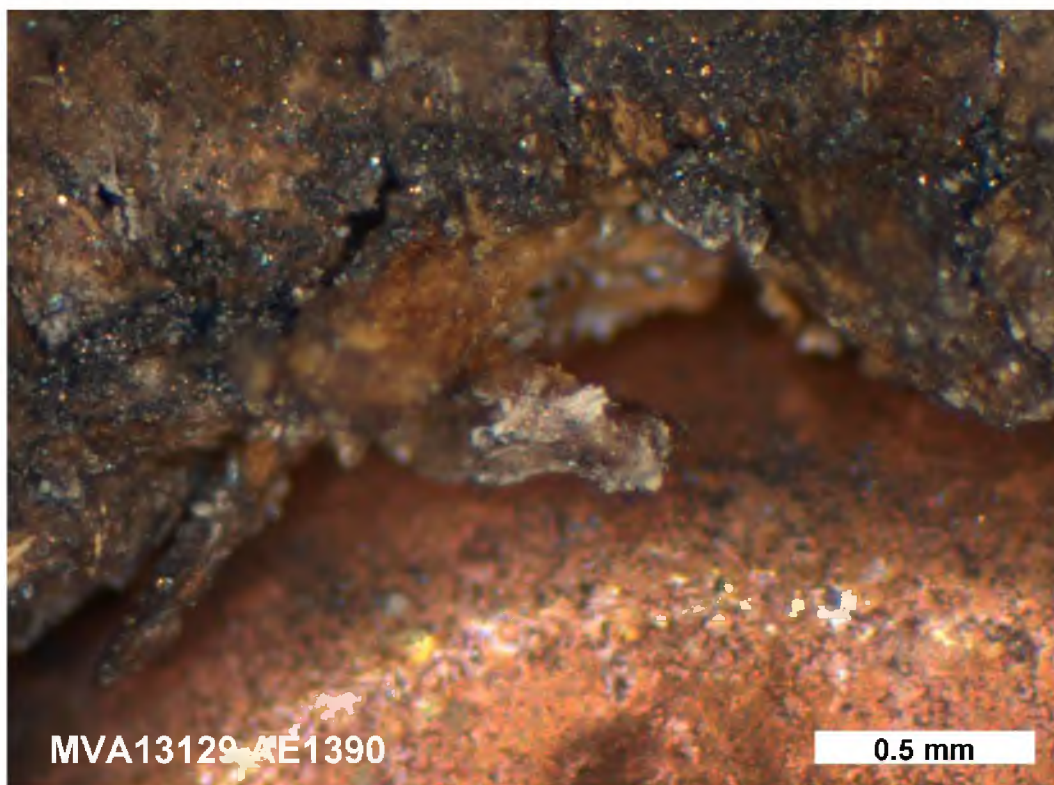
**Figure 32.** Stereomicroscope image of chrysotile bundle in sample AE1390, after firing.

Additional bulk analysis was performed on the basewad of a shell from set AE1390 after it was fired in the experiment. The fired shell shows some fracturing and spalling of the basewad, which demonstrates the effect of firing on the basewad. Gunshot residue was deposited in flakes, spheres and a partial coating, but unencapsulated chrysotile bundles were still visible. Photographs documenting the fracturing and spalling of the basewad are provided in Figures 31 and 32. The mass of recovered basewad material from an unfired AE1390 shell was measured at approximately 3.58 grams. The mass of recovered basewad material from a fired AE1390 shell was measured at approximately 3.52 grams, a difference of 0.06 grams; however, additional testing would be required to determine whether this mass difference is greater than any potential variability in mass from unfired basewads.

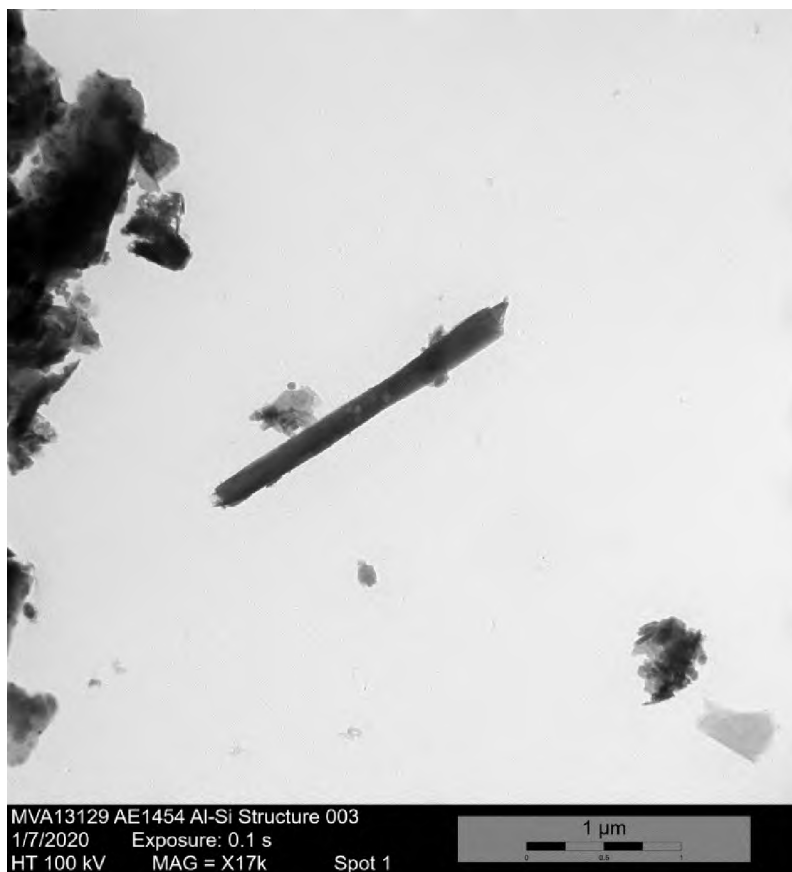
AE1454 Al-Si Structure 03(1)

**Figure 35.** TEM image (above) and EDS spectrum (below) of representative fibrous silicate detected in the environment from air sample AE1454 (Test A – Pump #05).

Aluminum silicate fibers were detected in air samples both inside and outside the test chamber (i.e. Pump #05). A micrograph and spectrum of a representative aluminum silicate fiber bundle are provided in Figure 35. The detection in air samples from outside of the containment area indicates that these fibers were present in the ambient air and were not the result of experimental testing. For NIOSH 7402 analyses, these fibers were counted as “non-asbestos” fibers since they are inconsistent with the elemental composition of chrysotile fibers under investigation in this test.
