**Inspection Report Addendum for Well: MT20060-00077**  
**Inspection Date: 10/25/2023**

| <b>U.S. Environmental Protection Agency</b><br><b>Region 8</b> | | <b>UIC PHOTOGRAPHIC LOG</b> | |
| <b>Facility Location:</b><br>MT20060-00077 (Reickhoff A12), Glacier County, UT | | <b>Photographer:</b><br>Gary Wang | <b>Camera:</b><br>Ricoh WG-5 |

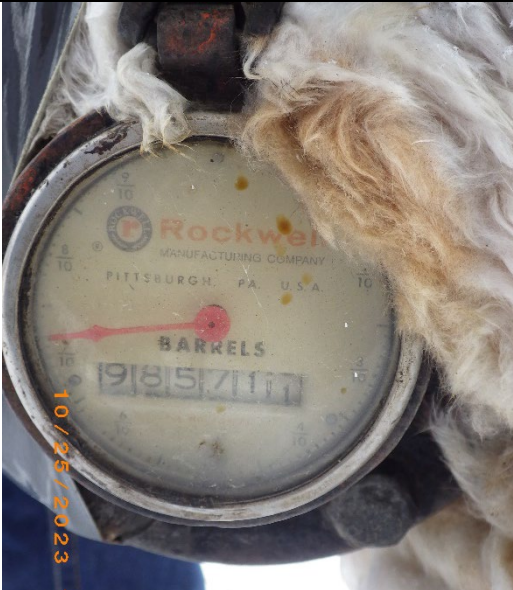
| <b>Photo No.</b><br>3 of 5 | <b>Time:</b><br>12:30 pm | | |

| <b>Photo Description:</b><br>Volume meter at wellhead read 985711 bbl. | | | |

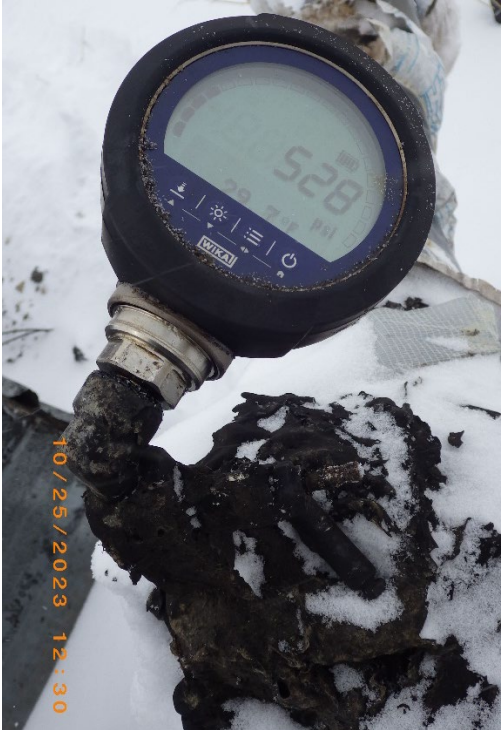
| <b>Photo No.</b><br>4 of 5 | <b>Time:</b><br>12:30 pm | | |

| <b>Photo Description:</b><br>EPA's digital pressure gauge on tubing read 528 psi on a 3000-psi range gauge.<br>Well's MAIP is 2350 psi | | | |

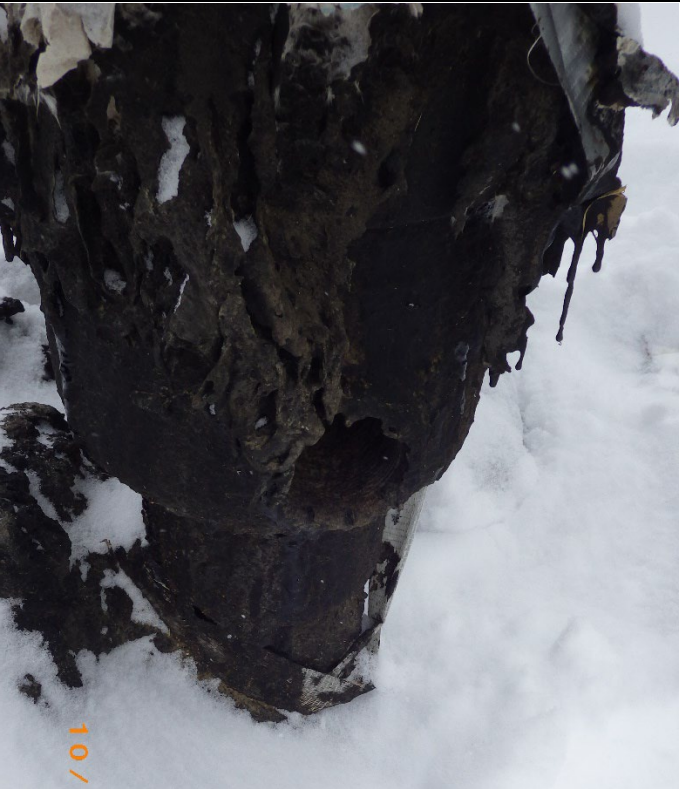
| <b>Photo No.</b><br>5 of 5 | <b>Time:</b><br>12:25 p m | | |

| <b>Photo Description:</b><br>Tubing-casing annulus observed to be maintained continuously open to atmospheric pressure. | | | |
