## RCRA Inspection Report

U.S. Army Garrison Fort Knox  
111 E. Chaffee Ave, BLDG 1101  
Fort Knox, Kentucky 40121

EPA ID#: KY6210020479  
NAICS #: 928110 – National Security

January 30, 2024, at 9:30 A.M. to 4:00 P.M.

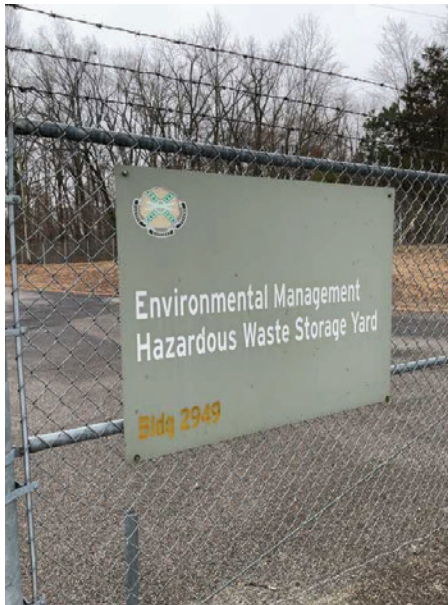
| Photo 1 | IMG-202401301022092295859990.jpg |

Fort Knox manages a hazardous waste CAA in Building 2949 (Photos 1-8). The CAA is surrounded by a secured fence and is equipped with a containment sump inside the building. The CAA was identified with a sign which read "Environmental Management Hazardous Waste Storage Yard." The inspectors observed a "No Smoking" sign at the entrance of the CAA.

| Building 2949 Central Accumulation Area | |

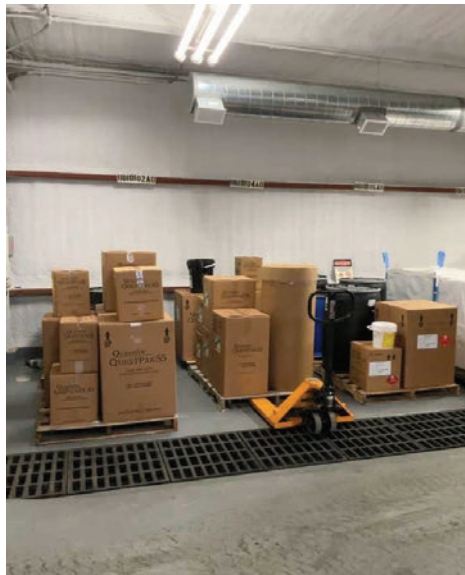
| Photo 2 | IMG-2024013010234023402368064.jpg |

| Building 2949 Central Accumulation Area | |

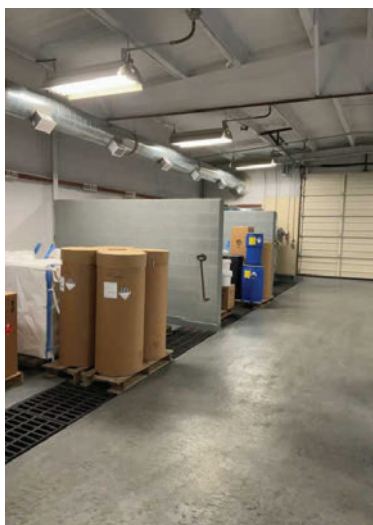
| Photo 3 | IMG-2024013010234523452456504.jpg |

| Building 2949 Central Accumulation Area | |

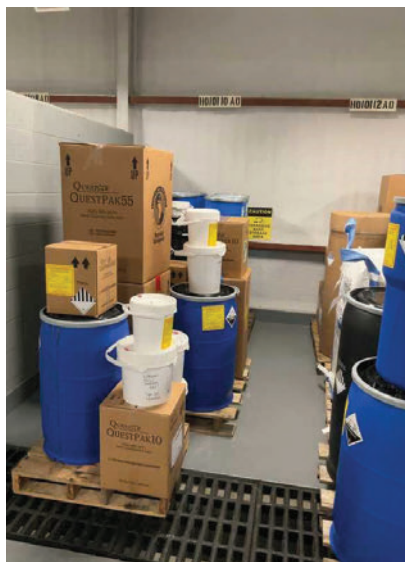
| Photo 4 | IMG-2024013010384238422510707.jpg |

| Building 2949 Central Accumulation Area | |

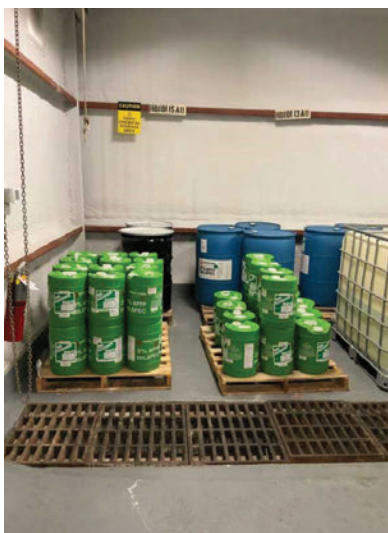
| Photo 5 | IMG-202401301039083982597636.jpg |

| Building 2949 Central Accumulation Area | |

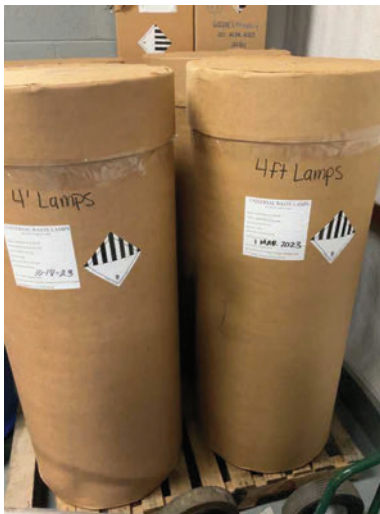
| Photo 6 | IMG-2024013010402040202410628.jpg |

| Building 2949 Central Accumulation Area | |

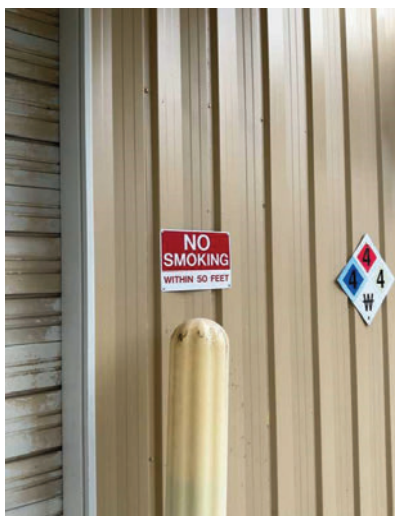
| Photo 7 | IMG-2024013010444544452894222.jpg |

| Building 2949 Central Accumulation Area: Entrance | |

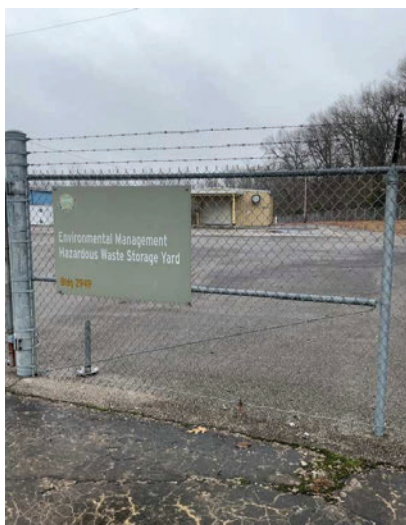
| Photo 8 | IMG-2024013010454945495017669.jpg |

| Building 2949 Central Accumulation Area: Entrance | |

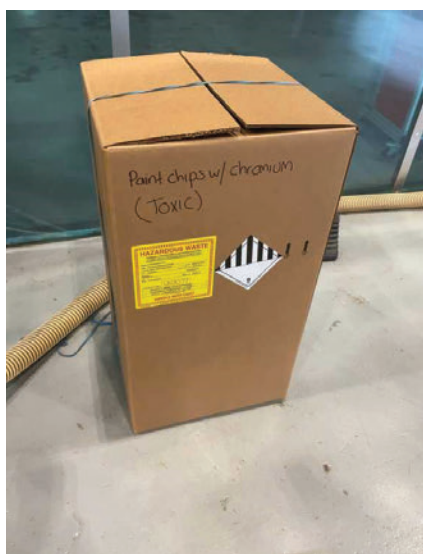
| Photo 9 | IMG-2024013010554155412370758.jpg |

- One (1) 30-gallon cardboard box of paint chips contaminated with chromium. The box was closed, labeled with the words “Hazardous Waste”, and marked to indicate the hazard of the contents.
- One (1) 55-gallon container of waste paint-related material. The container was closed, labeled with the words “Hazardous Waste”, and marked to indicate the hazard of the contents.

| Building 2778 Vehicle Maintenance: Hazardous waste paint chips with chromium. | |

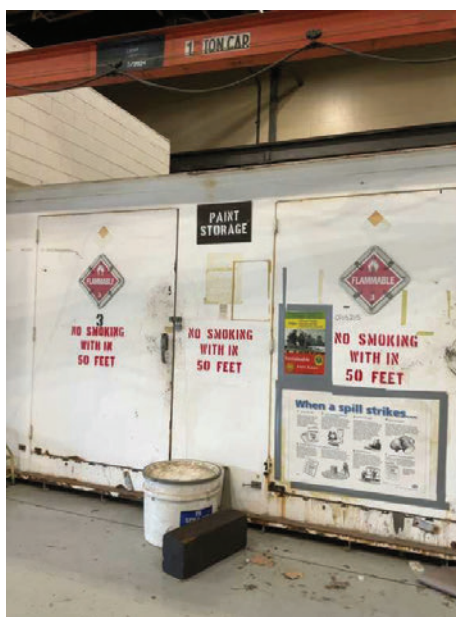
| Photo 10 | IMG-202401301058025822558177.jpg |

| Building 2778 Vehicle Maintenance: Paint product storage | |

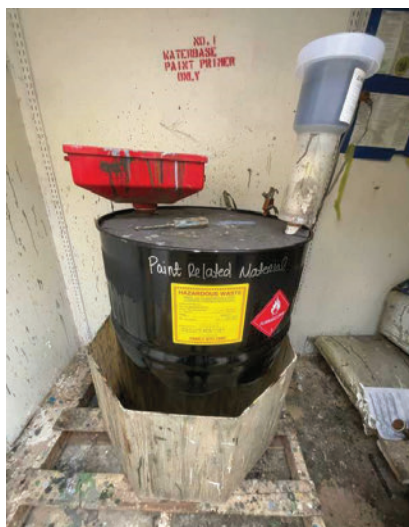
| Photo 11 | IMG-20240130110008082344331.jpg |

| Building 2778 Vehicle Maintenance: 55-gallon container of hazardous waste paint-related material. | |

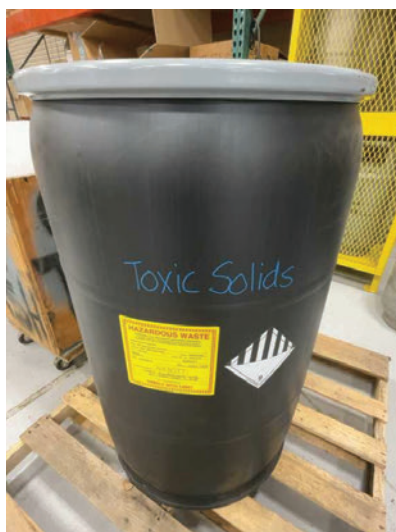
| Photo 12 | | | IMG-2024013011122512251328970.jpg |

- One (1) 55-gallon container of arsenic and lead waste. The container was closed, labeled with the words “Hazardous Waste”, and labeled “Toxic” to indicate the hazard of the contents (Photo 12).
- One (1) 55-gallon container of waste paint-related material. The container was closed, labeled with the words “Hazardous Waste”, and contained a flammable placard to indicate the hazard of the contents (Photo 13).

| Building 9312 Training and Support Command: Hazardous Waste SAA for arsenic and lead waste. | | | |

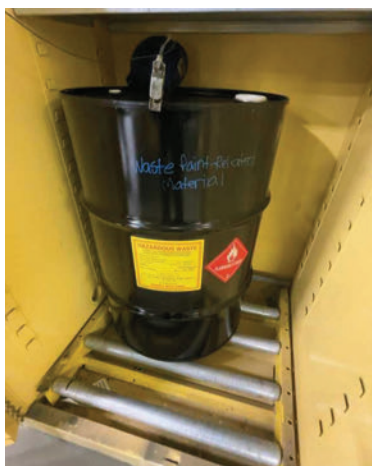
| Photo 13 | IMG-2024013011142914291210011.jpg |

| Building 9312 Training and Support Command: 55-gallon container of hazardous waste paint-related material. | |

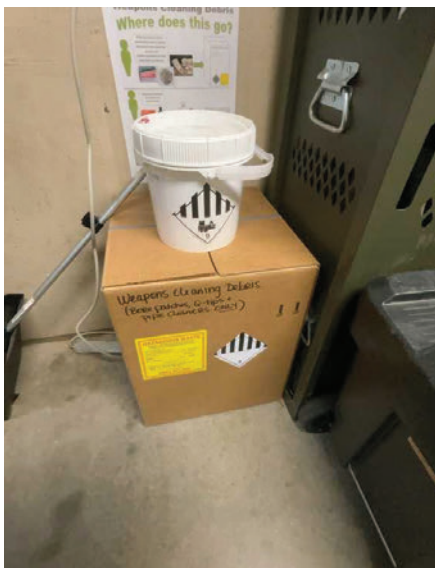
| Photo 14 | IMG-202401301127092791226589.jpg |

- One (1) 5-gallon-sized cardboard box of weapons cleaning debris. The container was closed, labeled “Hazardous Waste”, and marked to indicate the hazard of the contents.

| Building 1741 Armory: Cardboard box containing hazardous waste weapons cleaning debris and empty universal waste container. | |

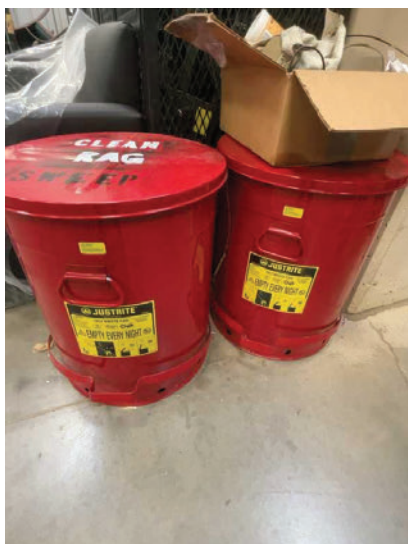
| Photo 15 | IMG-2024013011274627461214171.jpg |

| Building 1741 Armory: Container of clean rags and container of used oily rags. | |

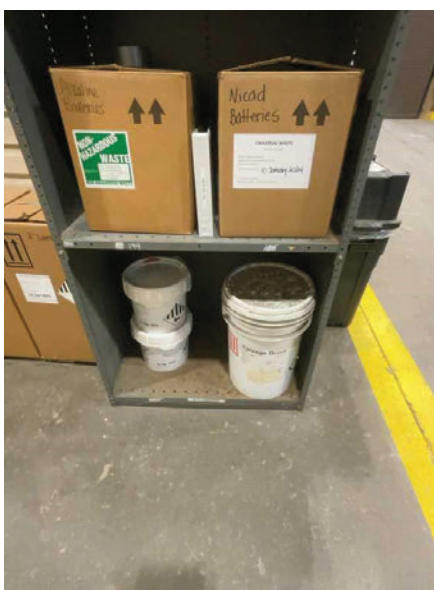
| Photo 16 | IMG-202401301134033431280072.jpg |

| Building 1730 PCSI Electricians: Universal waste battery storage. | |

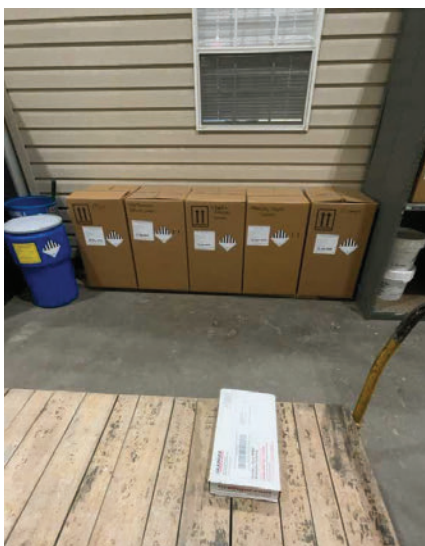
| Photo 17 | IMG-2024013011341834181341396.jpg |

- Six (6) cardboard boxes of universal waste spent fluorescent lamps. The containers were closed, labeled "Universal Waste", and dated. The oldest accumulation start date was 04/25/2023.
- Three (3) containers of universal waste batteries. The containers were closed, labeled "Universal Waste", and dated. The oldest accumulation start date was 11/16/2023.
- One (1) 15-gallon container of mercury waste. The container was closed, labeled "Hazardous Waste", and marked to indicate the hazard of the contents.
- One wooden pallet of used lead acid batteries to be recycled.

| Building 1730 PCSI Electricians: Cardboard boxes of universal waste lamps and hazardous waste broken lamp container. | |

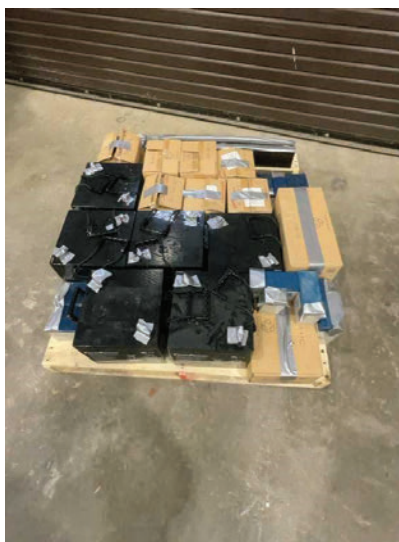
| Photo 18 | IMG-2024013011342834281267971.jpg |

| Building 1730 PCSI Electricians: Used lead acid batteries. | |

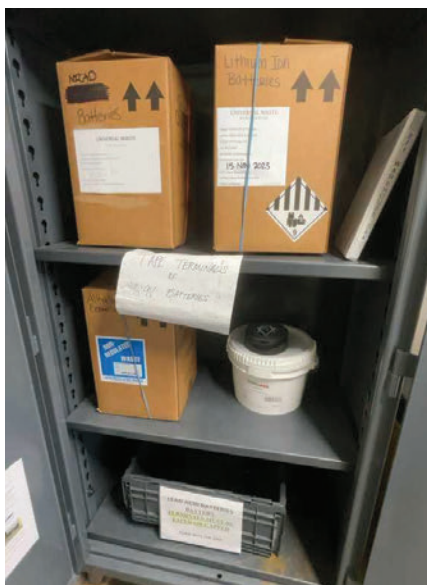
| Photo 19 | IMG-2024013011483848381264703.jpg |

| Building 871 Ireland Army Health Clinic: Universal waste batteries. | |

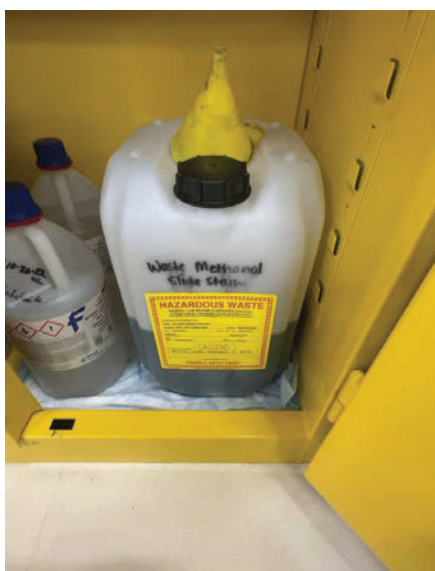
| Photo 20 | IMG-2024013011513151311139234.jpg |

- One (1) 5-gallon container of waste methanol slide stains. The container was closed, labeled "Hazardous Waste", and marked with an indication of the hazard of the contents.

| Building 871 Ireland Army Health Clinic: 5-gallon container of hazardous waste methanol slide stains. | |

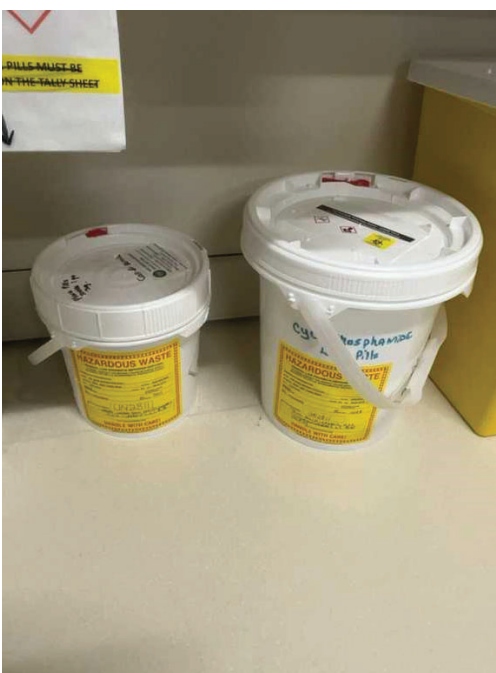
| Photo 21 | IMG-20240130115306536896410.jpg |

| Building 871 Ireland Army Health Clinic: SAA in pharmacy inside Building 871. | |

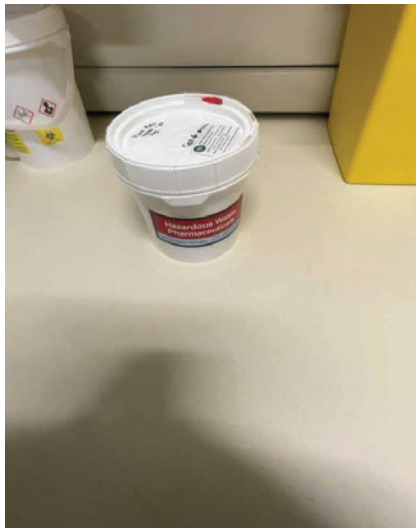
| Photo 22 | IMG-20240130115602562996660.jpg |

| Building 871 Ireland Army Health Clinic: Pharmacy SAA – hazardous waste pharmaceuticals. | |

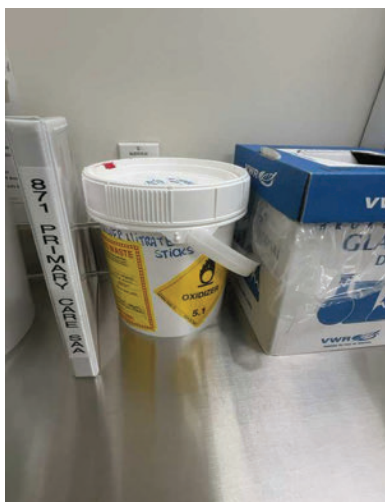
| Photo 23 | IMG-2024013011593159311248961.jpg |

| Building 871 Ireland Army Health Clinic: SAA for hazardous waste silver nitrate sticks. | |

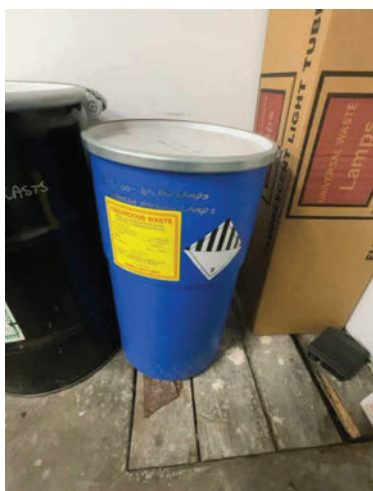
| Photo 24 | IMG-202401301207107101316134.jpg |

- One (1) 10-gallon container of broken fluorescent lamps. The container was closed, labeled "Hazardous Waste", and marked with an indication of the hazard of the contents.
- One (1) 8-ft cardboard box of spent fluorescent lamps. The container was closed, labeled "Universal Waste", and dated 12/30/2023.

| Building 1022 Valiant Medical Maintenance: Hazardous waste container for broken fluorescent lamps. | |

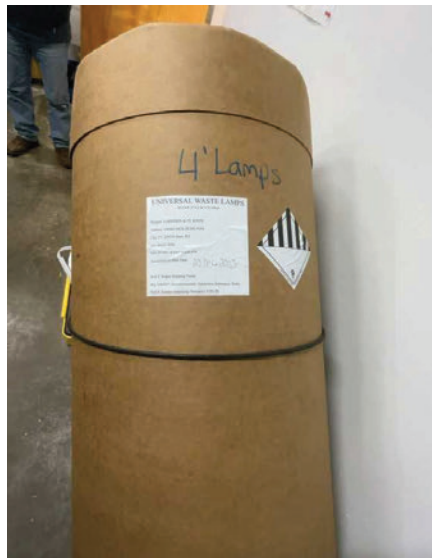
| Photo 26 | IMG-202401301207307301084210.jpg |

| Building 1022 Valiant Medical Maintenance: Universal waste spent fluorescent lamps. | |

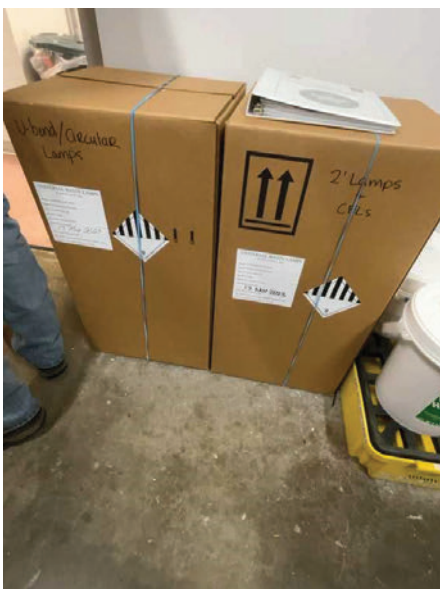
| Photo 27 | IMG-20240130120800801247012.jpg |

| Building 1022 Valiant Medical Maintenance: Universal waste spent fluorescent lamps. | |

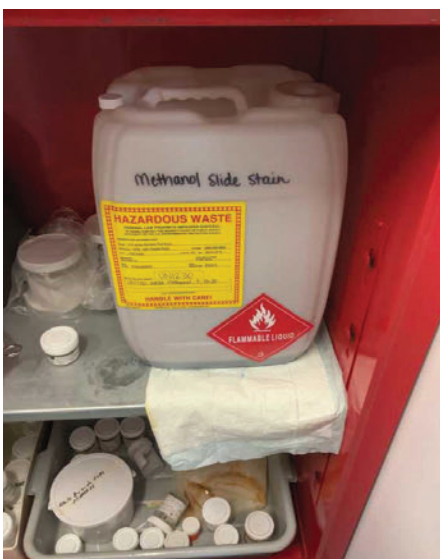
| Photo 28 | IMG-202401301214041442356281.jpg |

Fort Knox has a veterinary clinic equipped with a clinical laboratory. The inspectors observed one (1) 10-gallon container of used methanol slide stains (Photos 28). The container was closed, labeled “Hazardous Waste”, and marked with an indication of the hazard of the contents.

| Building 1006 Veterinarian Clinic: SAA for hazardous waste methanol slide stain. | |

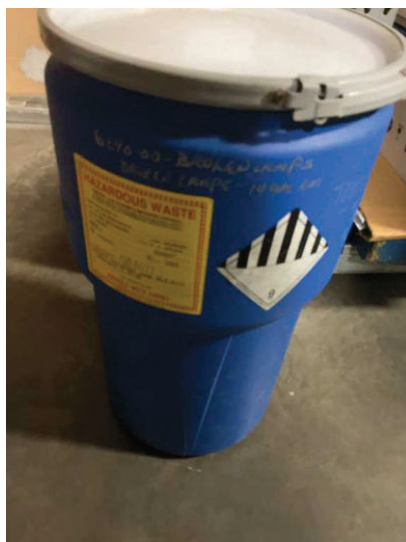
| Photo 31 | IMG-2024013012333133311980511.jpg |

- One (1) 30-gallon container of broken fluorescent lamps. The container was closed, labeled “Hazardous Waste”, and marked with an indication of the hazard of the contents.
- One (1) 4-ft cardboard box of spent fluorescent lamps. The container was closed, labeled “Universal Waste”, and dated 01/10/2024.
- One (1) 8-ft cardboard box of spent fluorescent lamps. The container was closed, labeled “Universal Waste”, and dated 05/01/2023.

| Building 121 Commissary – SAA for hazardous waste broken fluorescent lamps. | |

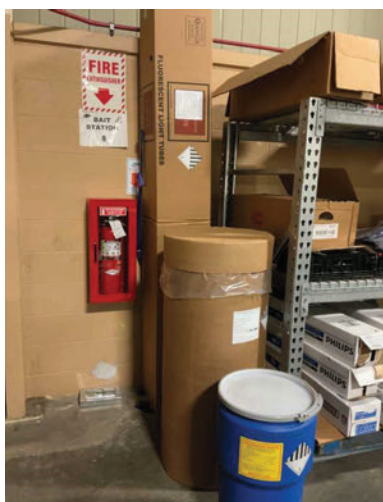
| Photo 32 | IMG-202401301234033432142271.jpg |

| Building 121 Commissary: Universal waste spent fluorescent lamps and SAA for broken fluorescent lamps. | |

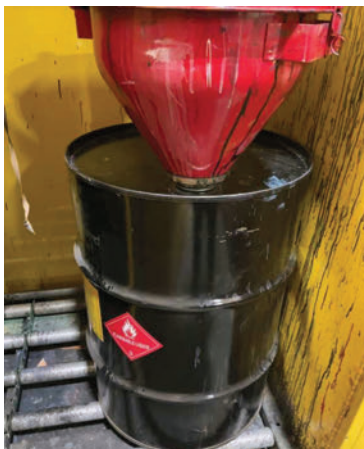
| Photo 34 | IMG-2024013012501650162338577.jpg |

| Building 206 Recruiting Command, Army Material, Recognition Group: SAA for hazardous waste paint-related material. | |

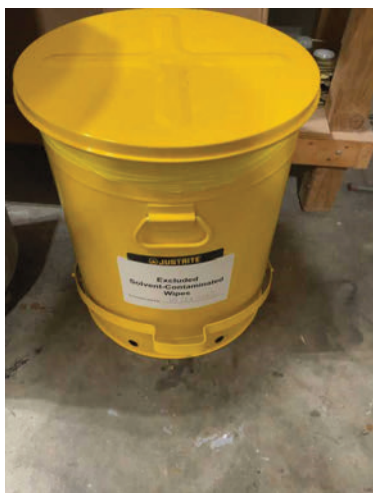
| Photo 35 | IMG-2024013012531853182335633.jpg |

| Building 206 Recruiting Command, Army Material, Recognition Group: 5-gallon container for excluded solvent-contaminated wipes. | |

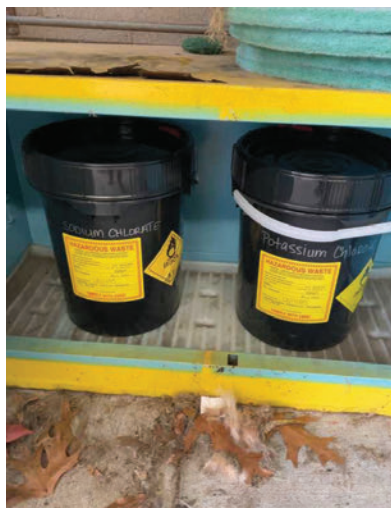
| Photo 36 | IMG-20240130130706762484923.jpg |

This building is a kennel and training center for military canine. This facility generates sodium chlorate waste and potassium chlorate waste which is used to train canine to detect explosives. The inspectors observed two (2) 5-gallon containers for used sodium chlorate and potassium chlorate (Photo 36). Both containers were closed, labeled “Hazardous Waste”, and marked to indicate the hazard of the contents.

| Building 7224 K-9 Unit: SAA for hazardous waste sodium chlorate and potassium chlorate. | |

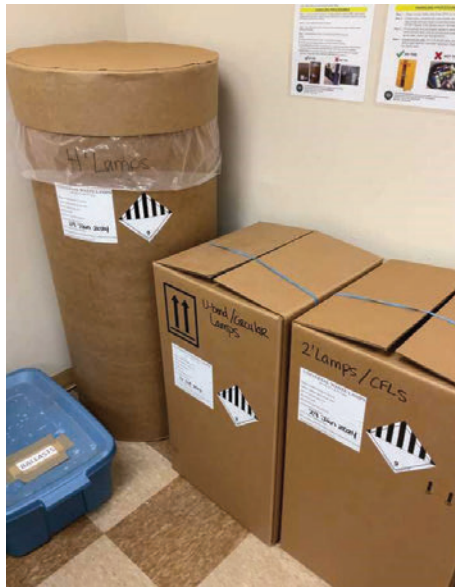
| Photo 37 | IMG-20240130140403432483806.jpg |

- One (1) 10-gallon container of broken fluorescent lamps. The container was closed, labeled “Hazardous Waste”, and marked to indicate the hazard of the contents.
- One (1) 3-gallon cardboard box for used batteries. The box was closed, labeled “Universal Waste”, and dated 01/29/2024.
- One (1) 4-ft cardboard box of spent fluorescent lamps. The box was closed, labeled “Universal Waste”, and dated 01/29/2024.
- Two (2) 2-ft cardboard boxes of spent fluorescent lamps. The box was closed, labeled “Universal Waste”, and dated 10/16/2023 and 01/29/2024.
- One (1) closed 5-gallon container of lead-acid batteries.

| Building 1327 IHG Hotel: Universal waste spent fluorescent lamps. | |

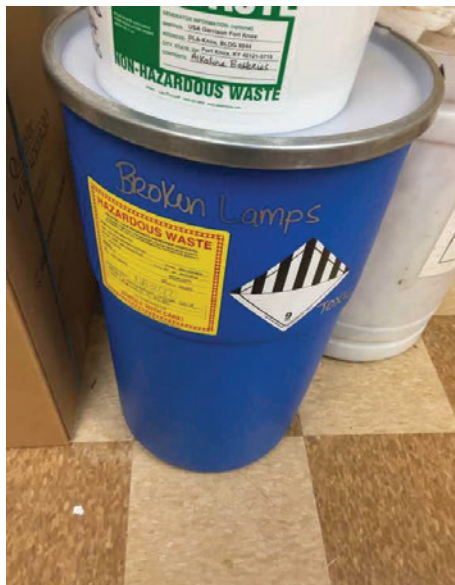
| Photo 38 | IMG-202401301404234232304387.jpg |

| 1327 IHG Hotel: SAA for hazardous waste broken fluorescent lamps. | |

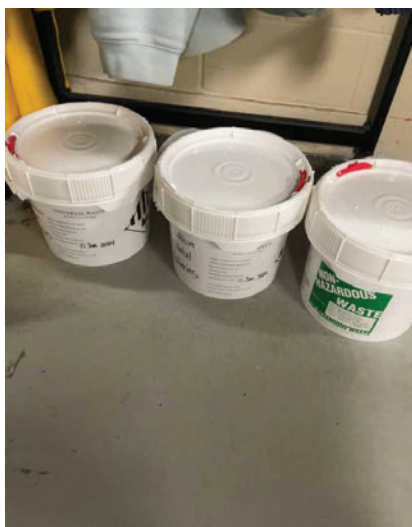
| Photo 39 | IMG-2024013014125912592517119.jpg |

The army airfield has a hanger which stores universal waste. The inspectors observed two (2) 1-gallon containers of used batteries. Both containers were closed, labeled “Universal Waste”, and dated 01/10/2024 (Photo 39).

| Building 5222 Godman Airfield: Universal waste batteries. | |

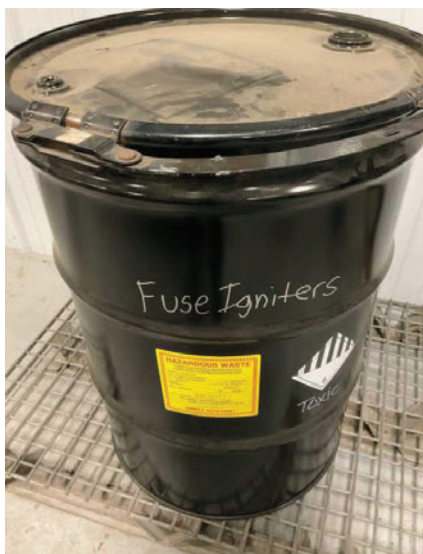
| Photo 40 | IMG-2024013014371037102153782.jpg |

Fort Knox houses ammunition in a series of bunkers. Building 3074 is amid these bunkers and is where materials are collected for recycling or waste disposal. There is a SAA container used to store hazardous waste fuse igniters (D006). The inspectors observed one (1) 55-gallon container of fuse igniters. The container was closed, labeled “Hazardous Waste”, and marked to indicate the hazard of the contents (Photo 40).

| Building 3075 Ammo Supply Point: SAA for hazardous waste fuse igniters. | |

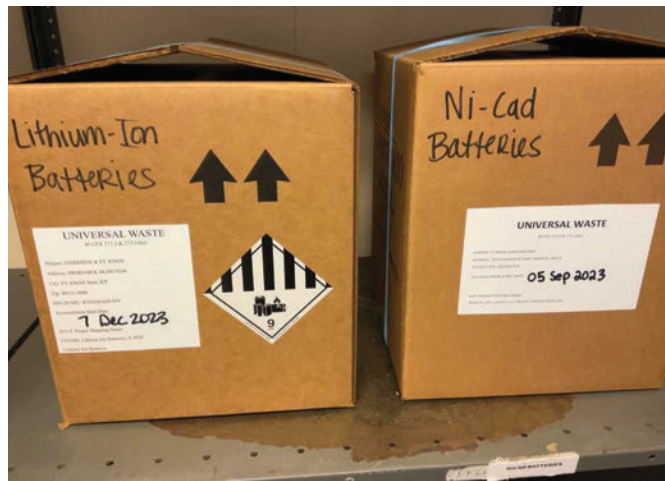
| Photo 41 | IMG-2024013014555455542316957.jpg |

- Four (4) 1-ft cardboard boxes of used batteries. The boxes were closed, labeled “Universal Waste”, and dated. The oldest accumulation start date was 09/05/2023.
- One (1) 5-gallon container of used mercury equipment. The container was closed, labeled “Universal Waste”, and dated 04/05/2023.
- One (1) 15-gallon container of broken lamps. The container was closed, labeled “Hazardous Waste”, and marked to indicate the hazard of the contents.

| Building 2954 – Universal Waste Storage: Universal waste batteries. | |

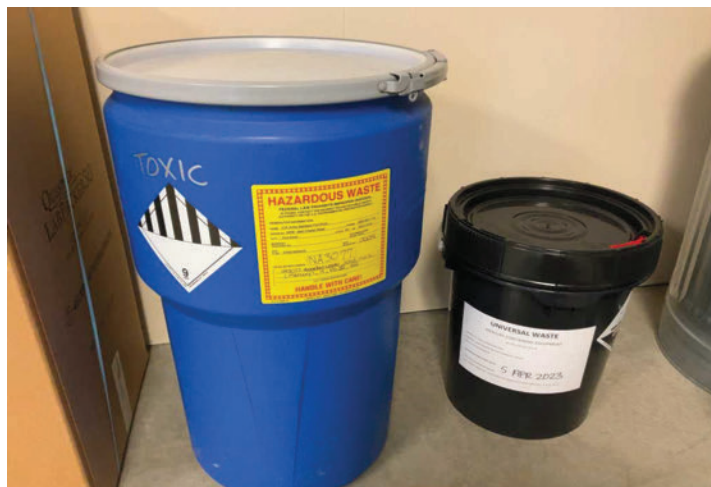
| Photo 41 | IMG-202401301456045642332385.jpg |

| Building 2954 Universal Waste Storage: Universal waste mercury containing equipment and SAA for hazardous waste broken fluorescent lamps. | |

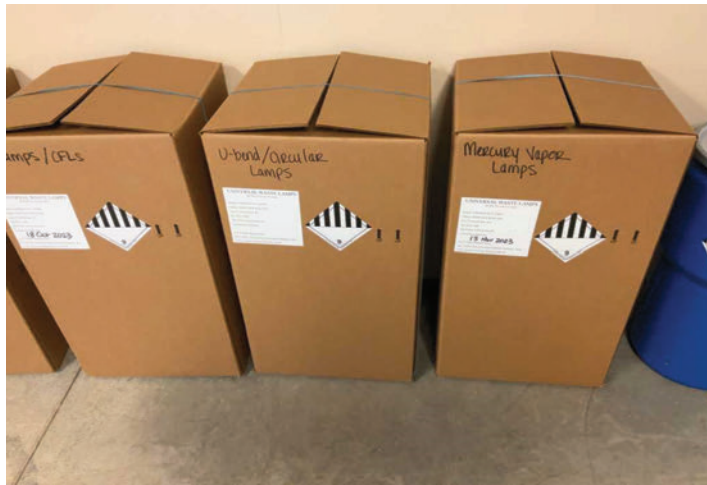
| Photo 42 | IMG-2024013014562456242265455.jpg |

| Building 2954 Universal Waste Storage: Universal waste spent fluorescent lamps. | |

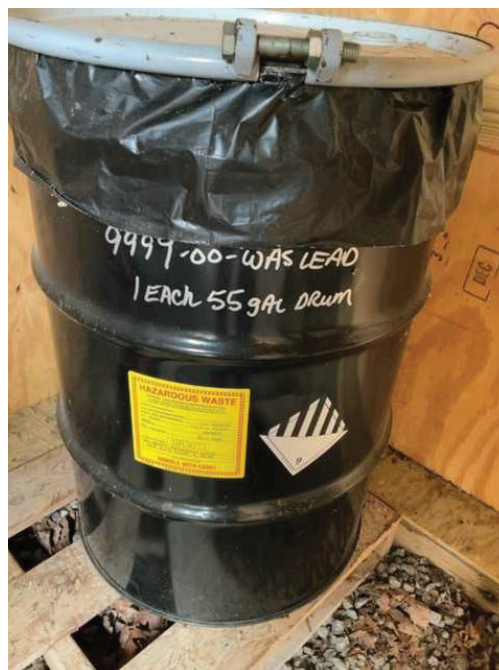
| Photo 43 | IMG-2024013110180818894455.jpg |

Andrew’s Shoot House is a shooting range for used by military personnel and occasionally law enforcement. Lead waste is generated from floor sweepings that accumulate from target practice. The inspectors observed one (1) 55-gallon container of floor sweepings. The container was closed, labeled “Hazardous Waste”, and marked to indicate the hazard of the contents (Photo 43).

| Building 9826 Andrew's Shoot House: SAA for hazardous waste floor sweepings. | |
