**Region 6 - Enforcement & Compliance Assurance Division**  
**INSPECTION REPORT**

| Media Program: | Water | |
| Regulatory Program(s) | NPDES | |
| Facility Name: | <b>Legacy at Sierra Vista</b> | |

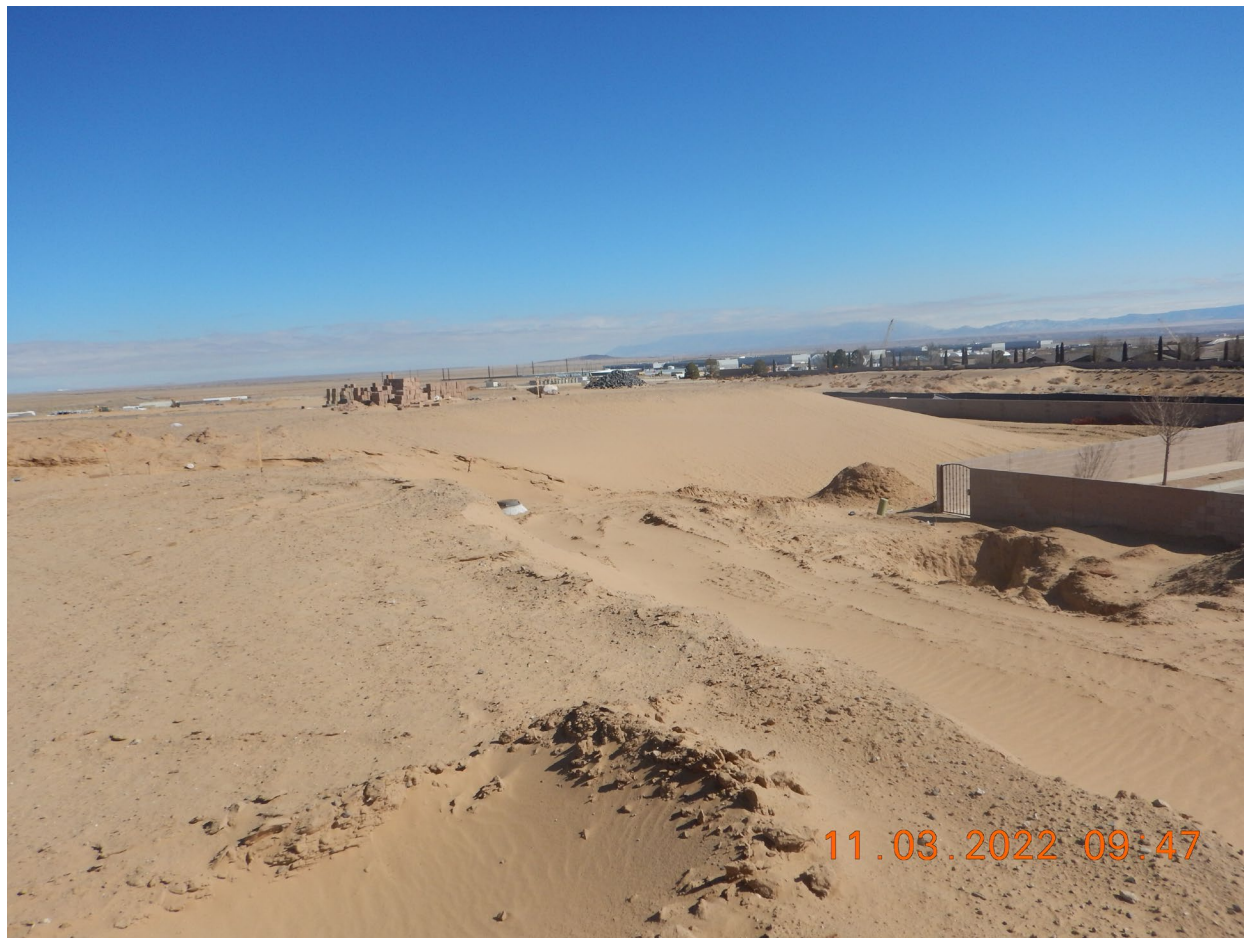
Photo No. 1

View looking towards the Northeast along eastern side of Legacy at Sierra Vista. (DSCN2149)  
Photographed by D. Esparza

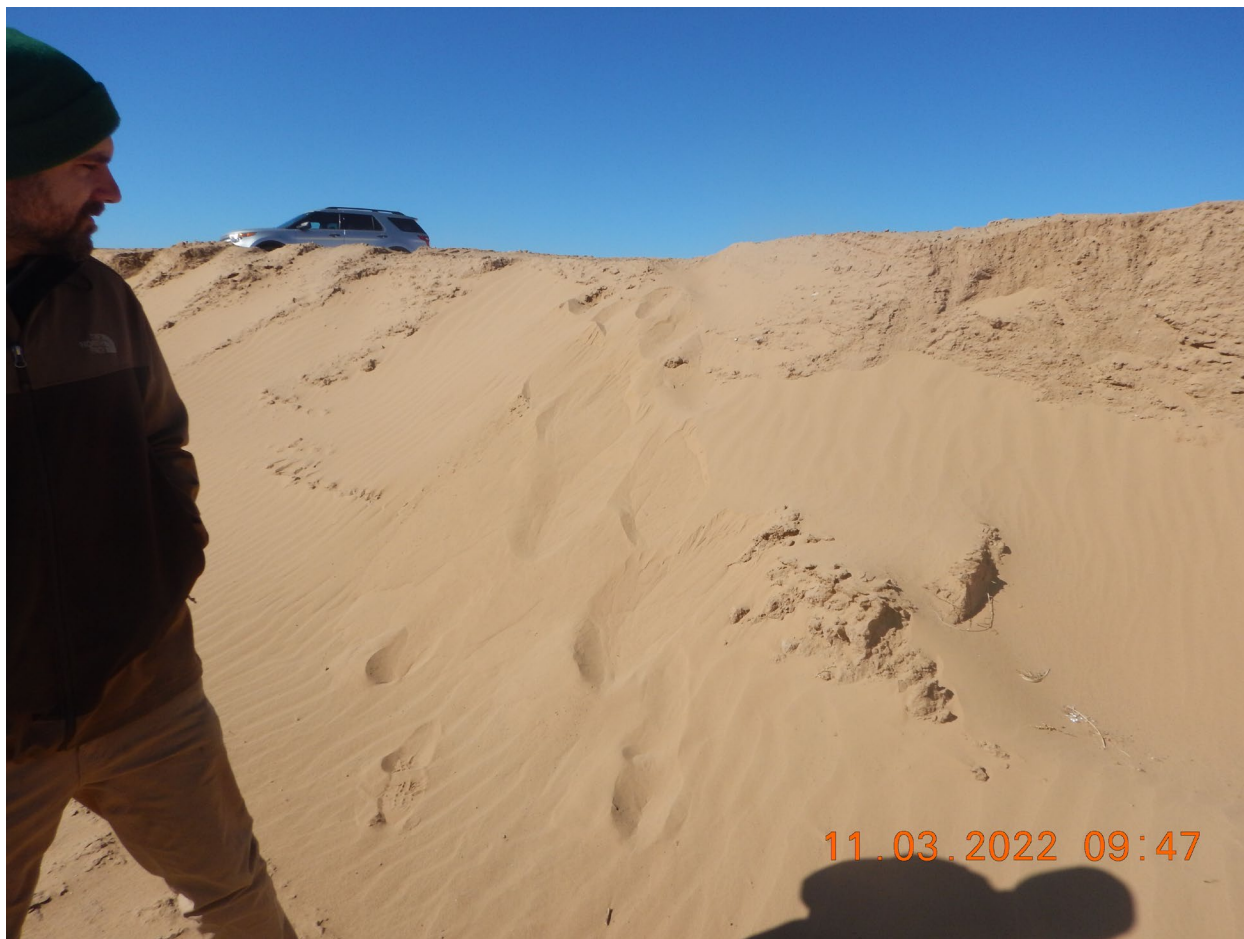
Photo No. 2

View of unstabilized embankment located along eastern side of development. (DSCN2150).  
Photographed by D. Esparza

- SWPPP pages 30 and 31 define dust control measures but do not define the quantity of acres disturbed. Additionally, the SWPPP states “Spray-on Chemical Soil Treatments (Palliatives) per limited research, the effectiveness of polymer stabilization methods range from 70 percent to 90 percent. Generally, dust control measures involving application of either water or chemicals require more monitoring than structural or vegetative controls to remain effective. However, on page 37, the SWPPP states that “Chemical treatment is not employed as a BMP on this project”. Additionally, on page 41, the SWPPP states “For areas of disturbance greater than five acres, stabilization must be complete as soon as practicable, but no less than seven (7) calendar days after stabilization has been initiated” (**Appendix 3 SWPPP Stabilization**) Furthermore, the SWPPP refers to stabilization but doesn’t indicate quantity of acreage addressed or define which Tracts the SWPPP is referring too. Finally, based on observation numerous areas not currently being worked displayed a total lack of stabilization. **Appendix 1 Photograph #1, Photograph #2, Photograph #3, Photograph #4, and Photograph #5.**

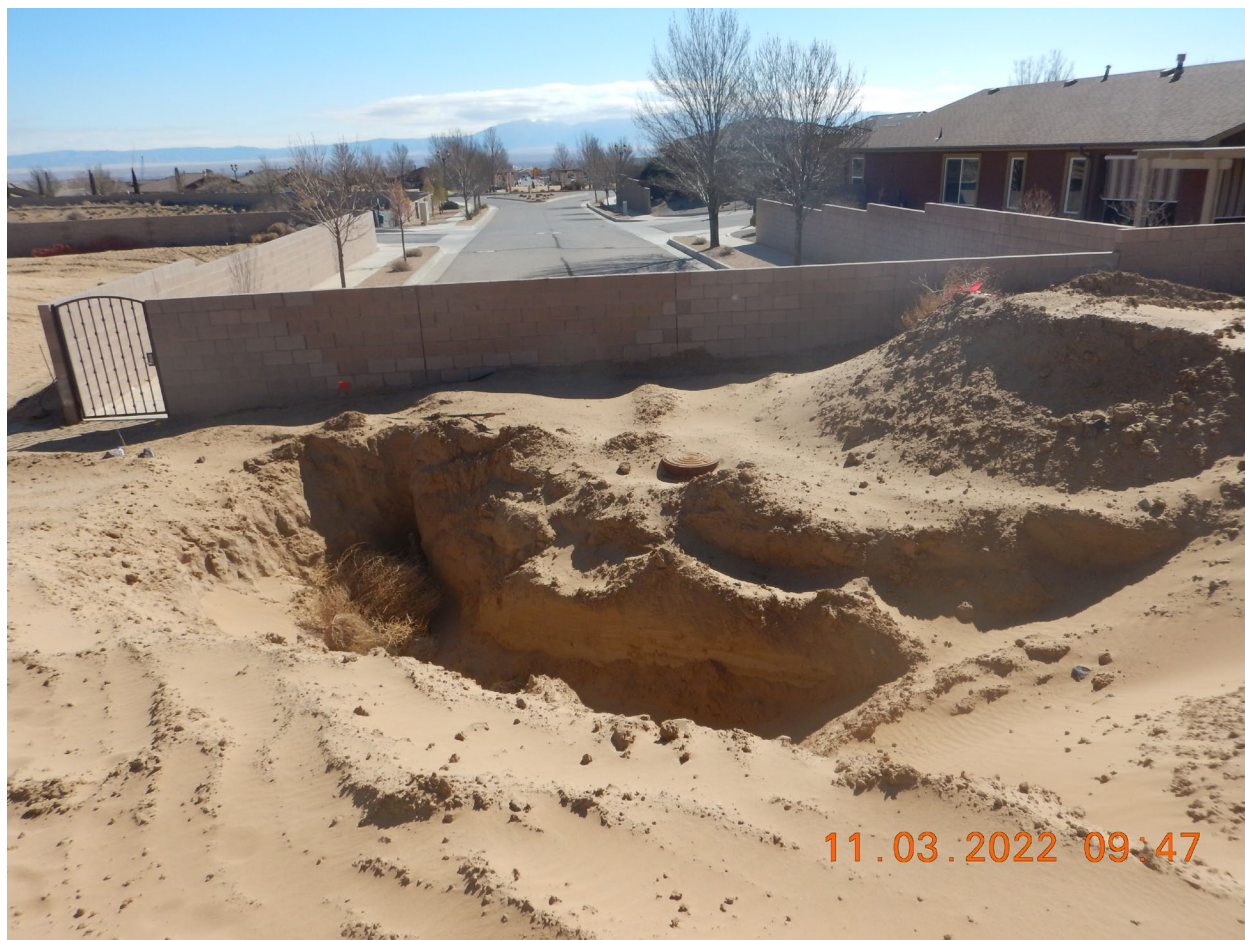
Photo No. 3

View of unstabilized excavation and embankment located along eastern side of development. (DSCN2151). Note: The Jubilee subdivision is in the upper portion of the photograph. Photographed by D. Esparza

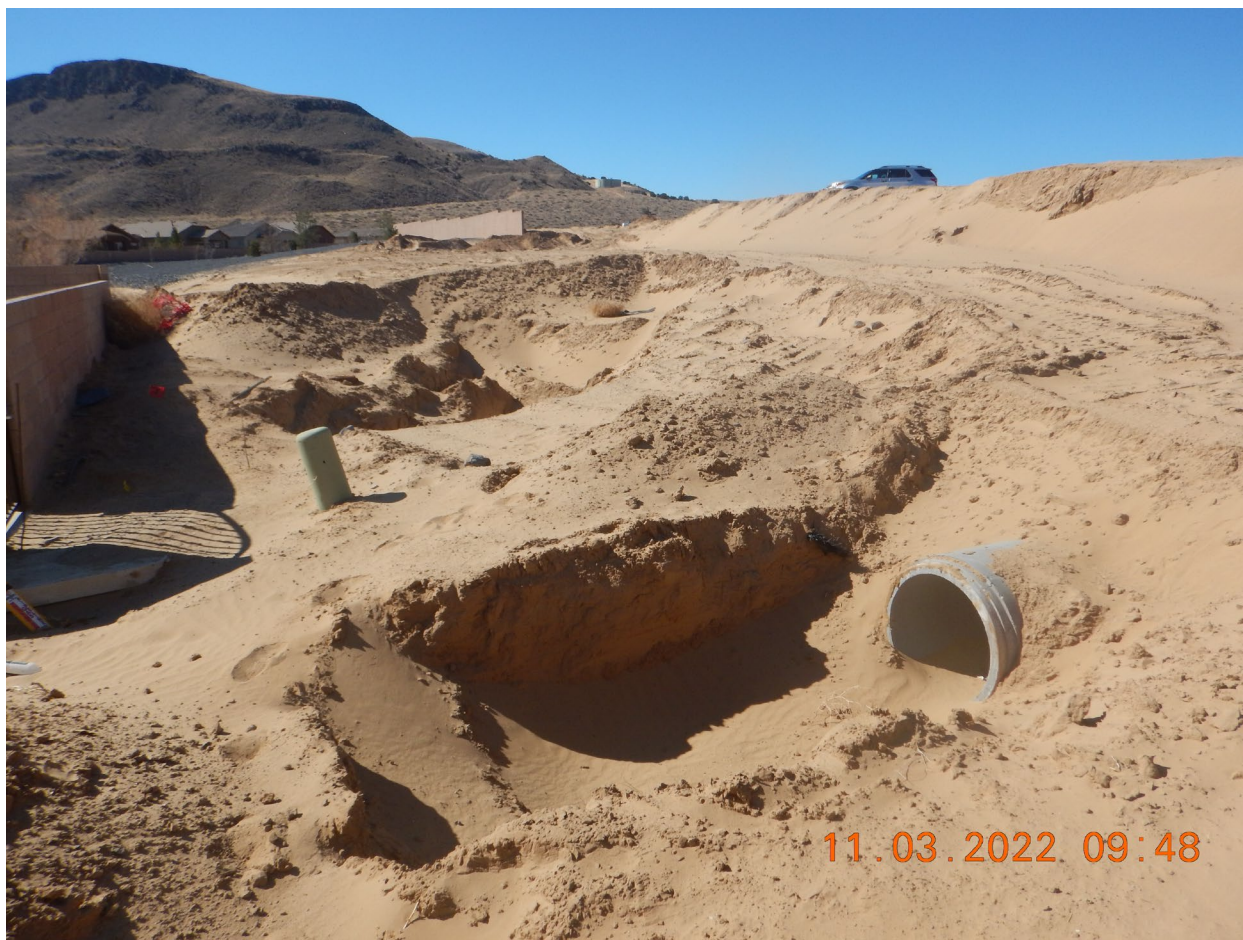
Photo No. 4

View of unstabilized excavation and embankment located along eastern side of development. (DSCN2153). Photographed by D. Esparza

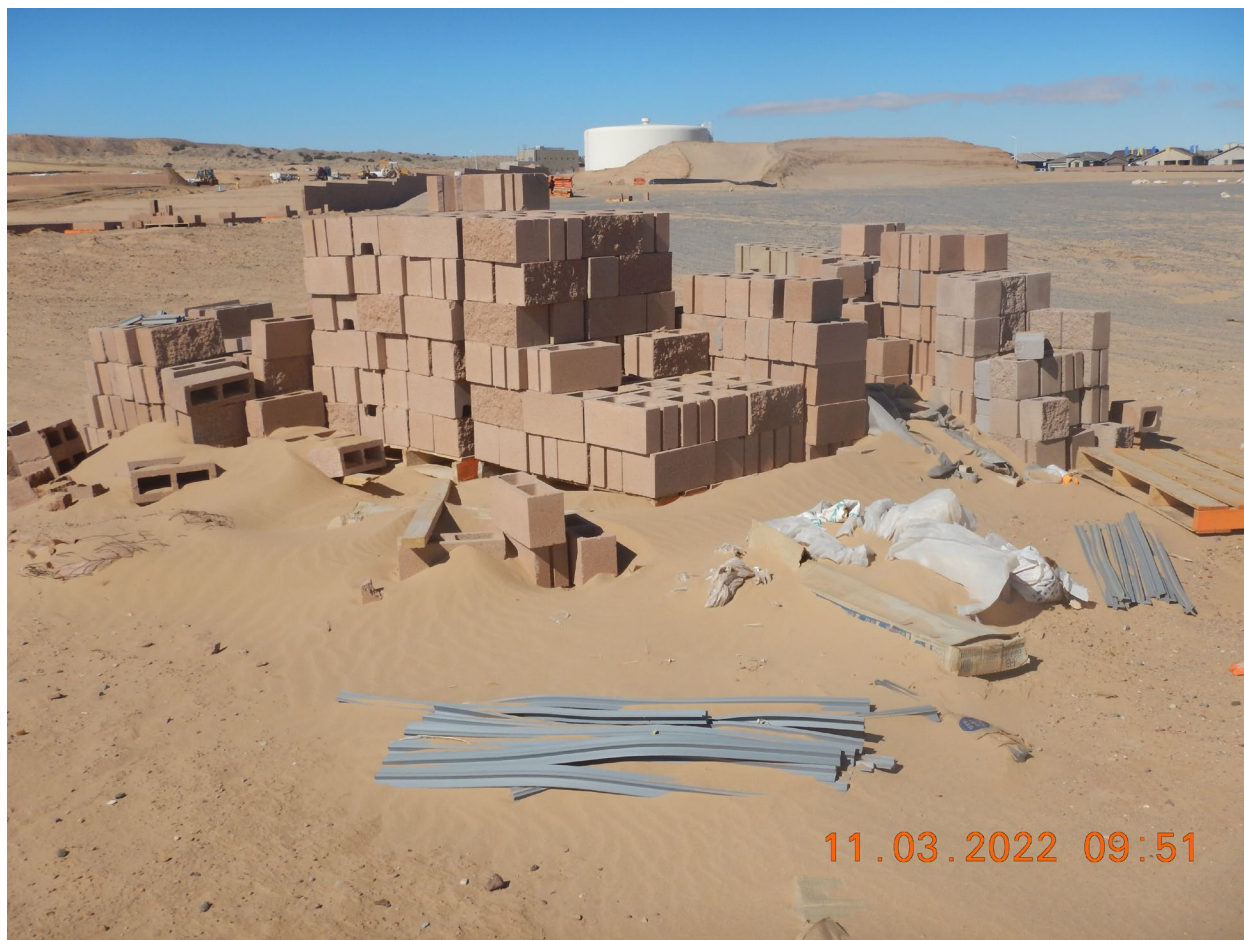
Photo No. 5

View indicative of unstabilized land surface, i.e., vagrant earthen material. (DSCN2159). Photographed by D. Esparza

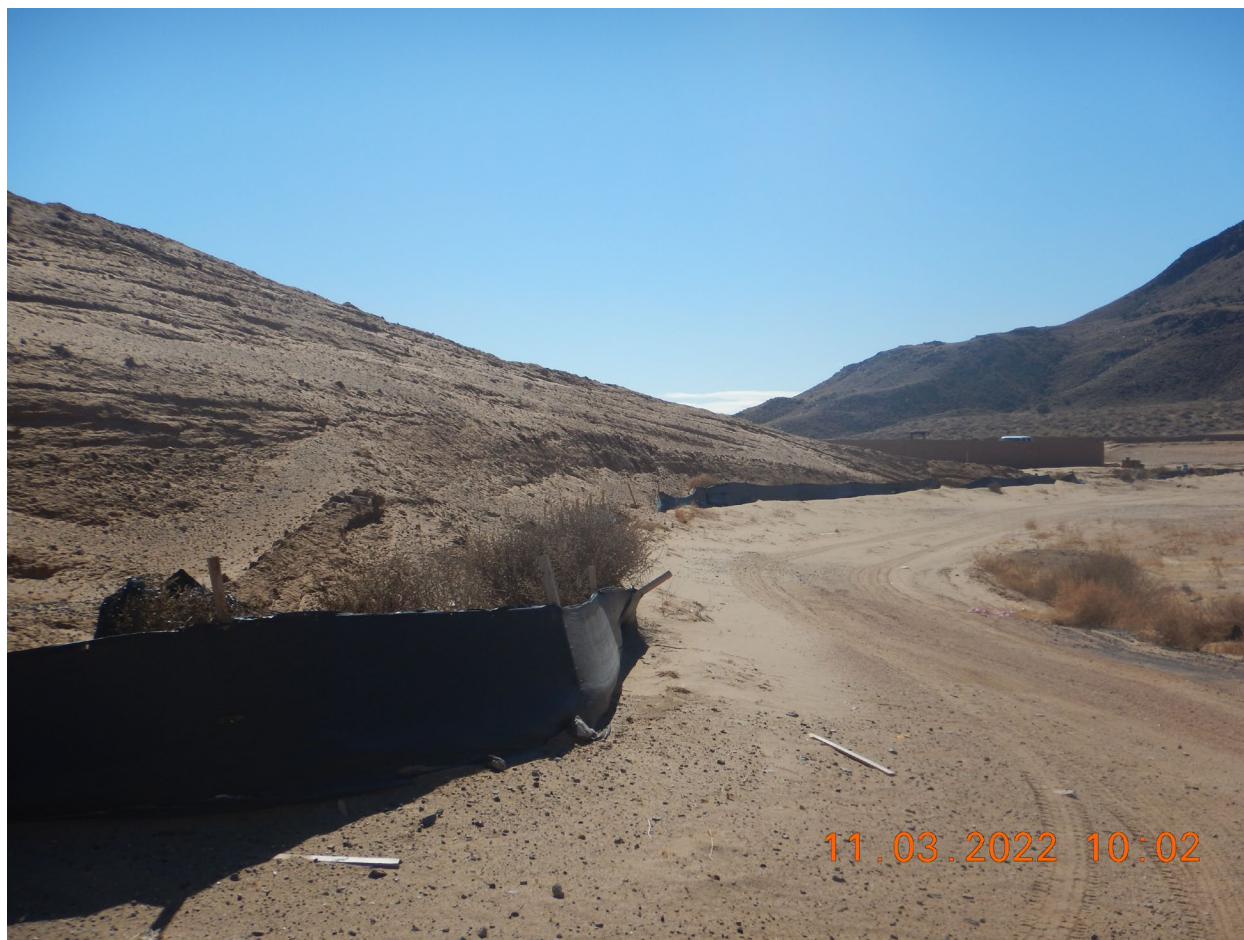
Photo No. 6

View of stockpiled unstabilized "cut" (earthen material) located along the east side of the Village of Los Lunas WST. (DSCN2165). Photographed by D. Esparza

- The updated SWPPP, on page 32, states “The project has 15% to 18% slopes on the exterior perimeters of Tract F (approximate 5.8 acres) (Vista Manzano) and Tract E (approximately 2.2 acres) (Cerro Vista)”. **Appendix 1 Photograph #6 and Photograph #7.**

- The SWPPP on page 35 states “The wire backed silt fence should be cleaned from collected sediment. If the material is damaged- punctured/torn -then it should be replaced. The silt fencing in numerous areas needed cleaning, repair and/or replacement. **Appendix 1 Photograph #6 and Photograph # 8 and Photograph #9.**

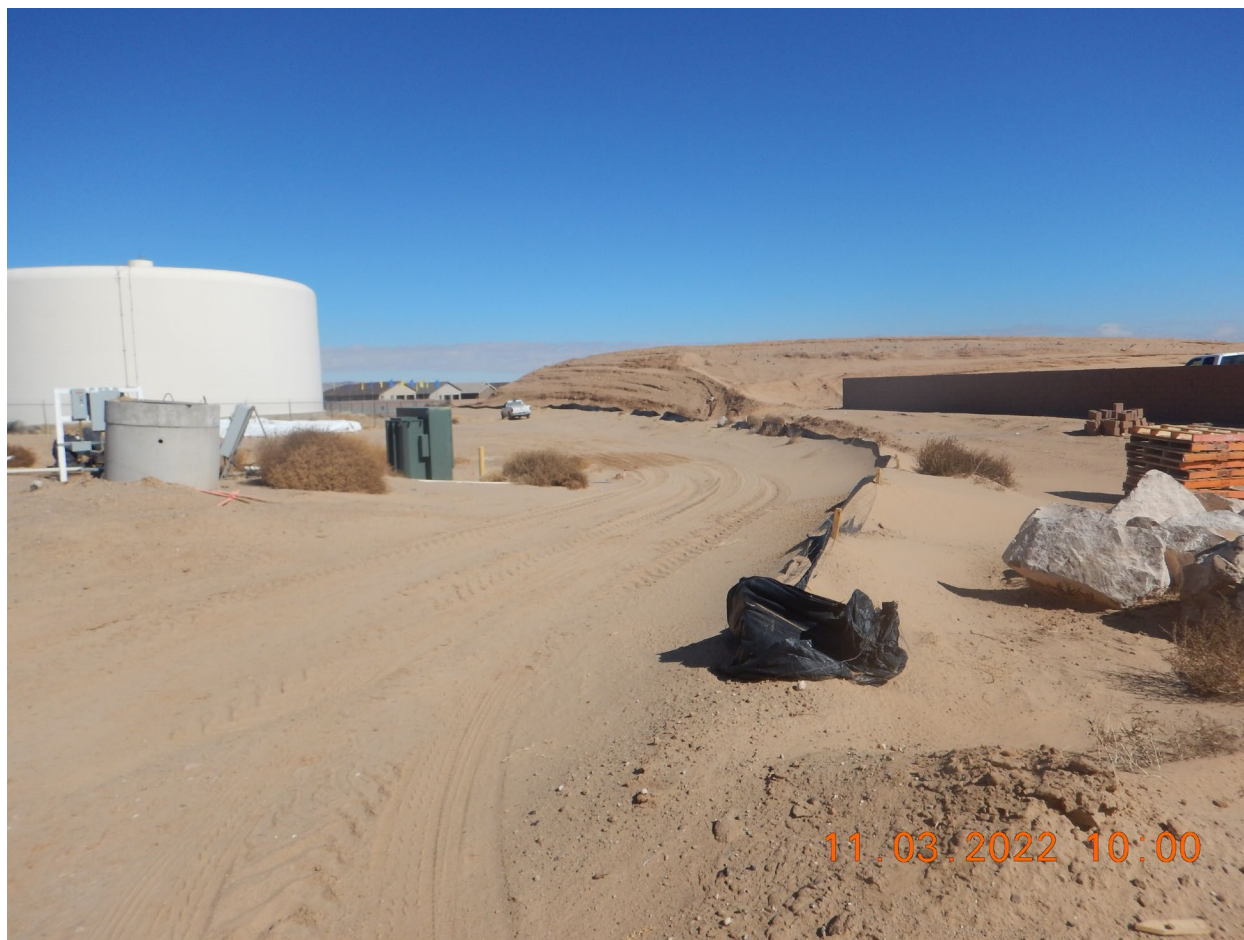
Photo No. 7

View of stockpiled unstabilized "cut" (earthen material) located along the east side of the Village of Los Lunas WST. Note: the height of the staged material in comparison to the vehicle and WST. (DSCN2163). Photographed by D. Esparza

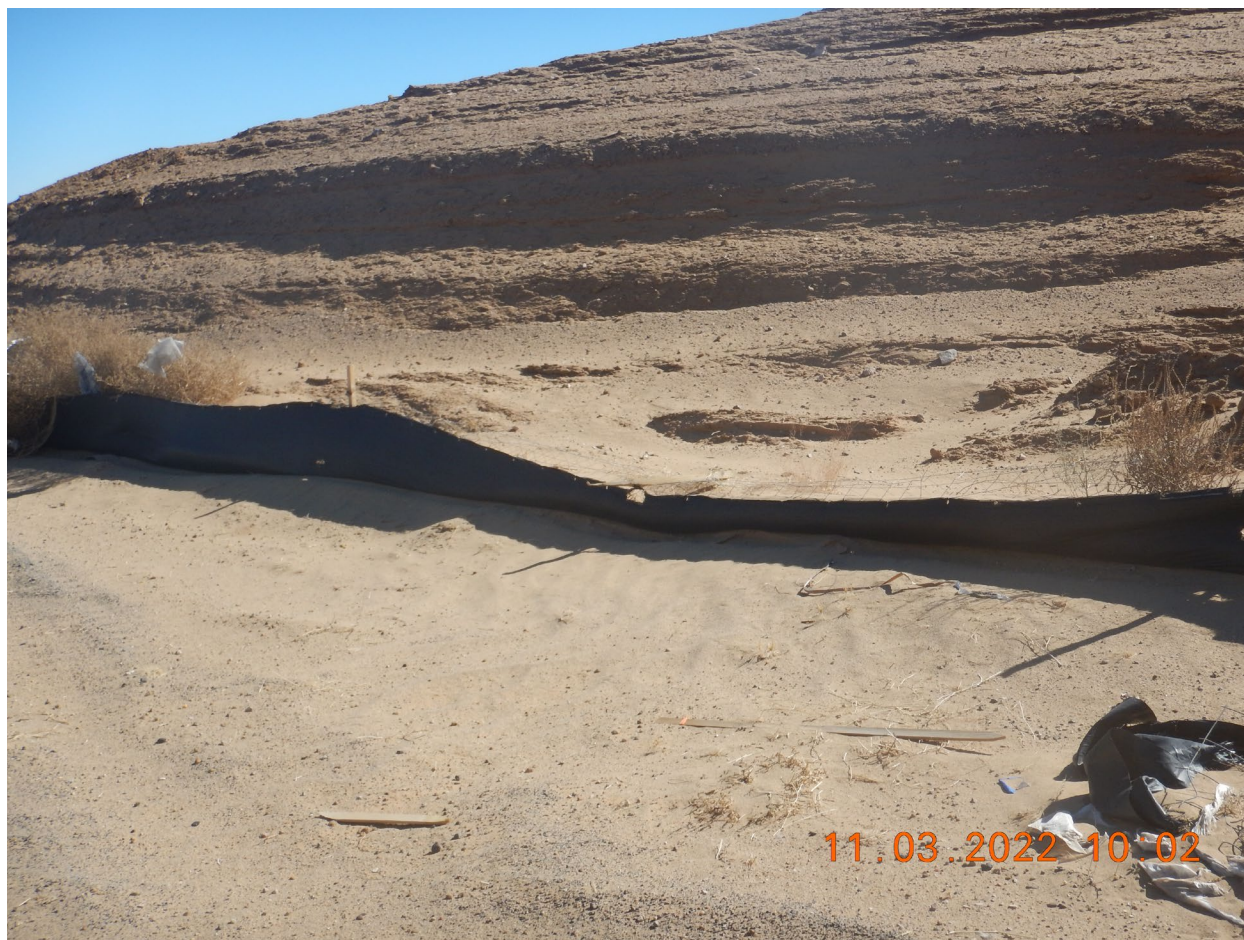
Photo No. 8

View of silt fencing in need of cleaning, repair, or replacement.(DSCN2166). Photographed by D. Esparza

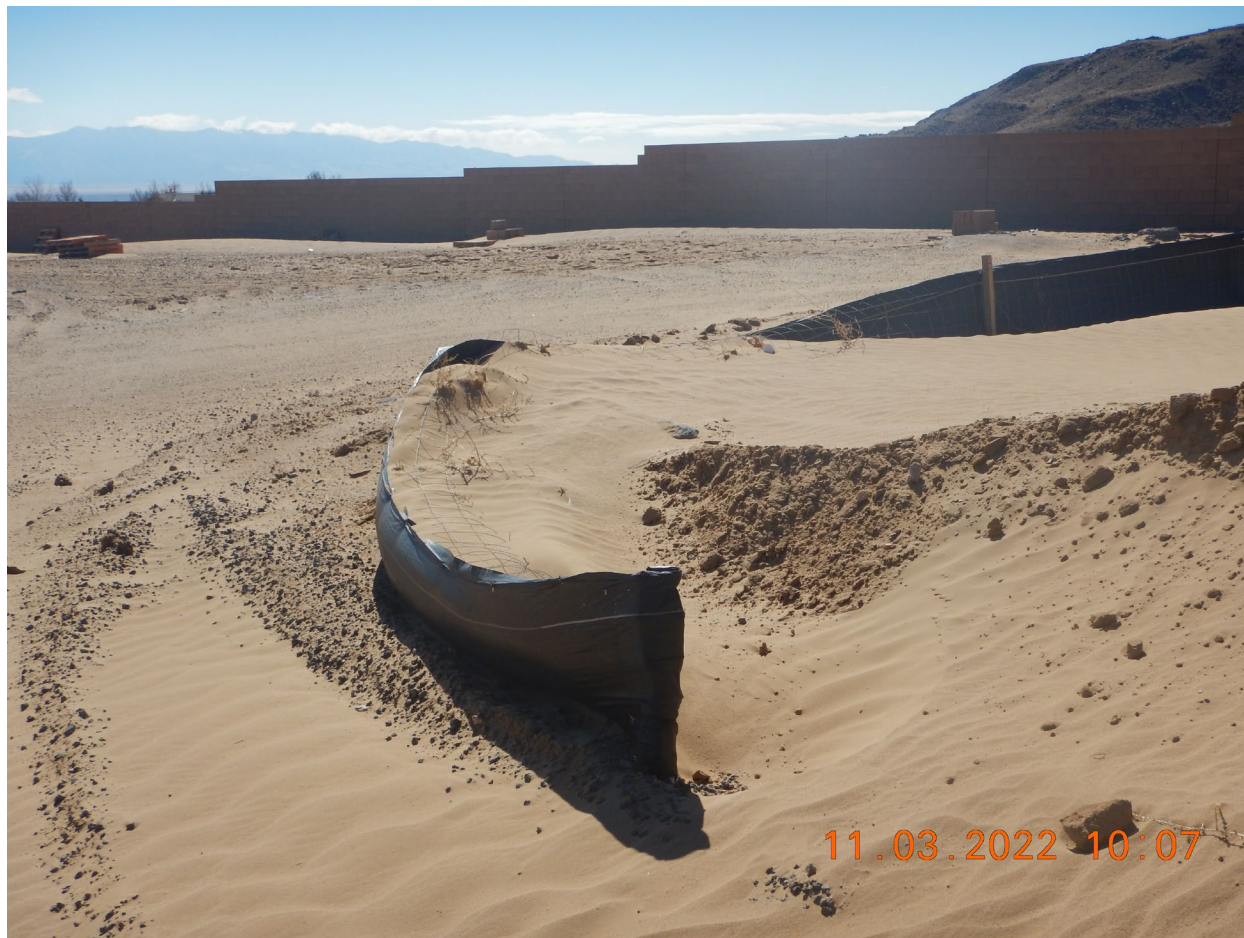
Photo No. 9

View of silt fencing in need of cleaning, repair, or replacement.(DSCN2173). Photographed by D. Esparza

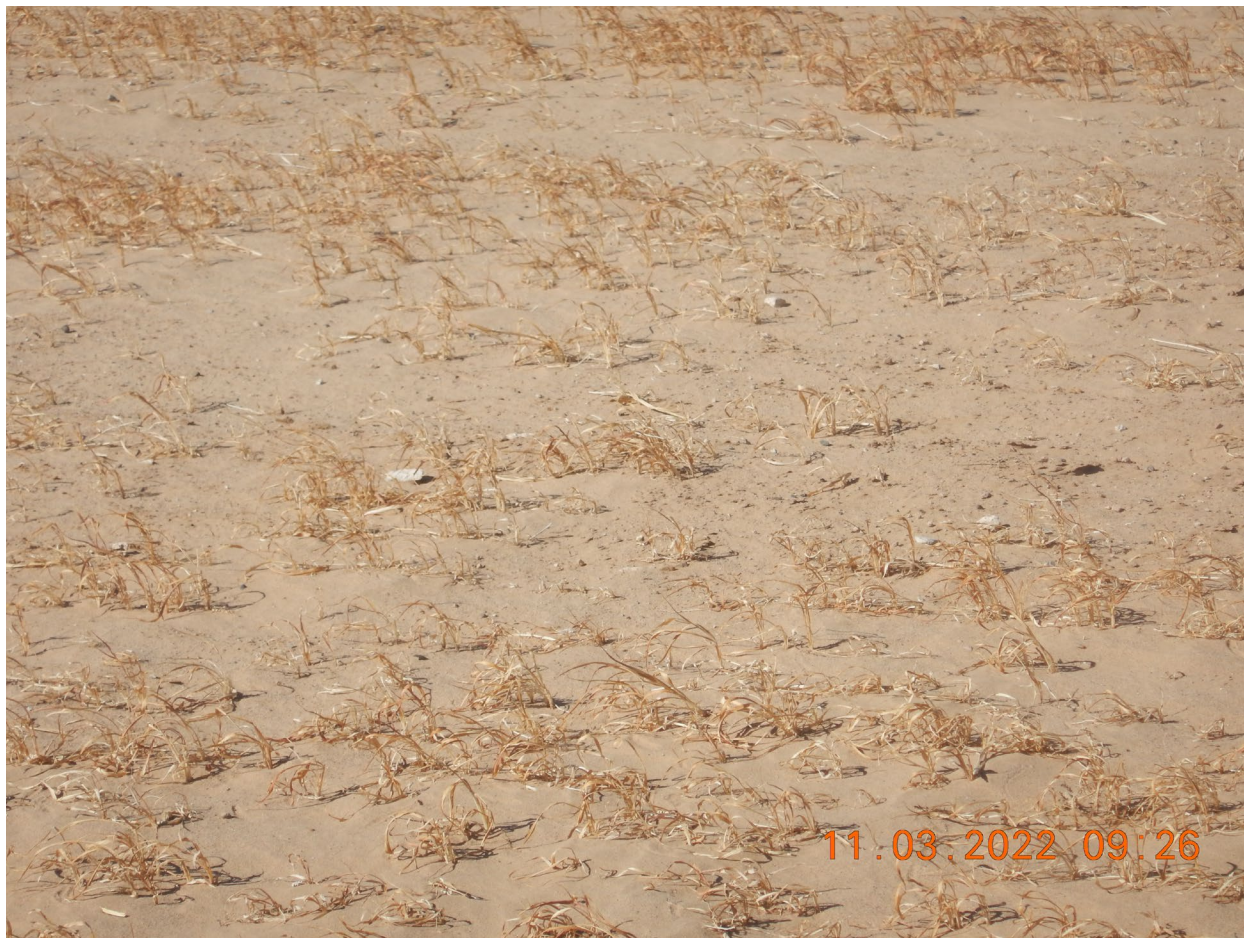
Photo No. 10

View of the sparse or frail vegetation along the western side of the development. (DSCN2132).  
Photographed by D. Esparza

- The Sierra Vista project area exhibited vegetation or re-vegetation, though extremely sparse, frail, or non-existent in most areas. NOTE: Sierra Vista representatives stated, Legacy is relying solely on rainfall or a storm event for watering. No mechanical means are utilized, i.e., sprinkler or water truck. Though two (2) water trucks were observed applying water in only areas that were actively being worked. **Appendix 1 Photograph #10, Photograph #11 and Photograph #12 and Appendix 4 Sierra Vista Fugitive Dust Management.**

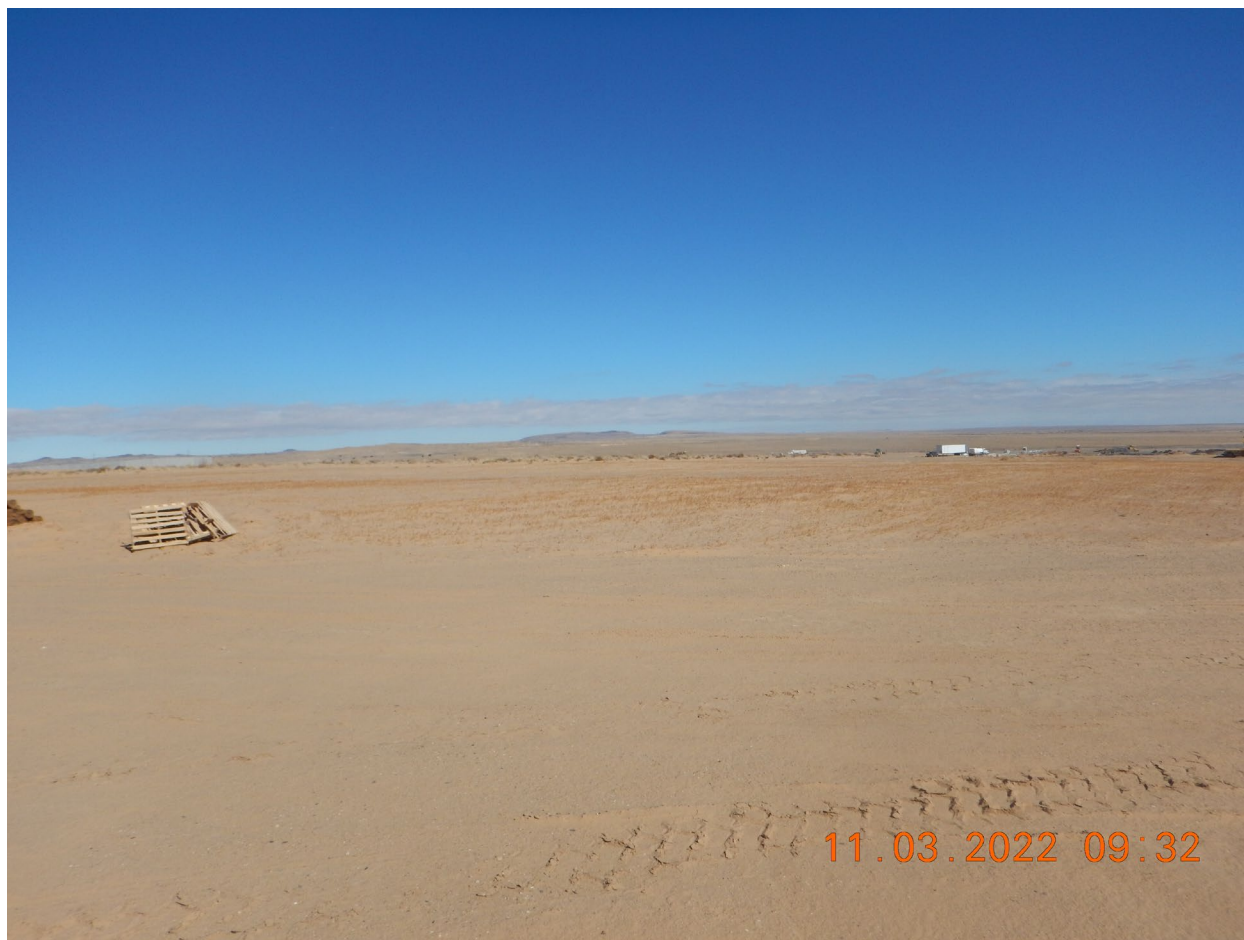
Photo No. 11

View looking approximately north towards New Mexico State Road 6 (SR-6) of the cleared and leveled land surface. Note: the lack of vegetation, no water trucks and that the area was not actively being worked. (DSCN2132). Photographed by D. Esparza

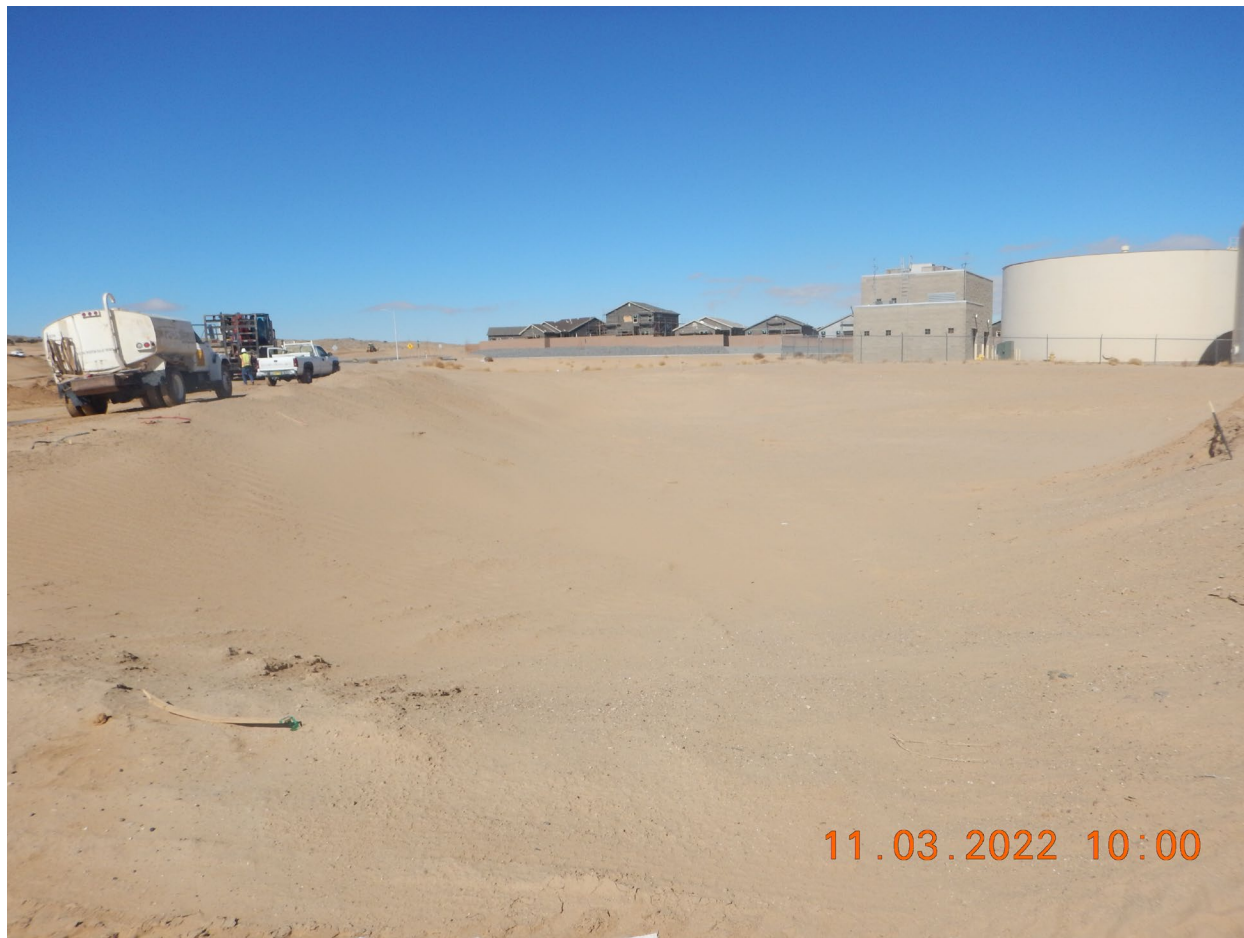
Photo No. 12

View looking approximately West in an area that was actively being worked. Note: The one (1) water truck and Village of Los Lunas WST. (DSCN2164). Photographed by D. Esparza

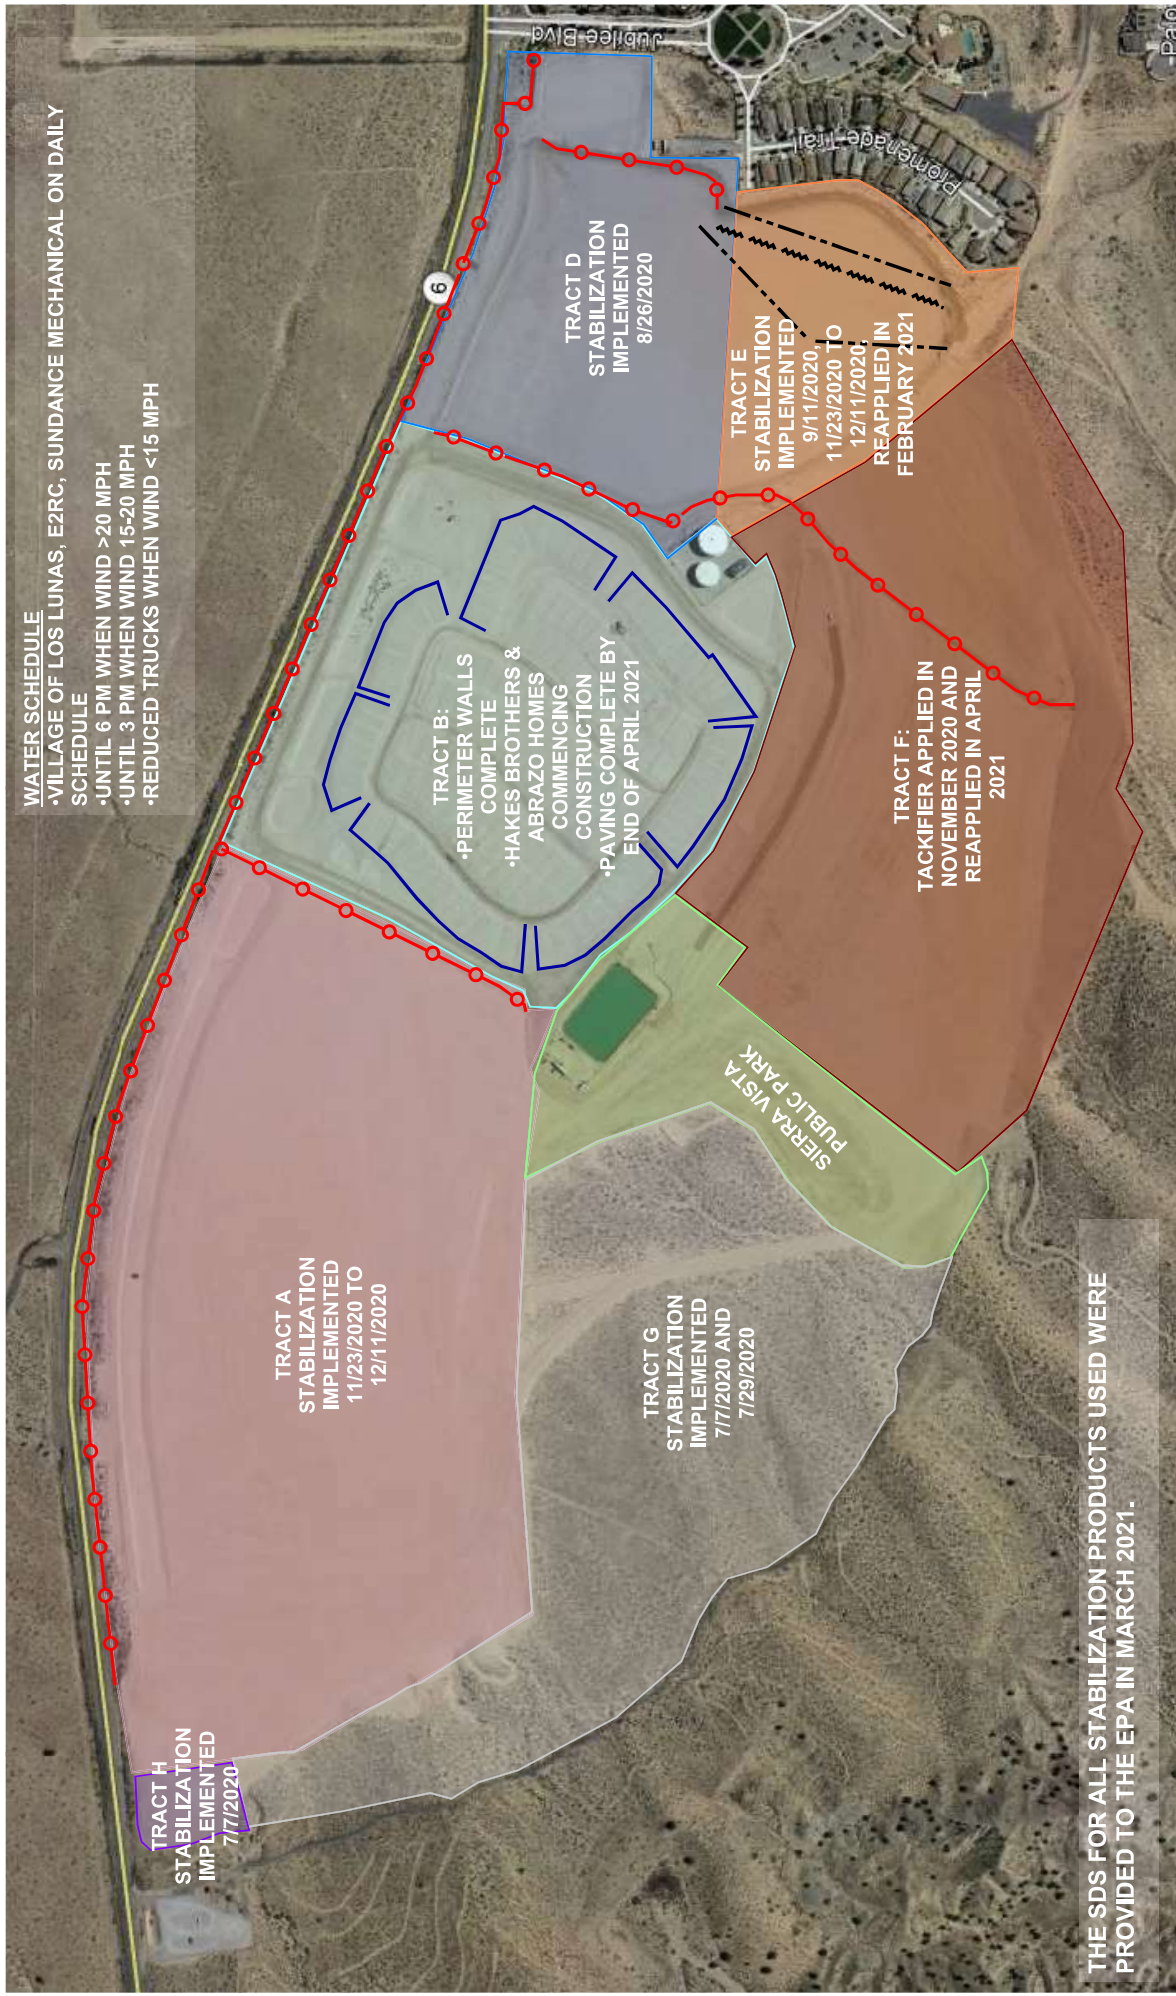
# WATER SCHEDULE

- VILLAGE OF LOS LUNAS, E2RC, SUNDANCE MECHANICAL ON DAILY SCHEDULE
- UNTIL 6 PM WHEN WIND >20 MPH
- UNTIL 3 PM WHEN WIND 15-20 MPH
- REDUCED TRUCKS WHEN WIND <15 MPH

THE SDS FOR ALL STABILIZATION PRODUCTS USED WERE PROVIDED TO THE EPA IN MARCH 2021.

- SILT FENCE: MAINTAINED AS OBSERVED AND NEEDED
- PERIMETER WALL
- ROCK BERM
- WIND FENCE: MAINTAINED AS OBSERVED AND NEEDED
