SUBJ: Resource Conservation and Recovery Act (RCRA) Compliance Evaluation Inspection (CEI)  
Possehl Connector Services  
EPA ID: SCD982085813

## **RCRA Inspection Report**

Possehl Connector Services EPA ID# SCD982085813  
445 Bryant Boulevard  
Rock Hill, South Carolina 29732

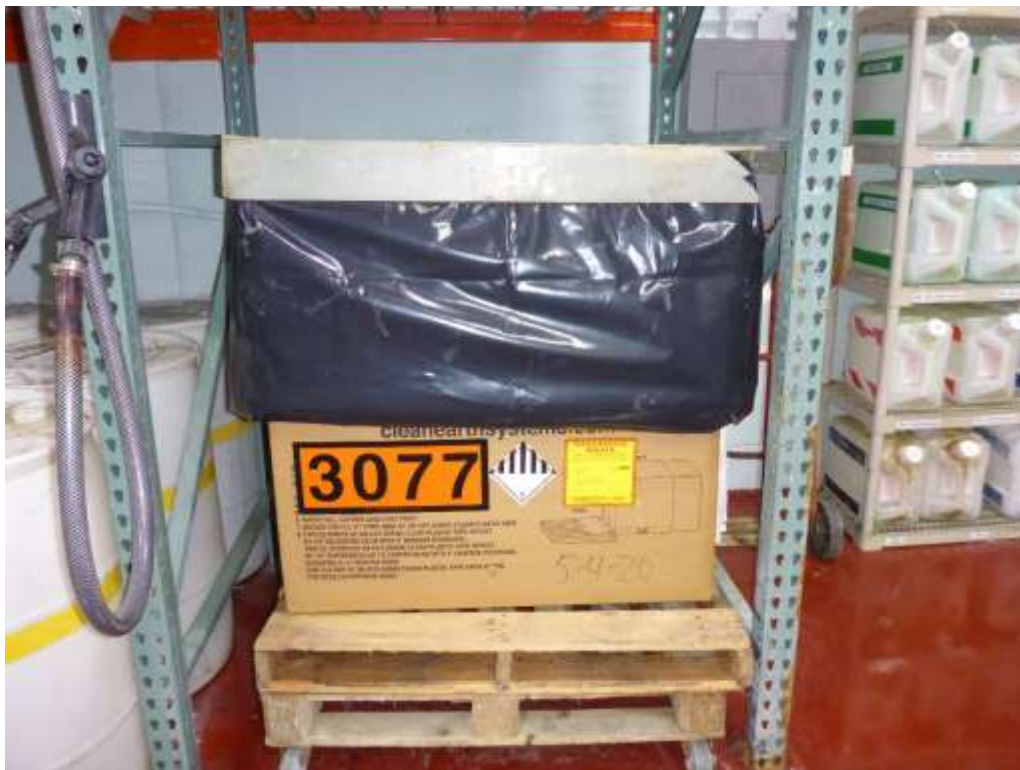
The inspectors observed one cubic yard box labeled hazardous waste solid (lead) contaminated filters, PPE, brooms, and floor sweepings on the bottom right shelf of the large metal shelving system (Photo #1). Mr. Davis explained that the container is used to manage and to store hazardous wastes generated from routine preventative maintenance activities. The box was marked with an accumulation start date of 02/04/2020 and identified as NA3077 and DOT hazard class 9.

**Photo 1:** Cubic yard box labeled hazardous waste solid (lead) contaminated filters, PPE, brooms, and floor sweepings on the bottom right shelf of the large metal shelving system in the chemical storage area.

**Pursuant to 25 S.C. Code Ann. Regs. 61-79.262.17(a)(5)(i)(B)\* [40 C.F.R. § 262.17(a)(5)(i)(B)], which is a condition of the LQG Permit Exemption, a generator is required to mark or label containers with an indication of the hazards of the contents clearly visible for inspection on each container.**

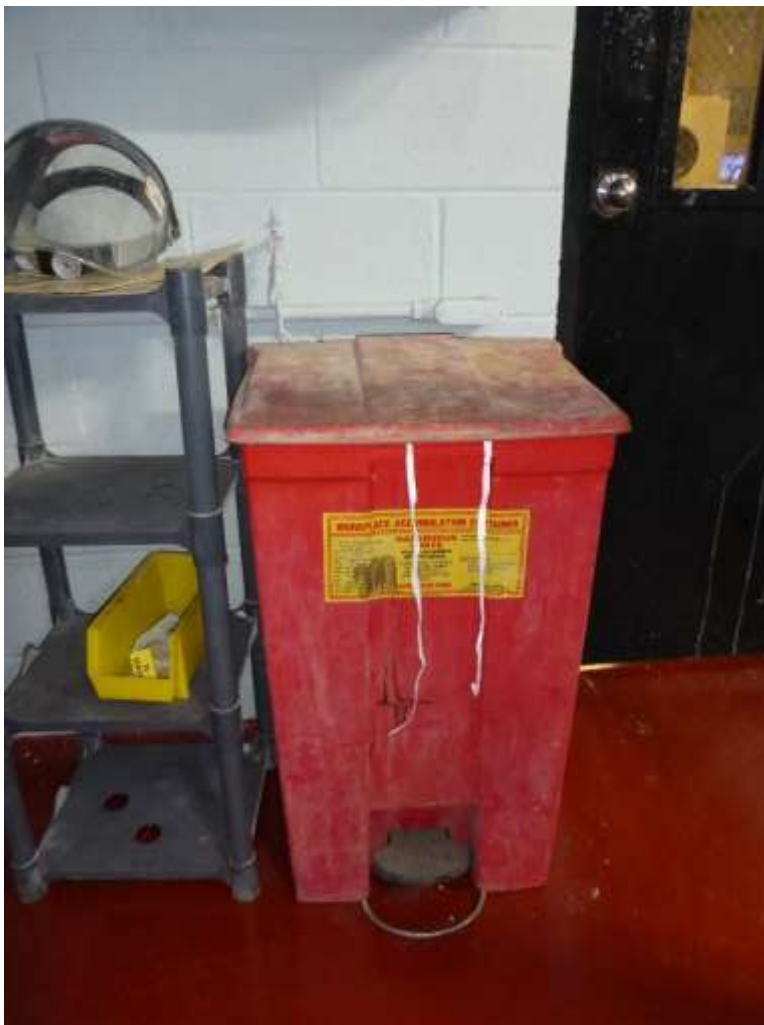
The first SAA in this room is located on the wall to the right in this room just outside the laboratory door (Photo #2). The inspectors observed a red flip-top 20-gallon trash can in this SAA. The can was identified as a workplace accumulation container and labeled hazardous waste solid air and bath filters and used PPE (containing lead), but it was not marked with an indication of the hazards.

**Photo 2:** Red flip-top trash can in SAA located on the wall to the right in the chemical storage area outside the laboratory door.

**Pursuant to 25 S.C. Code Ann. Regs. 61-79.262.15(a)(5)(ii)\* [40 C.F.R. § 262.15(a)(5)], which is a condition of the SAA Permit Exemption, a generator is required to mark or label containers with an indication of the hazards of the contents.**

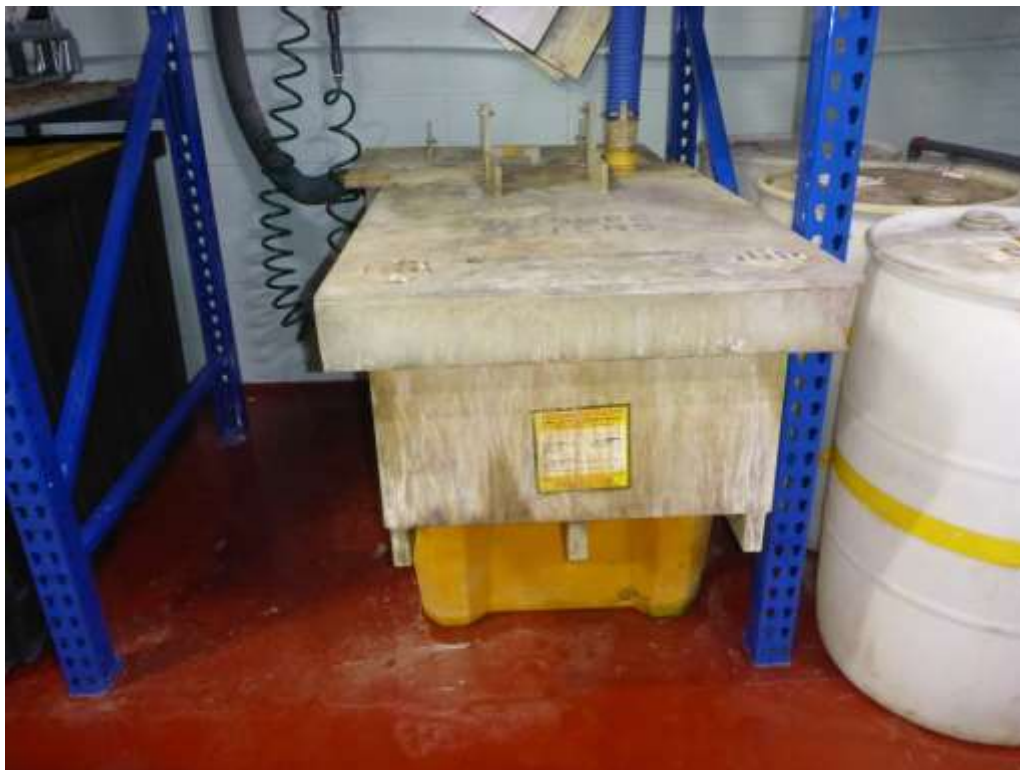
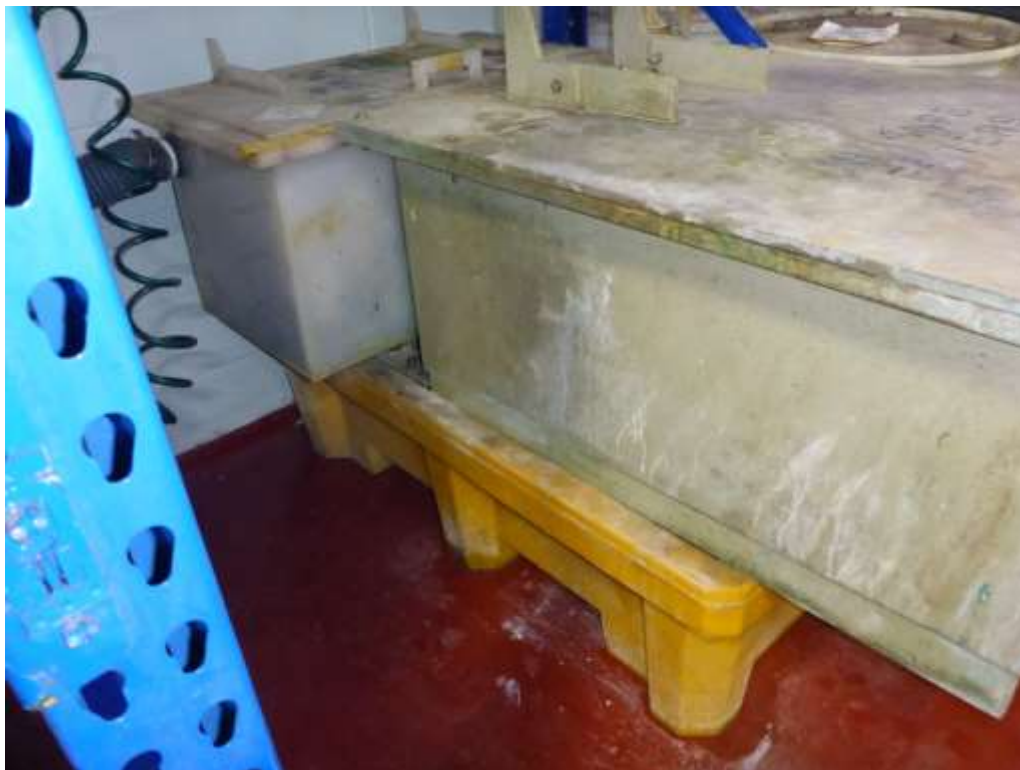
The two filter draining units located between the large metal shelving units are designed to drain filters that have been used in the plating lines (Photos #3 and 4). One of the units is used to drain filters removed from the nickel, tin and lead plating lines. This unit is labeled NI / SNPB filters (Photo #5) and identified with a DOT hazard 9 placard. It is also labeled D008 hazardous waste solids (lead) contaminated filters, PPE, brooms, and floor sweepings. Wet filters are placed above a wire mesh inside the unit and the lid is closed while liquids drain from the filters to the bottom of the unit. Once drained, the dry filters are placed in a solid hazardous waste storage container. Drained liquids are pumped from the bottom of this unit into the collection system and sump in the corner of the room. Although neither of the two filter draining units were marked with an accumulation start date, the facility maintains a log for tracking the time and date that materials are placed into and removed out of the units. The inspectors observed this log hanging on the wall behind the draining units.

**Photo 3:** Two filter draining units located between the large metal shelving units in the chemical storage area.

**Photo 4:** Two filter draining units located between the large metal shelving units in the chemical storage area.

**Pursuant to 25 S.C. Code Ann. Regs. 61-79.262.17(a)(5)(i)(B) and (C)\* [40 C.F.R. § 262.17(a)(5)(i)(B) and (C)], which is a condition of the LQG Permit Exemption, a generator is required to mark or label containers with an indication of the hazards of the contents and with the date upon which each period of accumulation begins clearly visible for inspection on each container.**

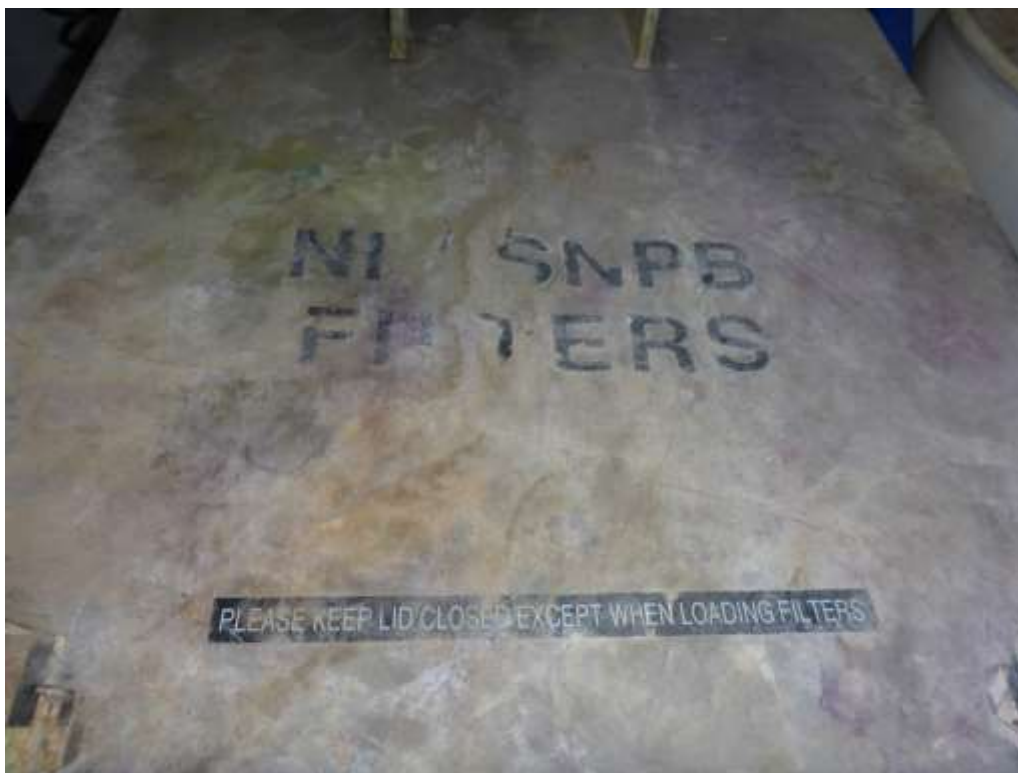
**Photo 5:** Lid of filter unit to drain filters from the nickel, tin and lead plating lines.

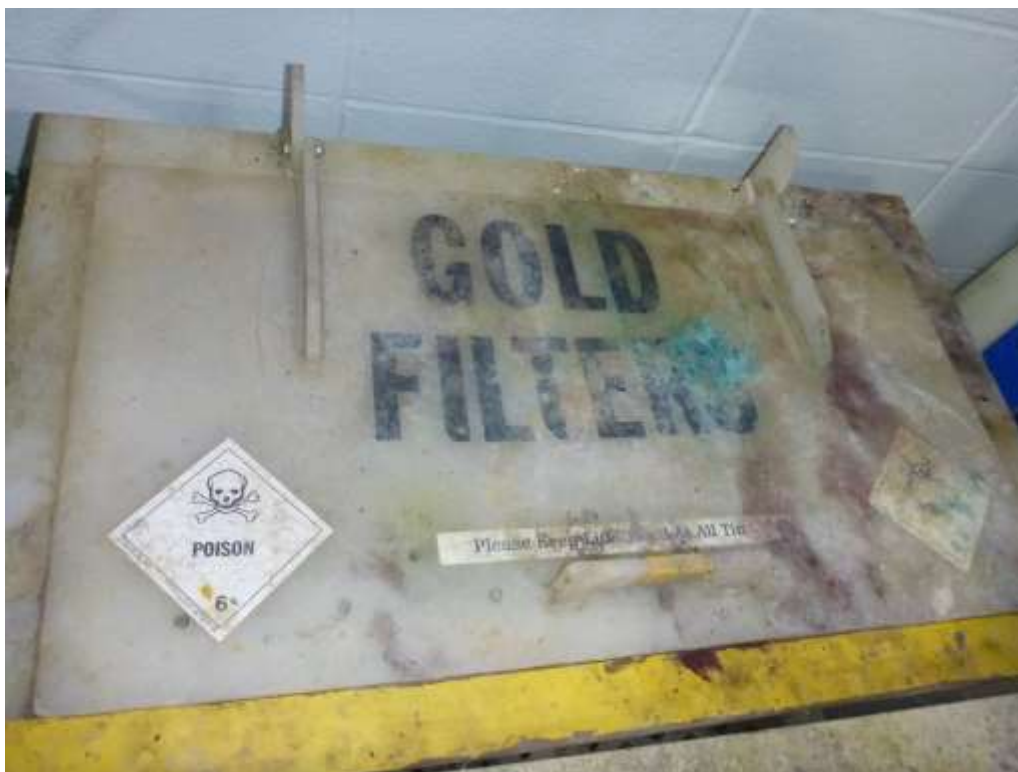
The second draining unit located between the large metal shelving units is used to drain filters removed from the gold plating lines. This unit is labeled gold filters and identified with a poison hazard placard (Photo #6), but it was not labeled with the words “hazardous waste.” Wet filters are placed above a wire mesh inside this unit and the lid is closed while liquids drain from the filters. Once drained, the dry filters are placed into a storage container and shipped off-site for precious metals recycling. Drained liquids are pumped to one of the 500-gallon F007 / D003 hazardous waste cyanide solution (contains potassium cyanide) recirculation tanks. This filter draining unit was also not marked with an accumulation start date.

**Photo 6:** Lid of filter unit to drain filters from the gold plating lines.

**Pursuant to 25 S.C. Code Ann. Regs. 61-79.262.17(a)(5)(i)(A) and (C)\* [40 C.F.R. § 262.17(a)(5)(i)(A) and (C)], which is a condition of the LQG Permit Exemption, a generator is required to mark or label containers with the words “Hazardous Waste” and with the date upon which each period of accumulation begins clearly visible for inspection on each container.**

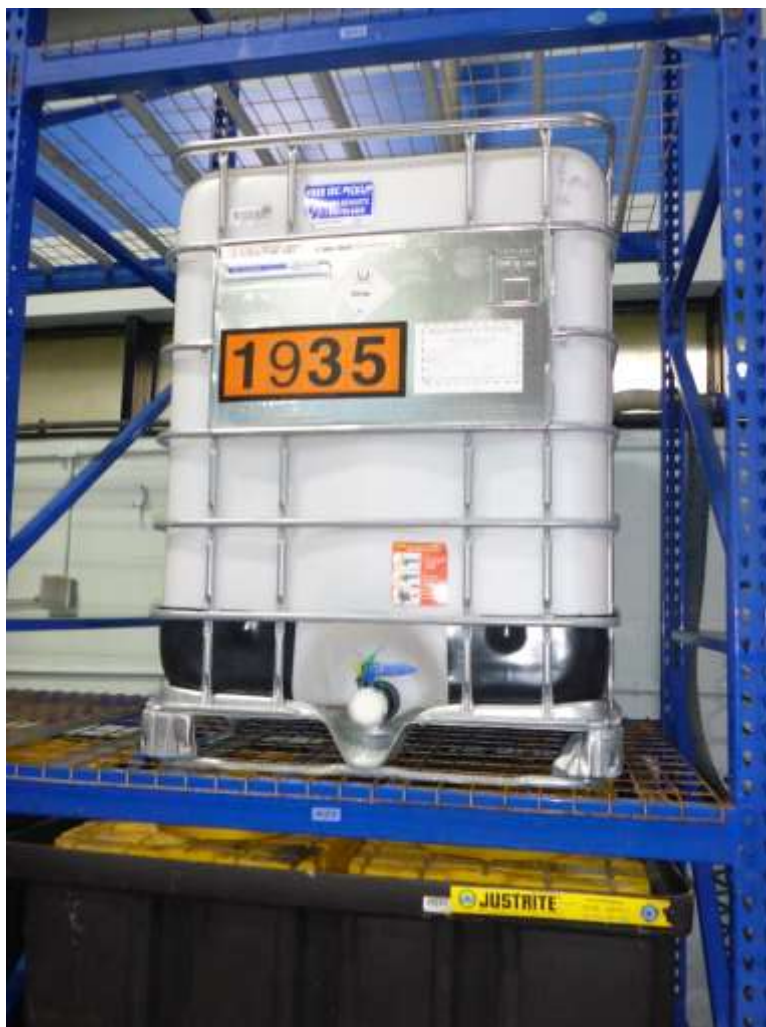
The inspectors observed one 300-gallon tote labeled F009 / D003 hazardous waste cyanide solution (potassium cyanide) on the middle shelf of the large metal shelving system to the left of the draining units (Photo #7). Mr. Davis explained that the container is used to manage and to store hazardous wastes rinsewaters generated from the gold plating process. The tote was identified with a poison hazard placard, but it was not marked with an accumulation start date because it was empty.

**Photo 7:** 300-gallon tote labeled F009 / D003 hazardous waste cyanide solution (potassium cyanide) on the middle shelf of the large metal shelving system to the left of the draining units.

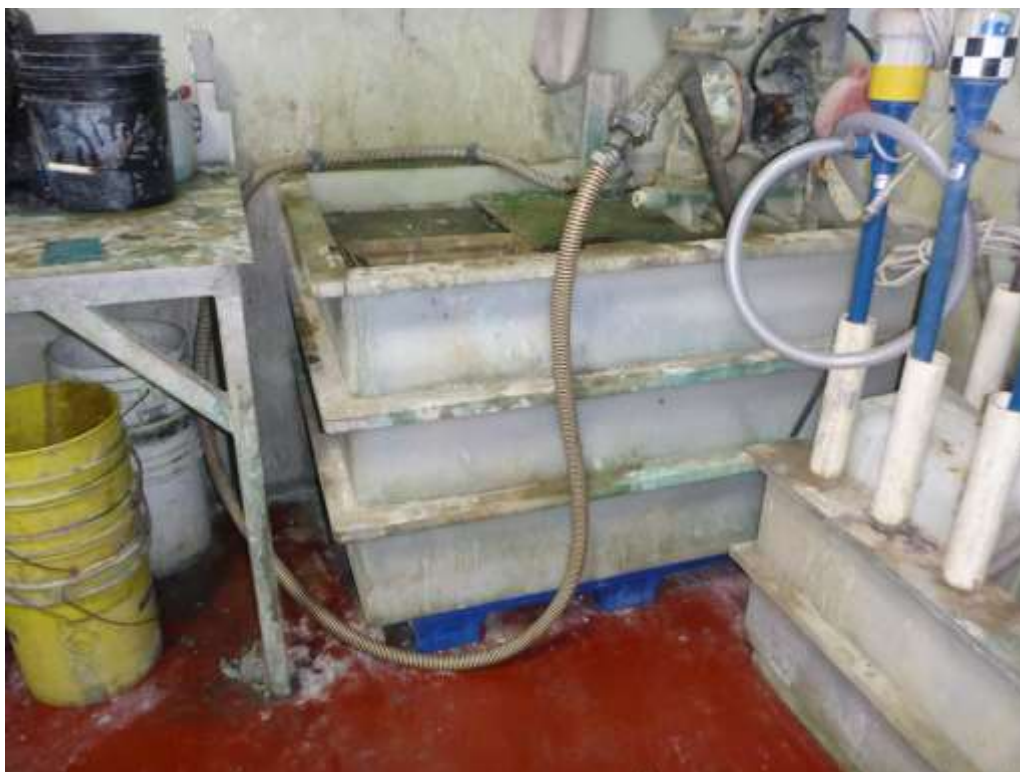
The collection system and sump in the corner of the chemical storage area room is used to transfer liquid hazardous waste from this area into the outdoor hazardous waste storage tank (Photo #8). From the production area, liquid waste is drained into a transfer container or drum and brought into the chemical storage area. The contents of the containers are pumped or poured into the sump vessel located in the corner of the room. The vessel was not labeled as hazardous waste, identified with an indication of the hazards of its contents, or marked with an accumulation start date. The lid remained open, because it was equipped with a strainer basin that can filter potential debris from the waste stream (Photo #9) and with a hole through which the pump wand can be placed into the vessel (Photo #10). The inspectors observed liquid sitting inside the sump unit.

**Photo 8:** Collection system and sump in the corner of the chemical storage area room used to transfer liquid hazardous waste from this area into the outdoor hazardous waste storage tank.

**Pursuant to 25 S.C. Code Ann. Regs. 61-79.262.17(a)(1)(iv)(A)\* [40 C.F.R. § 262.17(a)(1)(iv)(A)], which is a condition of the LQG Permit Exemption, a container holding hazardous waste must always be closed during accumulation, except when it is necessary to add or remove waste.**

**Pursuant to 25 S.C. Code Ann. Regs. 61-79.262.17(a)(5)(i)\* [40 C.F.R. § 262.17(a)(5)(i)(A-C)], which is a condition of the LQG Permit Exemption, a generator is required to mark or label containers with the words “Hazardous Waste;” with an indication of the hazards of the contents; and with the date upon which each period of accumulation begins clearly visible for inspection on each container.**

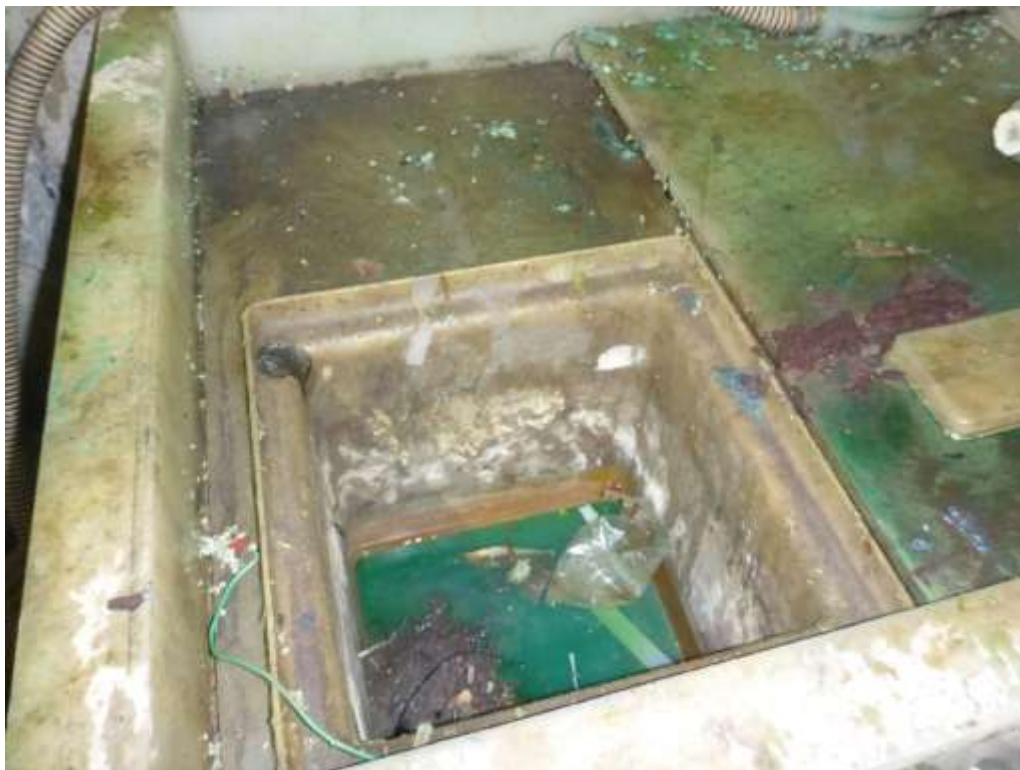
**Photo 9:** Strainer basin built into the lid of the collection system and sump in the corner of the chemical storage area.

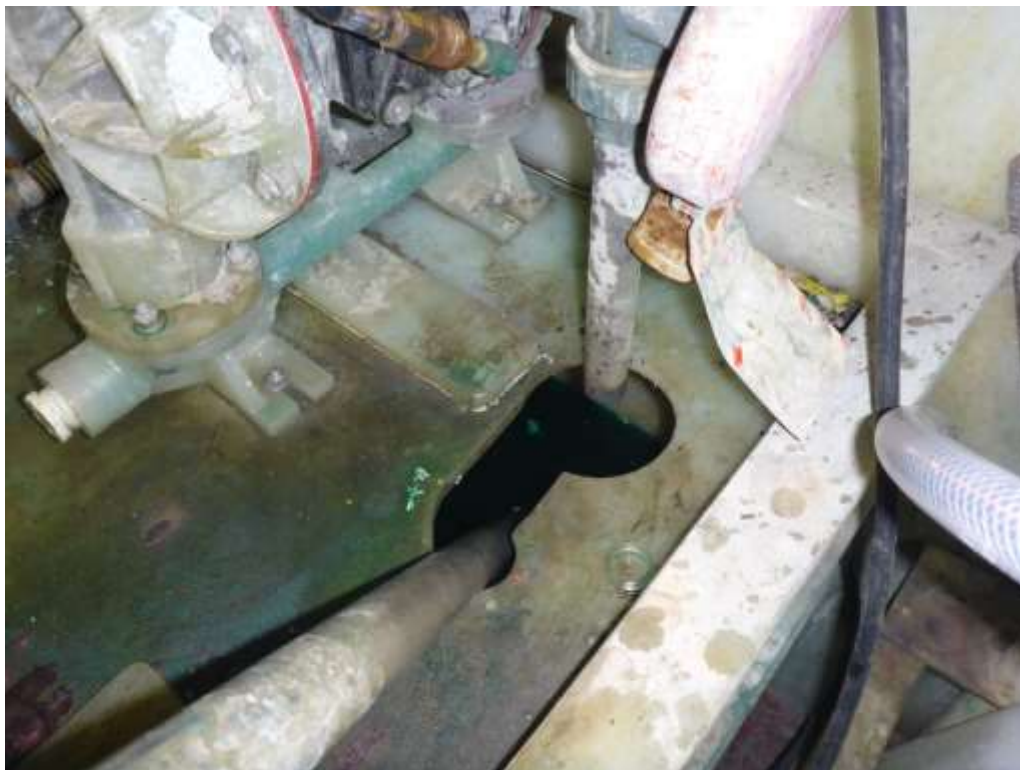
**Photo 10:** Hole built into the lid of the collection system and sump in the corner of the chemical storage area so that the pumping wand can be placed into the unit.

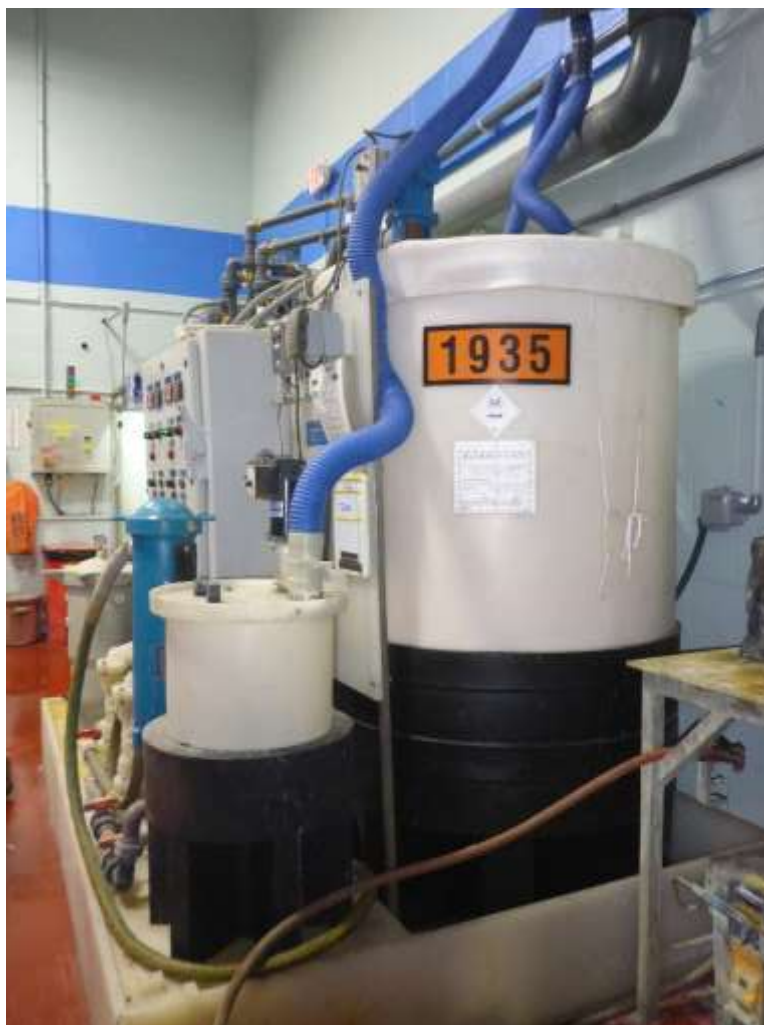
Possehl Connector Services manages hazardous waste liquids that contain precious metals in two 500-gallon storage tanks inside the chemical storage area (Photo #11). Each tank was labeled F007 / D003 hazardous waste cyanide solution (contains potassium cyanide) and identified with a poison hazard placard, but neither was identified with a reactive hazard placard. One tank was marked with an accumulation start date of 01/20/2020, and the other was marked with an accumulation start date of 01/14/2020. Both tanks were located within the same secondary containment unit. Liquids are pumped into these tanks from containers used to transfer the liquids from the point of generation to the tank. Liquids are kept circulating within each tank in order to prevent the precious metals from stratifying. This allows the facility to obtain a true representative sample of the material to estimate the amount of precious metals that may be recovered from the waste.

**Photo 11:** One of two 500-gallon storage tanks for managing hazardous waste liquids that contain precious metals inside the chemical storage area.

**Pursuant to 25 S.C. Code Ann. Regs. 61-79.262.17(a)(5)(ii)(B)\* [40 C.F.R. § 262.17(a)(5)(ii)(B)], which is a condition of the LQG Permit Exemption, a generator is required to mark or label tanks with an indication of the hazards of the contents.**

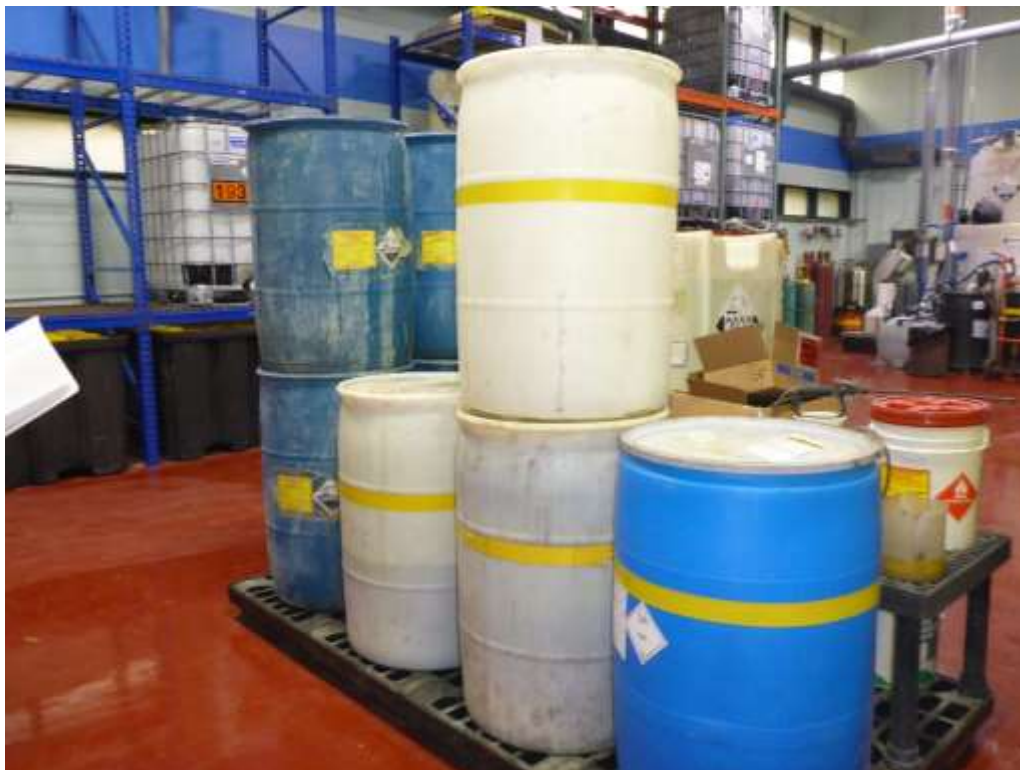
The inspectors observed two portable secondary containment pallets holding ten 55-gallon drums on the floor toward the center of the chemical storage area room (Photo #12). The five white poly drums held plating solution that will be returned to the plating process for further use. Four of the blue poly drums were labeled D002 / D008 hazardous waste corrosive liquid (phosphoric and methane sulfuric acid) and identified with a corrosive hazard placard. These drums are used to transfer hazardous waste from the point of generation to the sump tank in this area. Although the drums were not identified with a toxic hazard placard, they were all empty at the time of the inspection. The final drum (Photo #13) was labeled F007 hazardous waste toxic solid inorganic (potassium cyanide) and identified with a toxic hazard placard. The drum was dated 01/23/2020 and contained drained filters from the gold plating line. According to Mr. Davis, these filters will be sent off-site for precious metals recycling.

**Photo 12:** Two portable secondary containment pallets holding ten 55-gallon drums on the floor toward the center of the chemical storage area room.

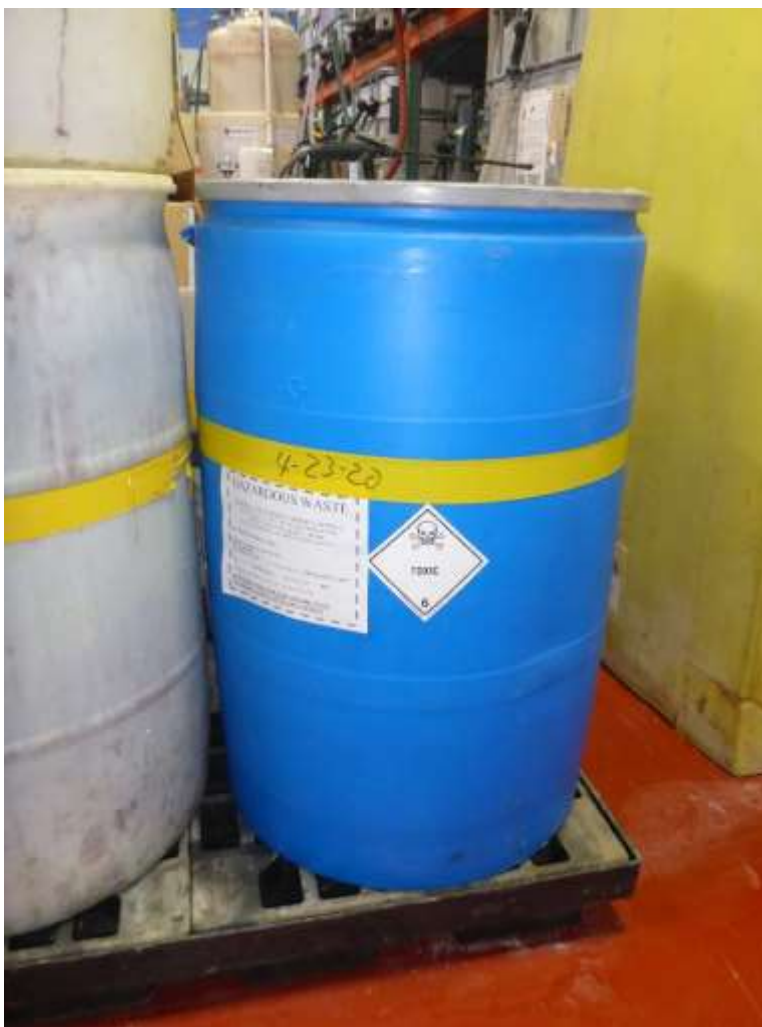
**Photo 13:** Drum of drained filters from the gold plating line labeled F007 hazardous waste toxic solid inorganic (potassium cyanide) and identified with a toxic hazard placard. The drum was marked with an accumulation start date of 01/23/2020.

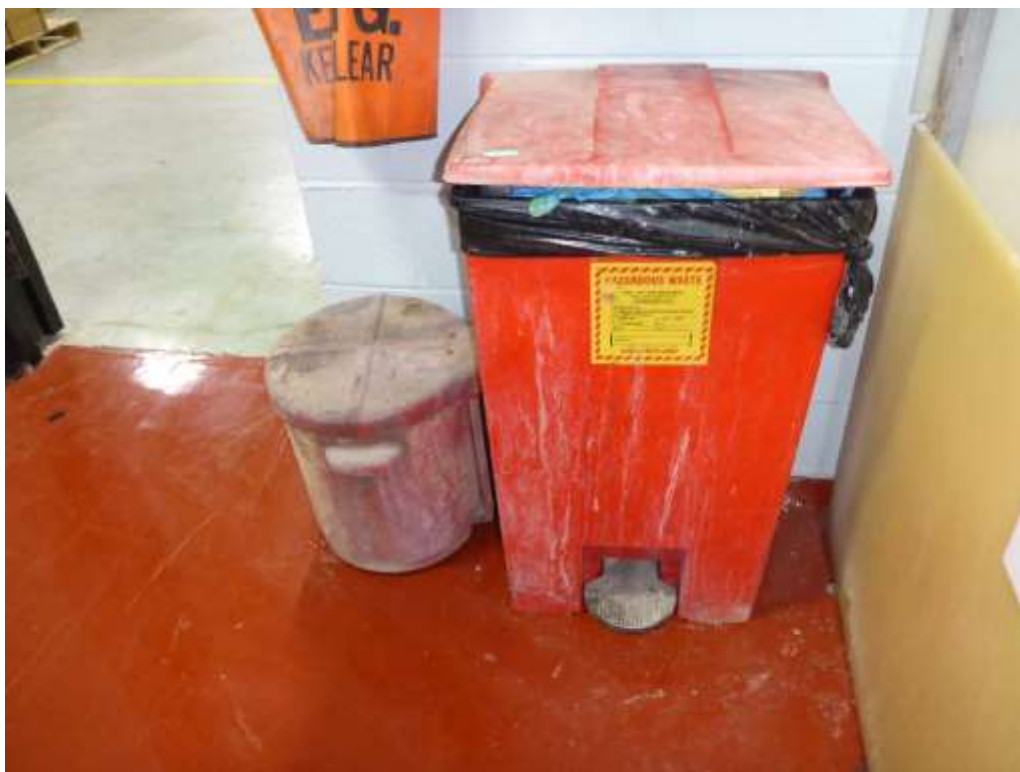
The second designated SAA was observed just inside the door near the wall on the far left in this room (Photo #14). The inspectors observed one 20-gallon step-to-open red trash can and one 5-gallon red step-to-open can in this SAA. The hazardous waste label observed on the 20-gallon container indicated that the waste was generated by Neco Metal Finishing, the company that operated at this location before Possehl Connector Services. The container appeared to be accumulating used PPE, absorbents and other solid hazardous wastes, and the volume of waste inside the container prevented the lid

**Photo 14:** SAA located just inside the door near the wall on the far left of the chemical storage area room.

**Pursuant to 25 S.C. Code Ann. Regs. 61-79.262.15(a)(4)\* [40 C.F.R. § 262.15(a)(4)], which is a condition of the SAA Permit Exemption, a generator is required to keep containers of hazardous waste closed at all times during accumulation, except when adding, removing, or consolidating waste; or when temporary venting of a container is necessary for the proper operation of equipment, or to prevent dangerous situations, such as build-up of extreme pressure.**

**Pursuant to 25 S.C. Code Ann. Regs. 61-79.262.15(a)(5)(ii)\* [40 C.F.R. § 262.15(a)(5)], which is a condition of the SAA Permit Exemption, a generator is required to mark or label containers with an indication of the hazards of the contents.**

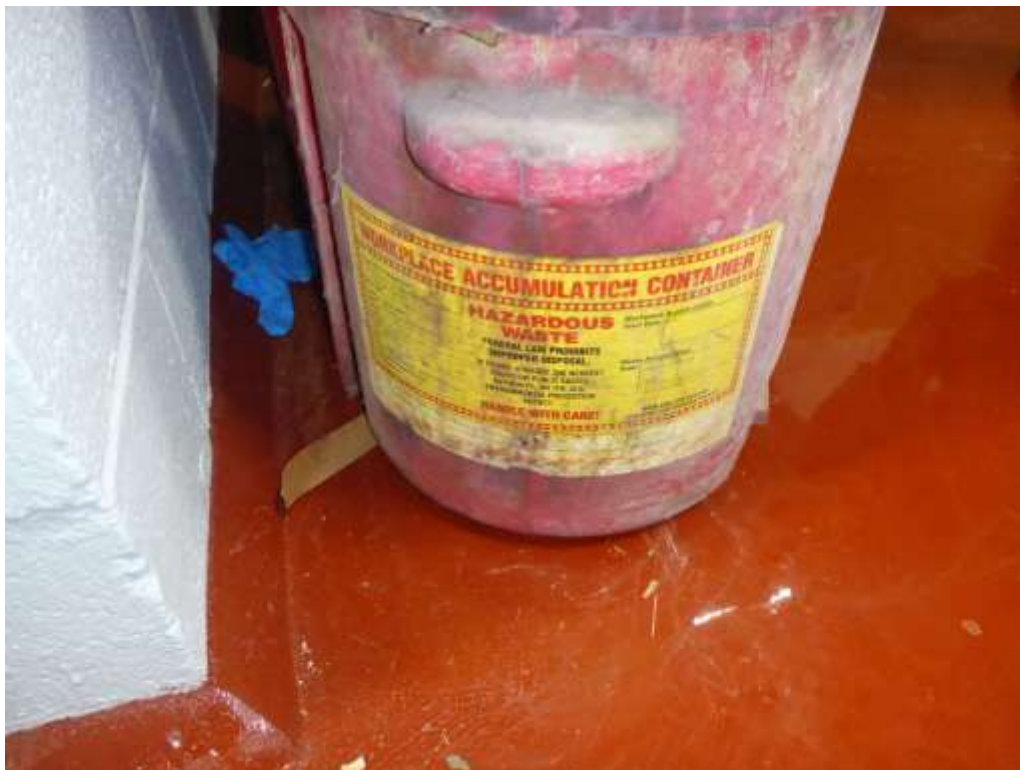
from closing completely. The container label did not include a description of the waste, and the container was not marked with an indication of the hazards of its contents. The 5-gallon container (Photo #15) was labeled as hazardous waste gold / palladium filters, but it was not marked with an indication of the hazards of its contents.

**Photo 15:** 5-gallon container at the SAA located just inside the door near the wall on the far left of the chemical storage area room.

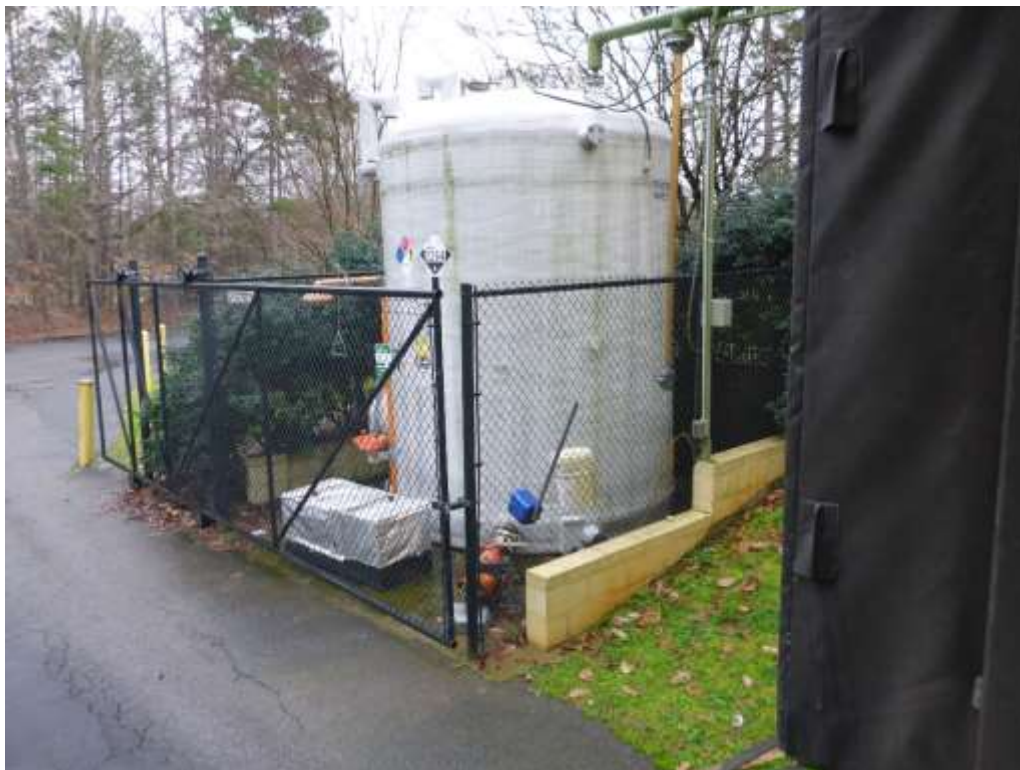
Outside: The inspectors observed a 5,000-gallon hazardous waste storage tank in an area just outside the bay door of the shipping and storage room (Photo #16). The tank was labeled as D002 / D008 hazardous waste, identified with a corrosive hazard placard, and marked with an accumulation start date of 02/04/2020. The tank was not identified with a toxic hazard placard. The inspectors did not observe a secondary containment dike surrounding the tank, but Mr. Davis explained that the it is a double-walled tank.

**Photo 16:** 5,000-gallon hazardous waste storage tank in an area just outside the bay door of the shipping and storage room.

**Pursuant to 25 S.C. Code Ann. Regs. 61-79.262.17(a)(5)(ii)(B)\* [40 C.F.R. § 262.17(a)(5)(ii)(B)], which is a condition of the LQG Permit Exemption, a generator is required to mark or label tanks with an indication of the hazards of the contents.**

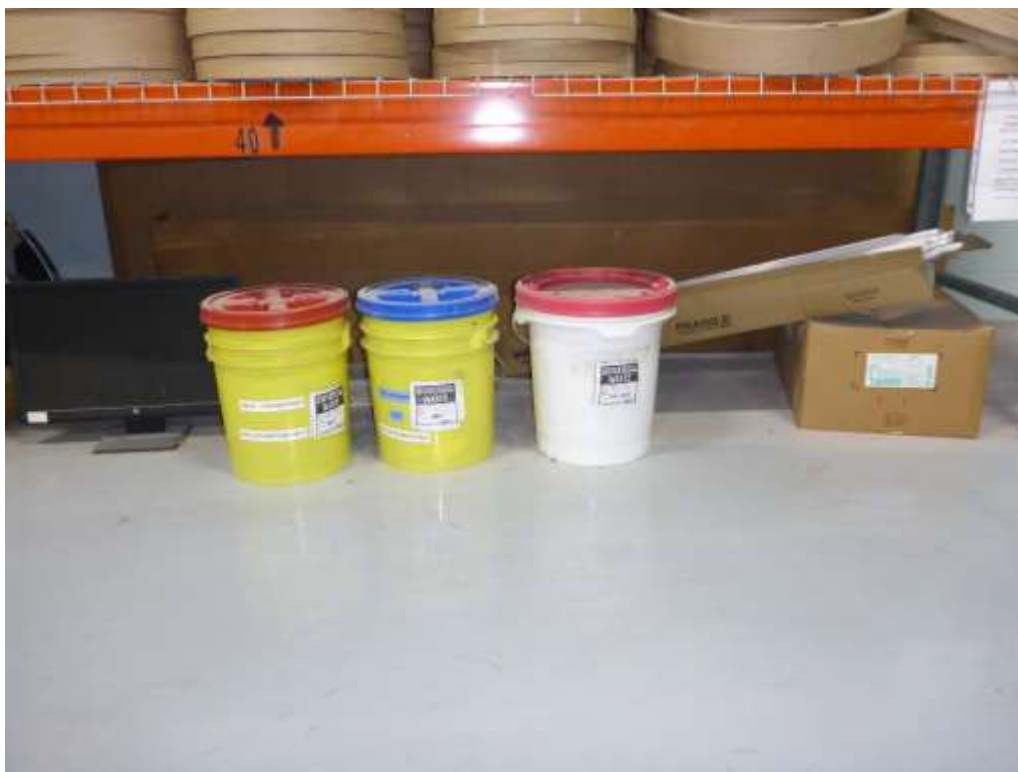
The inspectors observed three 5-gallon pails in this area during the inspection (Photo #17). The pails were all closed, labeled as universal hazardous waste, and dated 06/01/2015. One pail was labeled for lead-acid batteries; another was labeled for alkaline batteries; and the last pail was labeled for mercury devices.

**Photo 17:** Three 5-gallon pails of universal hazardous waste at the bottom of a shelving unit in the shipping and storage area.

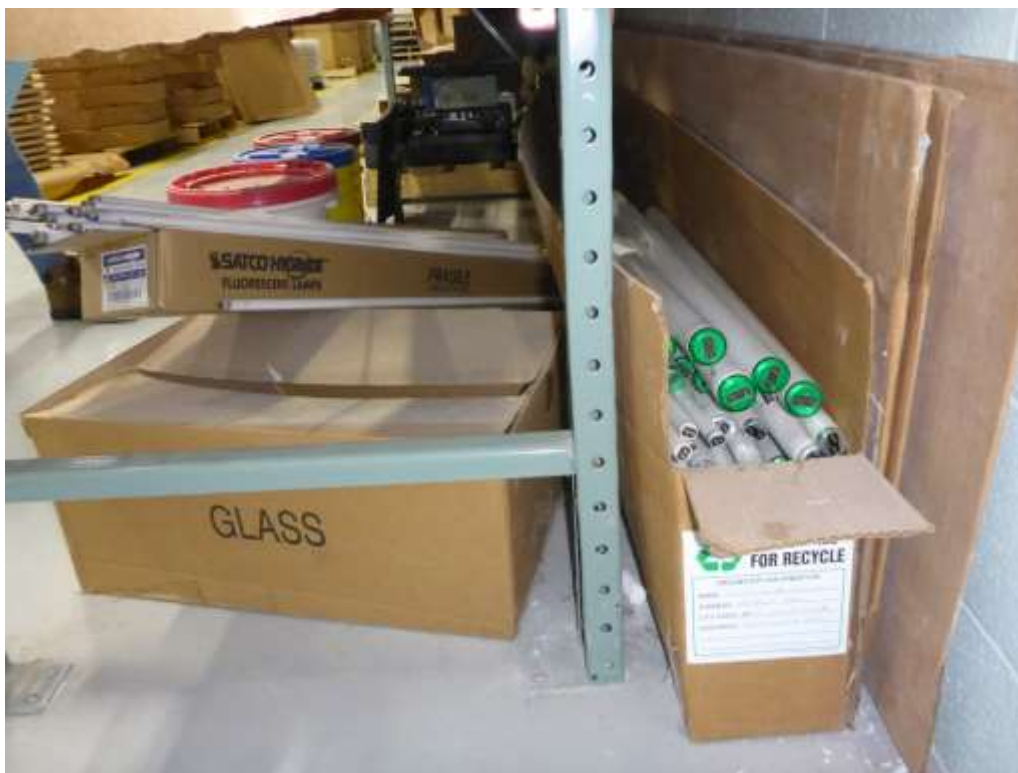
Universal hazardous waste fluorescent bulbs are also managed in this area (Photo #18). The inspectors observed one box of 4-foot used fluorescent lamps, which was open and not labeled. The inspectors also observed one box of 8-foot used fluorescent lamps, which was open and labeled universal waste. Finally, the inspectors observed a box of 4-

**Photo 18:** Containers of universal waste lamps at the bottom of a shelving unit in the shipping and storage area.

**Pursuant to 25 S.C. Code Ann. Regs. 61-79.273.13(d)(1) [40 C.F.R. § 273.13(d)(1)], a small quantity handler of universal waste must contain any lamp in containers or packages that are structurally sound, adequate to prevent breakage, and compatible with the contents of the lamps. Such containers and packages must remain closed and must lack evidence of leakage, spillage or damage that could cause leakage under reasonably foreseeable conditions.**

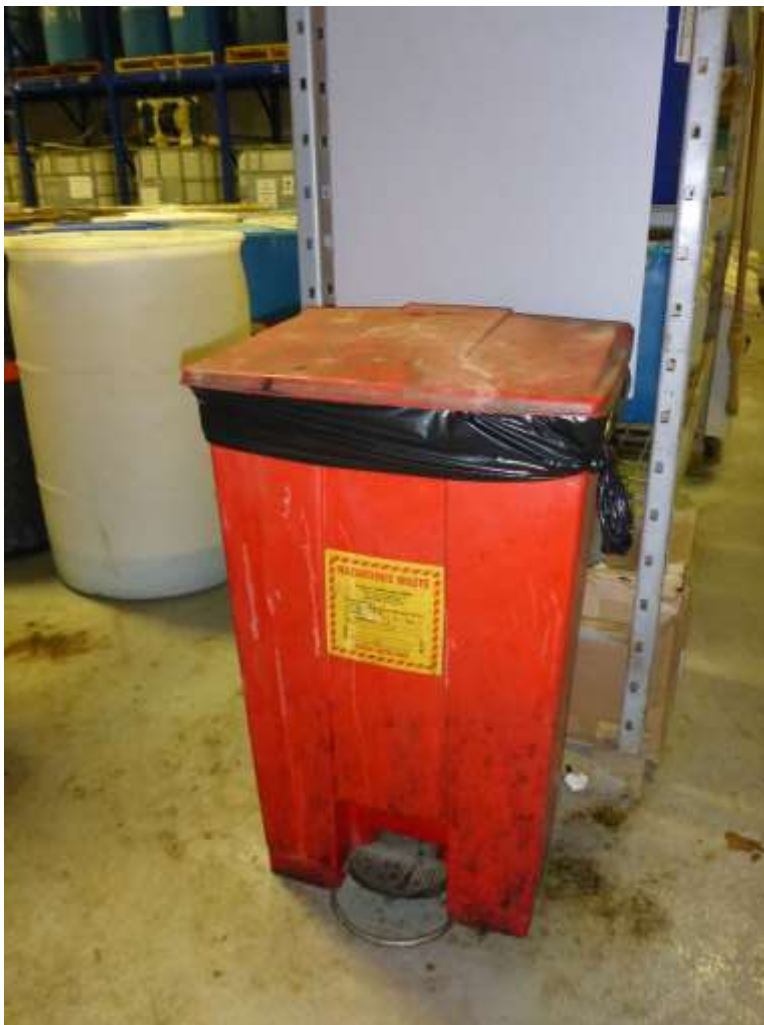
Process Chemical Storage Area: The facility manages a SAA inside the process chemical storage area, and the inspectors observed one 20-gallon step-to-open red trash can in this SAA (Photo #19). The hazardous waste label observed on the 20-gallon container indicated that the waste was generated by Neco Metal Finishing, the company that operated at this location before Possehl Connector Services. The container appeared to be accumulating used PPE, absorbents and other solid hazardous wastes, but the container label did not include a description of the waste. The container was not marked with an indication of the hazards of its contents.

**Photo 19:** SAA inside the process chemical storage area for accumulating used PPE, absorbents and other solid hazardous wastes.

**Pursuant to 25 S.C. Code Ann. Regs. 61-79.262.15(a)(5)(ii)\* [40 C.F.R. § 262.15(a)(5)], which is a condition of the SAA Permit Exemption, a generator is required to mark or label containers with an indication of the hazards of the contents.**
