## **RCRA Inspection Report**

Giant Cement Company  
654 Judge St  
Harleyville, South Carolina 29448  
EPA ID SCD003351699

June 30, 2022, 9:05am

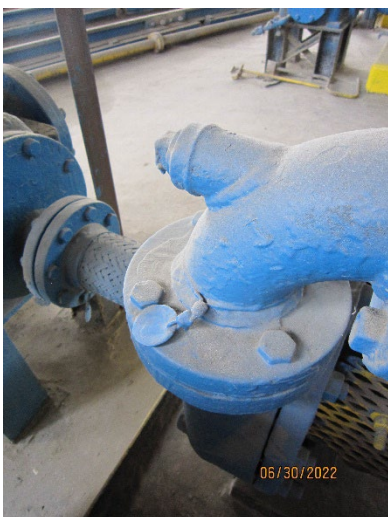
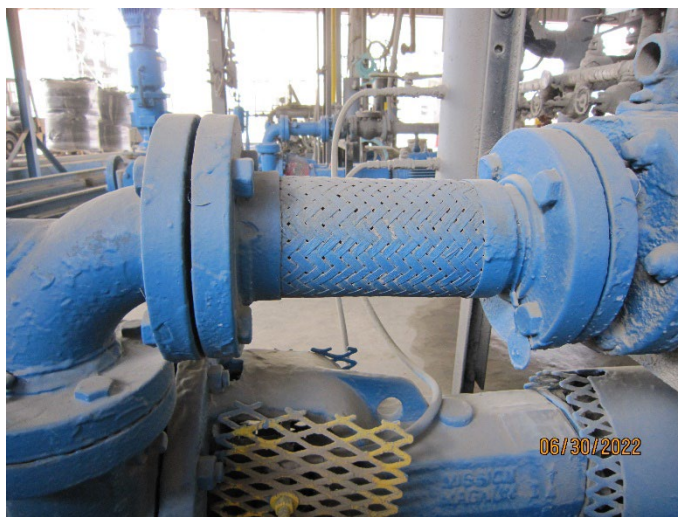
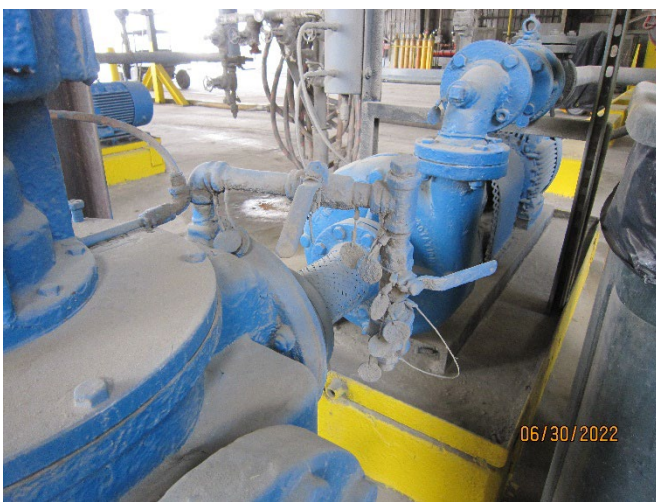
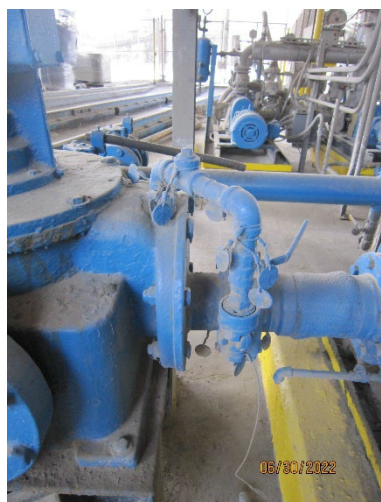
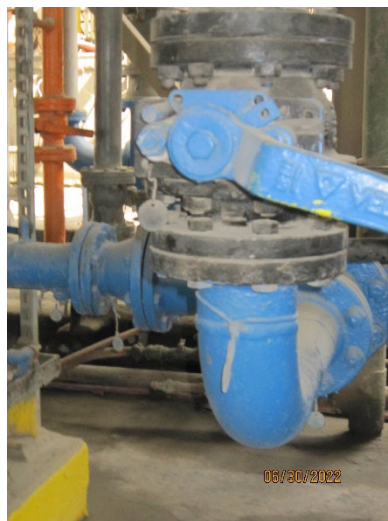
This loading area is where railcars containing hazardous blended fuels are pumped into the tank farm for energy use in their kiln. The inspectors observed several tags associated with ancillary equipment connected to the LWDF storage tanks, and all the tags observed were not legible (Photographs 1-4 and Photograph 6). The inspectors could not read tags located at pumps near the LWDF Control Room. The inspectors asked facility personnel their reasoning as to why they were unreadable; they responded that it was due to coats of paint relating to dust maintenance. Two closed 5-gallon containers were found labeled "Hazardous Waste" with EPA waste codes F001, F005, D001, D006, and D008, and an indication of the hazards of the contents (Photograph 5). Facility personnel mentioned that they were left there for use in cleaning up any residual spills from the railcars transferring waste to the pumps. The inspectors found one 2-gallon container and one 55-gallon container of solid debris dated May 27, 2022 in their satellite accumulation area (SAA) (Photograph 7-8). Facility personnel called this SAA a "one-year permitted storage area" and mentioned that it was an applicable standard under their permit.

LWDF Loading Area equipment with indistinguishable tags. Photograph 1 taken at 10:34am

LWDF Loading Area equipment with indistinguishable tags. Photograph 2 taken at 10:34am

LWDF Loading Area equipment with indistinguishable tags. Photograph 3 taken at 10:34am

LWDF Loading Area equipment with indistinguishable tags. Photograph 4 taken at 10:35am

LWDF Loading Area equipment with indistinguishable tags. Photograph 6 taken at 10:39am

**Pursuant to HW Permit SCD003351699, IV.D.3. Air Emission Standards, the Permittee shall insure that all hazardous wastes placed in tanks are managed in compliance with R.61-79.264.200 [40 C.F.R. § 264.200]. Pursuant to R.61-79.264.200 [40 C.F.R. §264.200], which incorporates R.61-79.264 Subpart BB [40 C.F.R. Part 264 Subpart BB], each piece of equipment to which this subpart applies shall be marked in such a manner that it can be distinguished readily from other pieces of equipment as required by R.61-79.264.1050(d) [40 C.F.R. § 264.1050(d)].**

**Pursuant to HW Permit SCD003351699, XI.B. Emission Control Technology, which incorporates the applicable requirements of R.61-79.264 Subparts AA and BB [40 C.F.R. Part 264 Subparts AA and BB], each piece of equipment to which this subpart applies shall**

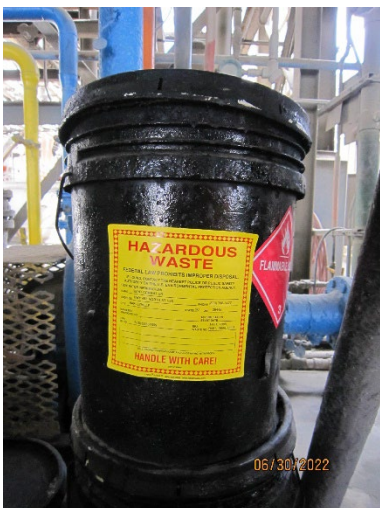
LWDF Loading Area containers found. Photograph 5 taken at 10:38am

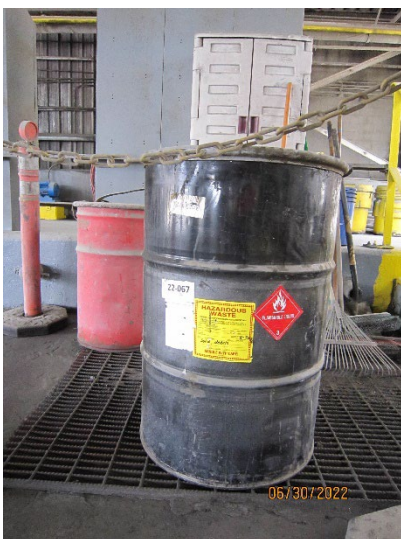
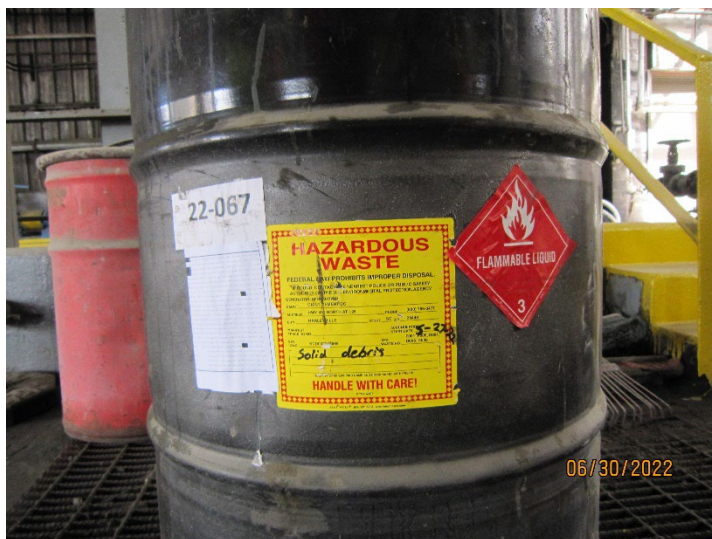
LWDF Loading Area permitted SAA. Photograph 7 taken at 10:40am

LWDF Loading Area permitted SAA. Photograph 8 taken at 10:42am

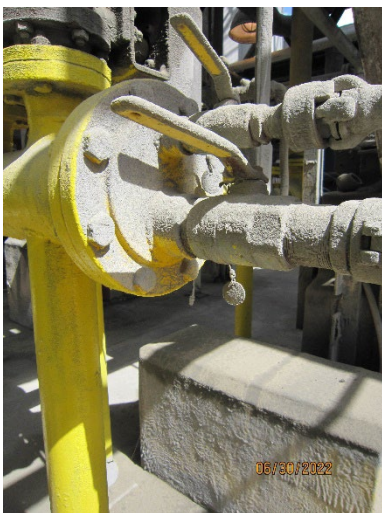
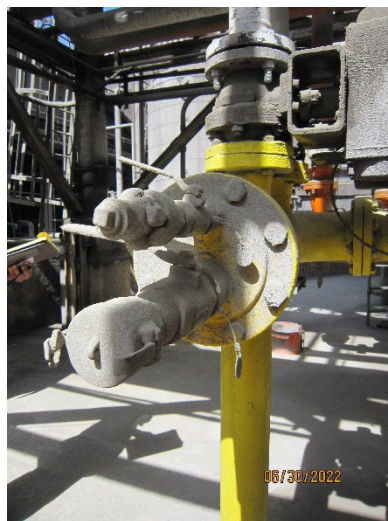
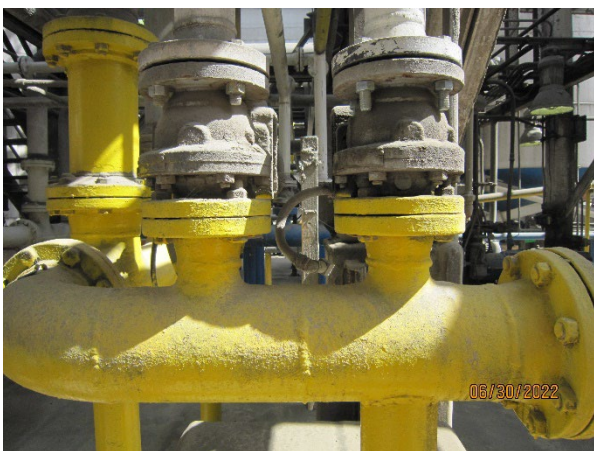
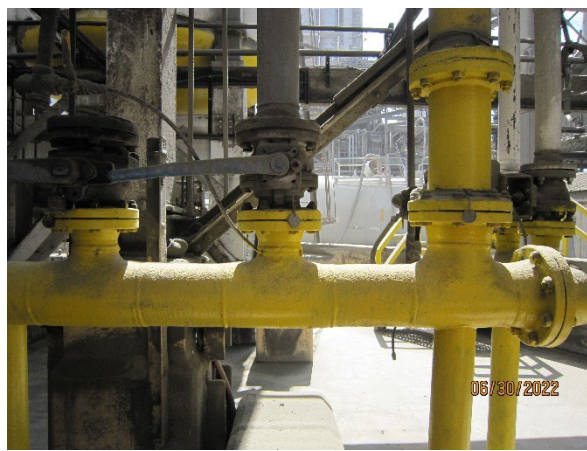
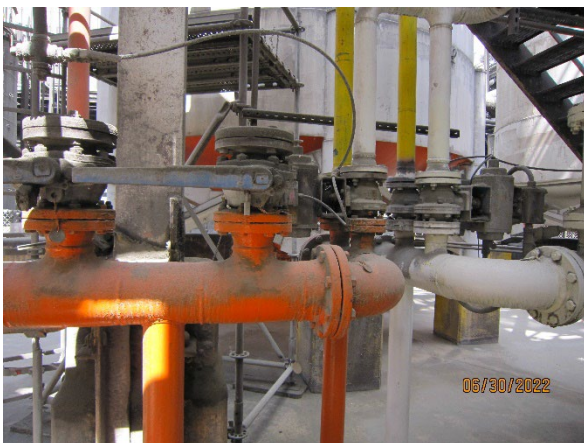
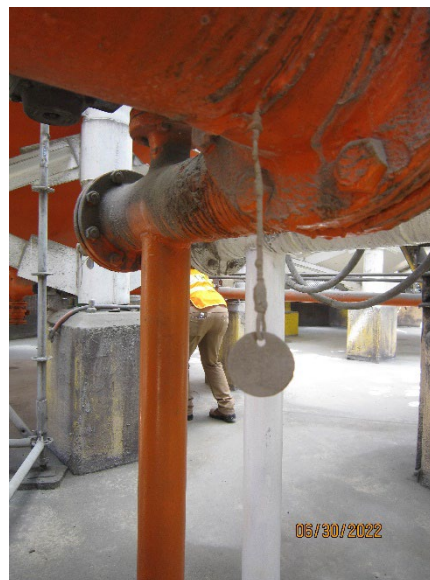
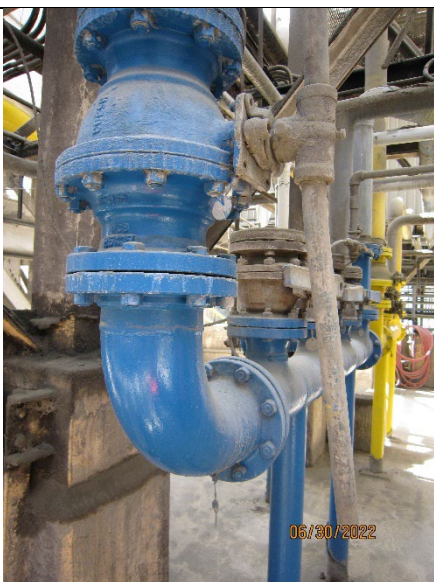
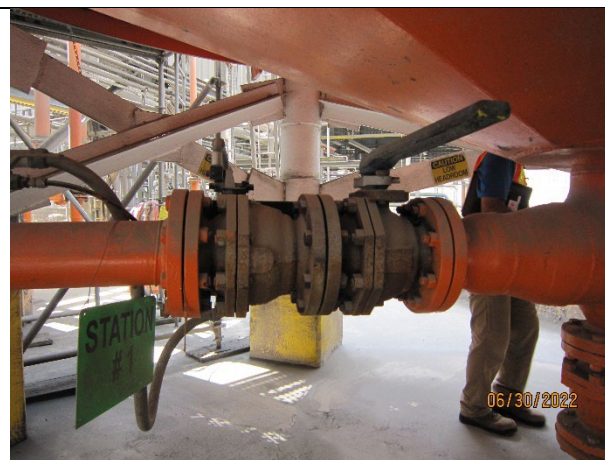
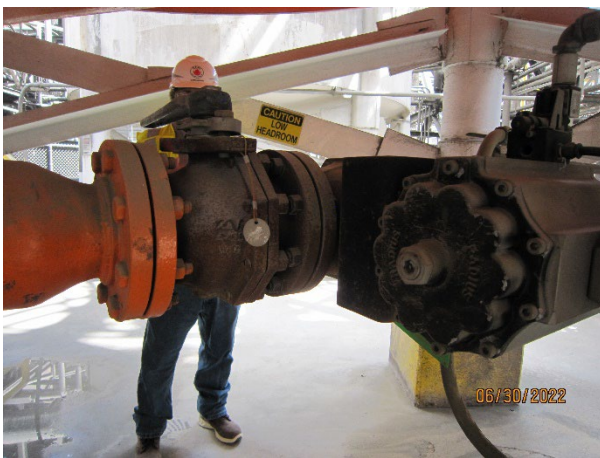
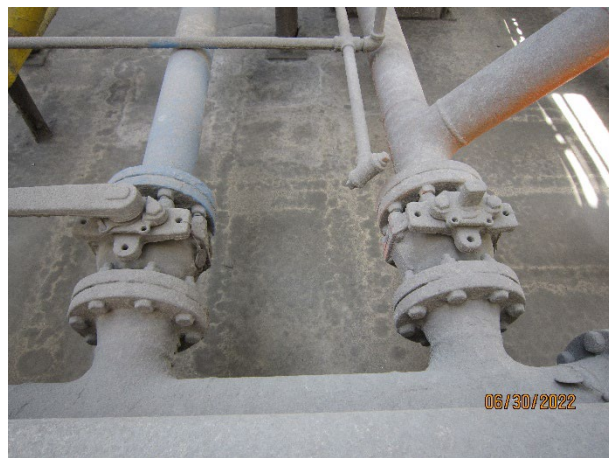
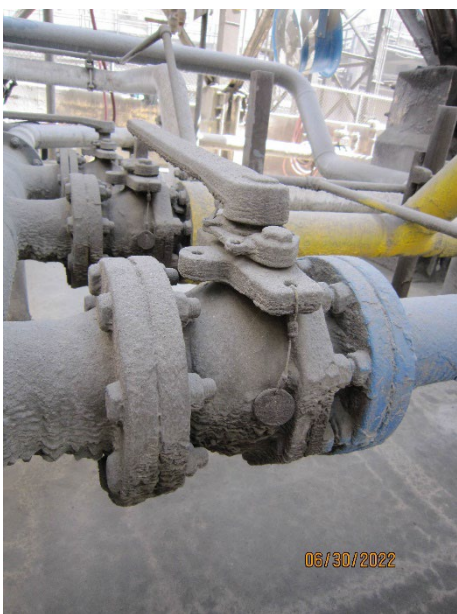
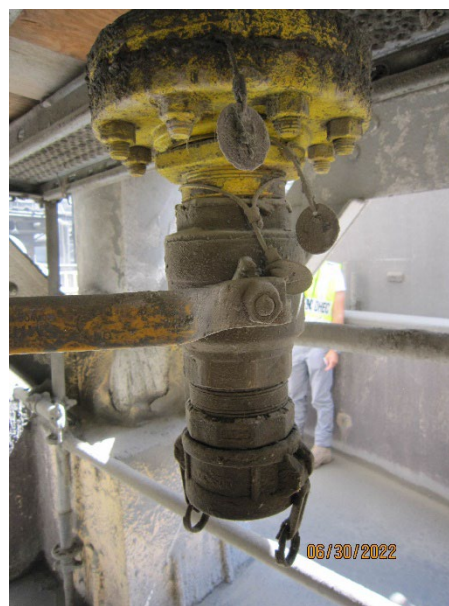
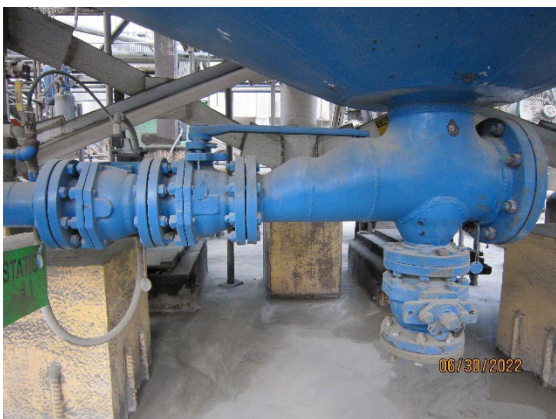
Multiple instances within the tank farm displayed tags that were unreadable due to coats of dust and paint (Photographs 9-21). Facility personnel mentioned that certain tags contained multiple connections (e.g., 5 connections correspond to one tag). Inspectors discovered three (3) 5-gallon containers within the tank farm; of which two contained tubing and one left opened (Photographs 23 and 24). Two containers were labeled “Hazardous Waste” with no indication of the hazards of the contents and one container potentially displaying no hazardous waste label or an indication of the hazards of the contents. Inspectors asked facility personnel to repaint, or properly clean the hazardous waste labels, Department of Transportation (DOT) placards, and the NFPA 704 labels displayed on the tanks as they were difficult to read from the amount of dust covered.

Tank Farm area with indistinguishable tags on equipment. Photograph 9 taken at 10:45am

Tank Farm area with indistinguishable tags on equipment. Photograph 10 taken at 10:47am

Tank Farm area with indistinguishable tags on equipment. Photograph 11 taken at 10:48am

Tank Farm area with indistinguishable tags on equipment. Photograph 12 taken at 10:49am

Tank Farm area with indistinguishable tags on equipment. Photograph 13 taken at 10:50am

Tank Farm area with indistinguishable tags on equipment. Photograph 14 taken at 10:50am

Tank Farm area with indistinguishable tags on equipment. Photograph 15 taken at 10:51am

Tank Farm area with indistinguishable tags on equipment. Photograph 16 taken at 10:53am

Tank Farm area with indistinguishable tags on equipment. Photograph 17 taken at 10:53am

Tank Farm area with indistinguishable tags on equipment. Photograph 18 taken at 10:57am

Tank Farm area with indistinguishable tags on equipment. Photograph 19 taken at 10:57am

Tank Farm area with indistinguishable tags on equipment. Photograph 20 taken at 10:59am

Tank Farm area with indistinguishable tags on equipment. Photograph 21 taken at 11:01am

**Pursuant to HW Permit SCD003351699, IV.D.3. Air Emission Standards, the Permittee shall insure that all hazardous wastes placed in tanks are managed in compliance with R.61-79.264.200 [40 C.F.R. § 264.200]. Pursuant to R.61-79.264.200 [40 C.F.R. §264.200], which incorporates R.61-79.264 Subpart BB [40 C.F.R. Part 264 Subpart BB], each piece of equipment to which this subpart applies shall be marked in such a manner that it can be distinguished readily from other pieces of equipment as required by R.61-79.264.1050(d) [40 C.F.R. § 264.1050(d)].**

**Pursuant to HW Permit SCD003351699, XI.B. Emission Control Technology, which incorporates the applicable requirements of R.61-79.264 Subparts AA and BB [40 C.F.R. Part 264 Subparts AA and BB], each piece of equipment to which this subpart applies shall be marked in such a manner that it can be distinguished readily from other pieces of equipment as required by R.61-79.264.1050(d) [40 C.F.R. § 264.1050(d)].**

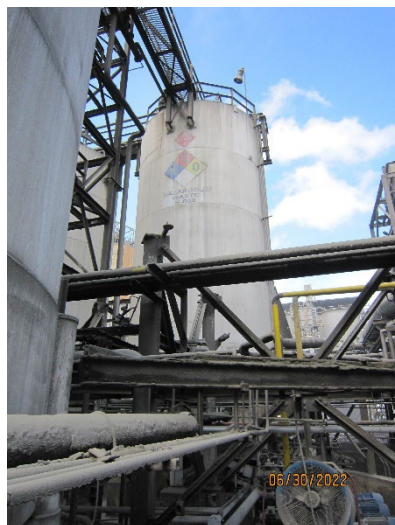
- 2) Main Burner Tank (K-802) had a Flammable label and a NFPA 704 label with a Health Hazard (blue) of 2, Flammability Hazard (red) of 2, and Stability Hazard (yellow) of 0 (Photograph 22).

Tank Farm area hazardous waste tank labels. Photograph 22 taken at 11:02am

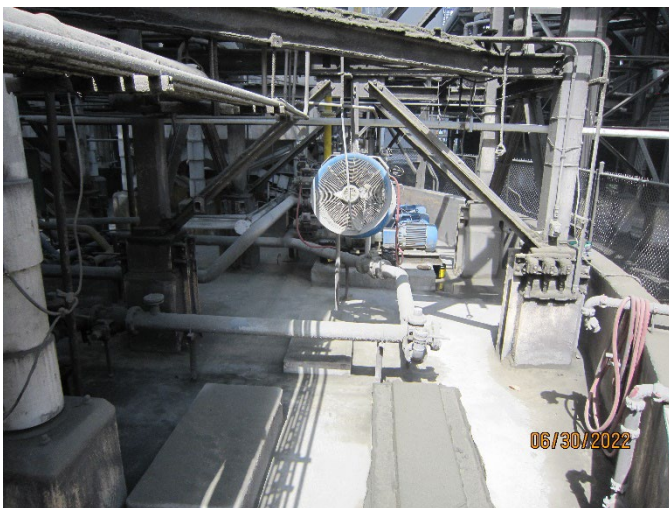
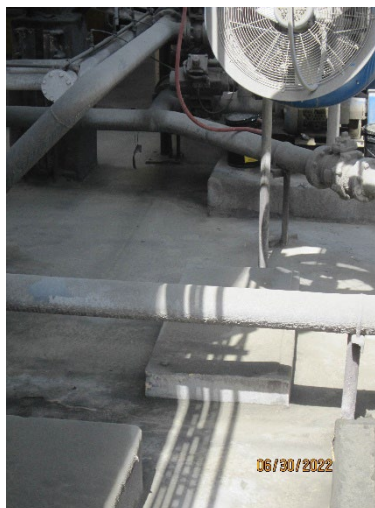
Tank Farm area with three (3) containers; two (2) with tubing and one (1) left open. Photograph 23 taken at 11:02am

Tank Farm area with tubing connected to containers. Photograph 24 taken at 11:03am

**Pursuant to S.C. Code Ann. Regs. 61-79.262.17(a)(1)(iv) [40 C.F.R. § 262.17(a)(1)(iv)], which is a condition of the LQG Permit Exemption, (A) a container holding hazardous waste must always be closed during accumulation, except when it is necessary to add or remove waste; and (B) A container holding hazardous waste must not be opened, handled, or stored in a manner that may rupture the container or cause it to leak.**

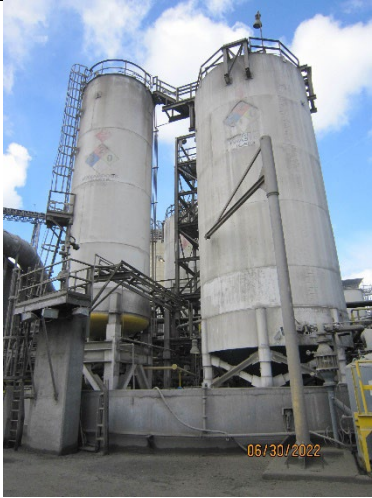
- 1) Calciner Burner Tank (K-801) was labeled with a National Fire Prevention Association (NFPA) 704 label included a Health Hazard (blue) of 2, Flammability Hazard (red) of 2, and Stability Hazard (yellow) of 0; from 0 being a minimal hazard to 4 being a severe hazard under the Occupational Safety and Health Administration (OSHA) Hazard Communication Standard (Photograph 25).

- 4) Cold Blend Tank (K-666) had a Flammable label and a NFPA 704 label with a Health Hazard (blue) of 2, Flammability Hazard (red) of 2, and Stability Hazard (yellow) of 0 (Photograph 25).

**Pursuant to S.C. Code Ann. Regs. 61-79.262.17(a)(5)(ii) [40 C.F.R. § 262.17(a)(5)(ii)], which is a condition of the LQG Permit Exemption, a generator must mark or label its tanks with the words “Hazardous Waste”; mark or label its tanks with an indication of the hazards of the contents; use inventory logs, monitoring equipment or other records to demonstrate that hazardous waste has been emptied within 90 days of first entering the tank; and keep inventory logs or records with the above information on site and readily available for inspection.**

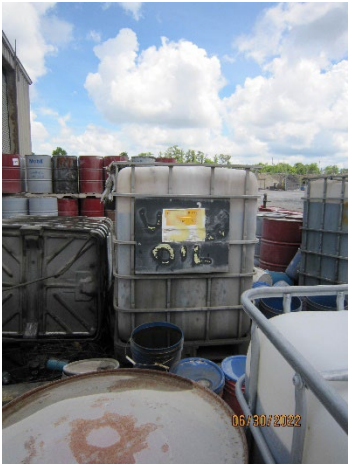
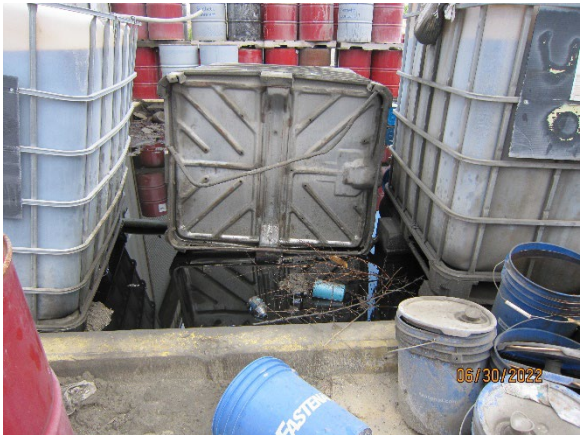
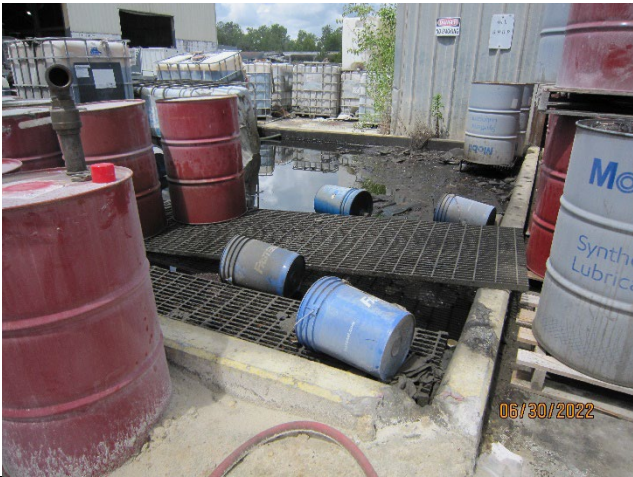
This area is adjacent to their Lube Shop and provides maintenance to their machinery. The inspectors observed four (4) 275-gallon containers, one of which was tipped over/broken (Photographs 26-28). The inspectors could not access and read labels of the used oil containers because oil/water was pooling in the secondary containment (Photograph 28). It appears that the facility was not maintaining and managing released used oil within the secondary containment. The inspectors instructed the facility to clean-up secondary containment and mark used oil containers stored adjacent to the Lube shop.

| Tank Farm area hazardous waste tank labels. Photograph 25 taken at 11:06am | Used Oil area with 275-gallon container labeled "Used Oil." Photograph 26 taken at 11:51am |
| Used Oil area with broken 275-gallon container. Photograph 27 taken at 11:52am | Used Oil area consisting of oil sheens. Photograph 28 taken at 11:52am |

**Pursuant to S.C. Code Ann. Regs. 61-79.279.22(d) [40 C.F.R. § 279.22(d)], upon detection of a release of used oil to the environment, the facility must clean up and manage properly the released used oil and other materials.**

**Pursuant to S.C. Code Ann. Regs. 61-79.279.22(c)(1) [40 C.F.R. § 279.22(c)(1)], containers and aboveground tanks used to store used oil at generator facilities must be labeled or marked clearly with the words “Used Oil.”**

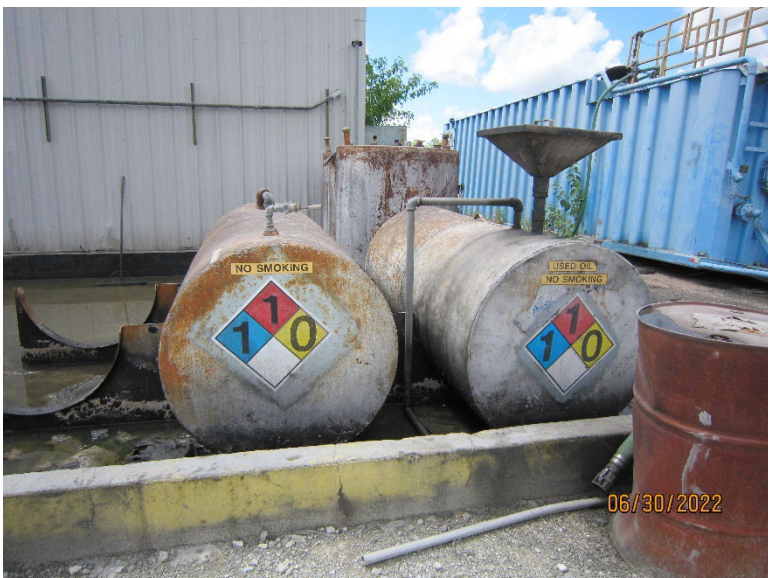
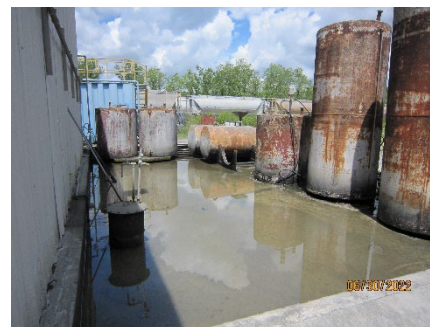
This tank farm included product tanks and two (2) 500-gallon used oil tanks (Photograph 29). The inspectors noticed the secondary containment also consisted of spilled oil sheens (Photograph 30). Facility personnel mentioned that they will clean up their secondary containments and have the used oil put in frac tanks sent to Giant Resource Recovery (GRR) Attala.

Product and Used Oil tank farm. Photograph 29 taken at 11:55am

Product and Used Oil tank farm consisting of oil sheens. Photograph 30 taken at 11:58am

**Pursuant to S.C. Code Ann. Regs. 61-79.279.22(d) [40 C.F.R. § 279.22(d)], upon detection of a release of used oil to the environment, the facility must clean up and manage properly the released used oil and other materials.**

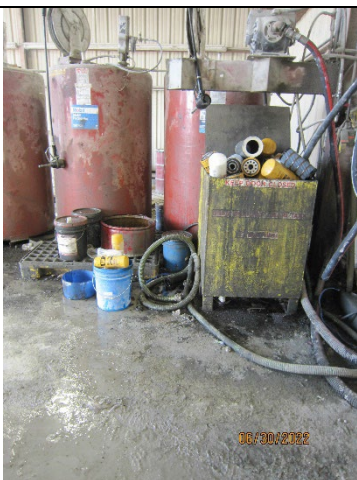
The oil shop adjacent to the product and used oil tank farm provides maintenance service to vehicles operating in the facility. Inspectors noticed one 40-gallon container and one 5-gallon container overfilled with oil filters (Photograph 31).

Oil Shop with containers overfilled with used oil filters. Photograph 31 taken at 11:59am

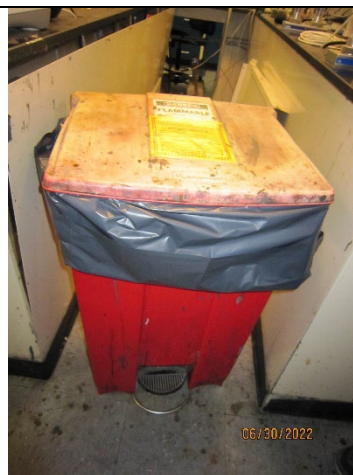
SAA Solids Area: Giant Cement manages a SAA in their SAA Solids Area for managing hazardous waste solids generated by lab sampling. The inspectors observed one (1) 30-gallon container in this SAA (Photograph 32). The container was in the middle of two lab countertops holding lab equipment, and it was equipped with a flip top lid, which was closed. The container was labeled “Hazardous Waste” with F005, D001, D006, D008 EPA hazardous waste codes, and an indication of the hazards of the contents were identified with a “Flammable” label..

SAA Solids Area. Photograph 32 taken at 1:45pm

**Pursuant to S.C. Code Ann. Regs. 61-79.262.15(a)(4) [40 C.F.R. § 262.15(a)(4)], which is a condition of the SAA Permit Exemption, a generator is required to keep containers of hazardous waste closed at all times during accumulation, except when adding, removing, or consolidating waste; or when temporary venting of a container is necessary for the proper operation of equipment, or to prevent dangerous situations, such as build-up of extreme pressure.**

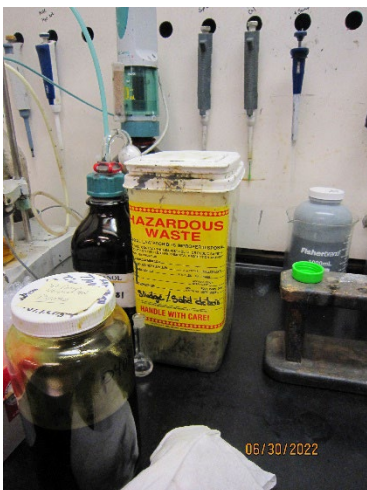
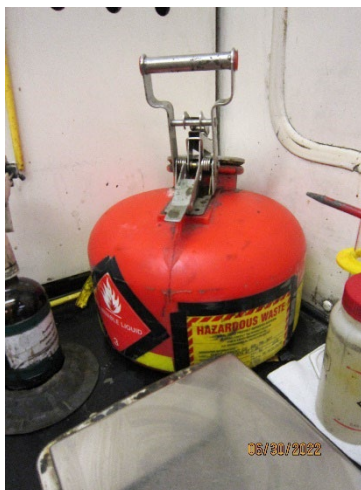
SAA Liquids Area: Giant Cement manages a SAA in their SAA Liquids Area for managing hazardous waste sludge/solid debris that is generated by lab sampling. The inspectors observed one (1) 0.6-gallon and one (1) 2-gallon container in this SAA (Photographs 33-34). The containers were located inside a lab ventilation hood and were equipped with a flip top and latched lid, respectively; both of which were closed. The containers were labeled F001-F005, D001, D006, and D008 hazardous waste. The 0.6-gallon container was named sludge/solid debris, both the 0.6-gallon and 2-gallon containers were identified with an indication of hazards of the contents.

SAA Liquids Area. Photograph 33 taken at 1:45pm

SAA Liquids Area. Photograph 34 taken at 1:45pm

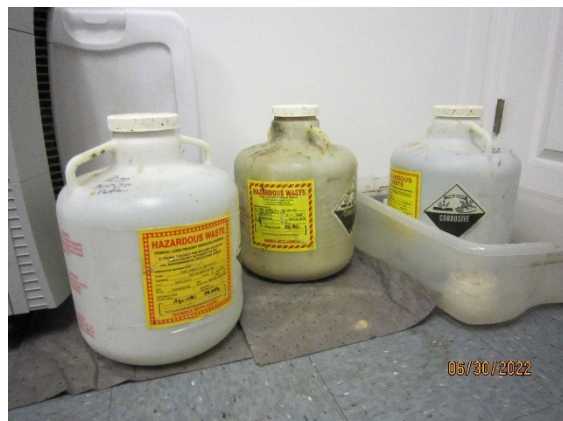
Metals Analysis Room (ICP Room): Giant Cement manages a SAA in their Metals Analysis Room for managing hazardous waste generated by lab sampling. The inspectors observed one (1) 30-gallon container and seven (6) 5-gallon containers in this SAA. The 30-gallon container was located near the corner door leading to the SAA Metals Prep, and was equipped with a flip top lid, which was closed. The container was labeled F001-F005, D001, F006, F008 hazardous waste, and identified with an indication of hazards of the contents. The 5-gallon containers were in multiple areas underneath lab equipment and near the rear door, equipped with a bottle cap with some connected tubing, of which one of the containers was partially open (Photograph 37). The containers were labeled F001-F005, D001, D006, D008 hazardous waste, and identified with an indication of hazards of the contents, corrosive labels (Photographs 32- 38). Two (2) 5-gallon containers were found full and missing the required accumulation start date. Since the total volumetric number for containers exceeded the required 55-gallon limit for satellite accumulation areas (SAA), accumulation start dates should be labeled and removal of excess should also be within three consecutive calendar days.

ICP Room. Photograph 35 taken at 1:56pm

ICP Room. Photograph 36 taken at 1:57pm

ICP Room 5-gallon container partially open.  
Photograph 37 taken at 1:59pm

ICP Room. Photograph 38 taken at 2:01pm

**Pursuant to S.C. Code Ann. Regs. 61-79.262.15(a)(6)(ii) [40 C.F.R. § 262.15(a)(6)(ii)], which is a condition of the SAA Permit Exemption, a generator who accumulates either acute hazardous waste listed in § 261.31 or § 261.33(e) of this chapter or non-acute hazardous waste in excess of the amounts listed in paragraph (a) of this section at or near any point of generation must remove the excess from the satellite accumulation area within three consecutive calendar days to a central accumulation area or to an on-site interim status or permitted treatment, storage, or disposal facility.**

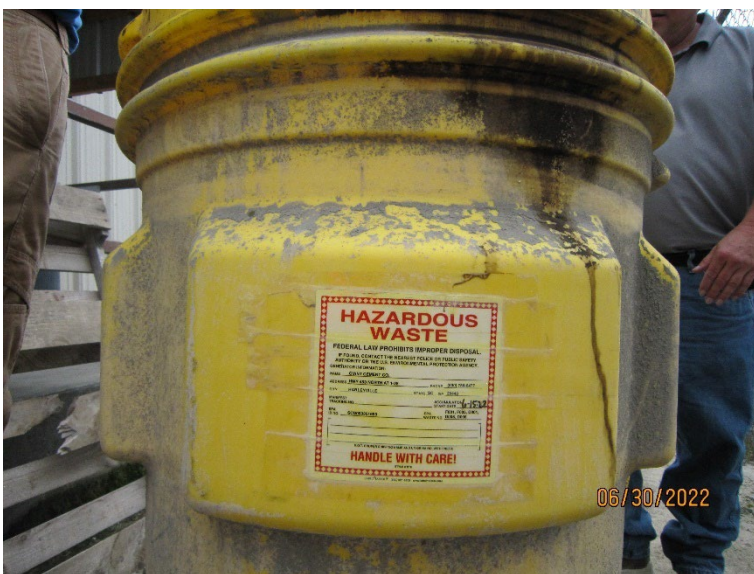
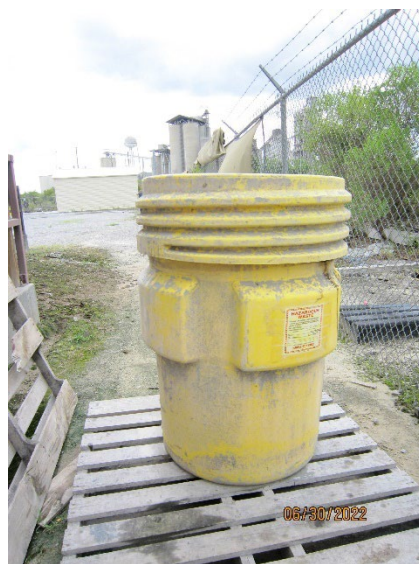
90-Day Storage Central Accumulation Area (CAA): Giant Cement manages a hazardous waste CAA in the 90 Day Storage Area. Their CAA is located outside their laboratory building. The facility manages ignitable waste in this CAA, and the inspectors did not observe “No Smoking”

signs within or near the CAA.

The area is not equipped with an internal communications or alarm system capable of providing immediate emergency instruction to facility personnel; it is not equipped with a device capable of summoning emergency assistance from local police departments, fire departments, or state or local emergency response teams; it is not equipped with portable fire extinguishers, fire control equipment, spill control equipment, and decontamination equipment; and it is not equipped with water to supply water hose streams, or foam producing equipment, or automatic sprinklers, or water spray system. Inspectors observed one (1) 55-gallon container within an overpack stored on a wooden pallet (Photographs 39-40). The container was closed, labeled F001, F005, D001, D006, D008 hazardous waste, identified with an indication of hazards of the contents, and dated June 15, 2022.

90-Day Storage Central Accumulation Area. Photograph 39  
taken at 2:04pm

90-Day Storage Central Accumulation Area. Photograph 40  
taken at 2:05pm
