SUBJ: Resource Conservation and Recovery Act (RCRA) Compliance Evaluation Inspection (CEI)  
Valmont Composite Structures  
EPA ID# SCD006540983

## **RCRA Inspection Report**

Valmont Composite Structures EPA ID# SCD006540983  
19845 US Hwy 76  
Newberry, South Carolina 29108

December 5, 2019

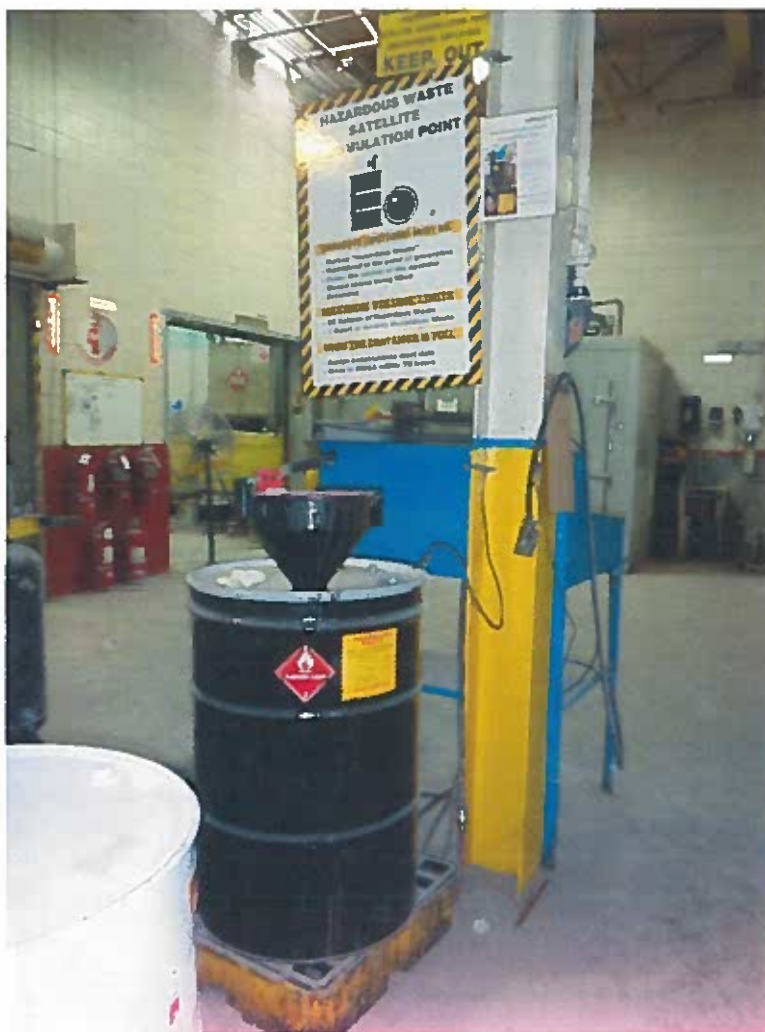
Valmont manages a SAA for accumulating waste acetone used during cleaning operations at the Shakespeare Protrusion Line (Photo 1). The inspectors observed one 55-gallon drum in this SAA, which was located just outside the door to the Mixing Room. The drum was equipped with a latched funnel lid, and it was situated on a portable secondary containment unit. The drum was labeled D001 / D035 / F003 / F005 hazardous waste acetone (acetone / MEK), and it was identified with a flammable liquid hazard placard. Mr. Senn estimated that this drum is filled and replaced about twice each month.

**Photo 1:** SAA located just outside the Mixing Room for accumulating waste acetone used in cleaning protrusion machines in the Shakespeare area.

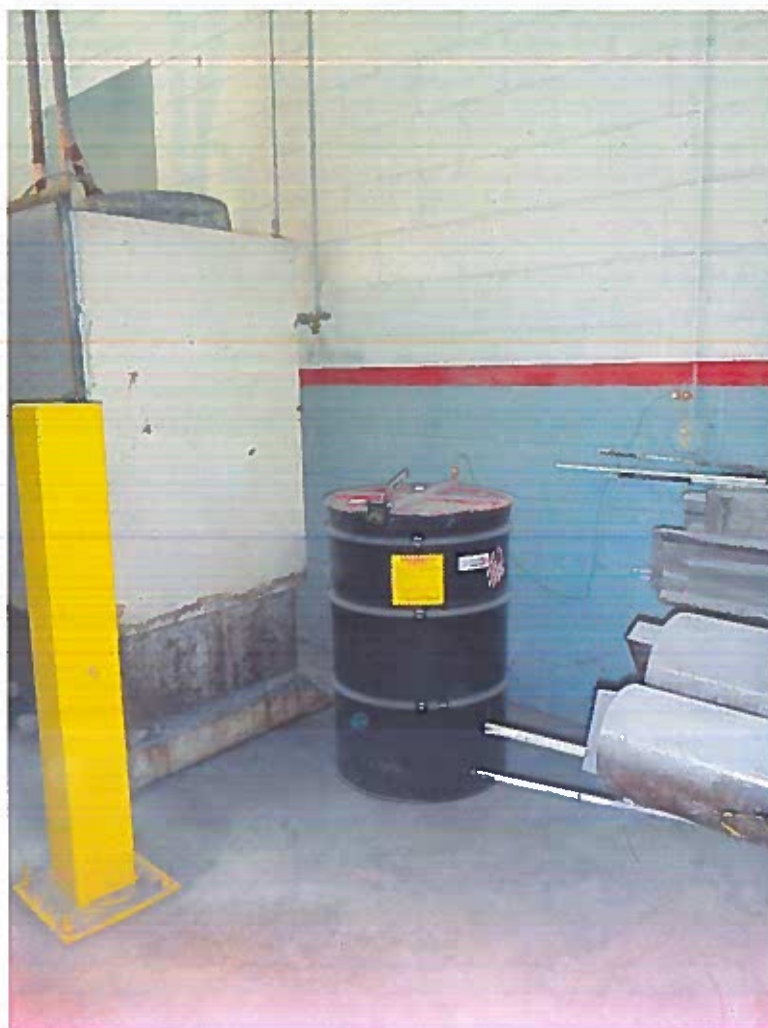
Valmont manages another SAA for accumulating used rags generated at the Shakespeare Protrusion Line (Photo 2). The inspectors observed one 55-gallon drum in this SAA, which was located along the wall opposite the Mixing Room. The drum was equipped with a latched, flip-top lid. It was labeled D001 / D035 / F003 / F005 hazardous waste flammable solids (acetone / MEK), and it was identified with a flammable solid hazard placard.

**Photo 2:** SAA for accumulating solvent contaminated rags used in cleaning protrusion machines in the Shakespeare area.

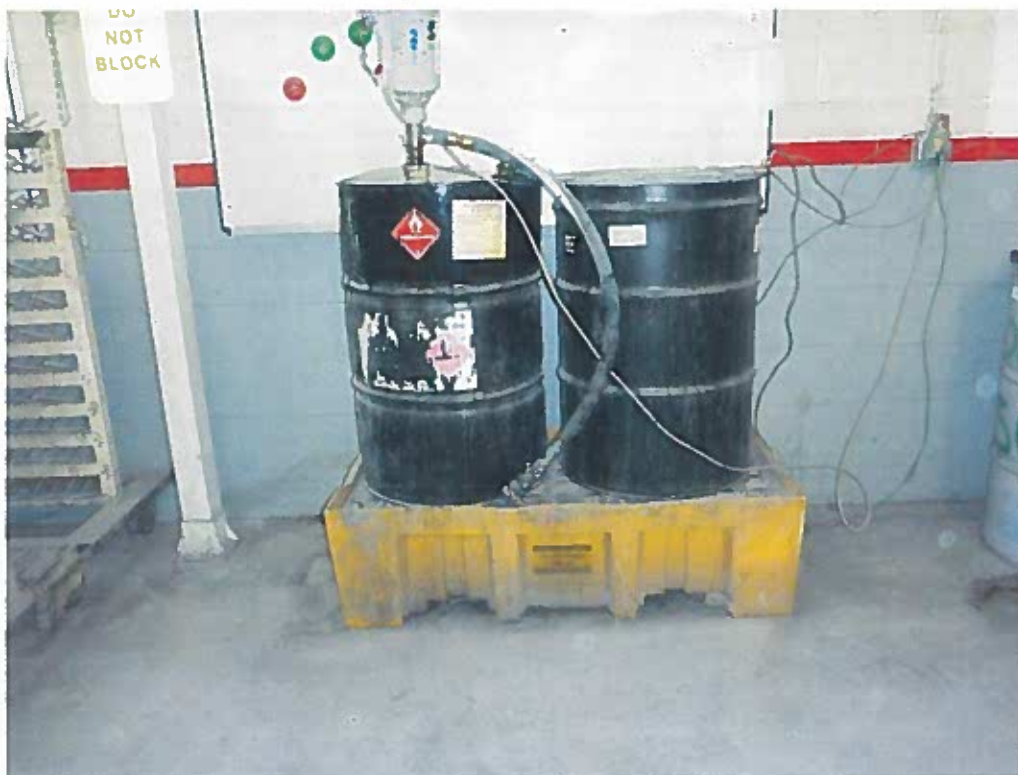
Along the wall in the Shakespeare Area opposite the Mixing Room, the inspectors observed two 55-gallon drums on secondary containment pallet (Photo 3). One drum was labeled recycled acetone, and the other was labeled hazardous waste (acetone / MEK) and identified with a flammable liquid hazard placard. Mr. Senn explained that these drums have been re-used on-site and that they contain clean acetone for use in cleaning the production lines.

**Photo 3:** Two 55-gallon drums on portable secondary containment in the Shakespeare area. Although one drum is labeled as recycled acetone, the other is labeled as hazardous waste flammable liquid containing acetone and MEK. Mr. Senn stated that the drums have been reused, but that the labels were not removed. He stated that these drums both contain clean acetone for use on-site.

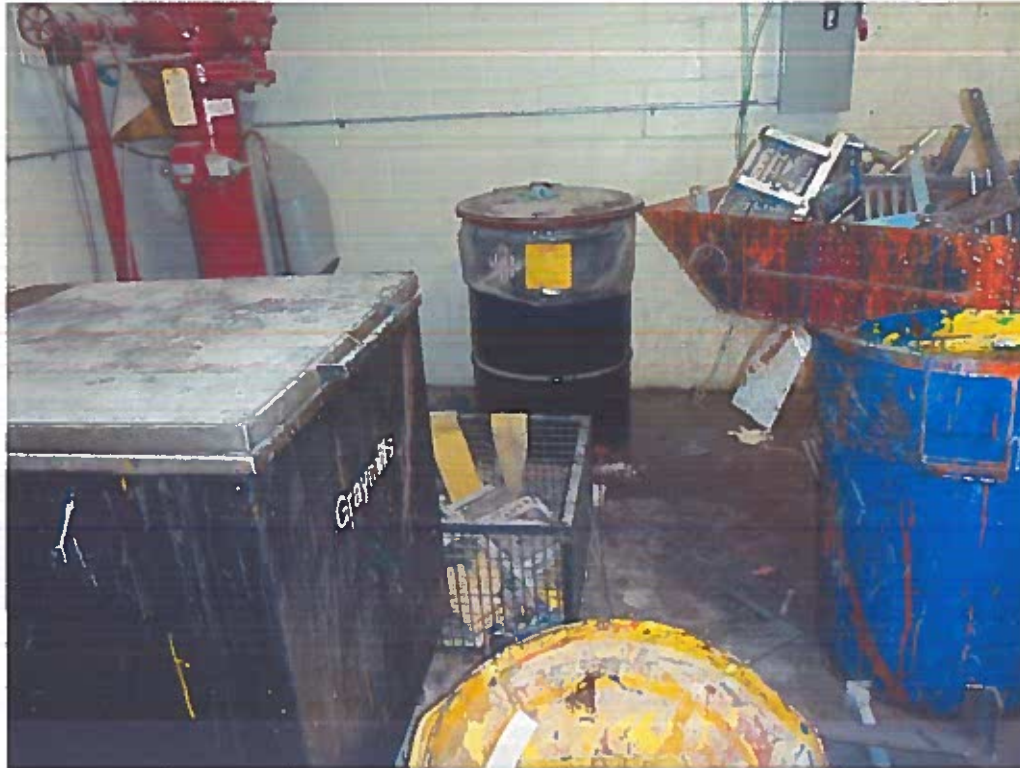
Main Building - Carsonite Line: Valmont operates a parts washer unit in a corner near the Mixing Room for washing Carsonite Line parts during shut-down and change-out events. Inspectors observed both a new parts-washing unit (Photo 4) and an old parts-washing unit (Photo 5) in this area. Mr. Senn explained that the old parts-washing unit uses acetone, and that the new parts-washing unit was purchased in an effort to reduce the use of acetone on-site. The new parts-washing unit uses a biogenic cleaning solution, which is heated during use. He stated that the old parts-washing unit was in use during the inspection, because the new unit was under repair.

Valmont manages a SAA for accumulating used rags generated at the Carsonite Line. The inspectors observed one 55-gallon drum in this SAA, which was located in the corner near the parts-washing units (Photo 4). The drum was equipped with a latched, flip-top lid. It was labeled D001 / D035 / F003 / F005 hazardous waste flammable solids organics (acetone / MEK), and it was identified with a flammable solids hazard placard.

**Photo 4:** New parts washing unit (black box with gray lid) on the left, and SAA in the corner for accumulating solvent contaminated rags used in cleaning protrusion machines in the Carsonite area.

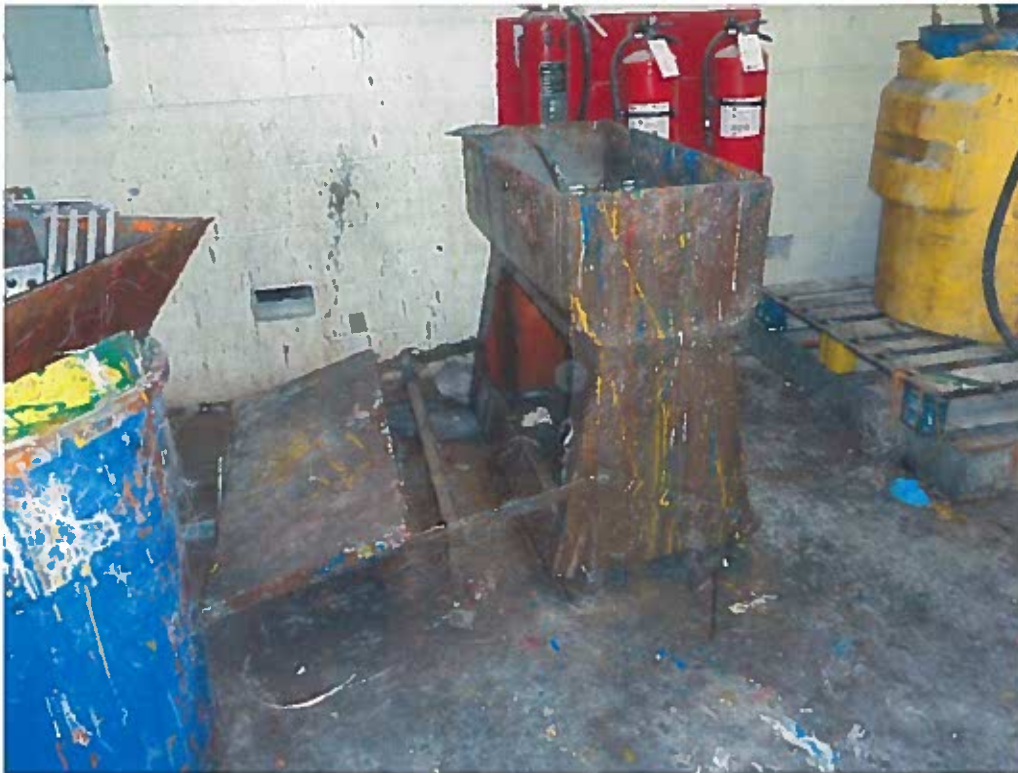
**Photo 5:** Old acetone parts washer used to clean parts removed from the protrusion lines in the Carsonite area.

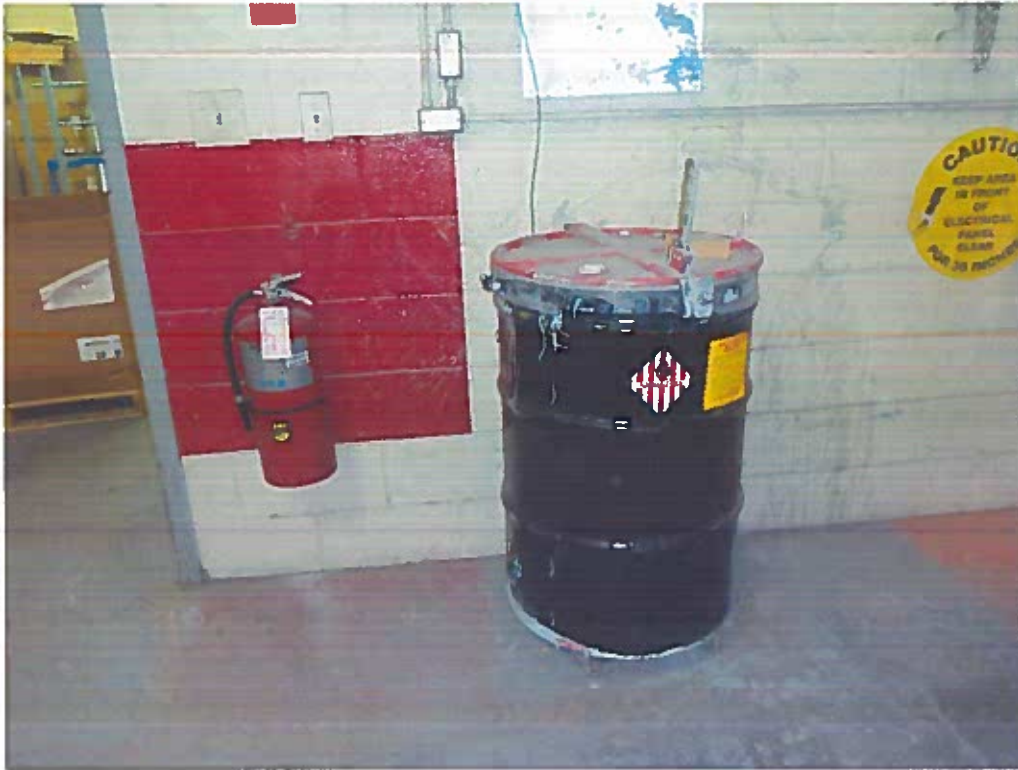
**Main Building – Manual Paint Area:** Valmont manages one SAA for accumulating used rags generated in the manual painting and paint booth areas (Photo 6). The inspectors observed one 55-gallon drum in this SAA, which was located just outside the manual paint area. The drum was equipped with a flip-top lid, with a broken latch. The latch on the lid was not capable of making contact to securely close the lid. The drum was labeled D001 / D035 / F003 / F005 hazardous waste flammable solids (acetone / MEK), and it was identified with a flammable solid hazard placard. The inspection participants returned to this area later during the inspection and observed that the lid had been replaced with one with a working latch, which was secured.

**Pursuant to 25 S.C. Code Ann. Regs. 61-79.262.15(a)(4)\* [40 C.F.R. § 262.15(a)(4)], which is a condition of the SAA Permit Exemption, a generator is required to keep containers of hazardous waste closed at all times during accumulation, except when adding, removing, or consolidating waste; or when temporary venting of a container is necessary for the proper operation of equipment, or to prevent dangerous situations, such as build-up of extreme pressure.**

**Photo 6:** SAA for accumulating solvent contaminated rags used in the manual painting area within the Main Building.

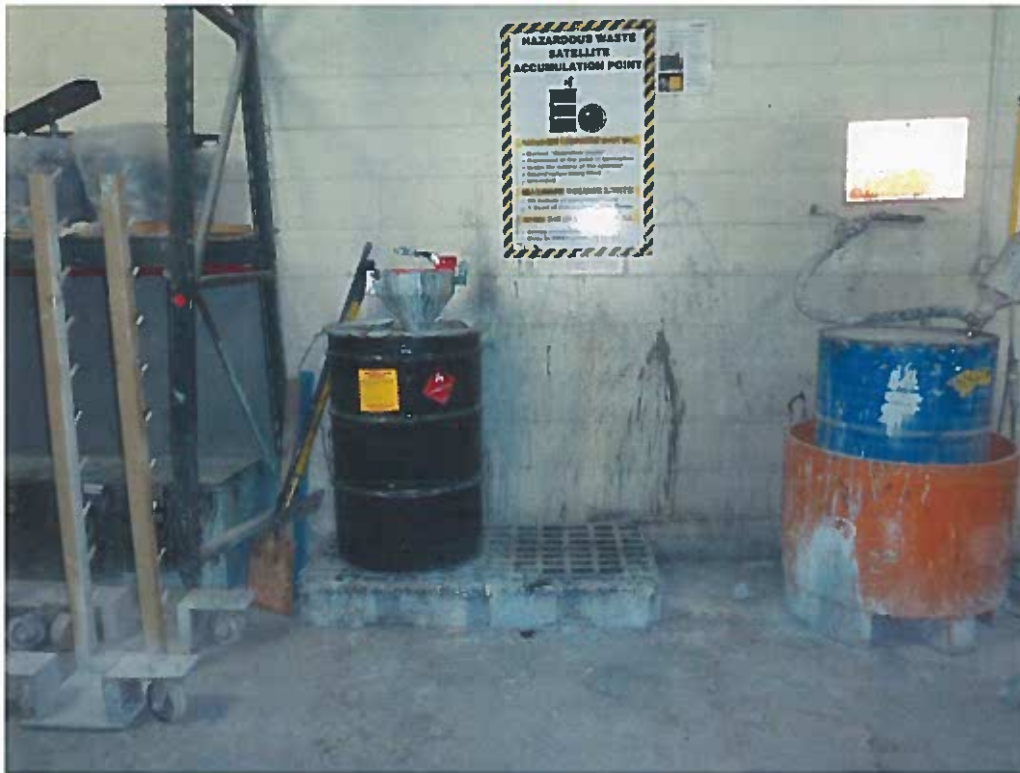
Valmont manages another SAA for accumulating waste paint related material generated during gun cleaning and line flushing activities performed during color changes or at the end of the day (Photo 7). The inspectors observed one 55-gallon drum in this SAA, which was located on a portable secondary containment unit just outside the paint booth. The drum was equipped with a latched funnel lid. It was labeled D001 / F003 / F005 hazardous waste paint related material (toluene / acetone), dated 12/05/2019, and identified with a flammable liquid hazard placard. According to Mr. Senn, some of the paints formerly used in these areas contained toluene, but Valmont no longer uses those paints at this facility. Mr. Senn stated that the manual painting and the paint booth operations currently use only acetone for cleaning, and that the filters are disposed of as non-hazardous waste.

**Photo 7:** SAA for accumulating waste paint related material generated in the paint booth within the Main Building.

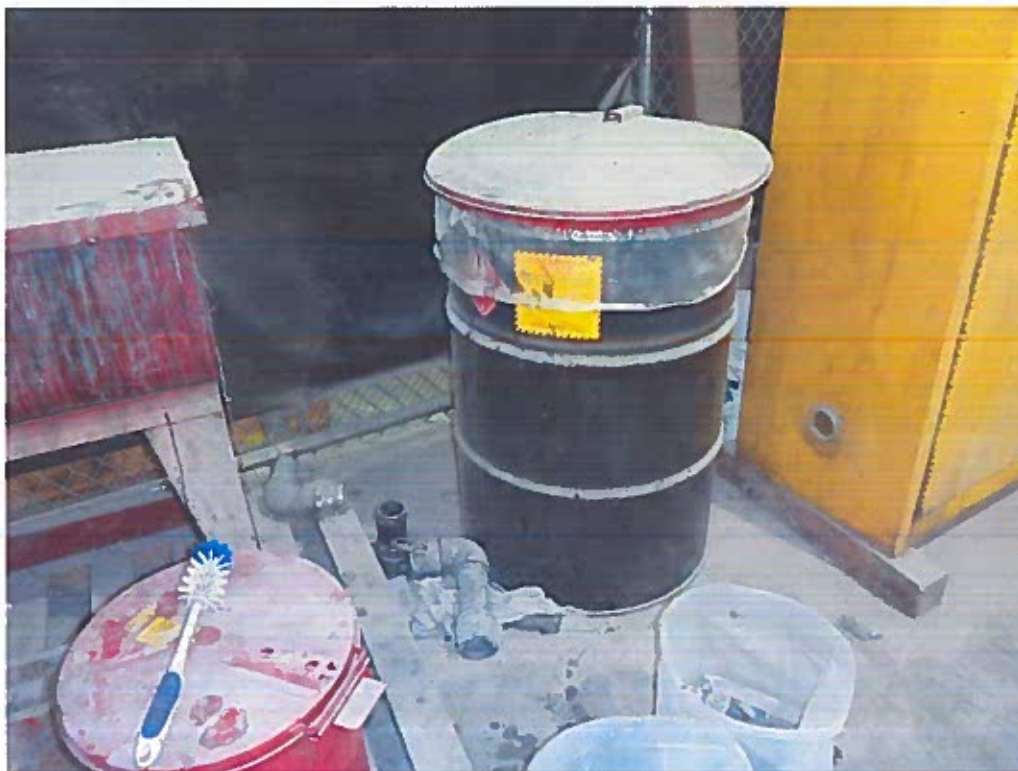
**Main Building - Maintenance:** Valmont manages one SAA for accumulating used aerosol cans generated at the facility (Photo 8). The inspectors observed one 55-gallon drum in this SAA, which was located just inside the Maintenance Area. The drum was equipped with a latched flip-top lid. It was labeled D001 / D035 hazardous waste aerosols, and it was identified with a flammable gas hazard placard. According to Mr. Senn, the facility generates approximately one 55-gallon drum of waste aerosols each year.

**Photo 8:** SAA in the Maintenance Area for accumulating used aerosol cans generated throughout the facility.

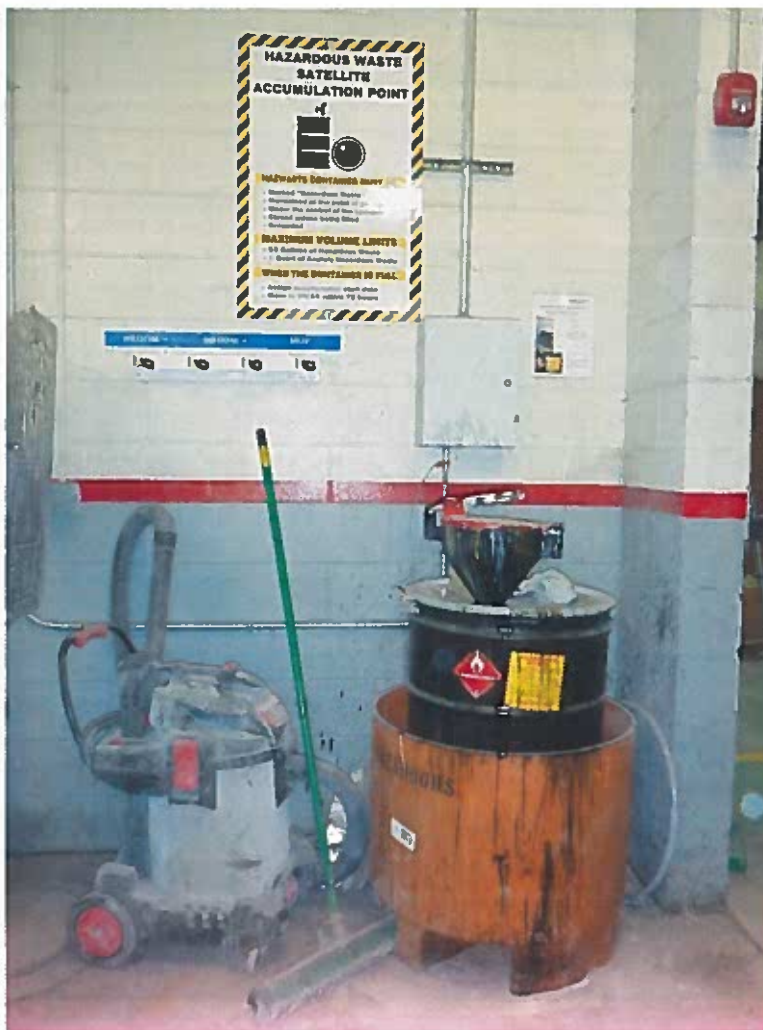
**Main Building - Dip Coat Room:** Valmont manages one SAA for accumulating waste paint related material generated in the Dip Coat Room and the Squeegee Coat area (Photo 9). The Dip Coat Room houses one 10 to 12-foot dip tank beneath the floor, and production pieces are coated with paint by dipping each piece into the tank. Hazardous waste paint related material is generated in this area during color changes and during

The inspectors observed one 55-gallon drum in this SAA, which was located in an overpack secondary containment unit in the Shakespeare Area just outside the Dip Coat Room. The drum was equipped with a funnel lid, which Mr. Senn latched during the inspection. It was labeled D001 / F003 / F005 hazardous waste paint related material (toluene / acetone) and identified with a flammable liquid hazard placard.

**Pursuant to 25 S.C. Code Ann. Regs. 61-79.262.15(a)(4)\* [40 C.F.R. § 262.15(a)(4)], which is a condition of the SAA Permit Exemption, a generator is required to keep containers of hazardous waste closed at all times during accumulation, except when adding, removing, or consolidating waste; or when temporary venting of a container is necessary for the proper operation of equipment, or to prevent dangerous situations, such as build-up of extreme pressure.**

**Photo 9:** SAA for accumulating waste paint related material generated in the dip tank area.

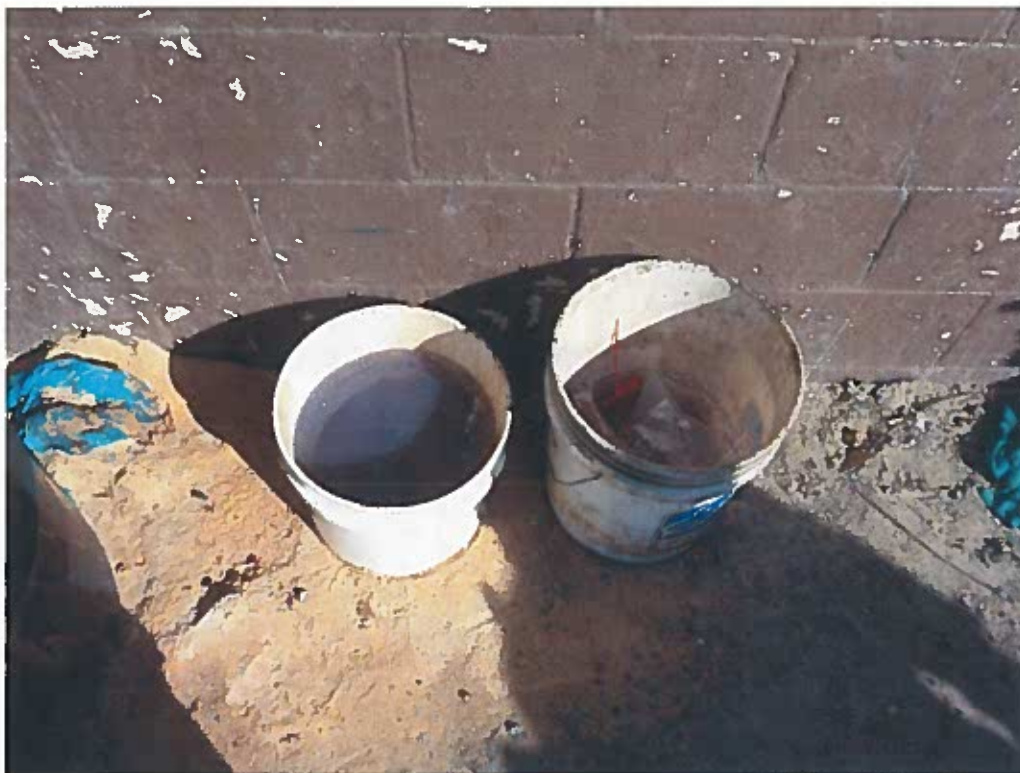
Tank Farm: Valmont manages one SAA for accumulating waste resin generated from leaks and spills in the Tank Farm (Photos 10 and 11). Because the waste resin generated in this area will not come into contact with a catalyst, the resin will remain a flammable liquid and not react or solidify to become a non-hazardous waste. The inspectors observed one 55-gallon drum, one 2.5-gallon bucket and one 5-gallon bucket of spilled resin in this SAA. The drum was equipped with a flip-top lid, which Mr. Senn latched during the inspection, but neither bucket was equipped with a lid. None of the containers were labeled with the words “hazardous waste” or marked with an indication of the hazards of the contents.

**Photo 11:** One 5-gallon bucket and one 2.5-gallon bucket located at the SAA for accumulating drips and spills of resin generated in the resin tank loading/unloading area. Neither bucket was closed or labeled.

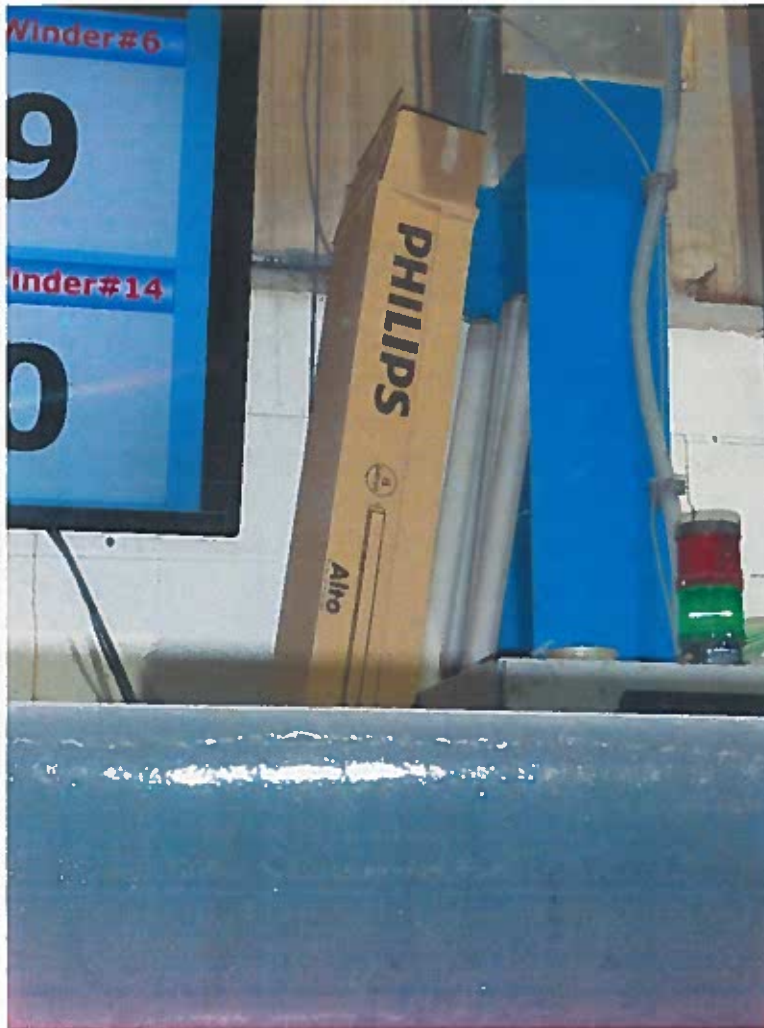
The inspectors observed five 8-foot used fluorescent lamps leaning up against the wall behind a cardboard box in this area (Photo 13).

**Photo 13:** Used fluorescent lamps leaning against the wall behind a box of new lamps inside the Light Pole Building.

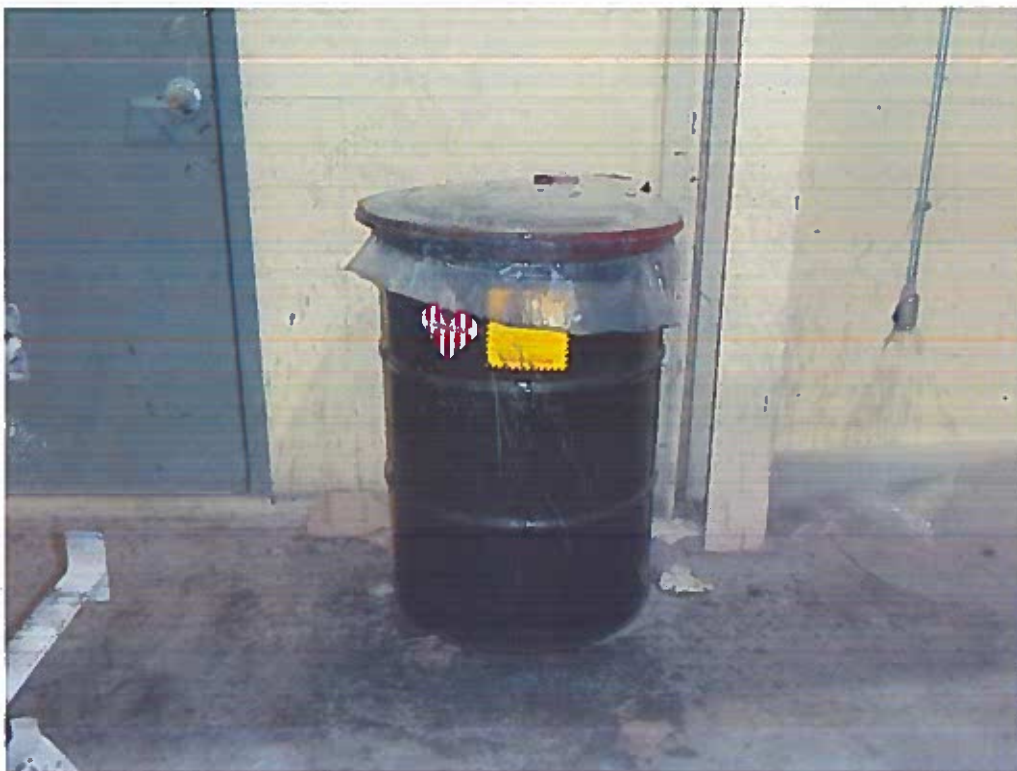
Valmont manages one SAA for accumulating used rags in the winding area (Photo 14). The inspectors observed one 55-gallon drum in this SAA, which was located along the wall near the door leading to the less-than 25-foot pole production lines. The drum was equipped with a spring-loaded lid. It was labeled D001 / D035 / F003/ F005 hazardous waste flammable solids (acetone / MEK), and it was identified with a flammable solid hazard placard.

**Photo 14:** SAA for accumulating solvent contaminated rags used in the winding area within the Light Pole Building.

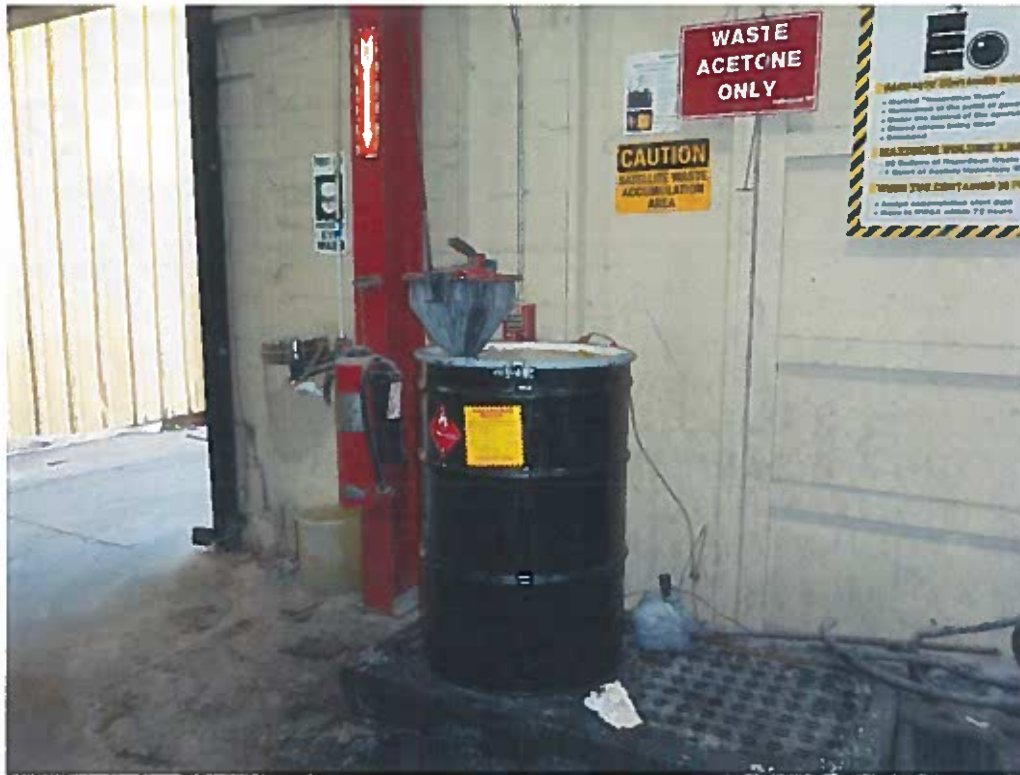
Valmont manages another SAA for accumulating waste acetone in the winding area (Photo 15). The inspectors observed one 55-gallon drum in this SAA, which was located on a portable secondary containment unit along the wall. The drum was equipped with a latched funnel. It was labeled D001 / D035 / F003 / F005 hazardous waste acetone, and it was identified with a flammable liquid hazard placard. The inspectors observed a few used rags and PPE on the portable secondary containment pallet, and not in the designated SAA container. Mr. Senn picked up the used rags and PPE and placed them into the nearby used rags SAA container.

**Pursuant to 25 S.C. Code Ann. Regs. 61-79.262.15(a)\* [40 C.F.R. § 262.15(a)], a generator may accumulate as much as 55 gallons of non-acute hazardous waste in containers at or near any point of generation where wastes initially accumulate which is under the control of the operator of the process generating the waste, without a permit or without having interim**

**Photo 15:** SAA for accumulating waste acetone generated in the winding area within the Light Pole Building.

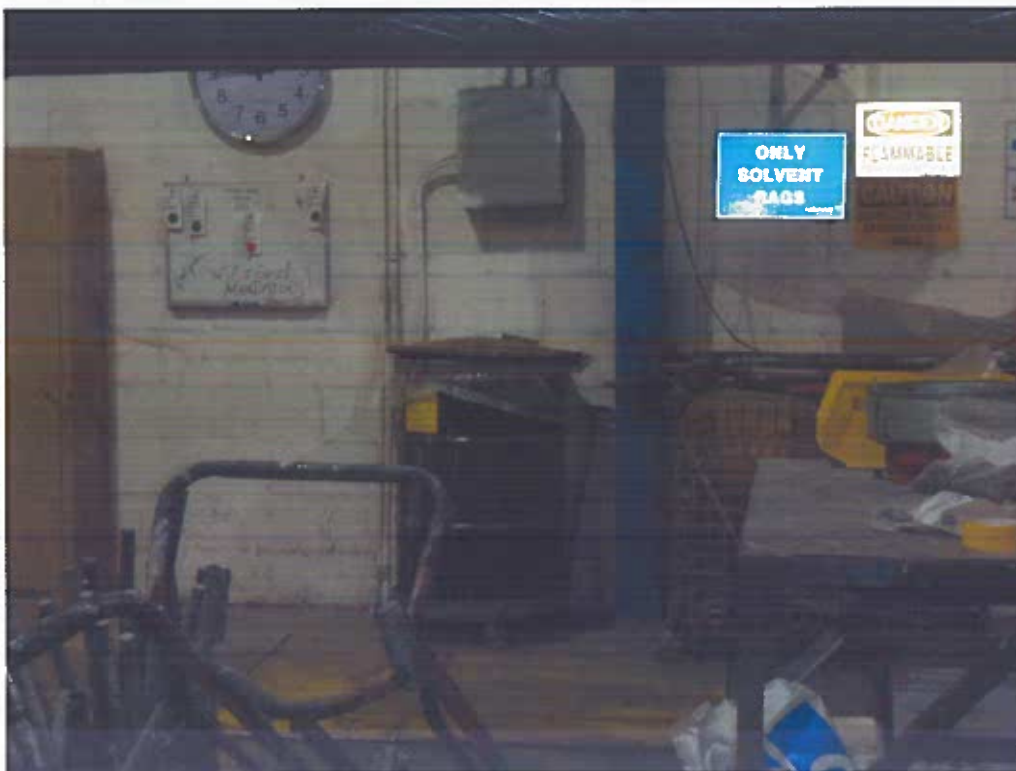
According to Mr. Senn, every pole manufactured in the Light Pole Building is wiped down with acetone before it is painted. Valmont manages a SAA for accumulating used rags generated during this process (Photo 16). The inspectors observed one 55-gallon drum in this SAA, which was located along the wall near the start of the painting area. The drum was equipped with a spring-loaded lid, but the lid was not making full contact with the top of the drum. The drum was labeled hazardous waste, and it was identified with a flammable solid hazard placard.

**Pursuant to 25 S.C. Code Ann. Regs. 61-79.262.15(a)(4)\* [40 C.F.R. § 262.15(a)(4)], which is a condition of the SAA Permit Exemption, a generator is required to keep containers of hazardous waste closed at all times during accumulation, except when adding, removing, or consolidating waste; or when temporary venting of a container is necessary for the proper operation of equipment, or to prevent dangerous situations, such as build-up of extreme pressure.**

**Photo 16:** SAA for accumulating solvent contaminated rags used in the painting area within the Light Pole Building.

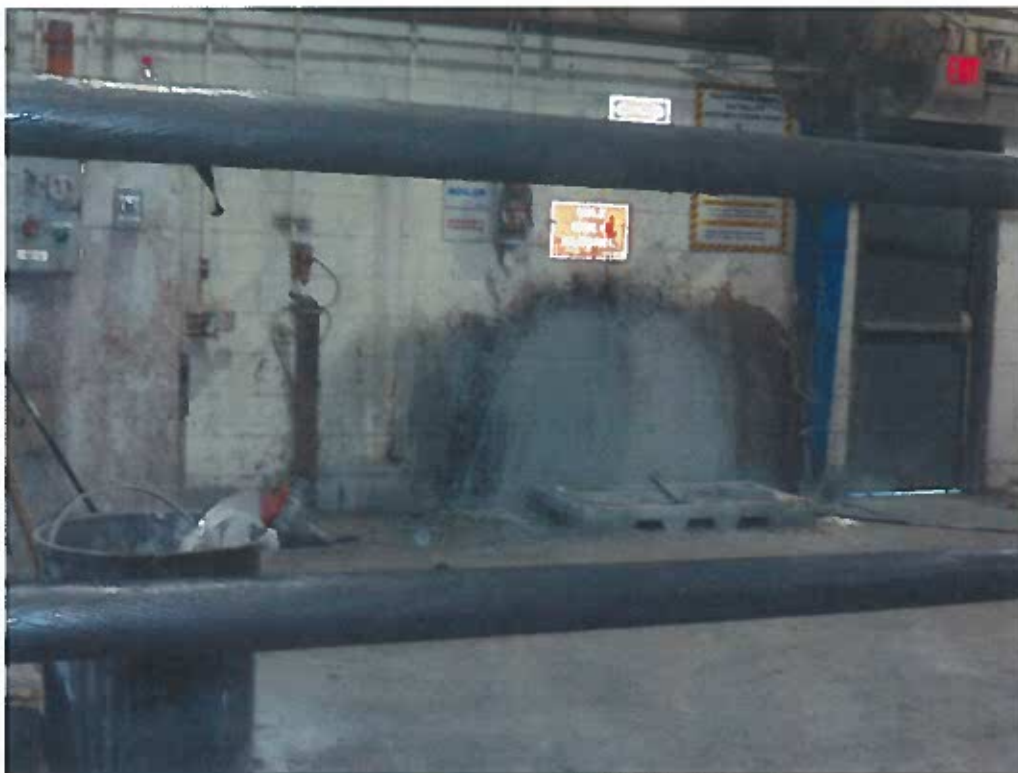
Valmont manages a SAA for accumulating spent MEK used to flush the lines in the paint booth (Photo 17). When flushing the lines, employees spray the spent MEK directly into a can, which is then emptied into the dedicated SAA container. The inspectors observed a portable secondary containment unit in this SAA, which was located along the wall near the start of the painting area. However, no containers were observed in this SAA during the inspection.

**Photo 17:** SAA for accumulating waste MEK used to flush painting lines in the automated painting area within the Light Pole Building.

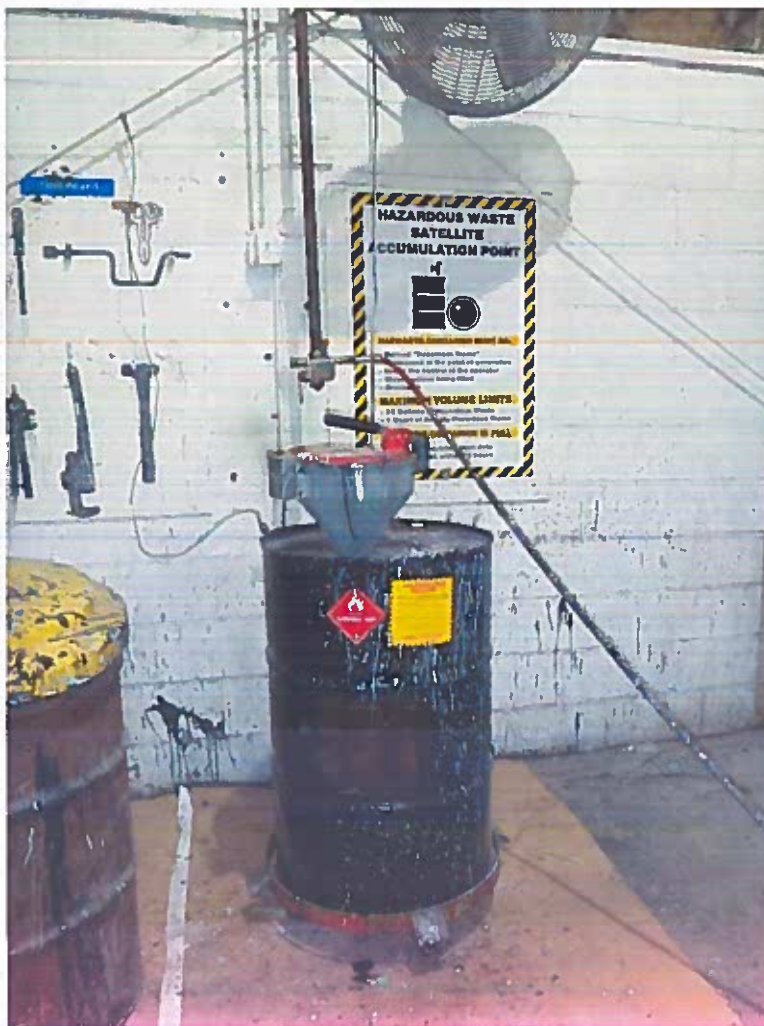
**Light Pole Building - Manual Paint Booth:** Valmont manages a SAA for accumulating waste paint related material generated in the Manual Paint Booth (Photo 18). The inspectors observed one 55-gallon drum in this SAA, which is located in the corner at the end of the Manual Painting Booth. The drum was equipped with a funnel, which Mr. Senn latched during the inspection. It was labeled D001 / F003 / F005 hazardous waste paint related material (toluene / acetone), and it was identified with a flammable liquid hazard placard.

**Pursuant to 25 S.C. Code Ann. Regs. 61-79.262.15(a)(4)\* [40 C.F.R. § 262.15(a)(4)], which is a condition of the SAA Permit Exemption, a generator is required to keep containers of hazardous waste closed at all times during accumulation, except when adding, removing, or consolidating waste; or when temporary venting of a container is necessary for the proper**

**Photo 18:** SAA for accumulating waste paint related material generated in the manual painting booths within the Light Pole Building.

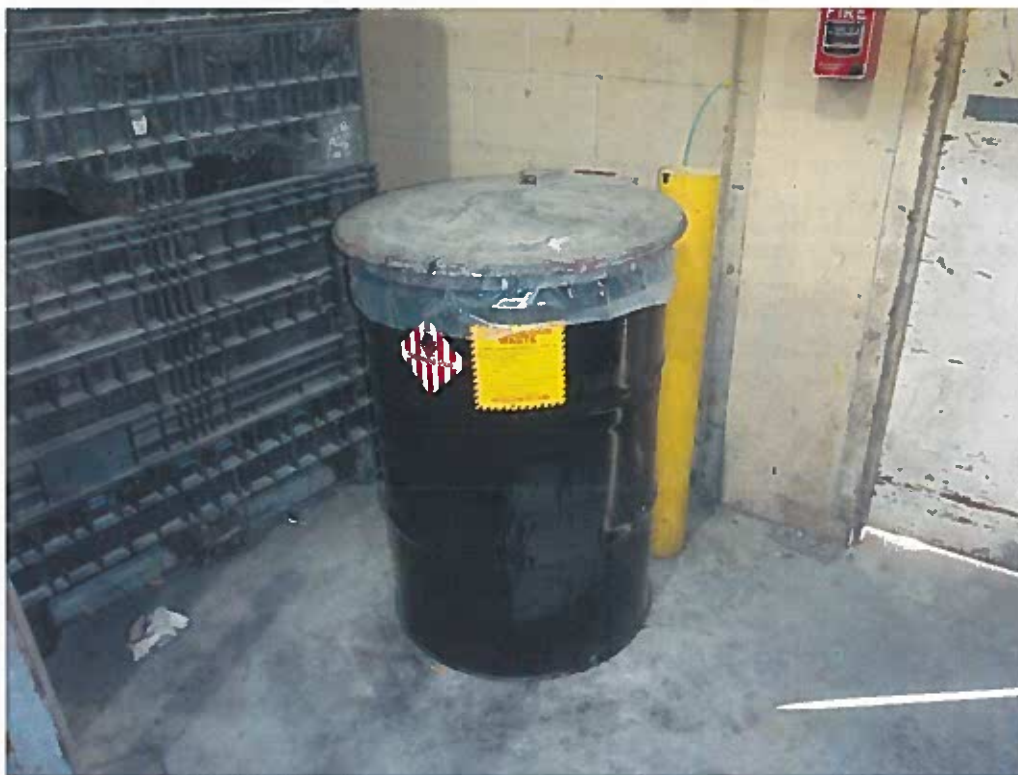
Valmont manages another SAA for accumulating used rags generated in the Manual Painting Booth (Photo 19). The inspectors observed one 55-gallon drum in this SAA, which is located near the exit door at the end of the Manual Painting Booth. The drum was equipped with a spring-loaded lid. It was labeled D001 / D035 / F003 / F005 hazardous waste flammable solids (acetone / MEK), and it was identified with a flammable solid hazard placard.

**Photo 19:** SAA for accumulating solvent contaminated rags generated in the manual painting booths within the Light Pole Building.

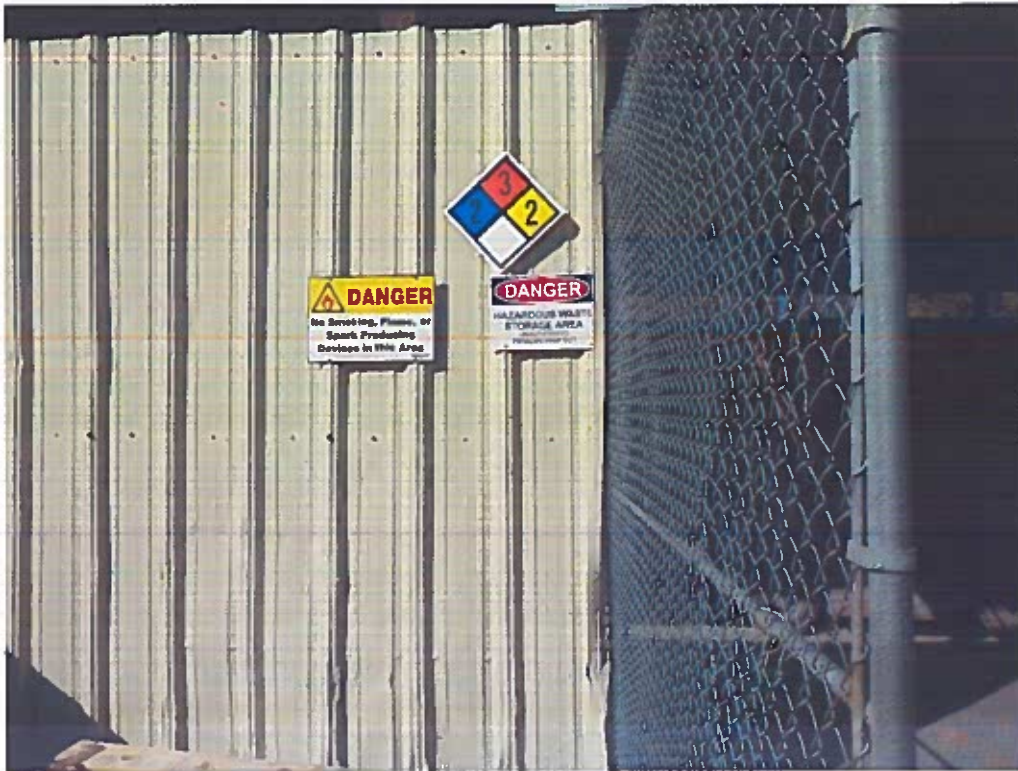
**Central Accumulation Area (CAA):** Valmont's CAA is a covered concrete pad with metal walls and a chain-link gate. The inspectors observed a spill response kit and shovels in one corner of the structure, a fire extinguisher at the door, and signs reading "danger," "no smoking," and "hazardous waste storage area" on the wall just outside of the gate (Photo 20). Mr. Senn explained that the area is not equipped with an alarm activation or communication system, but that employees carry cell phones when working here.

**Photo 20:** Signs on the outside of the CAA building identifying the area as a hazardous waste storage area.

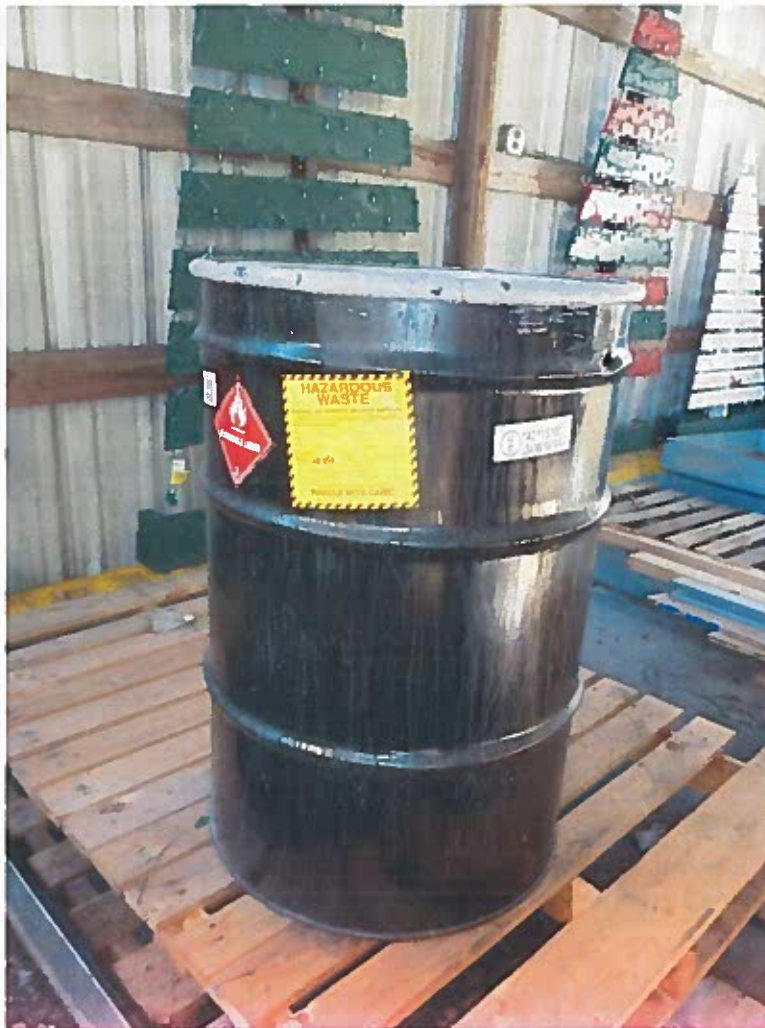
On the left side inside the structure, inspectors observed one 55-gallon drum on a wooden pallet. The drum was labeled D001 / F003 / F005 hazardous waste paint related material (toluene / acetone); it was identified with flammable liquid hazard placard; and it was dated 12/04/2019 (Photo 21).

**Photo 21:** One 55-gallon drum of waste paint related material located within the CAA.

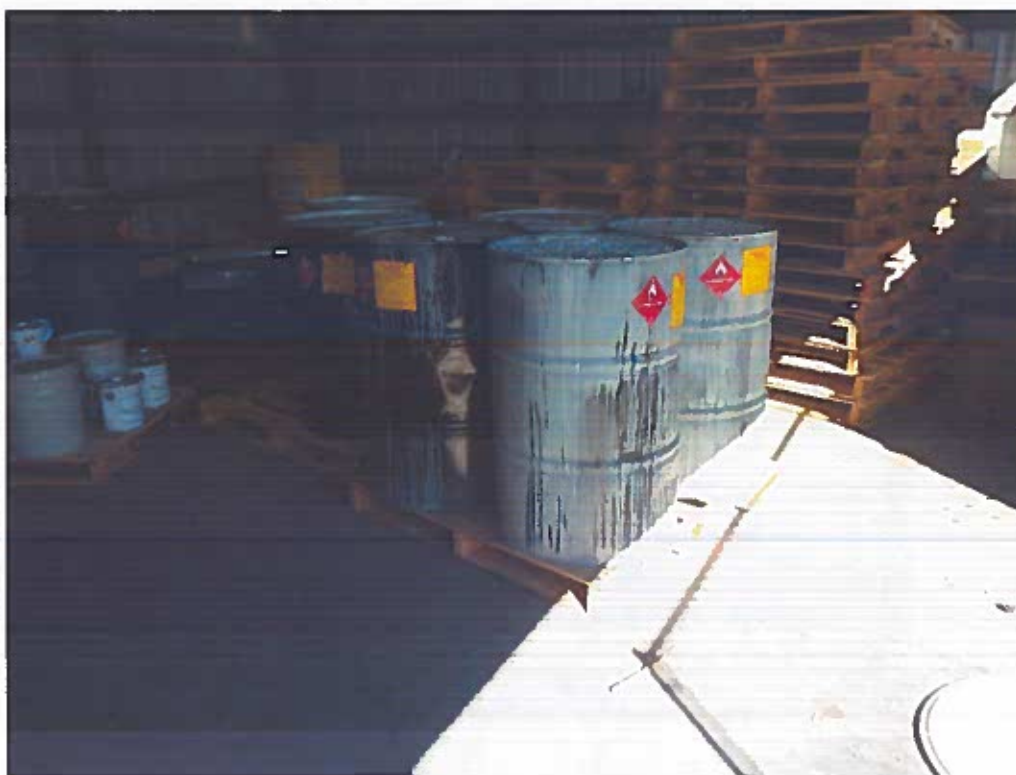
On the right side inside the structure, inspectors observed two wooden pallets holding six 55-gallon drums of hazardous waste (Photo 22). The labels on five of the drums were visible and identified the contents as D001 / D035 / F005 hazardous waste flammable liquids (waste MEK). The label on the sixth drum was facing inward toward the neighboring drum and could not be read. None of the drums were marked with an accumulation start date.

**Pursuant to 25 S.C. Code Ann. Regs. 61-79.262.17(a)(5)(i)\* [40 C.F.R. § 262.17(a)(5)(i)], which is a condition of the LQG Permit Exemption, a generator is required to mark or label containers with the date upon which each period of accumulation begins clearly visible for inspection on each container.**

**Photo 22:** Six 55-gallon drums of hazardous waste flammable liquids containing MEK in the CAA.

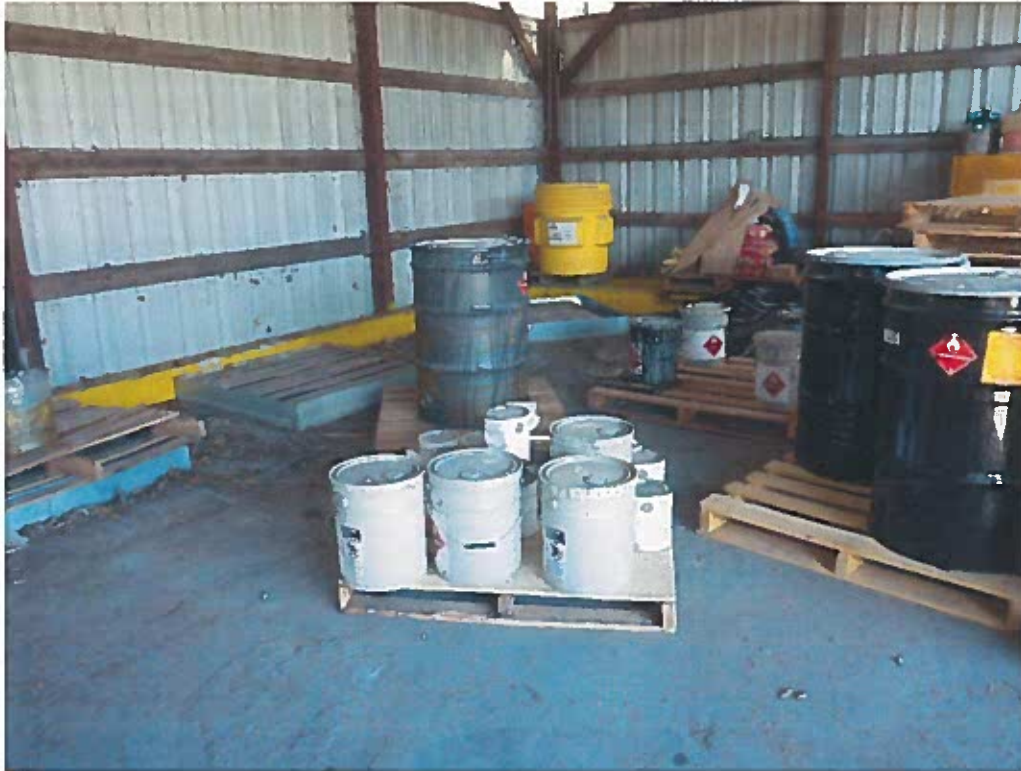
The inspectors observed another wooden pallet holding one 55-gallon drum of hazardous waste, and two wooden pallets holding smaller buckets of paint (Photo 23). The 55-gallon drum was labeled D001 / F003 / F005 hazardous waste paint related material (toluene / acetone); it was identified with a flammable liquid hazard placard; and it was dated 12/03/2019. According to Mr. Senn, the paint buckets were brought here from the product inventory area, but he was not certain if the materials had been removed from the inventory system. Mr. Senn explained that Valmont will make a hazardous waste determination on the containers as they are taken out of the inventory system.

**Photo 23:** One 55-gallon drum of hazardous waste paint related material containing toluene and acetone located behind a pallet of paint cans in the CAA. Mr. Senn stated that Valmont will make a hazardous waste determination on the contents of these containers, when the paint cans are removed from the facility inventory list. In the meantime, Valmont considers them to be product materials that are included on the inventory list.

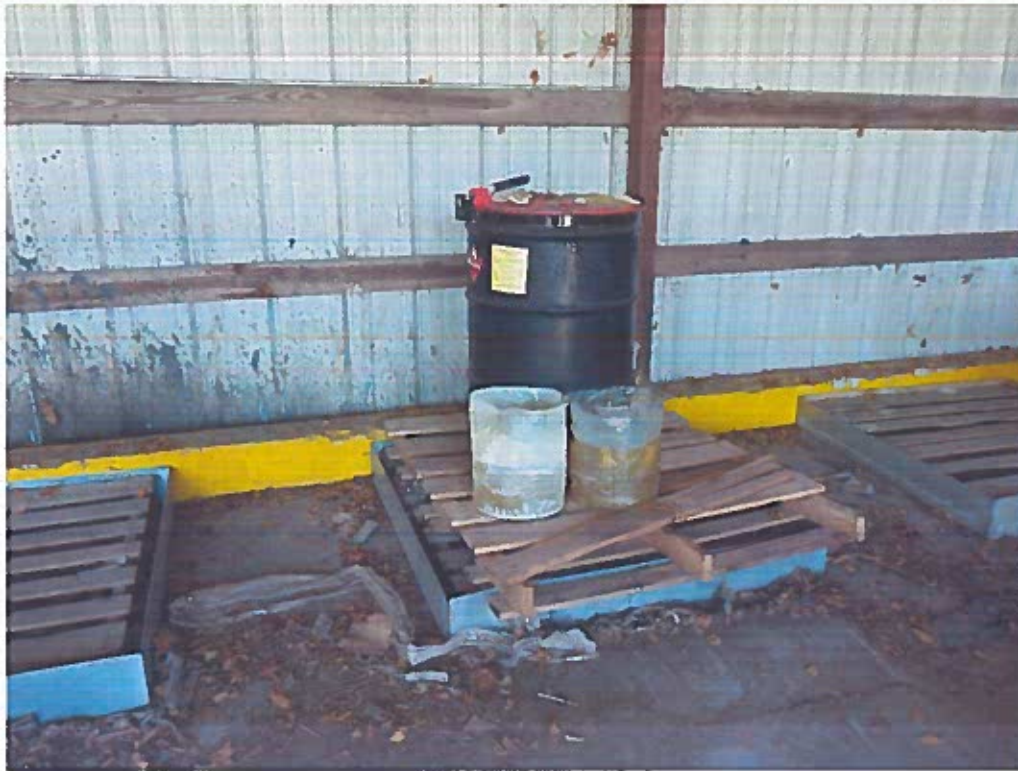
Finally, the inspectors observed one 55-gallon drum and two 5-gallon can liners on a wooden pallet beside the wall opposite the entry gate (Photo 24). The drum was equipped with a latched flip-top lid. It was labeled D001 hazardous waste flammable liquid resin, and it was identified with a flammable liquid hazard placard (Photo 25). The drum was not marked with an accumulation start date. The 5-gallon can liners held what appeared to be solidified glue. Mr. Senn explained that Valmont is managing this area as a SAA for accumulating epoxy / glue resin generated in two areas of the plant. The epoxy / glue resin is a two-part glue that hardens and solidifies when the parts come together within the appropriate ratio range. If the ratio is not within this range, the glue remains a liquid, which exhibits the characteristic of ignitability. The hardened glue does not exhibit the characteristic of ignitability. Mr. Senn explained that the waste glue is transferred to this area in a bucket, and that it is accumulated here because the facility generates approximately one 55-gallon drum over the course of a calendar year. Because this 55-gallon drum is not located at or near the point where the hazardous waste epoxy / glue resin is generated, it cannot be managed as a SAA container. Instead, this drum should be managed as a hazardous waste storage drum.

**Pursuant to 25 S.C. Code Ann. Regs. 61-79.262.17(a)(5)(i)\* [40 C.F.R. § 262.17(a)(5)(i)], which is a condition of the LQG Permit Exemption, a generator is required to mark or label containers with the date upon which each period of accumulation begins clearly visible for inspection on each container.**

**Photo 24:** 55-gallon drum containing drips and spills of epoxy glue generated at two epoxy glue mixing stations on-site.
