SUBJ: Resource Conservation and Recovery Act (RCRA) Compliance Evaluation Inspection (CEI)  
Valmont Composite Structures  
EPA ID# SCD006540983

## **RCRA Inspection Report**

Valmont Composite Structures EPA ID# SCD006540983  
19845 US Hwy 76  
Newberry, South Carolina 29108

December 5, 2019

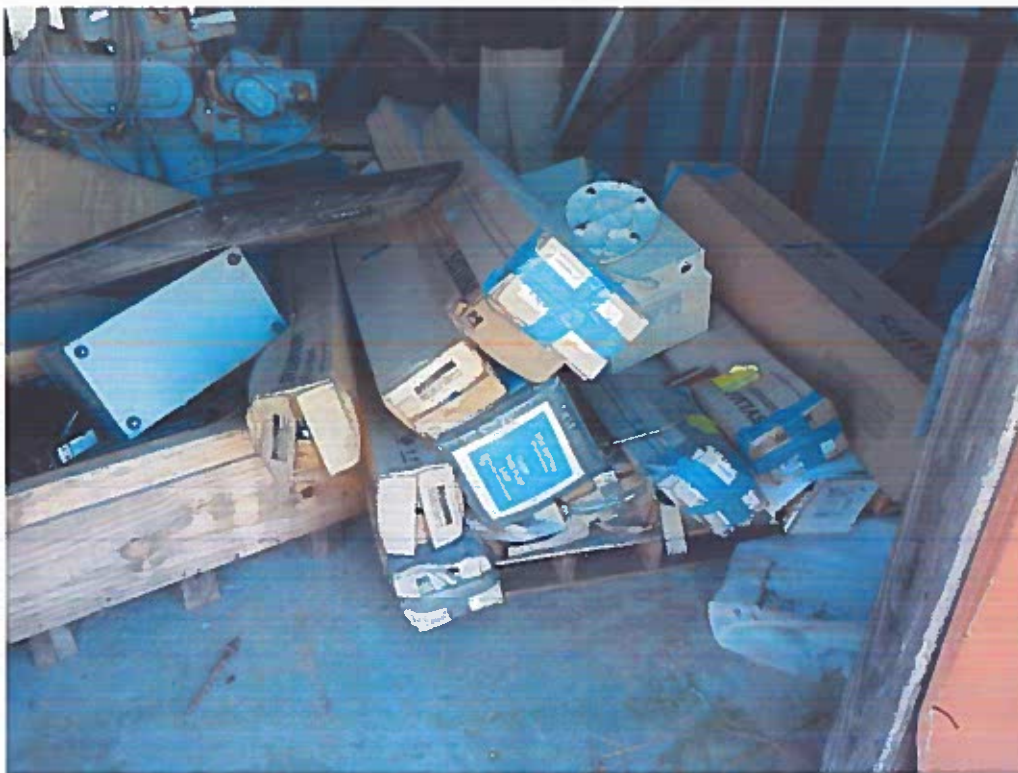
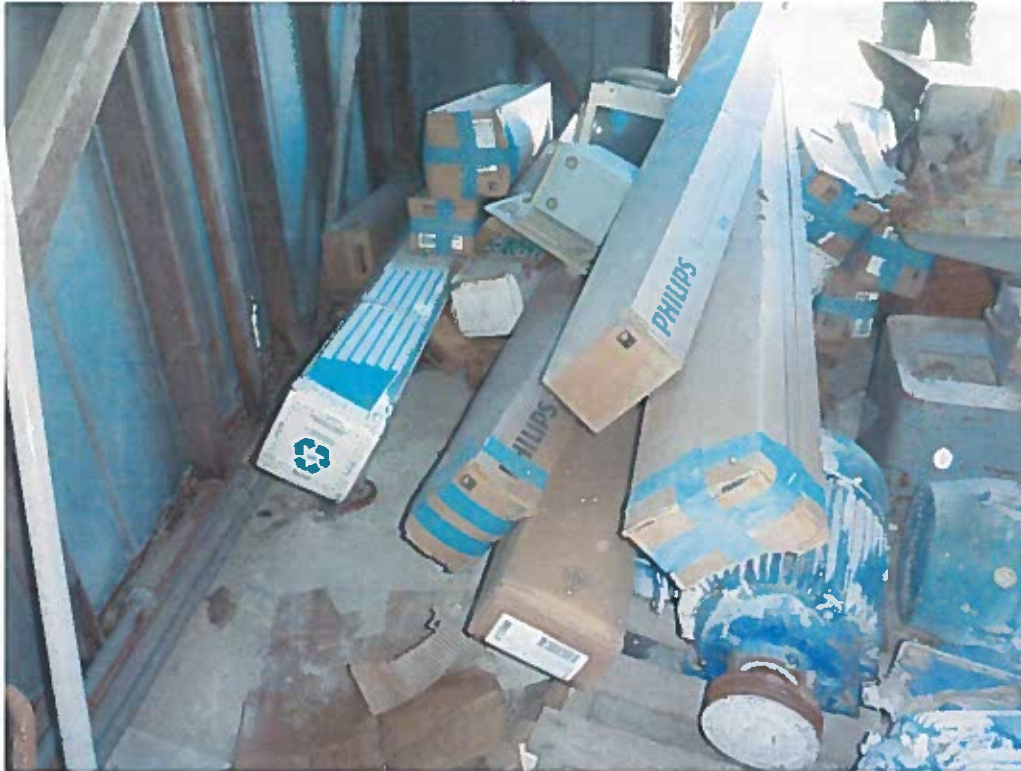
Outbuilding: Valmont manages used electronics, ballasts, universal waste in a small outbuilding at the facility (Photo 26 and 27). The inspectors observed seventeen boxes of used fluorescent lamps and one used 8-foot lamp leaning against the wall in this area during the inspection. The boxes all appeared to be labeled universal waste bulbs. Five of the boxes were not securely closed, and two were not marked with an accumulation start date. The inspectors also observed crushed and punctured boxes caused by the weight and corners of used electronics that were stacked on top of the boxes.

**Photo 26:** Boxes of used fluorescent lamps in an outbuilding.

**Photo 27:** Boxes of used fluorescent lamps in an outbuilding.

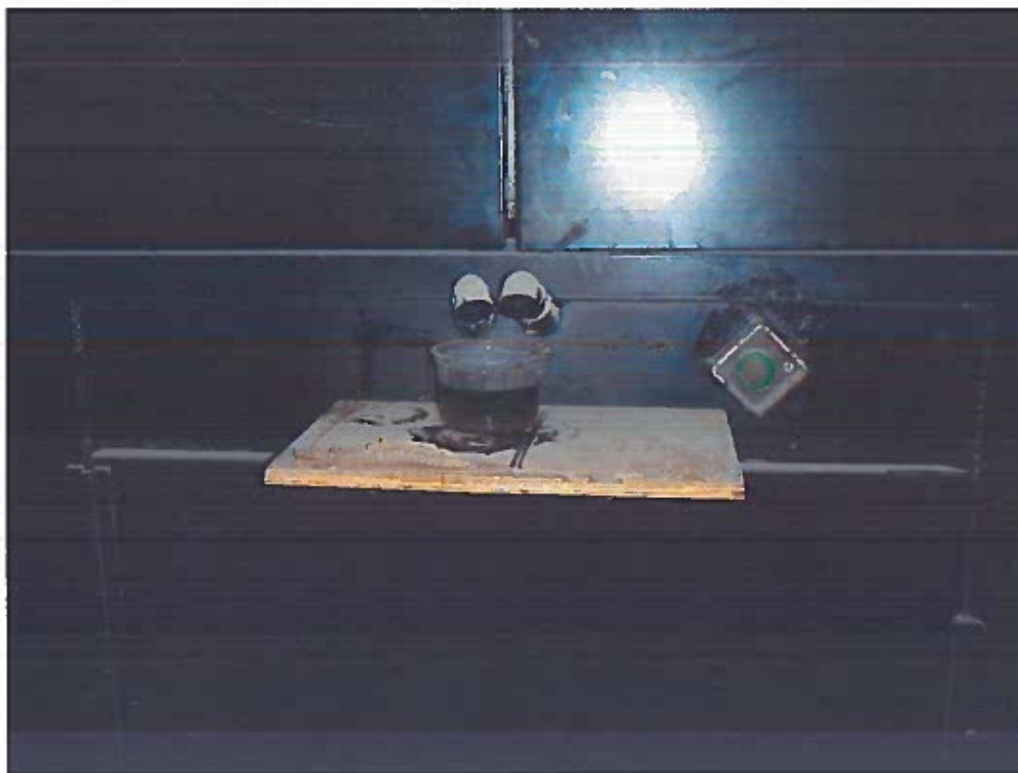
Epoxy Glue Station: The inspectors observed one of two epoxy glue stations at the facility (Photo 28). Each epoxy glue station is equipped with a container for accumulating waste drips from the dispensing taps and occasional excess generated during change-out events. Mr. Senn explained that the epoxy / glue resin is a two-part glue that typically hardens and solidifies to be disposed of as non-hazardous waste. However, if the parts do not come together within the appropriate ratio range (typically 65 / 45), the glue remains a liquid, which exhibits the characteristic of ignitability. When this happens, the waste glue is transferred from this area to a 55-gallon drum in the CAA. However, when the liquid waste epoxy / glue is generated and accumulated in this area, it should be managed as a hazardous waste.

**Pursuant to 25 S.C. Code Ann. Regs. 61-79.262.15(a)\* [40 C.F.R. § 262.15(a)], a generator may accumulate as much as 55 gallons of non-acute hazardous waste in containers at or near any point of generation where wastes initially accumulate which is under the control of the operator of the process generating the waste, without a permit or without having interim status, as required by Section 44-56-60(a)(2) and (b) of the SCHWMA, S.C. Code Ann. § 44-56-60(a)(2) and (b) [Section 3005 of RCRA, 42 U.S.C. § 6925], and without complying with 25 S.C. Code Ann. Regs. 61-79.262.16(b)\* or R.61-79-262.17(a)\* [40 C.F.R. § 262.16(b) or § 262.17(a)], except as required in 25 S.C. Code Ann. Regs. 61-79.262.15(a)(7) and (8)\* [40 C.F.R. § 262.15(a)(7) and (8)], provided that the generator complies with the conditions listed in the SAA Permit Exemption.**

**Photo 28:** Point of generation for hazardous waste epoxy / glue at one of the on-site mixing stations.
