## Clean Water Act Section 404: Site Visit/Case Development

| Site Name | SVG Holdings Property | | | | |
| Site Address* | 260 Bruyn Turnpike (106.1-1-28.111) | | | | |

| Inspection Purpose | Initial site visit | | |

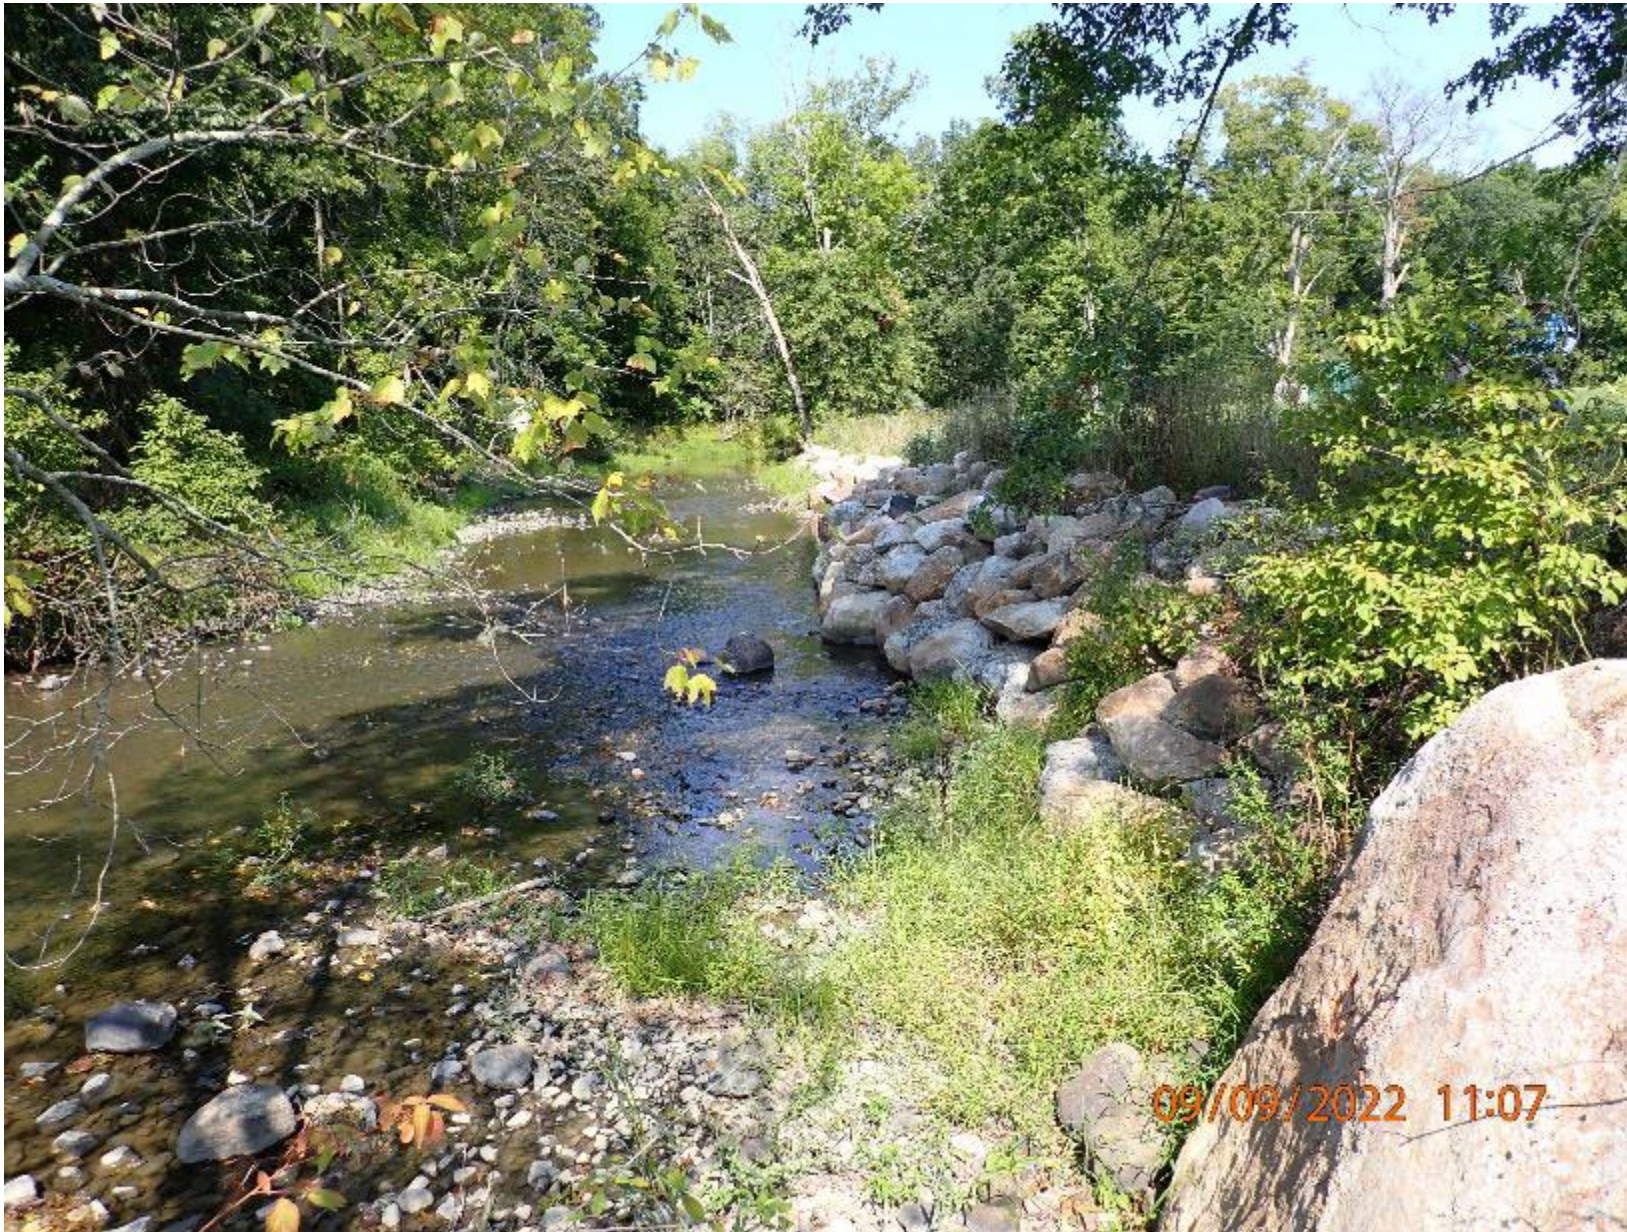
**Date:** 9/9/2022  
**Time:** 11:07 AM  
**Photographer:** SSA  
**Photo ID:** 9 – P9090472

Boulders placed on eastern bank of Dwaar Kill below the Ordinary High Water Mark

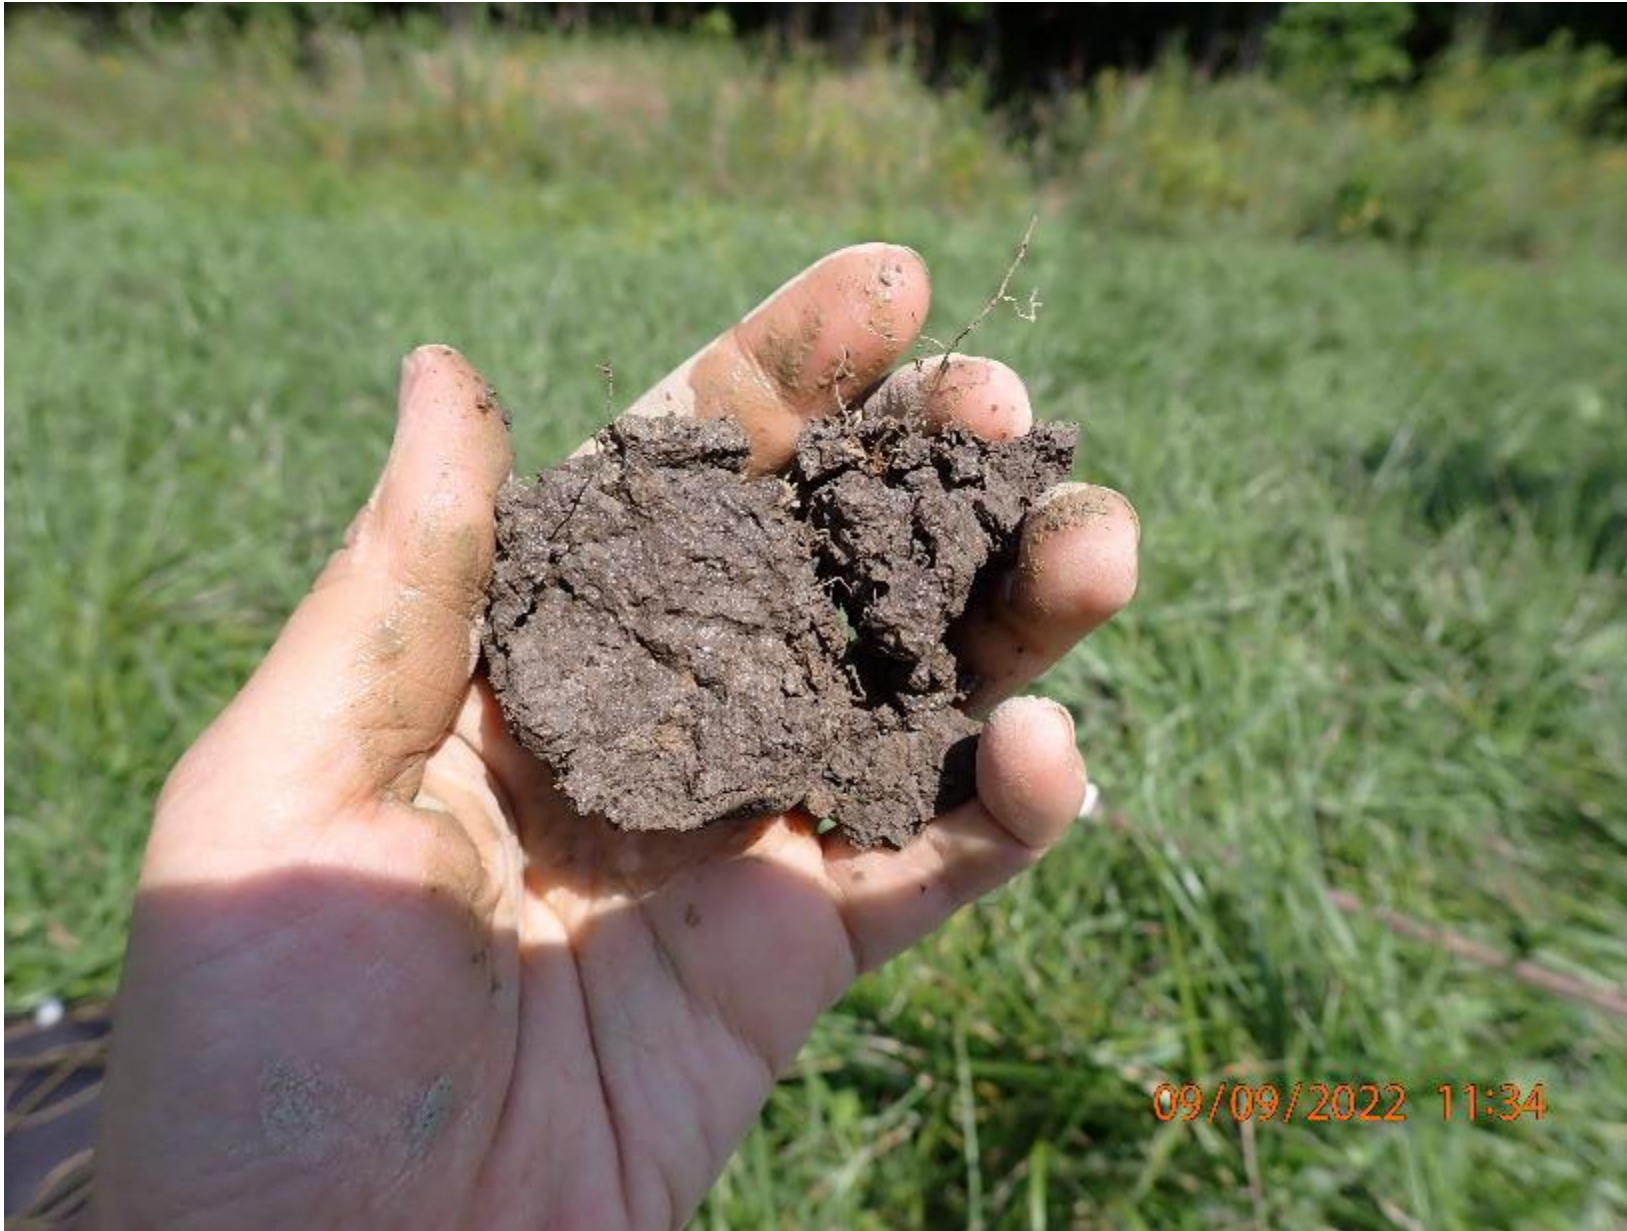
**Date:** 9/9/2022  
**Time:** 11:34 AM  
**Photographer:** SSA  
**Photo ID:** 10 – P9090473

Remarks:  
Oxidized rhizospheres observed in layer below fill

8-12" layer of soil profile SS1  
showing oxidized rhizospheres

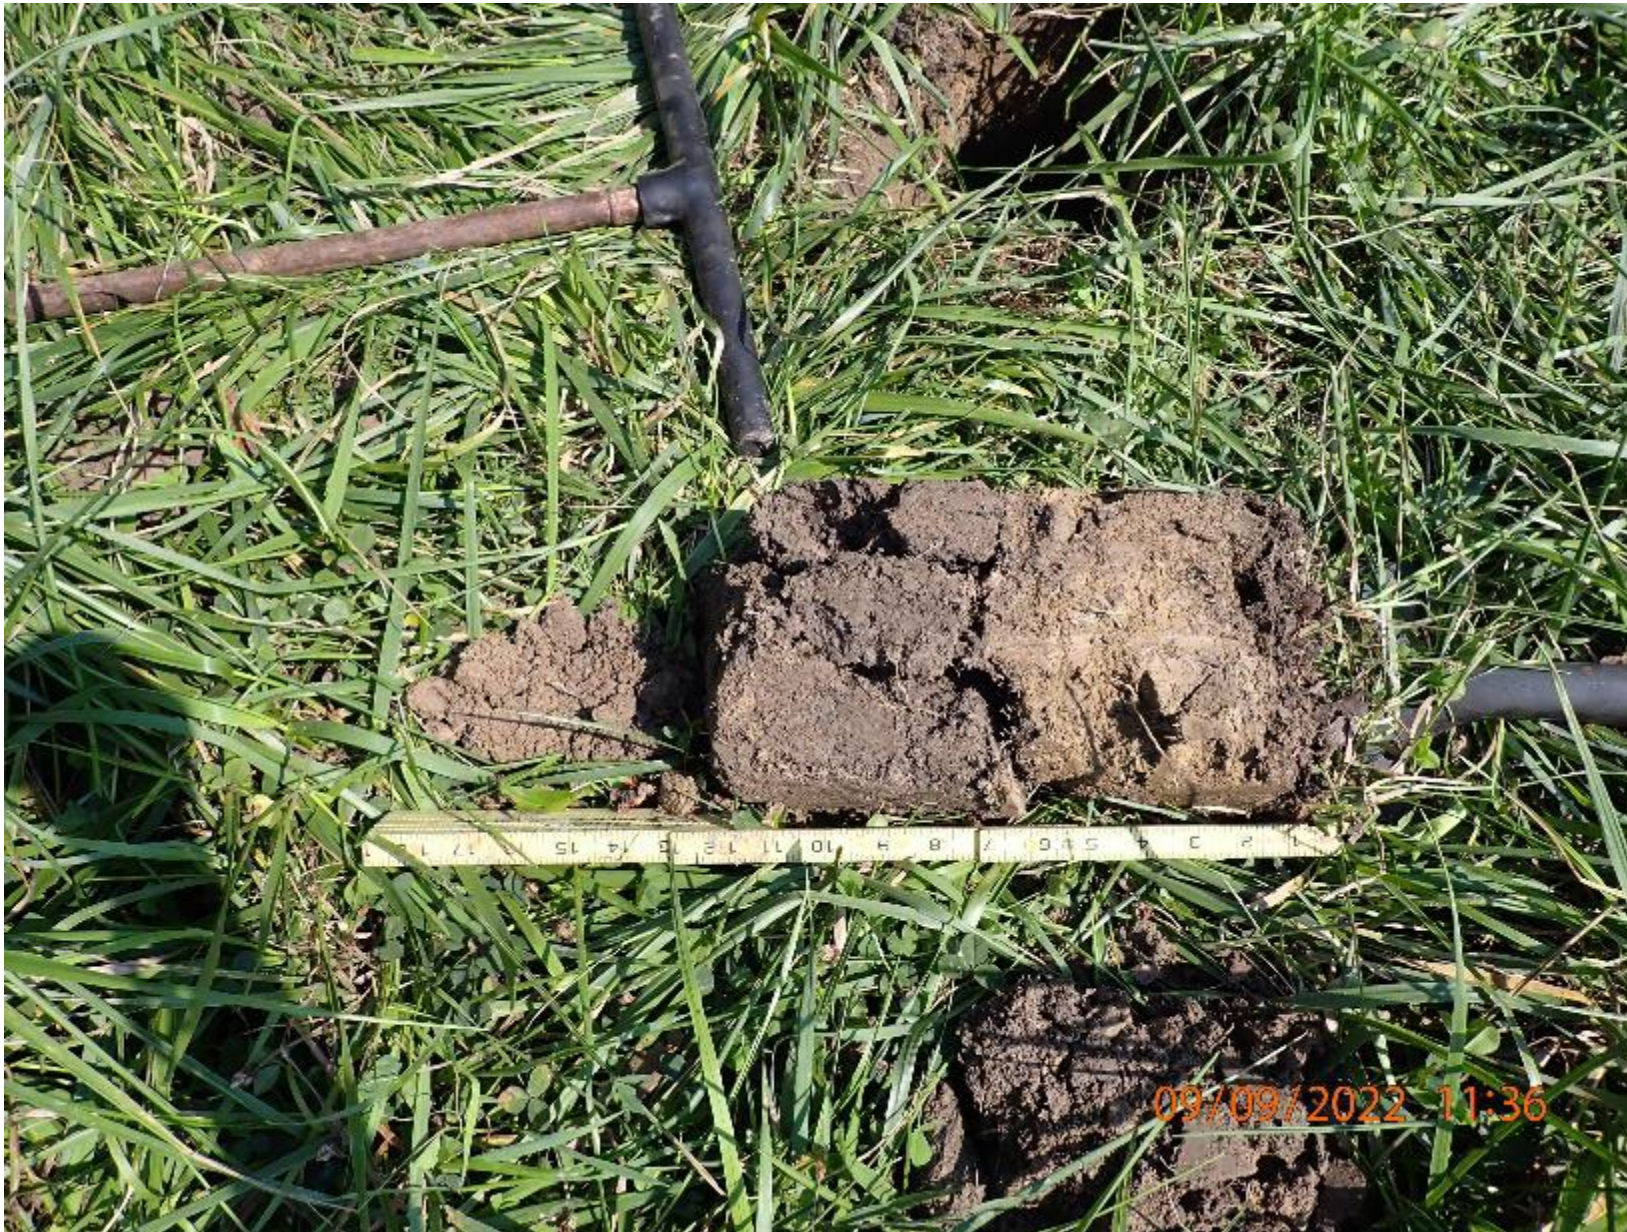
**Date:** 9/9/2022  
**Time:** 11:36 AM  
**Photographer:** SSA  
**Photo ID:** 11 – P9090474

SS1 soil profile showing 8 inches of fill material on top of hydric soil

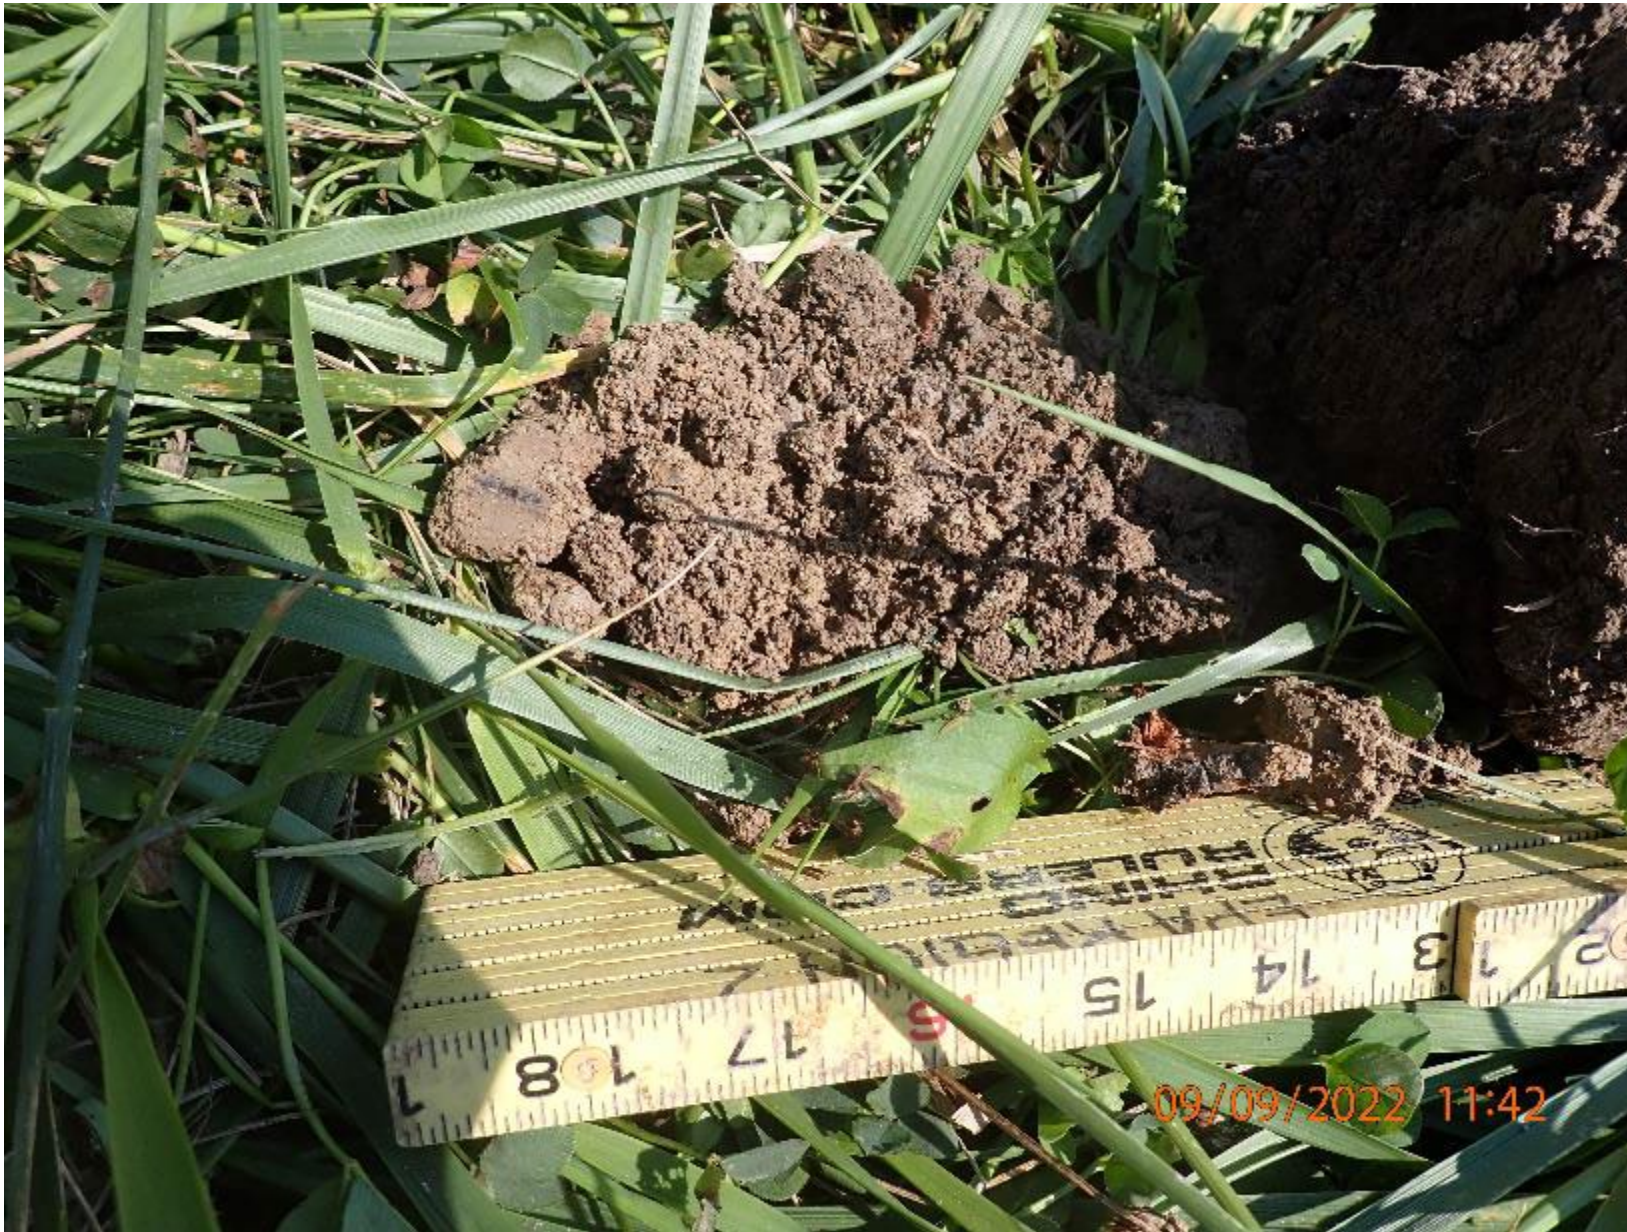
**Date:** 9/9/2022  
**Time:** 11:42 AM  
**Photographer:** SSA  
**Photo ID:** 12 – P9090475

12-18" layer of SS1 soil profile  
showing redoximorphic features

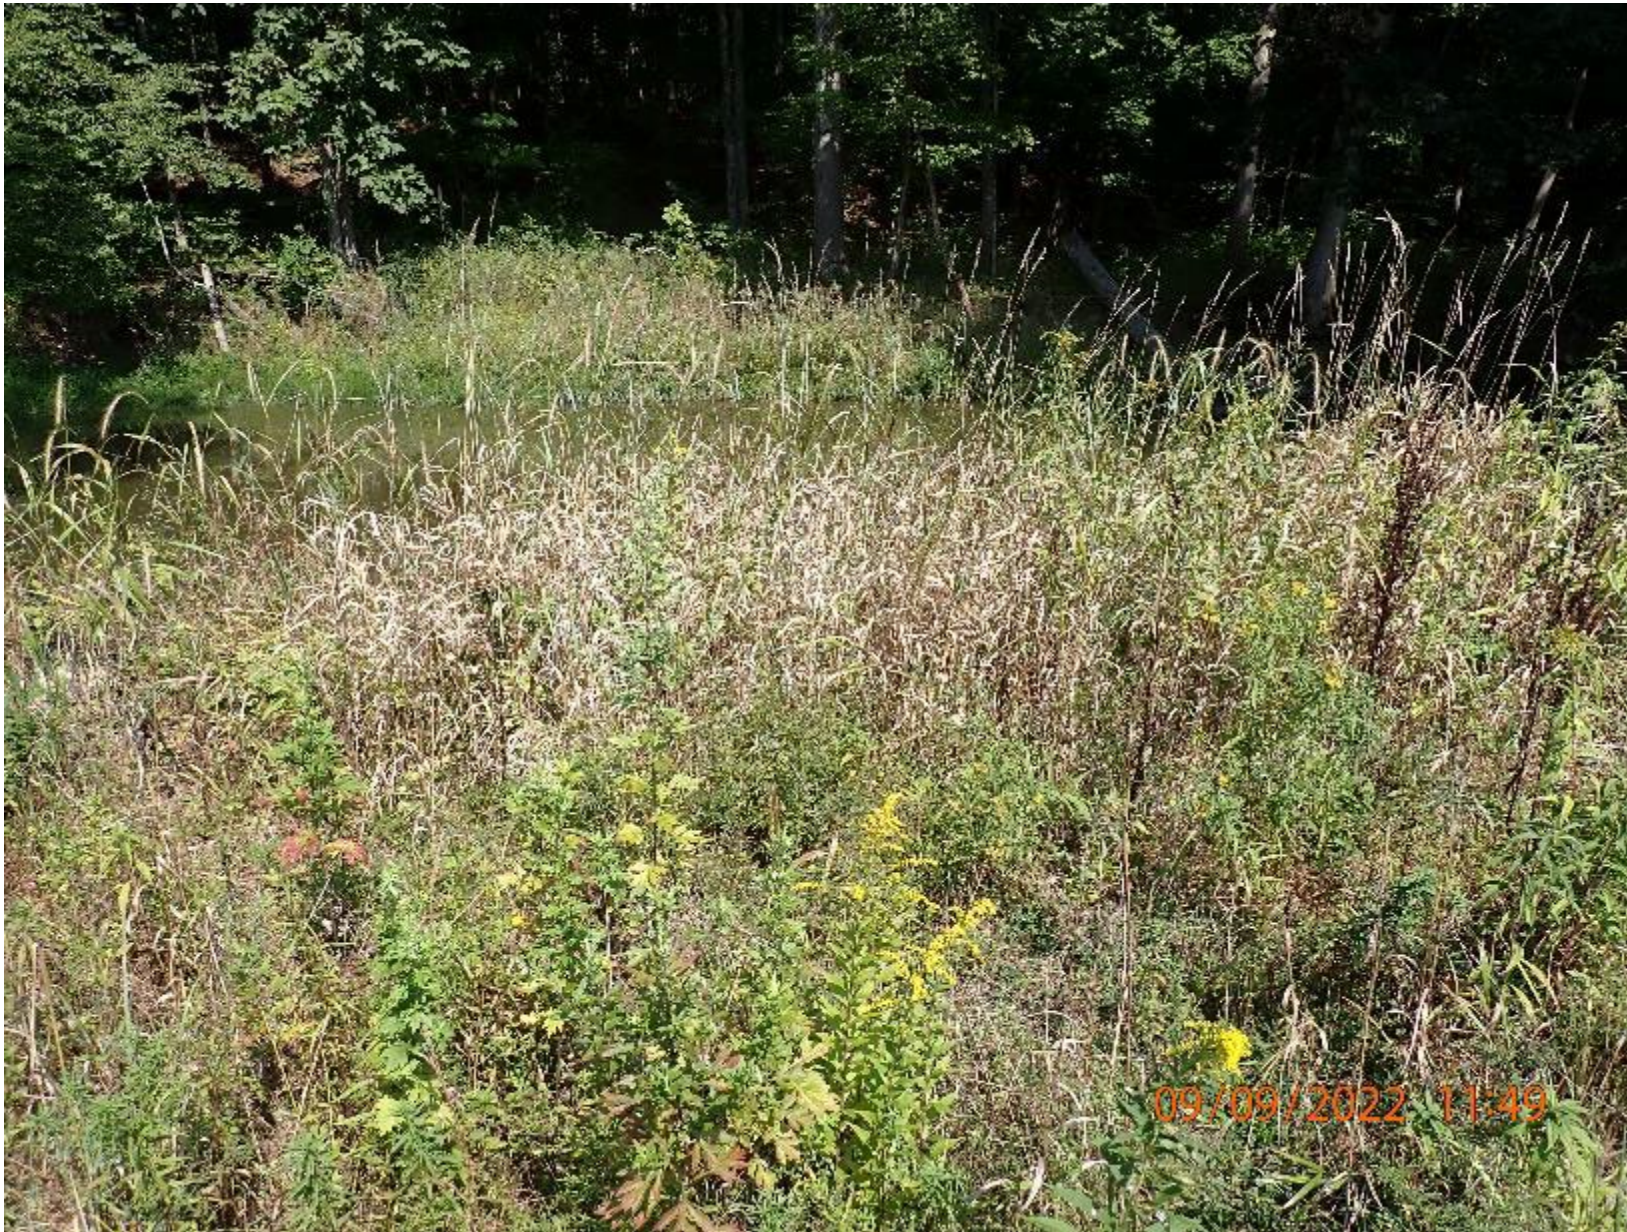
**Date:** 9/9/2022  
**Time:** 11:49 AM  
**Photographer:** SSA  
**Photo ID:** 13 – P9090476

Riparian vegetation. Dwaar Kill River in the background.

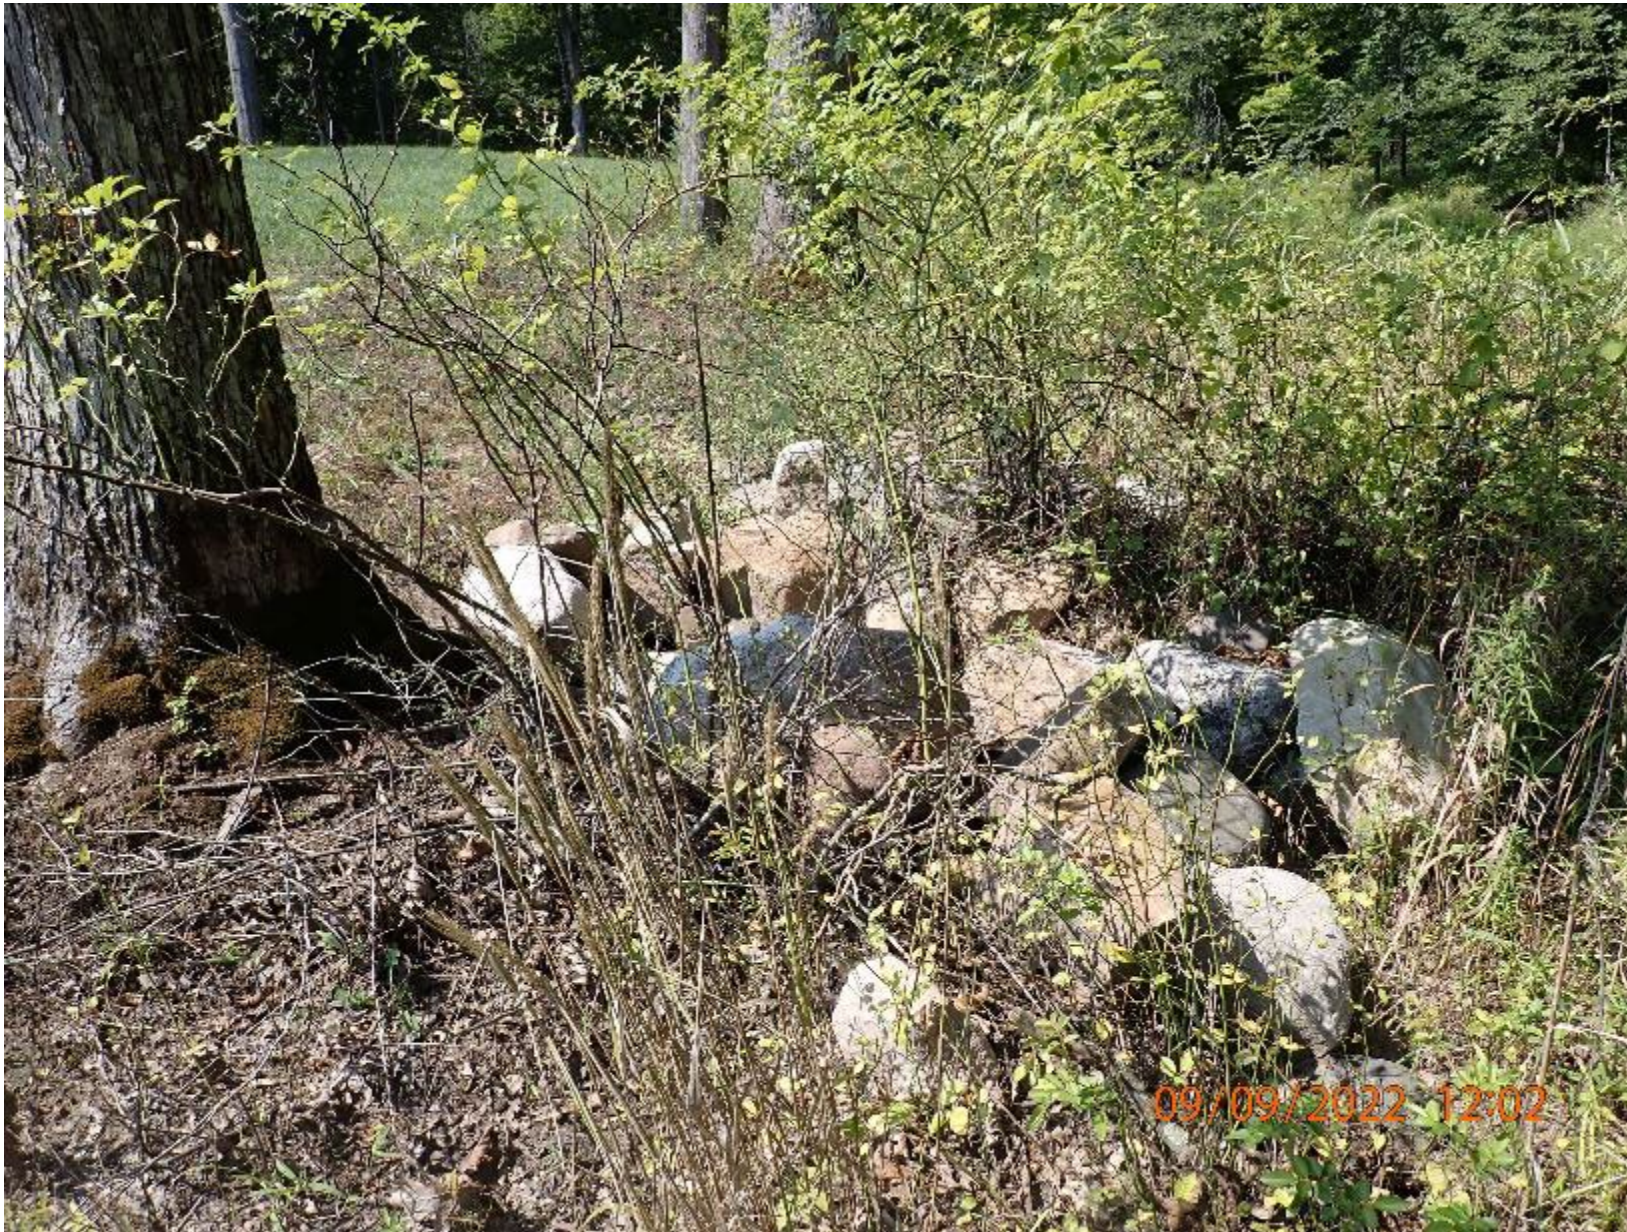
**Date:** 9/9/2022  
**Time:** 12:02 PM  
**Photographer:** SSA  
**Photo ID:** 14 – P9090477

Low spot along Dwaar Kill filled with boulder.

GPS point taken

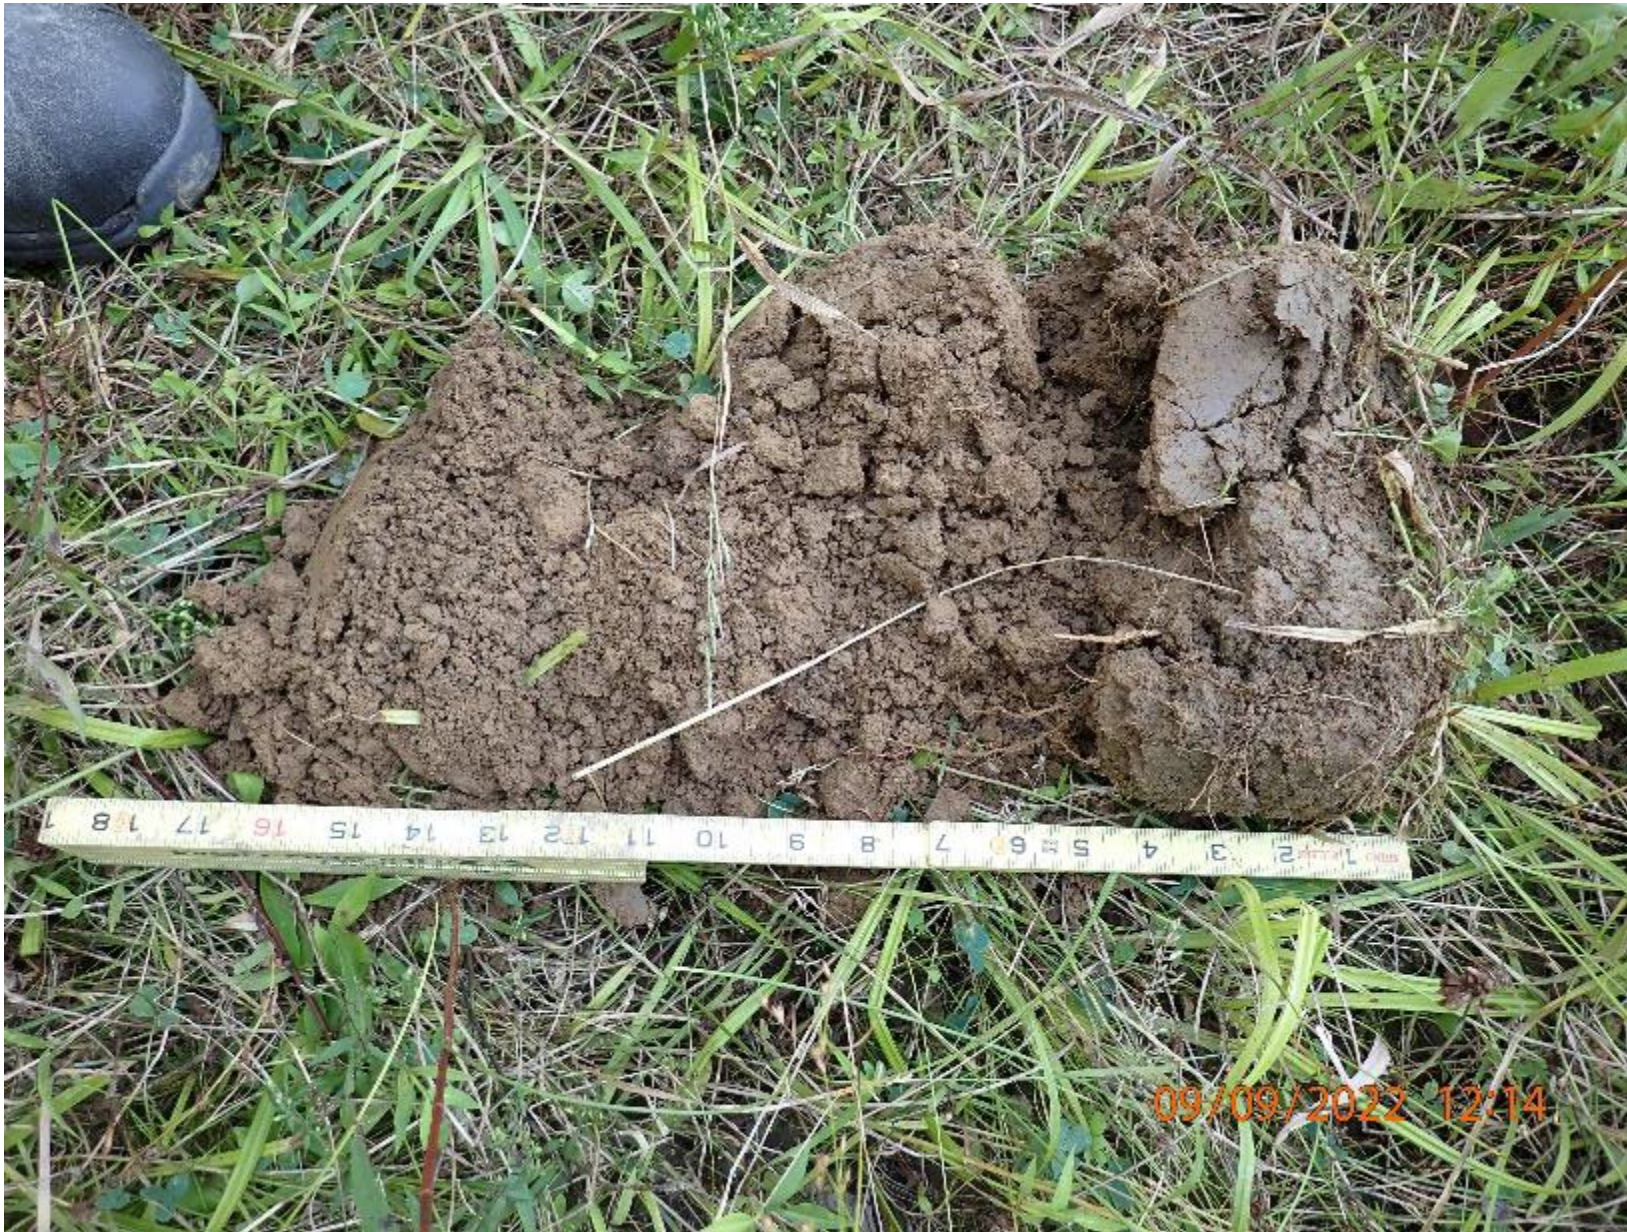
**Date:** 9/9/2022  
**Time:** 12:14 PM  
**Photographer:** SSA  
**Photo ID:** 15 – P9090478

**Description:**  
SS2 soil profile

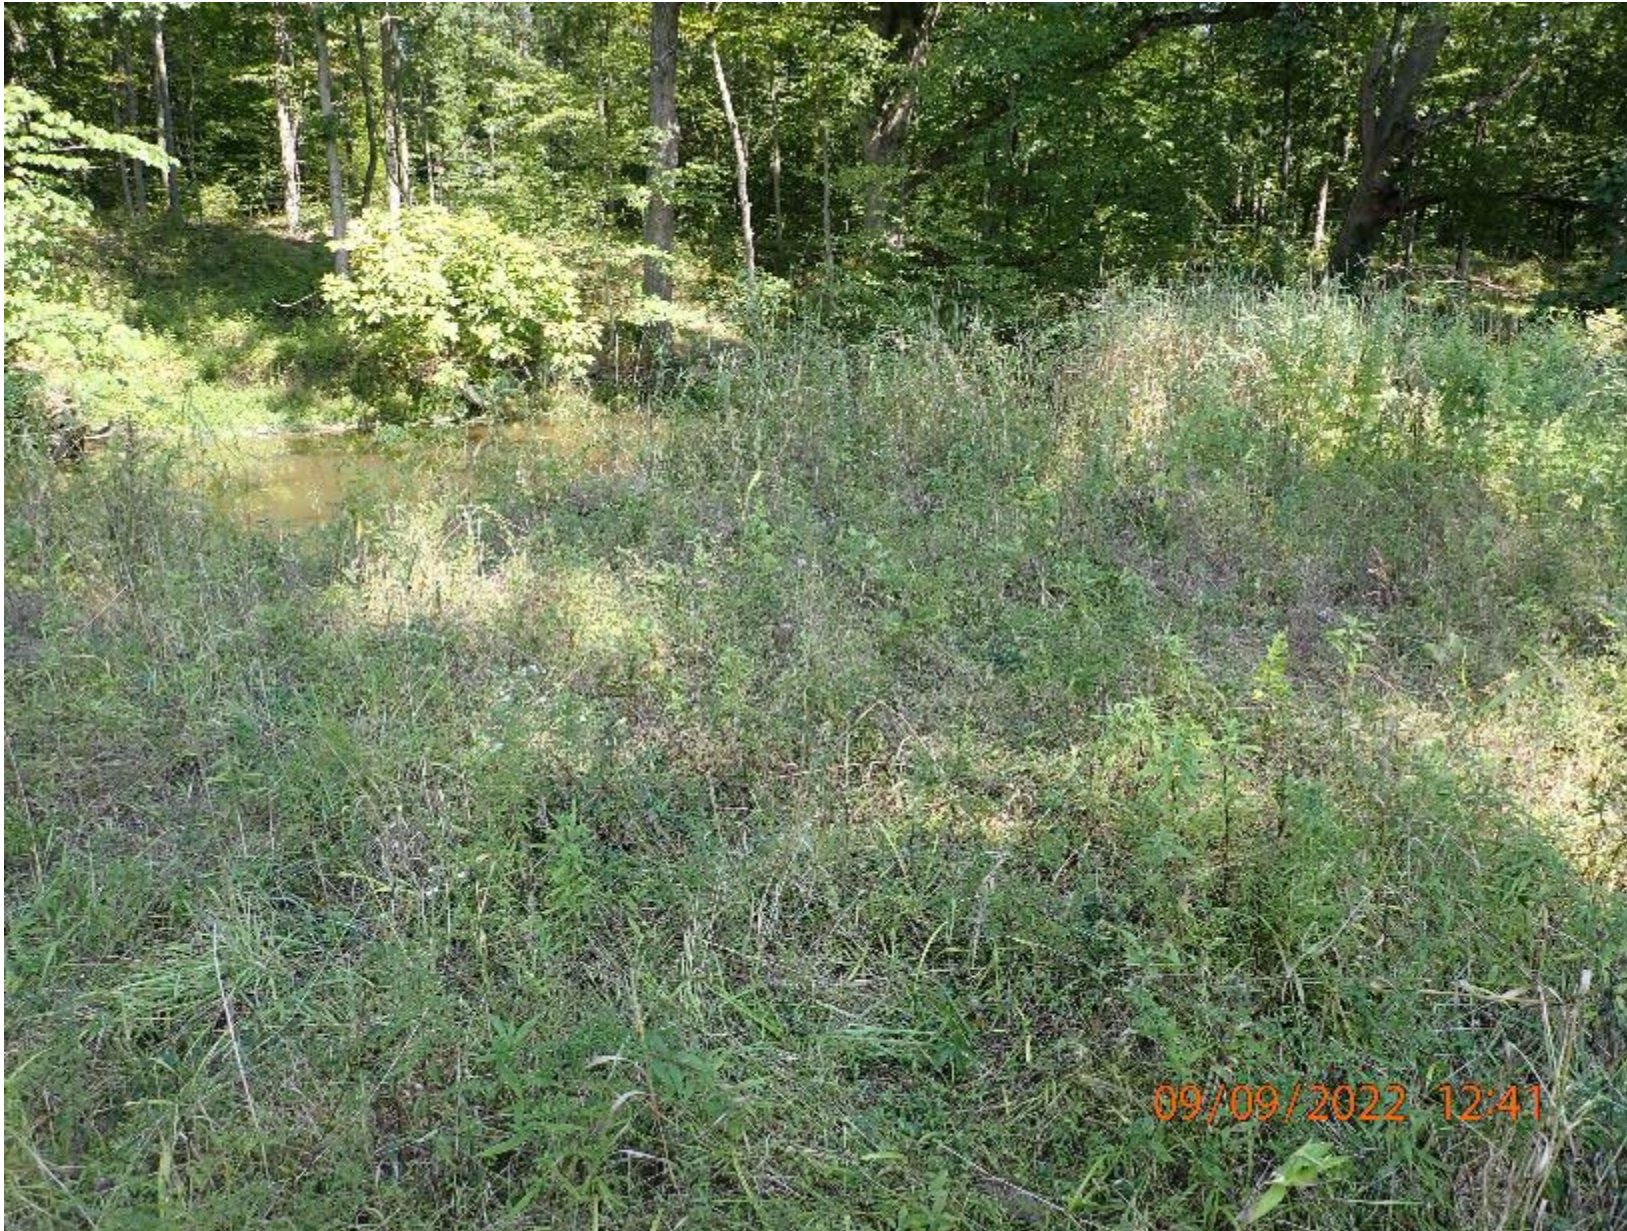
**Date:** 9/9/2022  
**Time:** 12:41 PM  
**Photographer:** SSA  
**Photo ID:** 16 – P9090479

**Description:**  
Vicinity of SS2

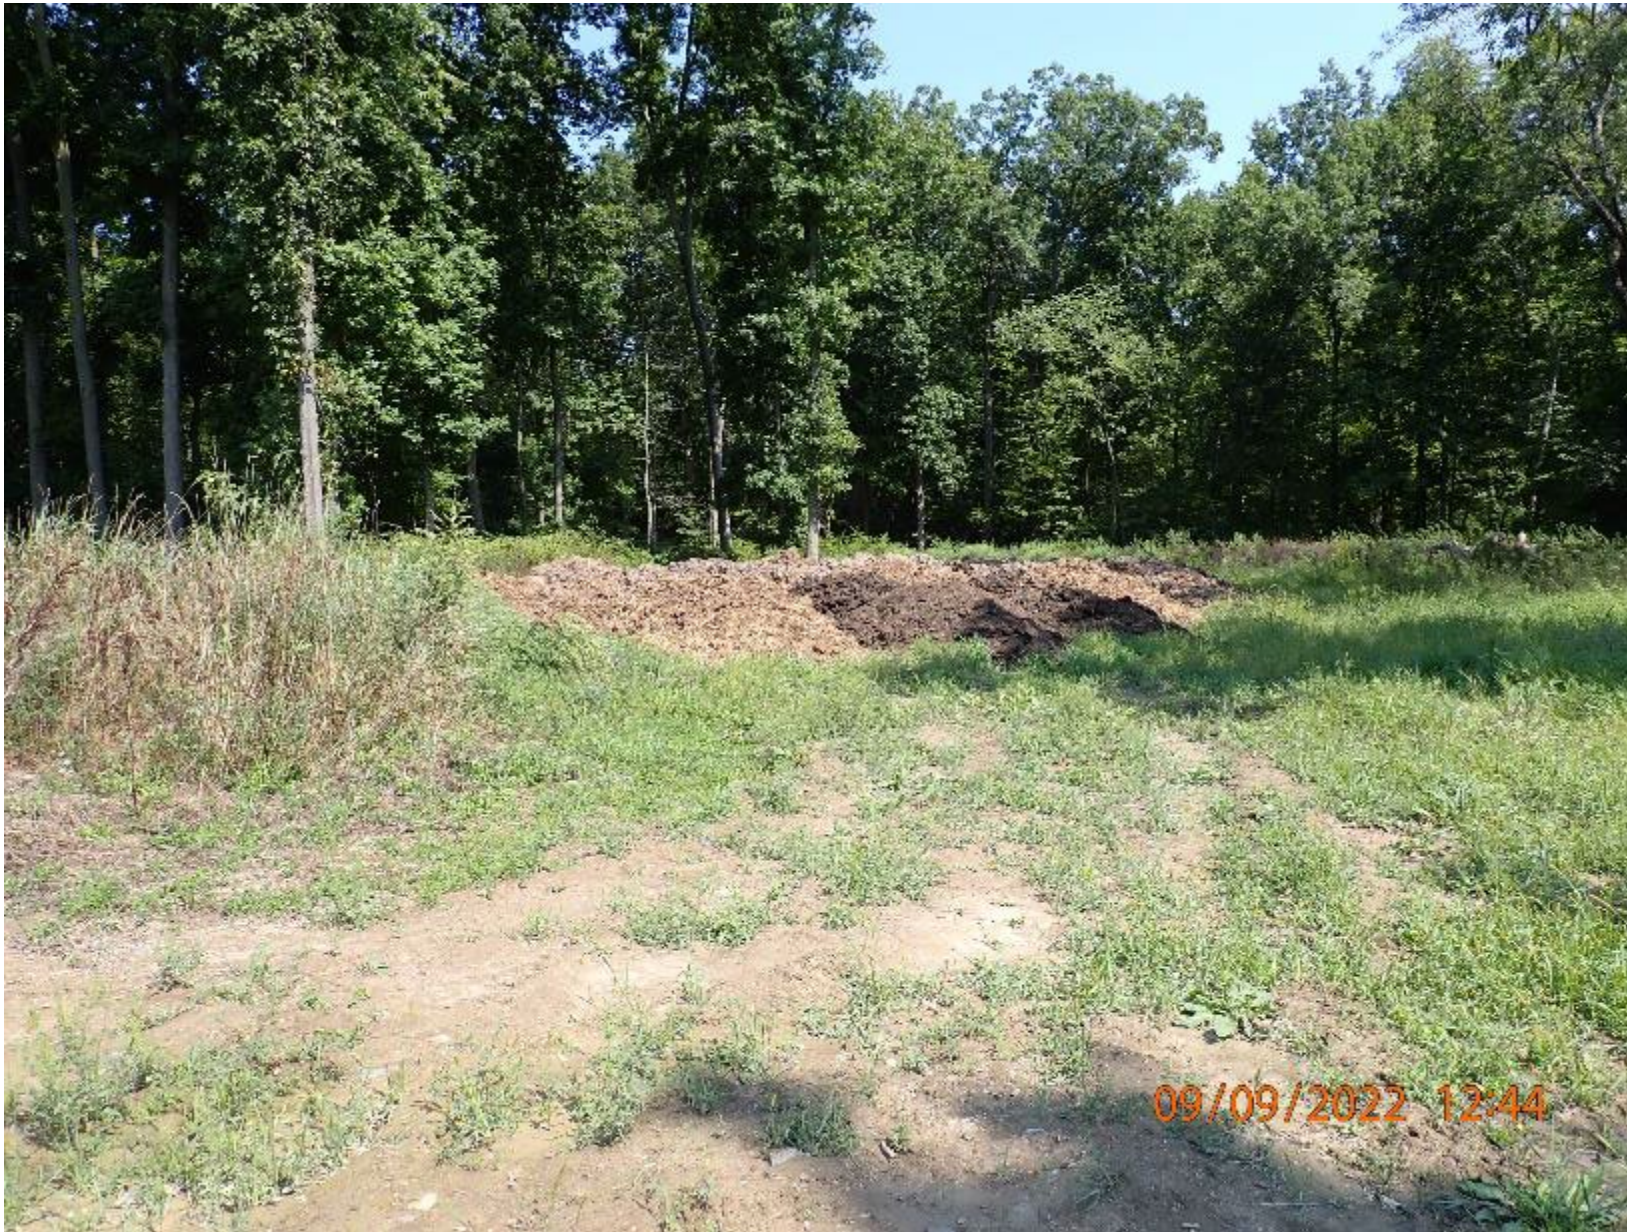
**Date:** 9/9/2022  
**Time:** 12:44 PM  
**Photographer:** SSA  
**Photo ID:** 17 – P9090480

Manure Piles south of SS2

Eastern side of northwestern  
hayfield

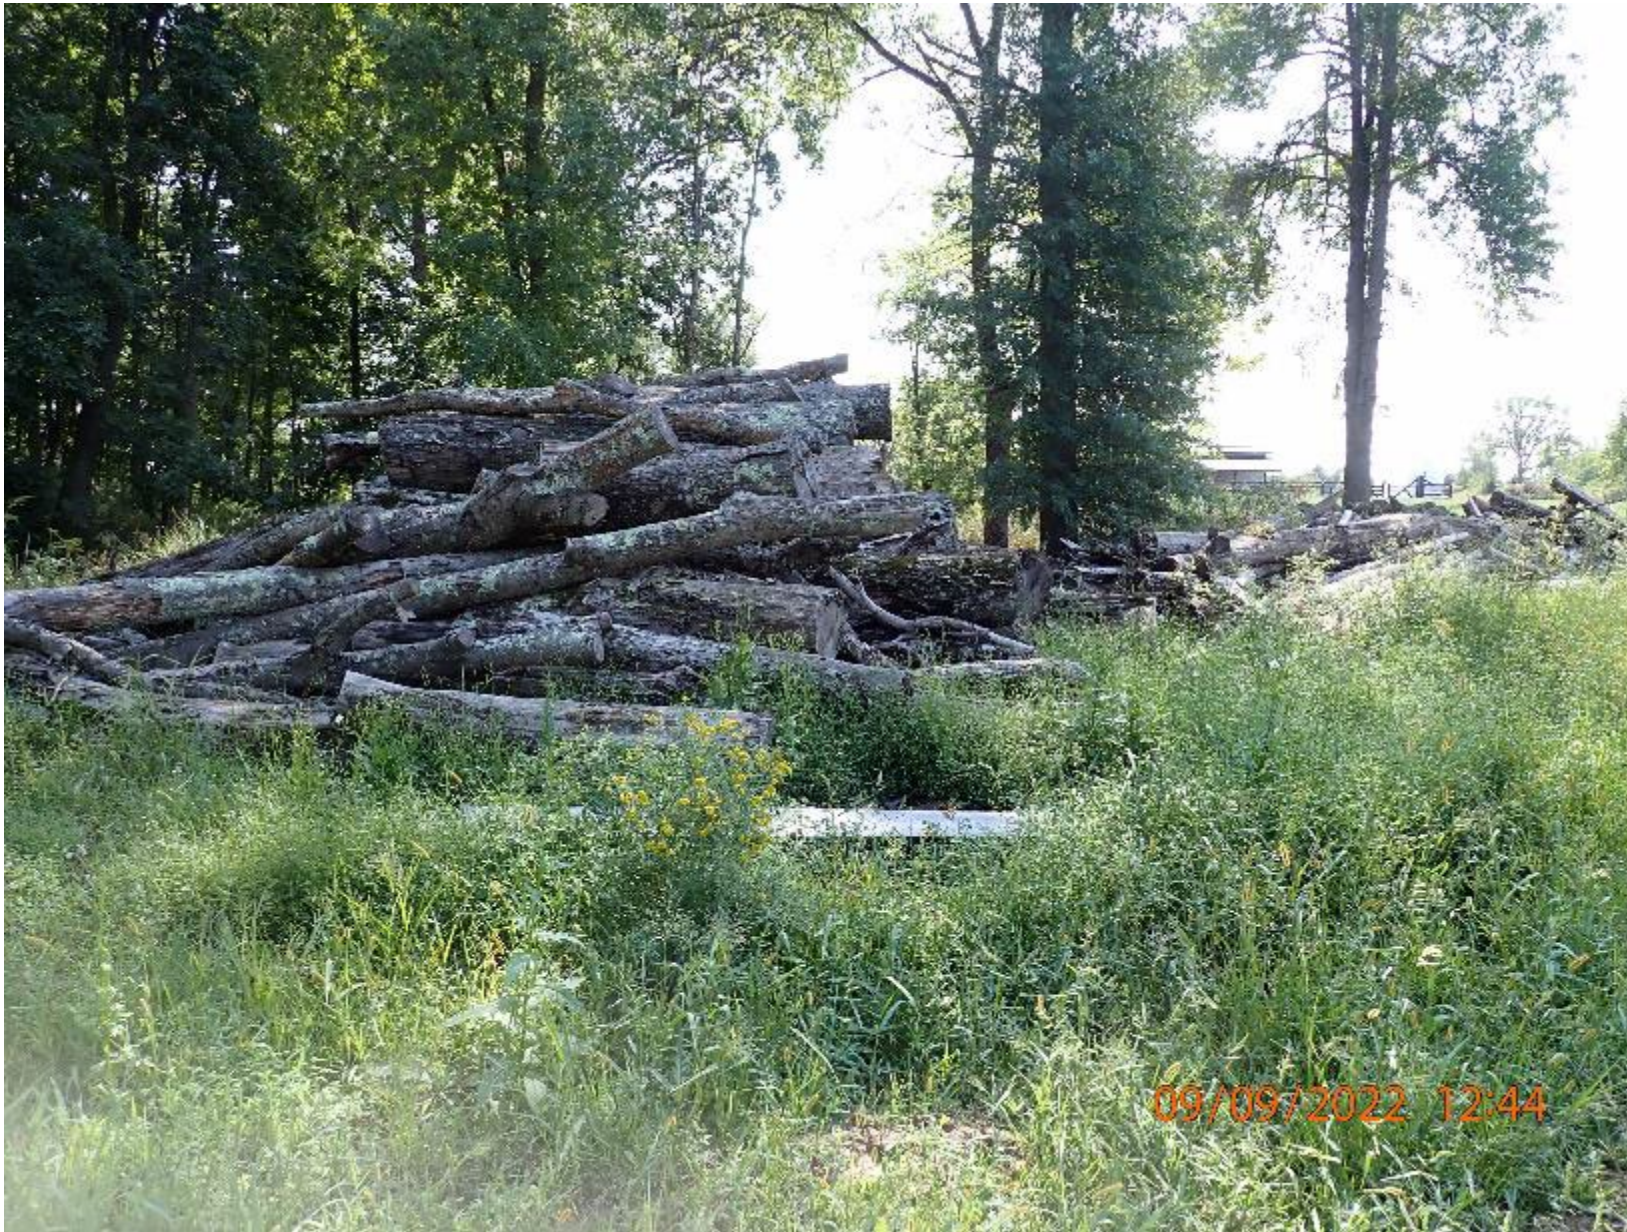
**Date:** 9/9/2022  
**Time:** 12:44 PM  
**Photographer:** SSA  
**Photo ID:** 18 – P9090481

Log stockpile

Eastern side of northwestern  
hayfield

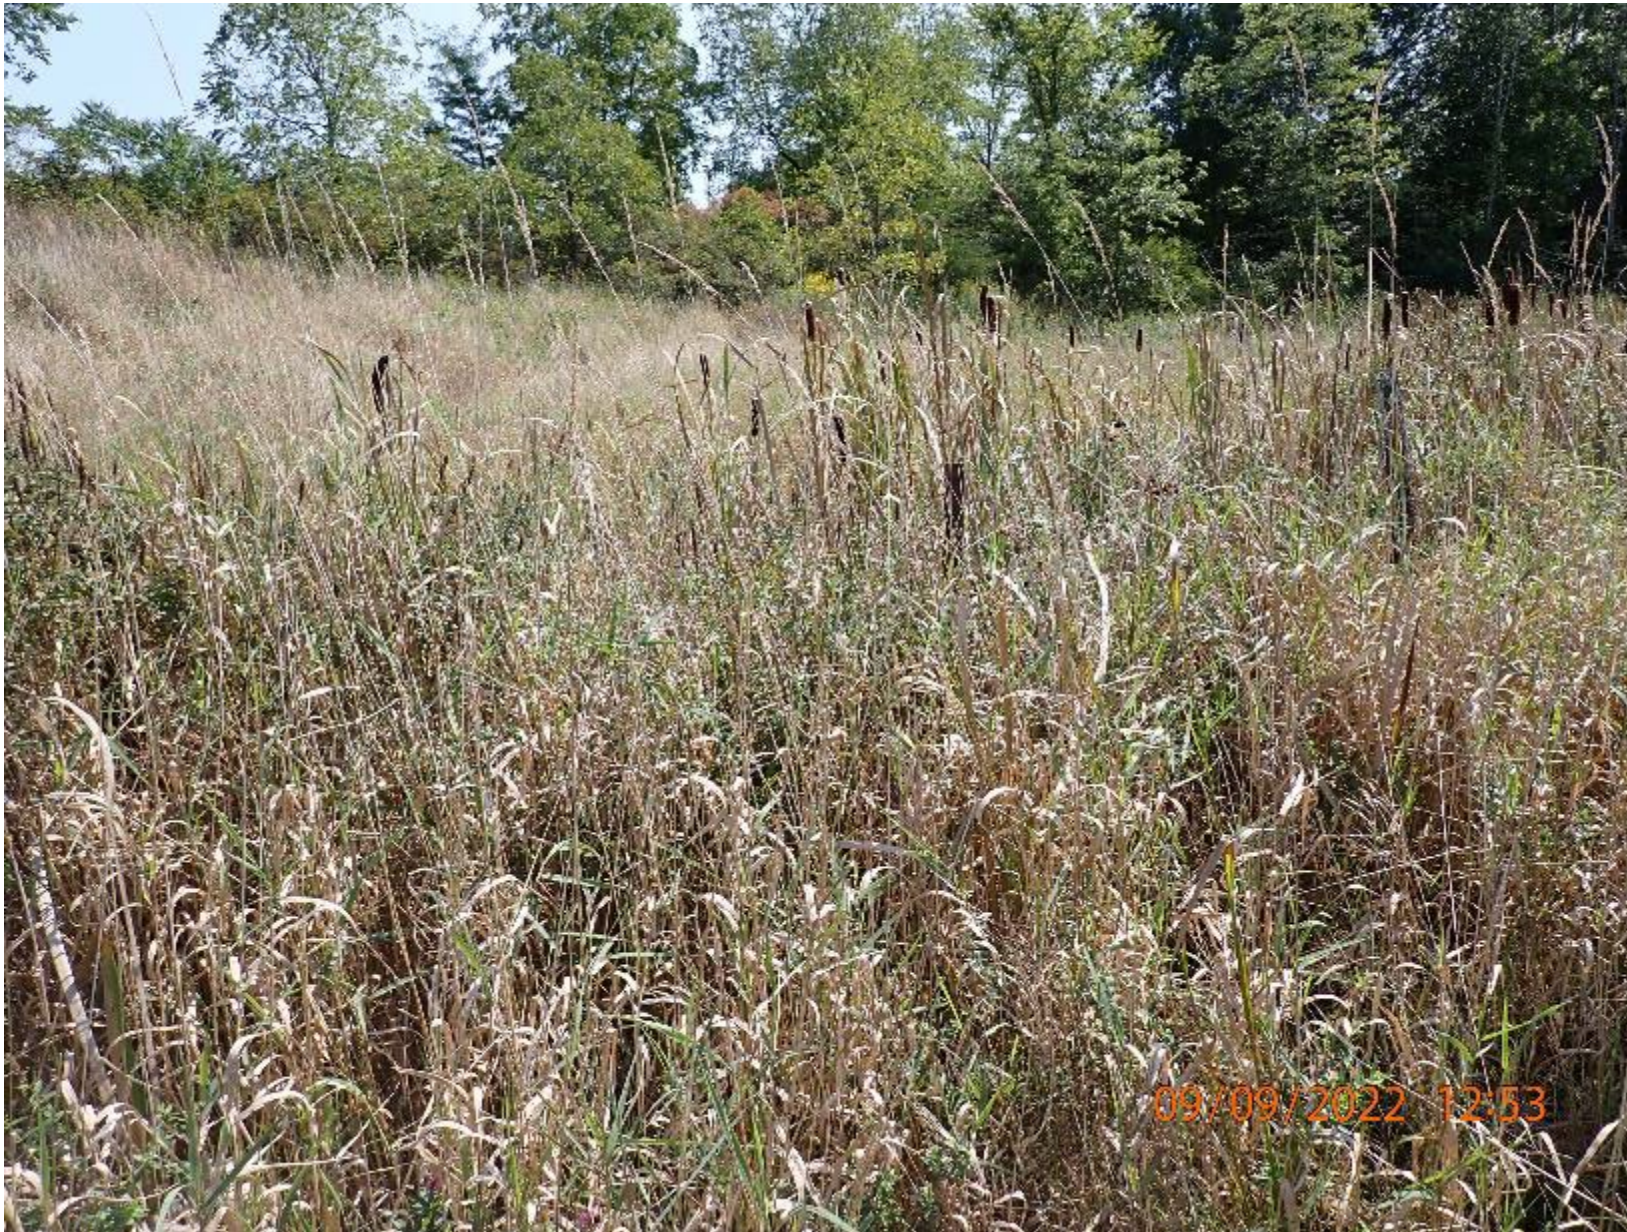
**Date:** 9/9/2022  
**Time:** 12:53 PM  
**Photographer:** SSA  
**Photo ID:** 22 – P9090485

Presumed wetland area on  
neighboring property

Adjacent to southwestern hay  
field
