## Clean Water Act Section 404: Site Visit/Case Development

| Site Name | SVG Holdings Property | | | | |
| Site Address* | 260 Bruyn Turnpike (106.1-1-28.111) | | | | |

| Inspection Purpose | Initial site visit | | |

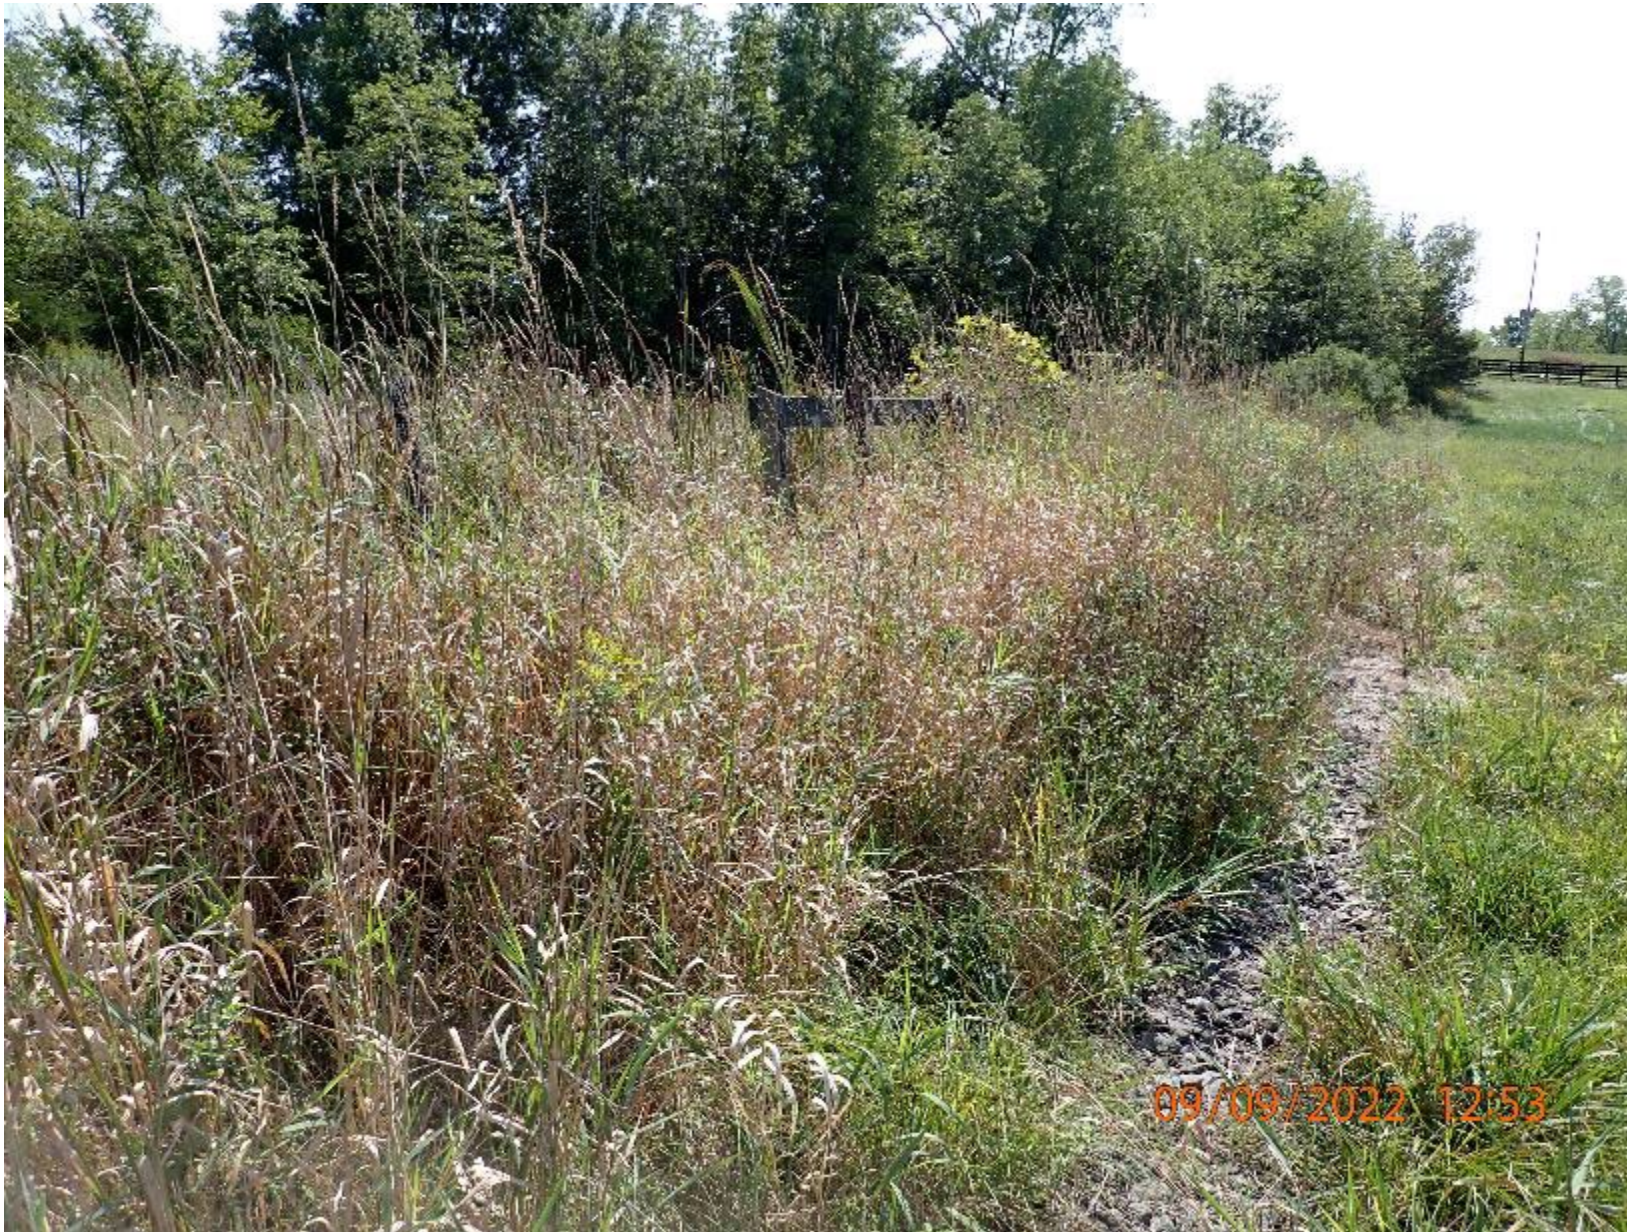
**Date:** 9/9/2022  
**Time:** 12:53 PM  
**Photographer:** SSA  
**Photo ID:** 23 – P9090486

Presumed wetland area on neighboring property; drain; hydrophytic vegetation

Adjacent to southwestern hay field

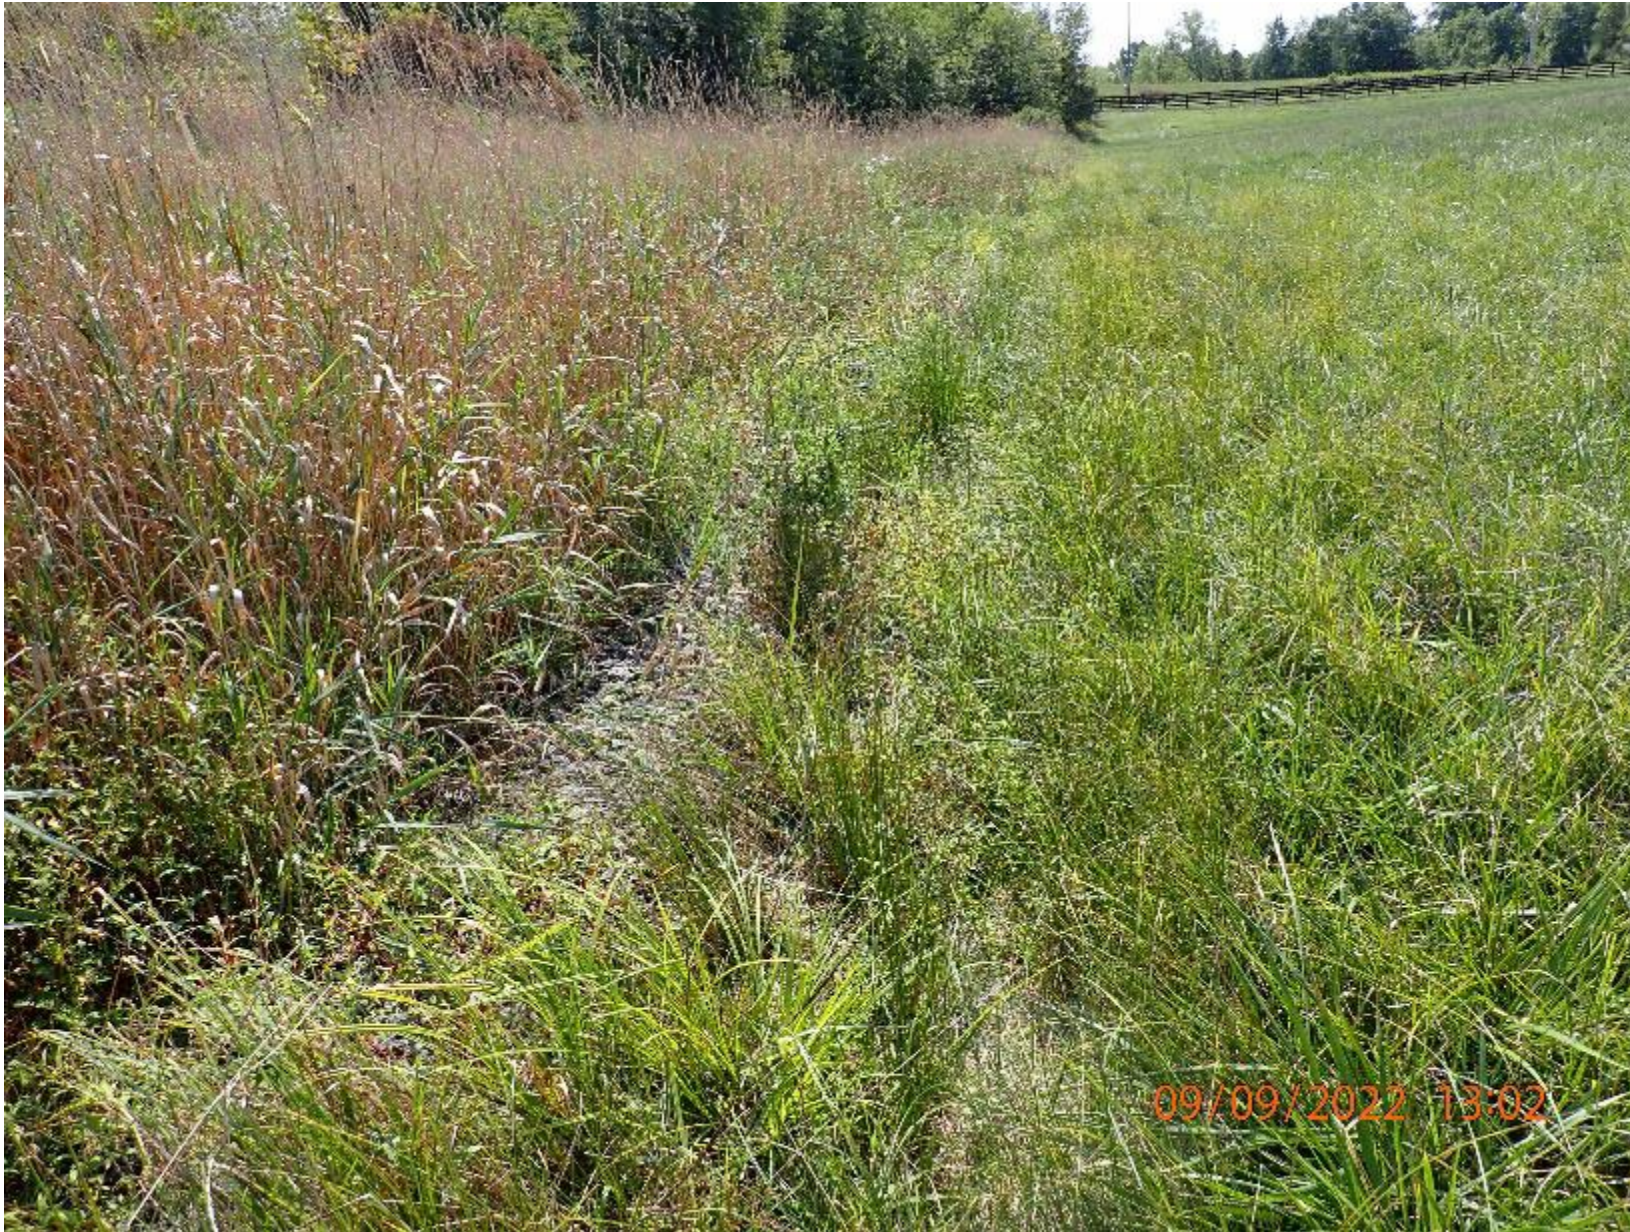
**Date:** 9/9/2022  
**Time:** 1:02 PM  
**Photographer:** SSA  
**Photo ID:** 24 – P9090487

Wetland vegetation growing in  
low spot in field

GPS Point taken
