# **NPDES Compliance Inspection Report**

## **Lummi Indian Business Council Gooseberry Point Wastewater Treatment Plant**

**Permit # WA0025666**

**Inspection Date: August 17, 2022**

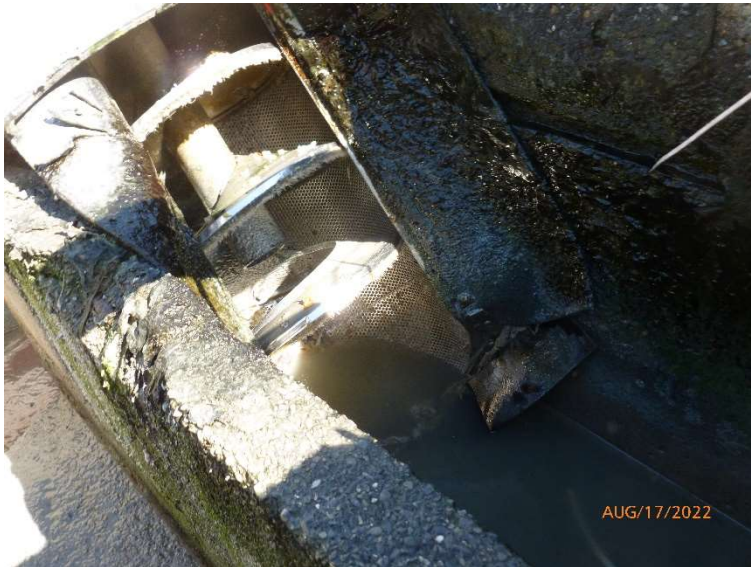
Photo 1

At the headworks, we inspected the headworks screening system (**Photo 1**), the influent flow device/monitor (**Photo 2**) and the aerated grit chamber (**Photo 3**) before flow is split and conveyed to the two primary clarifiers. We also observed and confirmed with Mr. Jefferies the

Headworks screening system

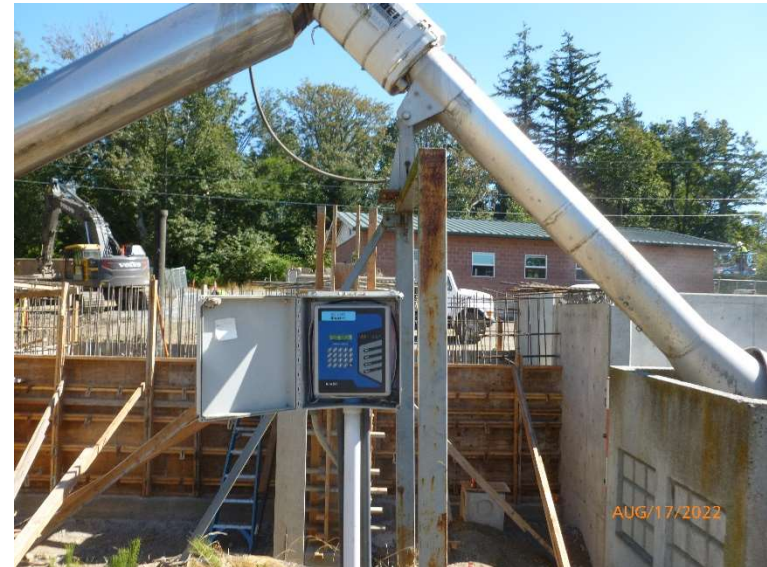
Photo 2

influent 24-hour composite ISCO sampling device was not connected to the influent flow monitoring device/system.

Influent flow measuring device/monitor

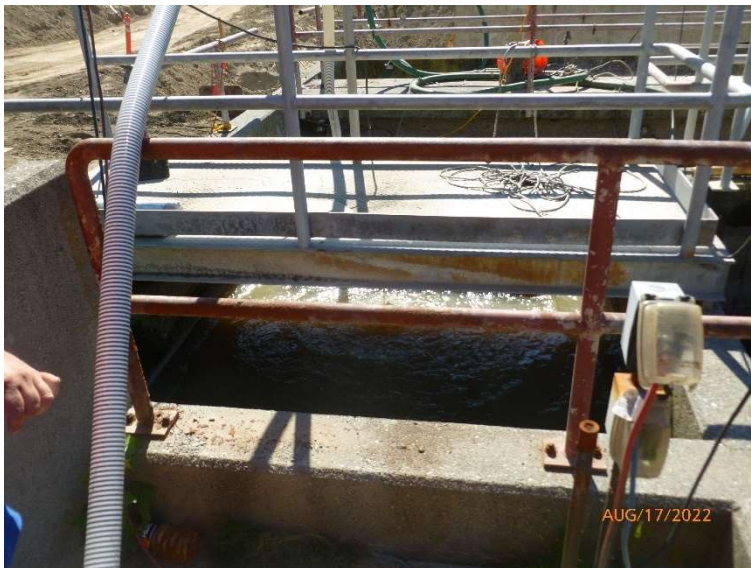
Photo 3

Aerated grit chamber

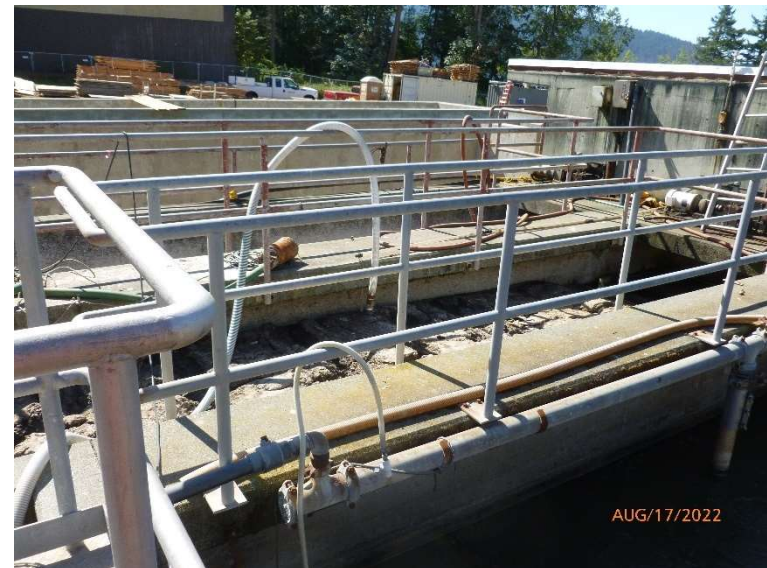
Photo 4

We observed the primary clarifiers which were loaded with a large amount of surface scum **(Photo 4)**. Mr. Jefferies said a service company had been called to come and remove the scum.

Primary clarifier

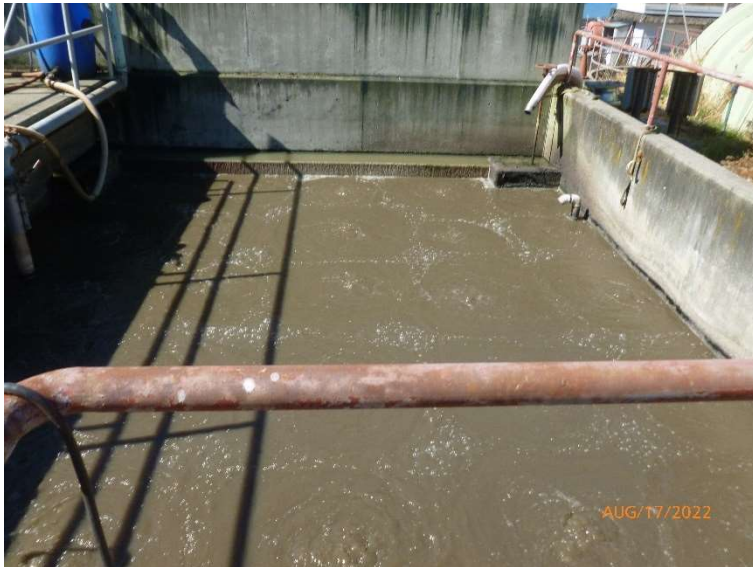
Photo 5

From the primary clarifiers, the wastewater enters the pre-aeration basin **(Photo 5)** where large amounts of air are entrained in the wastewater (see Photo showing bubbles on basin surface) before flowing to one of the two rotating biological contactors (RBCs) that provide secondary treatment. Mr. Jefferies opened up one of the RBCs so we could observe the filter media. Mr. Jefferies told us they clean the RBCs annually.

Pre-aeration basin

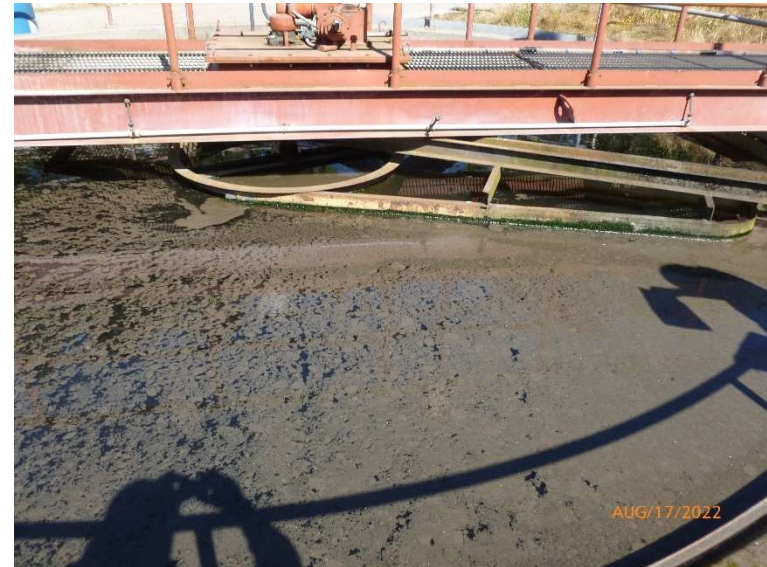
Photo 6

RBC effluent is directed to the secondary clarifiers **(Photo 6)** where Mr. Jefferies said the contractors had inadvertently disconnected the overhead water spray systems to the clarifiers' surface. From the secondary clarifiers, the effluent is directed to the UV system chamber **(Photo 7)**. I observed the adjacent back-up chlorine contact basin was not in use.

Secondary clarifier

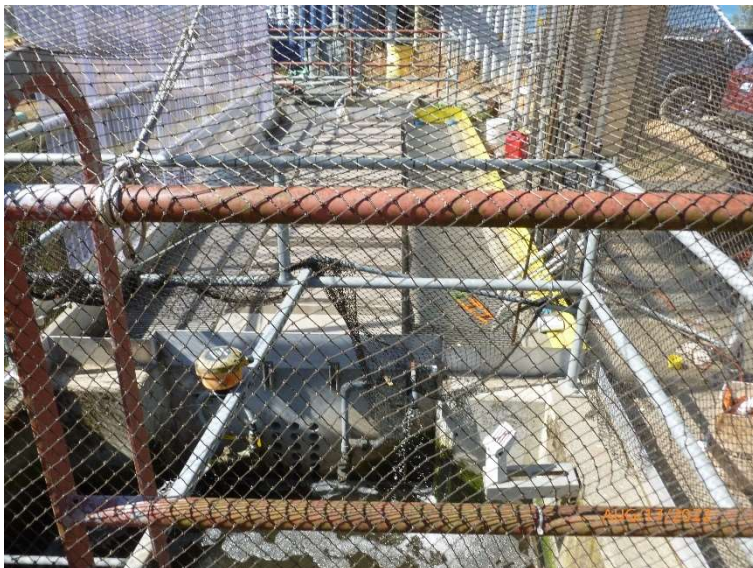
Photo 7

In response to EPA questions about UV system operations and maintenance procedures, Mr. Jefferies stated operators observe total suspended solids (TSS) levels as an indicator of potential UV bulb fouling. Operators brush the UV bulbs monthly and bulbs are changed out annually.

UV system chamber

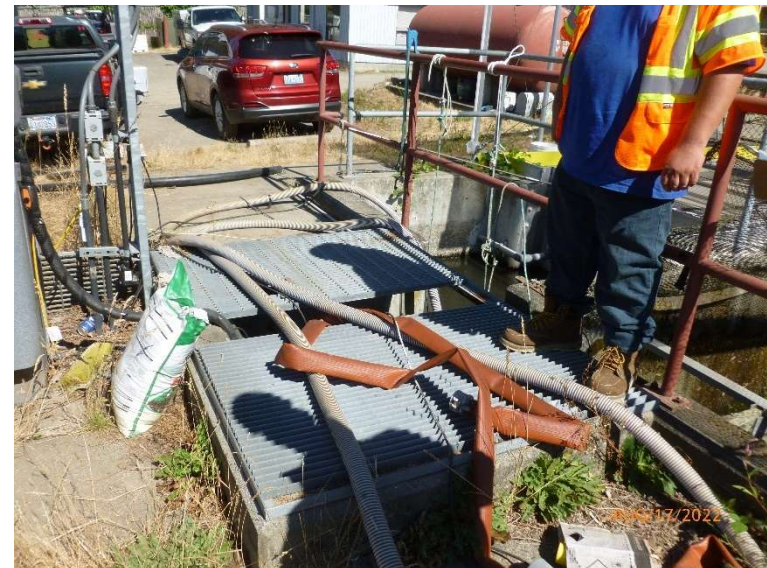
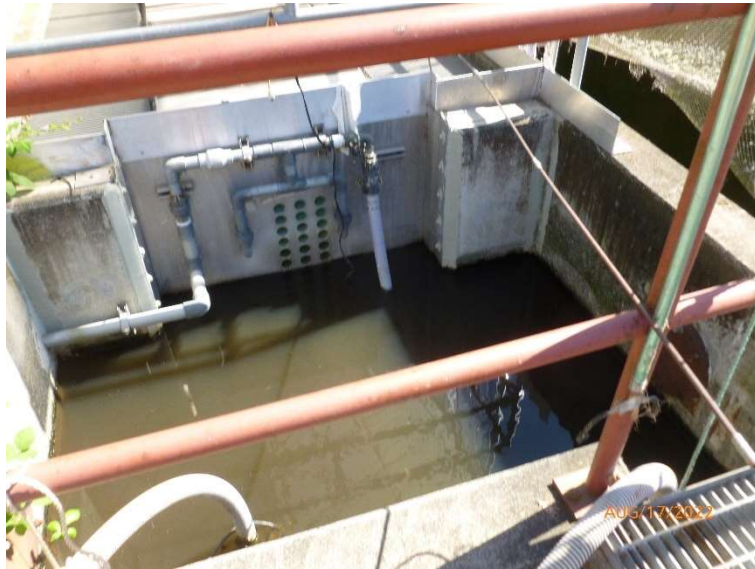
Photo 8

In response to EPA questions about what visual observations are made by LTSWD staff regarding the Permit, Part I.B.3 (i.e., "free from" condition), no discharge of floating solids, visible foam, etc. on the surface of the receiving water, LTSWD staff stated observations are not made of the outfall's surface water vicinity in Hale Passage. LTSWD staff said operators make observations of the treated effluent as it leaves the UV system chamber into the outfall box before entering the outfall piping system but those observations are not recorded.

As the disinfected effluent exits the UV system chamber, it enters the outfall box where the sampling occurs and where operators can make visual observations of treated effluent as it enters the outfall piping system **(Photos 8 and 9)**. We also observed and confirmed with Mr. Jefferies the effluent 24-hour composite ISCO sampling device was not connected to the effluent flow monitoring device system.

Outfall box/effluent sampling location

Outfall box at end of UV disinfection system chamber

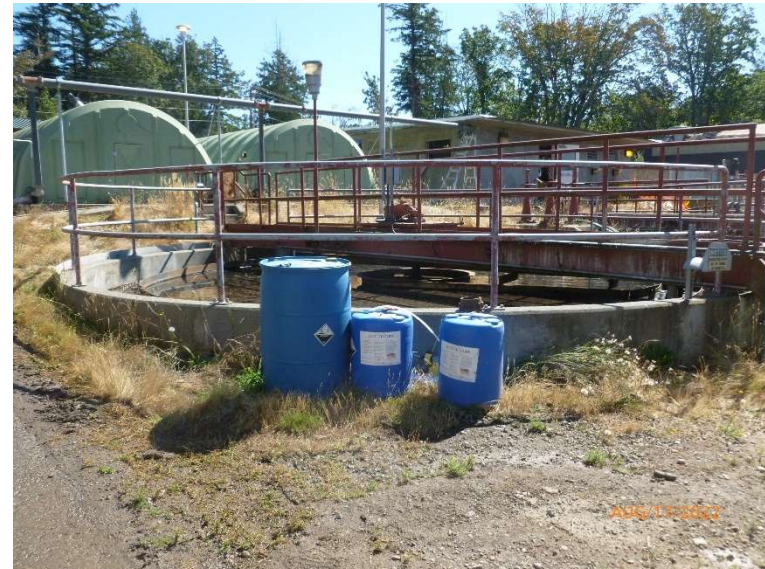
Photo 10

During the EPA inspection site tour of the WWTP, the EPA inspectors observed a jury-rigged chlorination injection system that LTSWD staff stated was used to inject chlorine into one of the secondary clarifiers, just upstream of where the wastewater would leave the secondary clarifier and enter the UV system chamber.

As we were completing the WWTP site tour, we observed a jury-rigged chlorination system located next to one of the secondary clarifiers **(Photo 10)**, consisting of a pump from one of three chlorine containers (i.e., one blue 55-gallon drum and two blue 15-gallon containers). Mr. Jefferies said this chlorination system was used just once recently when the UV system became inoperable due to a temporary electric device disruption. The WWTP's DMRs indicate this system was used and sampled in November 2021 based on TRC entries in the November 2021 DMR.

The Permit, Part IV.D, requires "the permittee must take all reasonable steps to minimize or prevent any discharge in violation of this permit that has a reasonable likelihood of adversely affecting human health or the environment." As EPA inspectors were completing the WWTP site tour, we observed a jury-rigged chlorination system located on the ground next to one of the secondary clarifiers (**Photo 10**), consisting of a pump from one of three chlorine containers (i.e., one blue 55-gallon drum and two blue 15-gallon containers). These chlorine containers were not located in secondary containment and there were no visible precautions taken to prevent contact, leakage, tippage, etc. but the drum and containers were located out in the open with the potential for discharge to the environment and employee exposure. One of the blue 15-gallon containers had an open bung, subjecting it to precipitation inflow and potential for container overflow.
