## Clean Water Act Section 404: Site Visit/Case Development

| Site Name | Ben Wellons | | | | |

| Inspection Purpose | Initial site visit | | |
| General Site Characteristics (layout of property, etc.)<br>This property is located off a dead end road and is primarily a forested wetland with Bayou Des Arc flowing through the property. Levees and a large dam structure were built across Bayou Des Arc. Refer to map attachments and photographs for details. | | | |

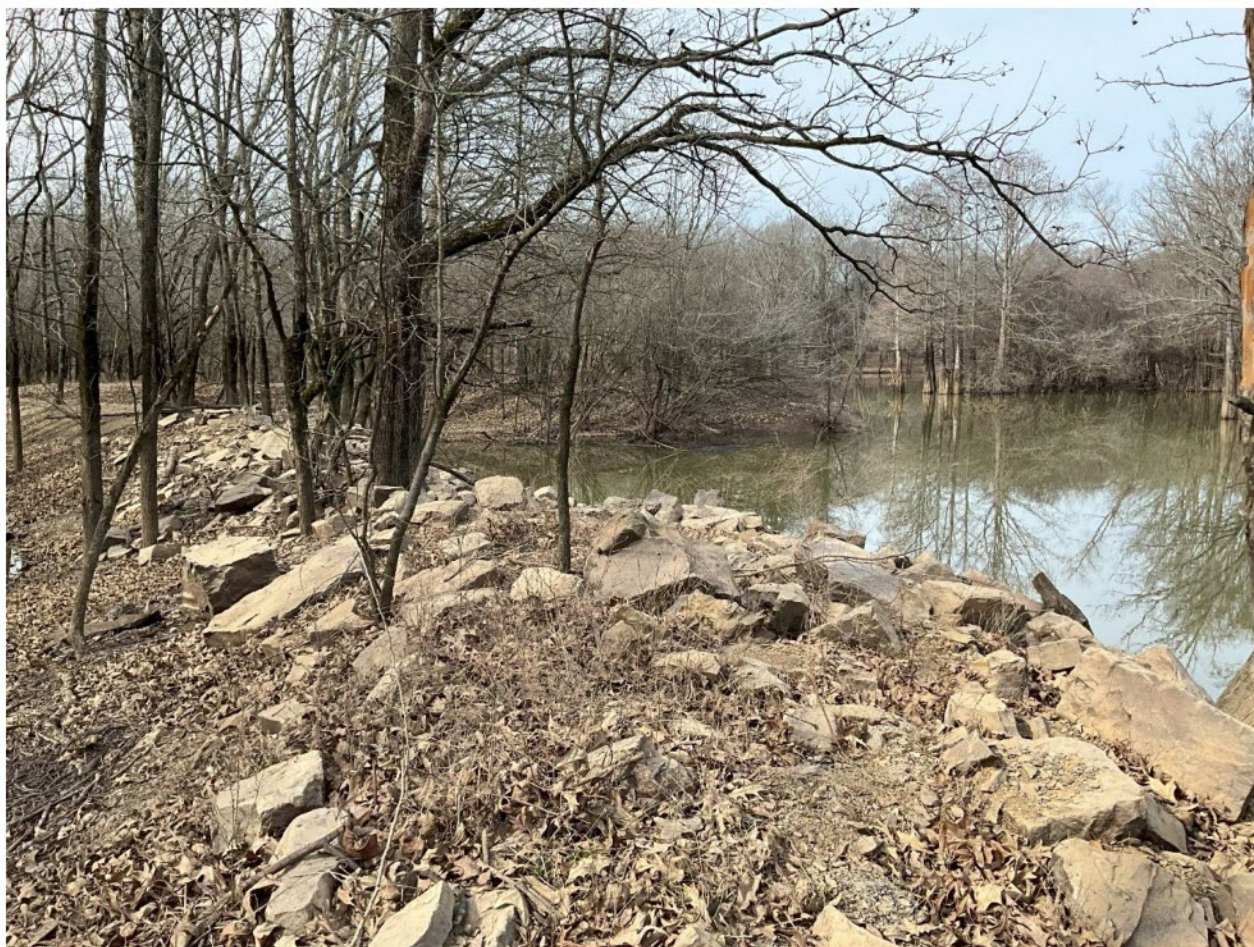
Photo No. 1

| Photo File Name | Date and Time of Photo | Photographer | Description |
|---|---|---|---|
| IMG_137.HEIC | 01/29/2025, 11:17 AM | Chelsey Sherwood | Showing the levee upstream of the large dam structure. Picture taken facing northwest. |

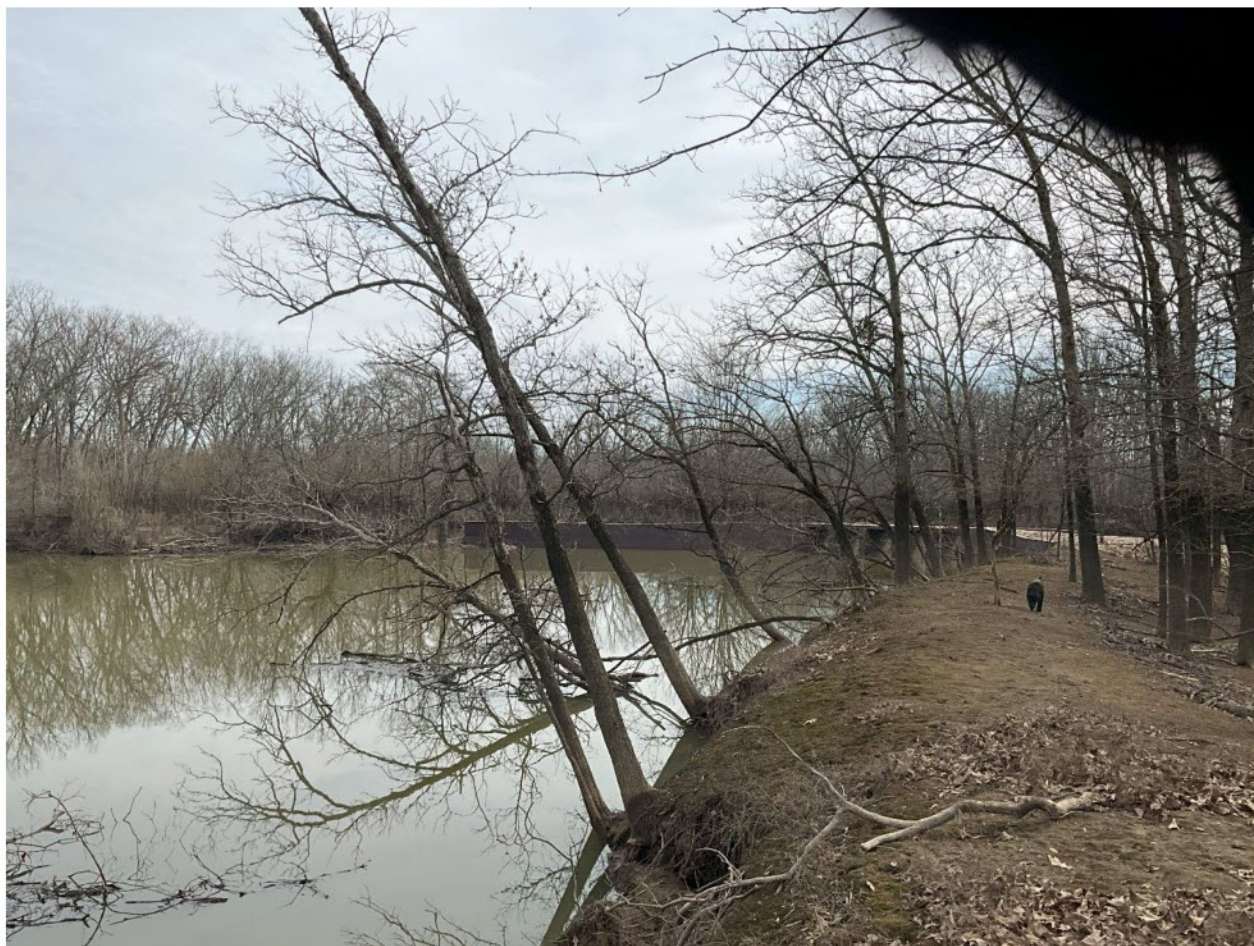
Photo No. 2

| Photo File Name | Date and Time of Photo | Photographer | Description |
|---|---|---|---|
| IMG_138.HEIC | 01/29/2025, 11:20 AM | Chelsey Sherwood | Showing the levee and large dam structure in the background. Picture taken facing southeast. |

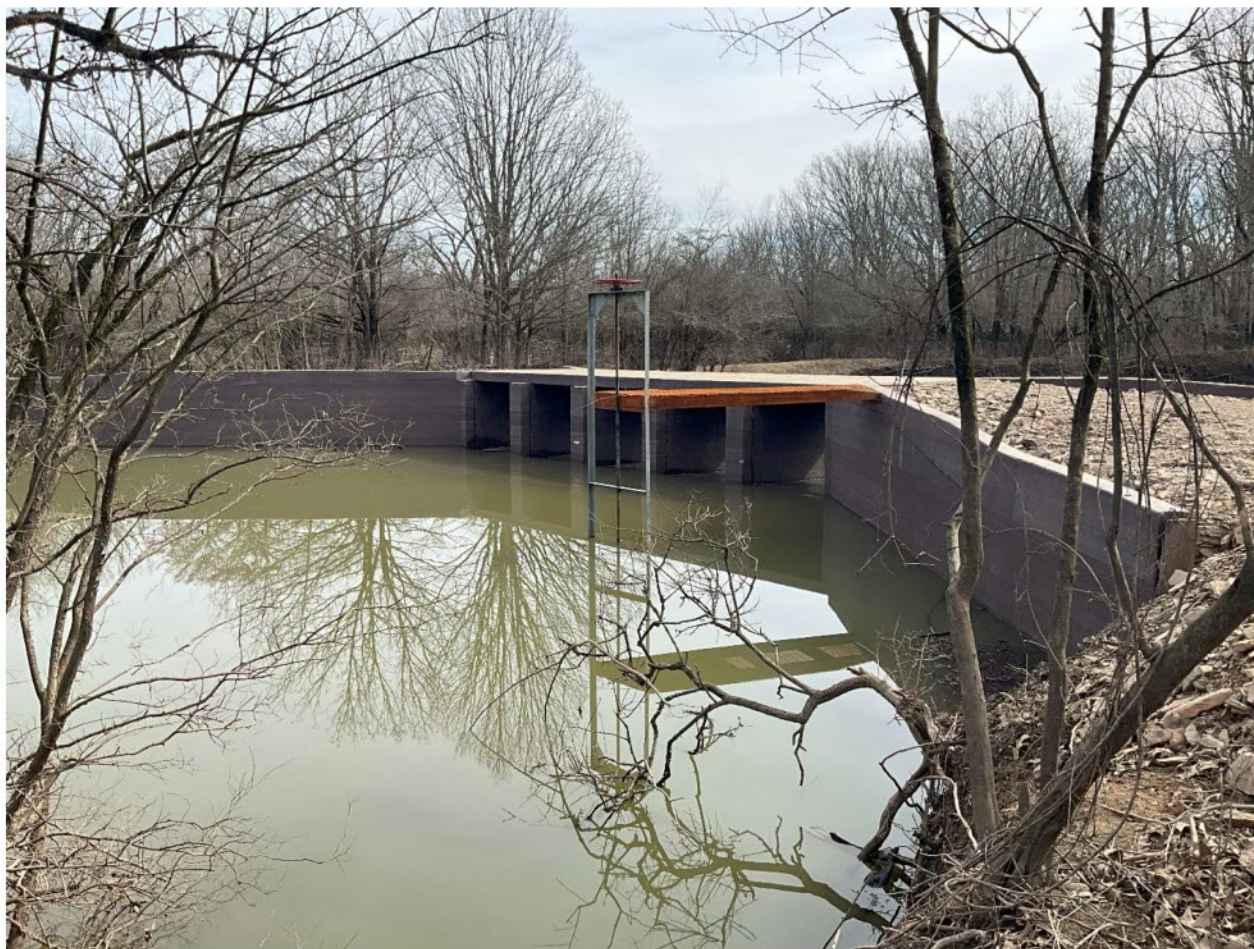
Photo No. 3

| Photo File Name | Date and Time of Photo | Photographer | Description |
|---|---|---|---|
| IMG_139.HEIC | 01/29/2025, 11:21 AM | Chelsey Sherwood | Showing the large dam structure. Picture taken facing southeast. |

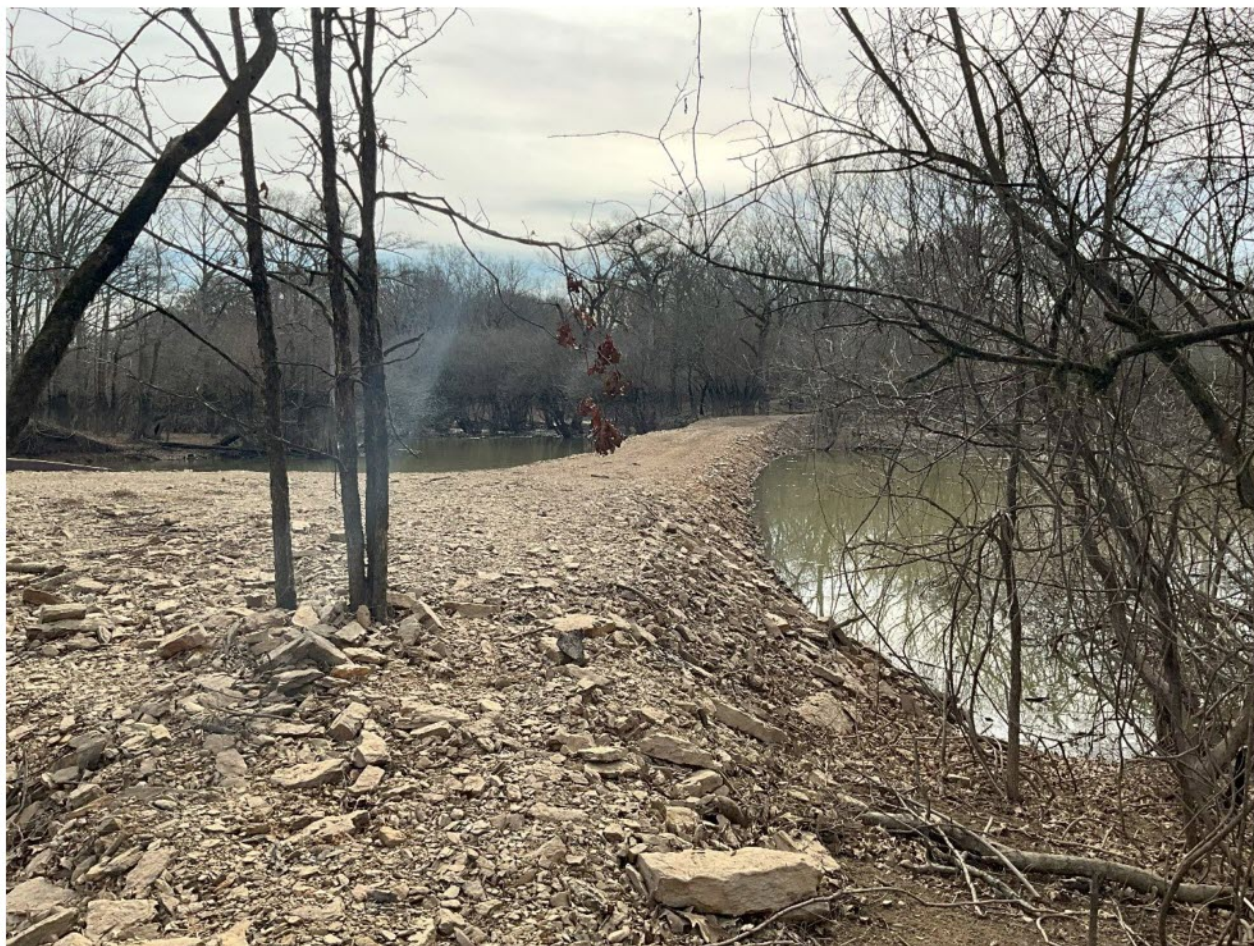
Photo No. 4

| Photo File Name | Date and Time of Photo | Photographer | Description |
|---|---|---|---|
| IMG_140.HEIC | 01/29/2025, 11:21 AM | Chelsey Sherwood | Showing the levee/road that was built across Bayou Des Arc that leads to the large dam structure. Picture taken facing south. |

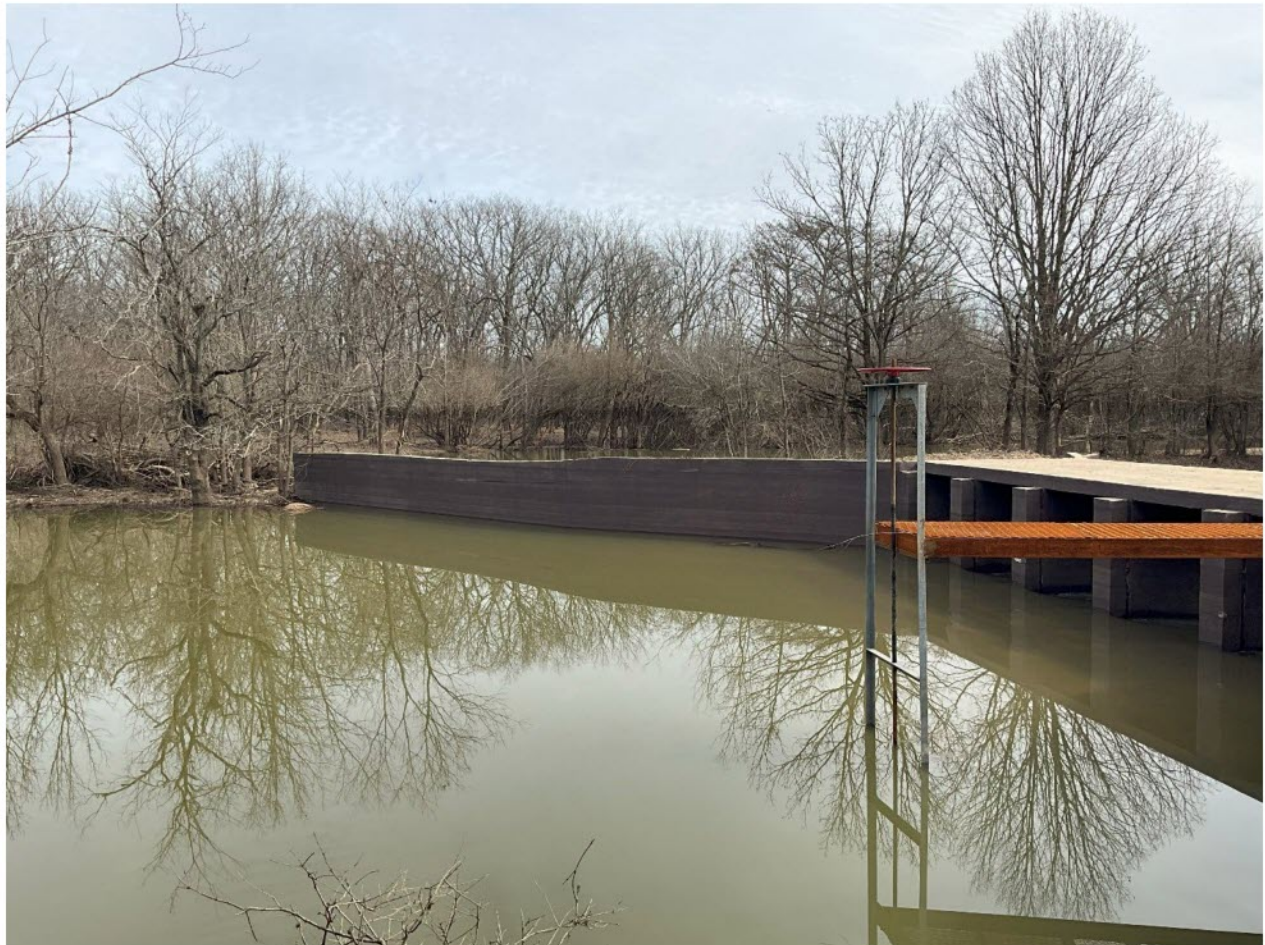
Photo No. 5

| Photo File Name | Date and Time of Photo | Photographer | Description |
|---|---|---|---|
| IMG_141.HEIC | 01/29/2025, 11:22 AM | Chelsey Sherwood | Showing the large dam structure. Picture taking facing east. |

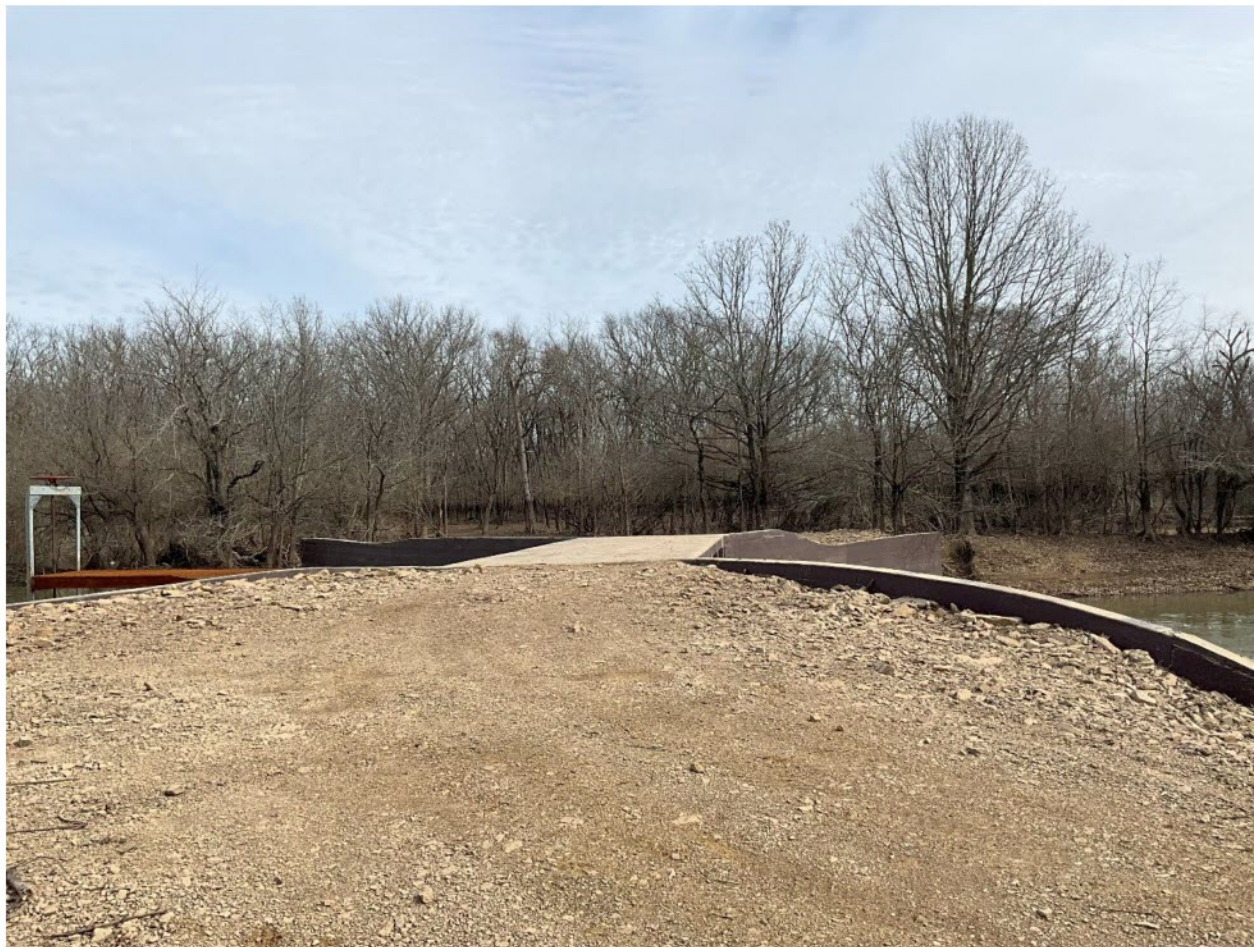
Photo No. 6

| Photo File Name | Date and Time of Photo | Photographer | Description |
|---|---|---|---|
| IMG_142.HEIC | 01/29/2025, 11:22 AM | Chelsey Sherwood | Showing the road over the damn structure that was constructed through Bayou Des Arc. Picture taken facing east. |

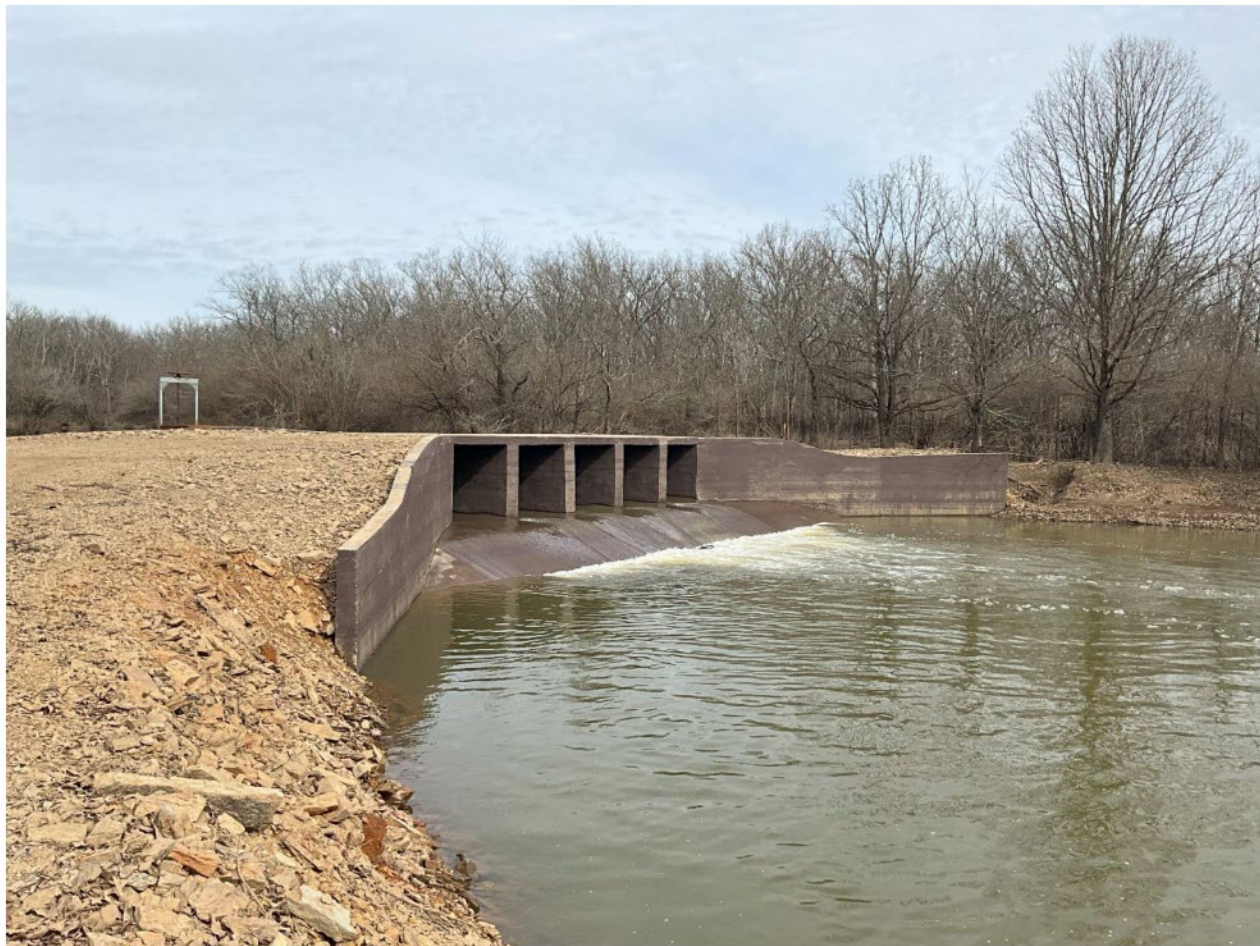
Photo No. 7

| Photo File Name | Date and Time of Photo | Photographer | Description |
|---|---|---|---|
| IMG_143.HEIC | 01/29/2025, 11:22 AM | Chelsey Sherwood | Showing the dam structure from the levee facing upstream. Picture taken facing north. |

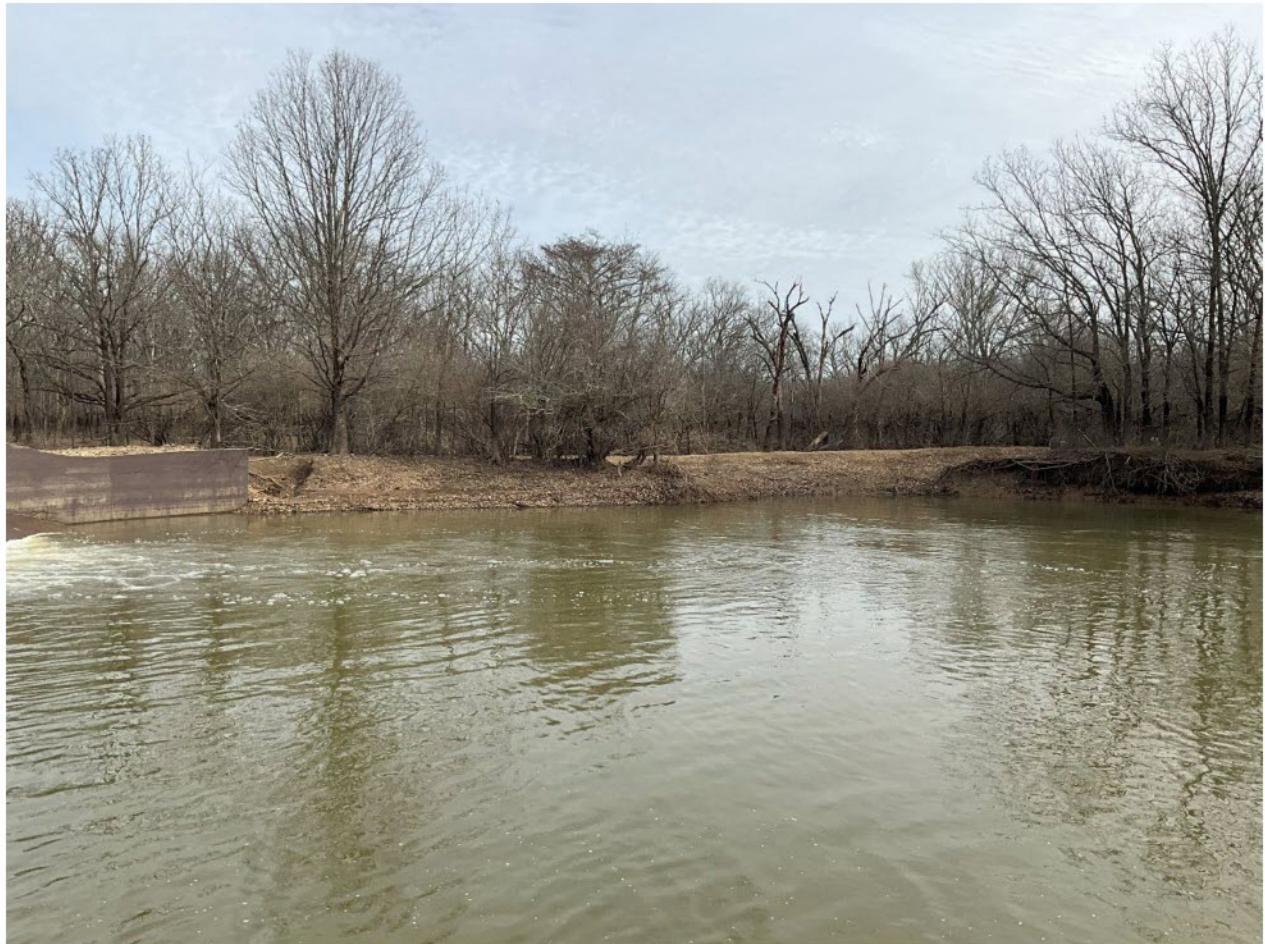
Photo No. 8

| Photo File Name | Date and Time of Photo | Photographer | Description |
|---|---|---|---|
| IMG_144.HEIC | 01/29/2025, 11:22 AM | Chelsey Sherwood | Showing just below the dam structure to the other levee on river left. Picture taken facing east. |

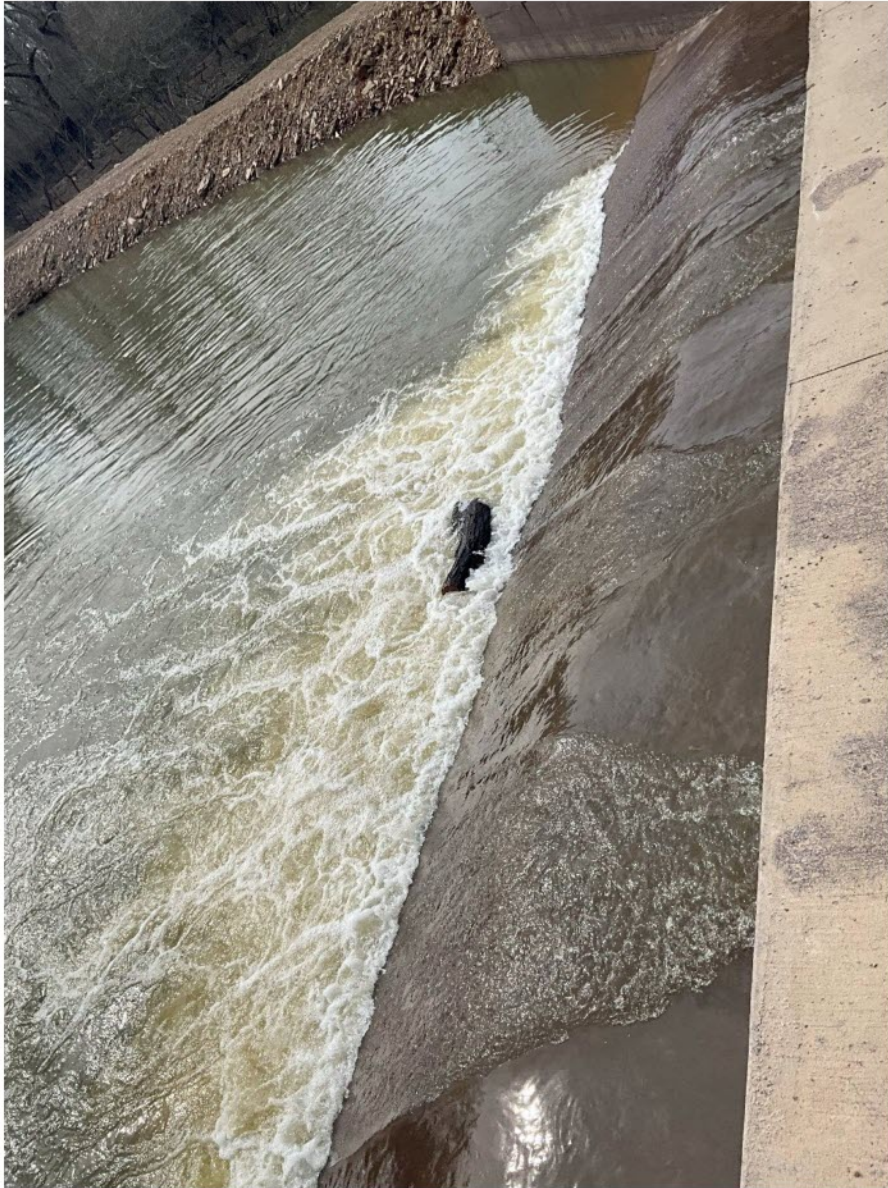
Photo No. 9

| Photo File Name | Date and Time of Photo | Photographer | Description |
|---|---|---|---|
| IMG_146.HEIC | 01/29/2025, 11:23 AM | Chelsey Sherwood | Showing the spillway from on top of the dam structure. |

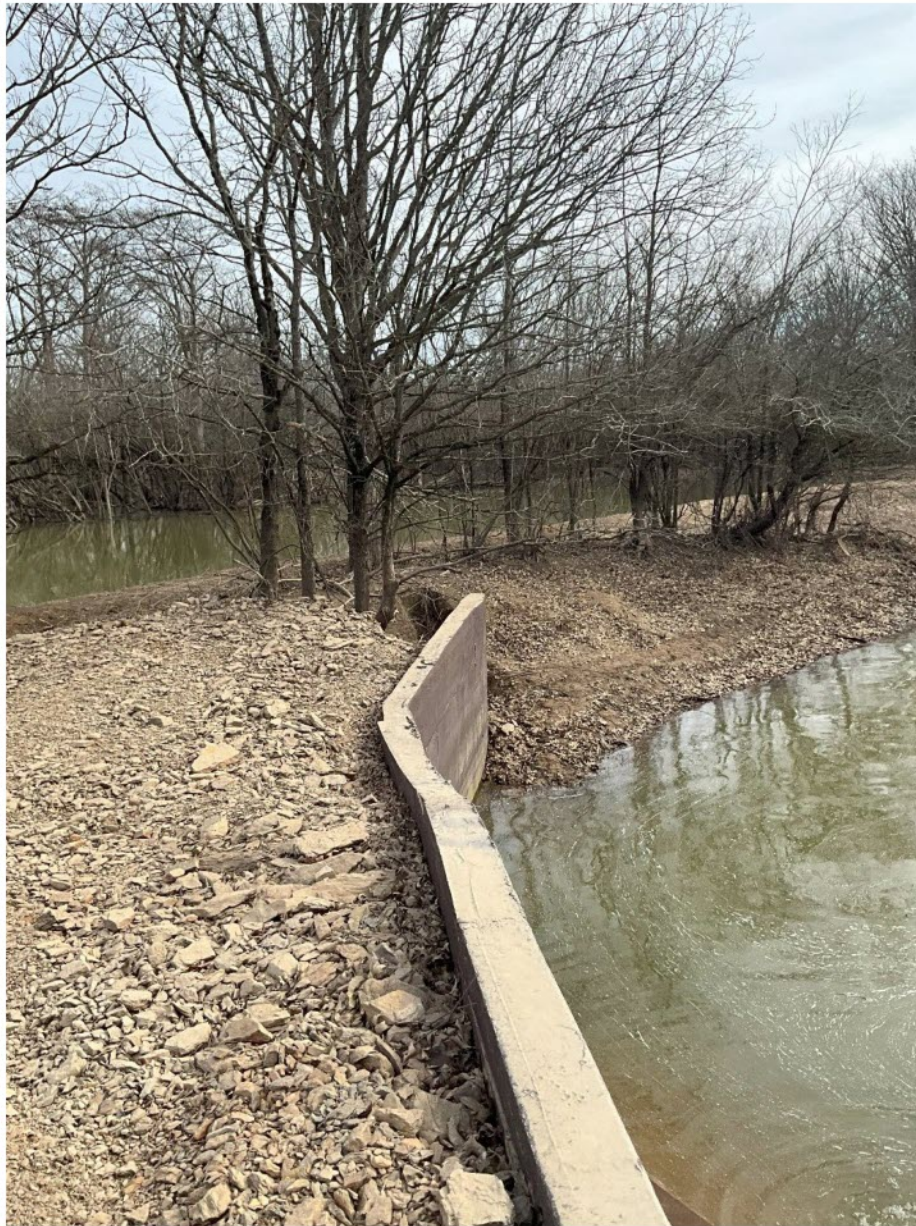
Photo No. 10

| Photo File Name | Date and Time of Photo | Photographer | Description |
|---|---|---|---|
| IMG_147.HEIC | 01/29/2025, 11:23 AM | Chelsey Sherwood | Showing the wing of the dam structure and levee on river right. Picture taken facing east. |

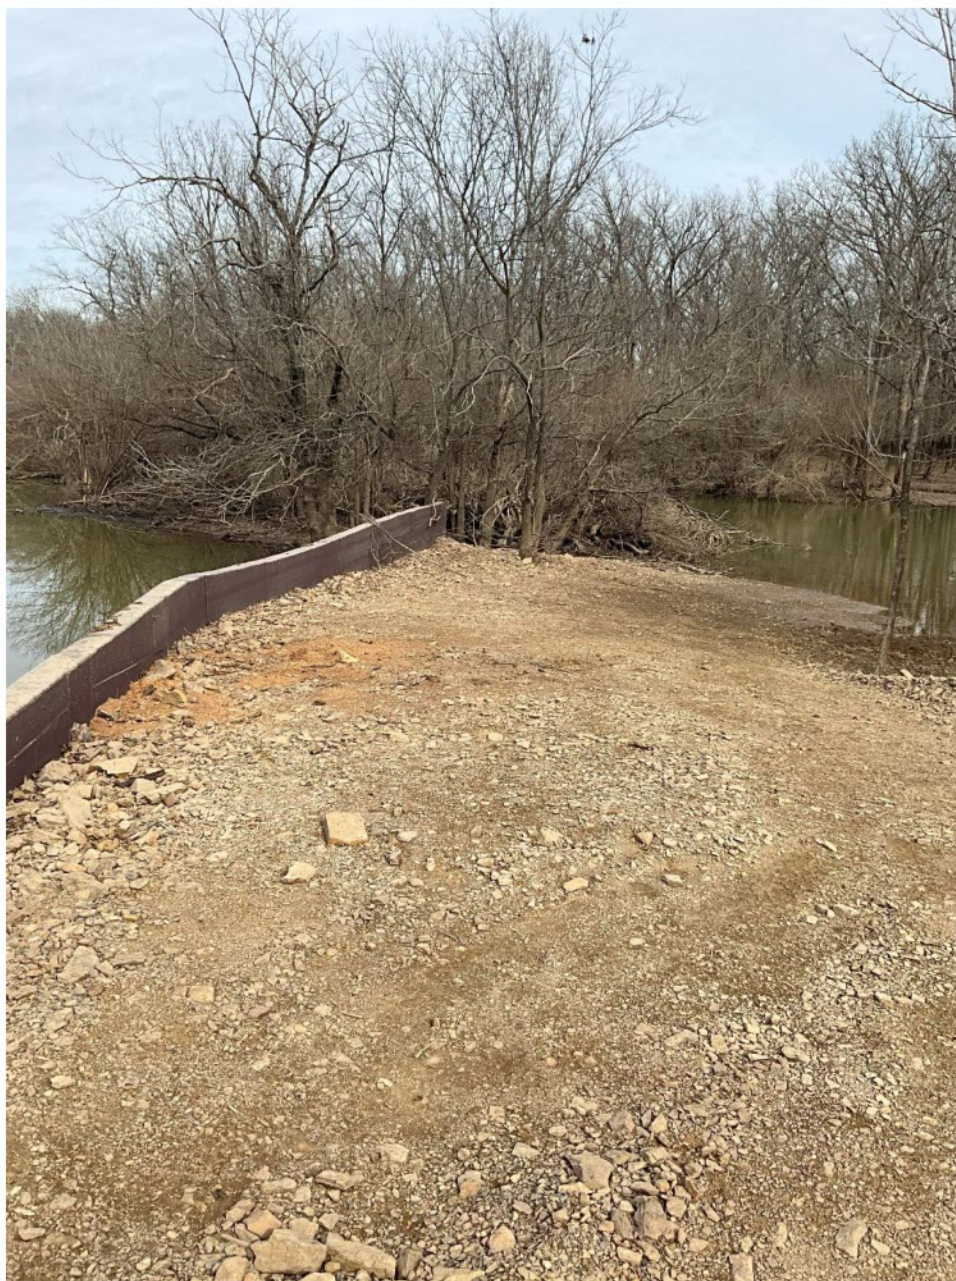
Photo No. 11

| Photo File Name | Date and Time of Photo | Photographer | Description |
|---|---|---|---|
| IMG_148.HEIC | 01/29/2025, 11:23 AM | Chelsey Sherwood | Showing more fill material in Bayou Des Arc. Picture taken facing east. |

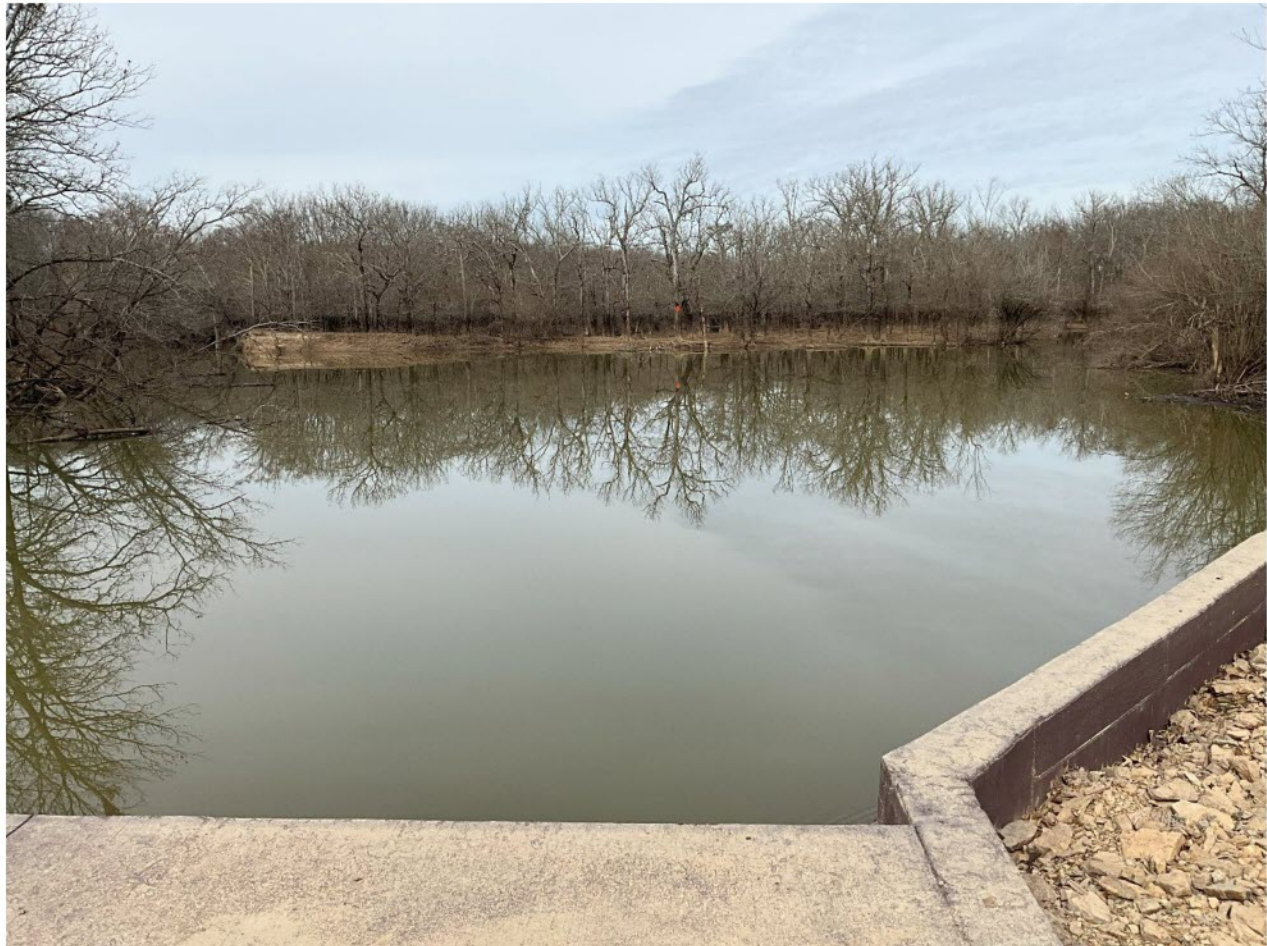
Photo No. 12

| Photo File Name | Date and Time of Photo | Photographer | Description |
|---|---|---|---|
| IMG_149.HEIC | 01/29/2025, 11:23 AM | Chelsey Sherwood | Showing upstream from on top of the dam structure. Picture taken facing northwest. |

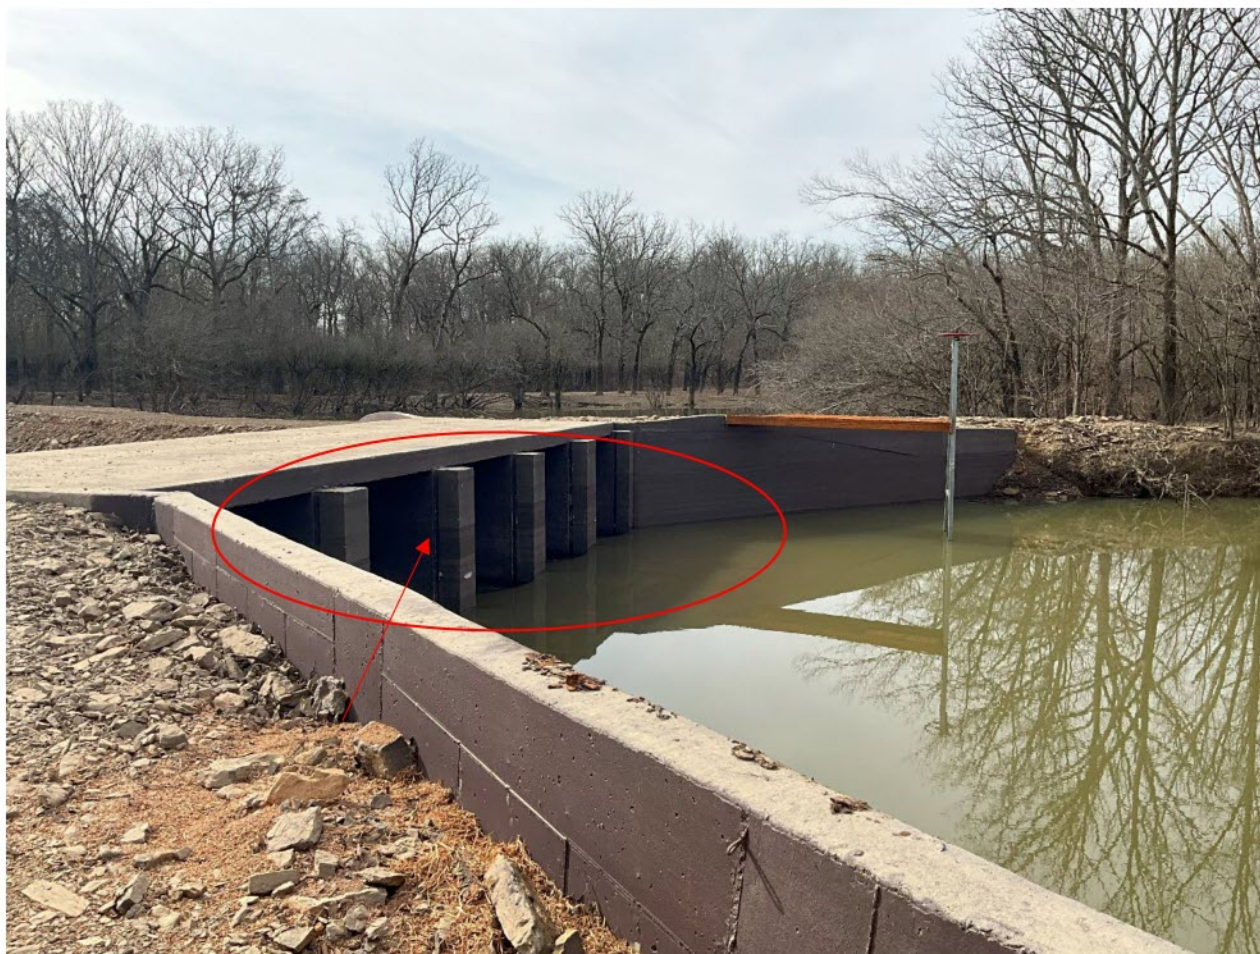
Photo No. 13

| Photo File Name | Date and Time of Photo | Photographer | Description |
|---|---|---|---|
| IMG_150.HEIC | 01/29/2025, 11:26 AM | Chelsey Sherwood | Showing the upstream side of the dam structure. Note the red circle and arrow pointing to the slits that appear to be able to hold boards to control the water level. Picture taken facing west. |

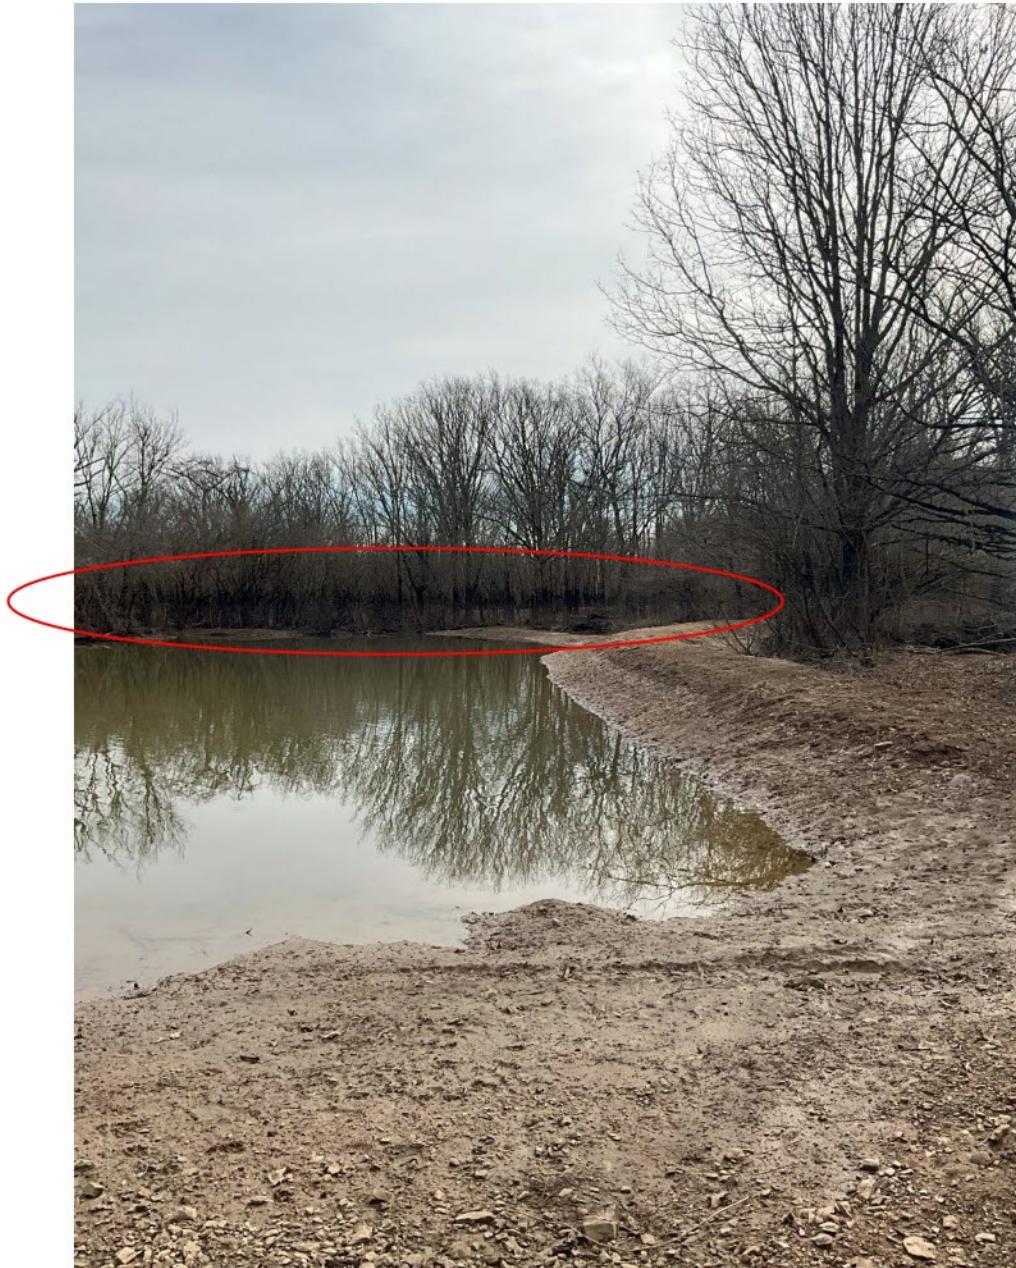
Photo No. 14

| Photo File Name | Date and Time of Photo | Photographer | Description |
|---|---|---|---|
| IMG_151.HEIC | 01/29/2025, 11:31 AM | Chelsey Sherwood | Showing the levee on river left of the dam and water staining on the trees circled in red. Picture taken facing southeast. |

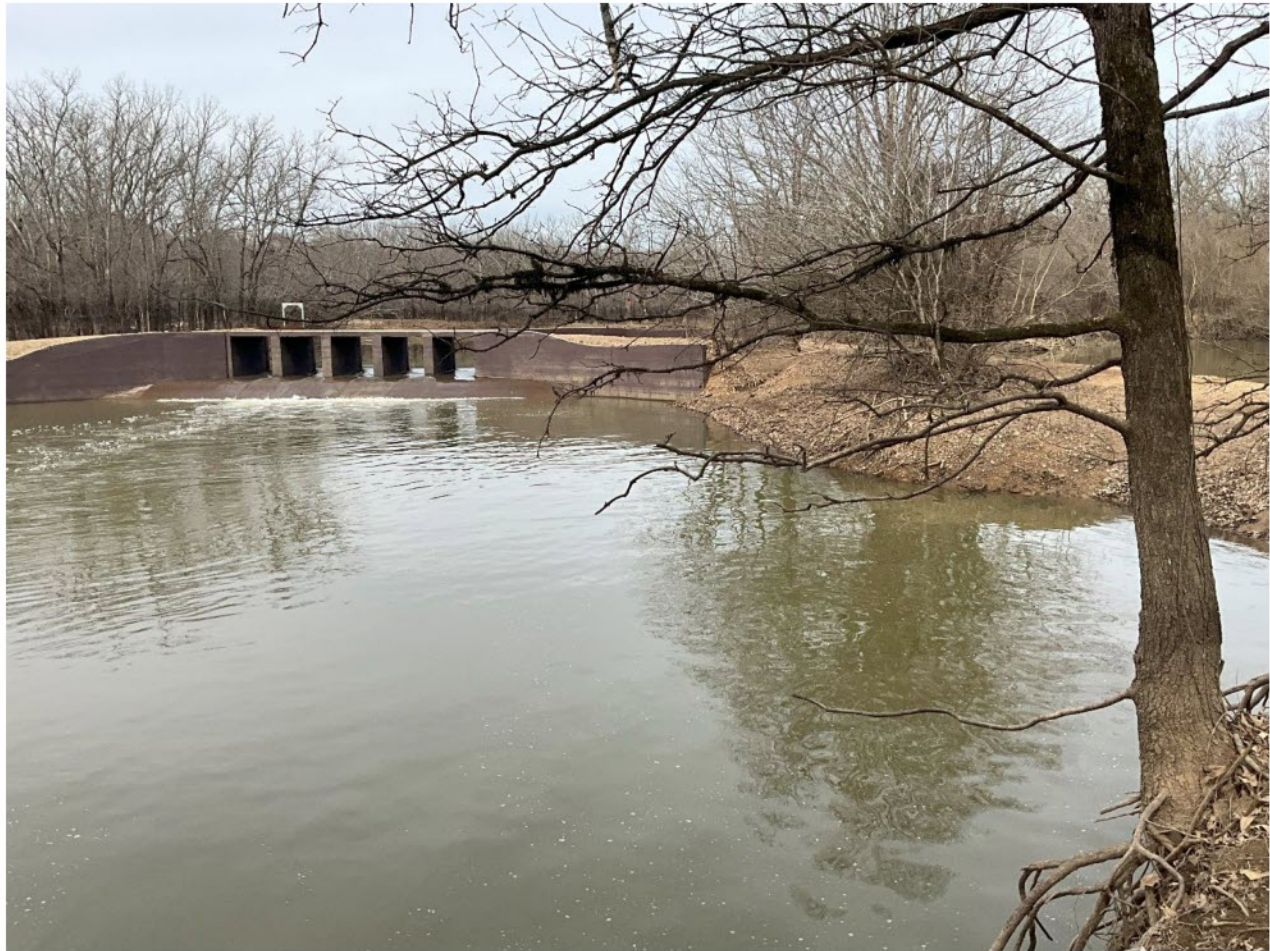
Photo No. 15

| A Section 404 permit was not obtained for the discharge of fill material below the Ordinary High Water Mark in Bayou Des Arc, a relatively permanent water, and a tributary to the White River, a traditional navigable water. This case was referred to EPA under the 1989 Memorandum of Agreement between the Corps and EPA. Refer to photos and map attachments for site inspection details. | | | |

| Photo File Name | Date and Time of Photo | Photographer | Description |
|---|---|---|---|
| IMG_152.HEIC | 01/29/2025, 11:40 AM | Chelsey Sherwood | Showing the dam structure facing upstream. Note that between the levees and the dam structure that were constructed; navigability appears to be blocked. Picture taken facing north. |

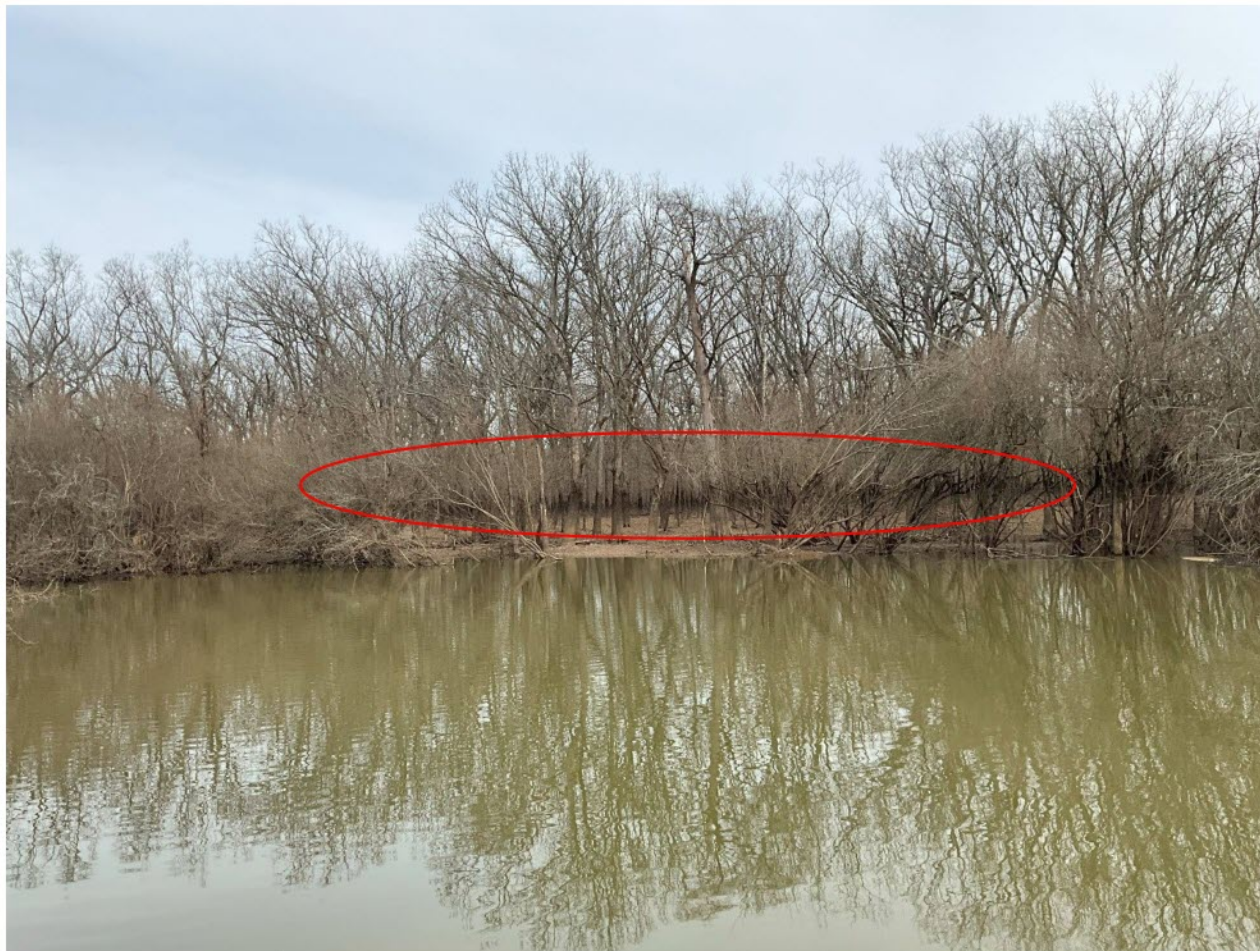
Photo No. 16

| Photo File Name | Date and Time of Photo | Photographer | Description |
|---|---|---|---|
| IMG_153.HEIC | 01/29/2025, 11:58 AM | Chelsey Sherwood | Showing water staining on the trees. Picture facing east. |

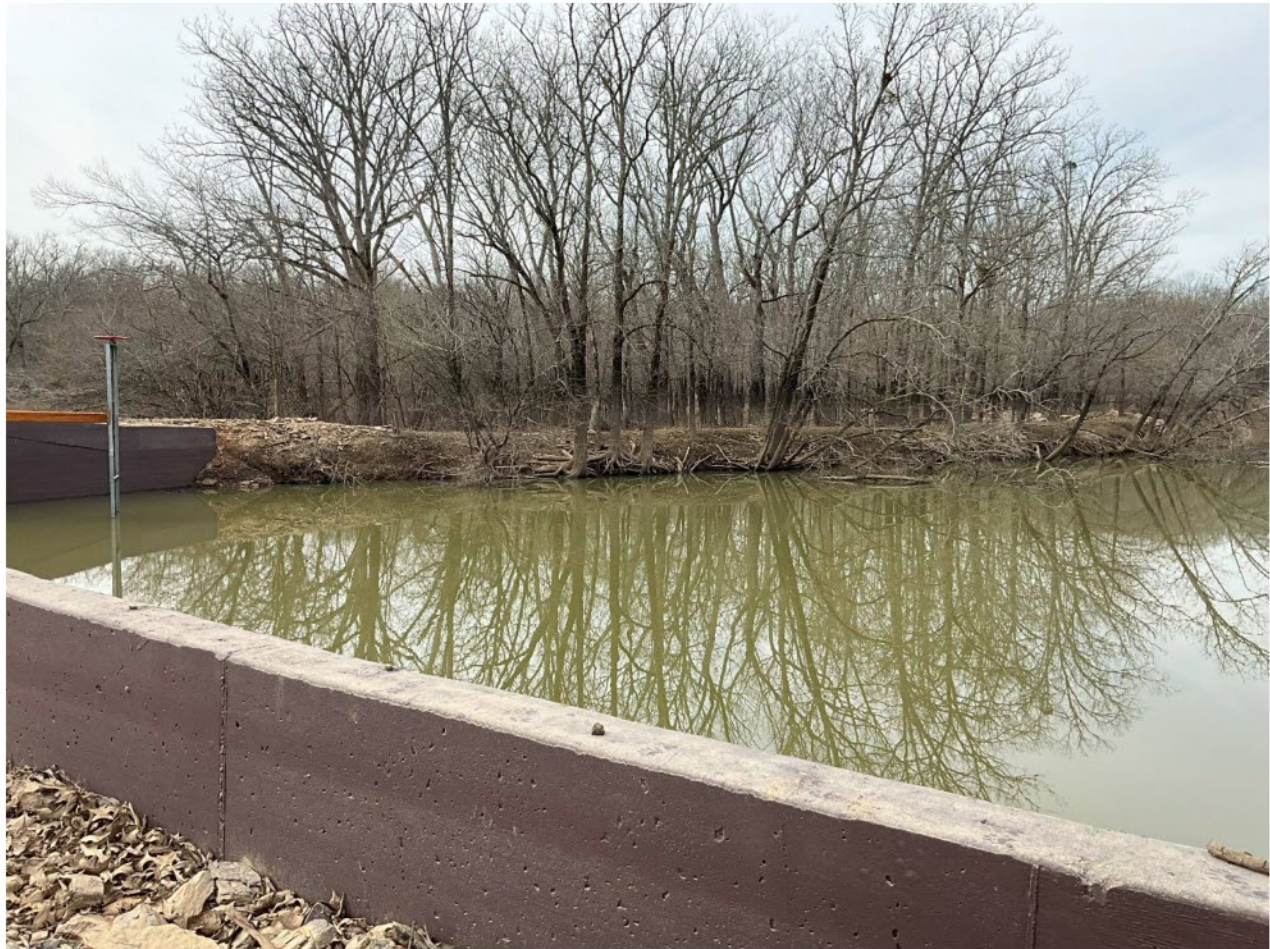
Photo No. 17

| Photo File Name | Date and Time of Photo | Photographer | Description |
|---|---|---|---|
| IMG_154.HEIC | 01/29/2025, 11:58 AM | Chelsey Sherwood | Showing the levee upstream of the dam structure and the water staining on the trees. Picture taken facing northwest. |

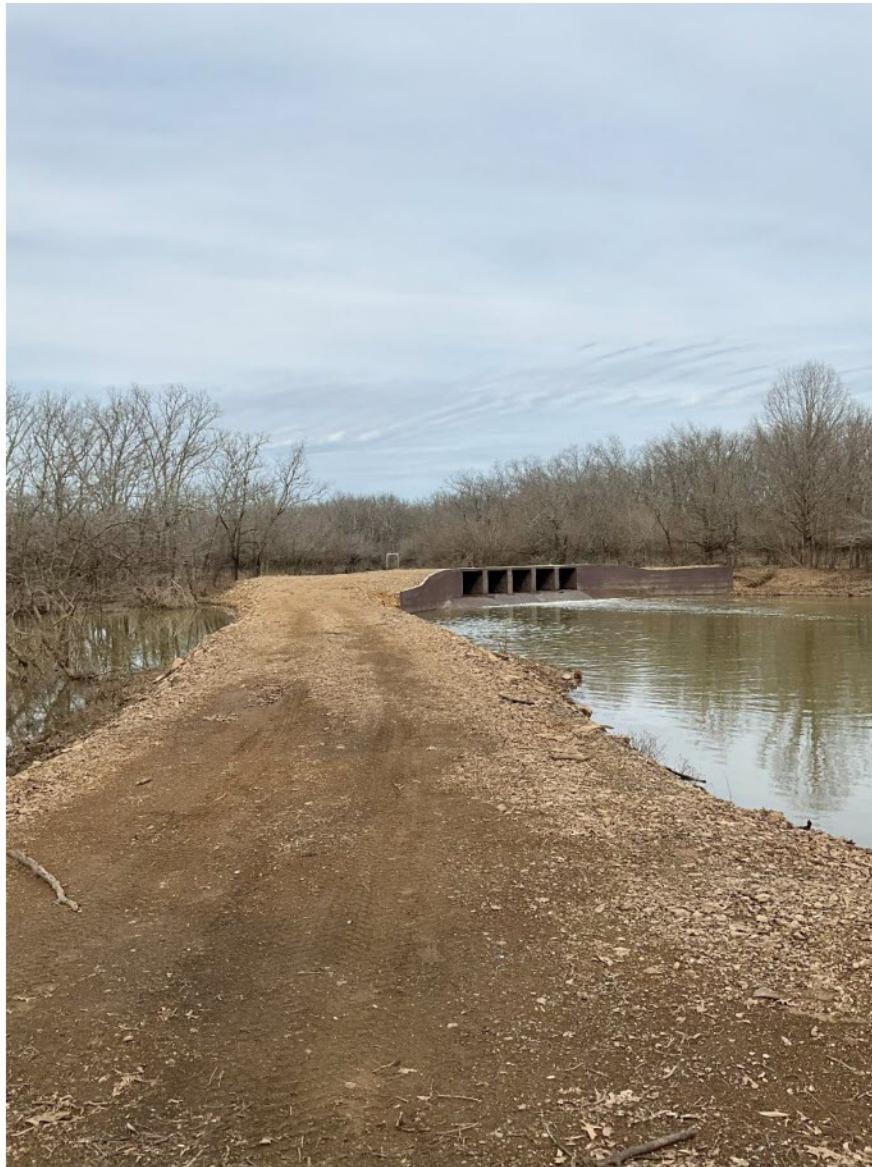
Photo No. 18

| Photo File Name | Date and Time of Photo | Photographer | Description |
|---|---|---|---|
| IMG_155.HEIC | 01/29/2025, 12:03 PM | Chelsey Sherwood | Showing the large road/levee built that is approximately 270 linear feet. Picture taken facing north. |
