## **RCRA Inspection Report**

Safety Kleen Systems, Inc., Lexington SCD077995488  
130A Frontage Road  
Lexington, Lexington County, South Carolina 29073

February 2, 2023

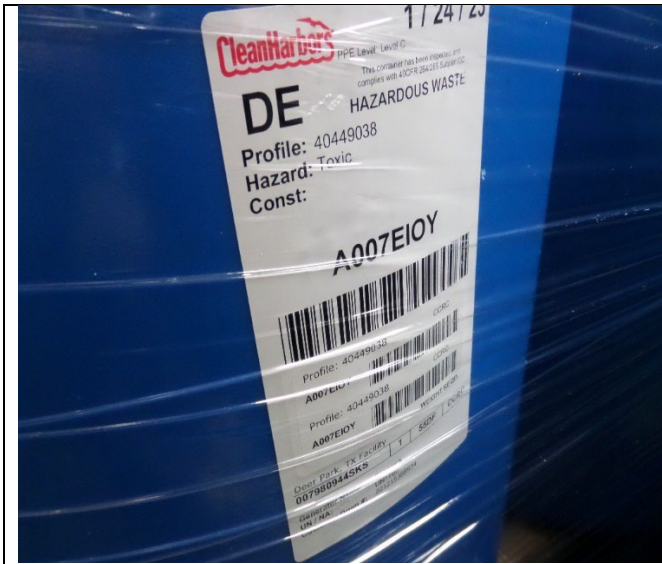
Permitted Container Inbound/Outbound Area. Observed container of hazardous waste transferred to designated container storage area. Container closed, in good condition, labeled and dated. Photograph 1 taken at 10:03 a.m.

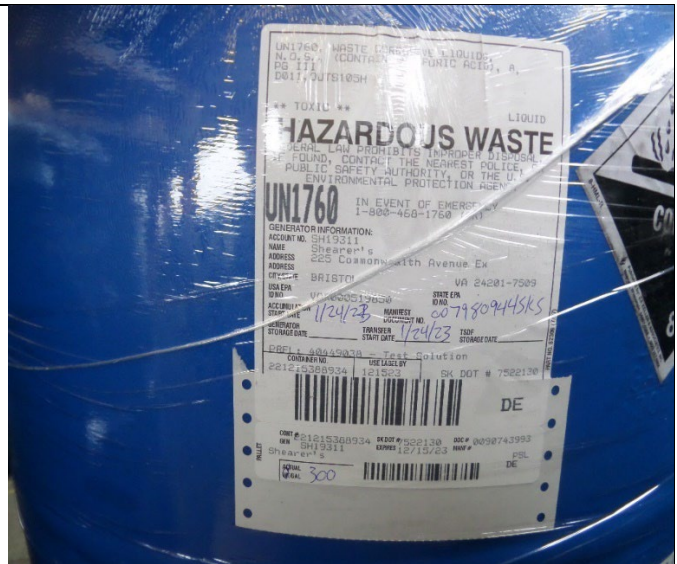
Permitted Container Inbound/Outbound Area. Observed container of hazardous waste transferred to designated container storage area. Container closed, in good condition, labeled and dated. Photograph 2 taken at 10:03 a.m.

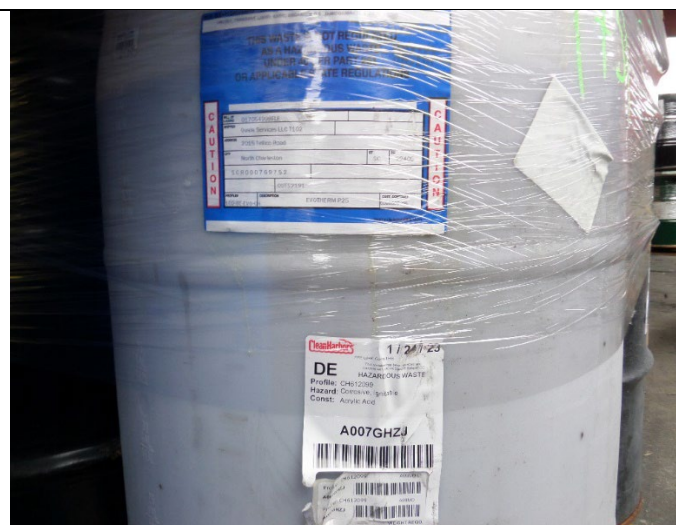
Permitted Container Inbound/Outbound Area. Container labeled with a bar code. Photograph 6 taken at 10:23 a.m.

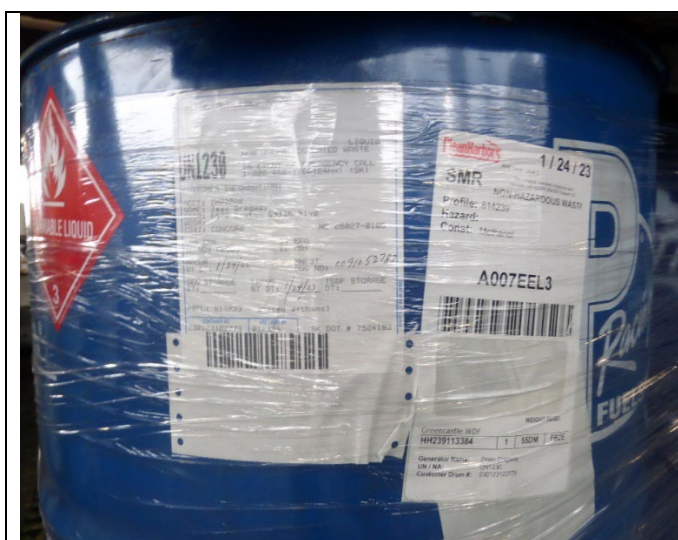
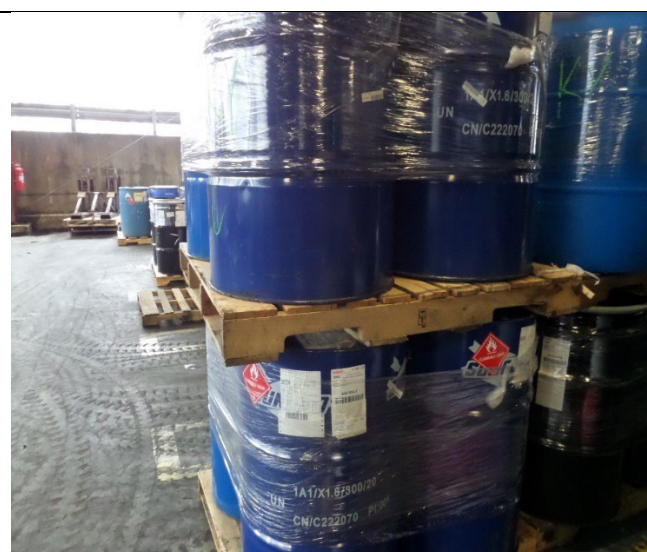
Inspectors observed eight 55-gallon containers of unused off-specification methanol (Photographs 7 and 8). SK indicated that the methanol is exempt as a hazardous waste and will be shipped for energy recovery. The inspectors reviewed the waste profile.

Permitted Container Storage Area 1A and 1B. The inspectors observed eight 55-gallon container of unused methanol for energy recovery. Photograph 7 taken at 10:30 a.m.

Permitted Container Storage Area 1A and 1B. The inspectors observed eight 55-gallon container of unused methanol for energy recovery. Photograph 8 taken at 10:30 a.m.

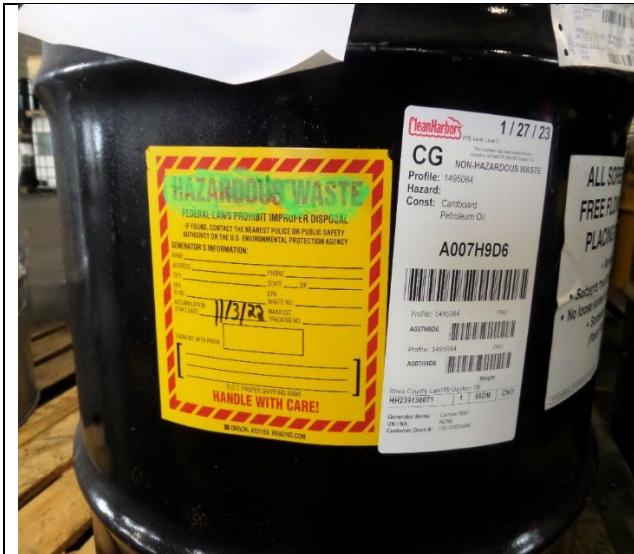
The inspectors observed a 55-gallon container labeled as hazardous waste by the generator. SK labeled the container with a non-hazardous waste label after determining and waste profiling the waste stream (Photograph 9).

Permitted Container Storage Area 1A and 1B. The inspectors observed a 55-gallon container labeled as hazardous waste by the generator. SK labeled the container with a non-hazardous waste after determining and waste profiling the waste stream. Photograph 9 taken at 10:37 a.m.

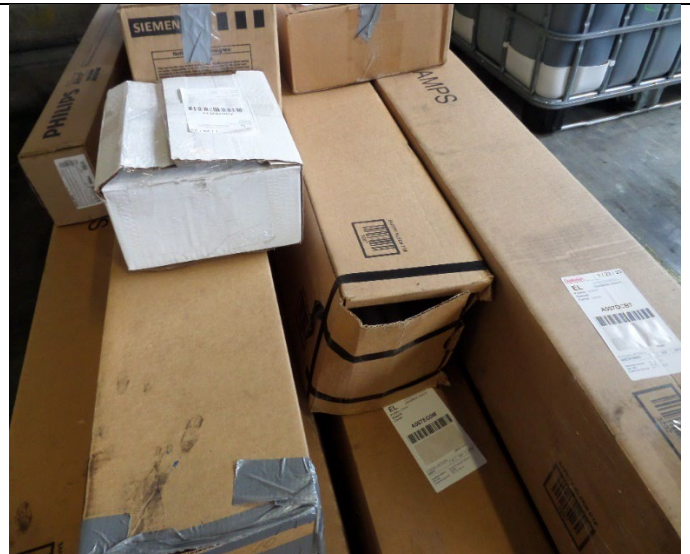
The inspectors observed several containers of universal waste lamps on pallets in this area. The inspectors observed one eight-foot container accumulating waste lamps. The container was not closed (Photograph 10). The containers were in good condition, labeled with the words "universal waste" and marked with dates less than one year. The SK representative closed the container (Photograph 11).

Permitted Container Storage Area 1B – Universal Waste. The inspectors observed one eight-foot container of lamps not kept closed. Photograph 10 taken at 10:40 a.m.

**quantity handler of universal waste must contain any lamp in containers or packages that are structurally sound, adequate to prevent breakage, and compatible with the contents of the lamps. Such containers and packages must remain closed and must lack evidence of leakage, spillage or damage that could cause leakage under reasonably foreseeable conditions.**

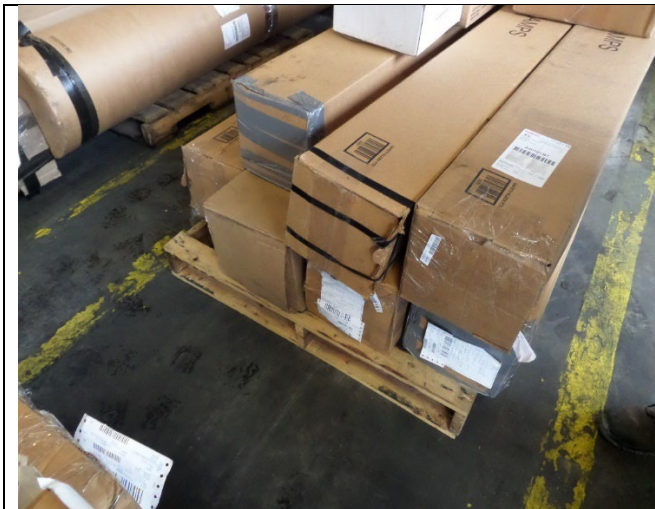
Permitted Container Storage Area 1B – Universal Waste. The SK representative closed the container of lamps. Photograph 11 taken at 10:42 a.m.

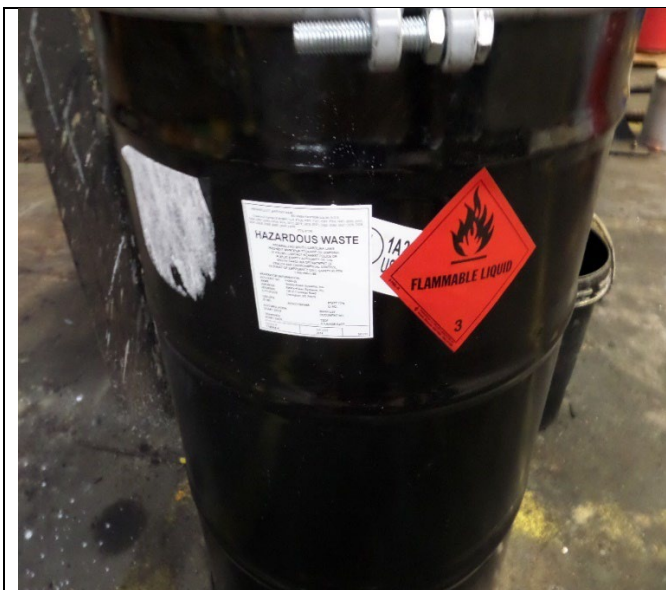
Empty part washers returned by customers are stored in this room. Anti-freeze is also stored in this room. The inspectors observed one 55-gallon container accumulating hazardous waste liquid and solids in the SAA. The container was closed, in good condition, labeled with the words "hazardous waste", and labeled with a flammable hazard indicator. The inspectors observed the

hazardous waste label marked with toxic codes (D004/D005/D006/D007/D008/D009/D010/D011/D018/D019/D021/D022/D026/D027/D028/D029/D034/D035/D038/D039/D040/D043), but not marked or labeled with a toxic hazard indicator (Photograph 13). The SK representative labeled the container with a toxic and a flammable solid hazard indicator (Photograph 14).

Antifreeze/Machine Return Area. The inspectors observed a 55-gallon container not labeled with all hazard indicators. Photograph 13 taken at 11:18 a.m.

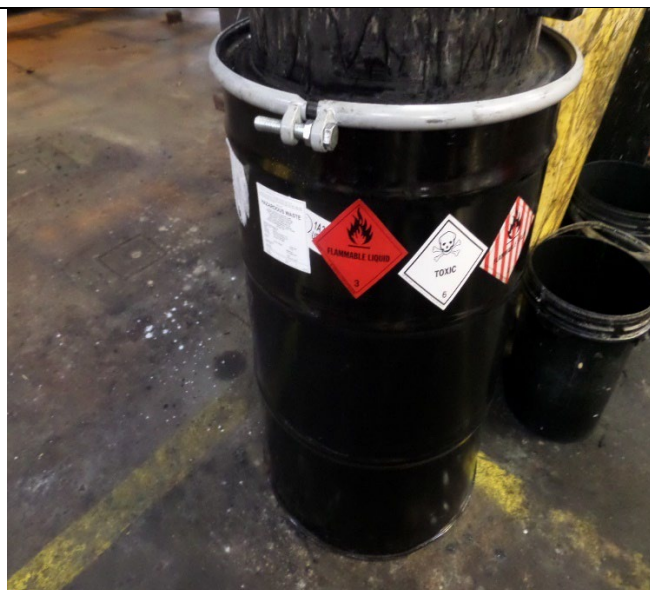
Antifreeze/Machine Return Area. SK representative labeled the container with all hazard indicators. Photograph 14 taken at 11:21 a.m.

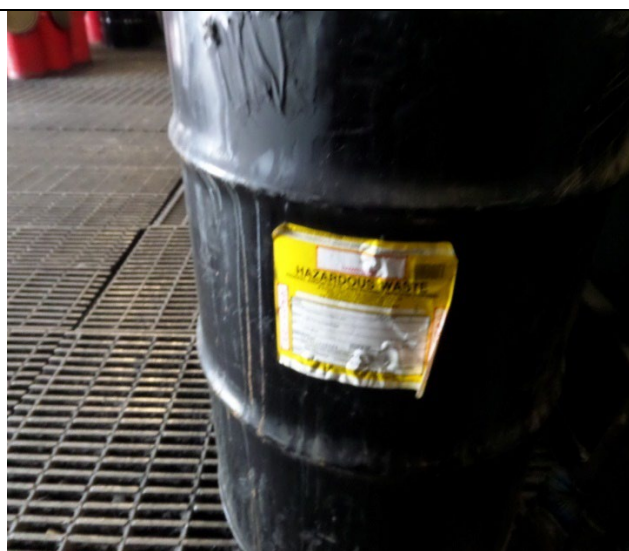
Branch Sales to Service. Container of waste solids debris missing flammable solids hazard indicator. Photograph 16 taken at 11:32 a.m.

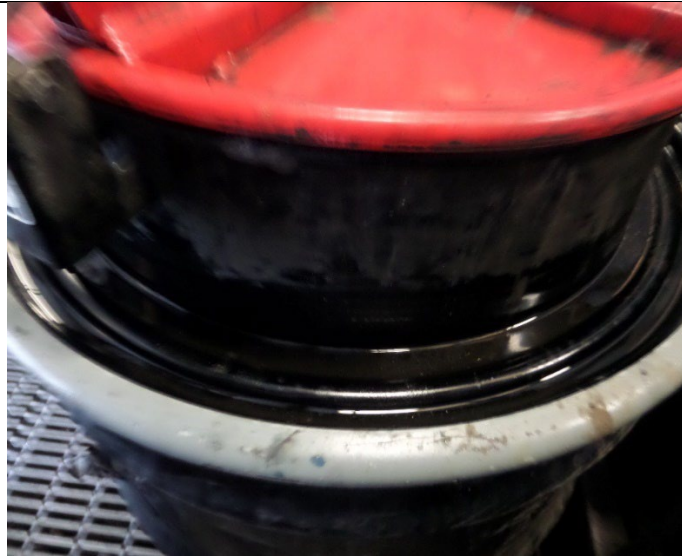
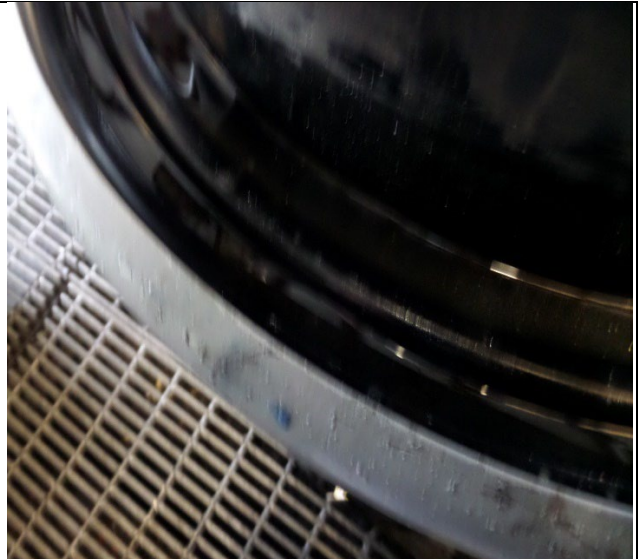
Branch Sales to Service. Container of waste solids debris with waste liquid on container lid and missing flammable solids hazard indicator. Photograph 17 taken at 11:32 a.m.

Branch Sales to Service. Container of waste solids debris with waste liquid on container lid and missing flammable solids hazard indicator. Photograph 18 taken at 11:32 a.m.

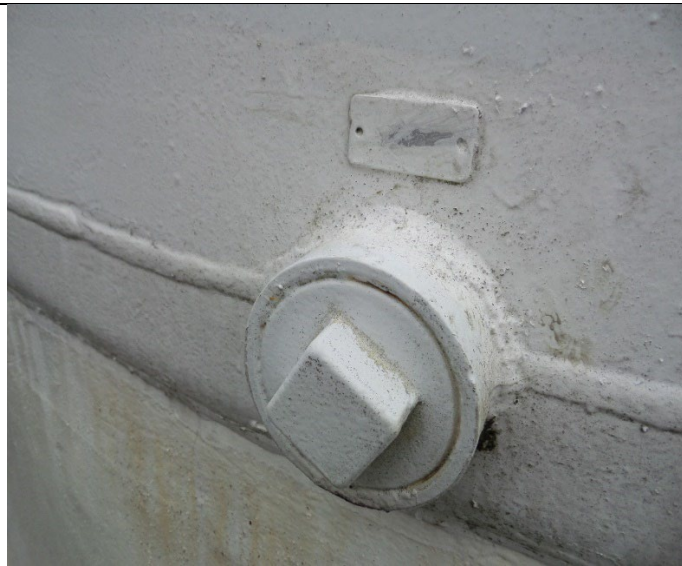
Permitted Tank Farm 6B. The inspectors observed one tag (above the fitting) that was completely covered by paint and unable to be read. SK provided a photograph of the tag (OE4610) after it had been cleaned in their email response dated February 10, 2023. Photograph 19 taken at 11:43 a.m.

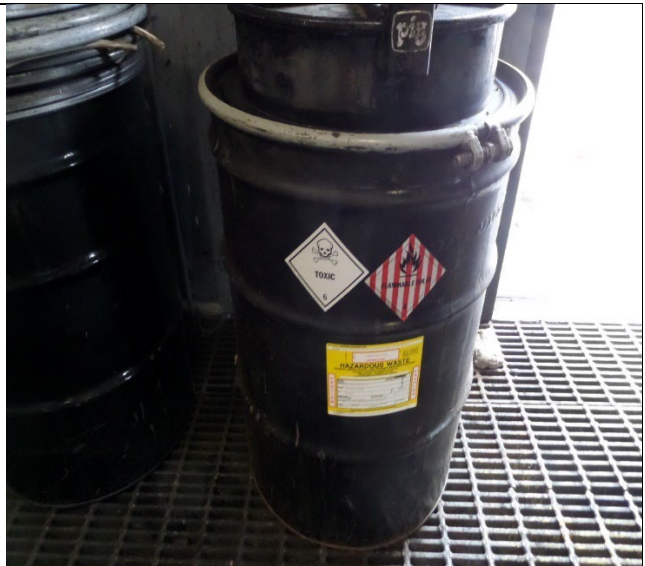
Branch Sales to Service. SK representative labeled the container of waste solvent sludge with larger hazard indicators. Photograph 20 taken at 11:45 a.m.

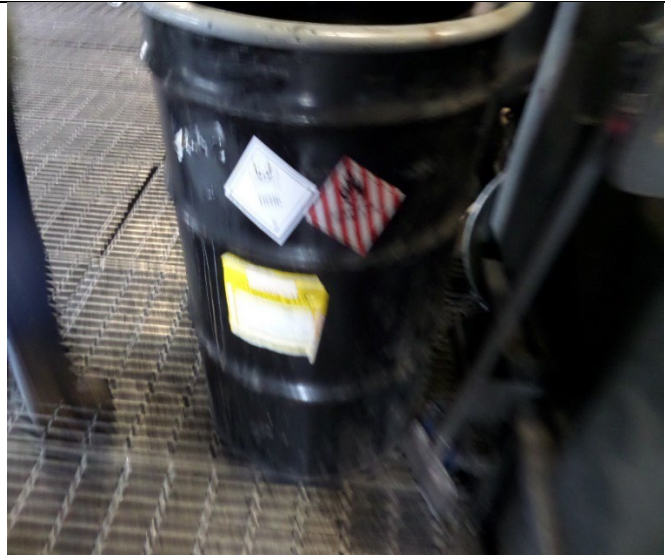
Branch Sales to Service. SK representative labeled the container of waste solids debris with hazard indicators. Photograph 21 taken at 11:45 a.m.

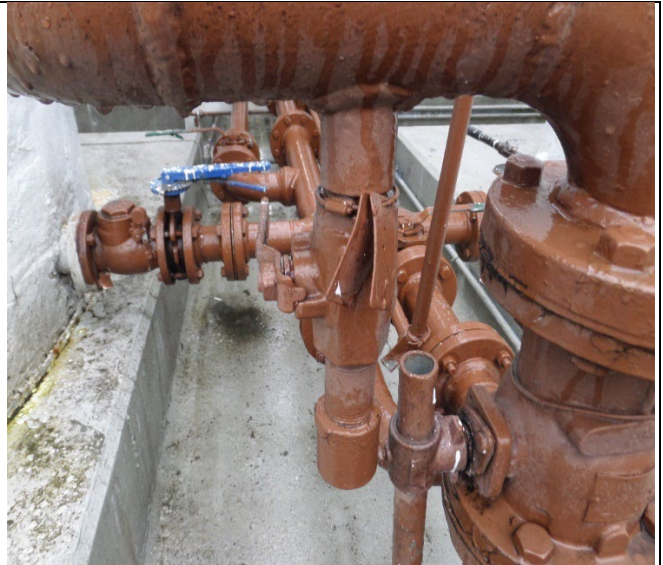
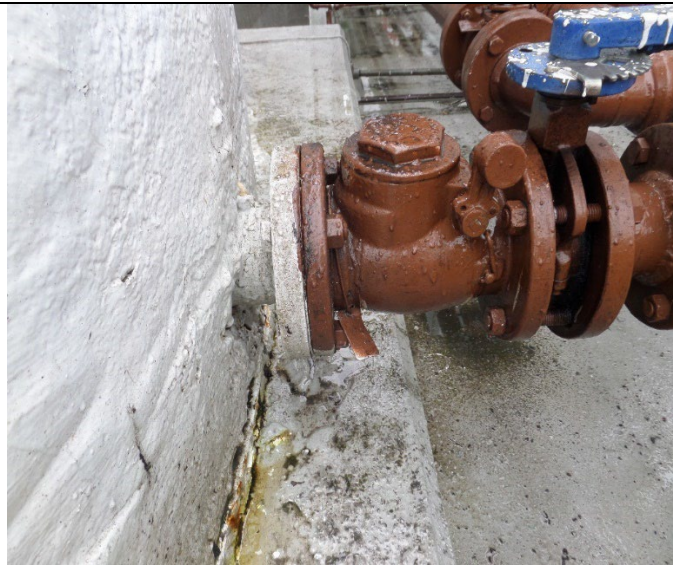
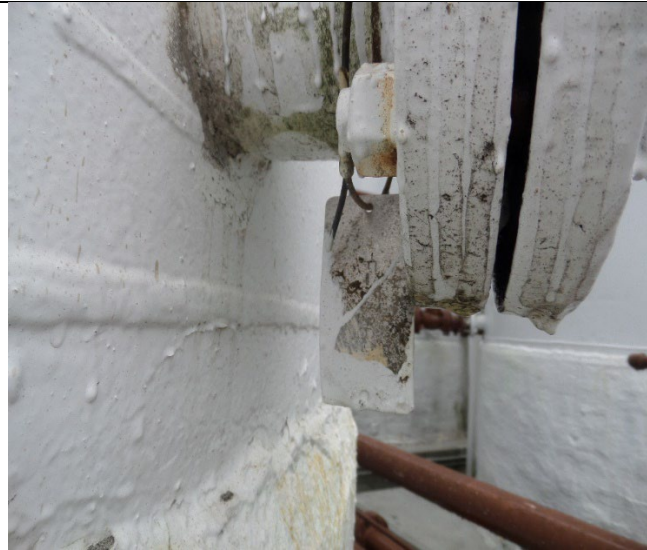
Permitted Tank Farm 3B. The inspectors observed several tags identifying pieces of equipment covered by paint and could not be read. Photograph 22 taken at 11:55 a.m.

Permitted Tank Farm 3B. The inspectors observed several tags identifying pieces of equipment covered by paint and could not be read. Photograph 23 taken at 11:55 a.m.

Permitted Tank Farm 3B. The inspectors observed several tags identifying pieces of equipment covered by paint and could not be read. Photograph 25 taken at 12:00 p.m.

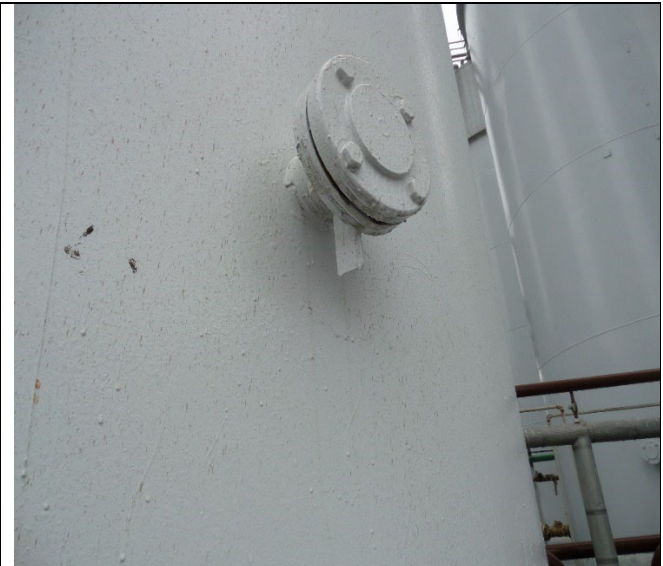
Permitted Tank Farm 3B. The inspectors observed the tag (tank connection port) identifying pieces of equipment covered by paint and could not be read. Photograph 24 taken at 12:00 p.m.

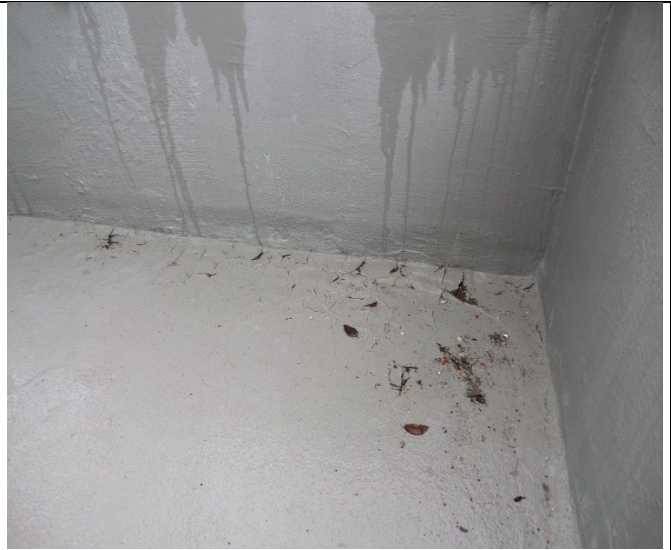
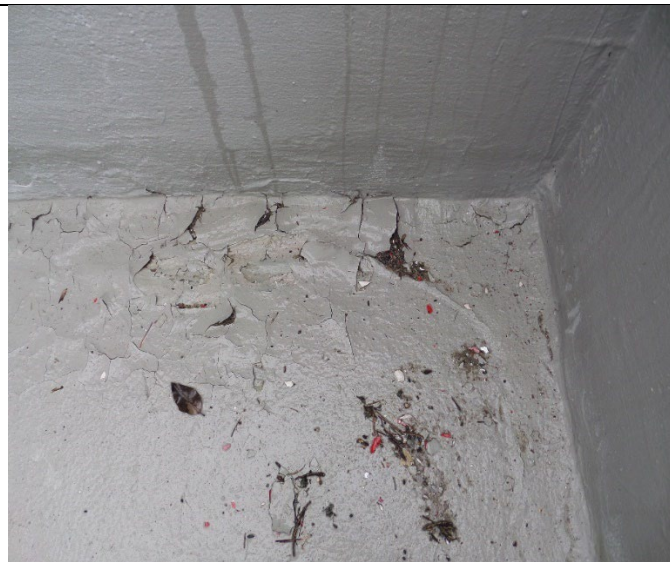
Permitted Tank Farm 1. The inspectors observed the secondary containment in the corner adjacent to Tank 21, showed signs of gaps and the paint/sealant was cracked and peeling away from the concrete floor in this area. Photograph 26 taken at 12:13 p.m.

Permitted Tank Farm 1. The inspectors observed the secondary containment in the corner adjacent to Tank 21, showed signs of gaps and the paint/sealant was cracked and peeling away from the concrete floor in this area. Photograph 27 taken at 12:13 p.m.

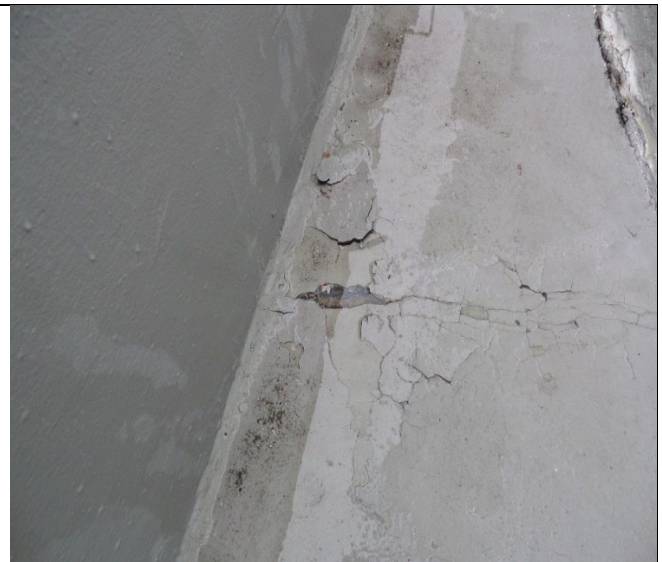
Permitted Tank Farm 1. The inspectors observed the secondary containment next to Tank 23, showed signs of gaps and the paint/sealant was cracked and peeling away from the concrete floor in this area. Photograph 28 taken at 12:14 p.m.

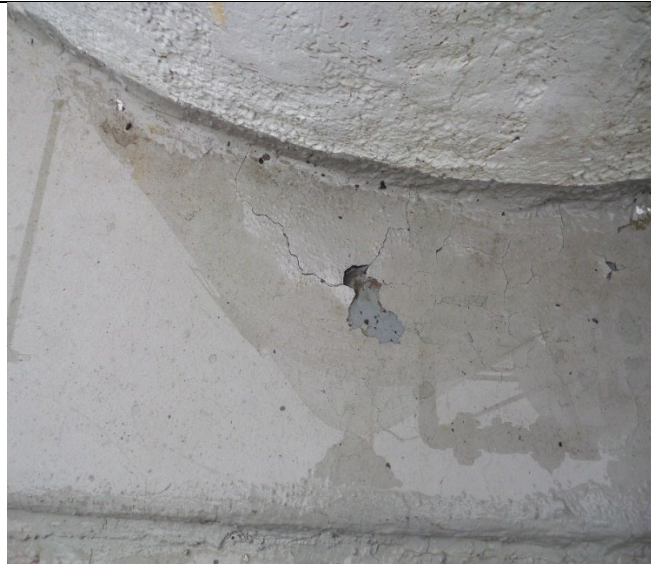
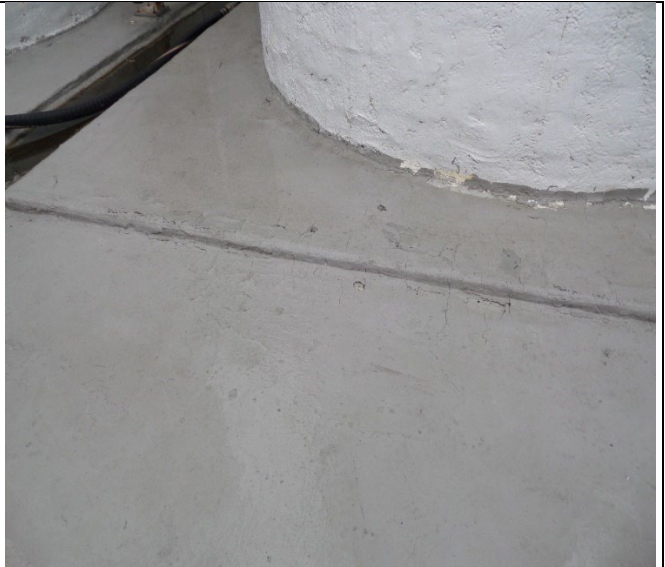
Permitted Tank Farm 1. The inspectors observed the secondary containment next to Tank 19, showed signs of gaps and the paint/sealant was cracked and peeling away from the concrete floor in this area. Photograph 29 taken at 12:15 p.m.

Permitted Tank Farm 1. The inspectors observed the secondary containment next to Tank 19, showed signs of gaps and the paint/sealant was cracked and peeling away from the concrete floor in this area. Photograph 30 taken at 12:16 p.m.

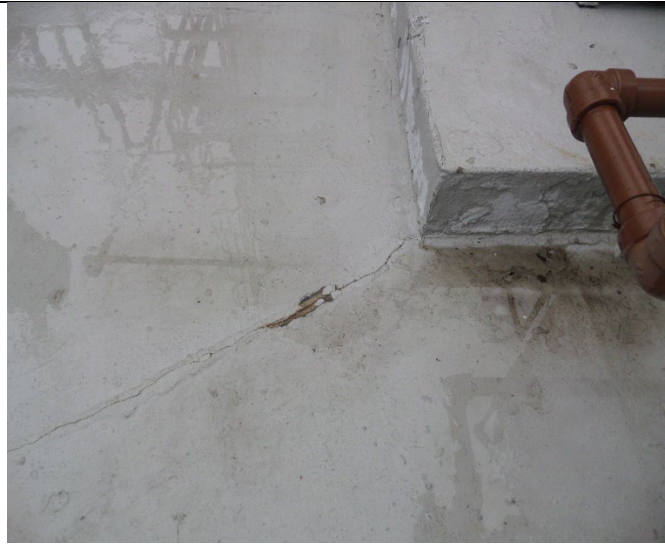
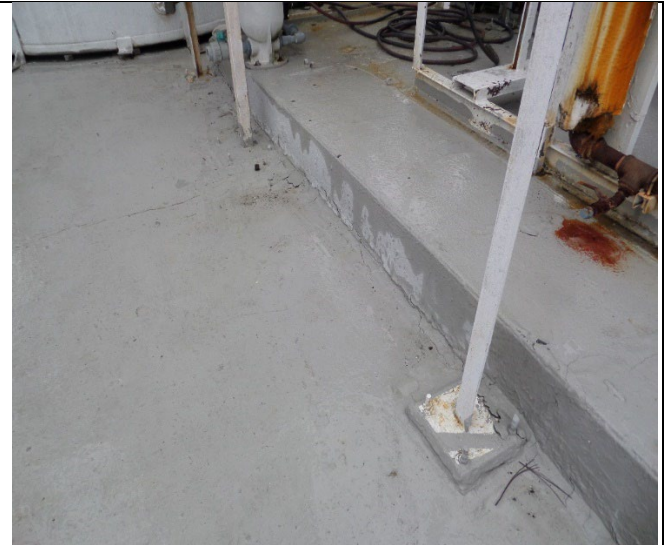
Permitted Tank Farm 1. The inspectors observed the secondary containment next to Tank 14, showed signs of gaps and the paint/sealant was cracked and peeling away from the concrete floor in this area. Photograph 31 taken at 12:17 p.m.

Permitted Tank Farm 1. The inspectors observed the secondary containment next to Tank 14, showed signs of gaps and the paint/sealant was cracked and peeling away from the concrete floor in this area. Photograph 32 taken at 12:17 p.m.

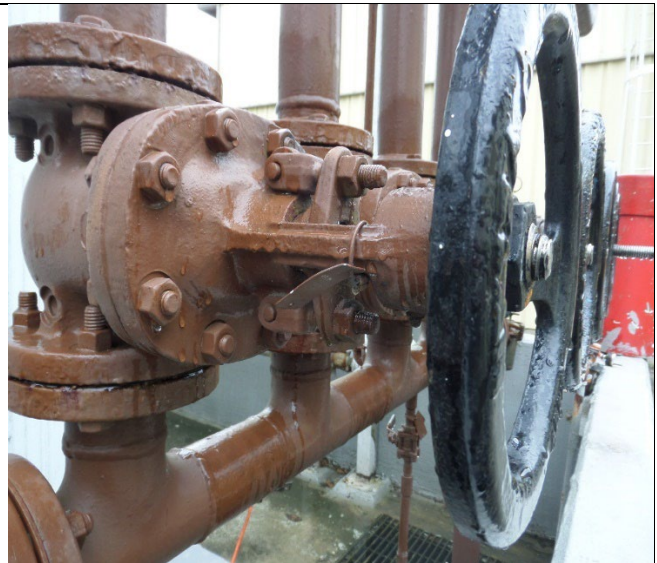
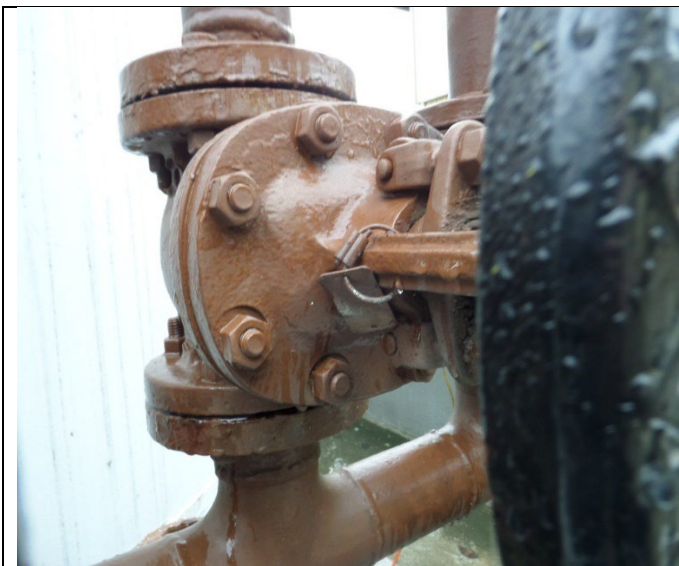
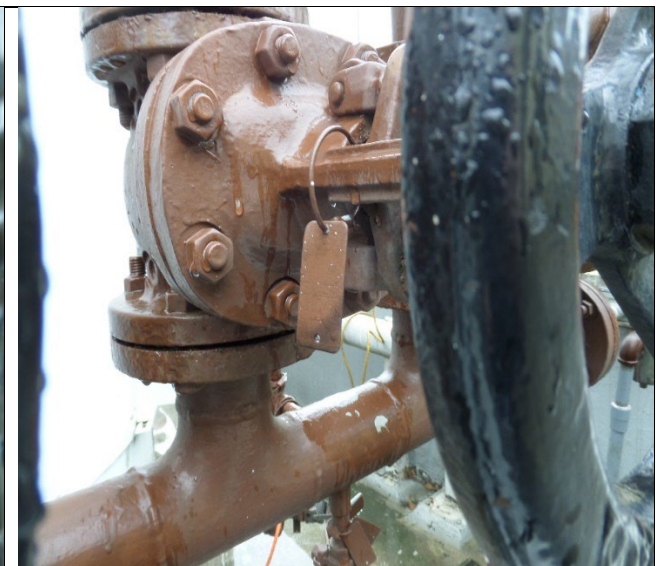
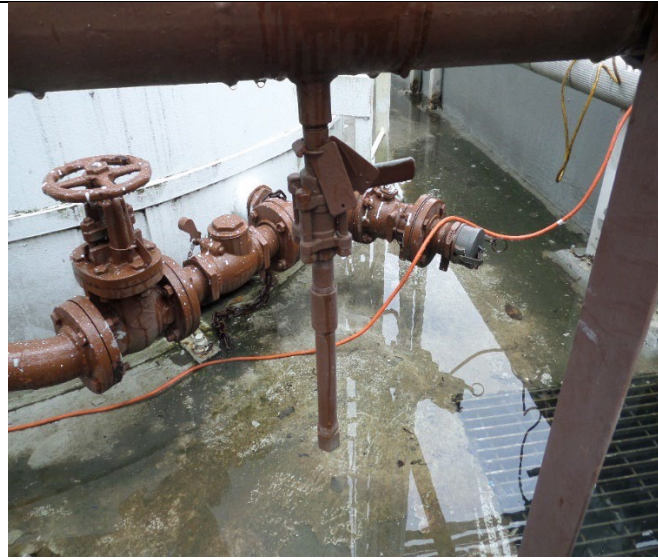
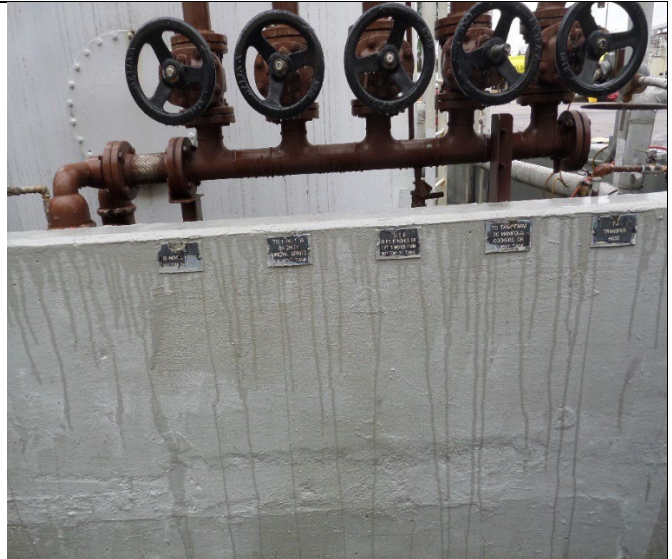
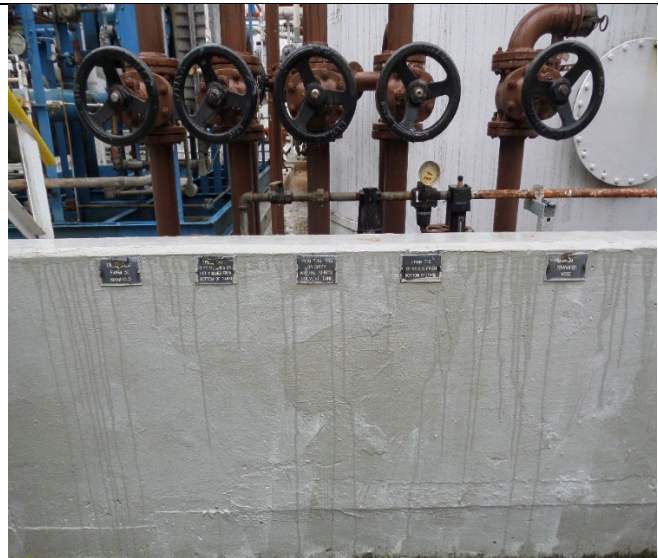
Permitted Tank Farm 1, Distribution Manifold. The inspectors observed several tags identifying pieces of equipment covered by paint and could not be read. Photograph 33 taken at 12:20 p.m.

Permitted Tank Farm 1, Distribution Manifold. The inspectors observed several tags identifying pieces of equipment covered by paint and could not be read. Photograph 34 taken at 12:21 p.m.

Permitted Tank Farm 1, Distribution Manifold. The inspectors observed several tags identifying pieces of equipment covered by paint and could not be read. Photograph 35 taken at 12:21 p.m.

Permitted Tank Farm 1, Distribution Manifold. The inspectors observed several tags identifying pieces of equipment covered by paint and could not be read. Photograph 36 taken at 12:21 p.m.

Permitted Tank Farm 1, Distribution Manifold. The inspectors observed several tags identifying pieces of equipment covered by paint and could not be read. Photograph 37 taken at 12:22 p.m.

Permitted Tank Farm 1, Distribution Manifold. The inspectors observed several tags identifying pieces of equipment covered by paint and could not be read. Photograph 38 taken at 12:23 p.m.

Permitted Tank Farm 1, Distribution Manifold. The inspectors observed several tags identifying pieces of equipment covered by paint and could not be read. Photograph 39 taken at 12:24 p.m.

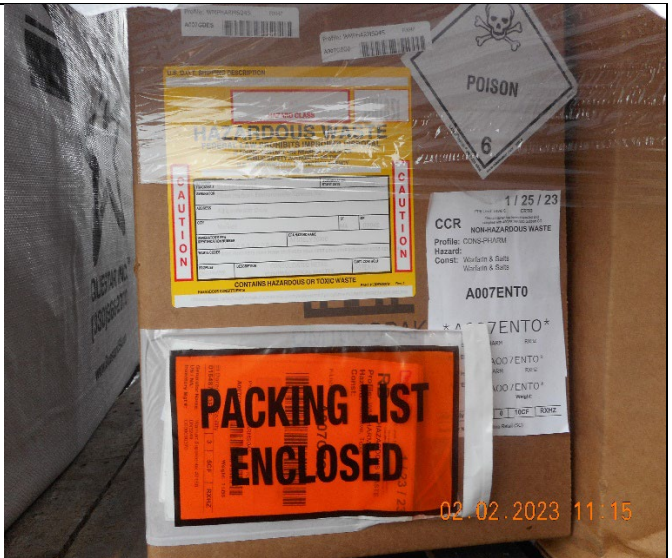
Electronic waste consisting of TVs, computer equipment and children's toys was observed in this area. Inspectors also observed a small (18"x18"x12") container that was labeled with the original generator hazardous waste label and marked as acutely toxic, consolidated retail pharmaceutical wastes (Photograph SCDHEC). There was also a "Poison" hazard indicator on the box. SK added a label during their acceptance process indicating the pharmaceutical waste (CONS-PHARM), containing Warfarin & Salts as non-hazardous. It was later confirmed in SK's email response dated February 10, 2023, to a verbal request from the inspectors during the inspection, that SK determined the consolidated pharmaceutical waste was a hazardous waste for toxicity and an error had occurred during processing. SK should follow their waste analysis plan and procedures for confirming any containers marked or labeled as hazardous waste.

Permitted Container Storage Area 1C - Electronic Waste and Pharmaceutical Waste. SK confirmed the container was storing hazardous waste. The inspectors observed the container of pharmaceutical waste (CONS-PHARM), containing Warfarin & Salts was not marked with a date. SCDHEC Photograph taken at 11:15 a.m.
