**Region 6 - Enforcement & Compliance Assurance Division**  
**INSPECTION REPORT**

| Regulatory Program(s) | NPDES Stormwater/ CWA 402 | |
| Company Name: | Turner Construction Company | |
| Facility Name: | Deloitte (Project Star) | |

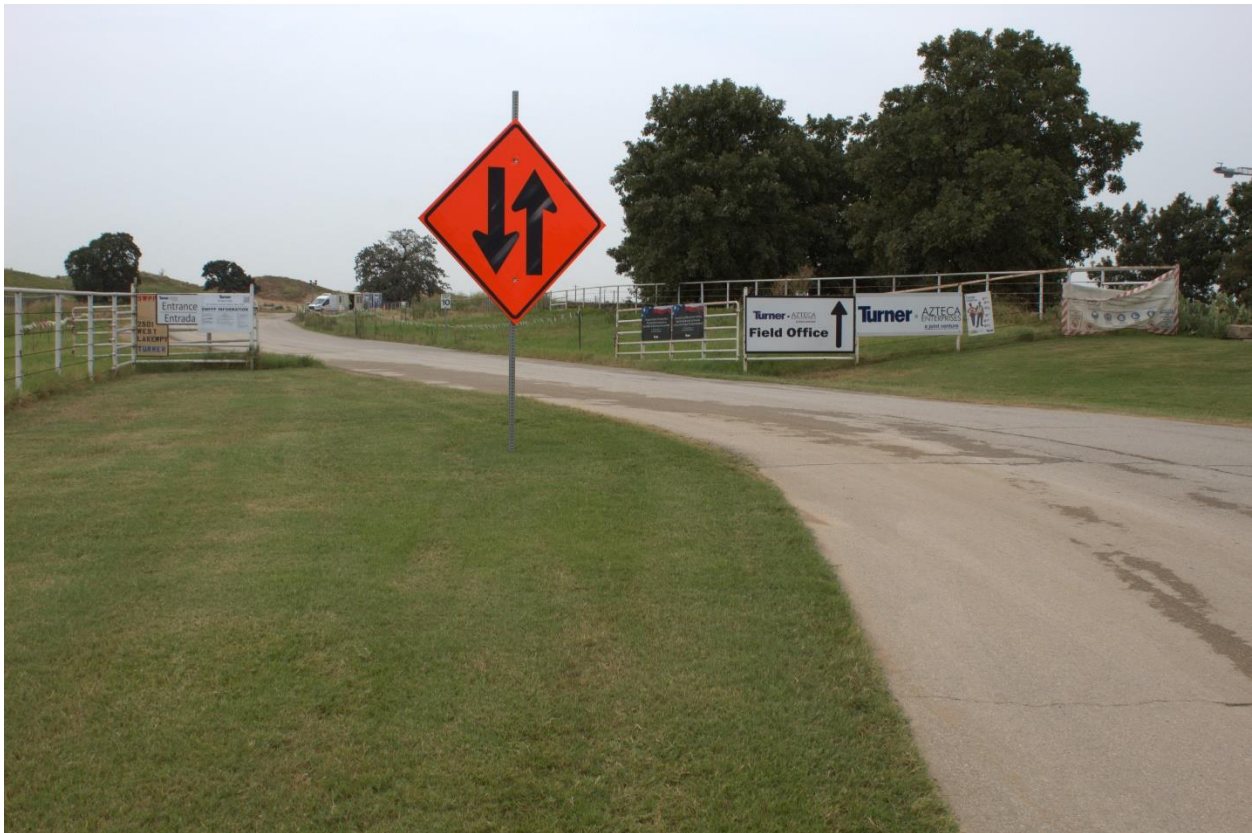
Photo no. 1

Description: Construction entrance with the posted Construction Site Notice (CSN) located approximately 150 feet west of the intersection of Capital Pkwy and Deloitte Way.

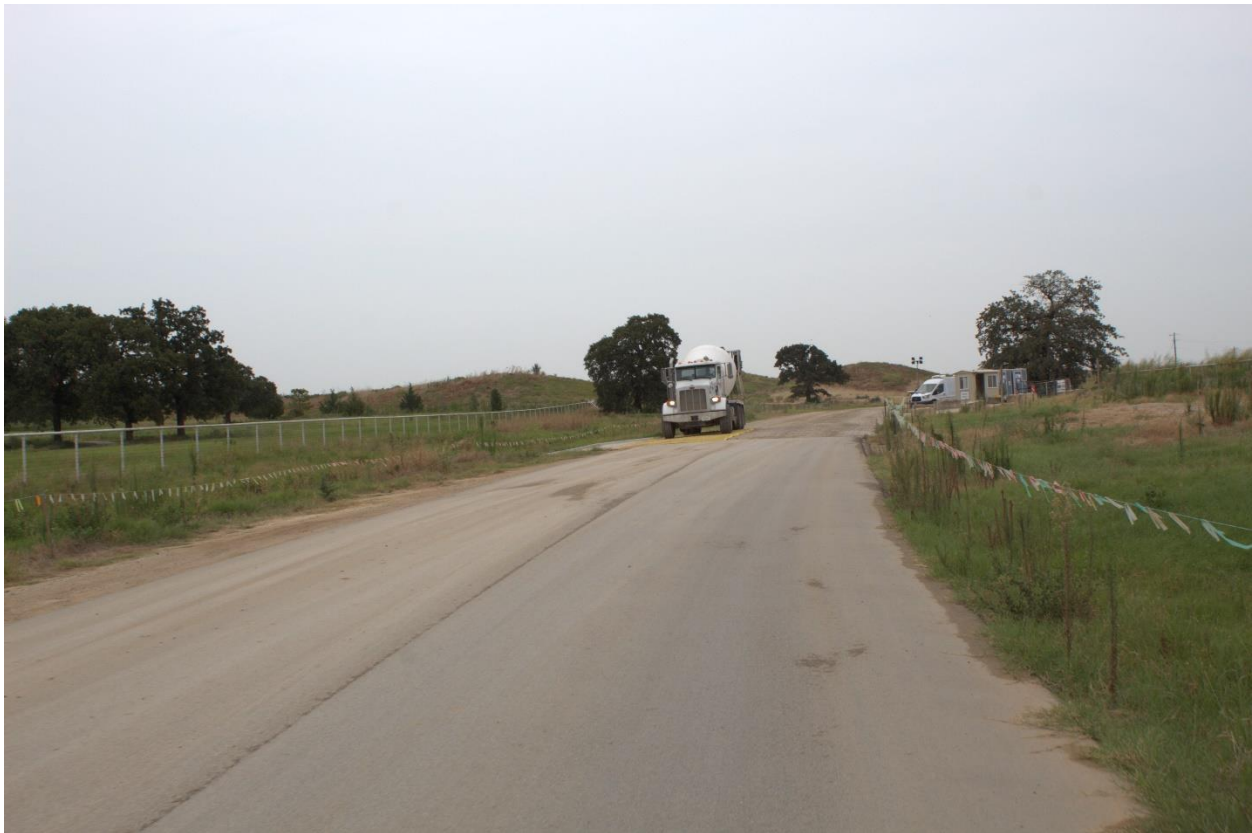
Photo no. 3

Description: A yellow track-out control mat was installed near the construction entrance/exit. The photo depicts a concrete mixer truck driving over the track-out control as it exits the construction site.

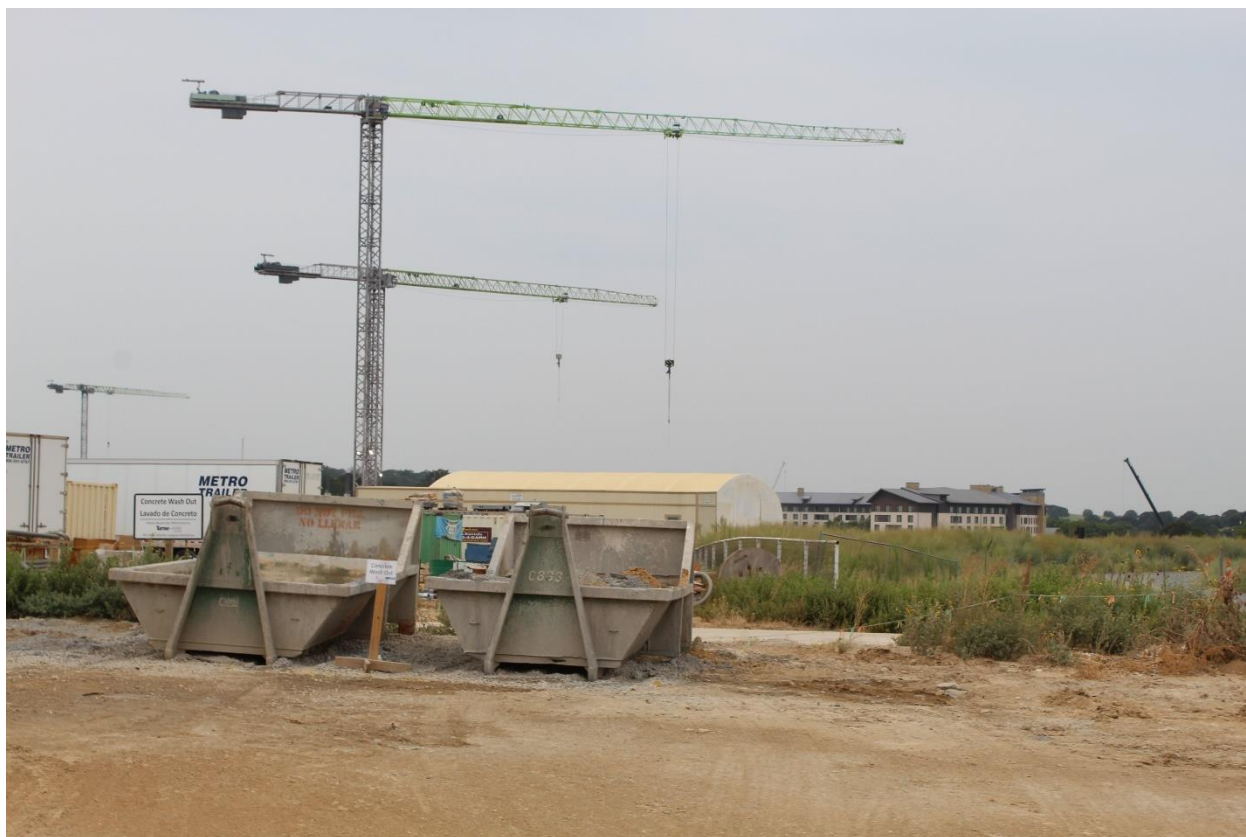
Photo no. 4

Description: One (1) of the two (2) concrete washout areas observed on-site. This concrete washout was located off the dirt road construction entrance.

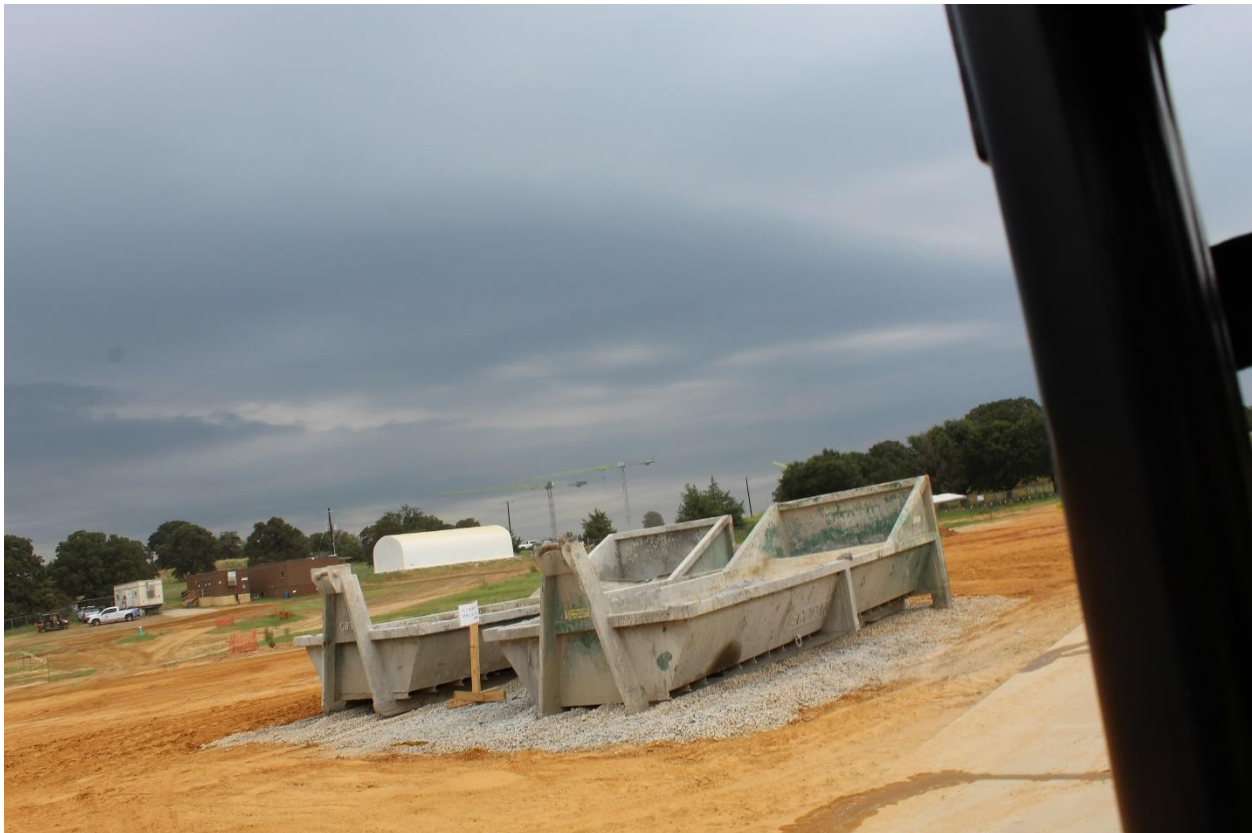
Photo no. 5

Description: The second concrete washout observed on-site. This concrete washout was located near the southern property line of the construction site.

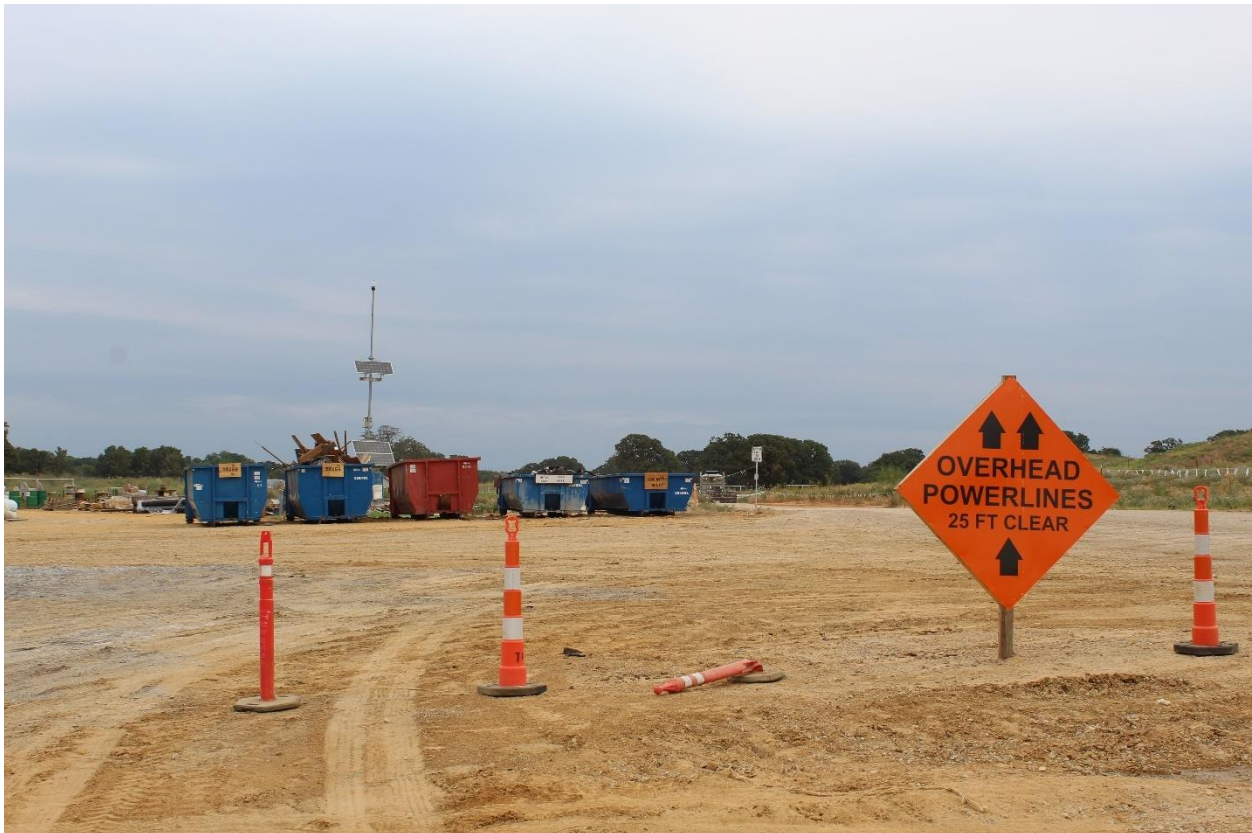
Photo no. 6

Description: Five (5) roll-off dumpsters observed near the construction entrance.

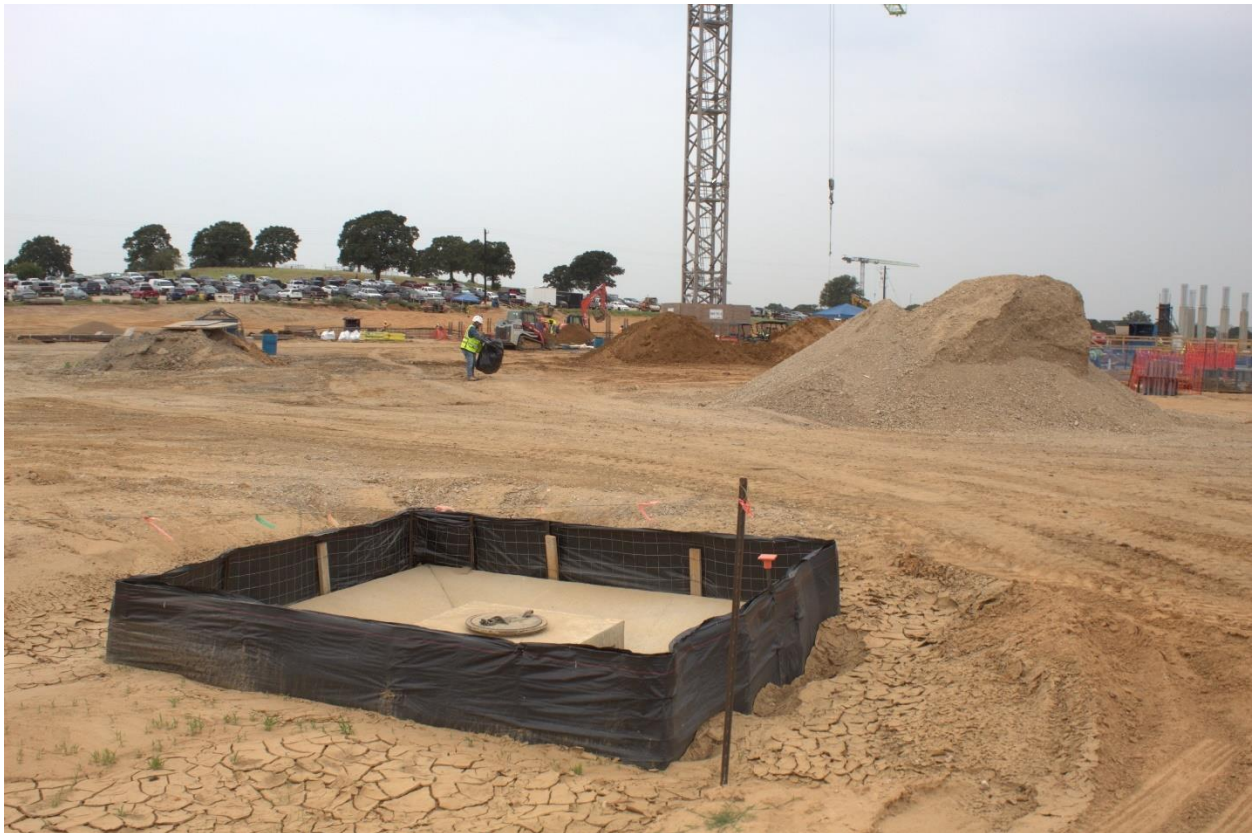
Photo no. 7

Description: Construction crew member observed picking up blowable trash. Also pictured is an inlet with silt fence installed around it. Mr. Hudler advised that the inlet(s) tie to a sediment pond on-site.

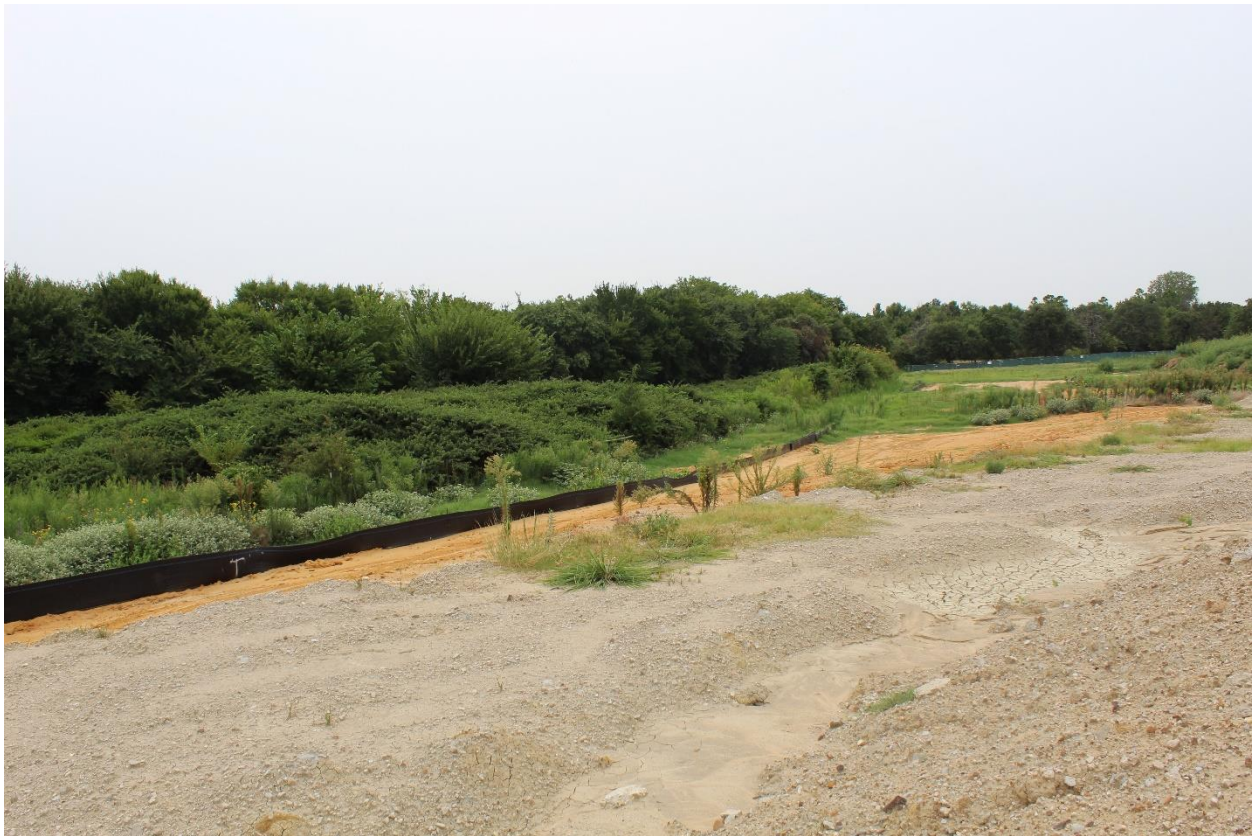
Photo no. 8

- Silt fence and rock filter berm was observed along the perimeter of the site (**Appendix 1, Photo 8**). A natural vegetative buffer was also noted along the east perimeter of the site (**Appendix 1, Photo 9**).

Description: Silt fence observed along the eastern perimeter of the site. A natural vegetative buffer was located immediately outside of the silt fence.

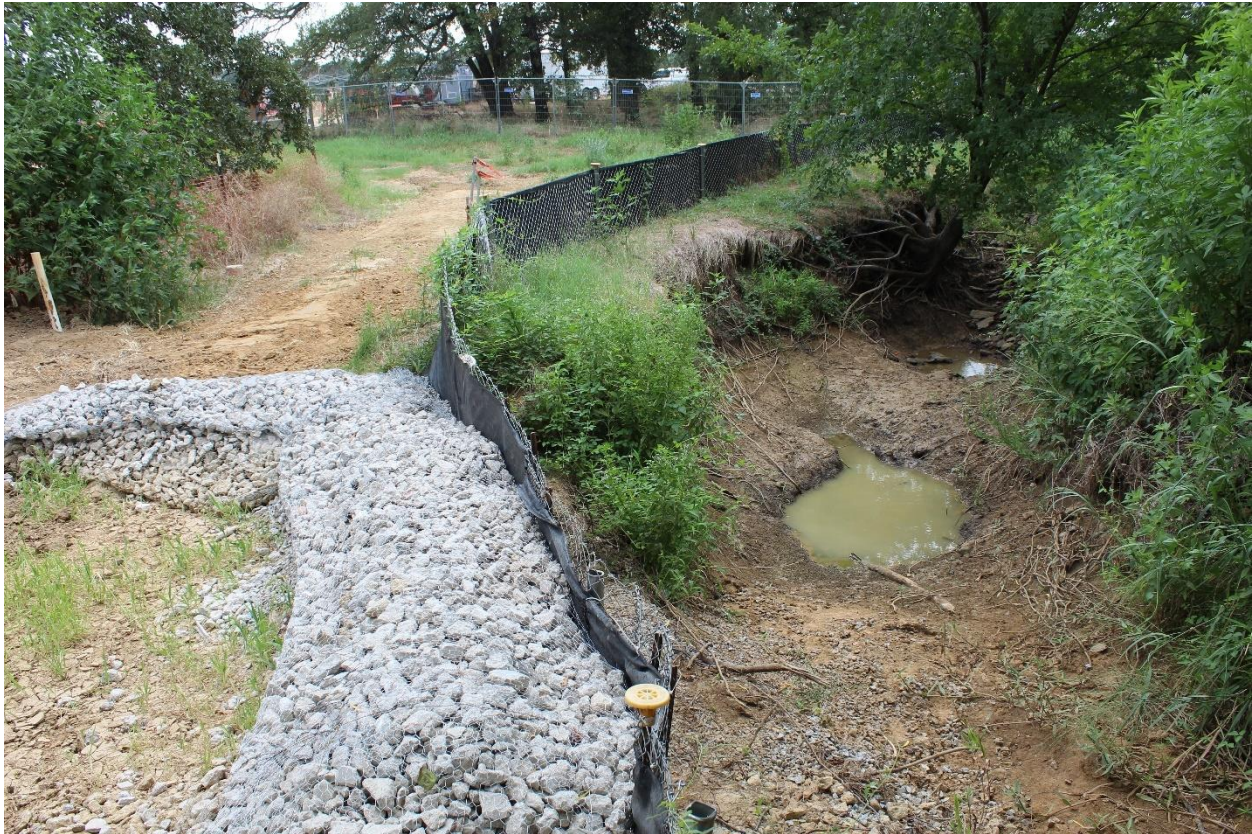
Photo no. 9

Description: Silt fence and a rock filter berm observed along the eastern perimeter of the site.

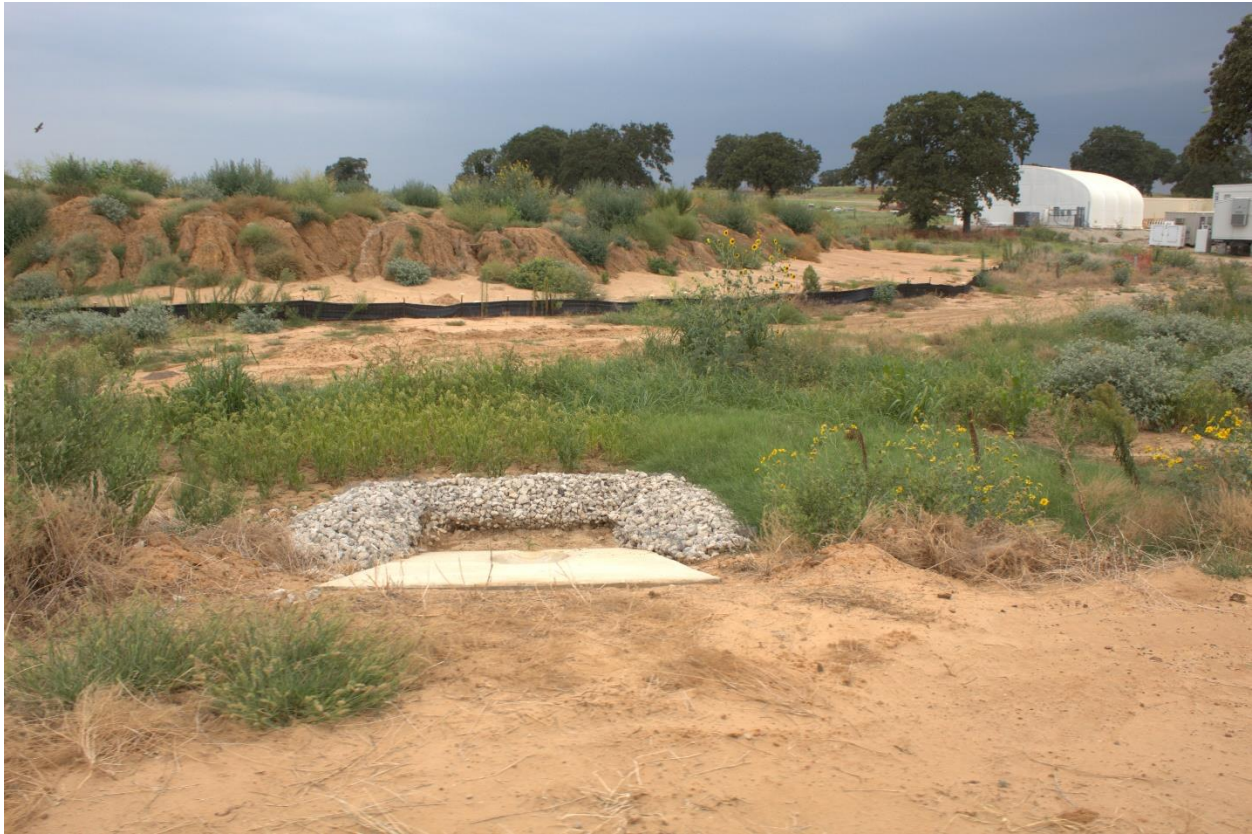
Photo no. 10

- Culverts had BMPs (i.e. rock filter berms, silt fence, erosion control blankets) installed to filter stormwater (**Appendix 1, Photo 10**).
- Rock check dams were observed along ditches (**Appendix 1, Photo 11**).

Description: Culvert with BMPs installed to filter sediment.

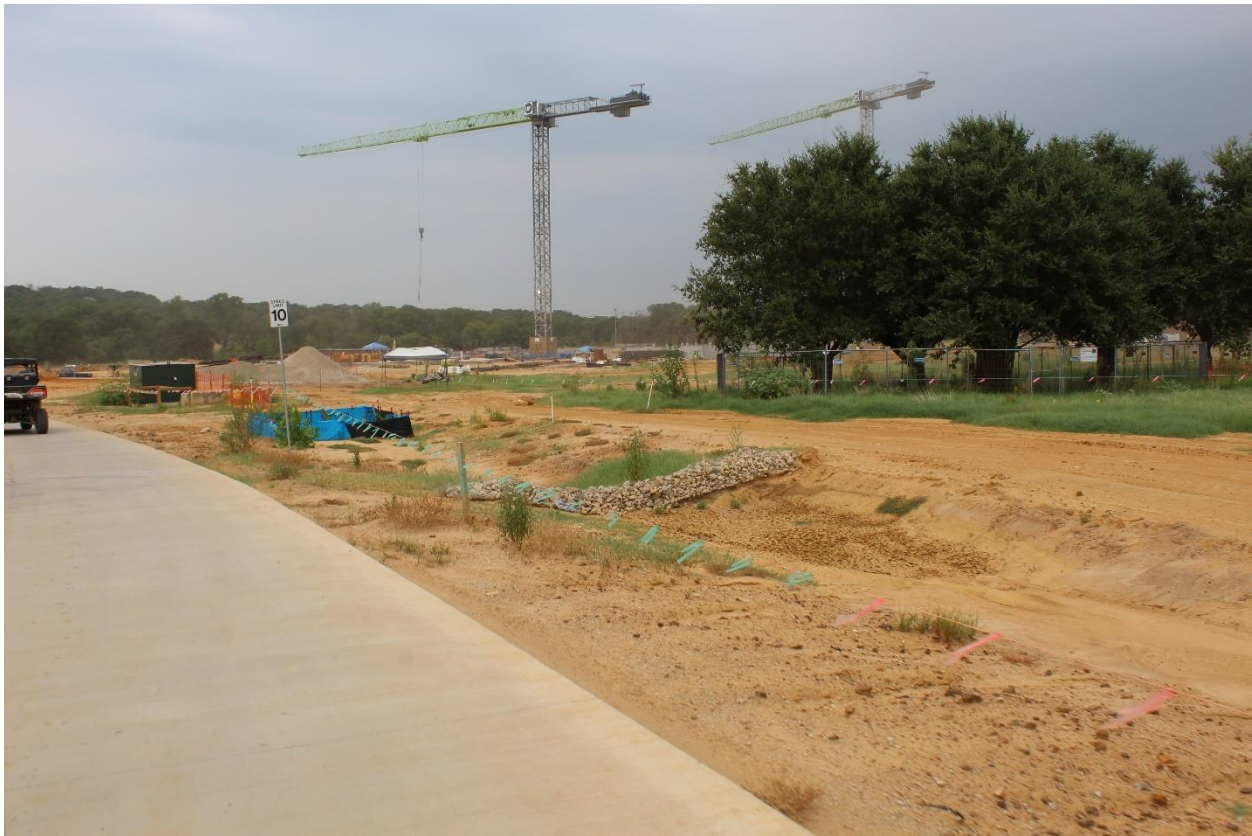
Photo no. 11

Description: Rock check dam along a ditch.

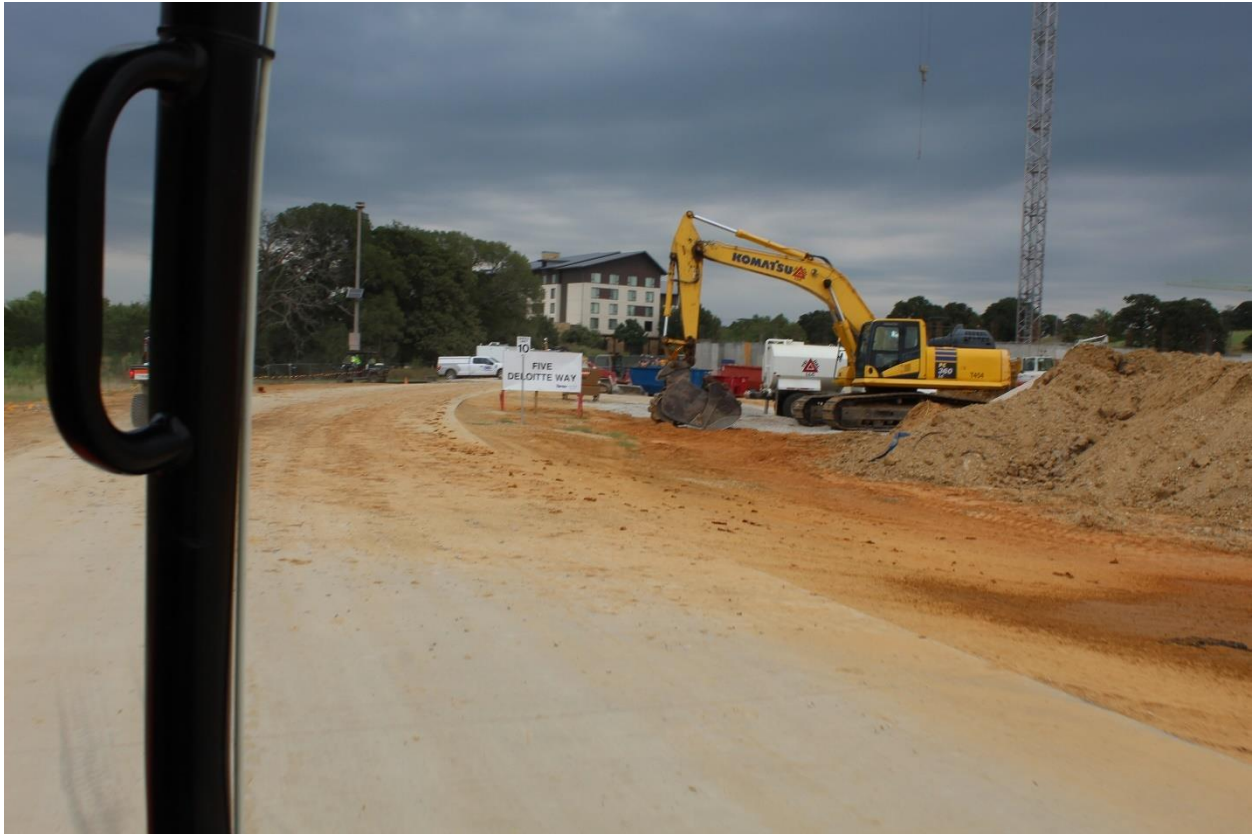
Photo no. 12

- Some sediment track-out from vehicles and equipment was observed on the paved areas on-site (**Appendix 1, Photo 12**). Mr. Hudler advised that the site is swept daily.

Description: Sediment track-out on the pavement caused by equipment and vehicles.

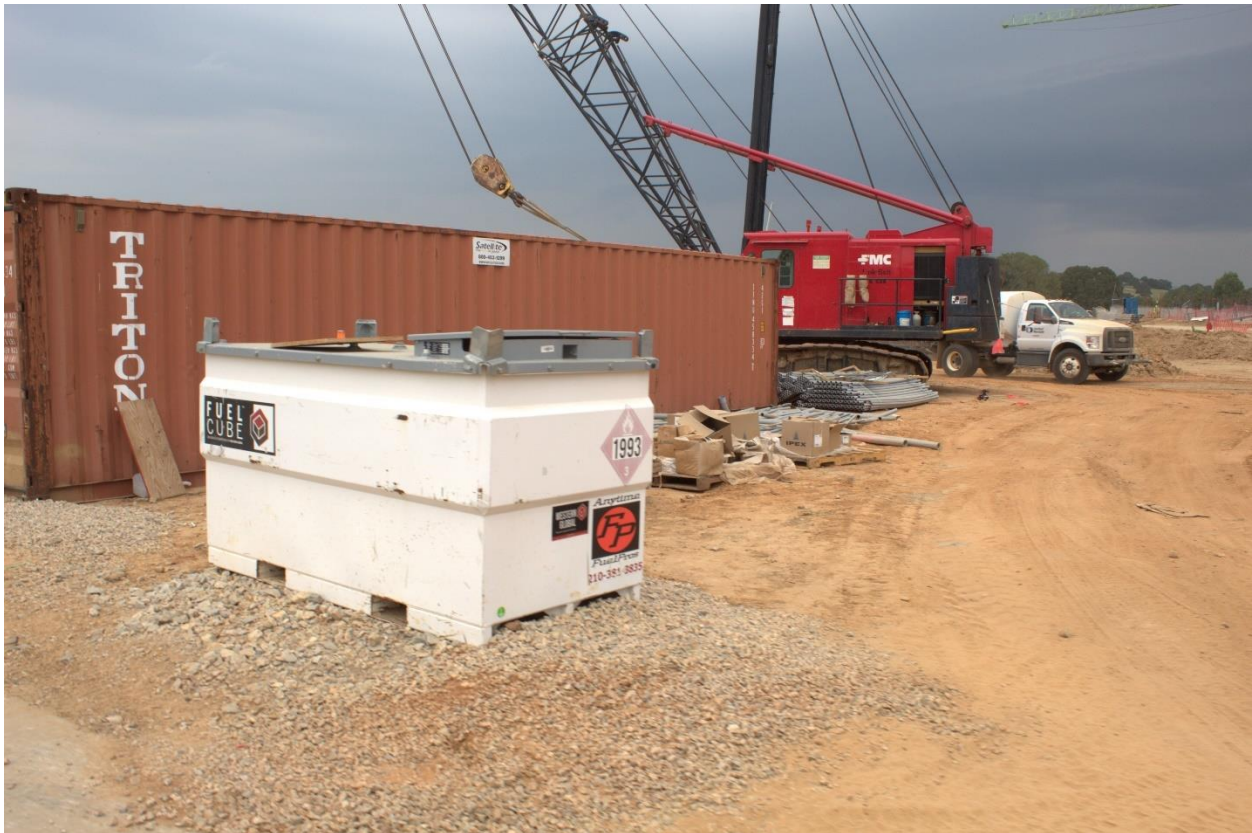
Photo no. 13

- Fuel storage tanks on-site were either double walled or in secondary containment (**Appendix 1, Photos 13**).
- The Stormwater Pollution Prevention Plan (SWPPP) and site map were observed and reviewed on-site in the field office/construction trailer (**Appendix 1, Photos 14-15**). Copies of the site's inspection reports were not printed and stored in the SWPPP. Mr. Hudler advised that the inspection reports were managed electronically.

Description: A double walled fuel container.
