## Clean Water Act Section 404: Site Visit/Case Development

| Site Name | Hash Properties, LLC | | | | |
| Site Address* | end of Pebble Beach Drive | | | | |

### Photograph Log

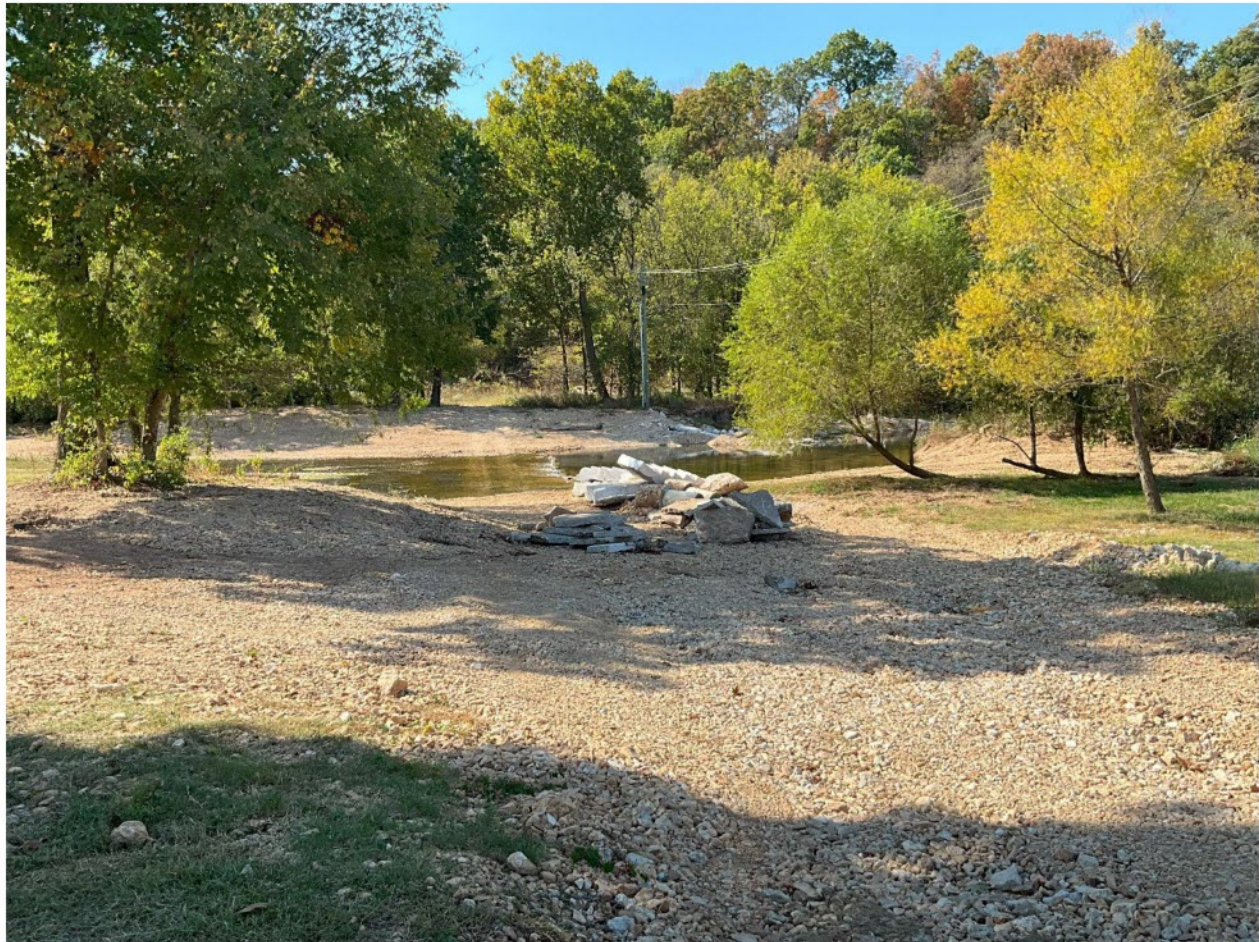
Photo No. 1

| Photo File Name | Date and Time of Photo | Photographer | Description |
|---|---|---|---|
| IMG_0074.JPG | 10/09/2024, 2:34 PM | Chelsey Sherwood | Showing stream crossing area and fill material consisting of broken concrete. Picture taken facing west from river left bank. |

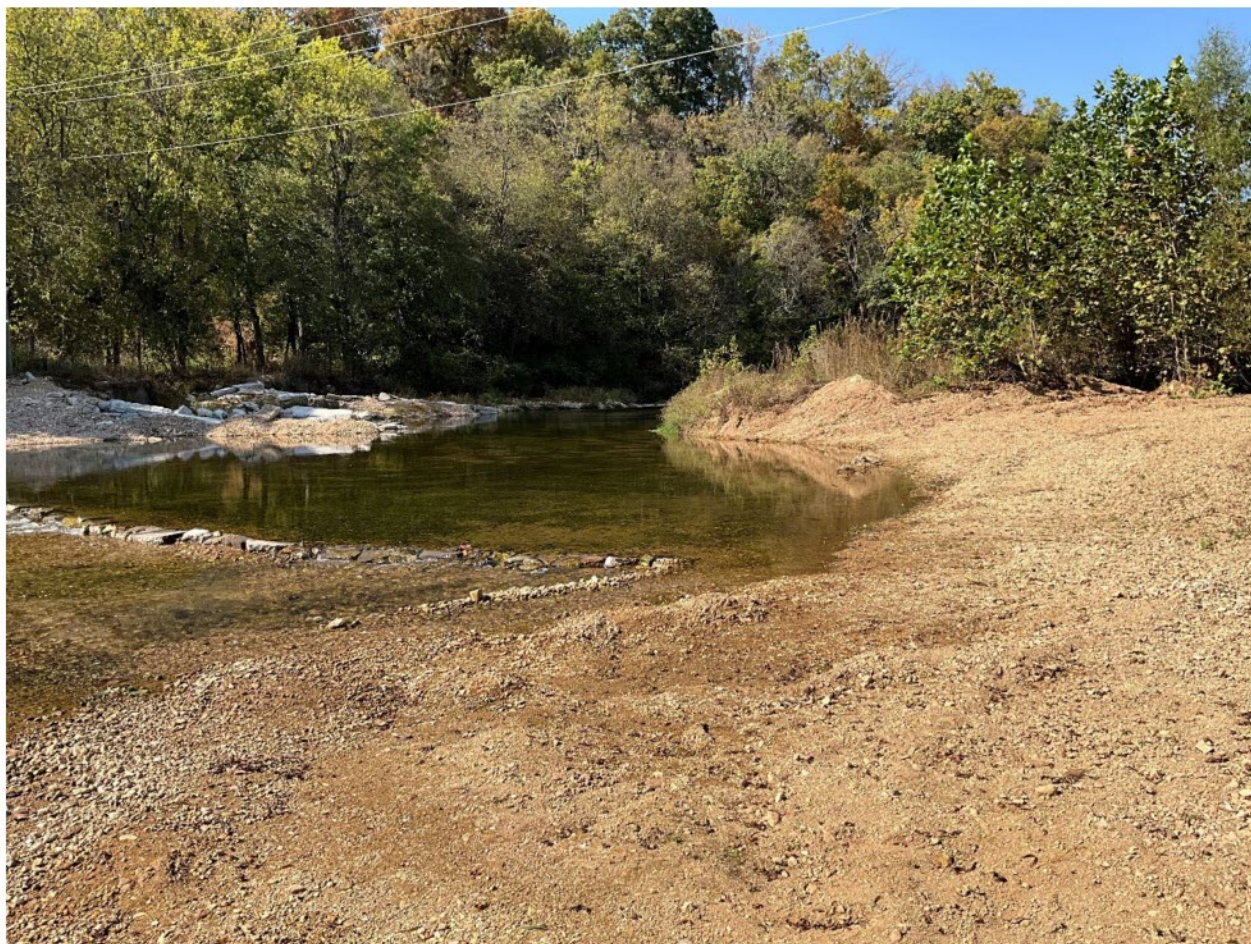
Photo No. 2

| Photo File Name | Date and Time of Photo | Photographer | Description |
|---|---|---|---|
| IMG_0075.JPG | 10/09/2024, 2:36 PM | Chelsey Sherwood | Showing dredged and fill material below the Ordinary High Water Mark piled throughout the stream and riparian areas. Picture taken facing north, upstream. |

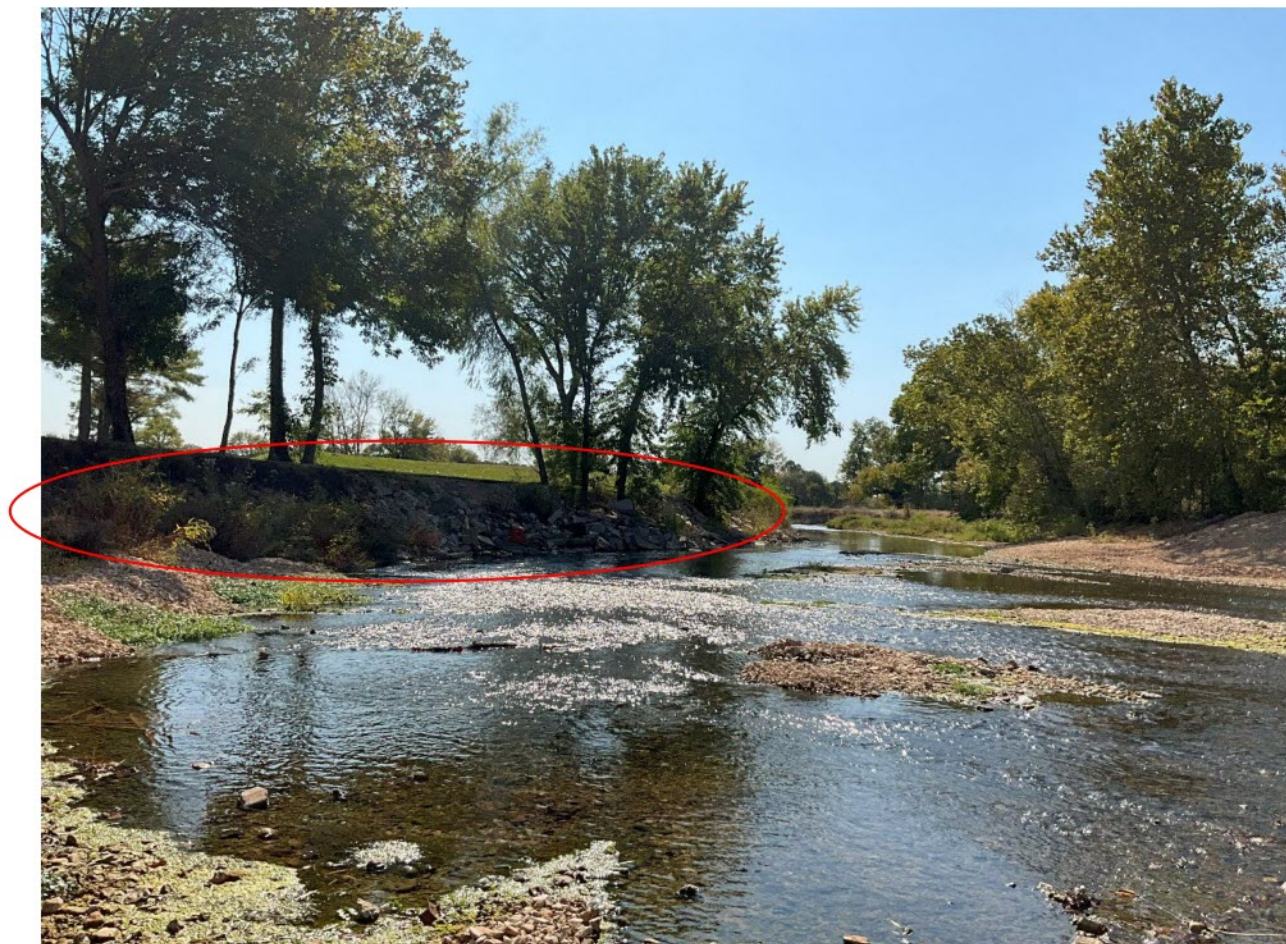
Photo No. 3

| Photo File Name | Date and Time of Photo | Photographer | Description |
|---|---|---|---|
| IMG_0076.JPG | 10/09/2024, 2:36 PM | Chelsey Sherwood | Showing fill material below the Ordinary High Water Mark. Note circled in red large pieces of broken concrete. Picture taken facing south, downstream. |

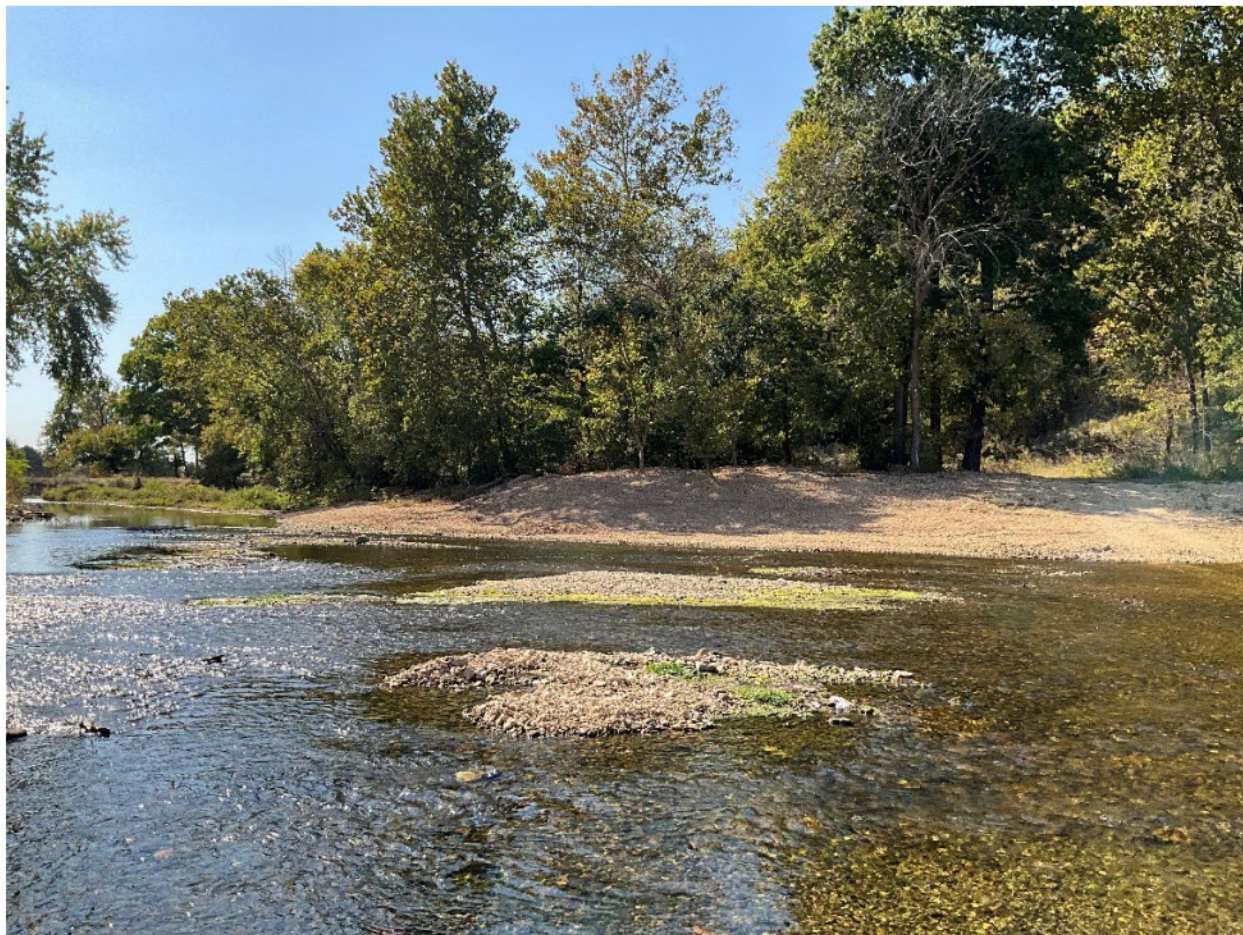
Photo No. 4

| Photo File Name | Date and Time of Photo | Photographer | Description |
|---|---|---|---|
| IMG_0077.JPG | 10/09/2024, 2:37 PM | Chelsey Sherwood | Showing tire tracks and the graded stream bank with dredged and fill material piled throughout the stream and riparian area. Picture taken facing west, towards river right bank. |
