## Clean Water Act Section 404: Site Visit/Case Development

| Site Name | SVG Holdings Property | | | | |
| Site Address* | 260 Bruyn Turnpike (106.1-1-28.111) | | | | |

CWA 404 Inspection  
SVG Holdings Property  
260 Bruyn Turnpike  
Wallkill, Ulster County, NY

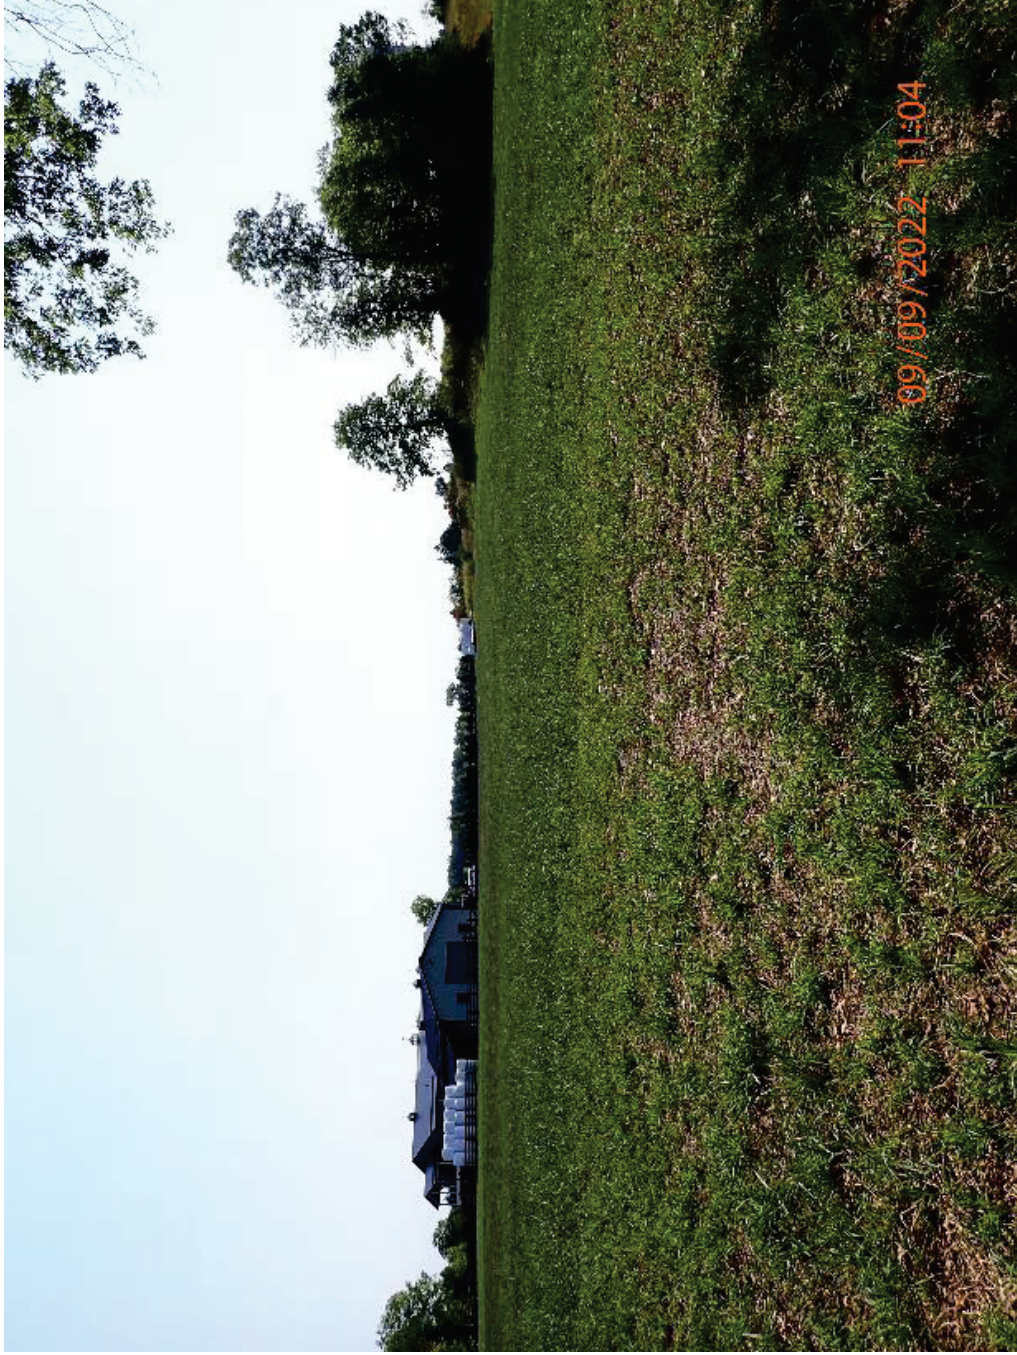
**Date:** 9/9/2022  
**Time:** 11:04 AM  
**Photographer:** SSA  
**Photo ID:** 1 – P9090464

**Description:**  
(1/8) Panorama of property

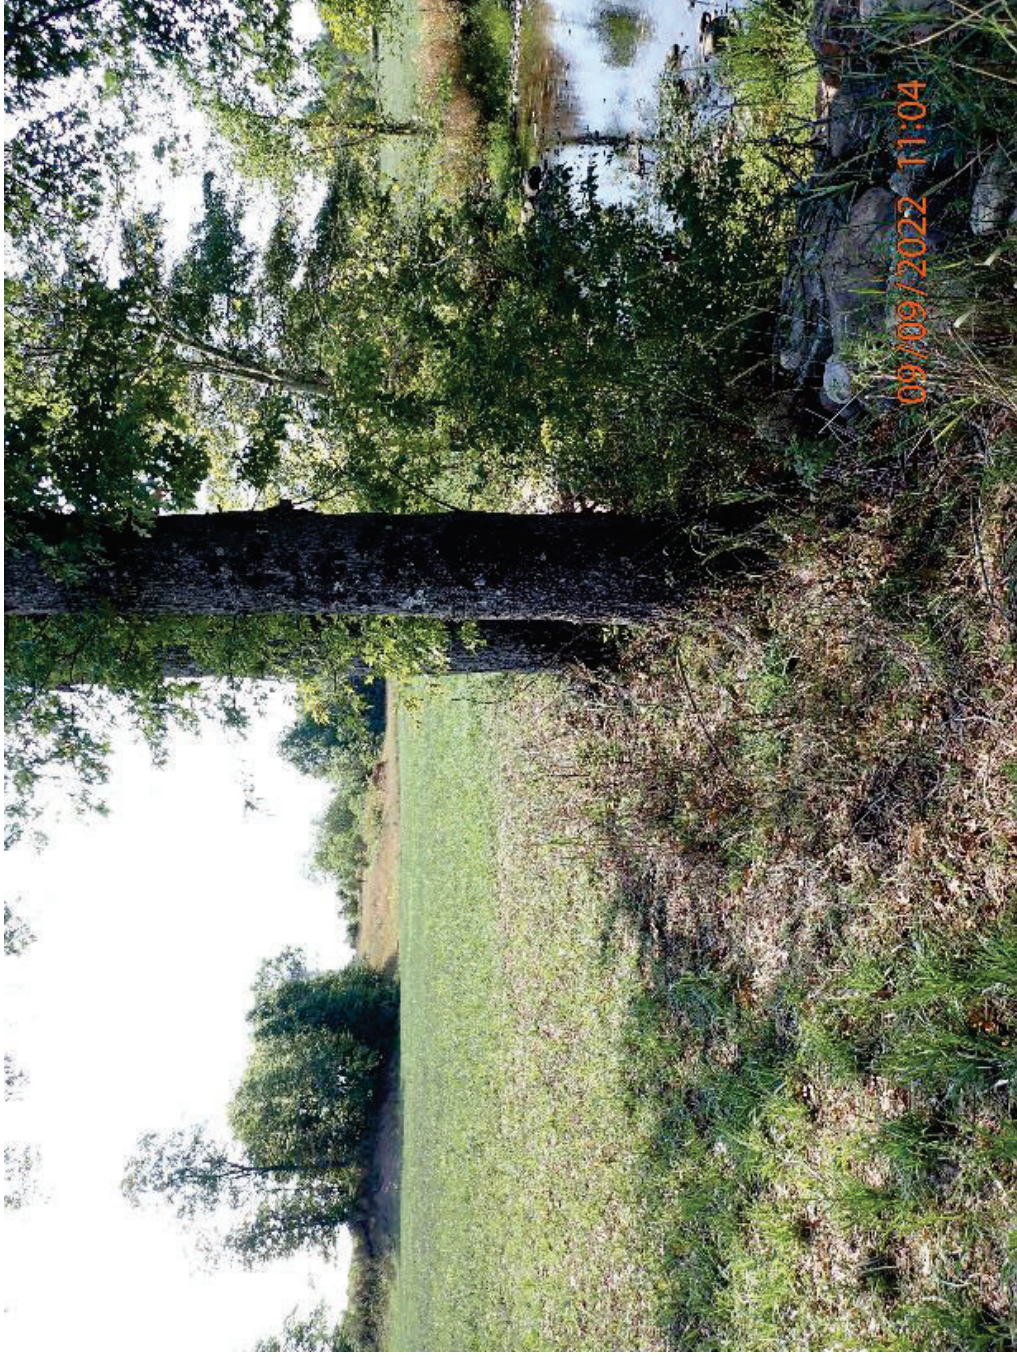
**Date:** 9/9/2022  
**Time:** 11:04 AM  
**Photographer:** SSA  
**Photo ID:** 2 – P9090465  
**Description:**  
(2/8) Panorama of property

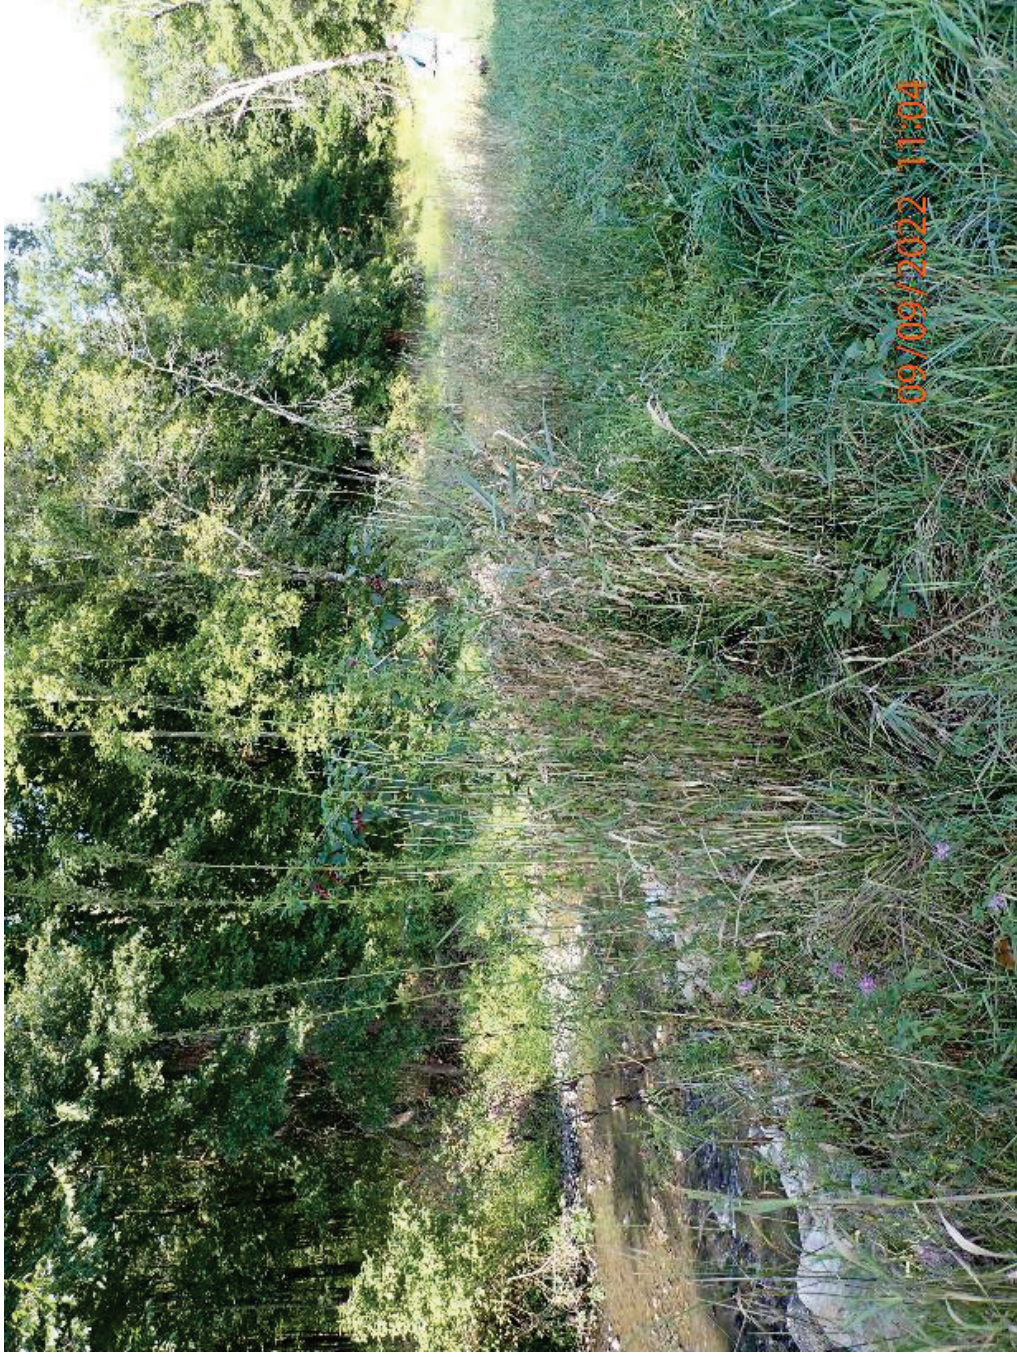
**Date:** 9/9/2022  
**Time:** 11:04 AM  
**Photographer:** SSA  
**Photo ID:** 4 – P9090467

**Description:**  
(4/8) Panorama of property

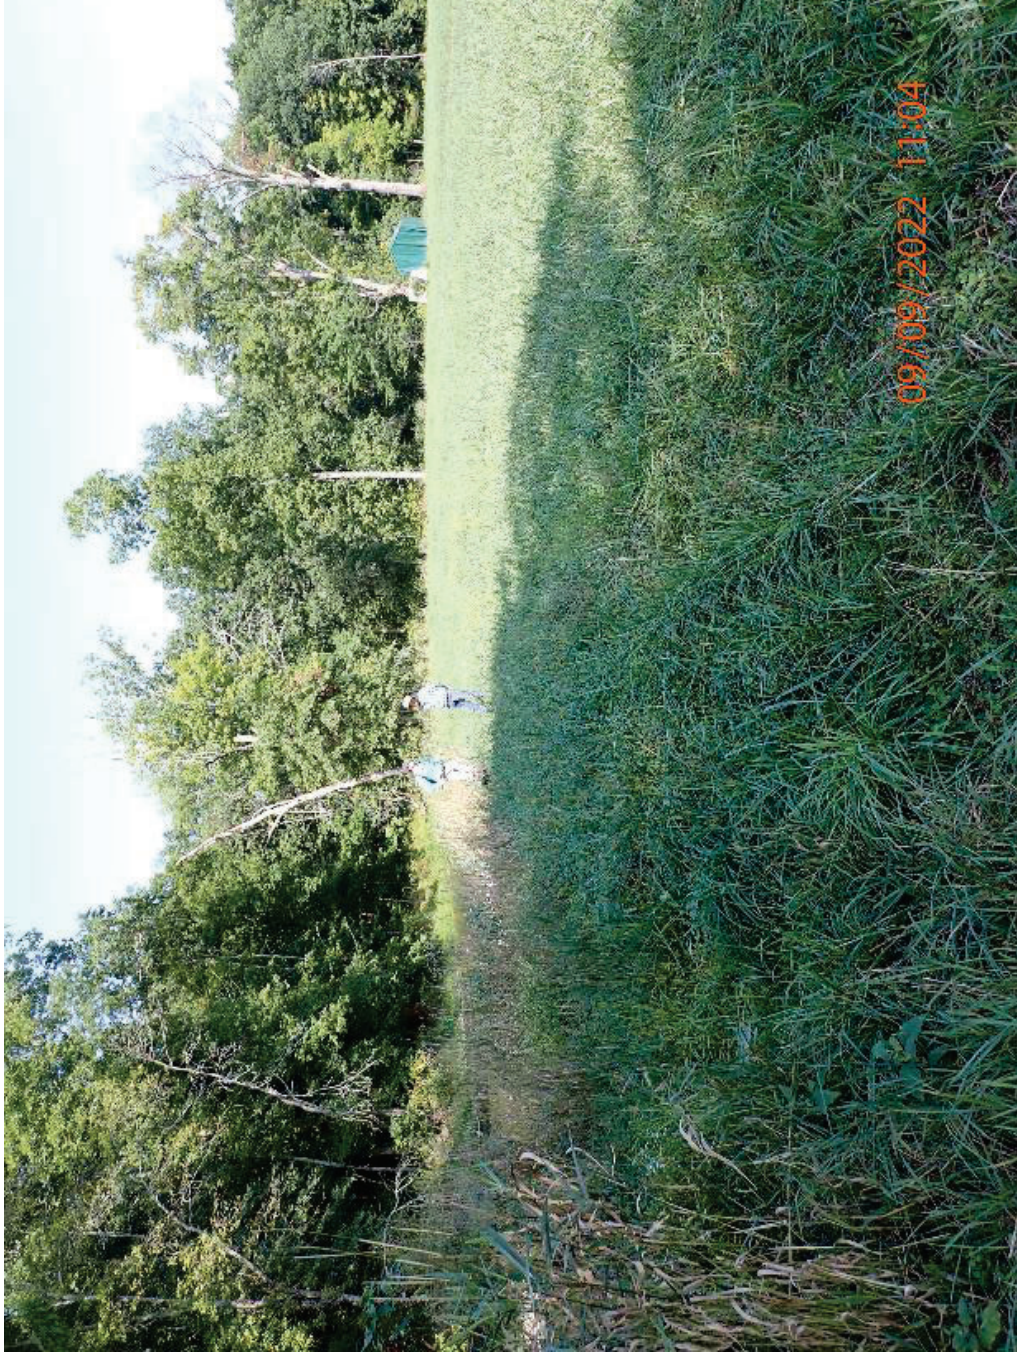
**Date:** 9/9/2022  
**Time:** 11:04 AM  
**Photographer:** SSA  
**Photo ID:** 5 – P9090468

**Description:**  
(5/8) Panorama of property

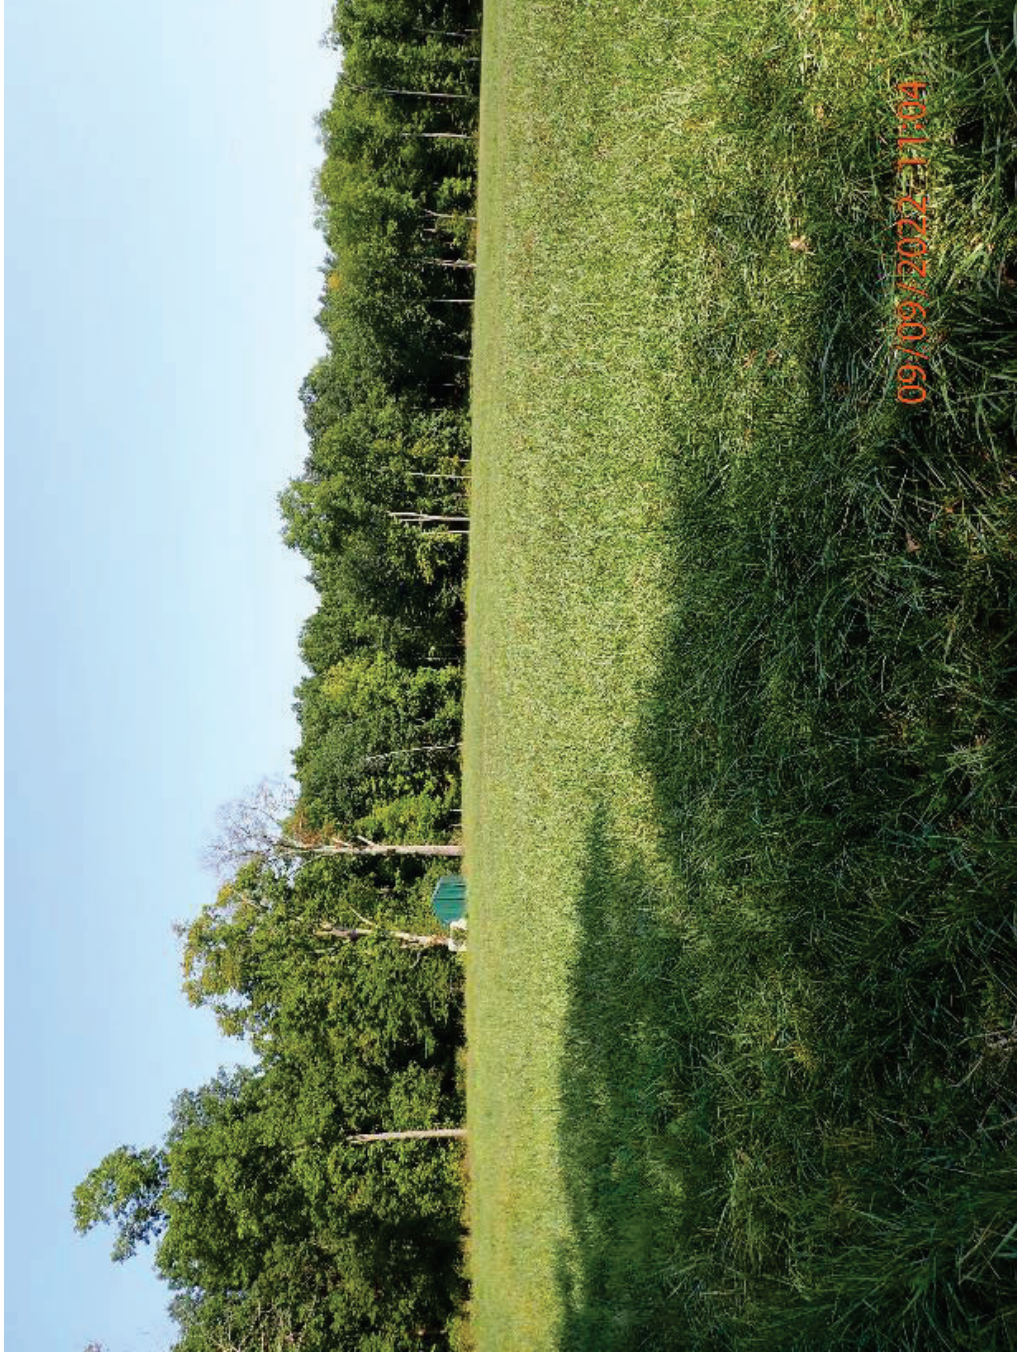
**Date:** 9/9/2022  
**Time:** 11:04 AM  
**Photographer:** SSA  
**Photo ID:** 6 – P9090469  
**Description:**  
(6/8) Panorama of property

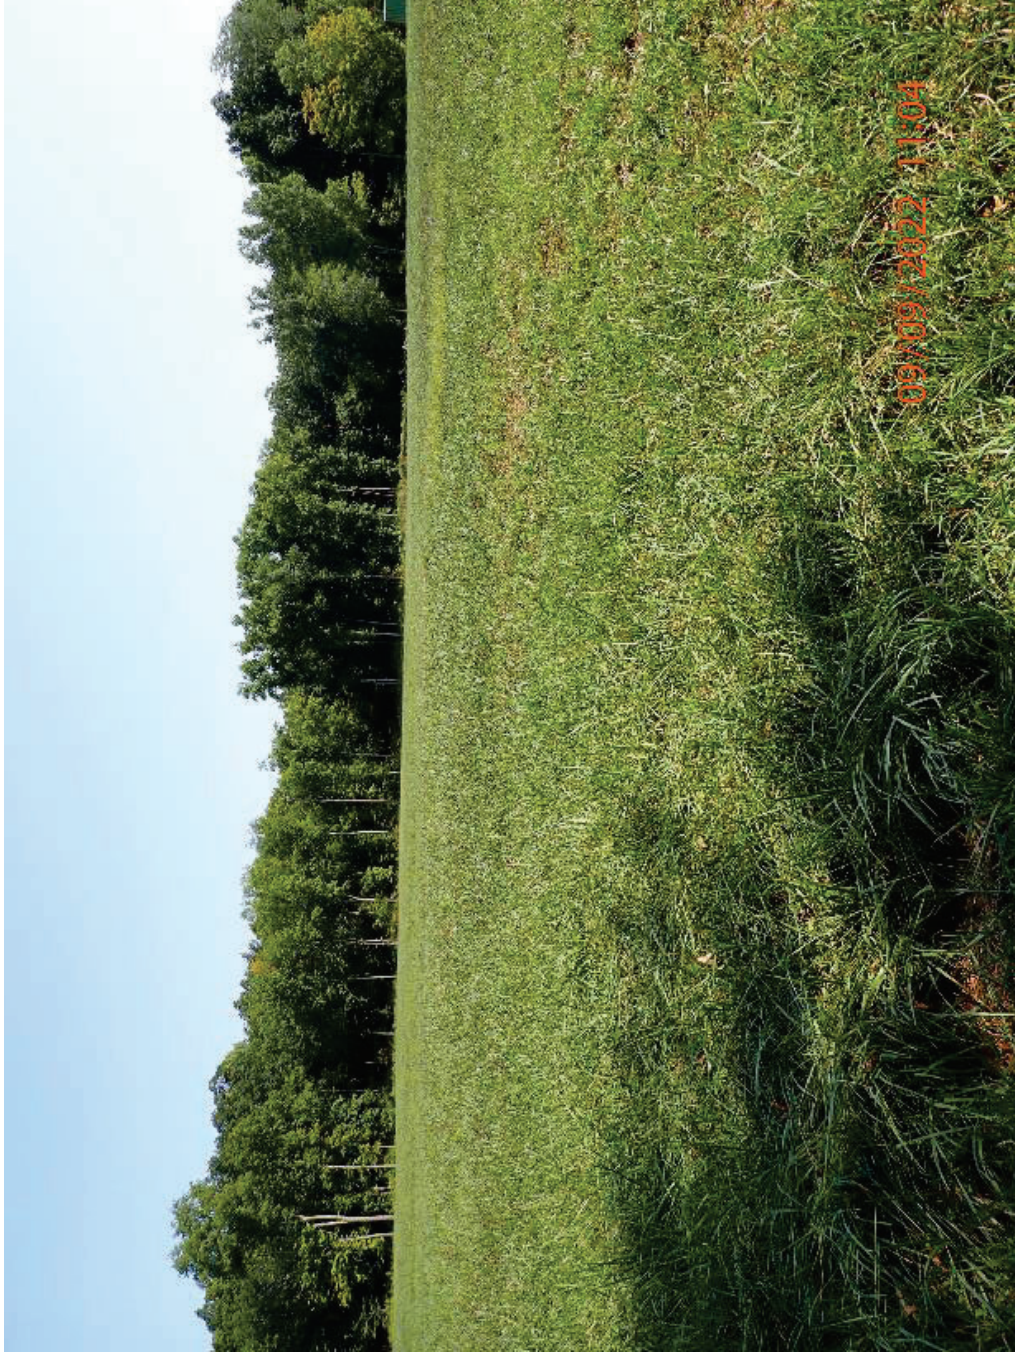
**Date:** 9/9/2022  
**Time:** 11:04 AM  
**Photographer:** SSA  
**Photo ID:** 7 – P9090470

**Description:**  
(7/8) Panorama of property

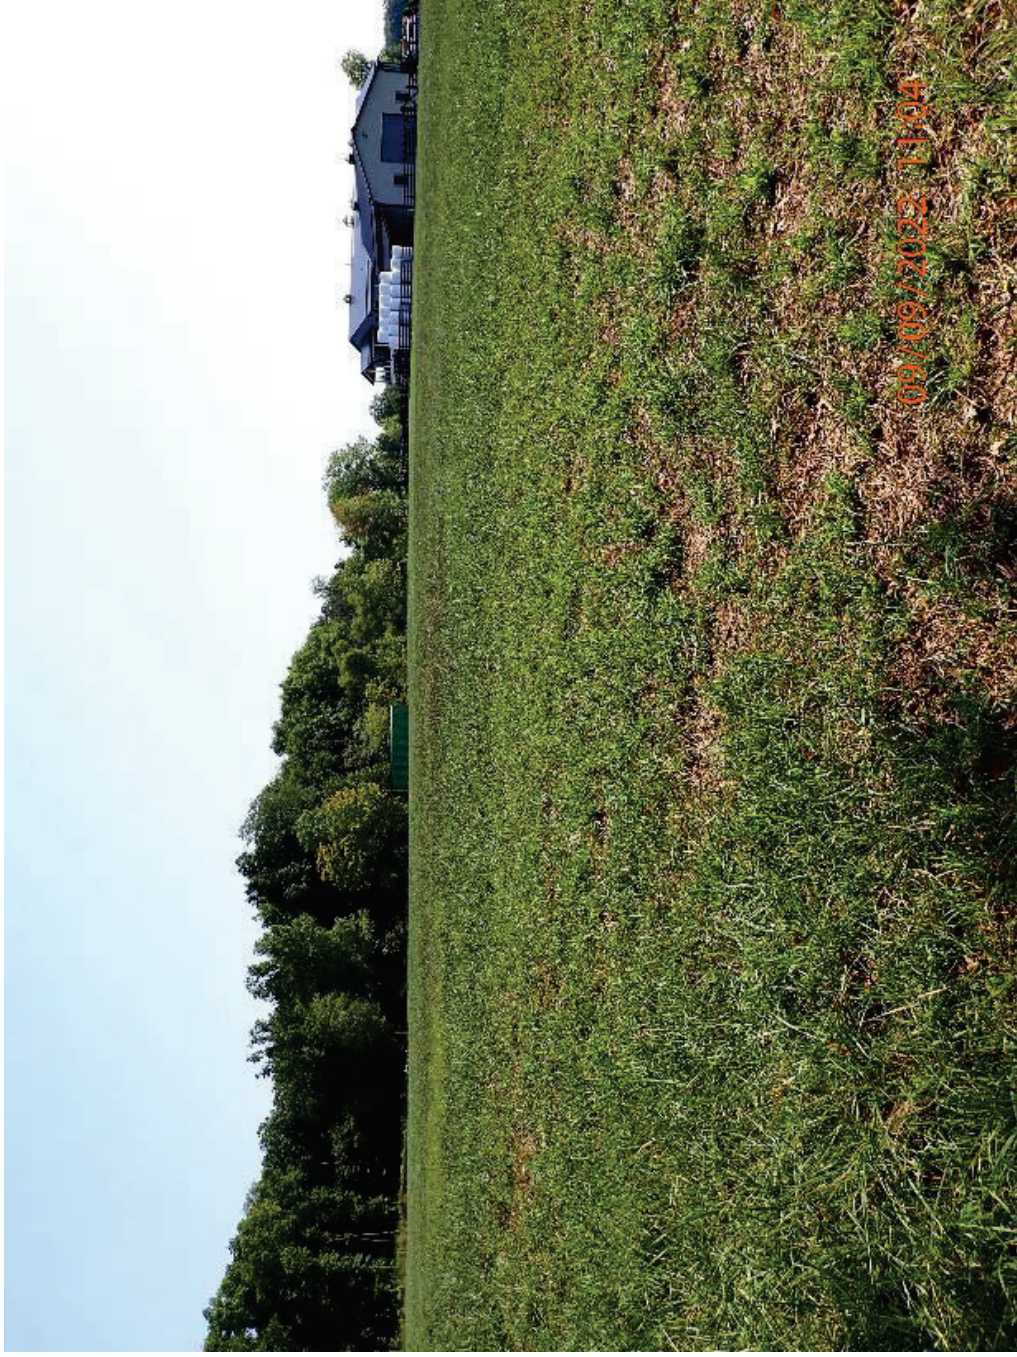
**Date:** 9/9/2022  
**Time:** 11:04 AM  
**Photographer:** SSA  
**Photo ID:** 8 – P9090471

**Description:**  
(8/8) Panorama of property

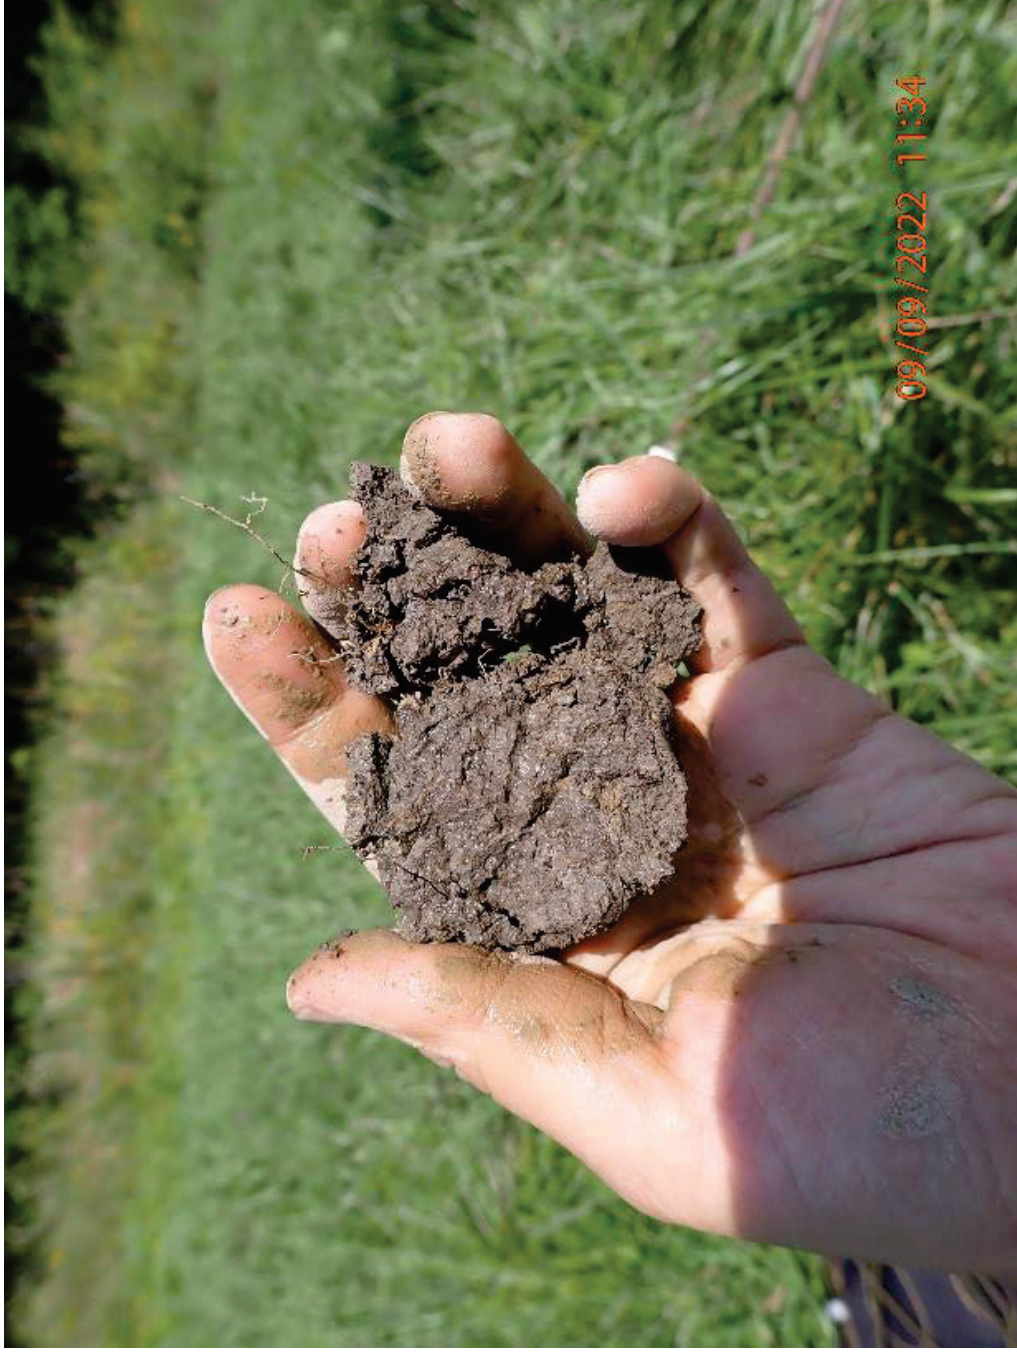
**Date:** 9/9/2022  
**Time:** 11:34 AM  
**Photographer:** SSA  
**Photo ID:** 10 – P9090473

8-12" layer of soil profile SS1  
showing oxidized rhizospheres

| Describe Recorded Data (stream gauge, monitoring well, aerial photos, previous inspections), if available:<br><br>Remarks:<br>Oxidized rhizospheres observed in layer below fill | | |

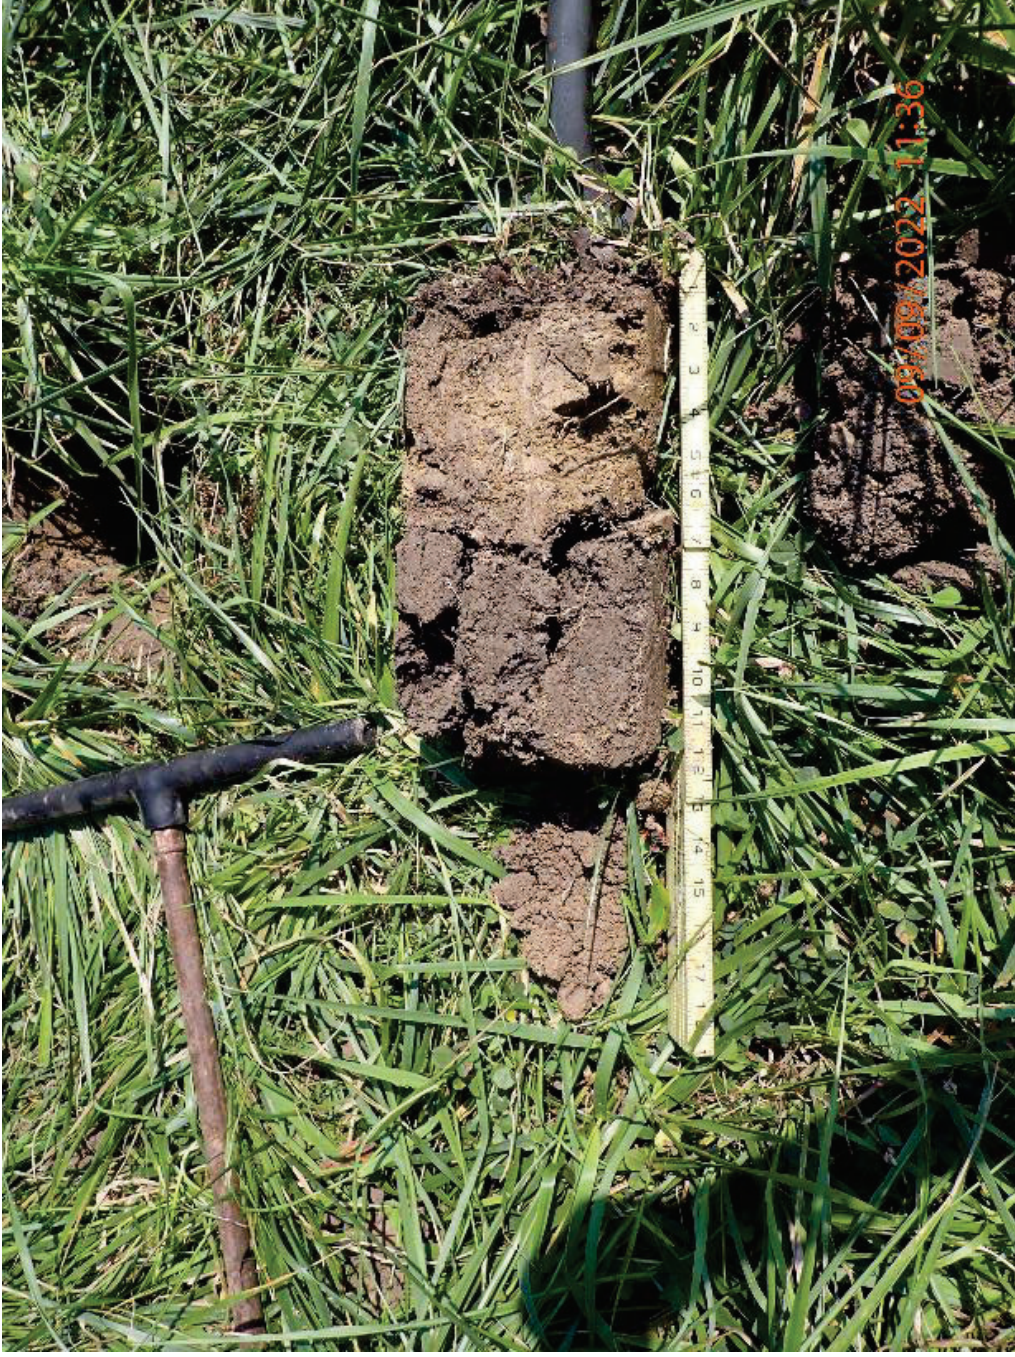
**Date:** 9/9/2022  
**Time:** 11:36 AM  
**Photographer:** SSA  
**Photo ID:** 11 – P9090474

SS1 soil profile showing 8 inches of fill material on top of hydric soil

| Fill material has been potentially discharged into stream and wetland areas without prior Corps authorization. | | | |

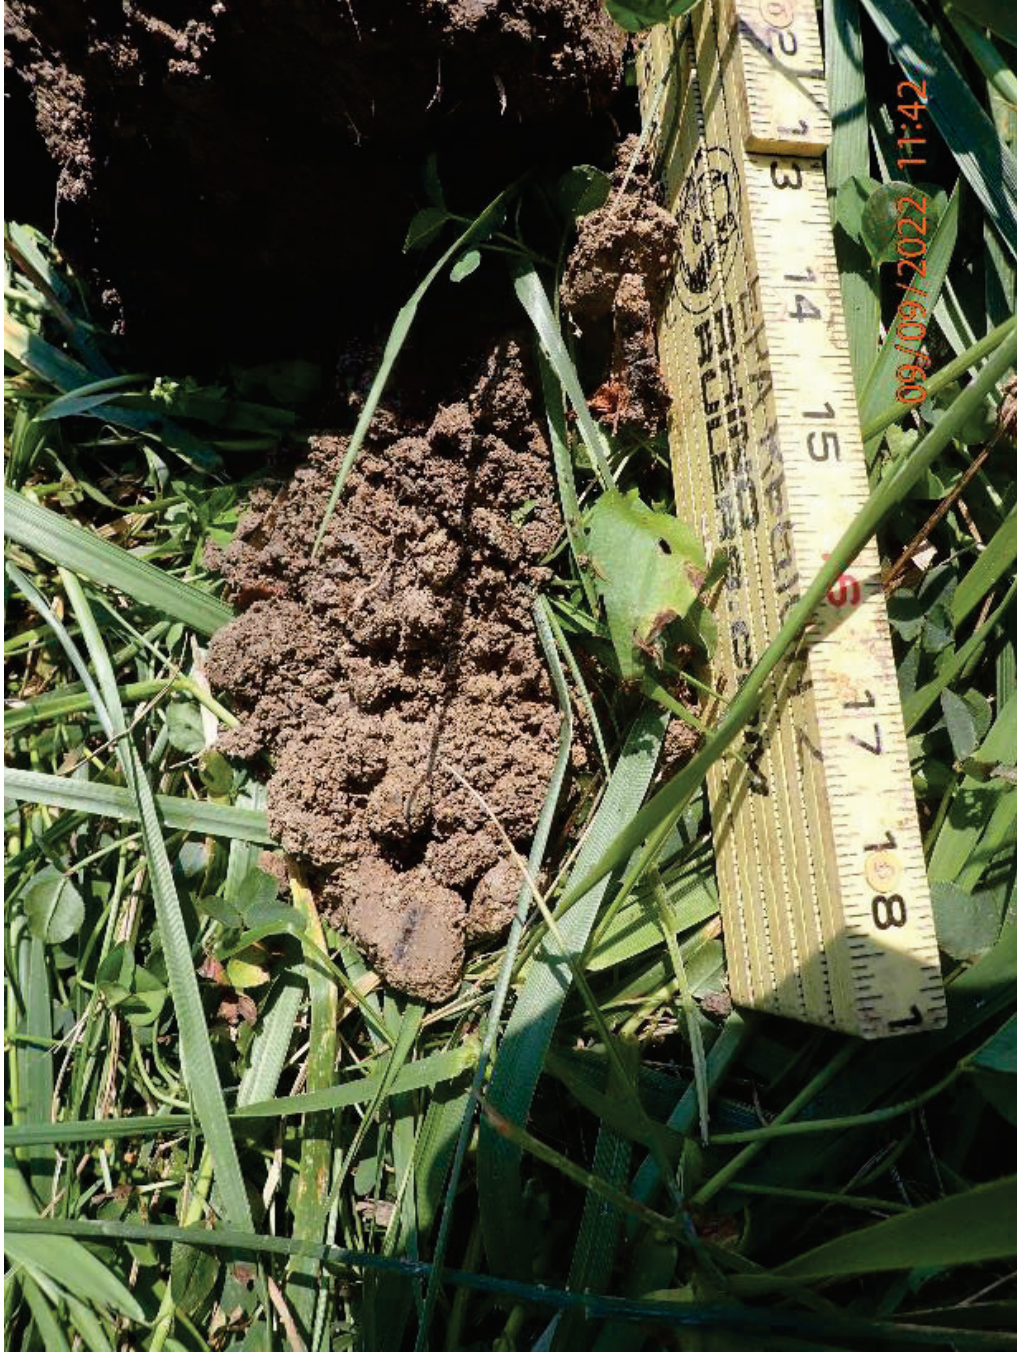
**Date:** 9/9/2022  
**Time:** 11:42 AM  
**Photographer:** SSA  
**Photo ID:** 12 – P9090475

12-18" layer of SS1 soil profile  
showing redoximorphic features

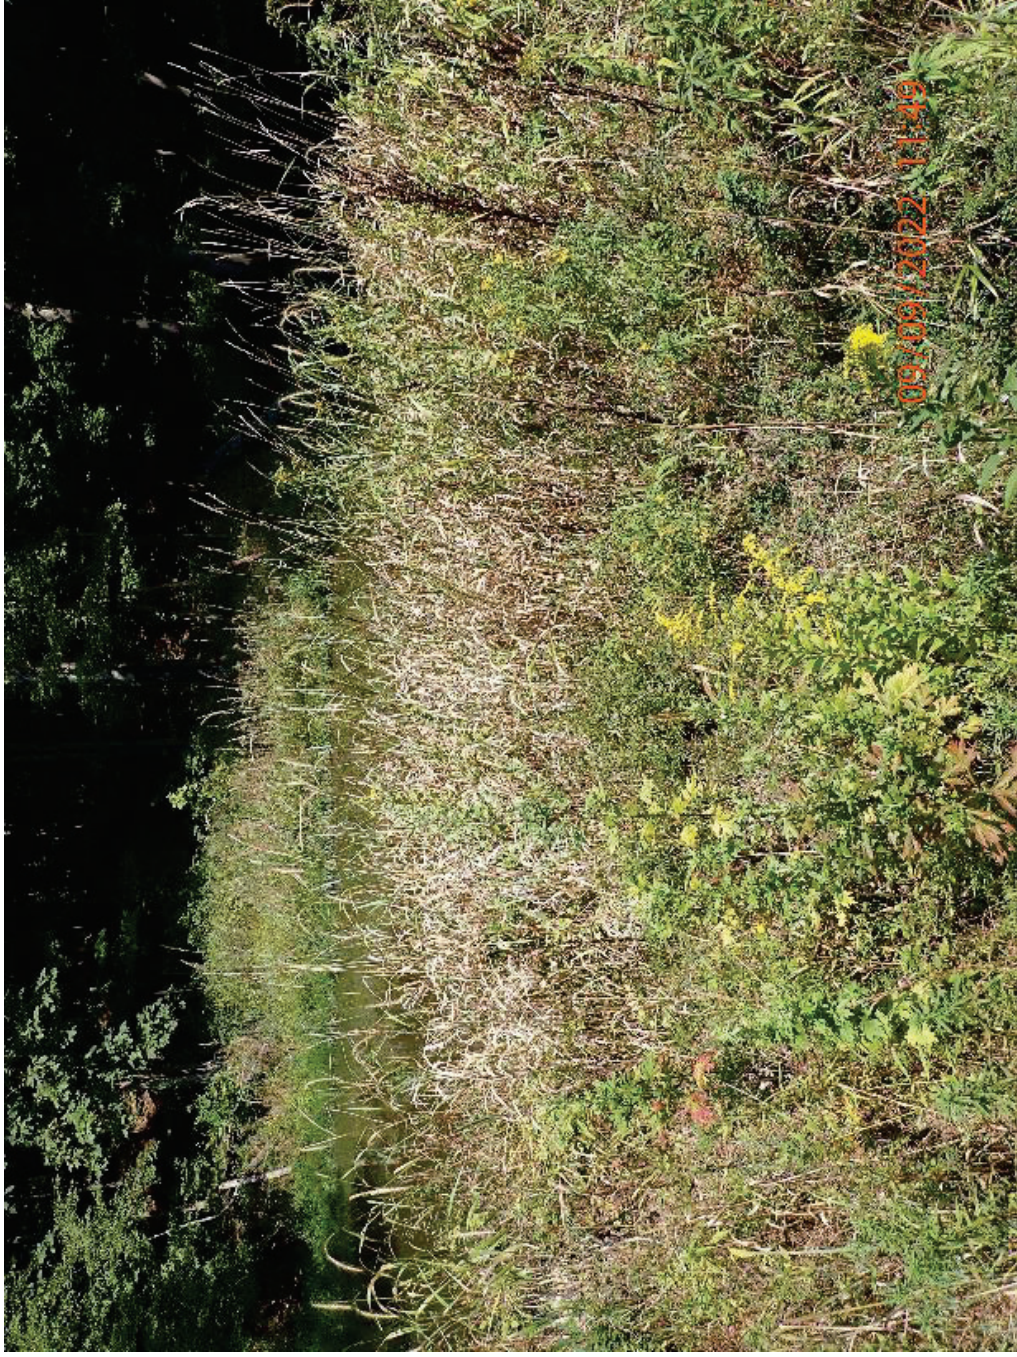
**Date:** 9/9/2022  
**Time:** 11:49 AM  
**Photographer:** SSA  
**Photo ID:** 13 – P9090476

Riparian vegetation. Dwaar Kill  
River in the background.

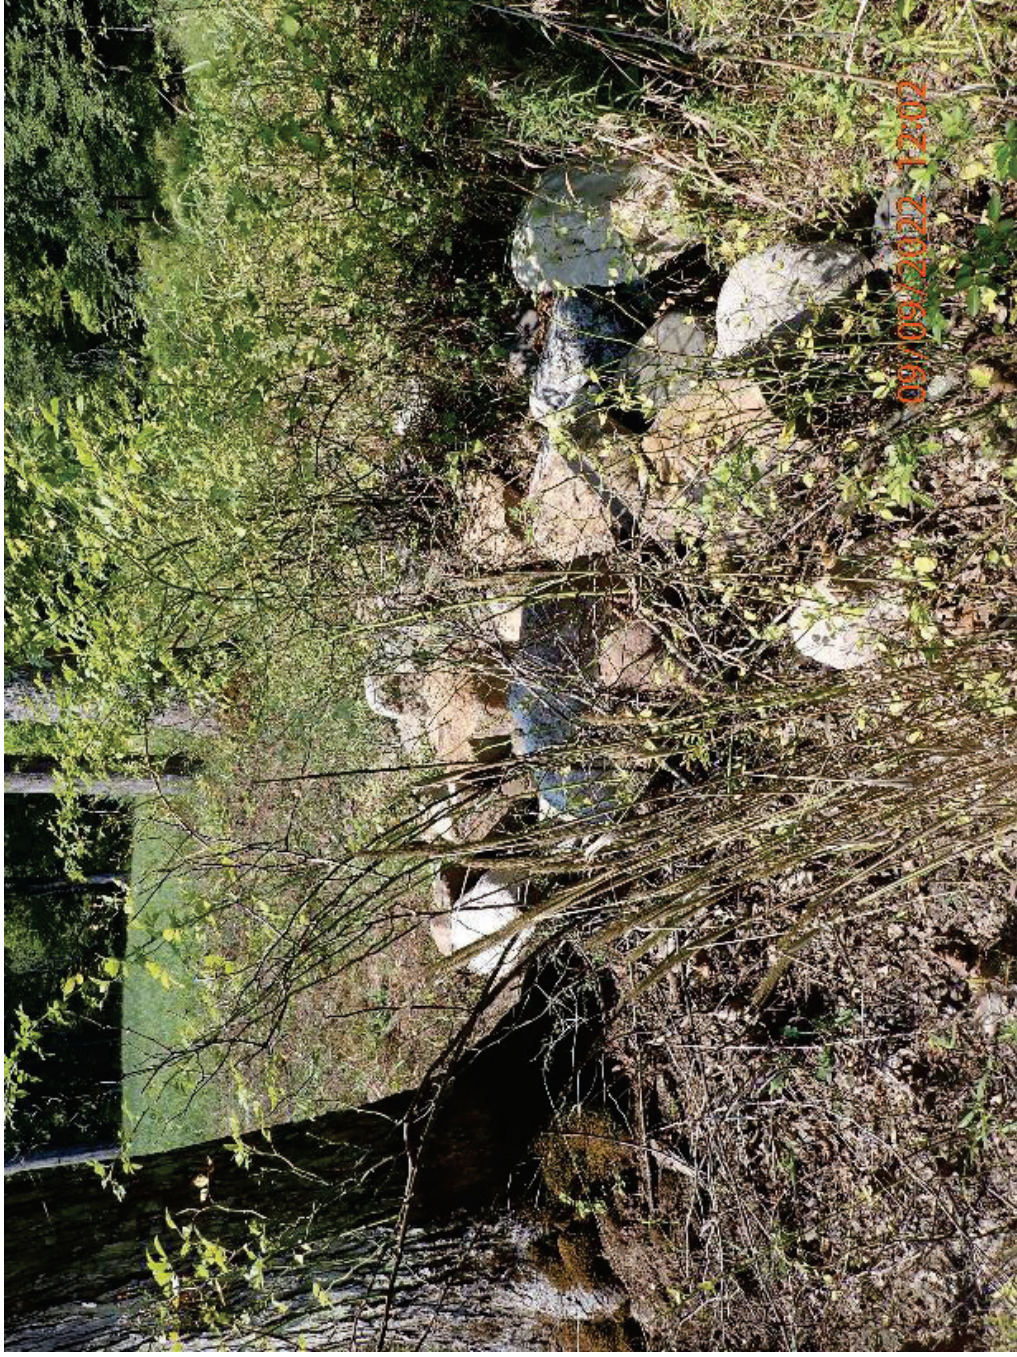
**Date:** 9/9/2022  
**Time:** 12:02 PM  
**Photographer:** SSA  
**Photo ID:** 14 – P9090477

Low spot along Dwaar Kill filled with boulder.

GPS point taken

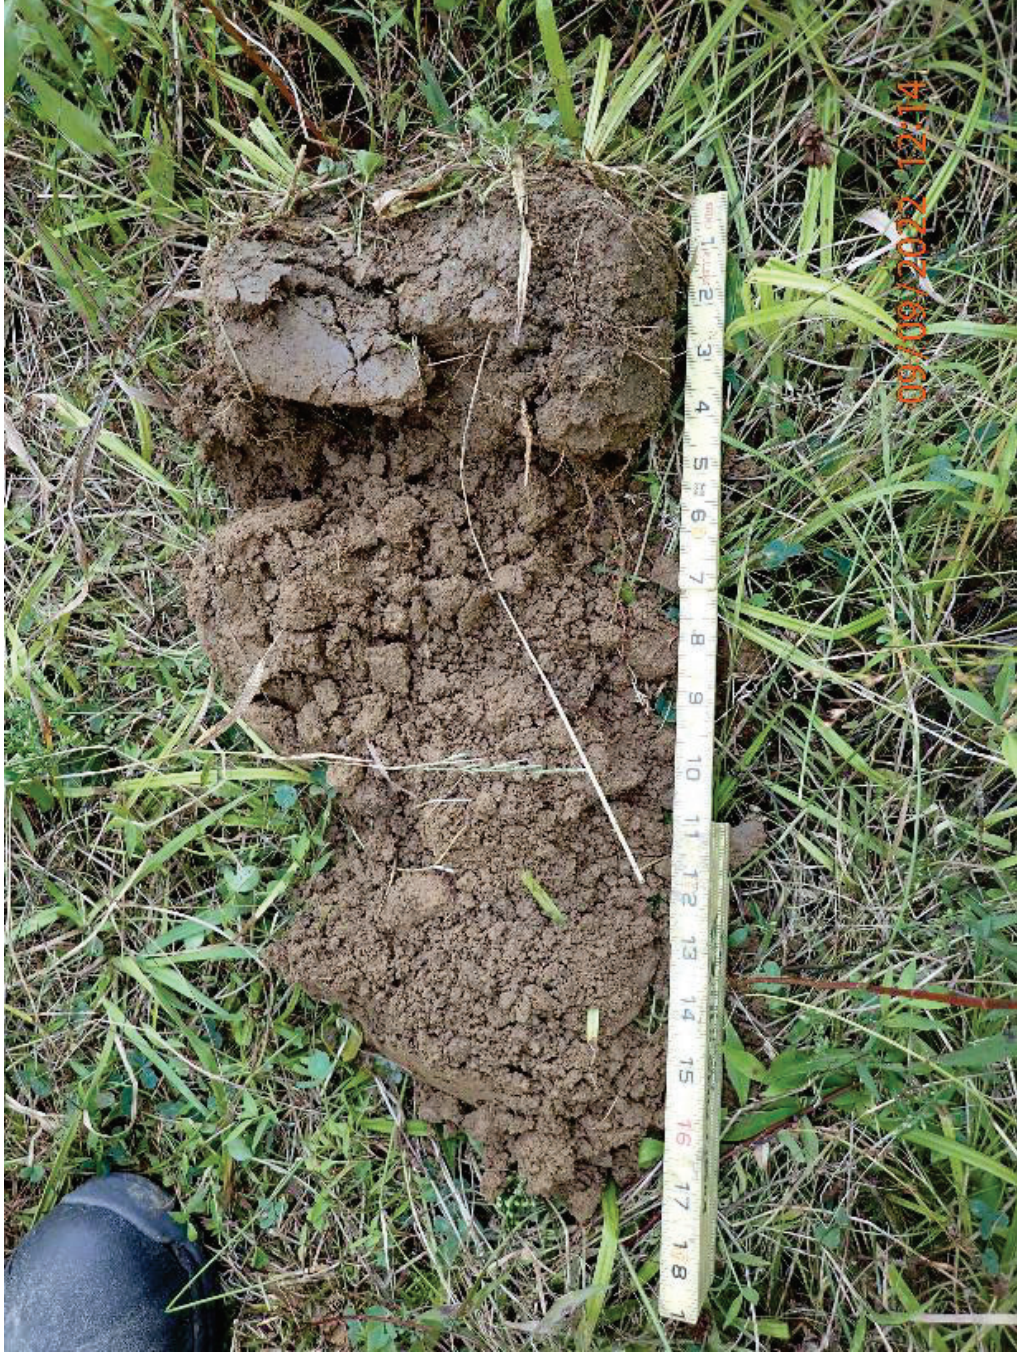
**Date:** 9/9/2022  
**Time:** 12:14 PM  
**Photographer:** SSA  
**Photo ID:** 15 – P9090478

**Description:**  
SS2 soil profile

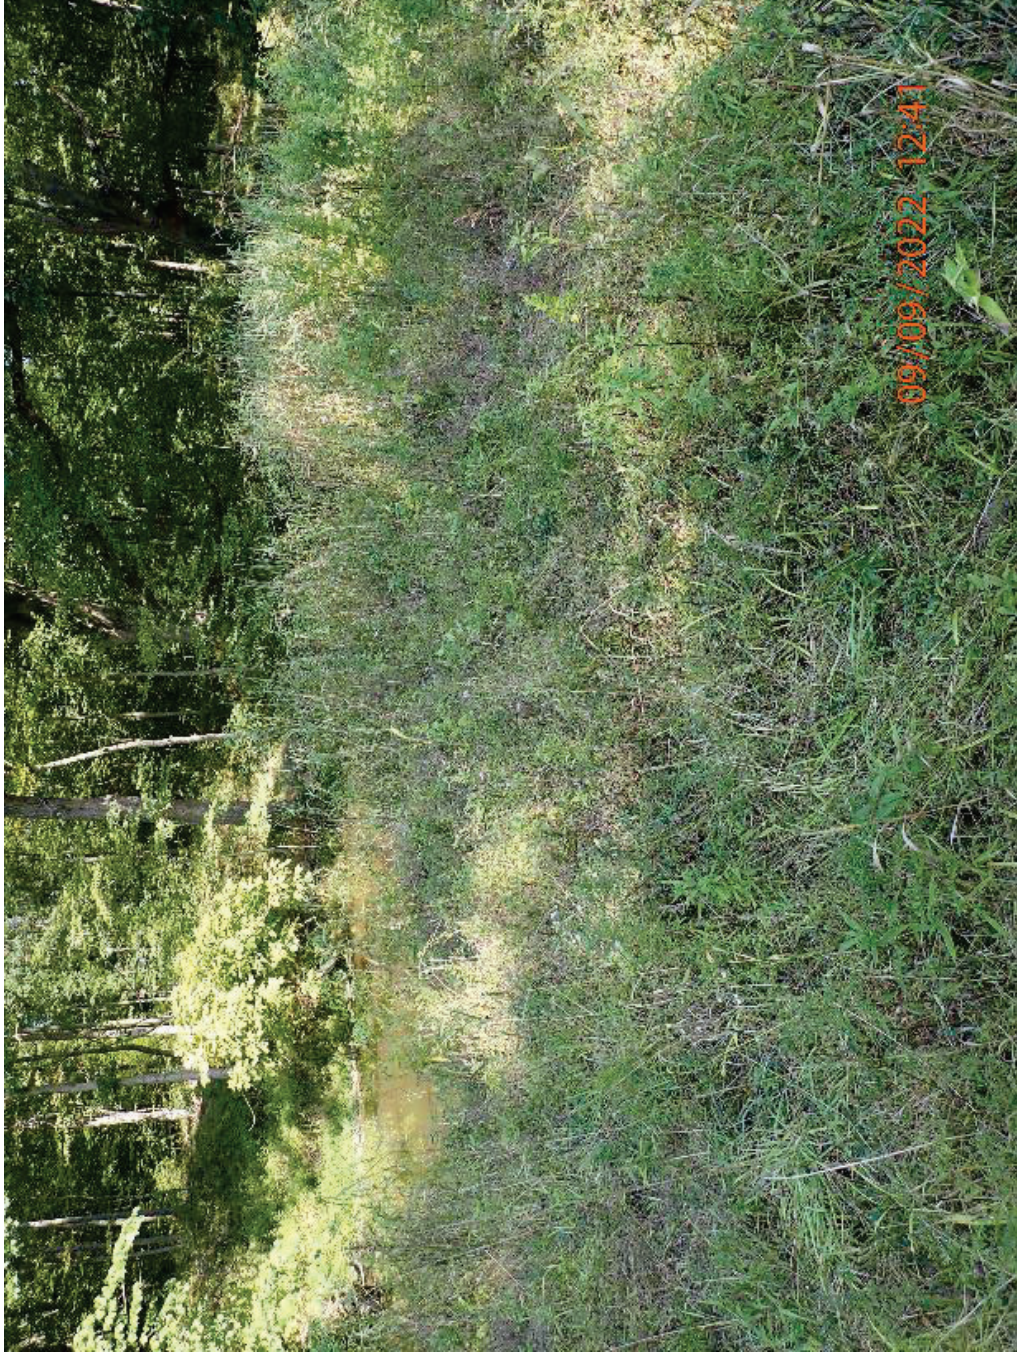
**Date:** 9/9/2022  
**Time:** 12:41 PM  
**Photographer:** SSA  
**Photo ID:** 16 – P9090479

**Description:**  
Vicinity of SS2

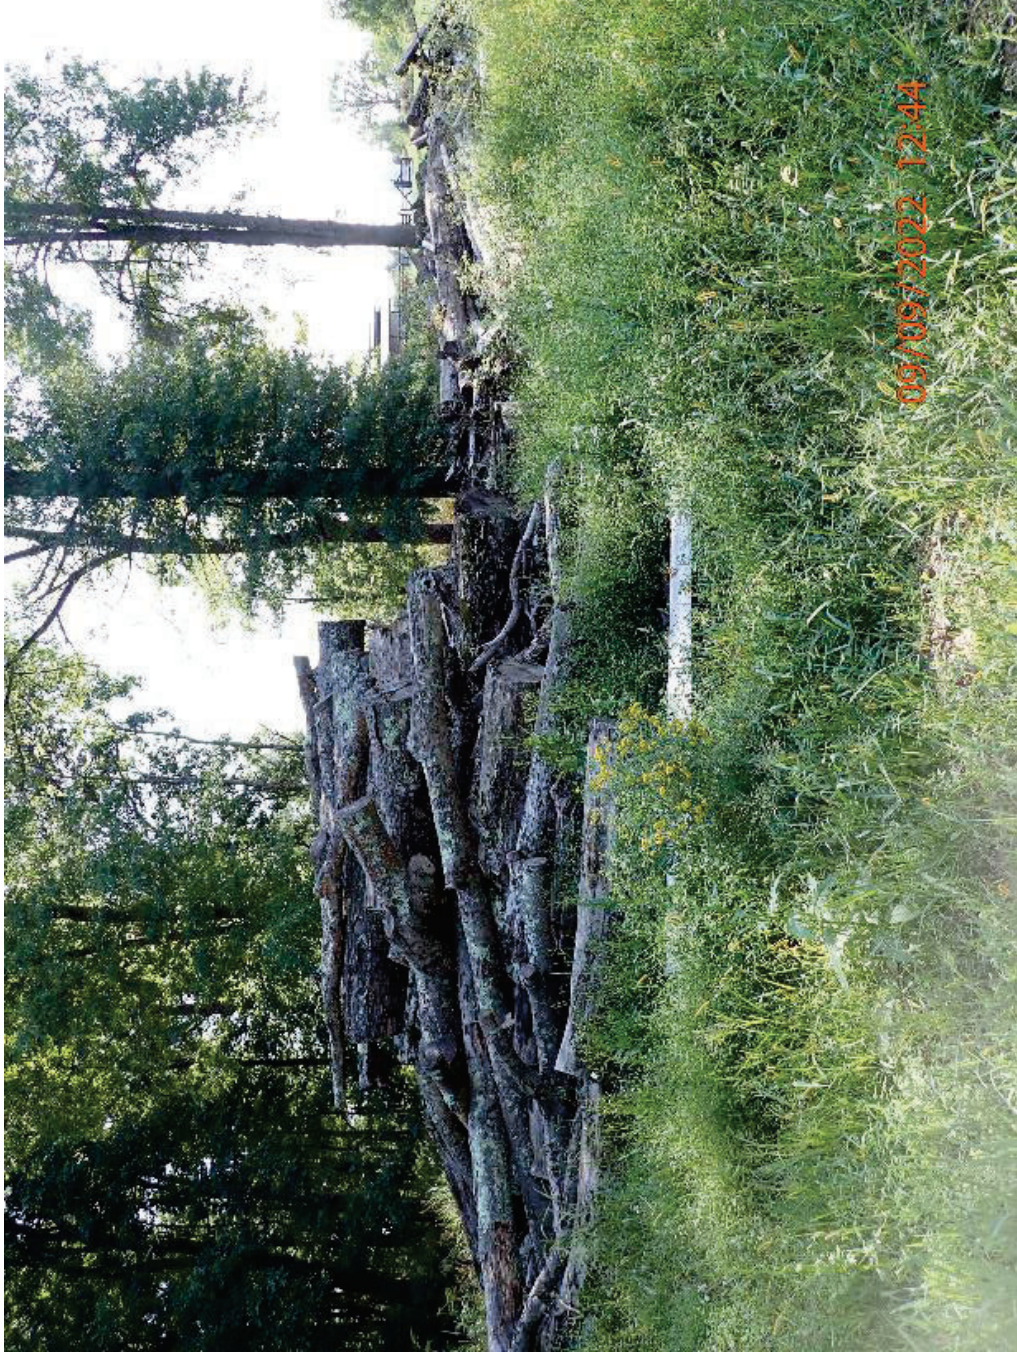
**Date:** 9/9/2022  
**Time:** 12:44 PM  
**Photographer:** SSA  
**Photo ID:** 18 – P9090481

**Description:**  
Log stockpile  
Eastern side of northwestern  
hayfield

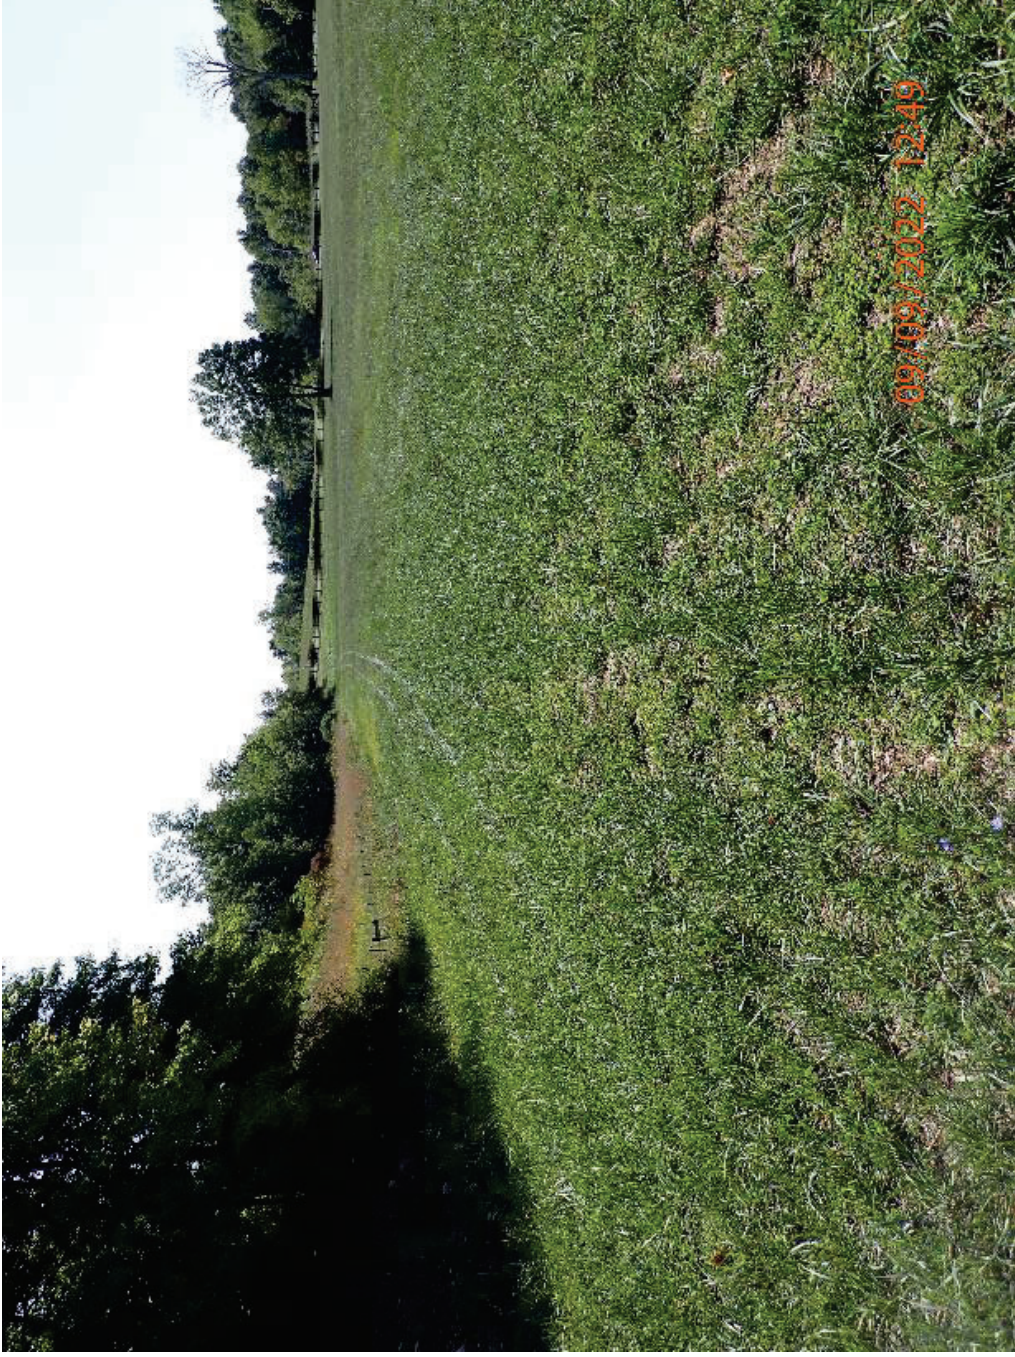
**Date:** 9/9/2022  
**Time:** 12:49 PM  
**Photographer:** SSA  
**Photo ID:** 19 – P9090482

**Description:**  
(1/3) Panorama of  
southwestern hayfield, eastern  
side
