## Clean Water Act Section 404: Site Visit/Case Development

| Site Name | SVG Holdings Property | | | | |
| Site Address* | 260 Bruyn Turnpike (106.1-1-28.111) | | | | |

CWA 404 Inspection  
SVG Holdings Property  
260 Bruyn Turnpike  
Wallkill, Ulster County, NY

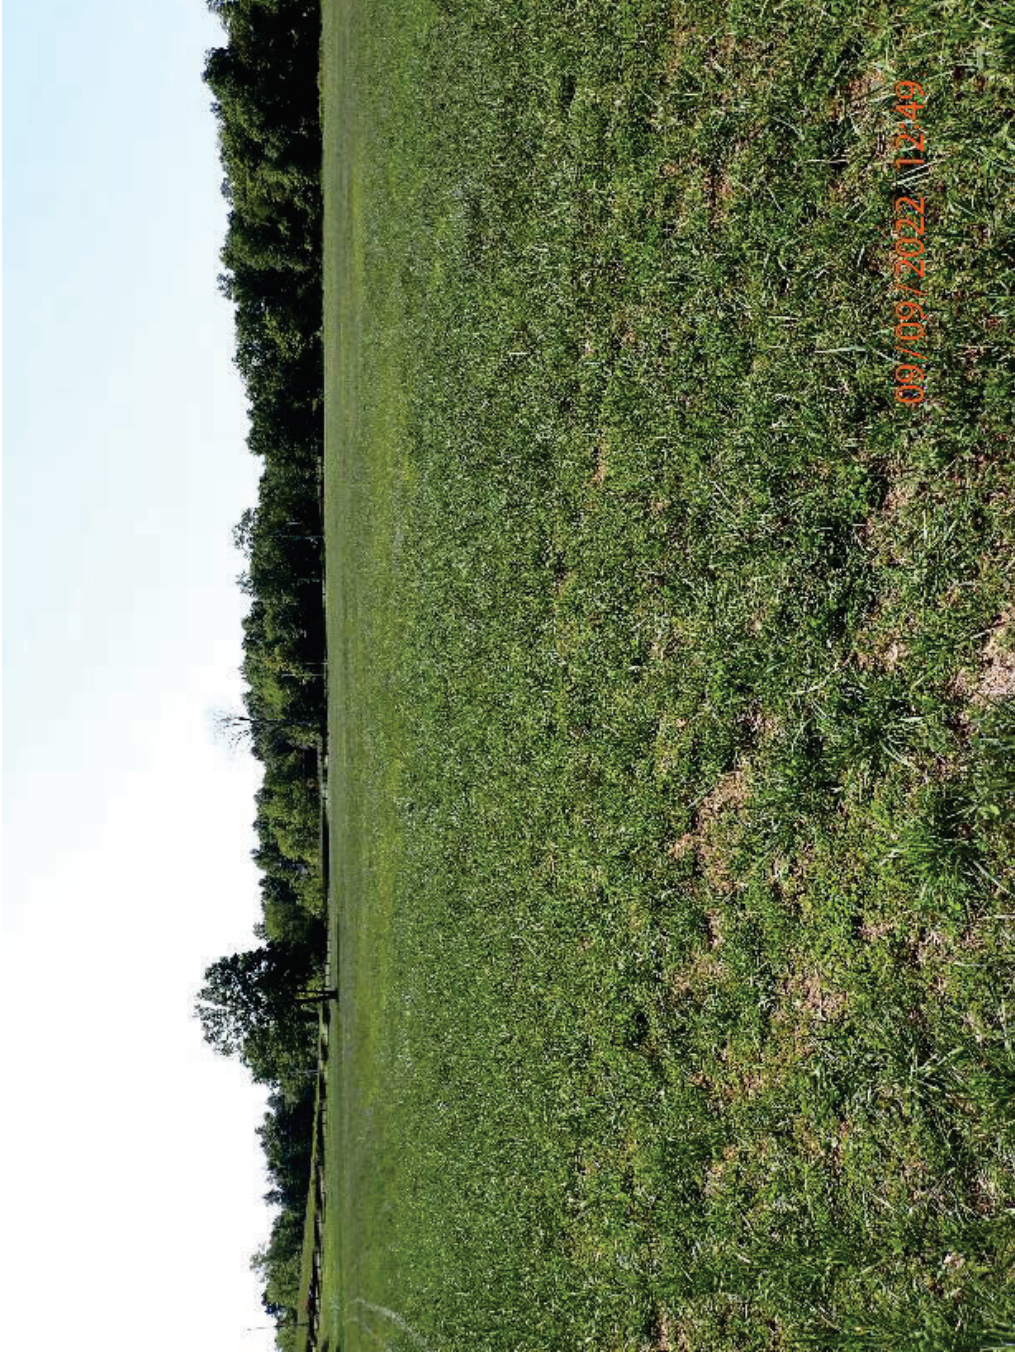
**Date:** 9/9/2022  
**Time:** 12:49 PM  
**Photographer:** SSA  
**Photo ID:** 20 – P9090483

**Description:**  
(2/3) Panorama of  
southwestern hayfield

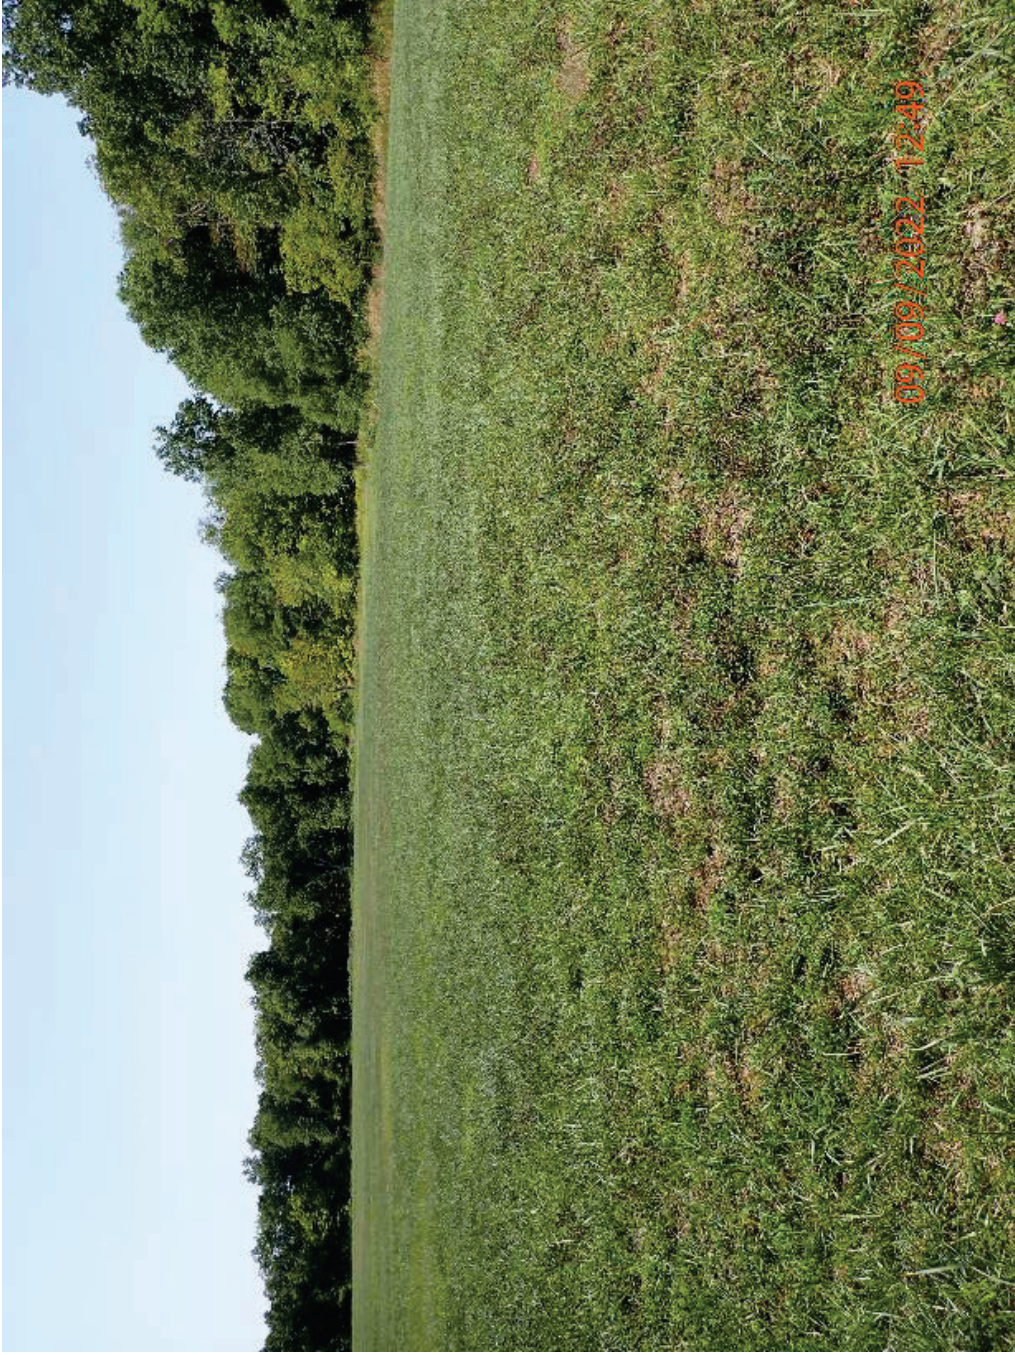
**Date:** 9/9/2022  
**Time:** 12:49 PM  
**Photographer:** SSA  
**Photo ID:** 21 – P9090484

**Description:**  
(3/3) Panorama of  
southwestern hayfield

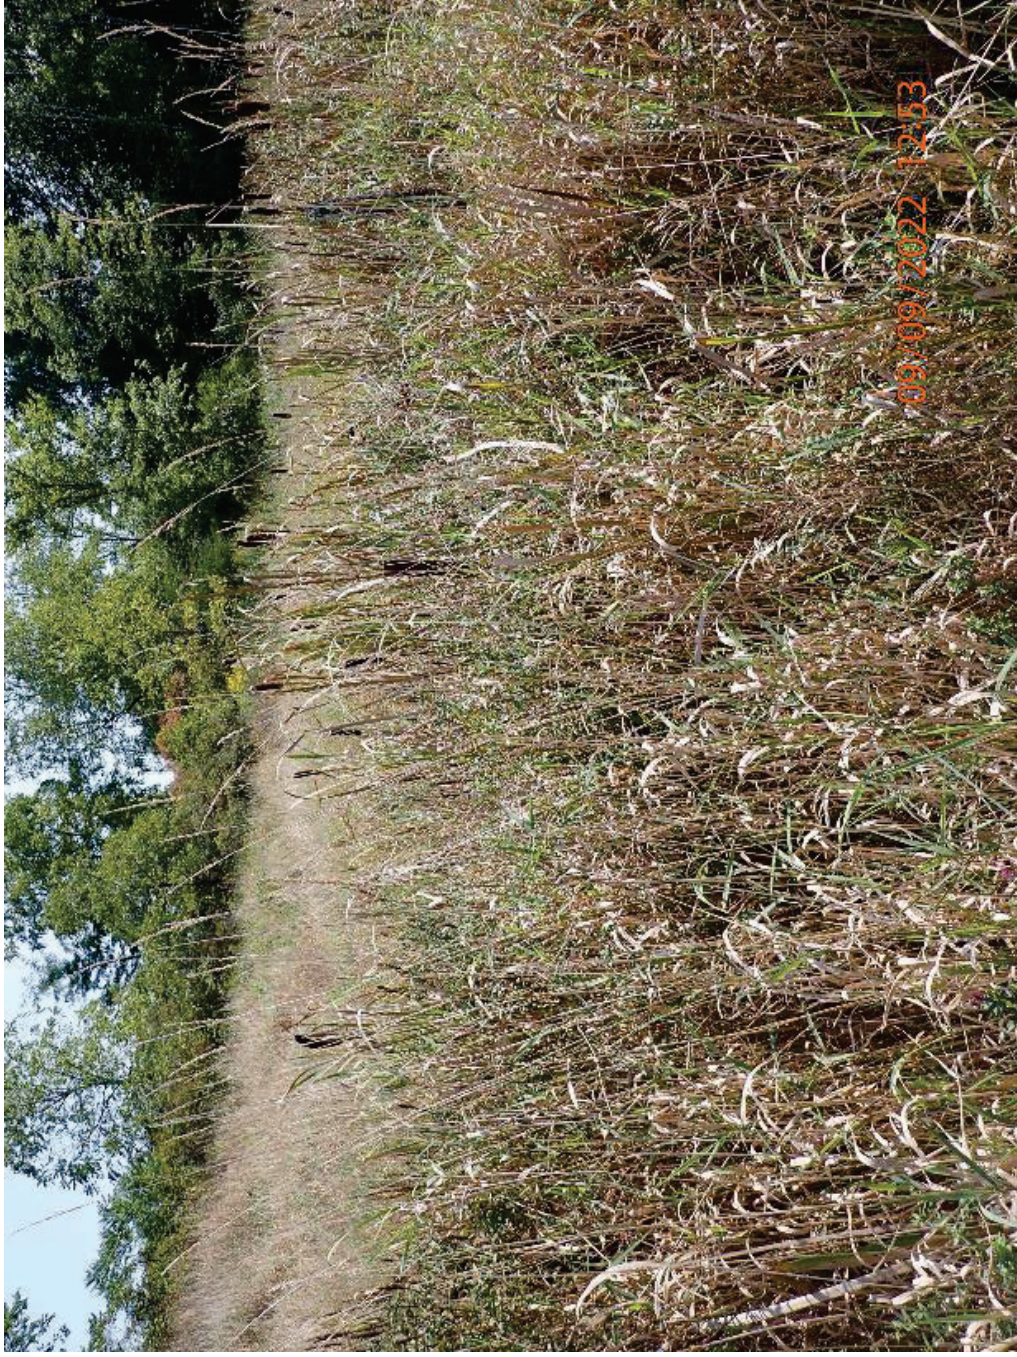
**Date:** 9/9/2022  
**Time:** 12:53 PM  
**Photographer:** SSA  
**Photo ID:** 22 – P9090485

Presumed wetland area on  
neighboring property  
Adjacent to southwestern hay  
field

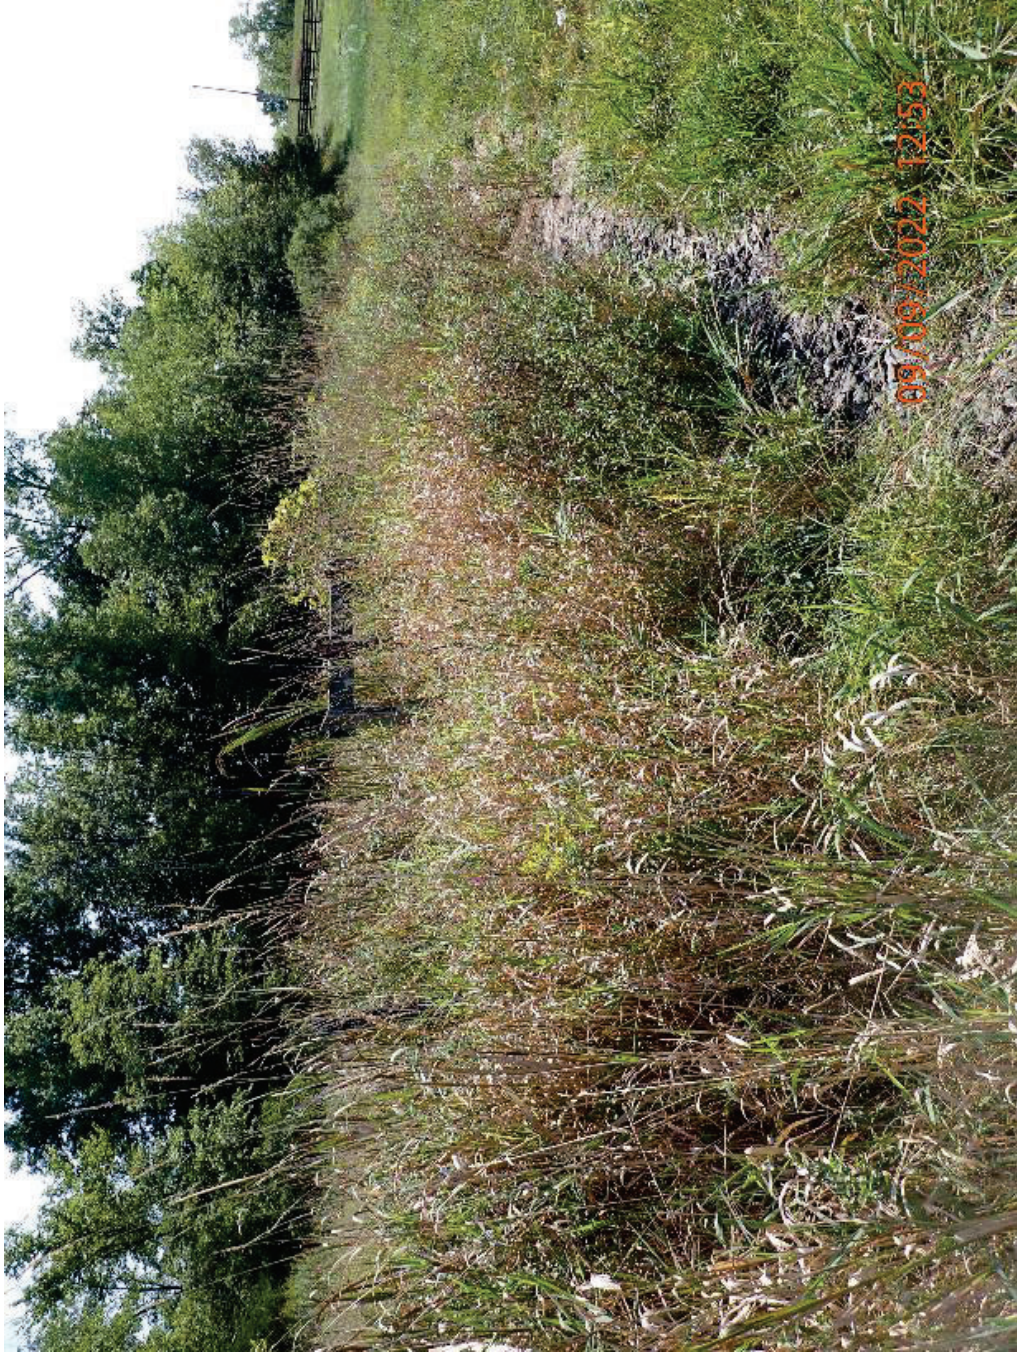
**Date:** 9/9/2022  
**Time:** 12:53 PM  
**Photographer:** SSA  
**Photo ID:** 23 – P9090486

Presumed wetland area on neighboring property; drain; hydrophytic vegetation  
Adjacent to southwestern hay field

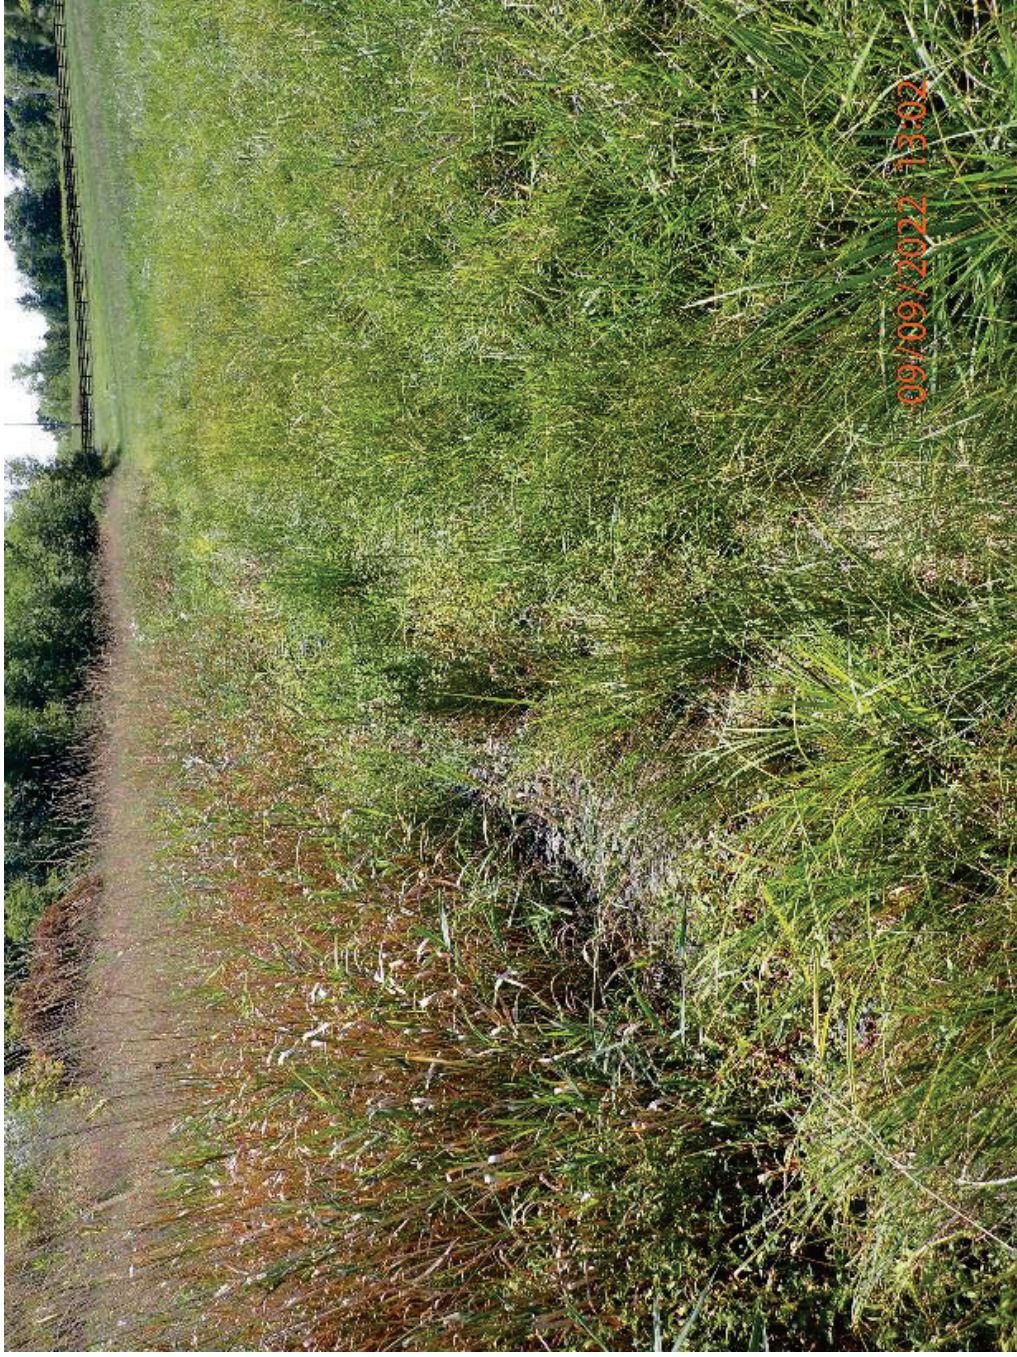
**Date:** 9/9/2022  
**Time:** 1:02 PM  
**Photographer:** SSA  
**Photo ID:** 24 – P9090487

Wetland vegetation growing in  
low spot in field  
GPS Point taken
