## Region 6 Compliance Assurance and Enforcement Division

### INSPECTION REPORT

| Company Name: | <b>Seven Cross Operating, LLC</b> | | |
| Facility Name: | <b>Novice Unit – Unknown Lease</b> | | |

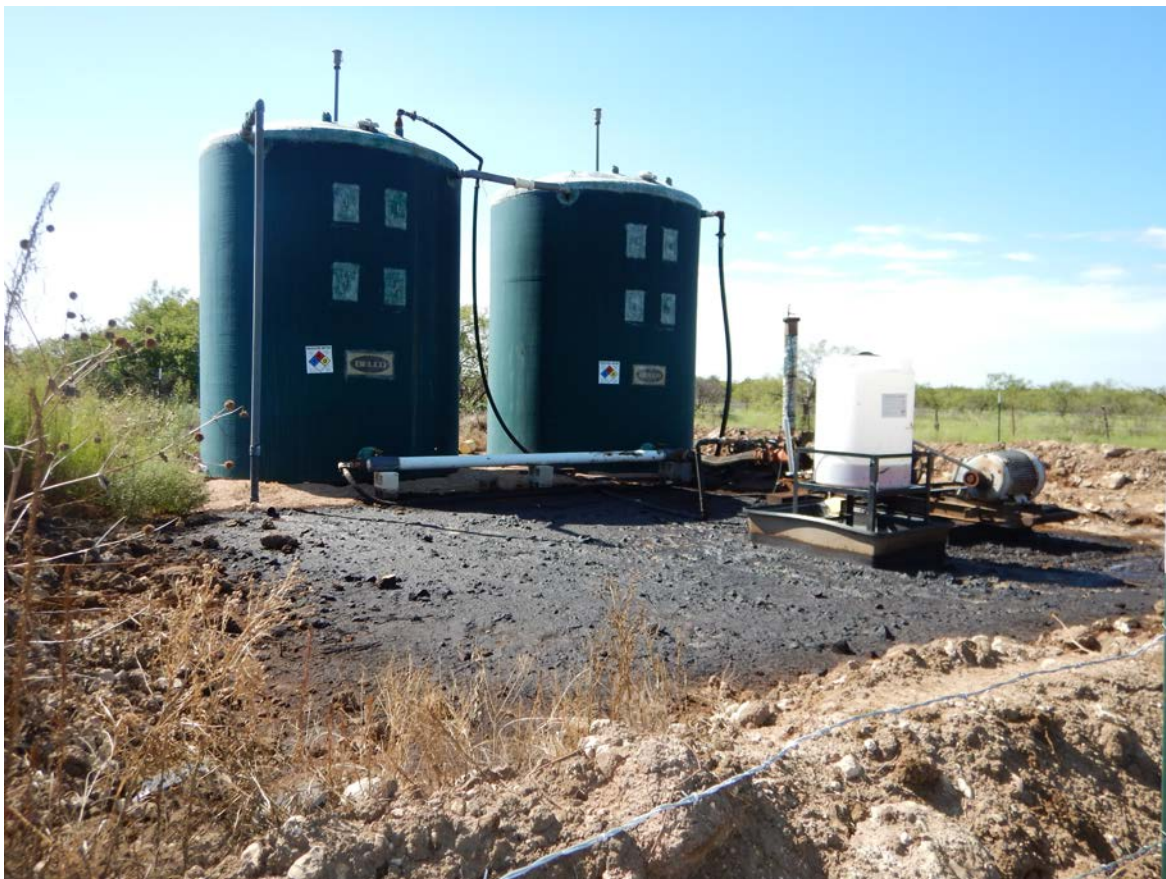
Photograph File Name: DSCN0891.JPG

Description: This image shows the Novice Unit – Unknown Lease that has two produced water storage tanks. We observed a large amount of oil and oil staining on the ground in the containment area. We saw that there was a chemical storage tank also being utilized at the facility. We observed active transfer pumps as well. There was an overflow pipe on the southern storage tank that had fluids pooled at the bottom of it. The secondary containment area was inadequate due to excessive vegetation, oil in the containment area, eroded and uncompact berm walls, and seepage occurring through the containment area north towards the tributary of the South Fork of the Jim Ned Creek.

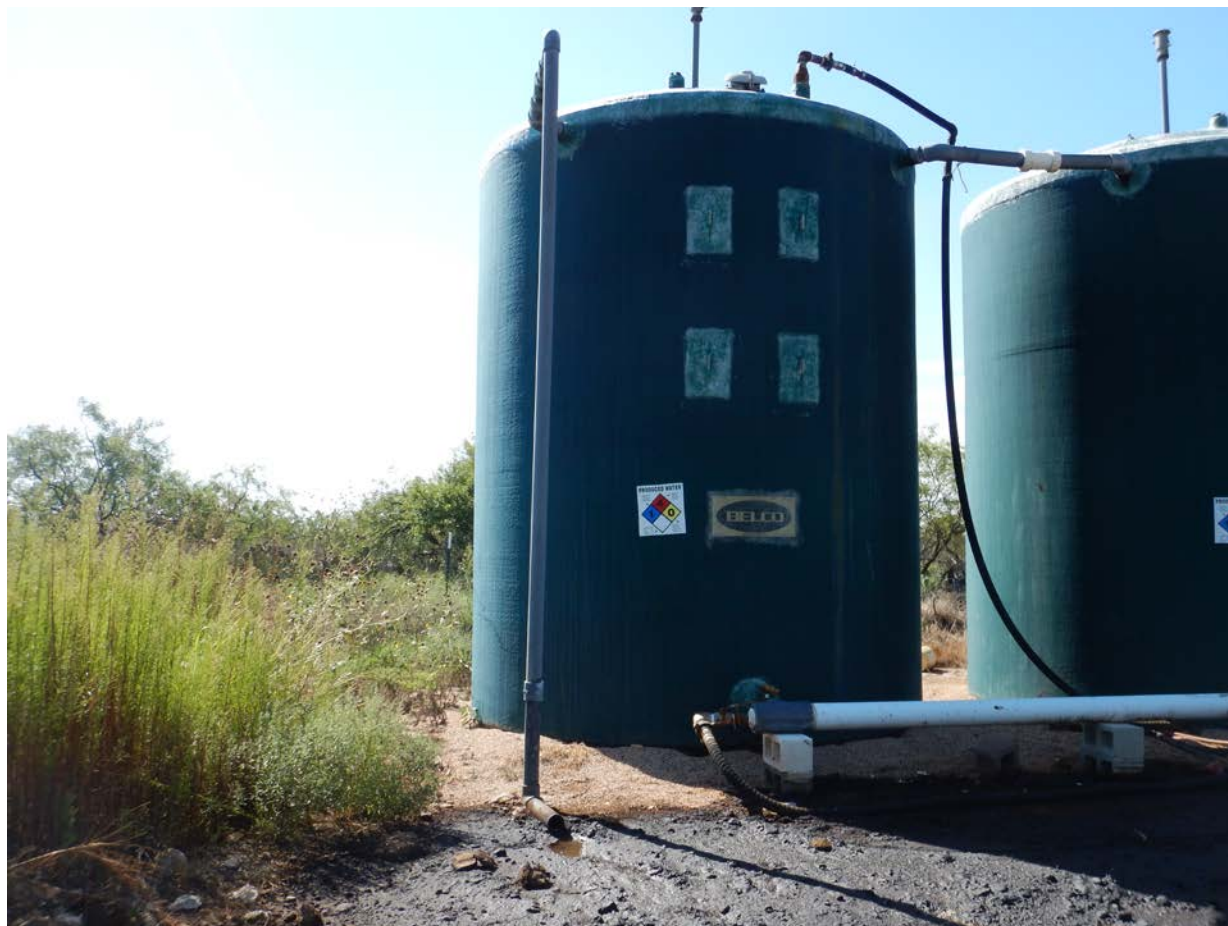
Photograph File Name: DSCN0892.JPG

Description: This image shows the produced water storage tanks at the Novice Unit – Unknown Lease, including the overflow pipe from one of the storage tanks that we observed. There was oil and oil staining that was significant at the time of the inspection. We observed fluids at the end of the overflow pipe. There was excessive vegetation on the southwestern sides of the containment area at the time of the inspection. We observed a leak at the bottom of the pipe at the time of the inspection.

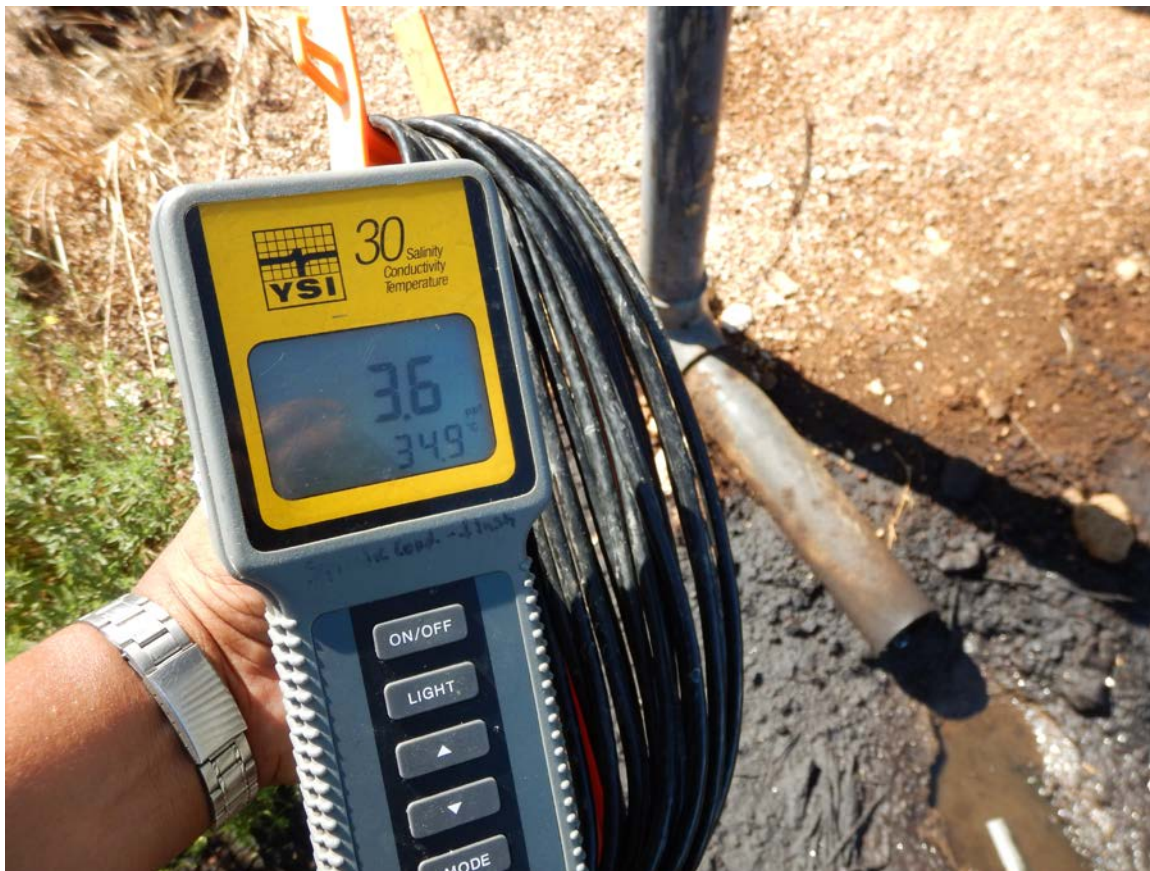
Photograph File Name: DSCN0893.JPG

Description: This image shows a Total Soluble Salts (TSS) reading of 3,600 parts-per-million (ppm) taken from the fluids at the end of the overflow pipe. We observed oil staining and oil in the containment area.

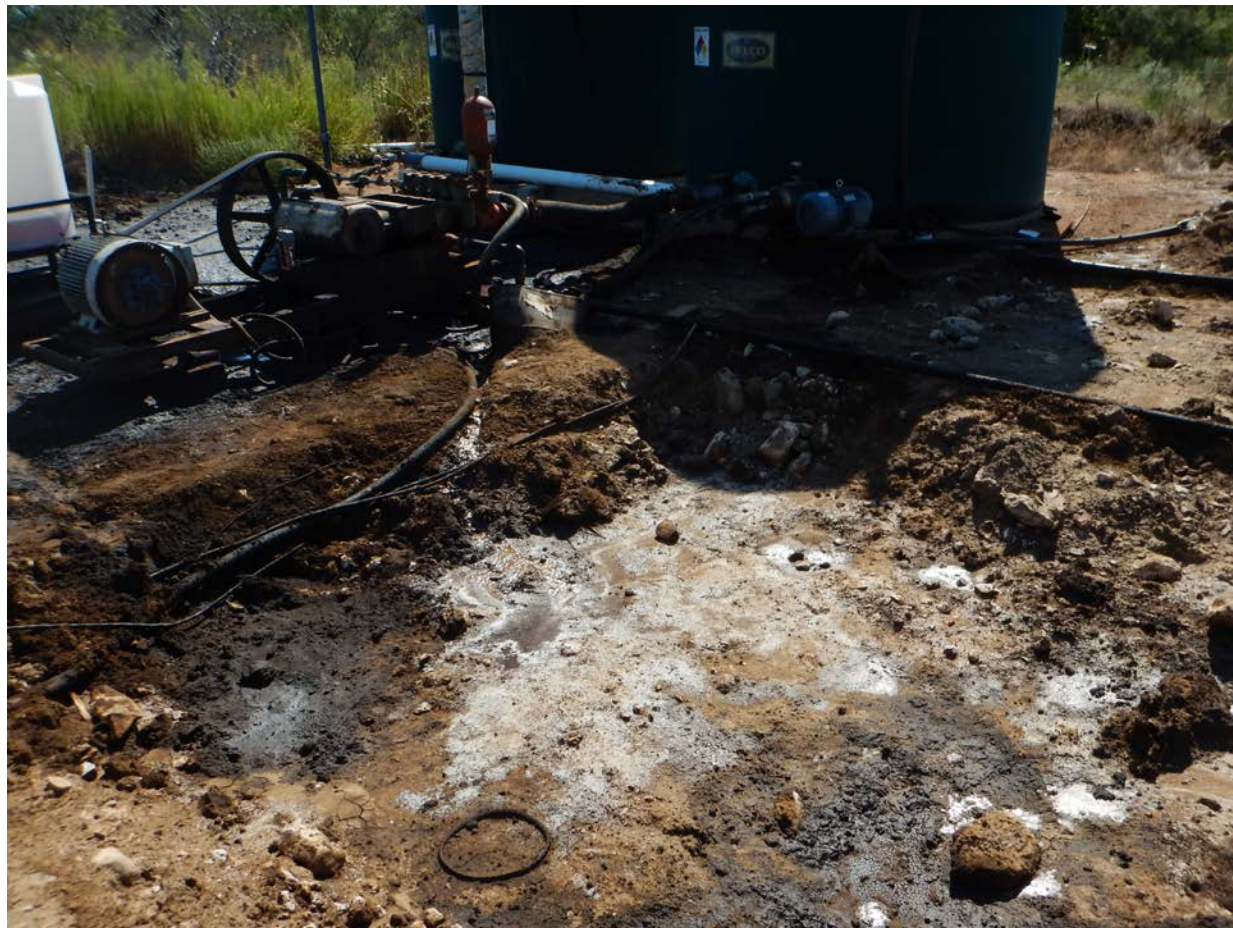
Photograph File Name: DSCN0894.JPG

Description: This image shows the containment area at the produced water storage tanks, a pump, the storage tanks, and a chemical storage tank. We observed oil, oil staining, salt crystals, and an area in the containment area where a hole had been dug.

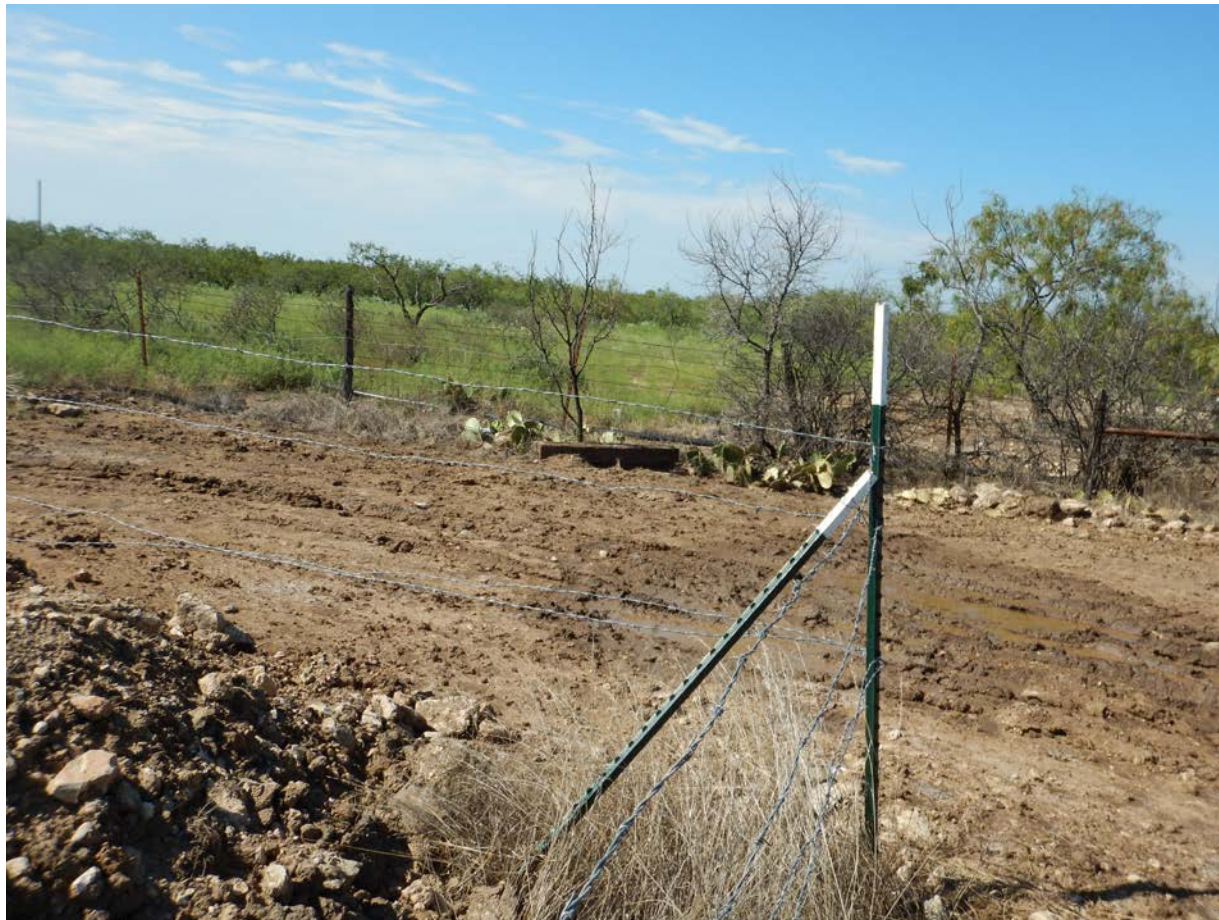
Photograph File Name: DSCN0895.JPG

Description: This image shows the north side of the tank battery, where we observed seepage from the tank battery and a dry flow path north towards the tributary of the South Fork of the Jim Ned Creek. The flow path had no visible vegetation, while visible vegetation was around the flow path at the time of the inspection.

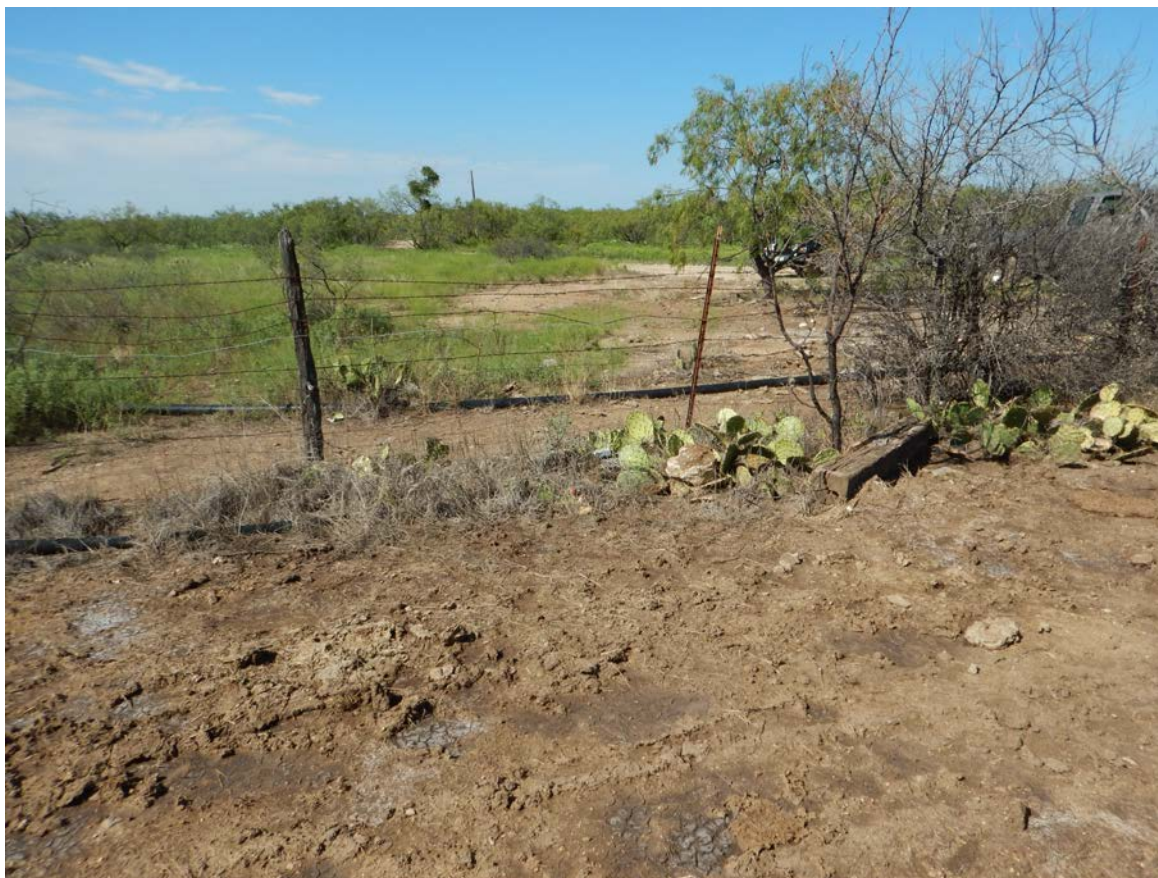
Photograph File Name: DSCN0896.JPG

Description: This image shows the north side of the tank battery, where we observed a dry flow path from the north of the facility towards the tributary of the South Fork of the Jim Ned Creek. We saw salt crystals and no vegetation along the flow path, which went north along a lease road. We observed seepage at the north berm walls of the tank battery at the time of the inspection.

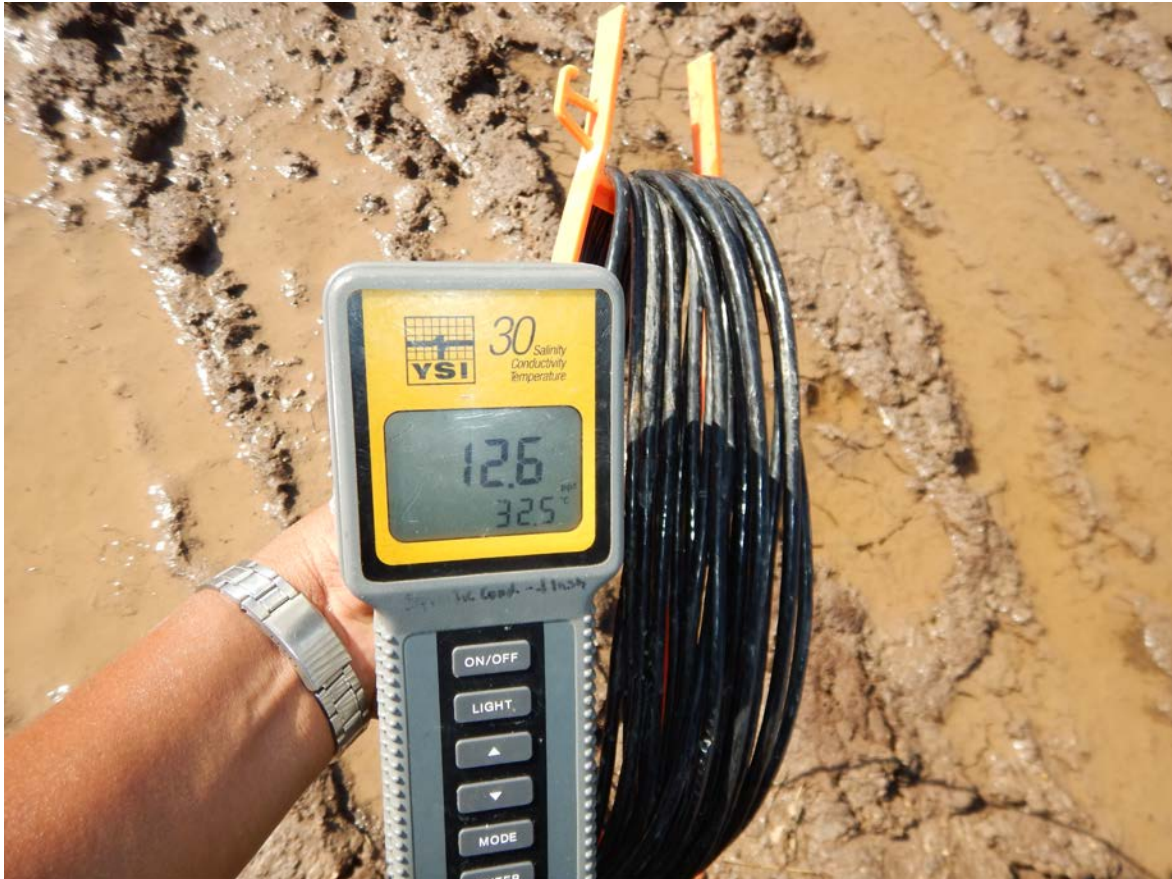
Photograph File Name: DSCN0897.JPG  
Date of Photograph: 08/23/2016  
Latitude: 31.998837 N  
Longitude: -99.642435 W  
Orientation: N  
Map Datum: WGS-84  
Time of Photo: 03:34 PM  
Photographer: Jack Arias  
Description:

This image shows the seepage on the north side of the Novice Unit – Unknown Lease tank battery. We observed the seepage outside of the containment area at the dry flow path, which we observed the flow path north towards the tributary of the South Fork of the Jim Ned Creek. A TSS reading of 12,600 ppm was taken from the fluids observed in the seepage area.

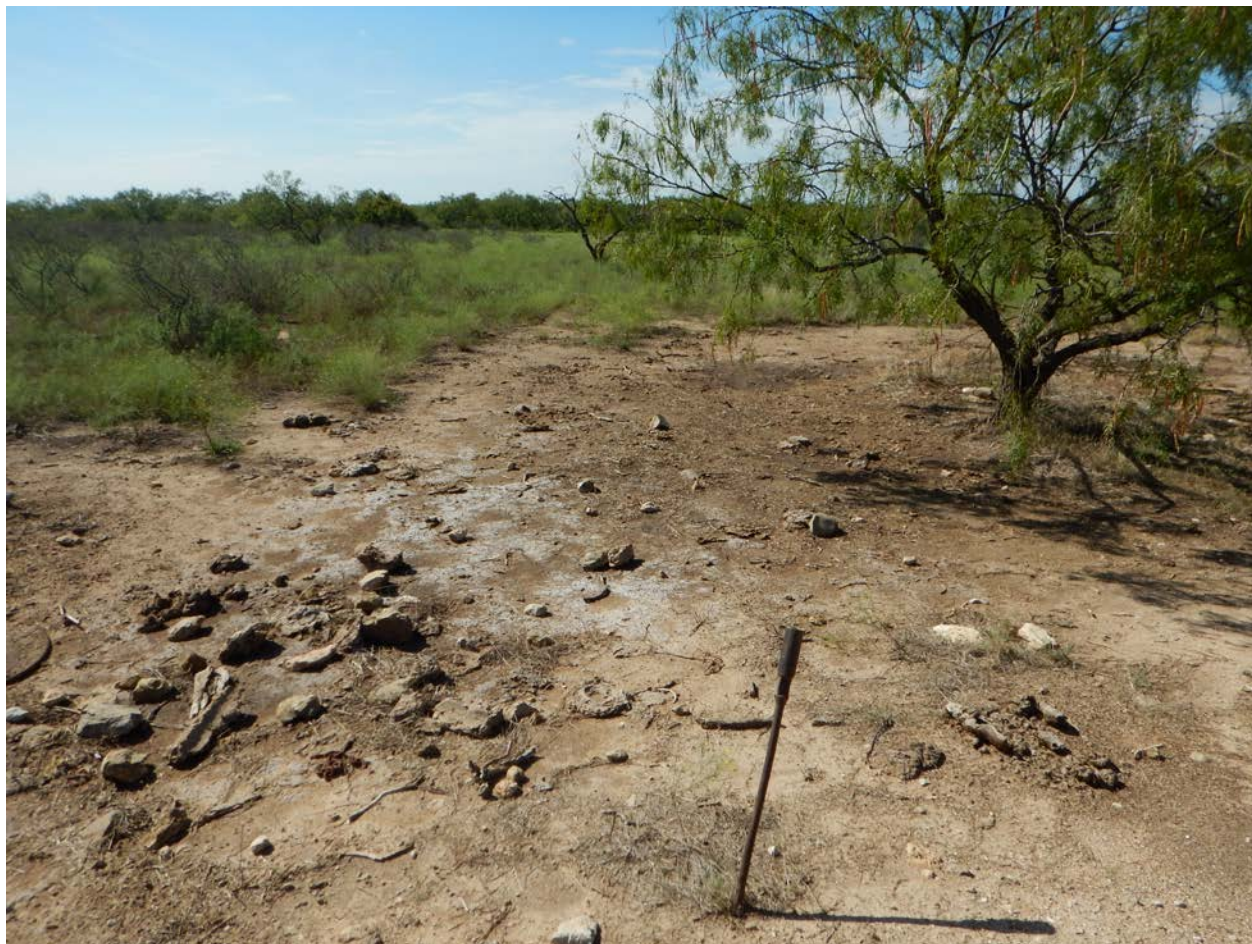
Photograph File Name: DSCN0898.JPG

Description: This image shows the flow path north of the Novice Unit – Unknown Lease tank battery. We observed dead vegetation, salt crystals, and a dry flow path towards the tributary of the South Fork of the Jim Ned Creek.

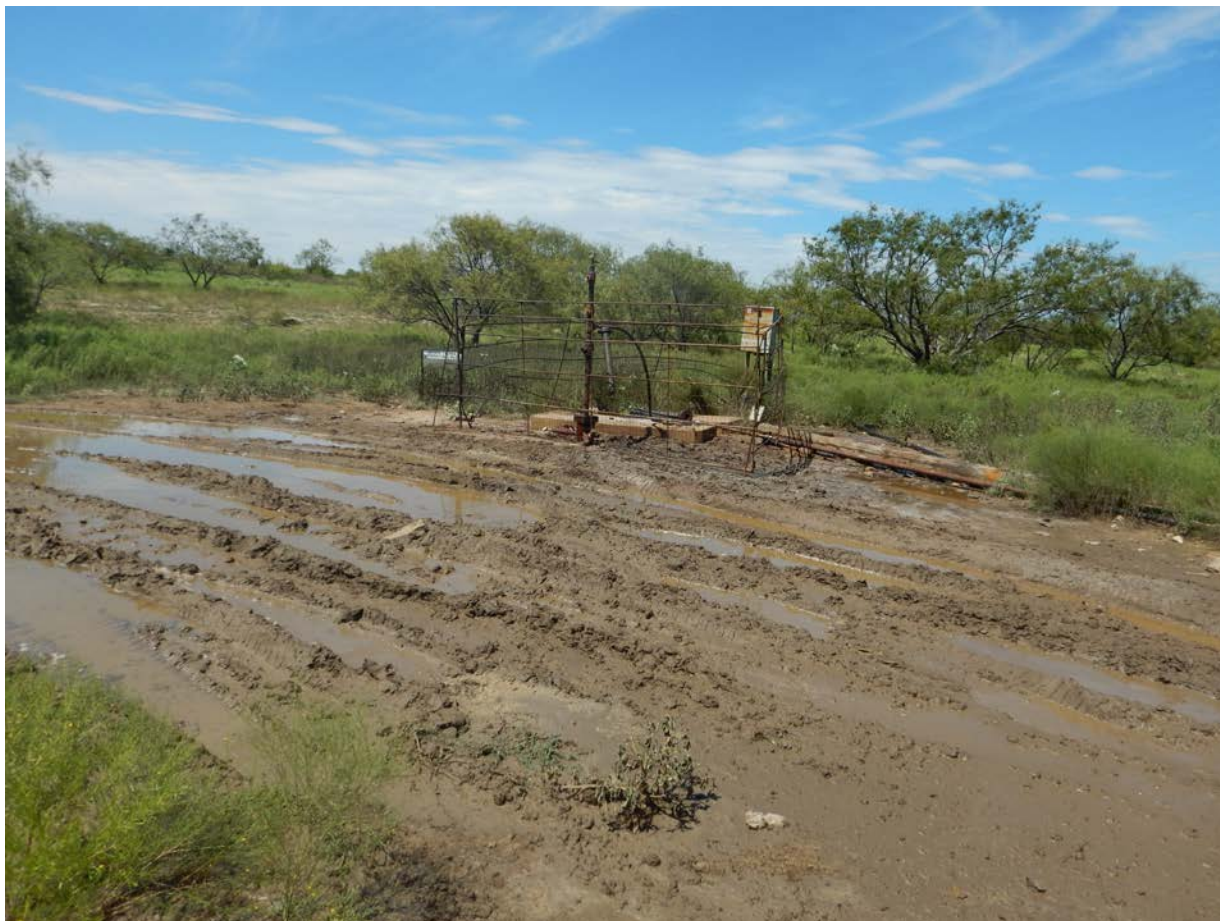
Photograph File Name: DSCN0848.JPG

Description: This image shows the Novice Unit Well No. 8025, which is associated with the Novice Unit – Unknown Lease. We observed a second discharge location downstream from the facility approximately 0.63 miles, north along the tributary of the South Fork of the Jim Ned Creek. We observed an active injection well at this site that was leaking and had ponded fluids around the well head. We saw salt crystals as well at the injection well area.

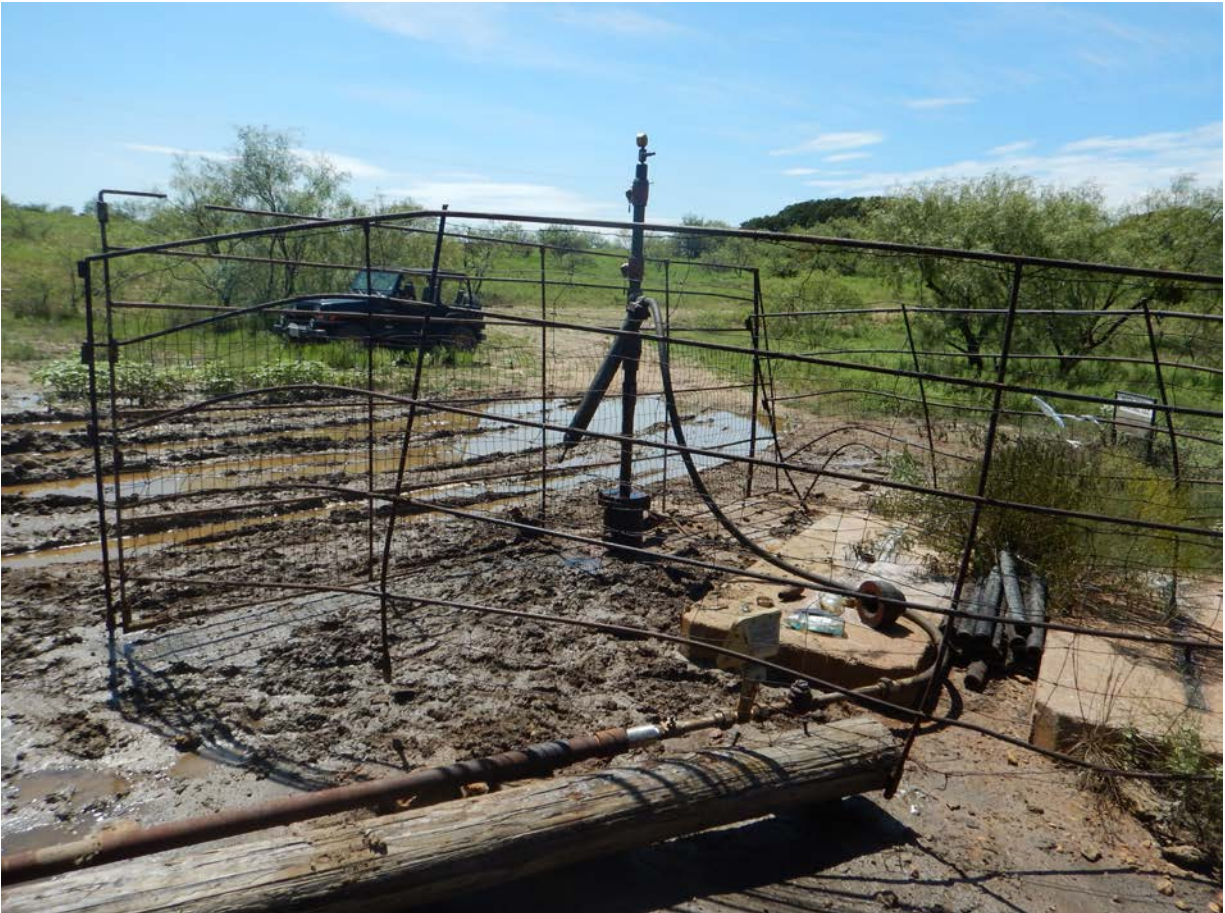
Photograph File Name: DSCN0847.JPG  
Date of Photograph: 08/23/2016  
Latitude: 32.007540 N  
Longitude: -99.642293 W  
Orientation: S  
Map Datum: WGS-84  
Time of Photo: 01:44 PM  
Photographer: Jeanne Eckhart  
Description:

This image shows the Novice Unit Well No. 8025, which is associated with the Novice Unit – Unknown Lease. At the time of the inspection, we observed visible fluids near the injection well and the injection well leaking near the tubing head. The pressure on the injection well gauge read approximately 800 psi and there was visible salt crystals near the well head.

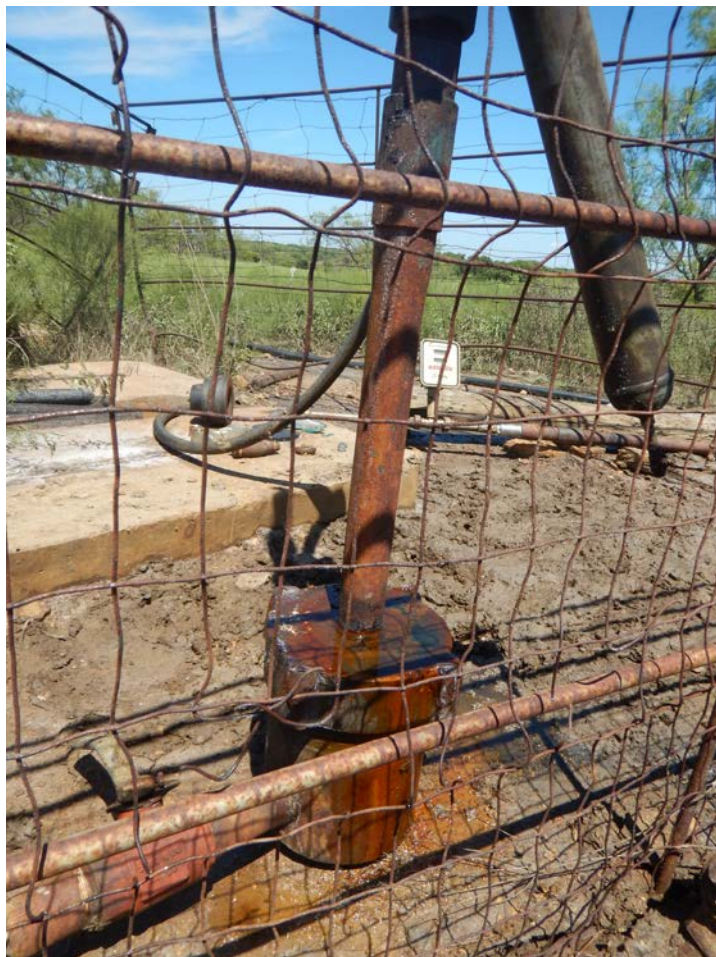
Photograph File Name: DSCN0849.JPG  
Date of Photograph: 08/23/2016  
Latitude: 32.007540 N  
Longitude: -99.642293 W  
Orientation: NE  
Map Datum: WGS-84  
Time of Photo: 01:50 PM  
Photographer: Jeanne Eckhart  
Description:

This image shows the Novice Unit Well No. 8025, which is associated with the Novice Unit – Unknown Lease. We observed the injection well was leaking at the well head, near the tubing casing, at the time of the inspection.

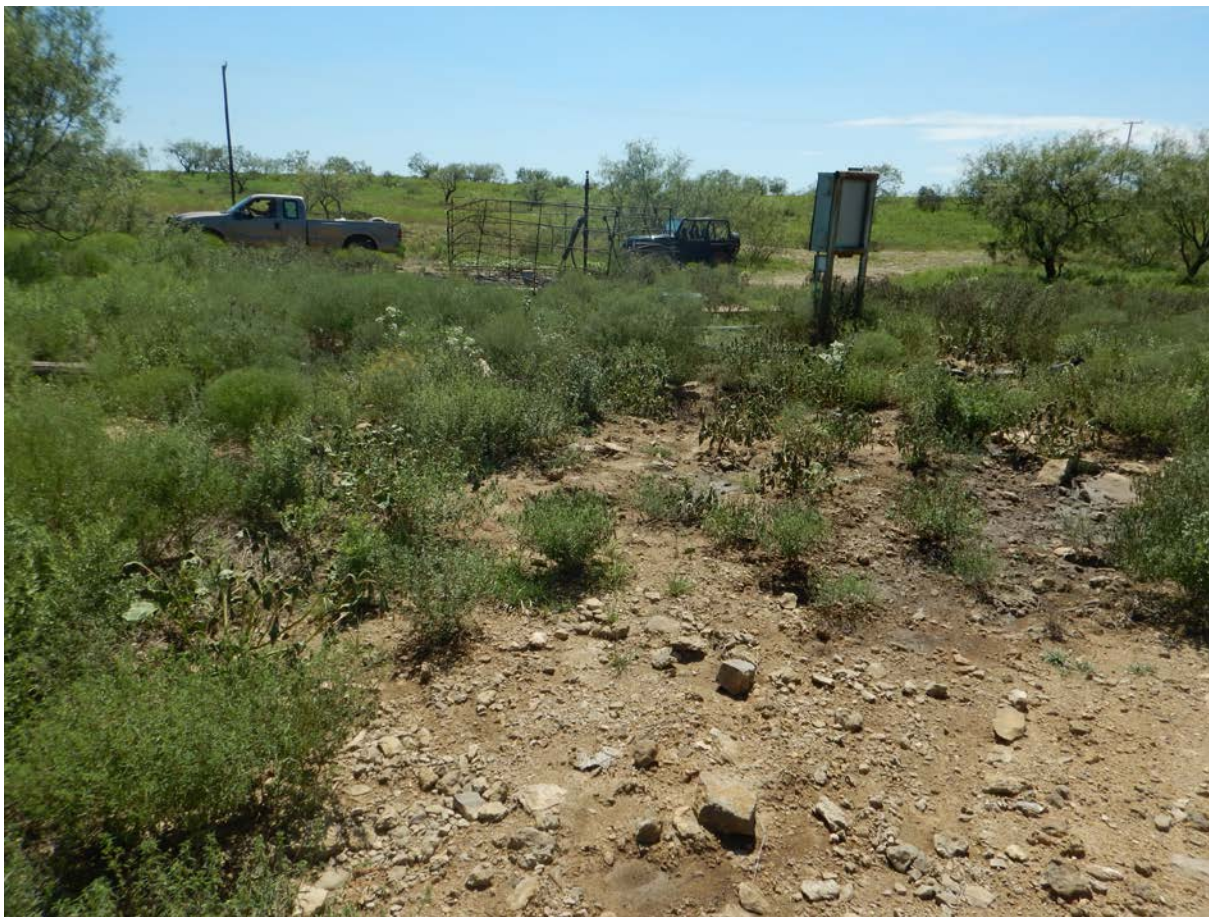
Photograph File Name: DSCN0851.JPG

Description: This image shows the Novice Unit Well No. 8025, which is associated with the Novice Unit – Unknown Lease. At the time of the inspection, we observed a dry flow path east of the leaking well area and pooled fluids towards the tributary of the South Fork of the Jim Ned Creek. We observed along the dry flow path that there was no vegetation and some erosion.

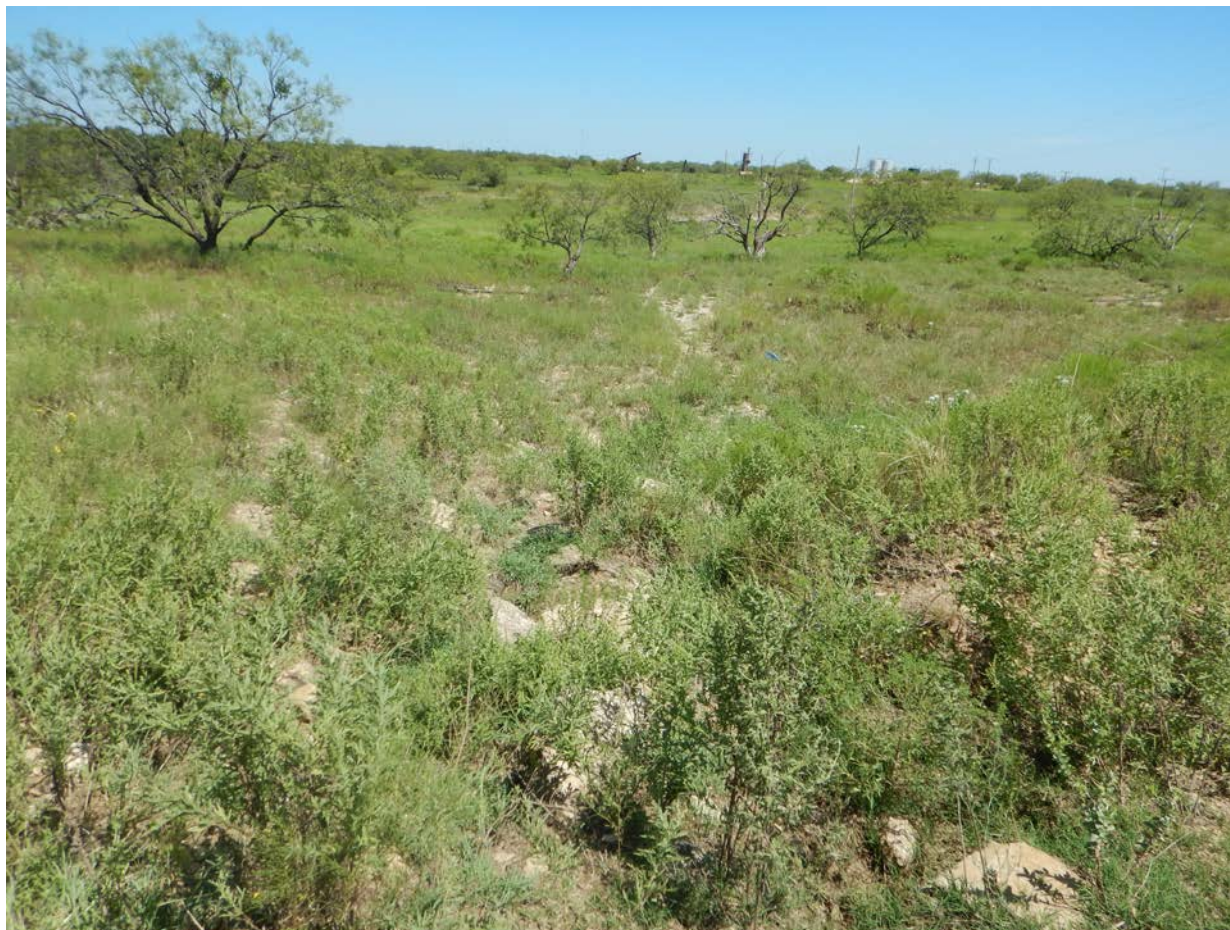
Photograph File Name: DSCN0852.JPG

Description: This image shows the Novice Unit Well No. 8025, which is associated with the Novice Unit – Unknown Lease. At the time of the inspection, we observed a dry flow path east of the injection well that was leaking and had pooled fluids near it at the time of the inspection. We saw visible erosion and no vegetation along the flow path east of the injection well towards the tributary of the South Fork of the Jim Ned Creek.

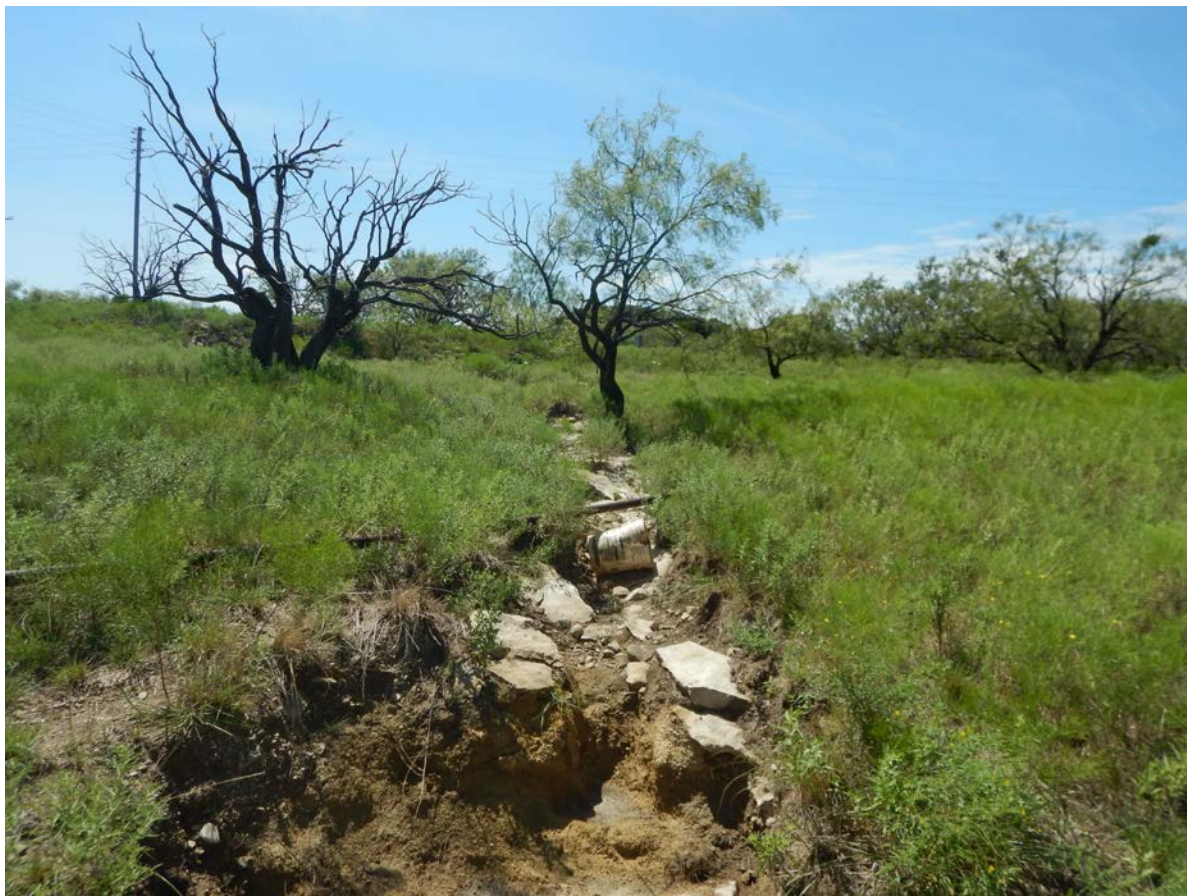
Photograph File Name: DSCN0853.JPG  
Date of Photograph: 08/23/2016  
Latitude: 32.007632 N  
Longitude: -99.641693 W  
Orientation: SW  
Map Datum: WGS-84  
Time of Photo: 01:58 PM  
Photographer: Jeanne Eckhart  
Description:

This image shows the Novice Unit Well No. 8025, which is associated with the Novice Unit – Unknown Lease. At the time of the inspection, we observed a dry flow path east of the injection well approximately 215 feet east from the injection well. We saw visible erosion and no vegetation along the flow path east of the injection well towards the tributary of the South Fork of the Jim Ned Creek. We also observed a flow line over the dry flow path and some debris in the flow path.

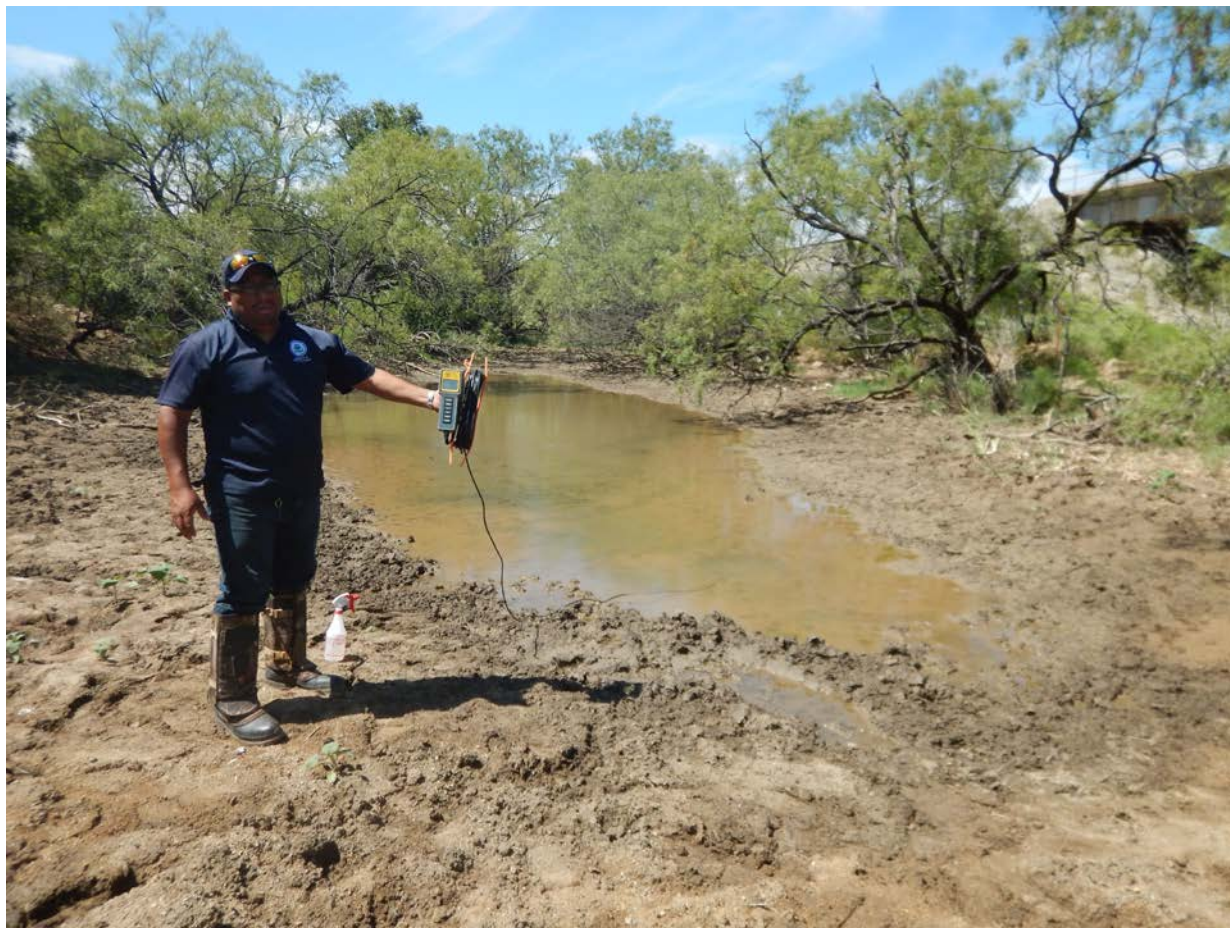
Photograph File Name: DSCN0856.JPG

Description: This image shows the dry flow path, downstream of the Novice Unit Unknown Tank Battery and the injection Well No. 8025 Lease. We observed a dry flow path to a tributary of the South Fork of the Jim Ned Creek and ponded fluids. We took a TSS reading at the point of entry of the flow path from the tank battery, downstream along the tributary. We observed visible bed and bank as well as high water marks shown on the tributary approximately 0.8 miles north and downstream from the facility.

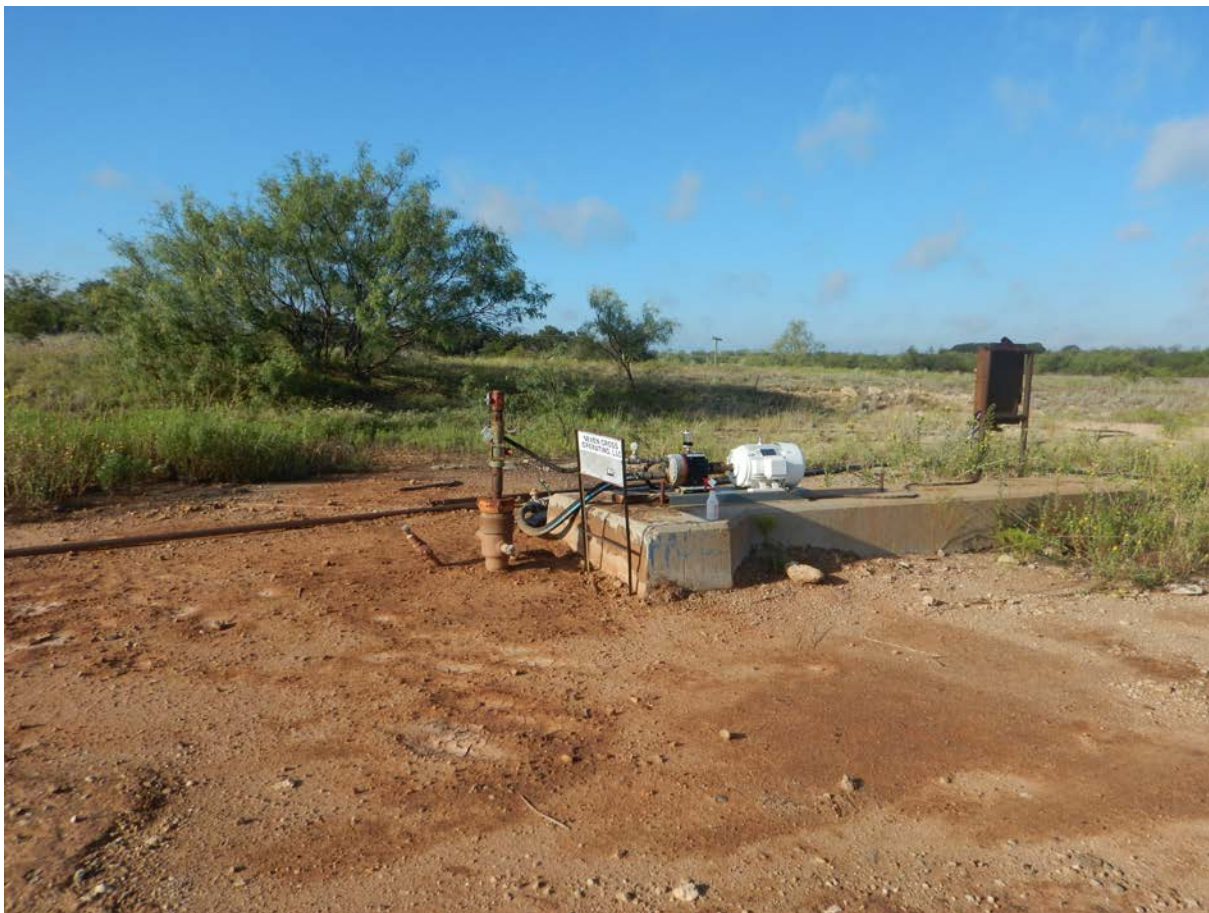
Photograph File Name: DSCN0911.JPG

Description: This image shows the Novice Unit Well No. 8024, which is associated with the Novice Unit – Unknown Lease. We observed that the injection well had a new pump at the well head. We observed the well had 125 psi from the top pressure gauge. Also, we saw that the side pressure gauge attached to the tubing head casing had approximately 200 psi of pressure. We observed no vegetation near the well head and some ponding of fluids near the well at the time of the inspection.

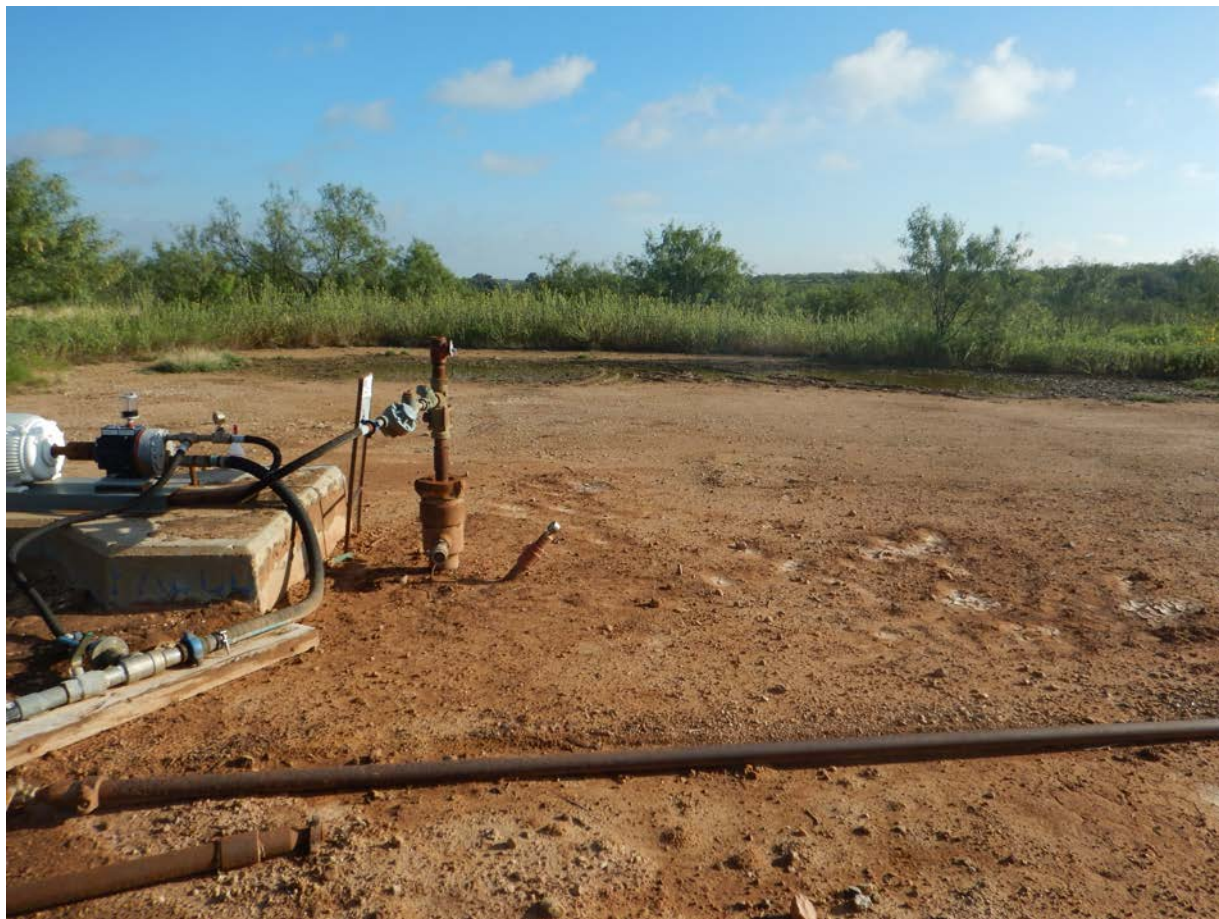
Photograph File Name: DSCN0912.JPG

Description: This image shows the Novice Unit Well No. 8024, which is associated with the Novice Unit – Unknown Lease. We observed that the injection well had a new pump at the well head. We observed the well had 125 psi from the top pressure gauge. Also, we saw that the side pressure gauge attached to the tubing head casing had approximately 200 psi of pressure. We observed no vegetation near the well head and some ponding of fluids near the well at the time of the inspection. A TSS reading was taken at the ponded fluids north east of the injection well near the well head.

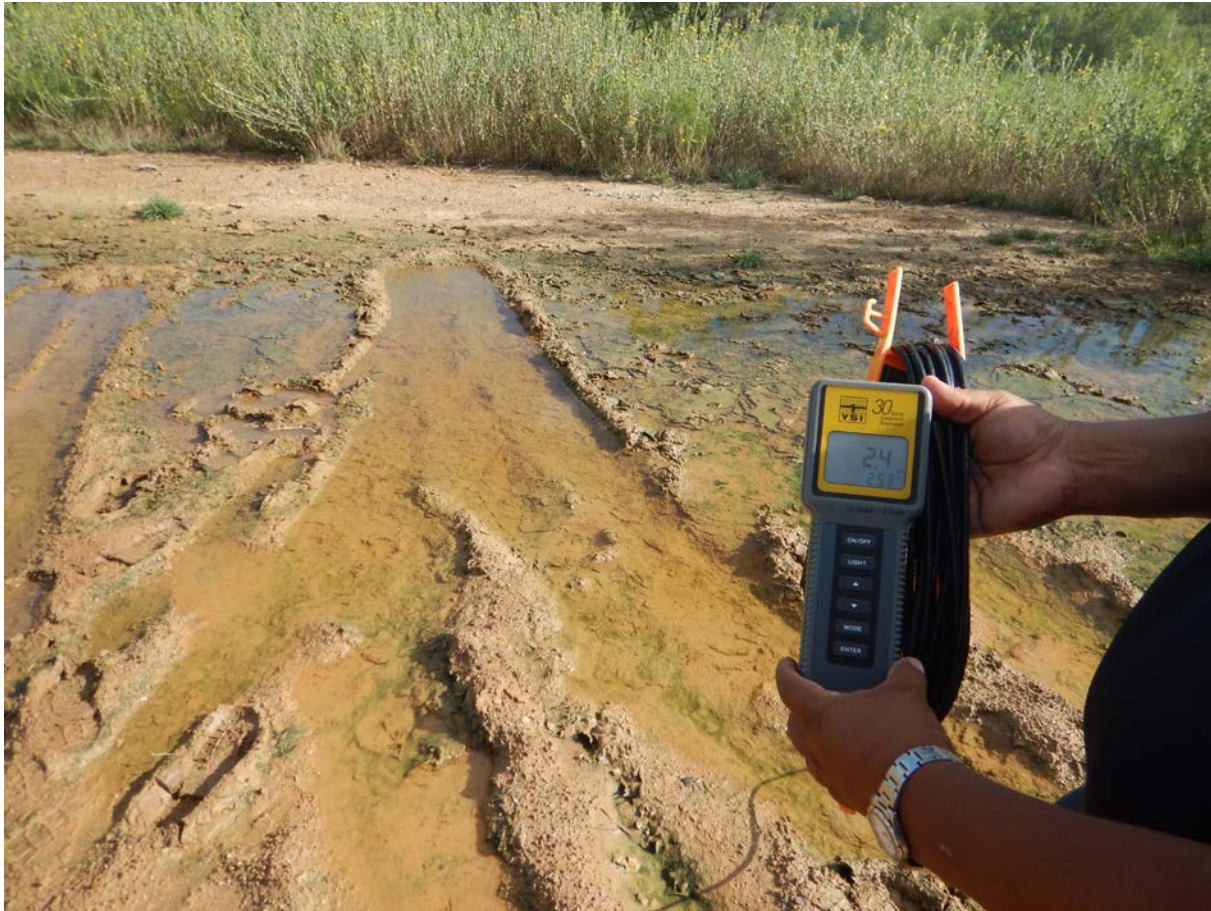
Photograph File Name: DSCN0919.JPG  
Date of Photograph: 08/24/2016  
Latitude: 32.010307 N  
Longitude: -99.639168 W  
Orientation: N  
Map Datum: WGS-84  
Time of Photo: 08:45 AM  
Photographer: Jeanne Eckhart  
Description:

This image shows the Novice Unit Well No. 8024, which is associated with the Novice Unit – Unknown Lease. We observed fluids pooled up north east of the injection well. We took a TSS reading of 2,400 ppm at the ponded fluids at the time of the inspection. This reading was taken approximately 0.8 miles north of the facility.

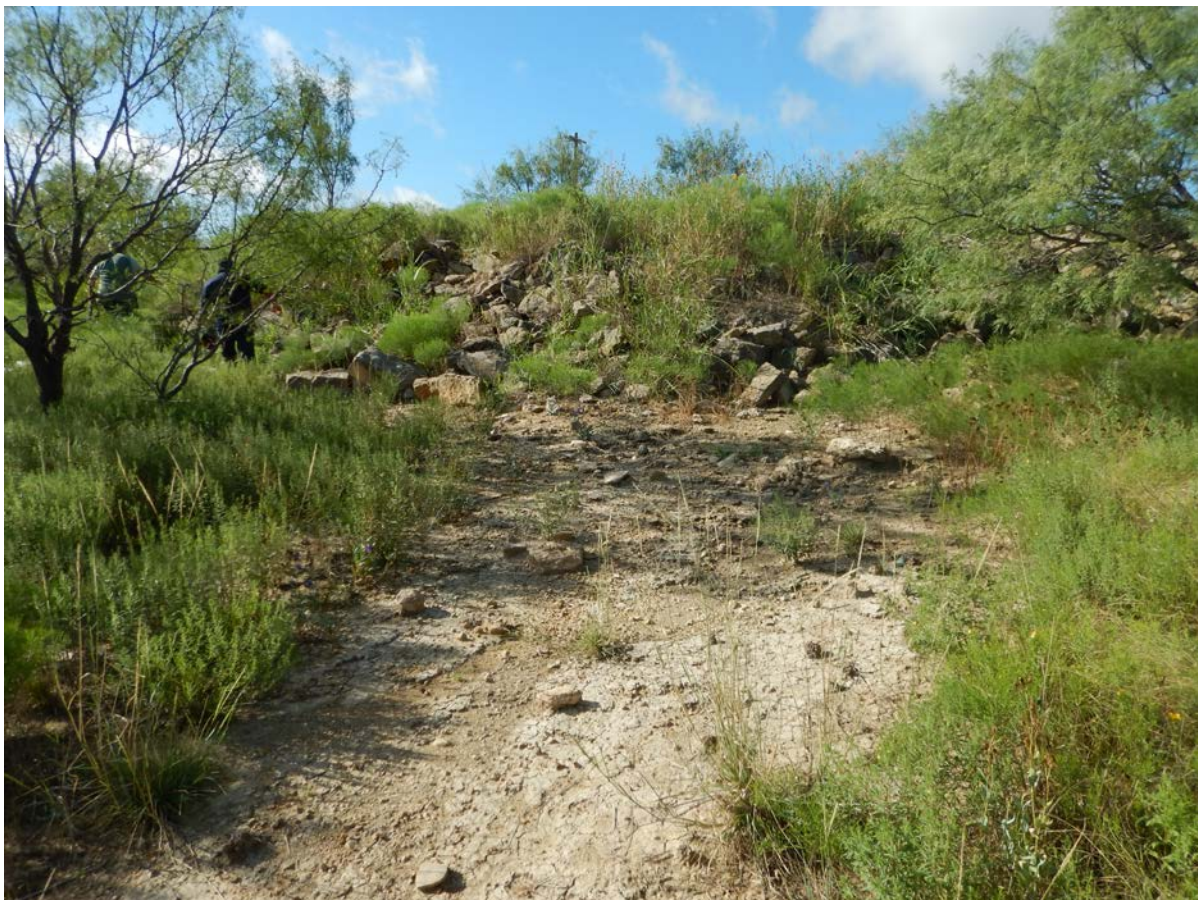
Photograph File Name: DSCN0918.JPG

Description: This image shows the Novice Unit Well No. 8024, which is associated with the Novice Unit – Unknown Lease. We observed a dry flow path from the facility, north east of the injection well, where there was no vegetation along the flow path. We observed salt crystals along the flow path as well. We saw this flow path approximately 140 feet north east from the injection well.
