## Region 6 Compliance Assurance and Enforcement Division

### INSPECTION REPORT

| Company Name: | <b>Seven Cross Operating, LLC</b> | | |
| Facility Name: | <b>Novice Unit – Unknown Lease</b> | | |

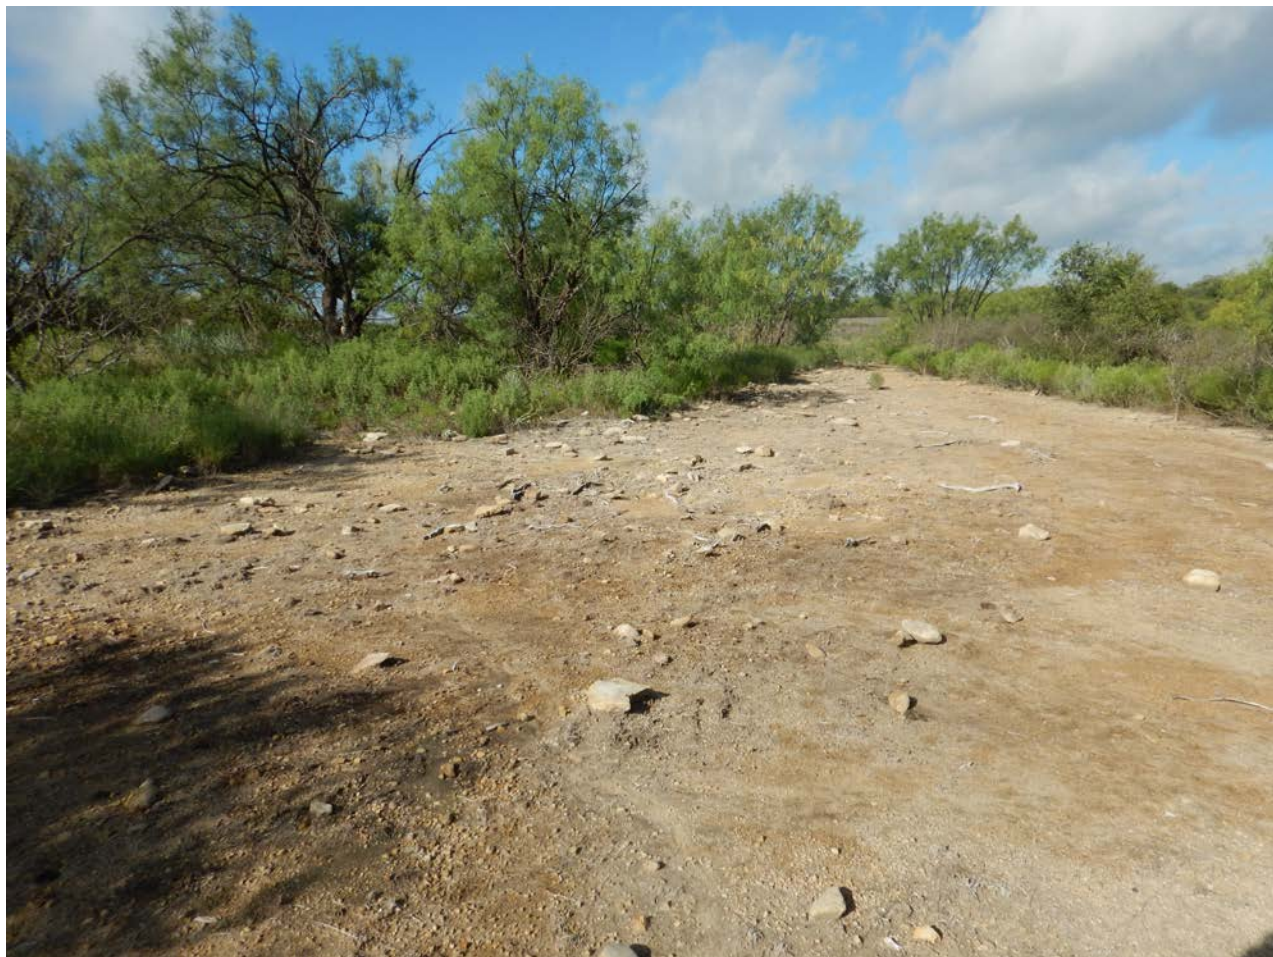
Photograph File Name: DSCN0917.JPG  
Date of Photograph: 08/24/2016  
Latitude: 32.010793 N  
Longitude: -99.639221 W  
Orientation: SW  
Map Datum: WGS-84  
Time of Photo: 08:36 AM  
Photographer: Jeanne Eckhart  
Description:

This image shows the Novice Unit Well No. 8024, which is associated with the Novice Unit – Unknown Lease. We observed a dry flow path from the facility, north east of the injection well, where there was no vegetation along the flow path. The dry flow path went west towards the tributary of the South Fork of the Jim Ned Creek. We observed salt crystals along the flow path as well. We saw this flow path approximately 300 feet along the flow path from the injection well.

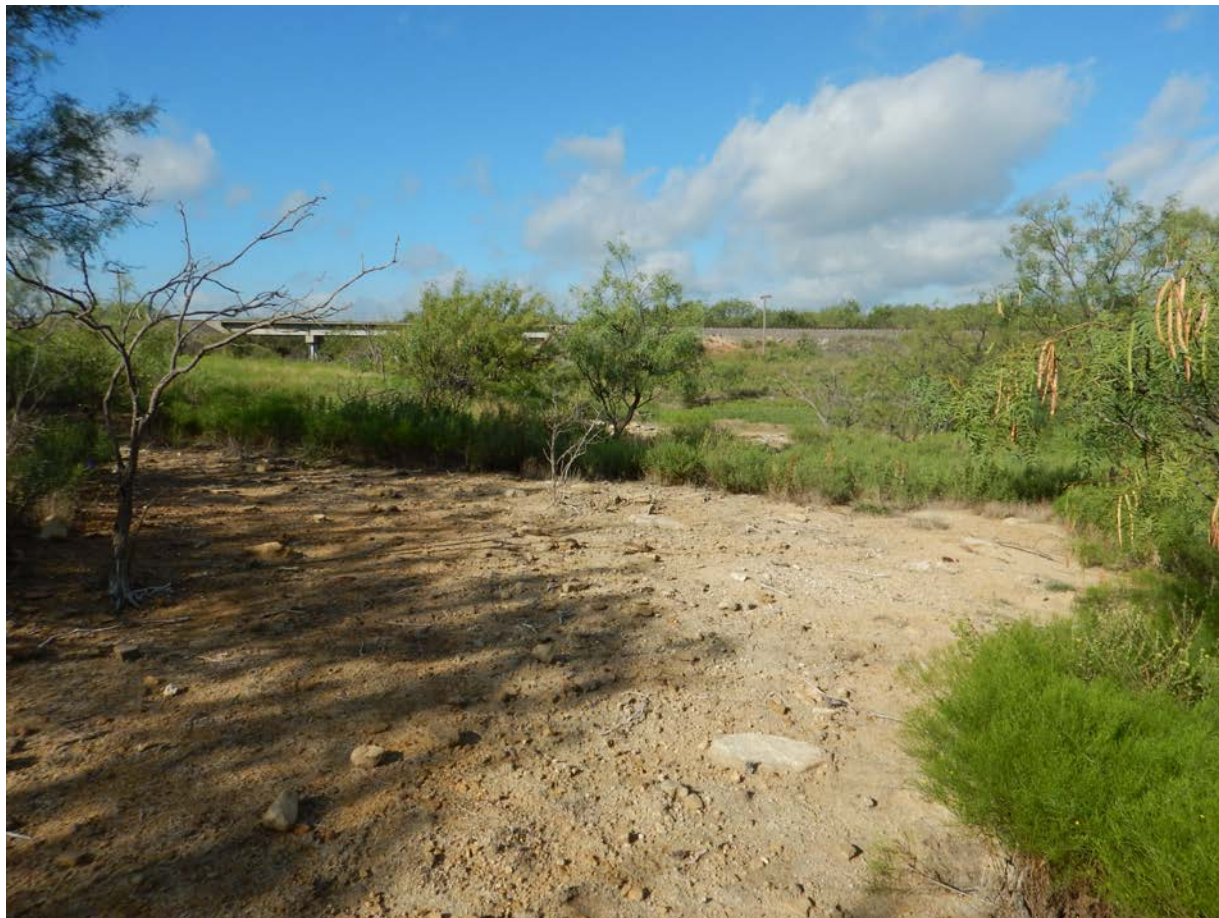
Photograph File Name: DSCN0916.JPG

Description: This image shows the Novice Unit Well No. 8024, which is associated with the Novice Unit – Unknown Lease. We observed a dry flow path from the facility, north east of the injection well, where there was no vegetation along the flow path. The dry flow path went west towards the tributary of the South Fork of the Jim Ned Creek. We observed salt crystals along the flow path as well. We saw this flow path approximately 350 feet along the flow path from the injection well.

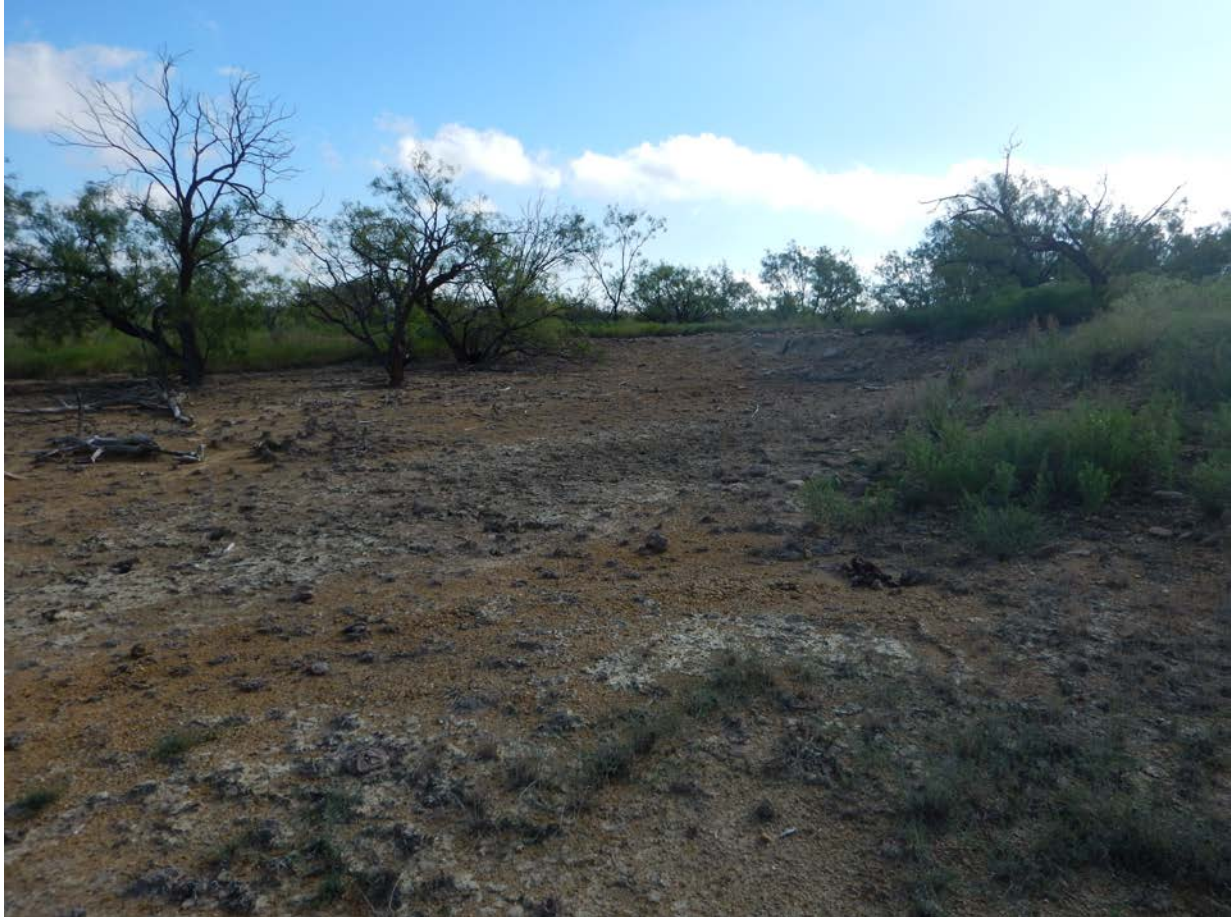
Photograph File Name: DSCN0914.JPG  
Date of Photograph: 08/24/2016  
Latitude: 32.010498 N  
Longitude: -99.640078 W  
Orientation: NE  
Map Datum: WGS-84  
Time of Photo: 08:31 AM  
Photographer: Jeanne Eckhart  
Description:

This image shows the Novice Unit Well No. 8024, which is associated with the Novice Unit – Unknown Lease. We observed a dry flow path from the facility, north east of the injection well, where there was no vegetation along the flow path. The dry flow path went west towards the tributary of the South Fork of the Jim Ned Creek. We observed salt crystals and some vegetation along the flow path as well. We saw this flow path approximately 500 feet along the flow path from the injection well.

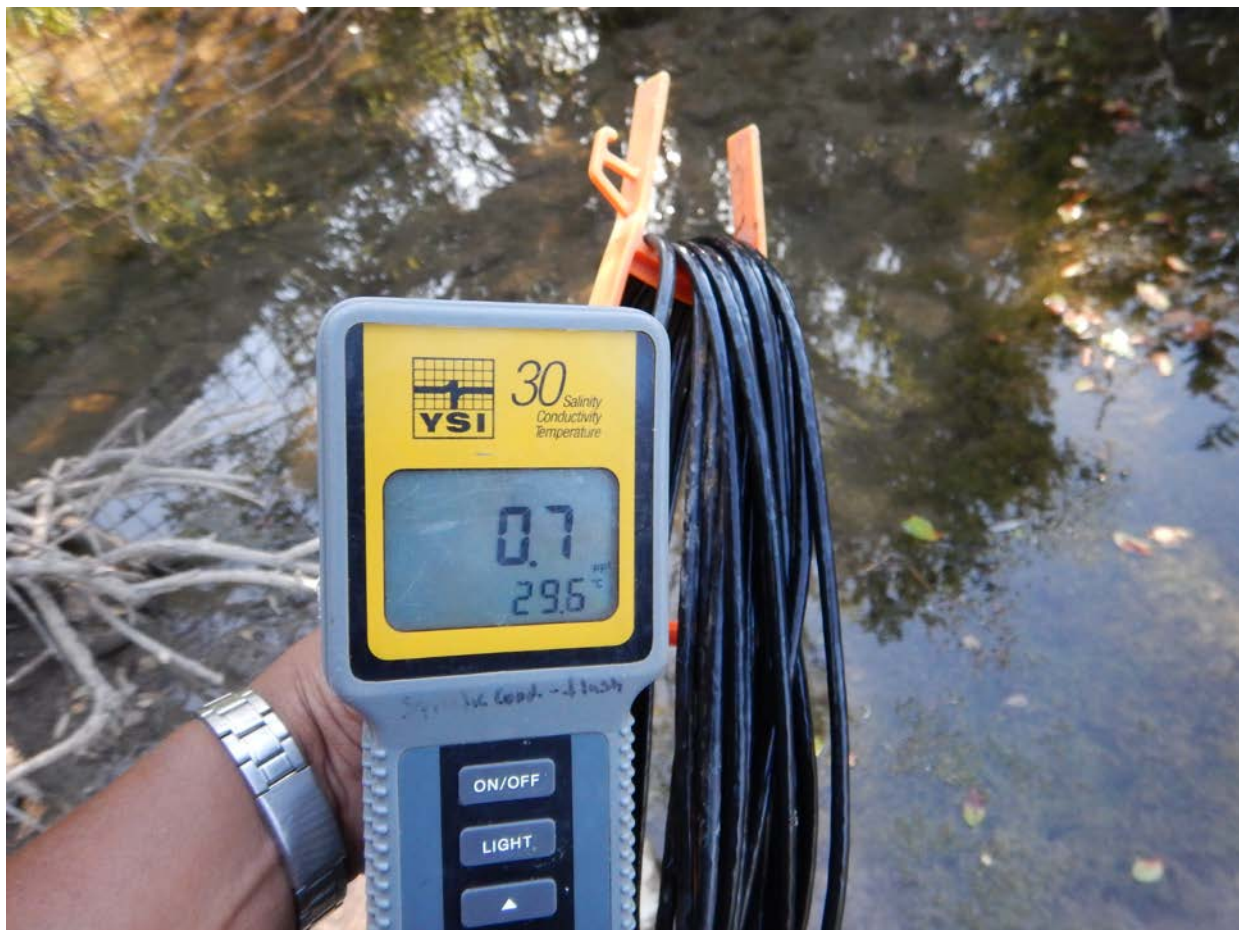
Photograph File Name: DSCN0909.JPG  
Date of Photograph: 08/23/2016  
Latitude: 32.015545 N  
Longitude: -99.640737 W  
Orientation: SW  
Map Datum: WGS-84  
Time of Photo: 04:48 PM  
Photographer: Jack Arias  
Description:

This image shows the South Fork of the Jim Ned Creek downstream from where the tributary coalesces with the South Fork of Jim Ned Creek. A TSS reading of 700 ppm was taken at this location. We observed riparian debris and vegetation at the time of inspection. This location was approximately 1.4 miles downstream from the Novice Unit – Unknown tank battery along the tributary of the South Fork of the Jim Ned Creek.

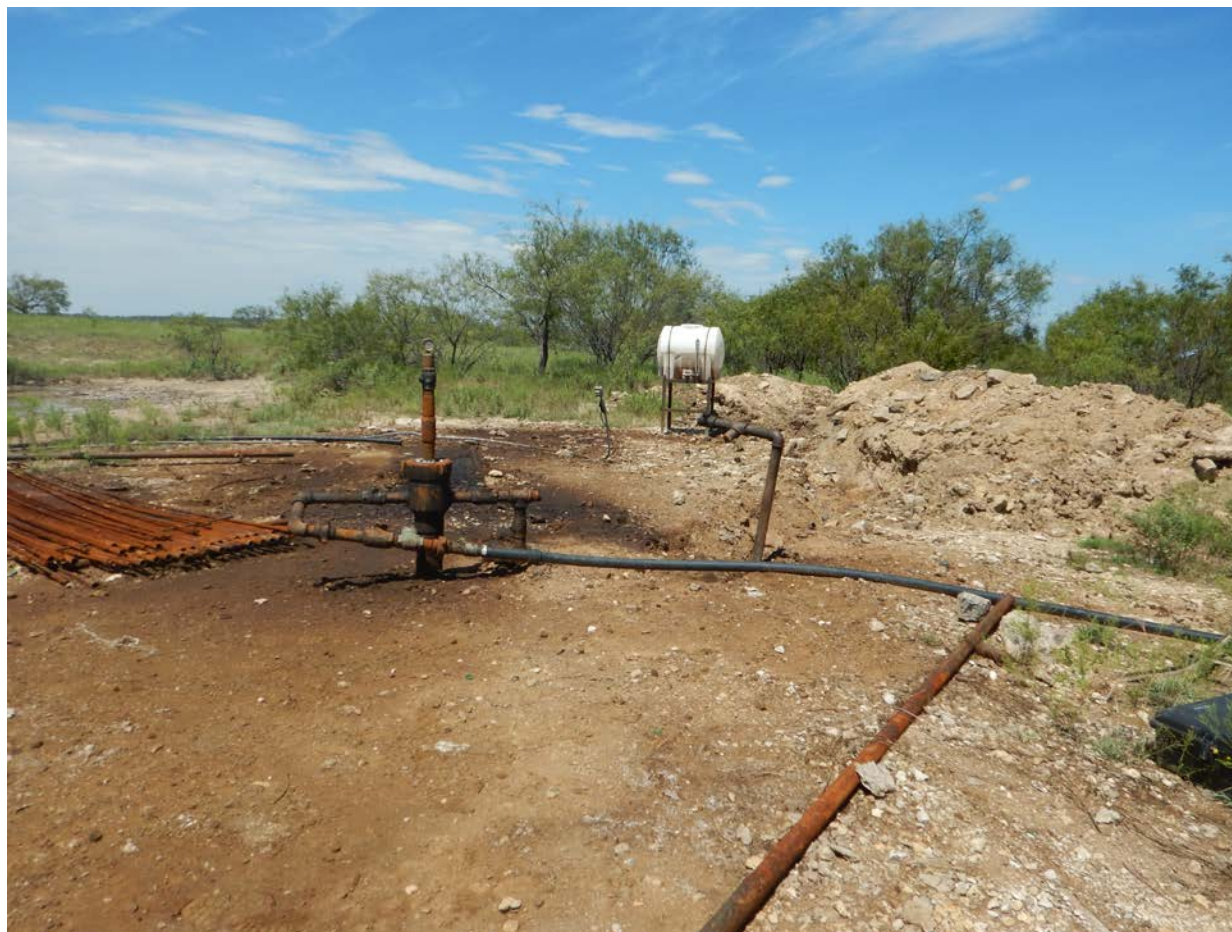
Photograph File Name: DSCN0842.JPG  
Date of Photograph: 08/23/2016  
Latitude: 32.010065 N  
Longitude: -99.642317 W  
Orientation: NE  
Map Datum: WGS-84  
Time of Photo: 01:30 PM  
Photographer: Jeanne Eckhart  
Description:

This image shows the Novice Unit Well No. 8030, which is associated with the Novice Unit – Unknown Lease. We observed oil staining, debris, exposed steel piping near the well head, and a chemical storage tank container with no secondary containment at the time of the inspection. We saw a dirt pit that had been dug and had debris and fluids in it near the well head. The pressure on the gauge was approximately 185 psi at the time of the inspection.

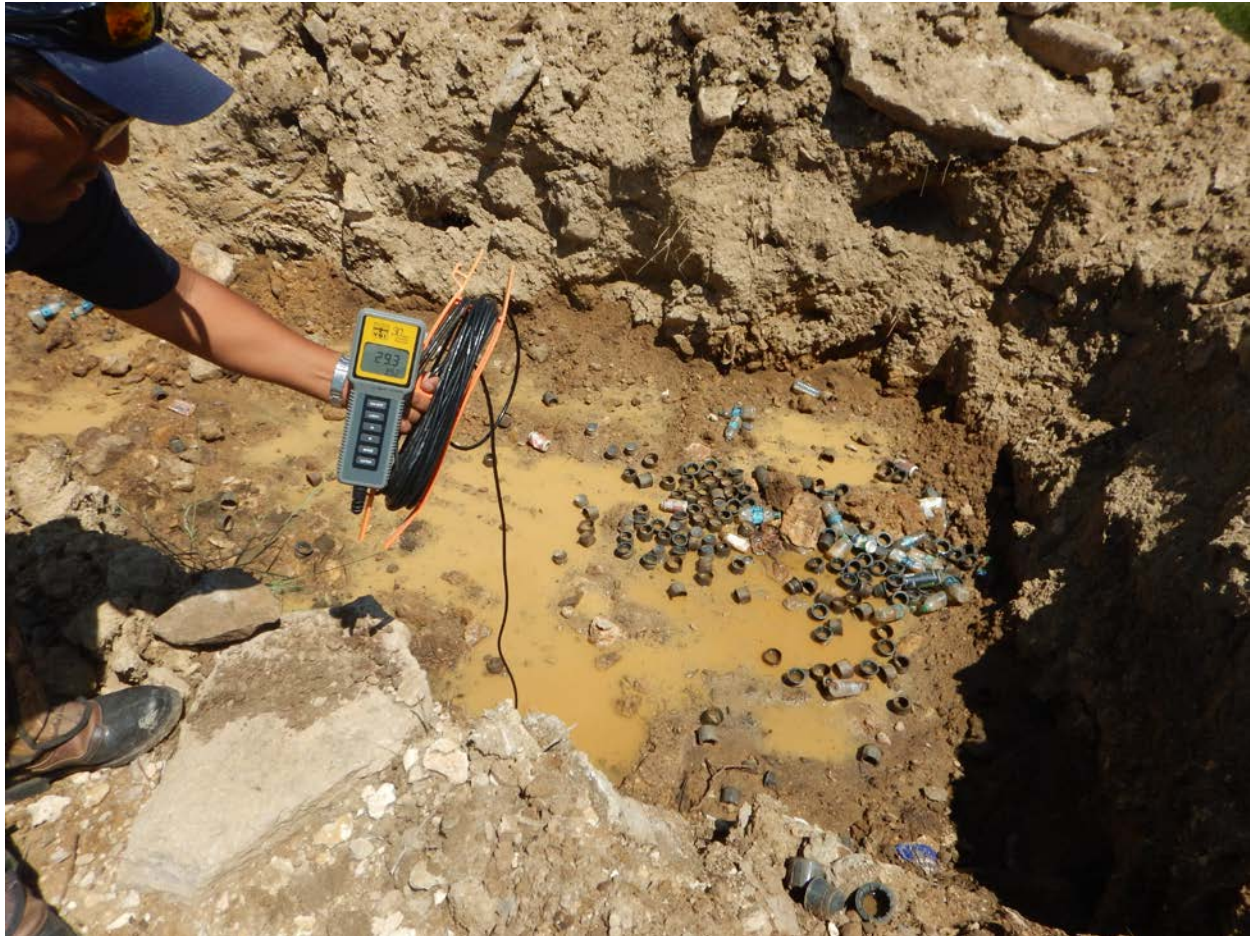
Photograph File Name: DSCN0843.JPG  
Date of Photograph: 08/23/2016  
Latitude: 32.010153 N  
Longitude: -99.642267 W  
Orientation: E  
Map Datum: WGS-84  
Time of Photo: 01:32 PM  
Photographer: Jeanne Eckhart  
Description:

This image shows the Novice Unit Well No. 8030, which is associated with the Novice Unit – Unknown Lease. We observed oil staining, debris, exposed steel piping near the well head, and a chemical storage tank container with no secondary containment at the time of the inspection. We saw a dirt pit that had been dug and had debris and fluids in it near the well head. We took a TSS reading of 29,300 ppm at the time of the inspection from the fluids in the unlined pit near the well head.
