**Region 6 - Enforcement & Compliance Assurance Division**  
**INSPECTION REPORT**

| Inspection Date(s): | 11/07/2024 | |
| Company Name: | <b>HPC Industrial Services LLC</b> | |
| Facility Name: | <b>Norco Oil Recovery Facility</b> | |

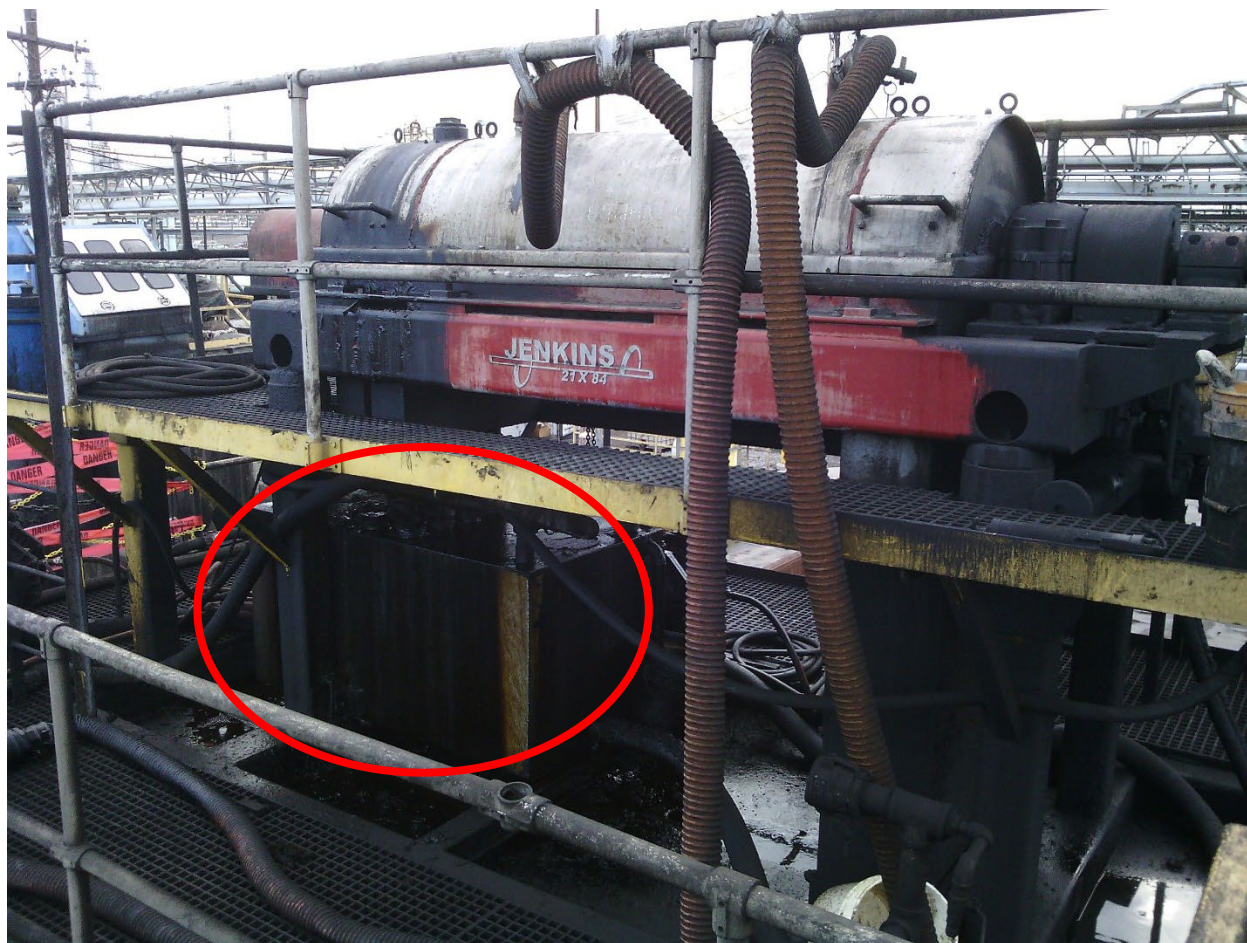
Photo No. 2

We observed the backup control device to the thermal oxidizer, the shaker screen, the centrifuge and separator box, the "3-Sided Box" and solids hopper, and a sump that operates as a final oil water separator before discharging the Facility's wastewater to the co-located refinery. In this area, we observed significant oil staining below the centrifuge at the separator box (Appendix 1 - Photo No. 2). We also noted that the "3-Sided Box" and solids hopper are open to the atmosphere. See AOC 1.

| Description: | Photograph in southern portion of the Facility <ul style="list-style-type: none"><li>• Circled in Red: significant oil staining at the separator box below the centrifuge</li></ul> |

- 1) I reviewed a subset of records documenting the types of waste NORF receives (i.e., bills of lading). During the third quarter of 2024, NORF received wastes from 22 sites. Some of these wastes are identified as BWON-controlled wastes; therefore, NORF must manage each of these wastes pursuant to 40 C.F.R. §§ 61.343 through 61.347 at each waste management unit. Based on the visual defects at the separator box below the centrifuge, because the "3-Sided Box" and solids hopper were open to the atmosphere, and the detectable emissions at the oil water separator, NORF may not be managing controlled BWON wastes in accordance with the requirements of the rule.

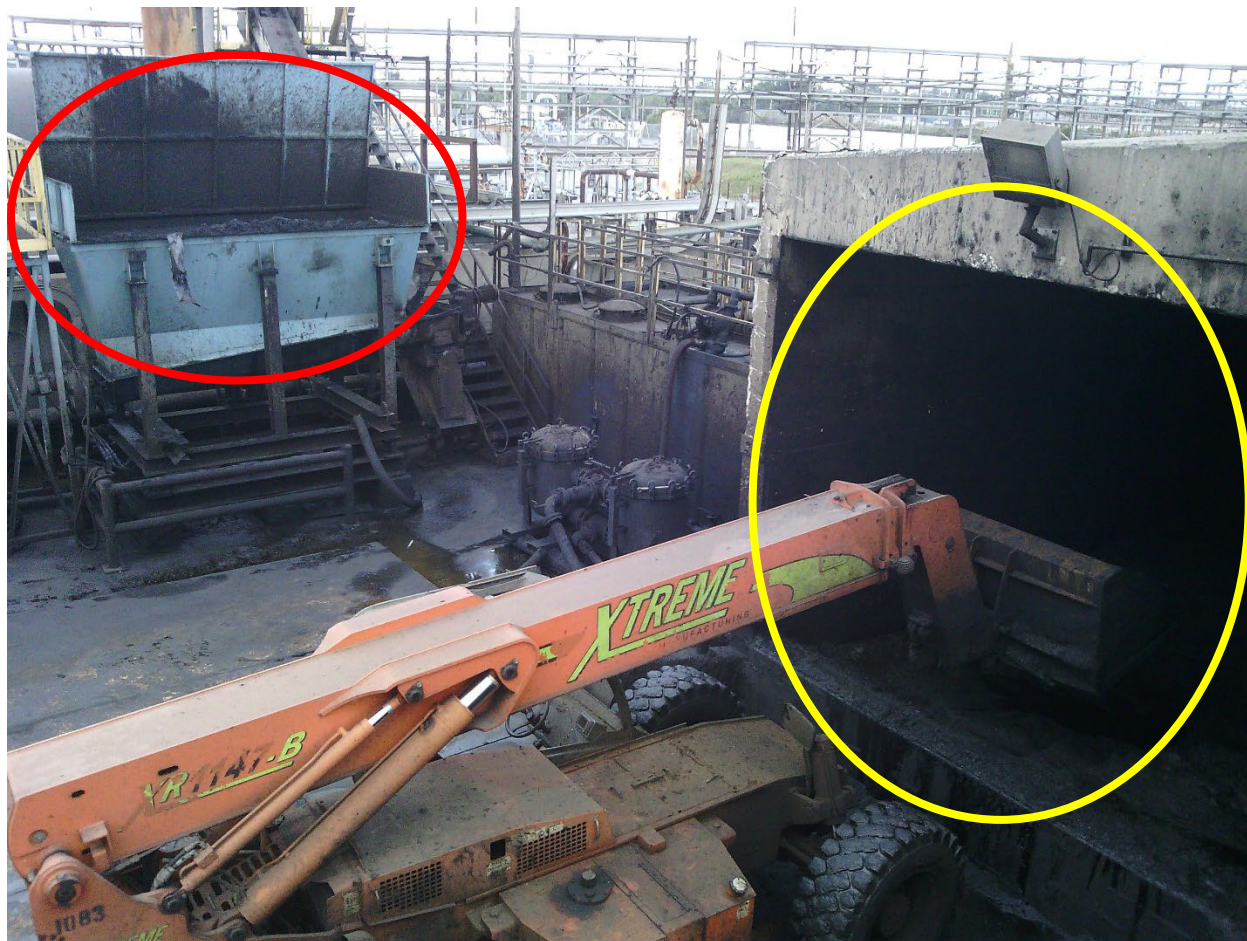
Photo No. 3

We walked to the southern portion of the Facility where waste is received at the Facility. Pumpable liquids, sludges, and slurries received in vacuum trucks are pumped into mix tanks for holding before they can be processed in the centrifuge. Other wastes that cannot be pumped are placed in the Facility's "3-Sided Box" where it can be loaded into the solids hopper that feeds a conveyer system to the ADTU (Appendix 1 - Photo No. 3).

| Description: | <p>Photograph in southern portion of the Facility</p> <ul style="list-style-type: none"><li>• Circled in Red: open solids hopper used to feed a conveyer system into the ADTU</li><li>• Circled in Yellow: open "3-Sided Box" used to store solids prior to loading into the hopper</li></ul> |

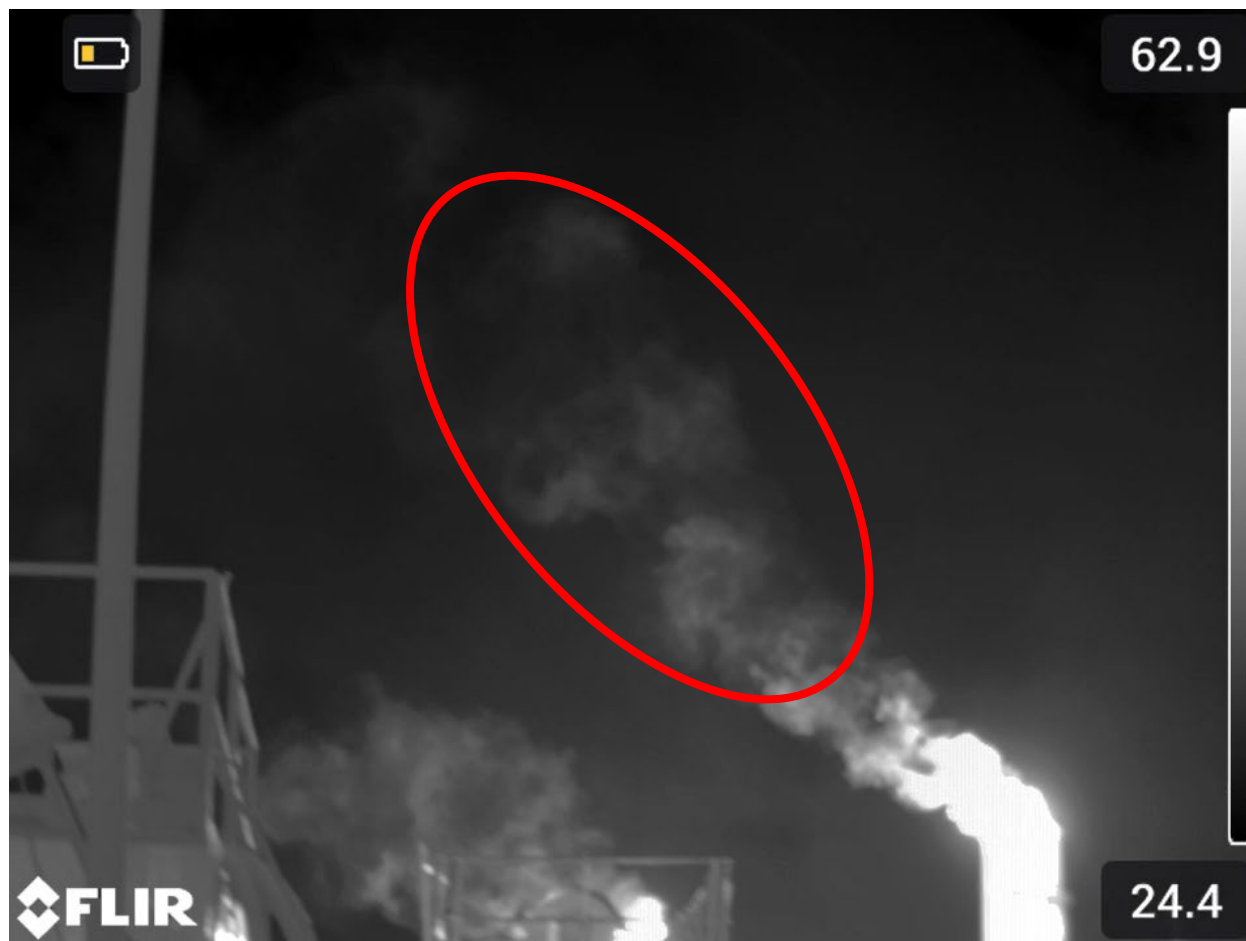
Photo No. 4

While in the southern portion of the Facility, I observed the thermal oxidizer using the OGI camera and noted a plume of hydrocarbons trailing from the stack (Appendix 1 - Photo No. 4). See AOC 2.

- 2) I reviewed the OGI video of hydrocarbons trailing from the thermal oxidizer. The plume may indicate that the combustion unit is not achieving the required efficiency. The thermal oxidizer is the control device for waste management units at the Facility.

| Description: | Still image from FLIR0083.mp4 video <ul style="list-style-type: none"><li>• Circled in Red: hydrocarbon plume trailing from NORF's thermal oxidizer</li></ul> |
