INSPECTION REPORT

| Type of Inspection | Compliance Evaluation Inspection (CEI) | |
| Company Name | Seekins Ford-Lincoln, Inc. | |
| Facility/Site Physical Address | 1625 Old Steese Hwy | |

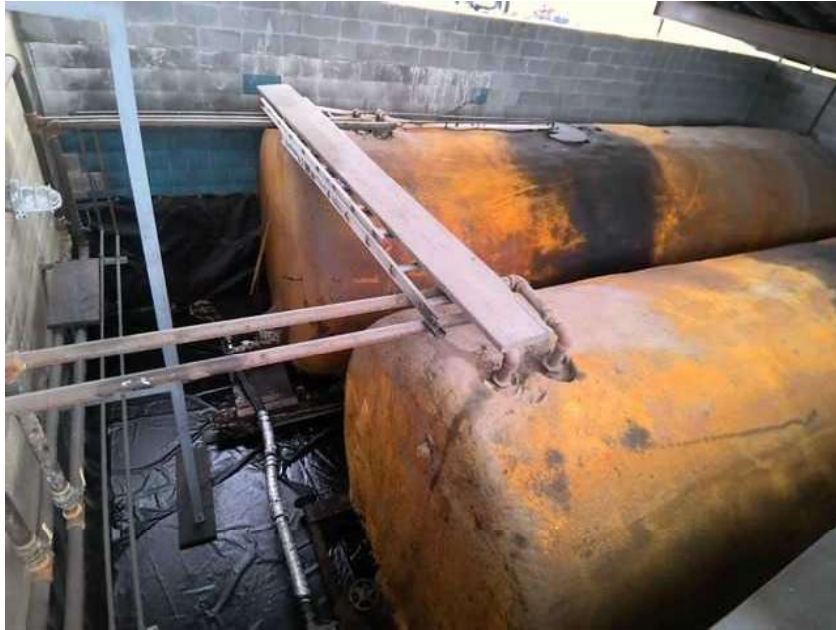
| 20,000 Gallon Used Oil Tanks | | | IMG-20240911085844584489387.jpg |

| <p>When we asked about where used oil is stored, we were directed to the back of the building where I observed two above ground storage tanks totaling 20,000 gallons in capacity. The amount of oil in the tanks at the time of the inspection was unknown. Mr. Snyder said Republic (formerly US Ecology) pumped out the tanks two months ago. At the time of the inspection, the facility had not labeled the tanks with the words "Used Oil." There was a concrete wall concealing the tanks that the facility had also not labeled.</p> <p>On 10/02/2024, Marty Snyder sent a photo showing facility personnel had labeled the tanks with the words "Used Oil."</p> | | | |

| Used oil storage tanks not labeled with the words "Used Oil."<br><br>On 10/02/2024, Marty Snyder sent a photo showing the facility labeled the tanks with the words "Used Oil." | <b>Regulation:</b> | <b>Sections:</b> |

| The two above ground tanks serving as used oil storage, each tank totals 10,000 gallons in capacity. The tanks are missing a "Used Oil" label. | | | |

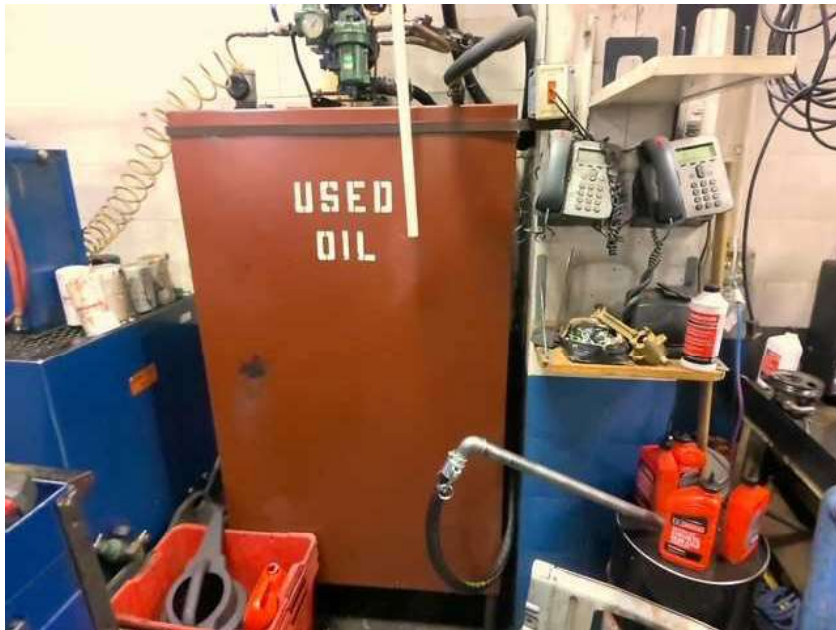
| Used Oil Pump | | | IMG-2024091109031631682225.jpg |

| This is where used oil is accumulated and pumped into the 10,000-gallon tanks for storage and pickup. | | | |

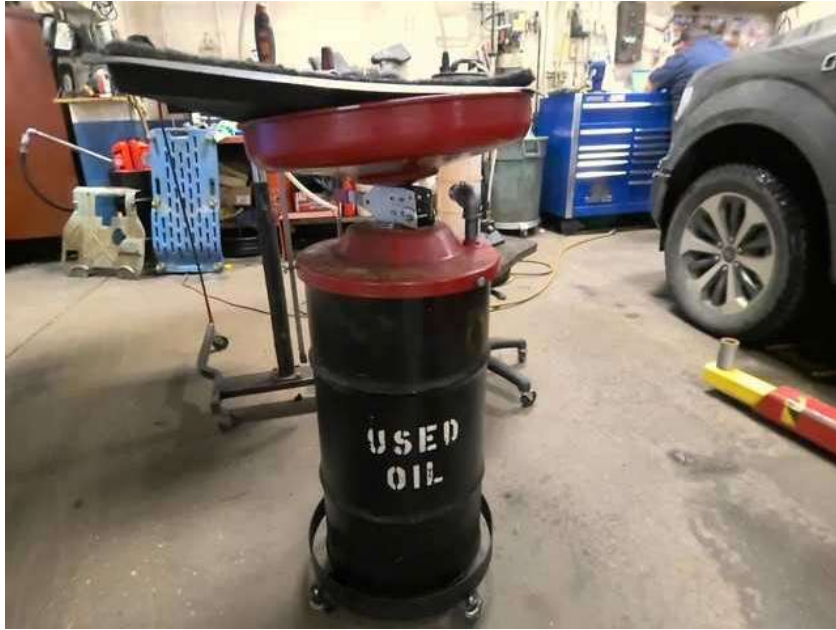
| Rolling Used Oil Container | | | IMG-2024091109033833879665.jpg |

In the service bays, I observed a rolling used oil collection container with faded and illegible labeling. I explained that containers storing used oil were required to be clearly marked with the words "Used Oil."

| This is a rolling used oil container, of which there are 25-30 in the entire facility. | | | |

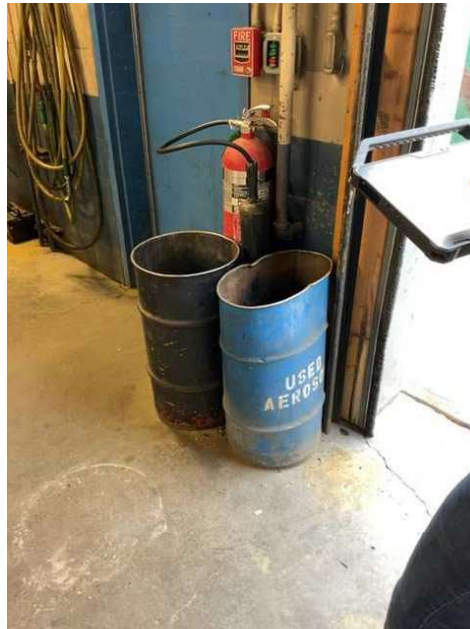
| Open Aerosol Can Container | | | IMG-2024091109091691686111.jpg |

| <p>At the south end of a service bay within the service shop, I observed a universal waste aerosol container that facility personnel labeled with the words "Used Aerosols." At the time of the inspection, the container was not closed and there were two aerosol cans inside the container.</p> | | | |

| Universal waste aerosol container at south end of service shop. The container is not marked with the date that waste aerosol cans first became a waste. | | | |

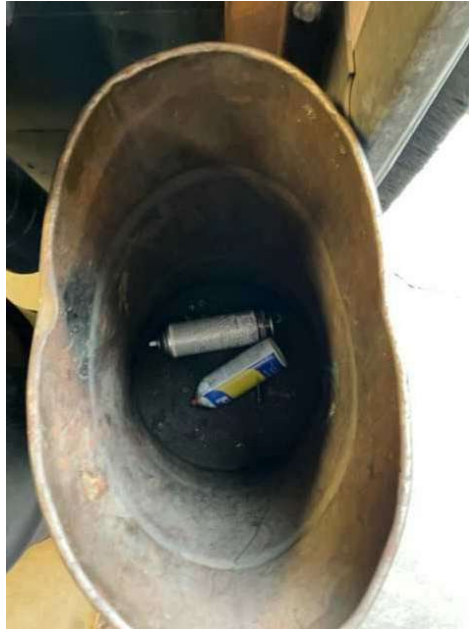
| Open Aerosol Can Container | | | IMG-2024091109092392355451.jpg |

| Second photo showing the inside of the universal waste aerosol container at south end of service shop. | | | |

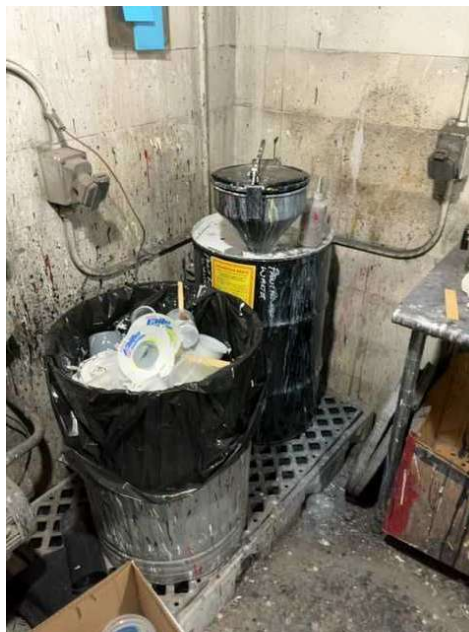
| Waste paint SAA | | | IMG-202409110915431543103815.jpg |

| <p>Within the service shop, we visited the paint mixing room. I observed a 55-gallon SAA drum that the facility was using to accumulate solvent waste. Facility personnel labeled the container with the words "Hazardous Waste," but did not mark it with a hazardous waste indicator. The lid to the funnel mechanism at the top was ajar. The lid was closed during the inspection.</p> <p>At the time of the inspection, the facility was operating as a VSQG and although the labeling and marking containers is a good practice, it's not required for a VSQG.</p> | | | |

| Waste paint SAA, the lid on the funnel mechanism is ajar and the drum does not have a hazard indicator. | | | |

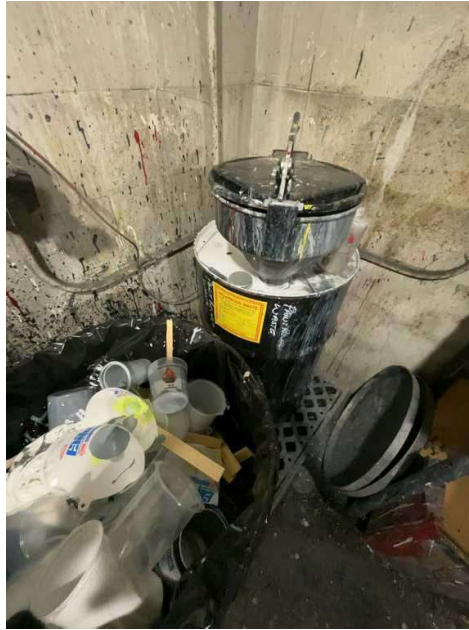
| Waste paint SAA | | | IMG-202409110916011612118514.jpg |

| Second photo of waste paint SAA, the lid on the funnel mechanism is ajar and the drum does not have a hazard indicator. | | | |

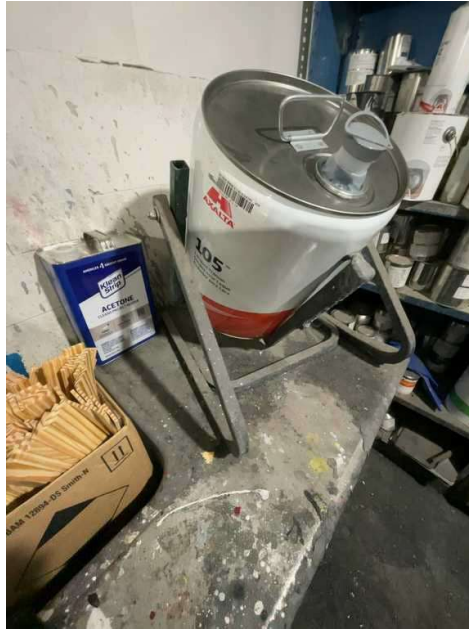
| Acetone Waste Container | | | IMG-2024091109164516451886465.jpg |

| Photo of acetone container. | | | |

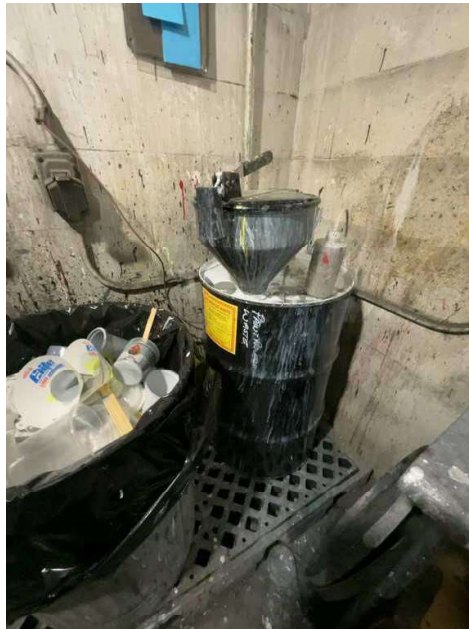
| Paint Waste SAA | | | IMG-202409110920062062020777.jpg |

| Fourth photo of the waste paint SAA funnel mechanism that was closed at the time of the inspection | | | |

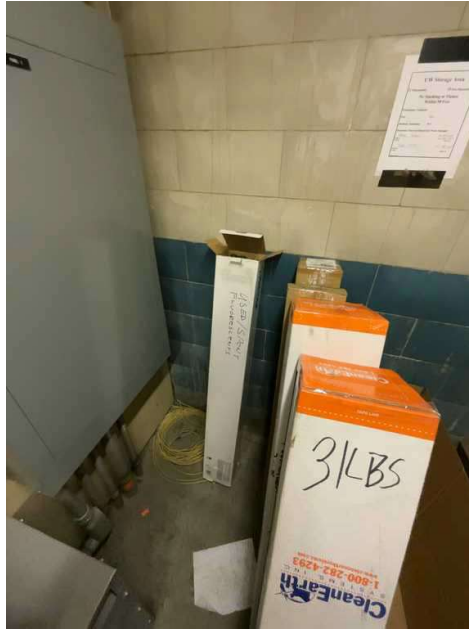
| Used Fluorescent Bulbs | | | IMG-2024091109274327431670088.jpg |

In the electrical room, I observed five boxes containing used fluorescent lamps that the facility labeled "Used Fluorescent Lamps." The facility labeled four of the five boxes with the date 8-22-2024. According to Mr. Snyder the facility replaces all of their lamps at one time. During the inspection, we saw one box the facility had not closed or marked with the date the lamps first became a waste.

| A container of universal waste lamps was not closed or marked with the date the lamps first became a waste.<br><br>On 10/02/2024, Marty Snyder sent a photo showing the facility had closed and dated that container. | <b>Regulation:</b> | <b>Sections:</b> |

| View of box of used fluorescent lamps that is not closed or dated. | | | |

On 10/02/2024, Marty Snyder sent a photo showing that the facility closed and dated that box of used lamps.

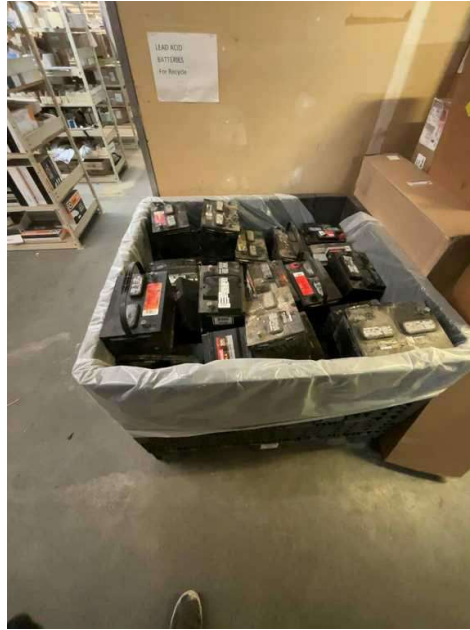
| Used Batteries | | | IMG-2024091109434243421804025.jpg |

In the parts area, I observed a large container of used automotive batteries. According to onsite personnel, the facility recycles their used batteries through Airland Factory Motor Parts, and they ultimately end up at a lead smelter. At the time of the inspection, the facility did not have a Land Disposal Restriction Notice (LDR) on file for the batteries.

| JJ1-OB-006 | | |
|---|---|---|
| There was no LDR on file at the facility for the waste automotive batteries the facility was recycling, and their recycler sends the batteries to a lead smelter. | Regulation: | Sections: |

| A box of used batteries that is awaiting shipment to a recycling facility. | | | |
