## **RCRA Inspection Report**

Techno Coatings, Inc.  
1865 N.E. 144<sup>th</sup> St.  
North Miami Beach, Florida 33181  
EPA ID No: FLD982173874

January 27, 2022

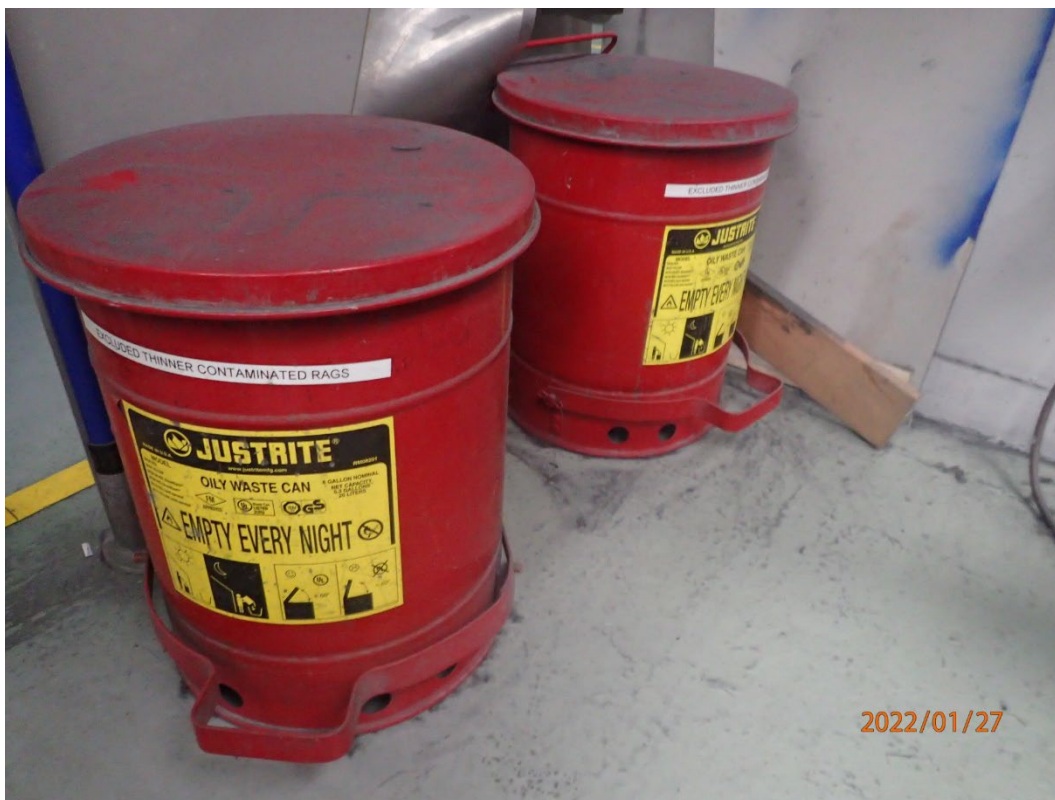
The inspectors observed two (2) 6-gallon closed containers for excluded solvent-contaminated rags (Photo 1), closed, and labeled. The containers were not dated to demonstrate that the excluded solvent-contaminated rags were not exceeding the 180-day accumulation time limit.

**Photo 1:** Two (2) 6-gallon closed containers for excluded solvent-contaminated rags, closed, and labeled. The containers were not dated to demonstrate that the excluded solvent-contaminated rags were not exceeding the 180-day accumulation time limit.

**Pursuant to Fla. Admin. Code Ann. r. 62-730.030(1) [40 CFR 261.4(b)(18)(v)(B)],  
Generators must maintain at their site the following documentation: (B) Documentation**

**that the 180-day accumulation time limit in 40 CFR 261.4(b)(18)(ii) is being met.**

UPDATE: Following the inspection on January 27, 2022, Mr. Rojas submitted photos of the containers with excluded solvent contaminated rags with accumulation start dates.

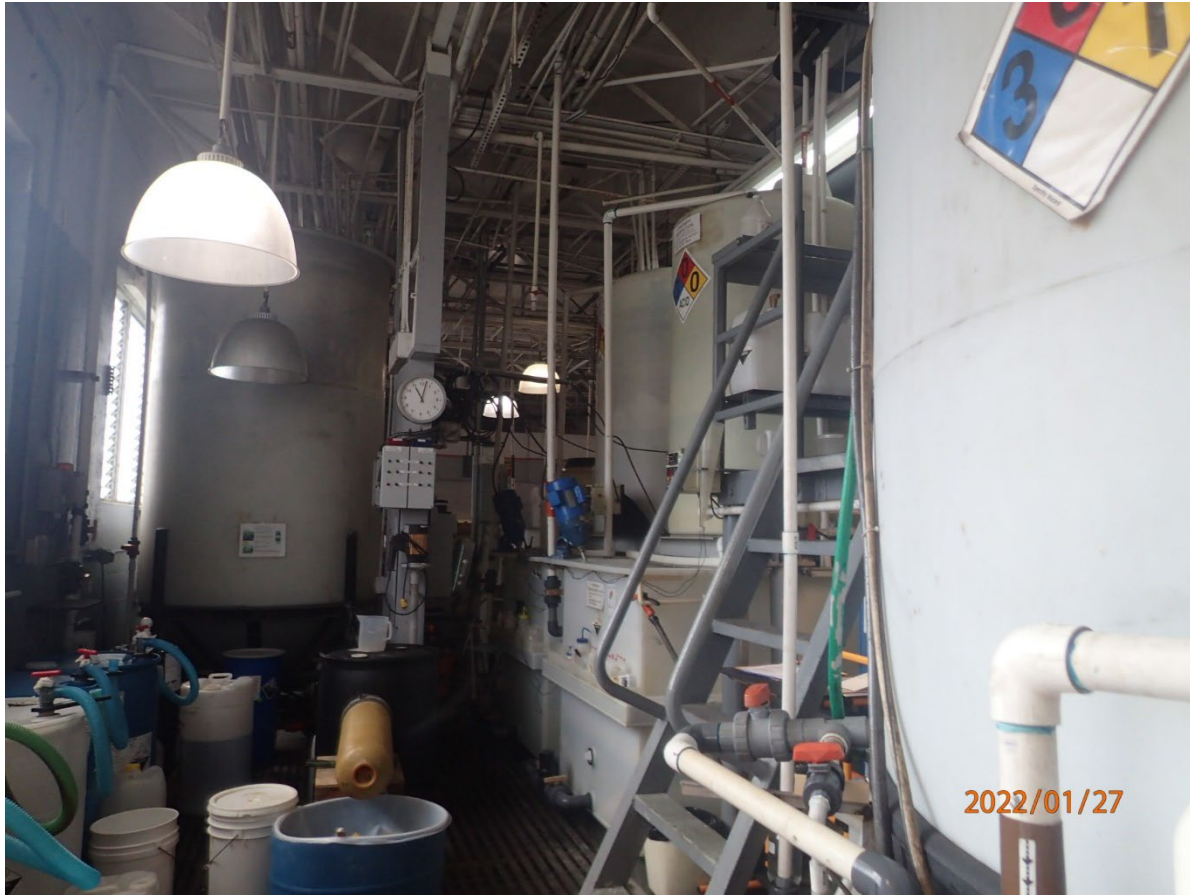
This plant (Photo #2) is used to pre-treat wastewater from the electroplating processes and is located along the east side of the plating process lines. The system is permitted by the Miami-Dade County Department of Regulatory and Economic Resources (DRER). The primary functions of the system are pH adjustment, cyanide destruction, and removal of heavy metals. Wastewater is sampled monthly. Wastewater sludge from the system is dewatered using a plate-and-frame filter press located in the back of the facility, near to the Stripping Area. No hazardous waste was observed in this area.

**Photo 2:** Wastewater Pre-treatment Plant.

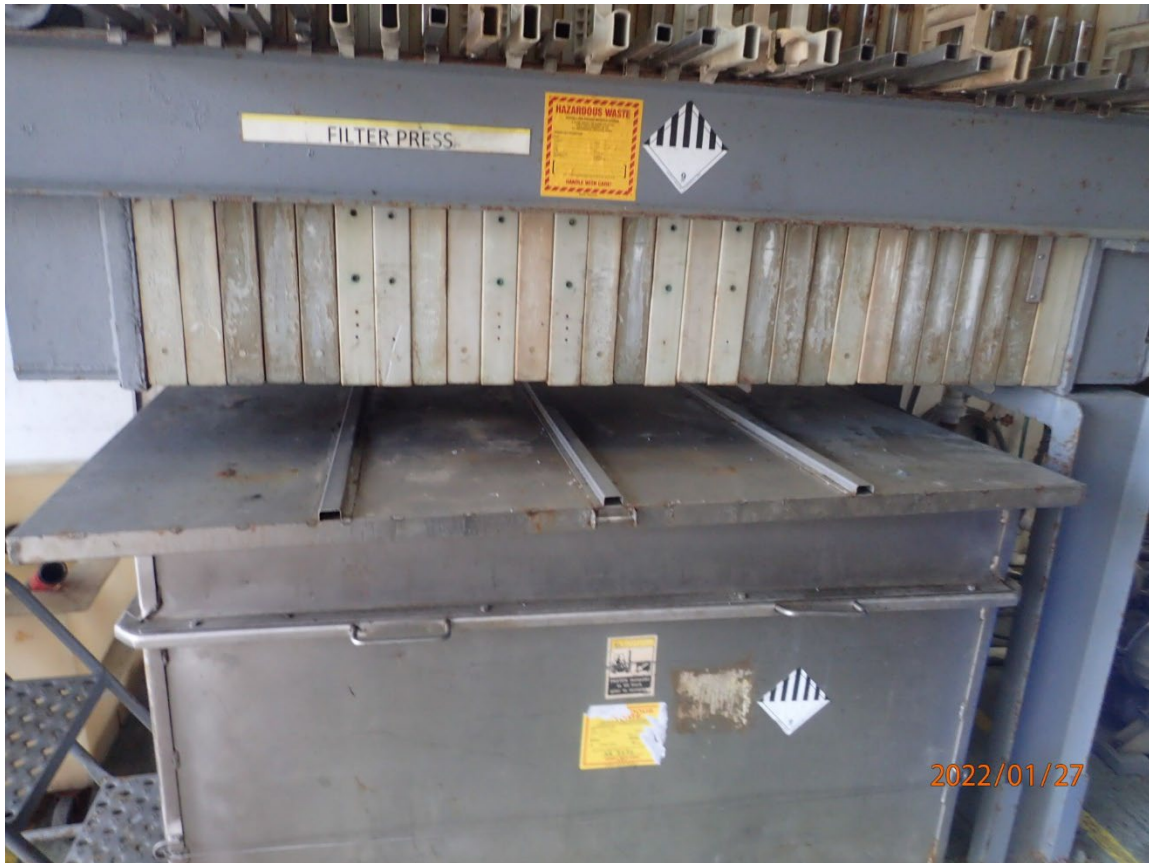
The filter press and 90-day CAA is located towards the North-side of the facility. Dewatered F006 filter cake is collected beneath the filter press in an open-top metal 5'x4'x4' container (Photo #3). The metal container was closed and empty at the time of the inspection. The metal container had a hazardous waste label and a Class 9 Placard. The inspectors explained to Mr. Rojas that the Class 9 D.O.T. placard is described as "Miscellaneous" and does not indicate the hazard content of the material. We recommended to Mr. Rojas that when F006 filter cake is generated in the metal container, that a different indication of hazard be used to mark the container as described in 40 CFR 262.17(a)(5)(i)(B).

**Photo 3:** Dewatered F006 filter cake is collected beneath the filter press in an open-top metal 5'x4'x4' container. CAA1.

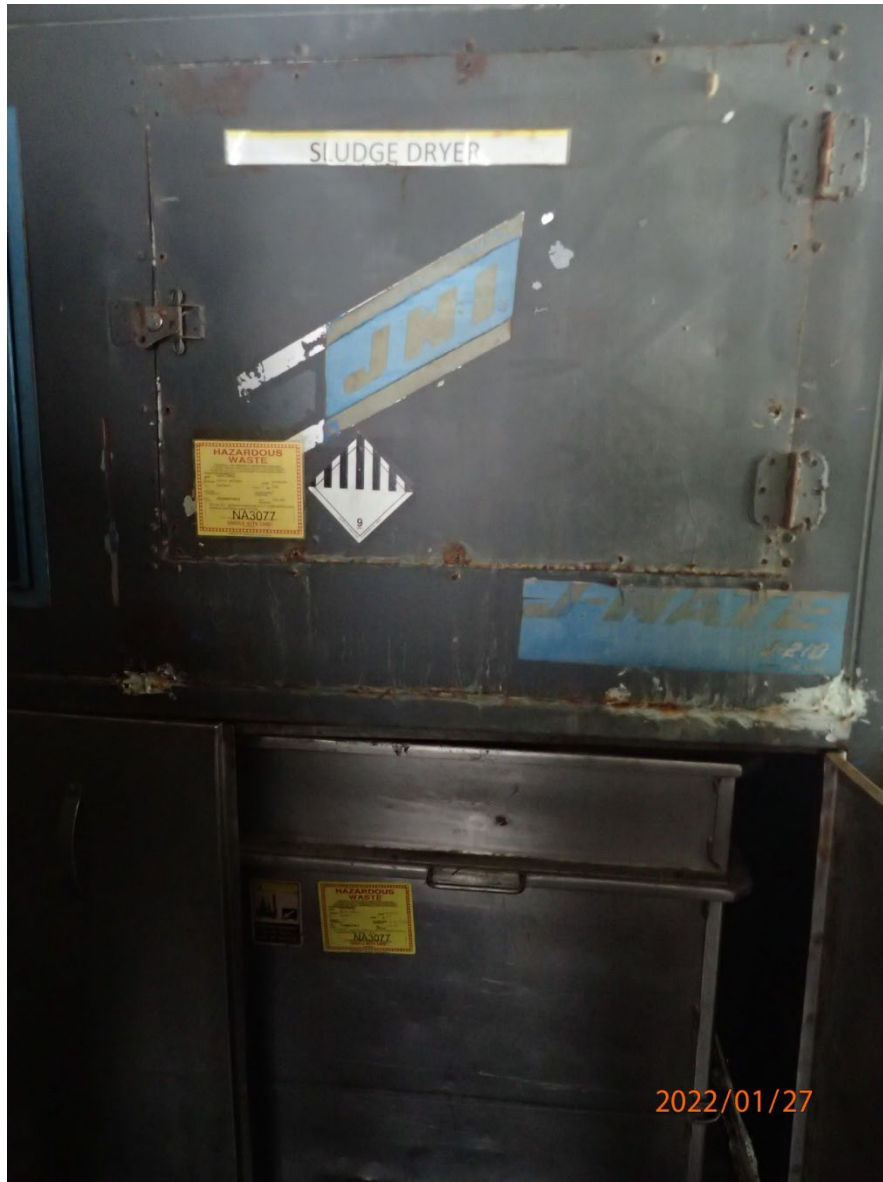
When the metal box is full, it is moved to an electrically heated sludge dryer for further dewatering (Photo #4 and #5). The dryer was identified as JWIJ-MATE J-210. After the filter cake is dried, it is transferred to a cubic yard plastic-lined cardboard shipping box. The metal container box under the sludge dryer was labeled "Hazardous Waste—Chromium Plating Sludge" and dated December 21, 2021. The container also had a Class 9 D.O.T. placard which represents "miscellaneous good" and does not specify the specific hazards.

**Photo 4:** Electrically heated sludge dryer: JWIJ-MATE J-210. CAA1.

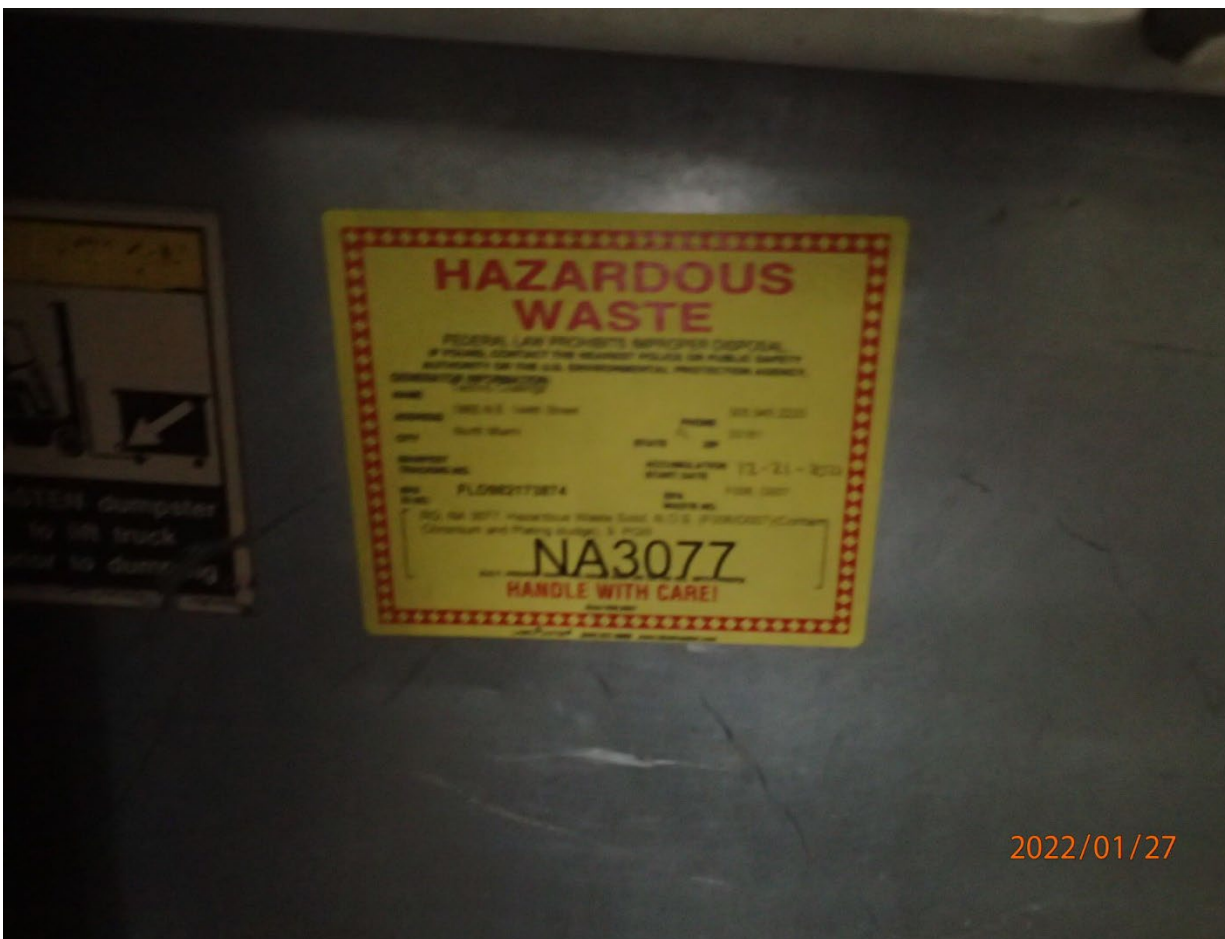
**Photo 5:** The metal container box under the sludge dryer was labeled “Hazardous Waste—Chromium Plating Sludge” and dated 12/21/2021. The container also had a Class 9 D.O.T. placard which represents “miscellaneous good” and does not specify the specific hazards.

**Pursuant to Fla. Admin. Code Ann. r. 62-730.160(1) [40 CFR 262.17(a)(5)(i)(B)], A large quantity generator must mark or label its containers with the following: (B) An indication of the hazards of the contents (examples include, but are not limited to, the applicable hazardous waste characteristic(s) (i.e., ignitable, corrosive, reactive, toxic); hazard communication consistent with the Department of Transportation requirements at 49 CFR**

**part 172 subpart E (labeling) or subpart F (placarding); a hazard statement or pictogram consistent with the Occupational Safety and Health Administration Hazard Communication Standard at 29 CFR 1910.1200; or a chemical hazard label consistent with the National Fire Protection Association code 704).**

CORRECTED ONSITE: Mr. Rojas immediately marked the container with the word “Toxic”.

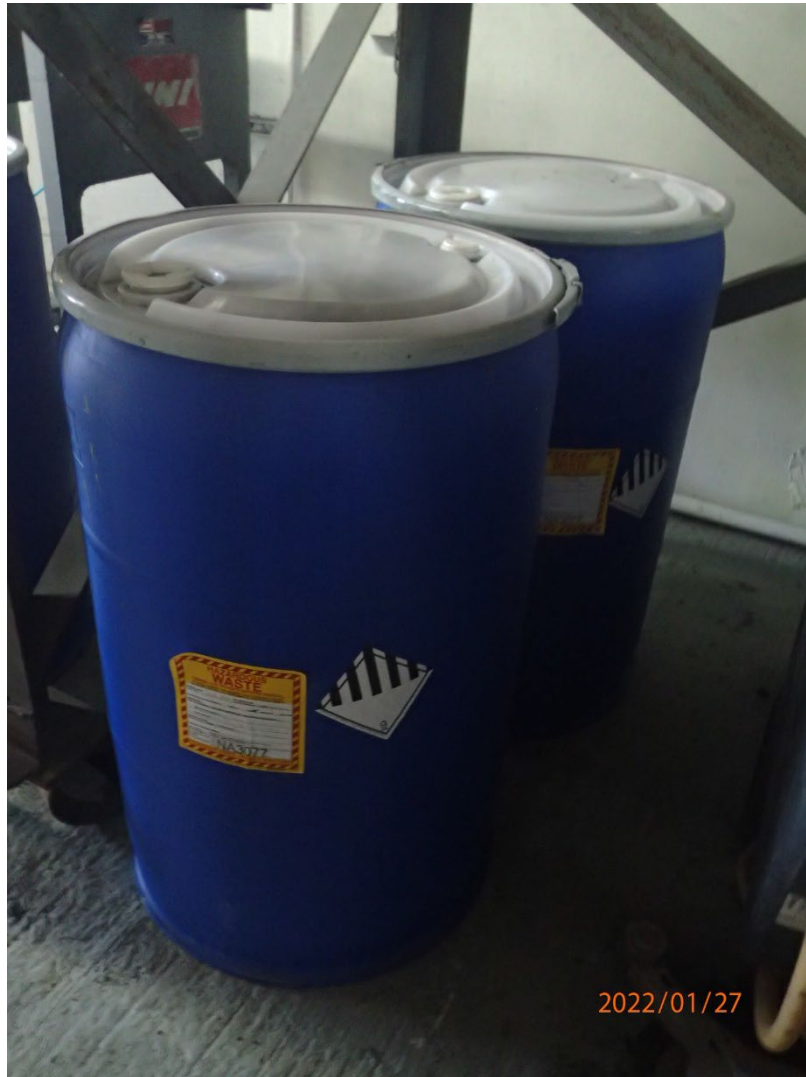
**Photo 6:** Wastewater treatment sludge with a hazardous waste label that contained the accumulation start date and marked for Toxic. CAA1.

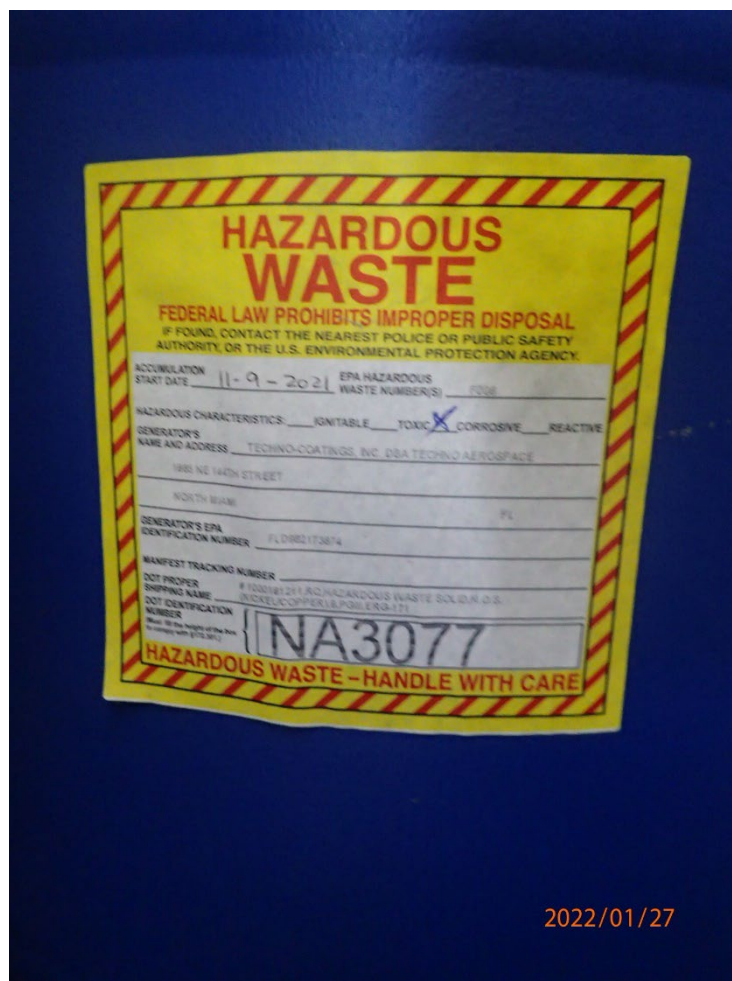
**Photo 7:** Close-up of hazardous waste label of wastewater treatment sludge marked toxic.

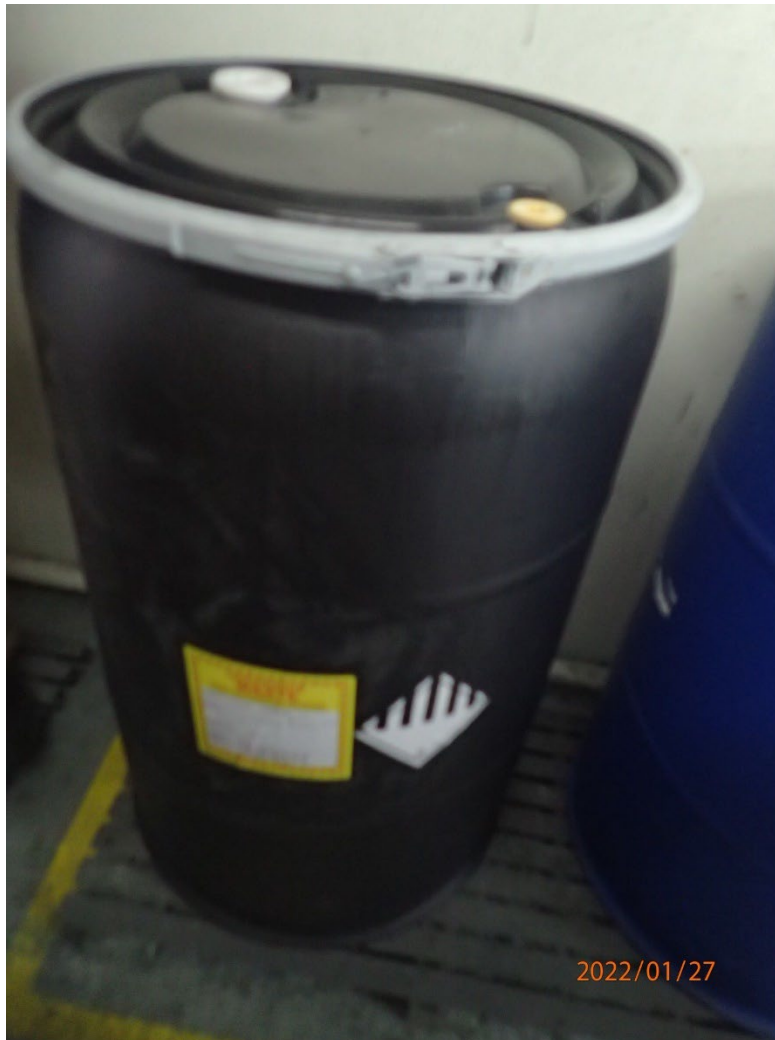
**Photo 8:** Wastewater treatment sludge with a hazardous waste label that contained the accumulation start date and marked for Toxic. CAA1.

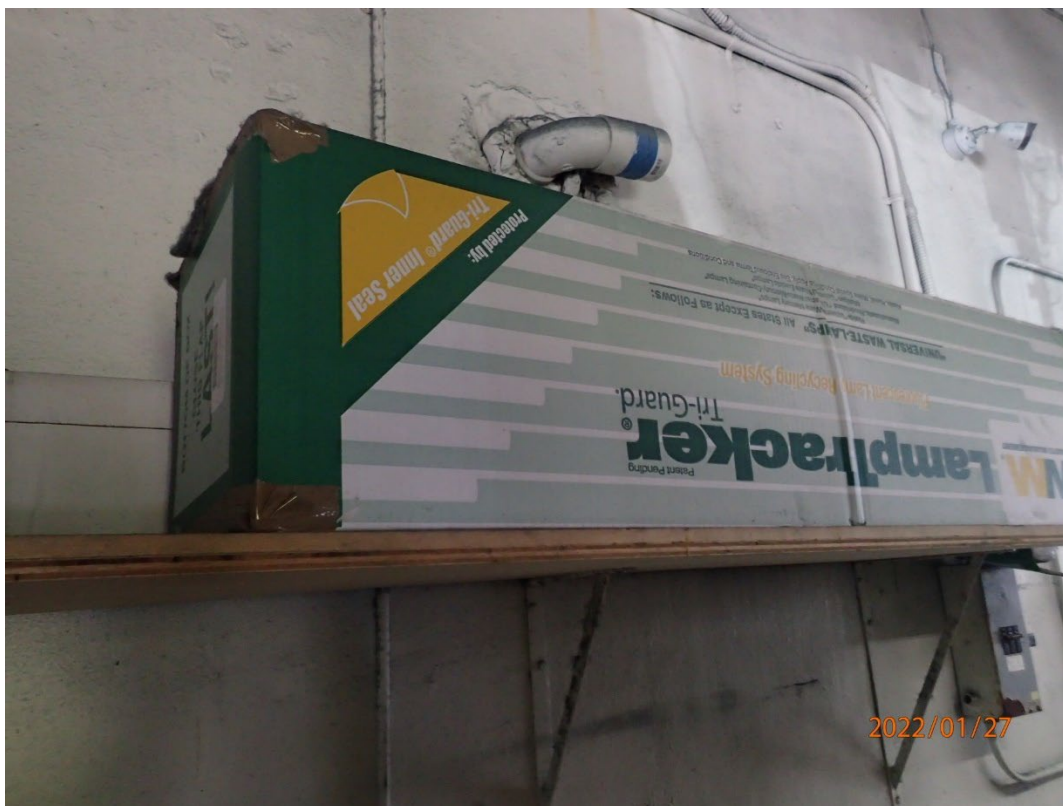
**Photo 10:** Two cardboard boxes of spent mercury lamps labeled “Universal Waste”, closed, and dated 11/01/2021. CAA1.

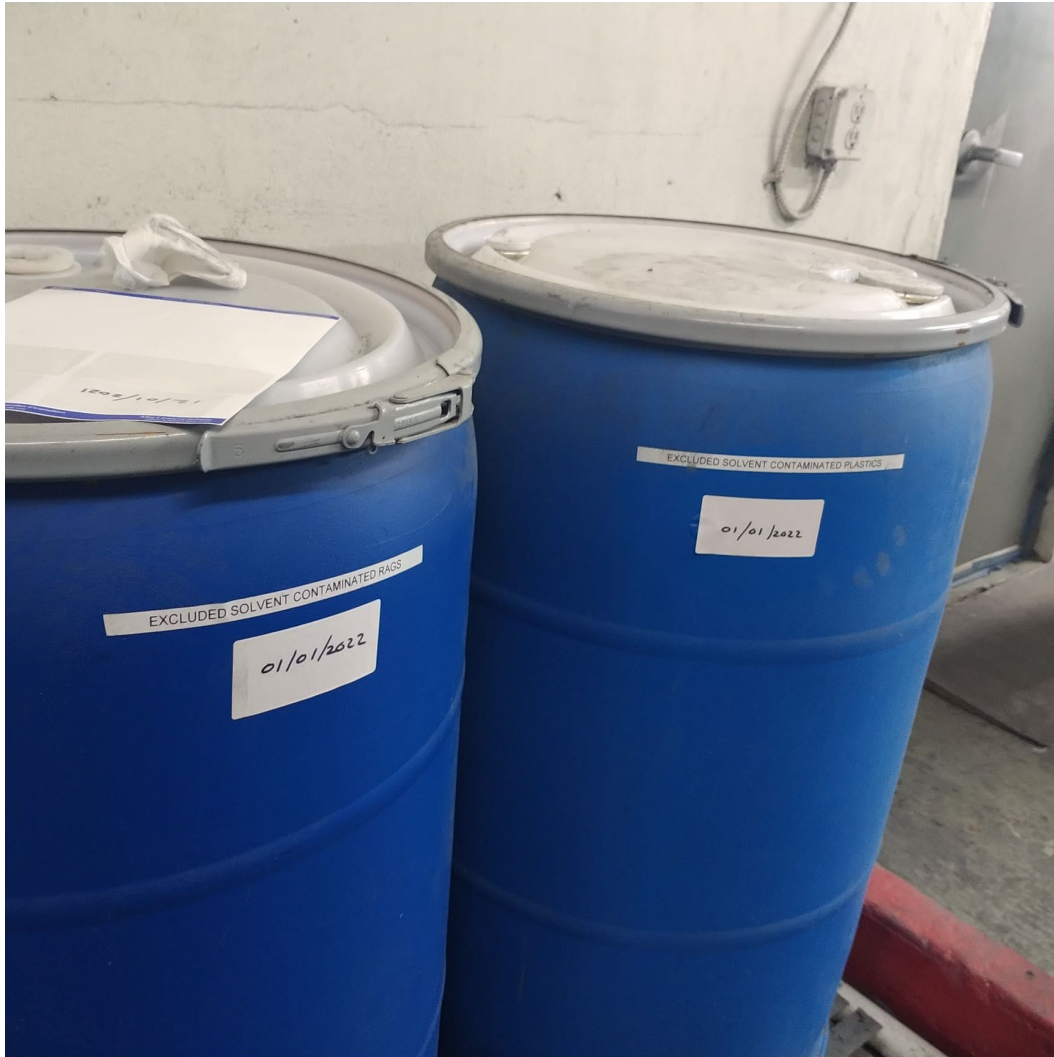
UPDATE: Following the inspection on January 27, 2022, Mr. Rojas submitted photos of the containers with excluded solvent contaminated rags with accumulation start dates. (Photo #11)

**Photo 11:** Excluded solvent contaminated rags with accumulation start dates. CAA1.

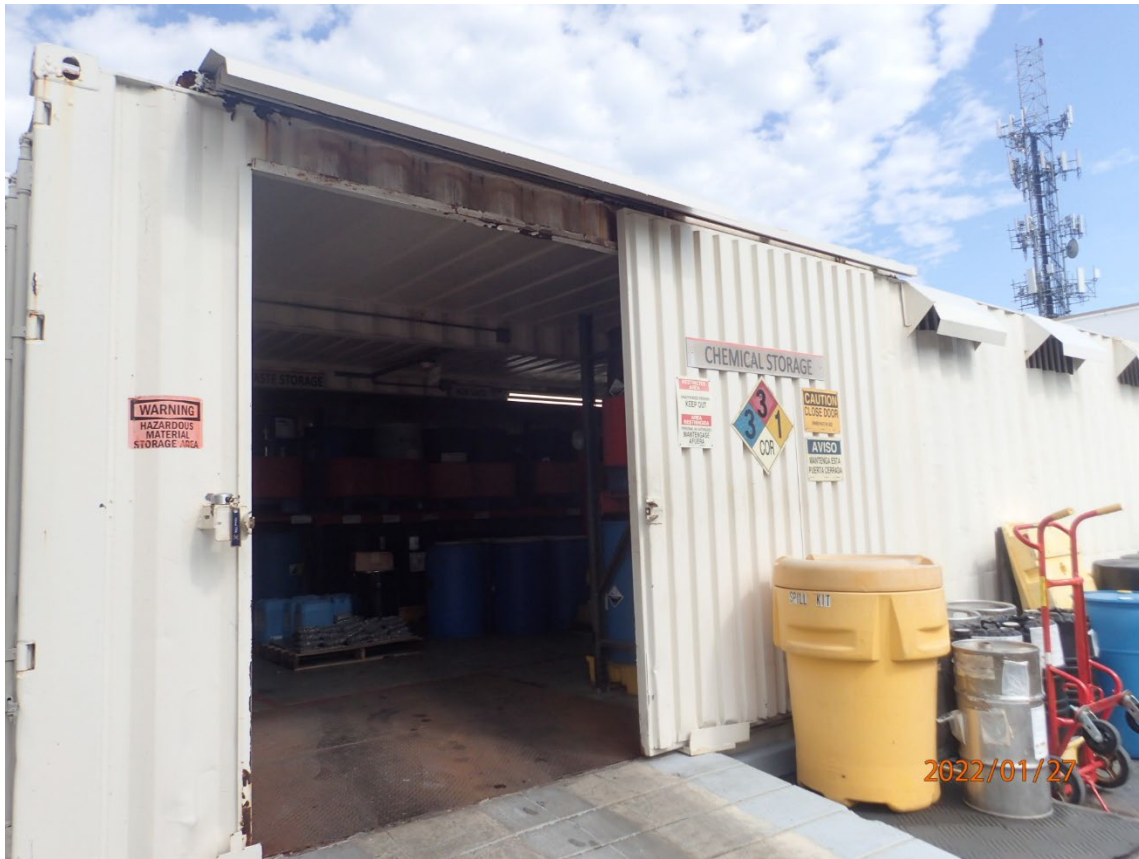
The Chemical storage is a cargo container building located next to the Shipping Area. The building has signage that reads “Waste Storage” and “Hazardous Material Storage Area” with an NFPA placard. Fire extinguishers, a spill kit, and an eyewash station are located near the CAA as well as throughout the facility. The chemical storage contains chemical products and the second 90-day CAA for hazardous waste (Photo #12, #13, and #14). Adequate aisle space was observed. The inspectors observed the following waste:

**Photo 12:** Chemical storage and CAA2.

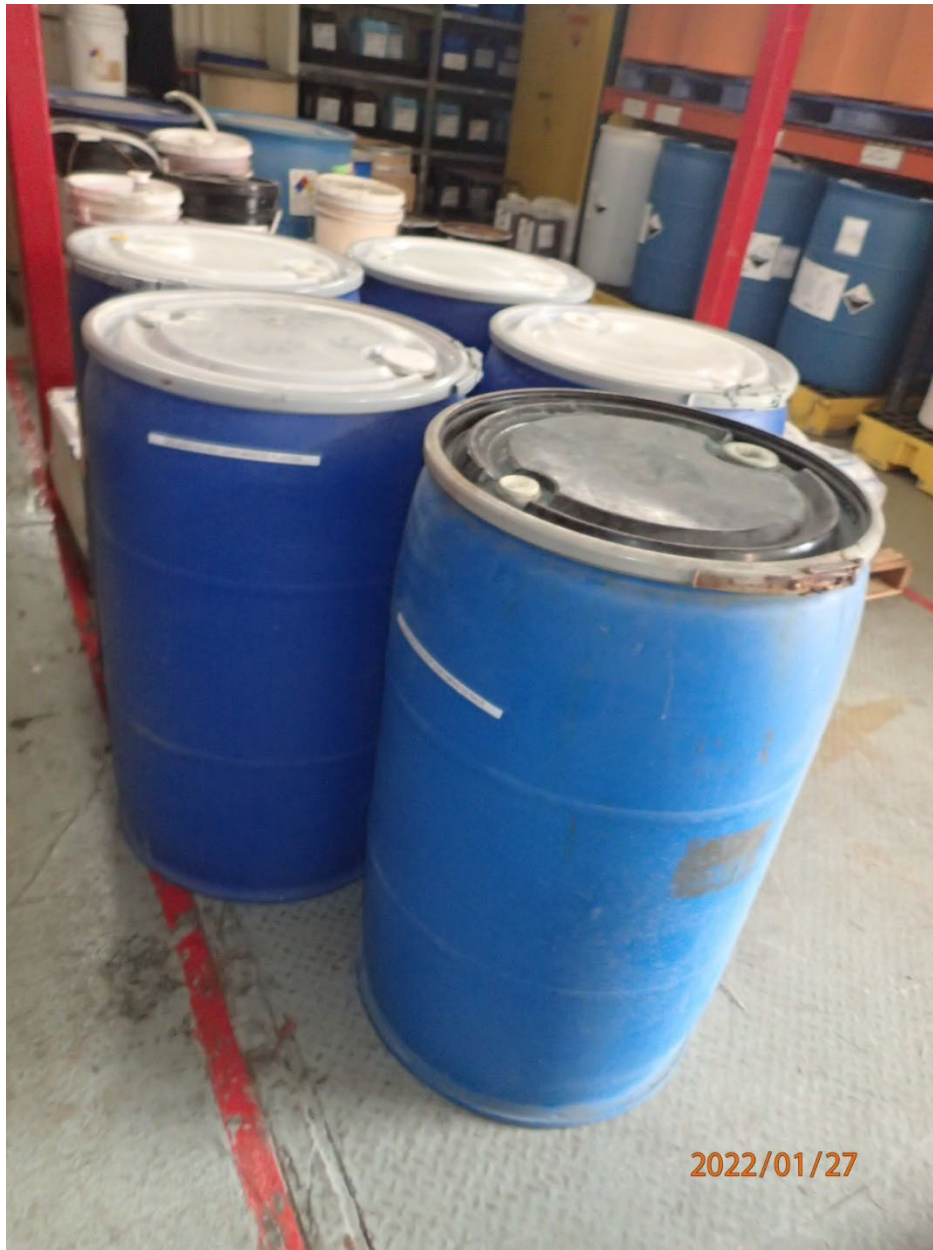
- Four (4) 55-gallon closed drums of nickel/ copper hazardous waste solids, labeled “Hazardous Waste”, with the earliest date being November 1, 2021, and marked with an indication of hazard.
- One (1) 55-gallon closed drums of spent nitric acid labeled “Hazardous Waste”, dated November 19, 2021, and marked with an indication of hazard.
- One (1) 55-gallon closed drums of spent plating filters labeled “Hazardous Waste”, dated December 30, 2021, and marked with an indication of hazard.
- One (1) 55-gallon closed drum of excluded solvent-contaminated rags, labeled, no accumulation start date (Photo 15).
- One (1) 55-gallon closed drum of excluded solvent-contaminated plastics.

**Photo 15:** CAA2—excluded solvent contaminated rags with no start accumulation date.

**Pursuant to Fla. Admin. Code Ann. r. 62-730.030(1) [40 CFR 261.4(b)(18)(v)(B)], Generators must maintain at their site the following documentation: (B) Documentation that the 180-day accumulation time limit in 40 CFR 261.4(b)(18)(ii) is being met.**

UPDATE: Following the inspection on 01/27/2022, Mr. Rojas submitted photos of the containers with excluded solvent contaminated rags with accumulation start dates. (Photo #16).

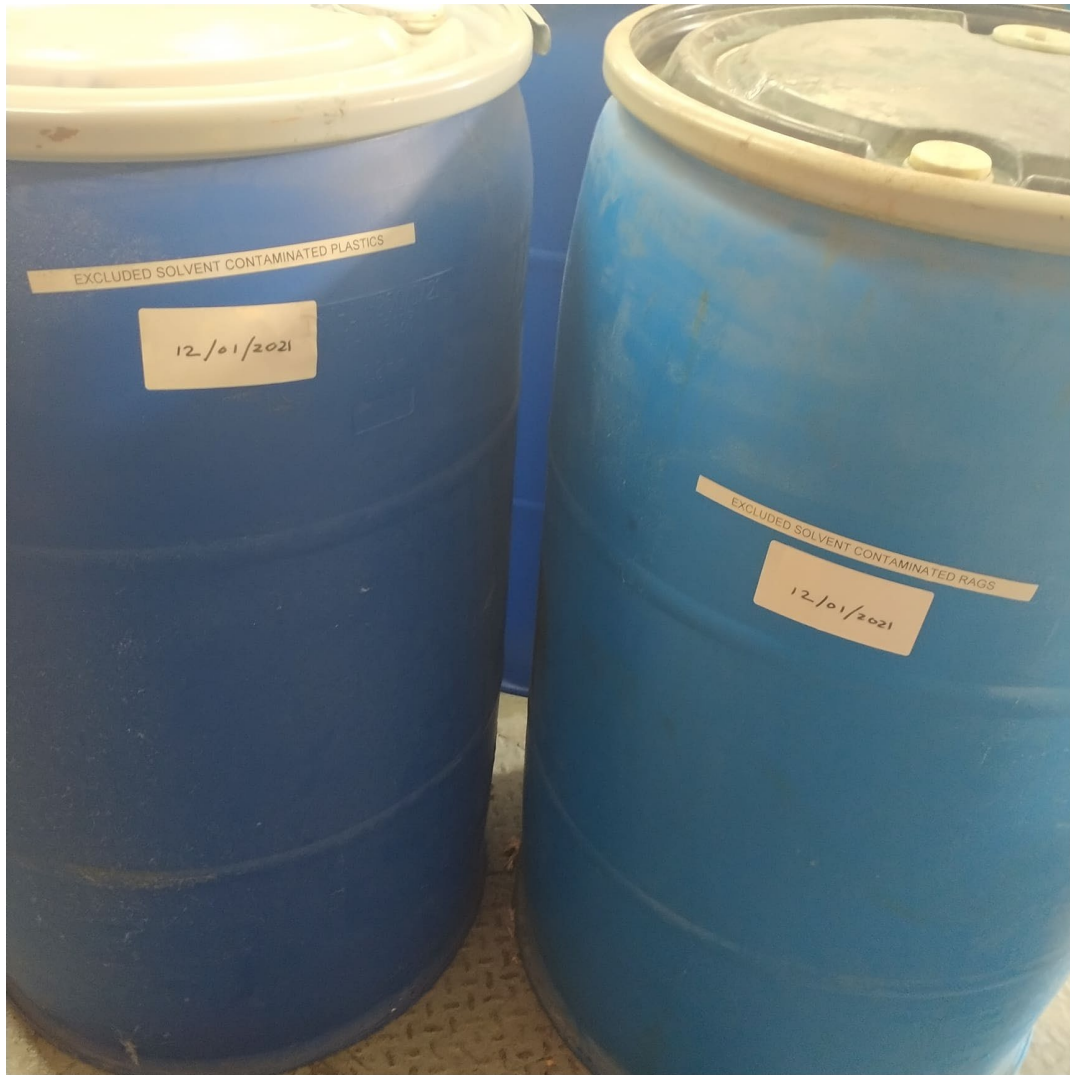
**Photo 16:** Excluded solvent contaminated rags with accumulation start dates.

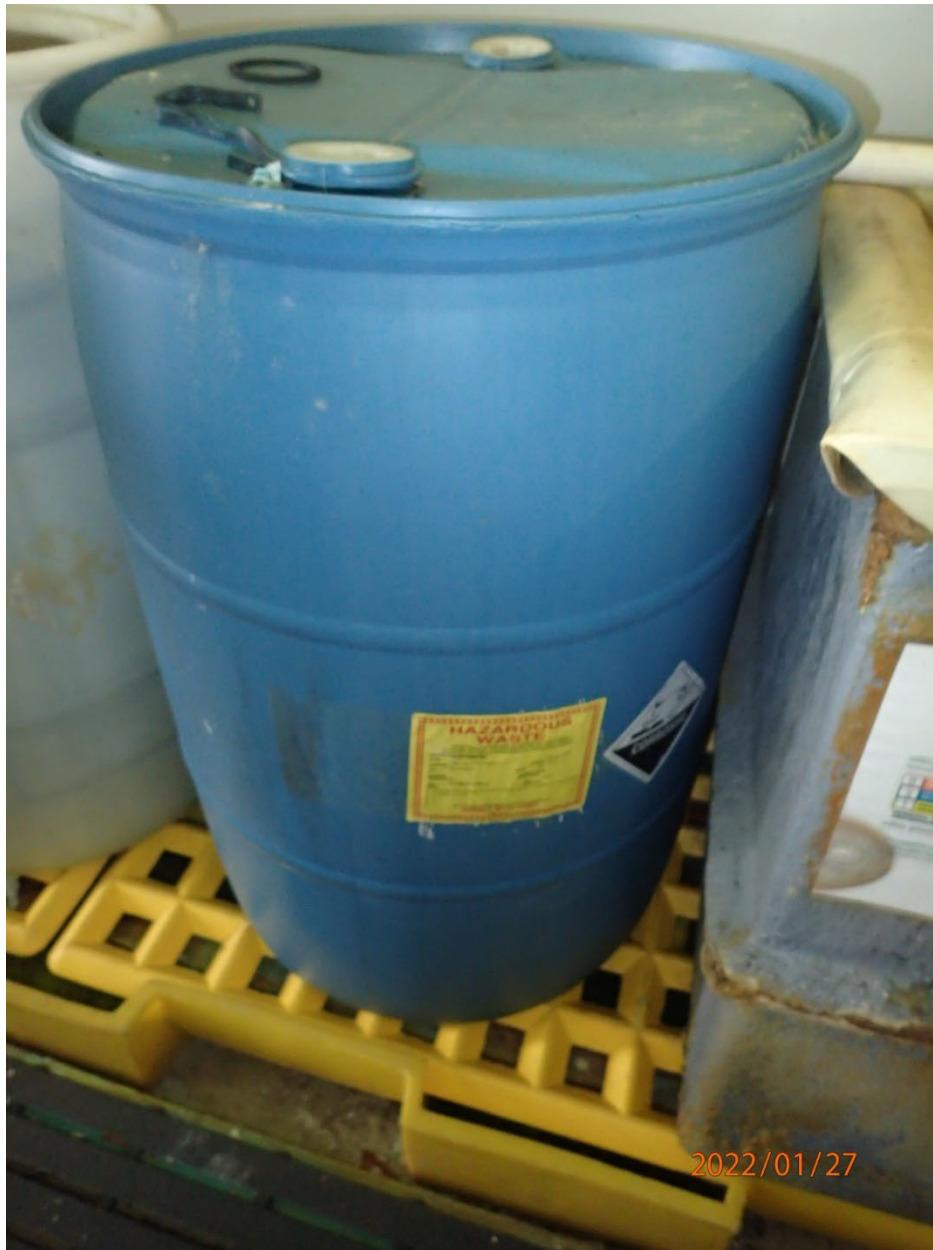
one (1) 55-gallon closed drum of sulfuric acid, labeled “Hazardous Waste”, and marked with an indication of hazard (Photo #17).

**Photo 17:** One (1) 55-gallon closed drum of sulfuric acid, labeled “Hazardous Waste”, and marked with an indication of hazard
