SUBJECT: CLEAN AIR ACT INSPECTION REPORT
Waste Connections Winnebago Landfill, Rockford, IL

Facility Name: Waste Connections Winnebago Landfill

Purpose of Inspection: To determine Clean Air Act (CAA) compliance and perform a comparative Surface Emissions Monitoring (SEM) survey

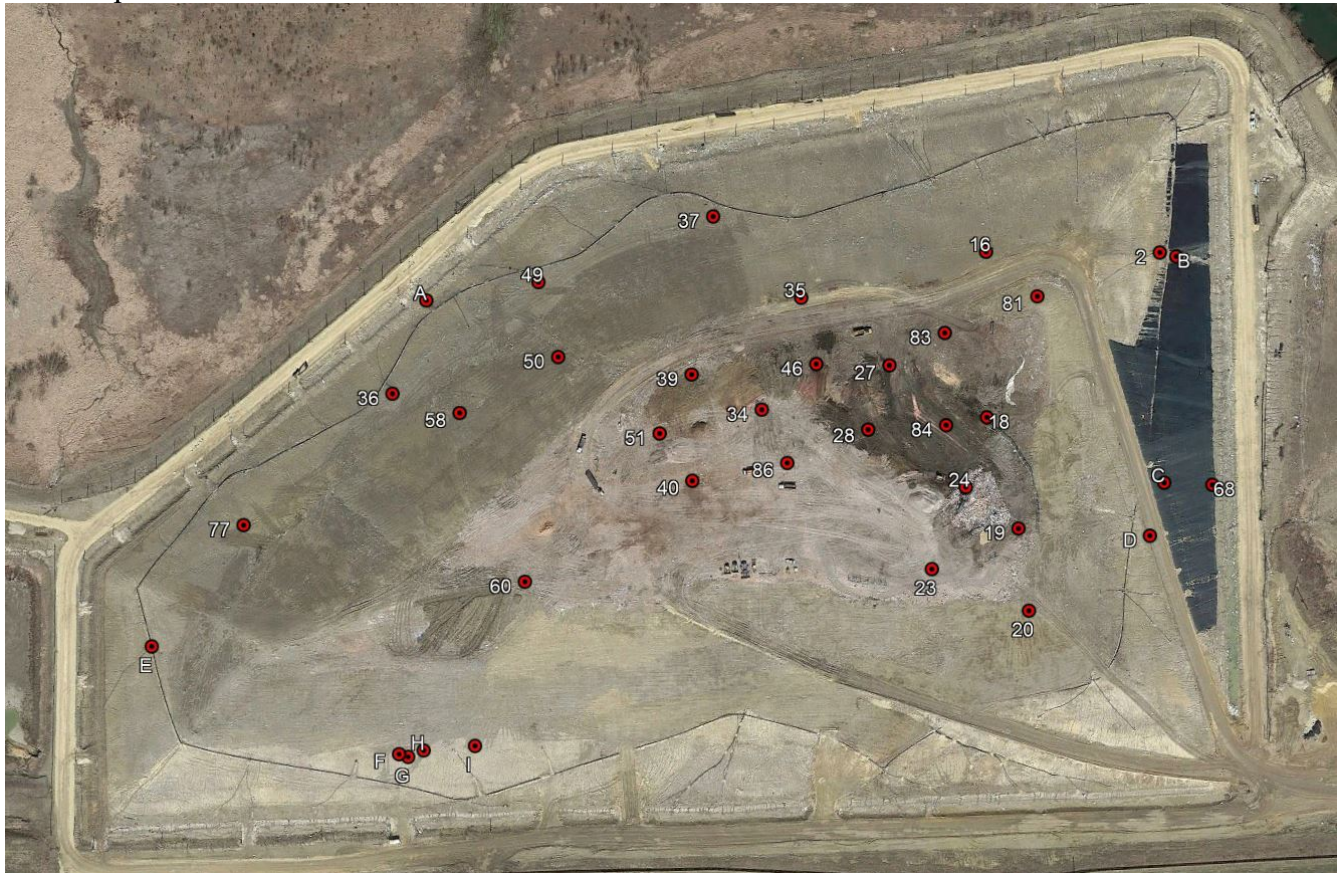
West Expansion Unit

Well Number or Map Label	Latitude	Longitude	Reading 1 Value (ppm)	Reading 1 Inst	Reading 2 Value (ppm)	Reading 2 Inst	Other Notes
D	42.152918	-89.066368	500	KL	396	KL	
C	42.153208	-89.06625	360	KL	300	KK	
68	42.153189	-89.065892	650	KL	500	KK	
77	42.153121	-89.073107	13000	KL	10000	KK	
B	42.154454	-89.066112	500	KK	315	KL	
2	42.154478	-89.066233	500	KK	430	KL	
36	42.153822	-89.071972	6000	KL	1%	KK	
37	42.154748	-89.069548	14000	KL	3%	KK	
49	42.154414	-89.070862	6000	KL	12000	KK	
A	42.154331	-89.0717	8746	KJ	6000	KL	Gurgling, possible leachate problems
60	42.152764	-89.071027	1%	KK	800	JH	
23	42.152769	-89.067997	1000	KK	3315	JH	flag from Q1 March
20	42.152524	-89.067284	1000	KK	250	JH	
19	42.152979	-89.067344	1800	DJH	1100	JH	
24	42.153215	-89.067727	2400	DJH	5800	JH	Prior Flag
84	42.15356	-89.06786	800	DJH	950	JH	Prior Flag
18	42.153597	-89.067555	5%	DJH	2500	JH	Prior Flag
81	42.154256	-89.067154	2%	DJH	1300	JH

16	42.15451	-89.067526	1.30%	DJH	3717	JH

Well Number or Map Label	Latitude	Longitude	Reading 1 Value (ppm)	Reading 1 Inst	Reading 2 Value (ppm)	Reading 2 Inst	Other Notes
35	42.154286	-89.068911	2000	DJH	4525	JH	
39	42.15388	-89.069742	1.20%	DJH	8715	JH	
34	42.153675	-89.069228	4.20%	DJH	5.5%	JH	
46	42.153918	-89.068813	3%	DJH	2.8%	JH	
27	42.153899	-89.068269	2200	DJH	1750	JH	
83	42.154069	-89.06785	1700	DJH	1225	JH	
28	42.153548	-89.068441	4500	DJH	1503	JH	
86	42.153377	-89.06905	5%	DJH	2.6%	JH	
40	42.153294	-89.06976	6000	DJH	2300	JH	
51	42.15356	-89.069993	3.50%	JH			
50	42.153998	-89.070731	1900	JH			
58	42.153705	-89.071476	3250	JH			
E	42.1524667	-89.073817	503	KJ			
F	42.1518333	-89.072	667	KJ			
G	42.1518167	-89.071933	1930	KJ			
H	42.15185	-89.071817	516	KJ			
I	42.1518667	-89.071433	1118	KJ

Map of Detected Hits

SEM hit locations plotted over satellite imagery from April 7, 2019 as depicted on Google Earth.

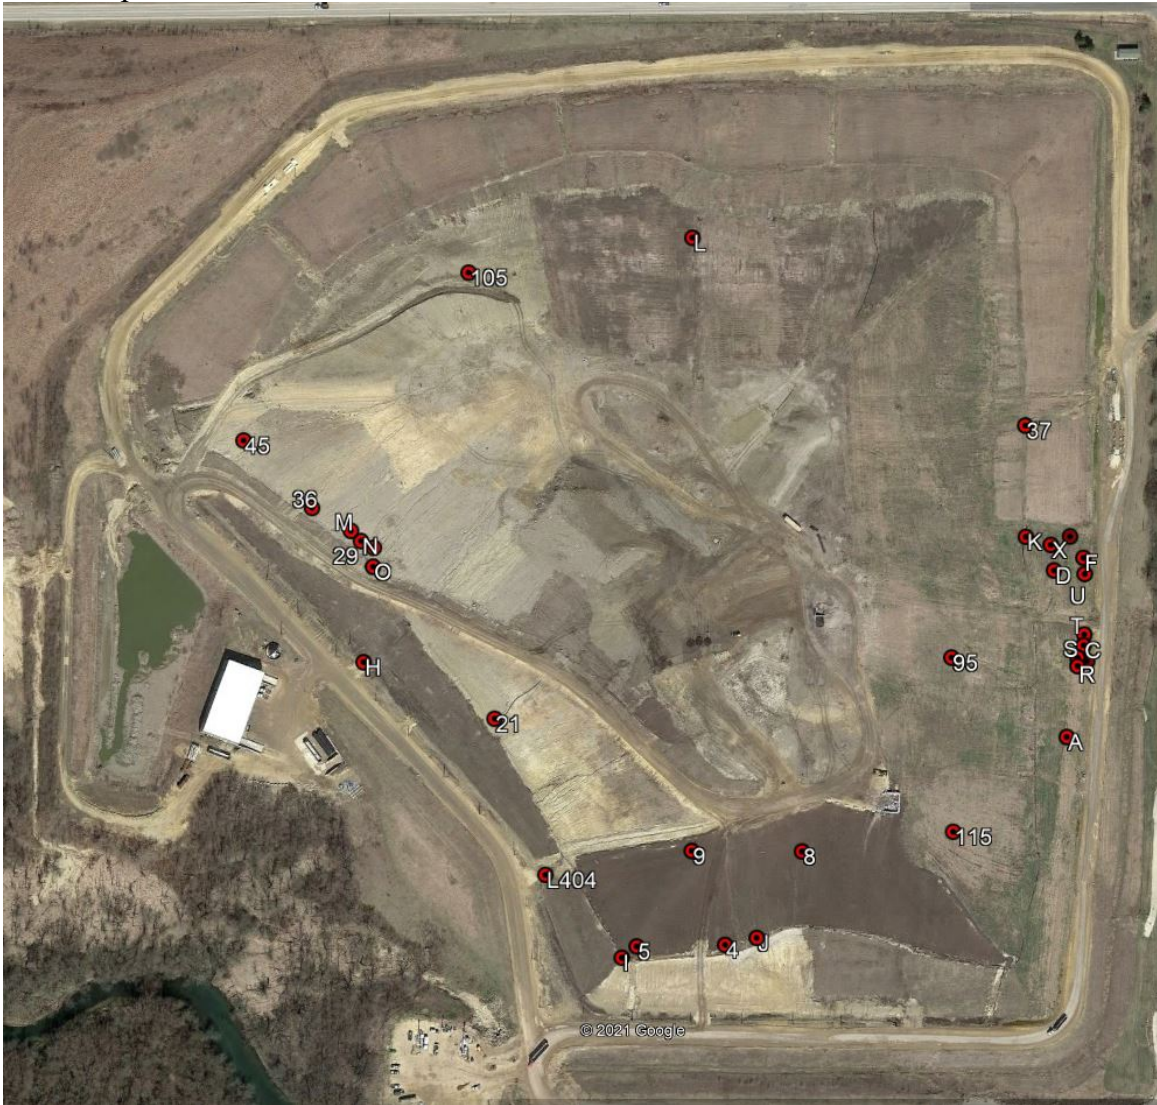
North Expansion Unit

Well Number or Map Label	Latitude	Longitude	Reading 1 Value (ppm)	Reading 1 Inst	Reading 2 Value (ppm)	Reading 2 Inst	Other Notes
A	42.161223	-89.05788	788	KL	476	KJ	
B	42.161662	-89.057726	820	KL	520	KJ	
C	42.161754	-89.057755	450	KL	387	KJ	
D	42.162186	-89.05799	750	KL	>300	KJ	
F	42.16226	-89.057761	2620	KL	558	KJ	Two adjacent flags
105	42.163882	-89.062575	500	KL	450	JH	
H (Leachate Riser)	42.161623	-89.06337	500	KK	460	KL	
I (NEU Header)	42.159925	-89.061337	3000	KL	2000	JH	
4	42.160004	-89.060532	600	KL	330	VM	
J (South slope header valve)	42.160046	-89.060286	1500	VM	2500	KJ	
K	42.162379	-89.058211	350	VM			generally elevated area, 100 to 200 ppm verified by Connor. Area of erosion
L	42.164094	-89.060831	350	VM	350	KL	generally elevated area, 100 to 200 ppm
45	42.1629	-89.06432	4000	DJH	1.50%	KK	Broken air line
36	42.162513	-89.063782	1195	KL	2000	KK	
M	42.162382	-89.063477	642	KL	500	KK	Erosion trench

29	42.162286	-89.063297	430	KL	450	KK	
N	42.162324	-89.063398	750	KL	1000	KK	
O	42.162176	-89.063302	1000	KK	670	JH	
L404	42.160401	-89.061938	1400	DJH	3200	JH	
5	42.159991	-89.061222	1%	KK	1500	JH	
9	42.160546	-89.060798	3%	KK	10000	KL	
8	42.160548	-89.059938	1%	KK	4000	JH	
115	42.160669	-89.05876	1%	KK	2000	JH

Well Number or Map Label	Latitude	Longitude	Reading 1 Value (ppm)	Reading 1 Inst	Reading 2 Value (ppm)	Reading 2 Inst	Other Notes
37	42.163023	-89.058223	2%	KK	1200	JH	
21	42.161302	-89.062344	1200	DJH	450	JH	
R	42.1616333	-89.0578	515	KJ			
S	42.1616833	-89.0578	315	KJ			
T	42.1618167	-89.05775	337	KJ			
U	42.1621667	-89.05775	336	KJ			
W	42.1623833	-89.057867	505	KJ			
X	42.1623333	-89.058017	1902	KJ			
95	42.161677	-89.058784	384	KJ
