**Region 6 - Enforcement & Compliance Assurance Division**  
**INSPECTION REPORT**

| Inspection Date(s): | 01/30/2025 | |
| Company Name: | <b>ArklaTx Operating Co., Inc.</b> | |
| Facility Name: | <b>Spooner, WW Lease Tank Battery</b> | |

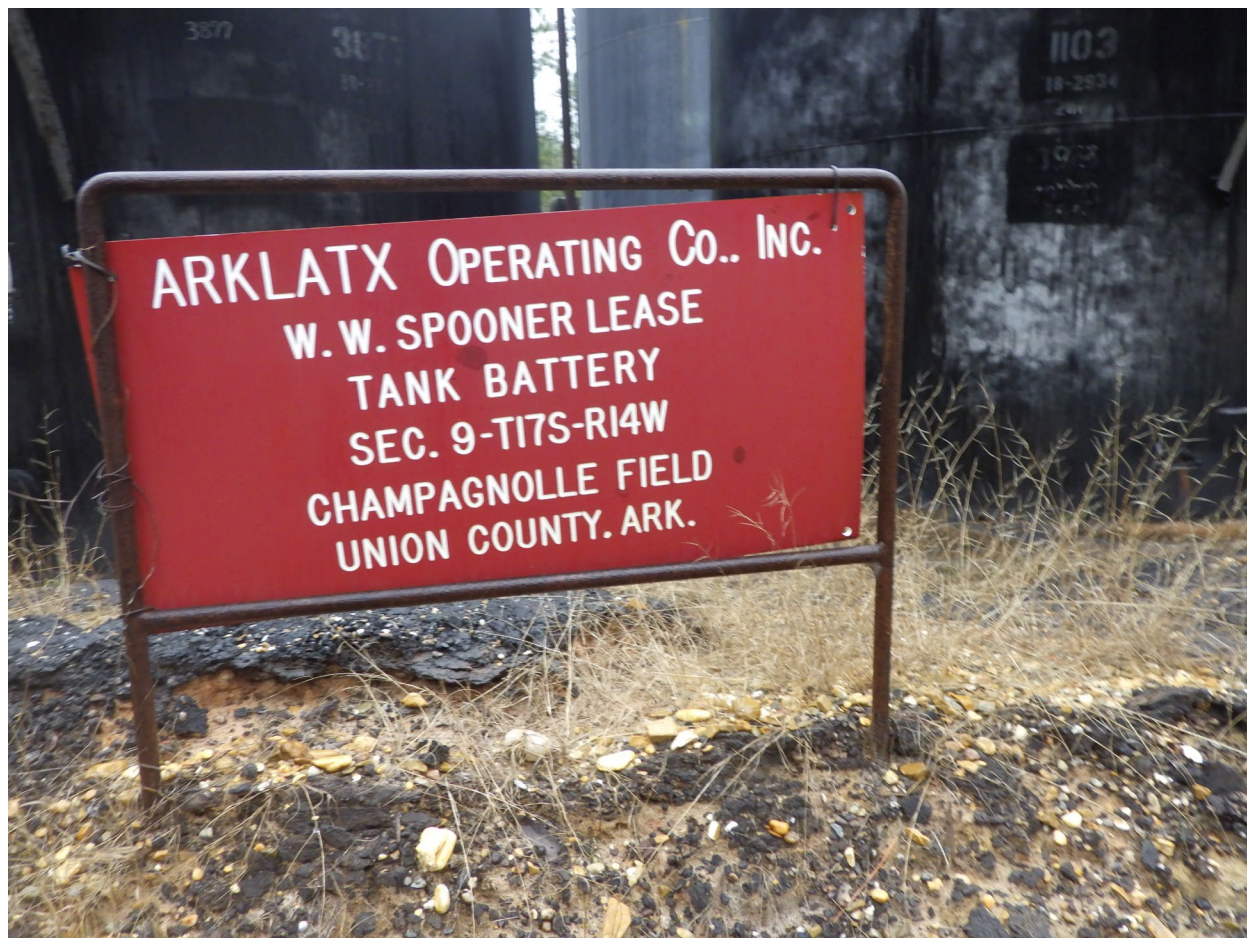
Photo No. 1

**Description:** Looking NE, this photo shows the signage for the facility.

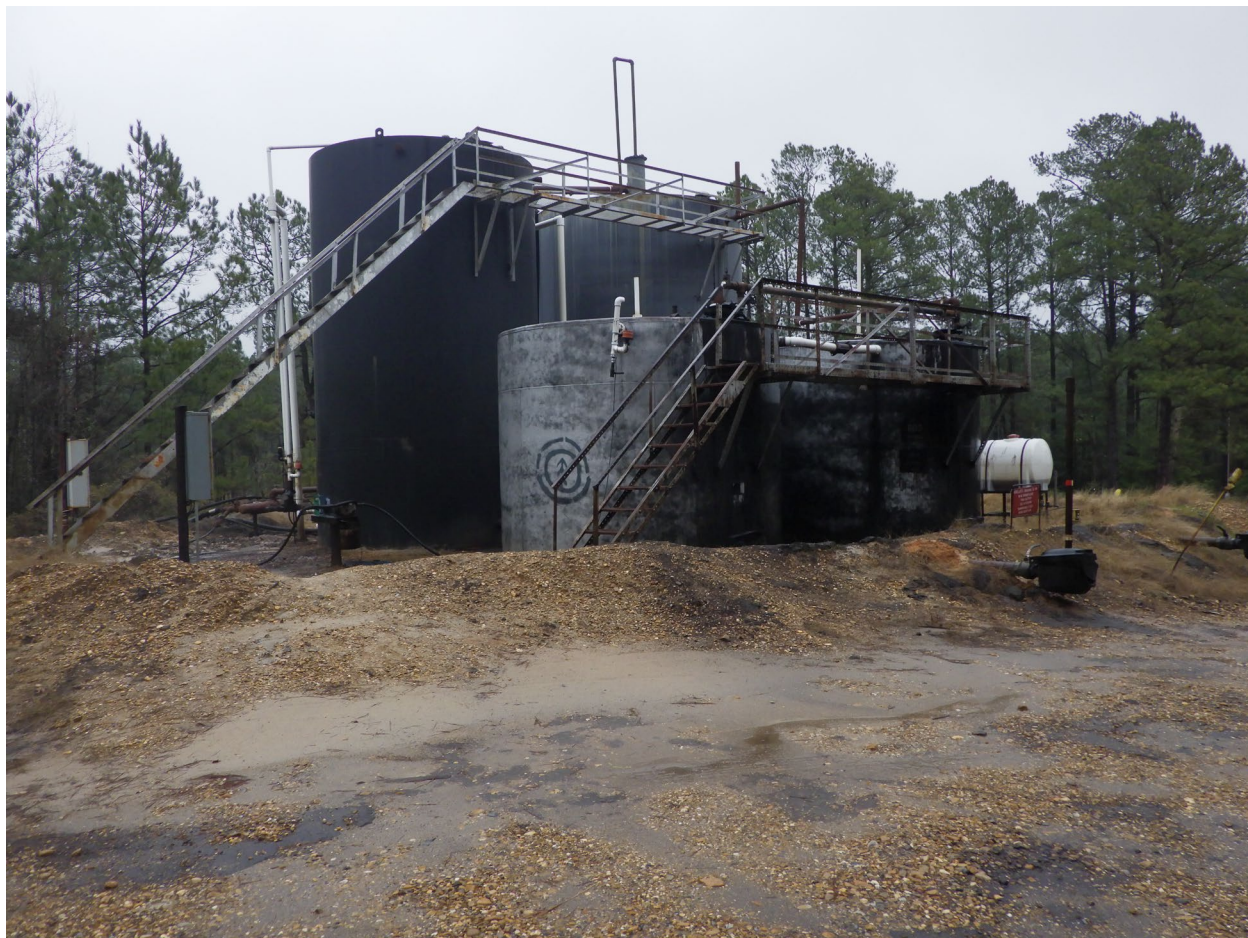
Photo No. 2

**Description:** Looking NE, this photo shows an overview of the facility.

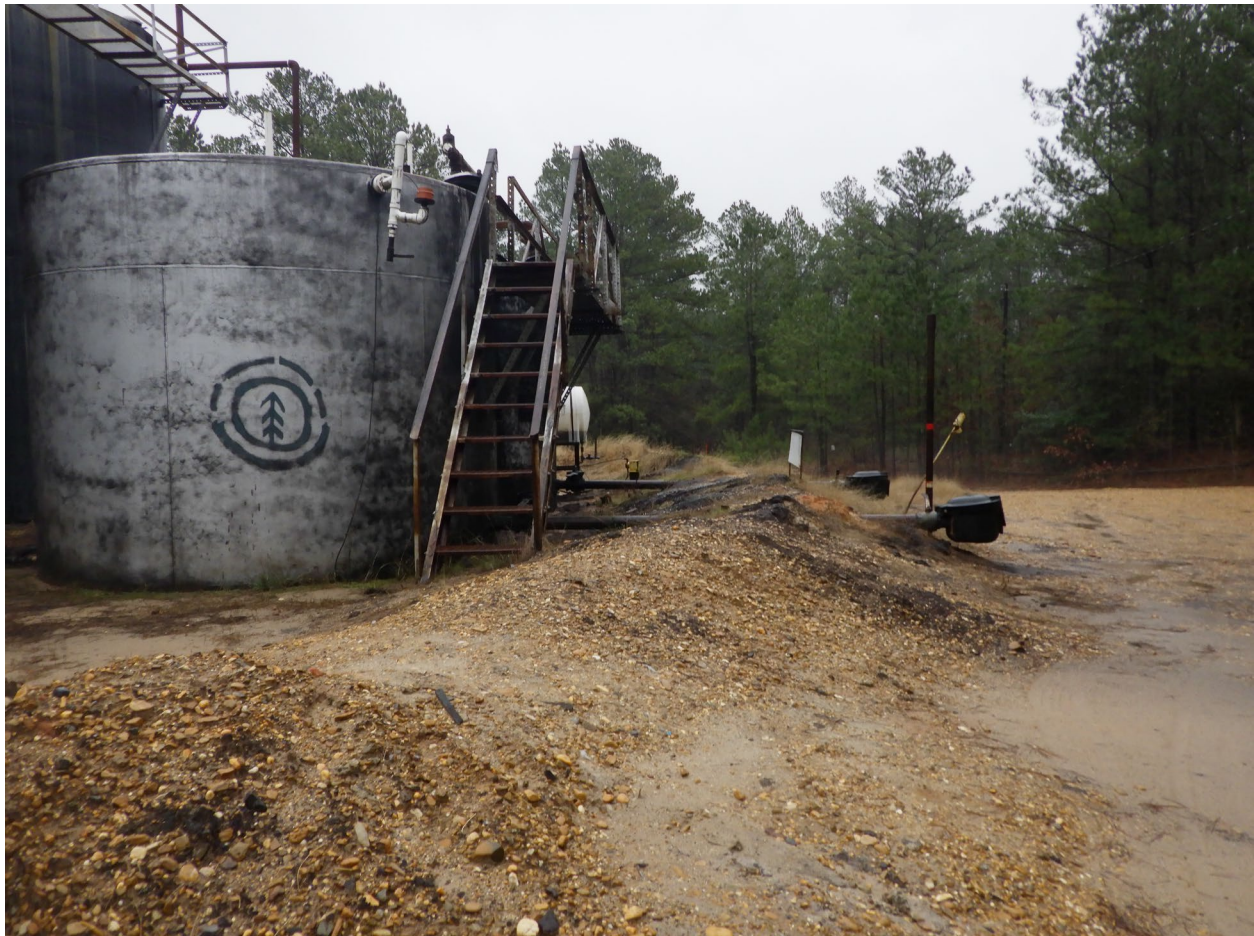
Photo No. 3

**Description:** Looking E, this photo shows the frontside of the tank battery with transfer lines and catchment for product.

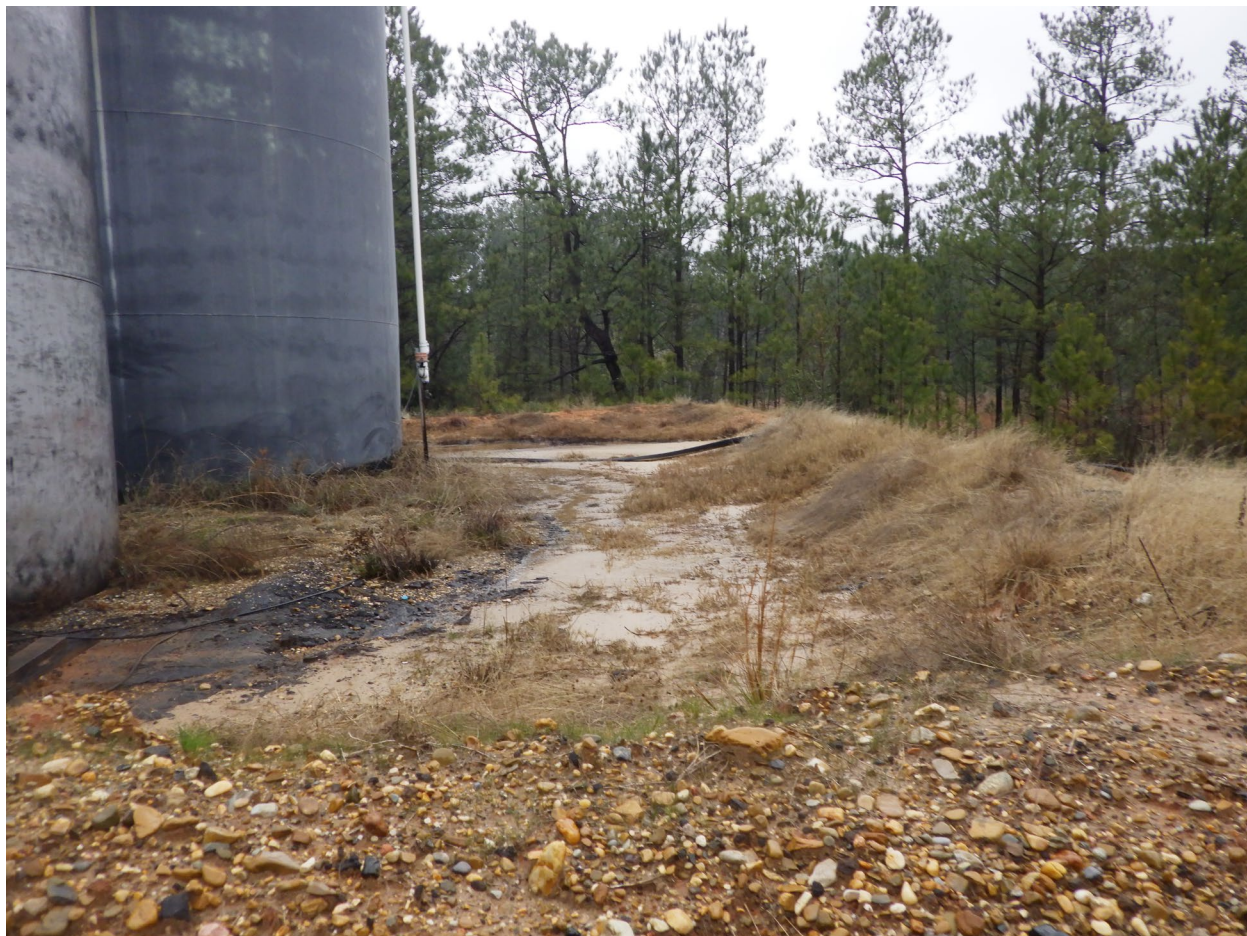
Photo No. 4

**Description:** Looking NNE, this photo shows the backside of the tank battery with some residual oil noted inside the tank battery.

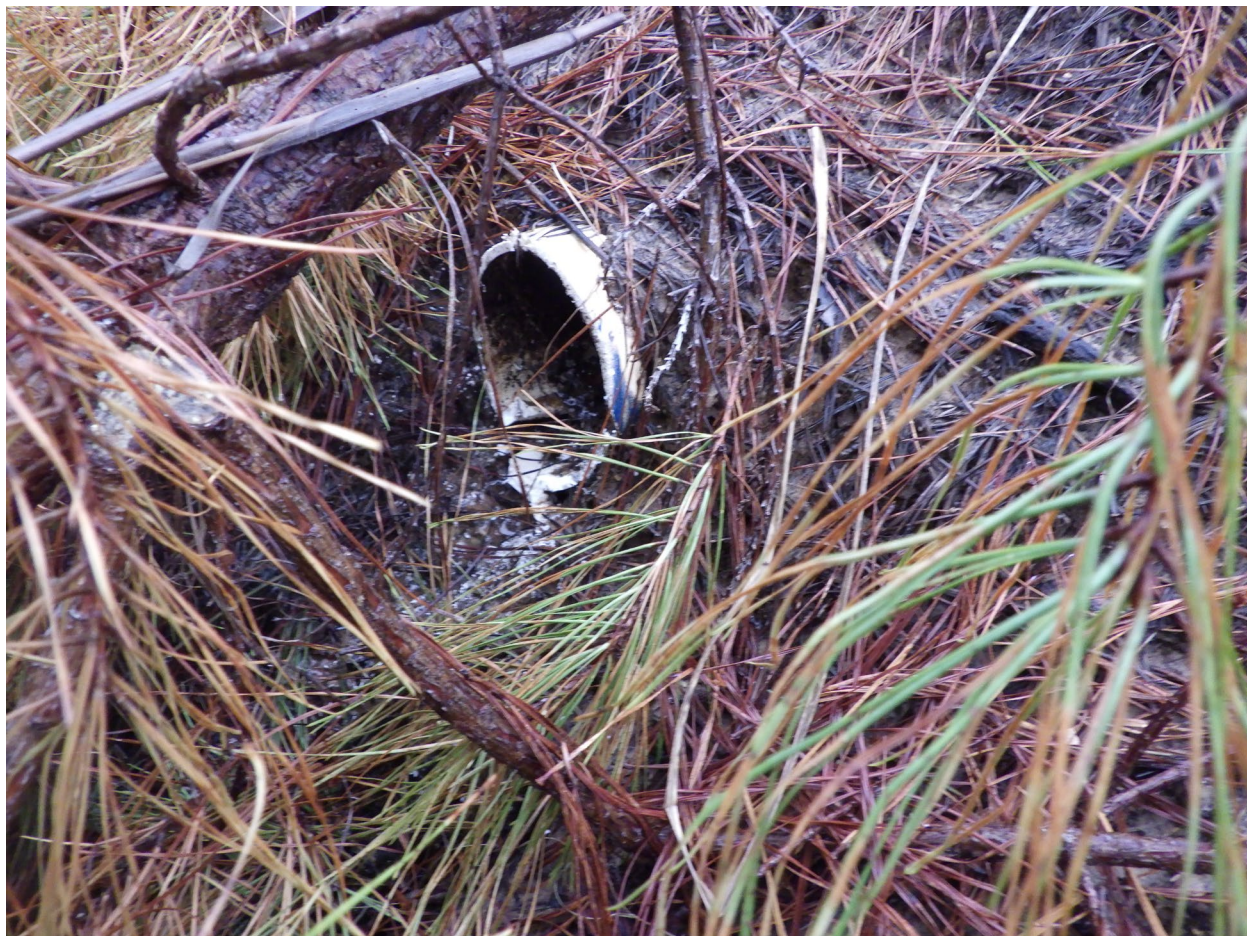
Photo No. 5

- Residual, loose crude oil inside the tank battery (Photo No. 5),
- An open pipe through the secondary containment berm of the tank battery (Photo No. 6),
- An excavated pit adjacent to the tank battery with residual, loose crude oil and a flowline passing through the earthen levee of the pit (Photo No. 7 through No. 12),
- Residual, loose oil around the SWD injection well onsite (Photo No. 14),
- Residual, loose oil around a nearby production well (Photo No. 15), and
- Elevated TDS readings from surface water of a wetland near the production well (Photos No. 17, No. 21, and No. 24).

**Description:** Looking ENE, this photo shows an open pipe coming through the secondary containment of the tank battery without a shutoff valve or cap.

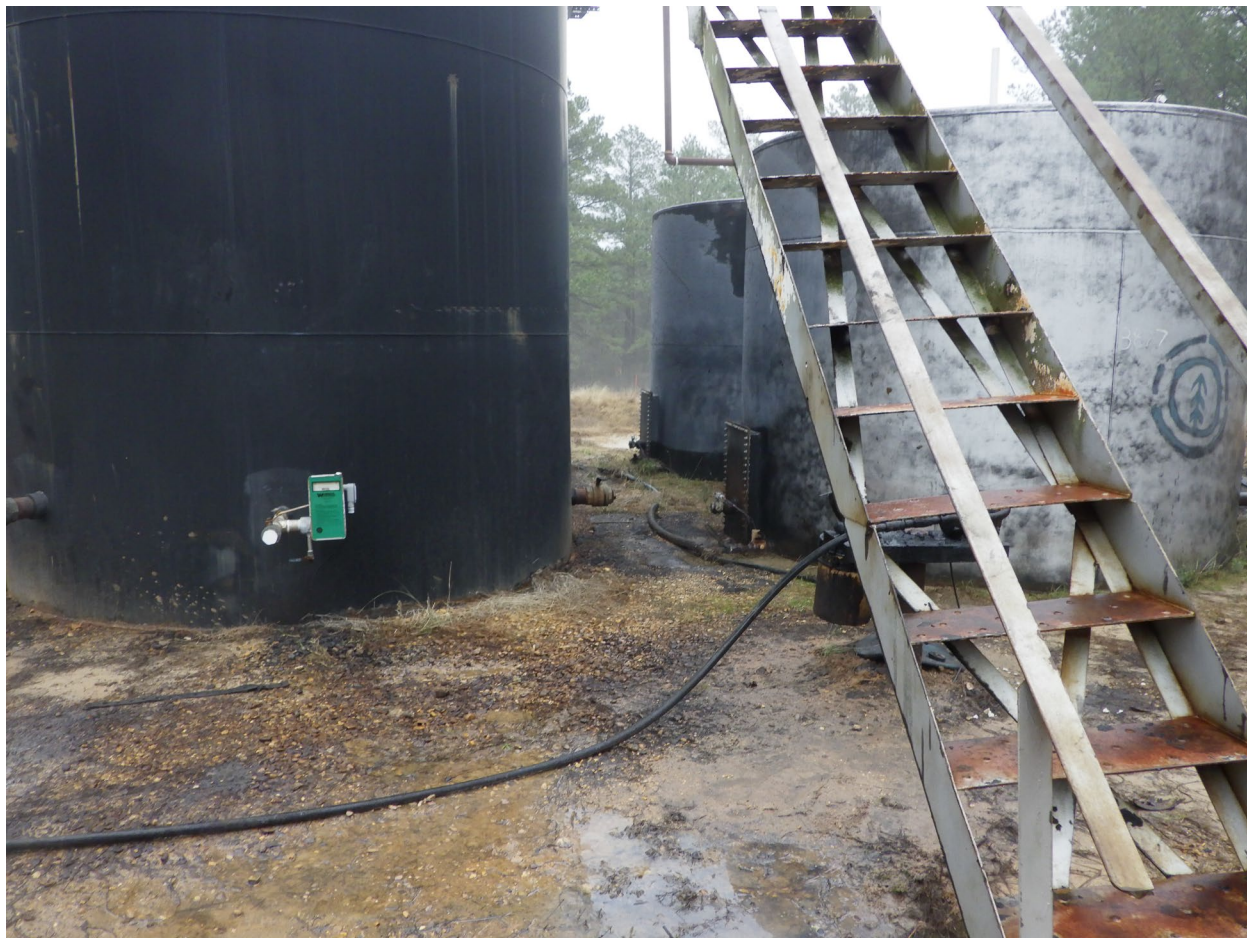
Photo No. 6

**Description:** Looking E, this photo shows residual, loose oil inside secondary containment.

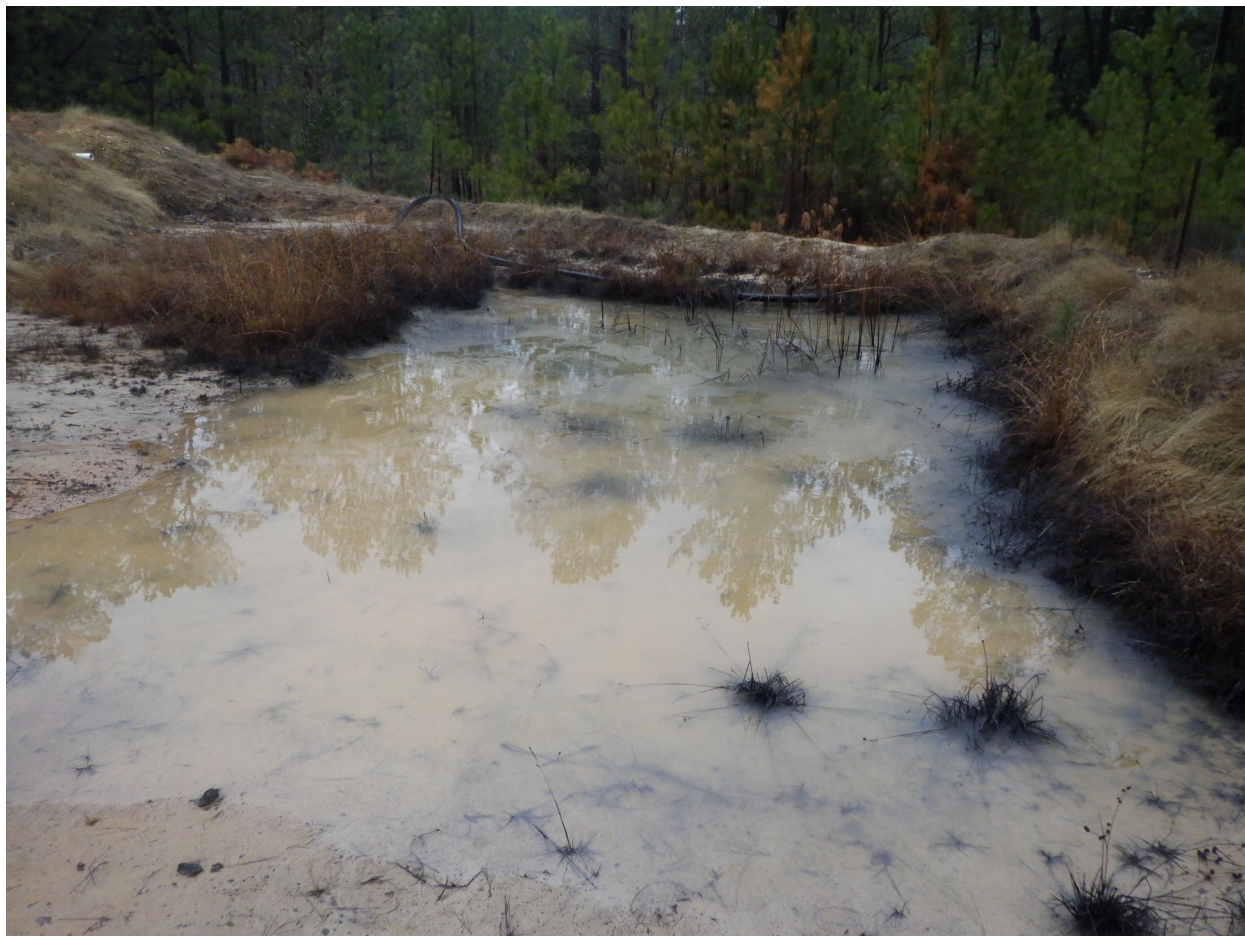
I observed an excavated pit adjacent to the tank battery, which had a drainpipe open to the pit. The pit contained residual crude oil, and there was a flowline passing through the pit's earthen levee, see Photo No. 7 through No. 12.

**Description:** Looking NNE, this photo shows a pit directly behind the drainpipe for the tank battery. Residual, loose oil staining was noted within the pit.

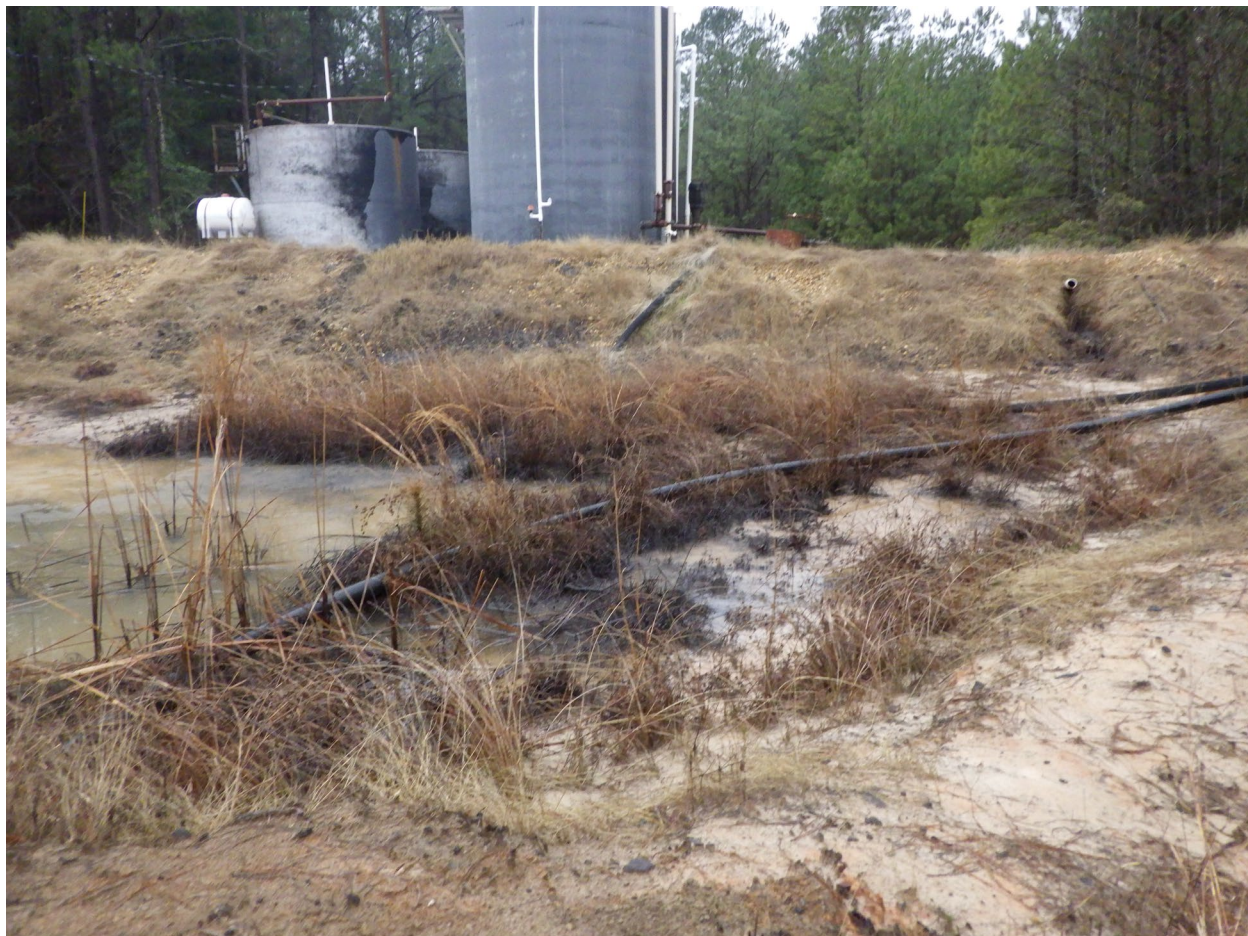
Photo No. 8

**Description:** Looking SW, this photo shows an alternate view of the pit, drainpipe, and residual oil from Photo No. 7.

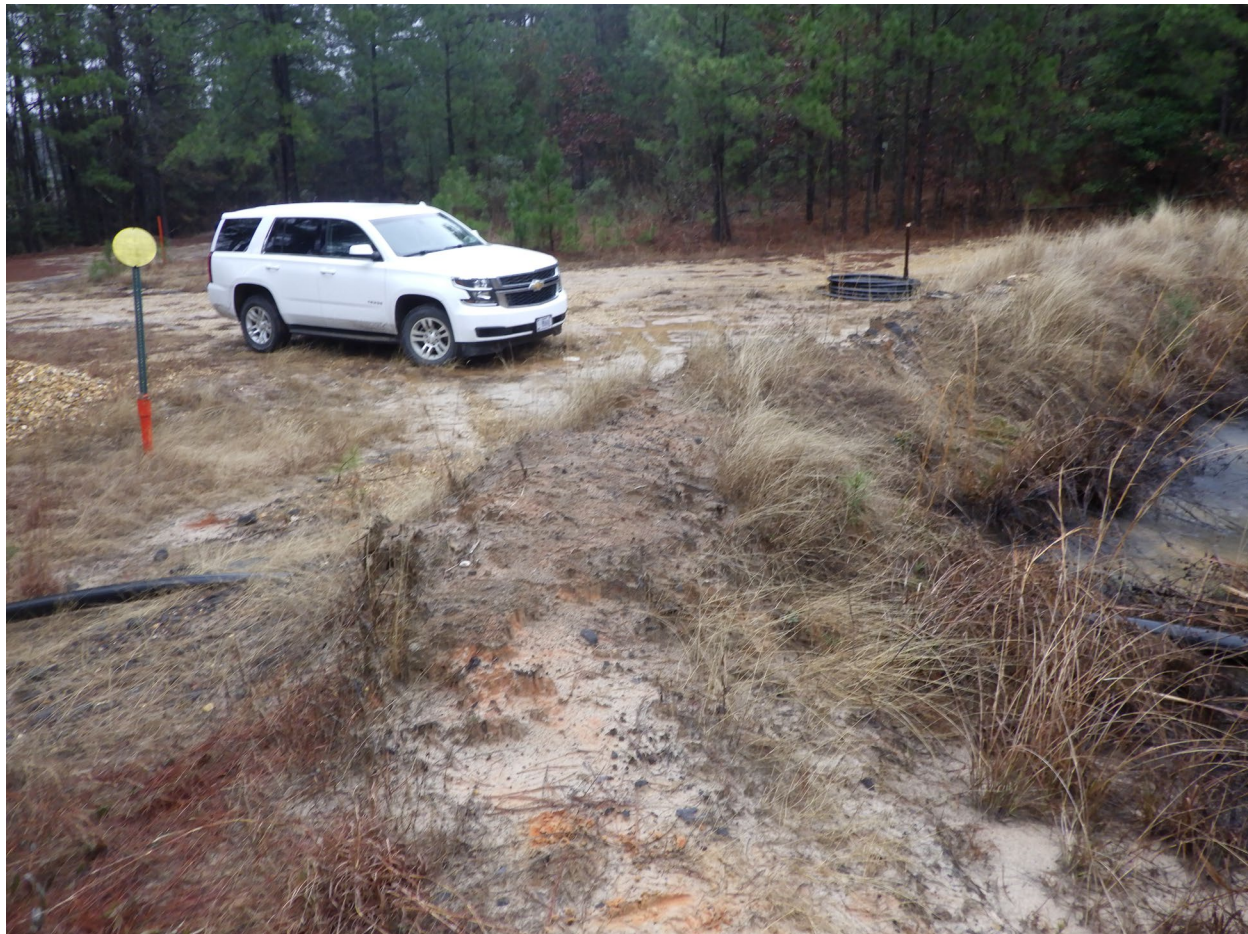
Photo No. 9

**Description:** Looking E, this photo shows a flowline ran through the levee of the pit from Photo No. 7.

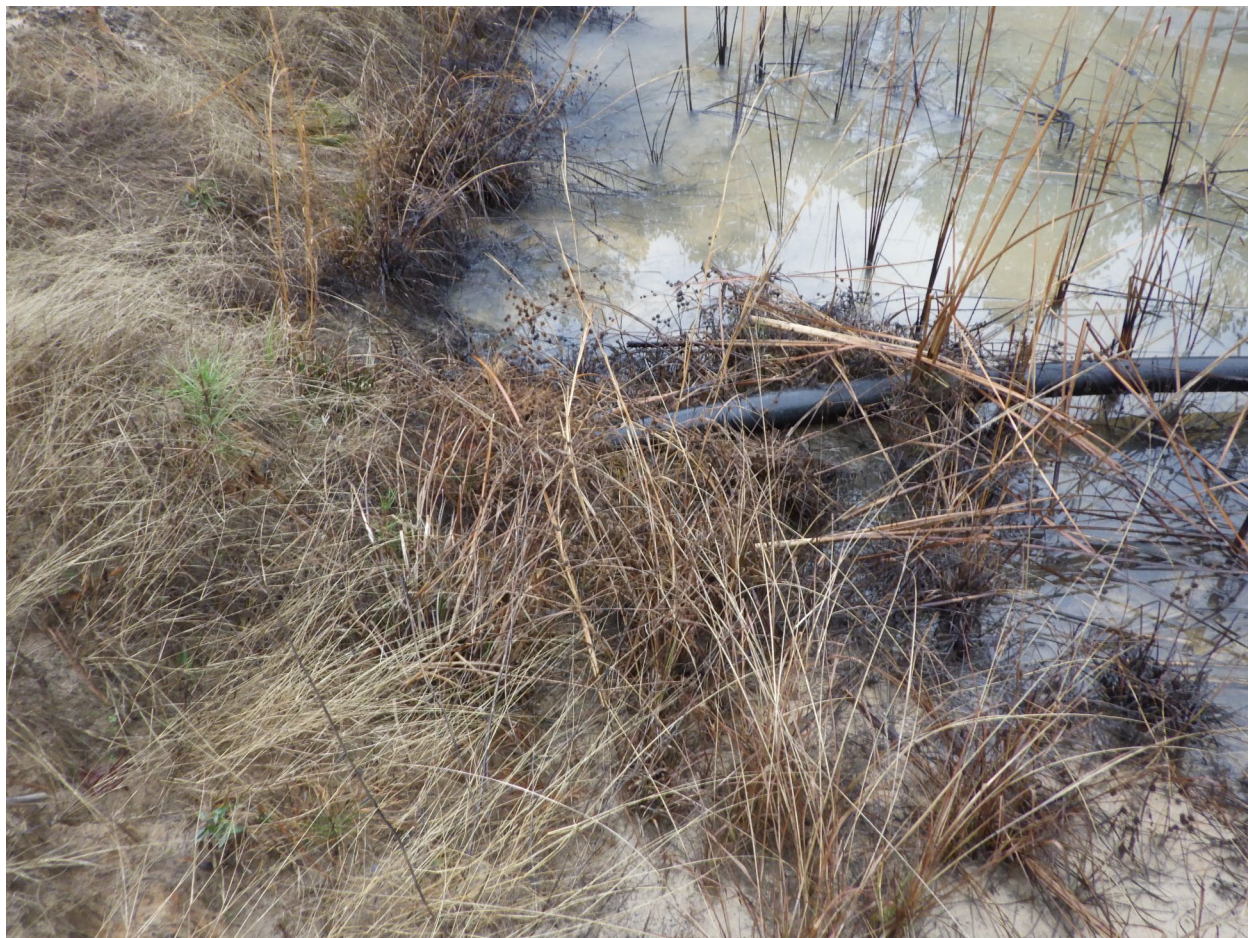
Photo No. 10

**Description:** Looking E, this photo shows the flowline from Photo No. 9 from the inside of the pit.

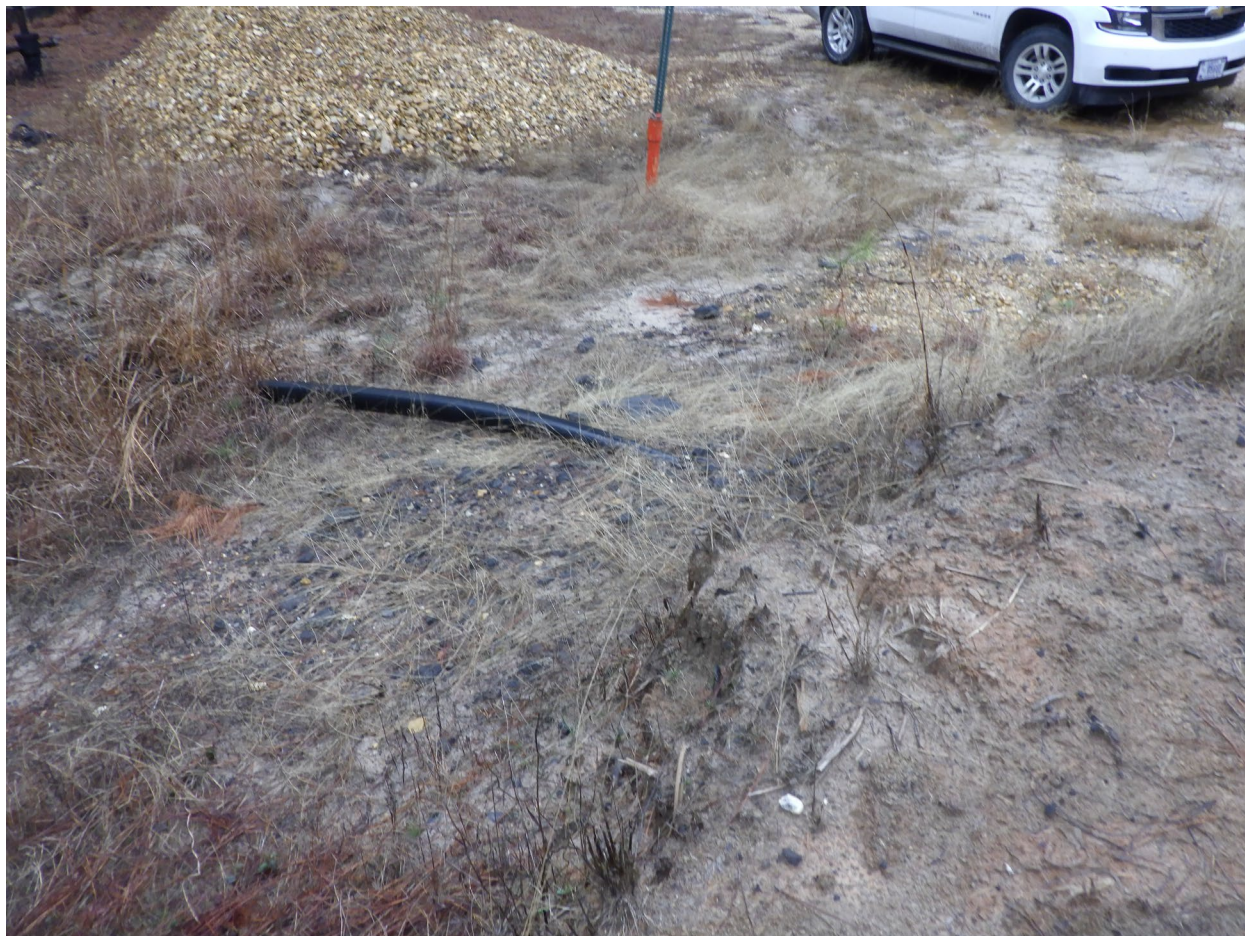
Photo No. 11

**Description:** Looking ENE, this photo shows the flowline from Photo No. 9 from the outside of the pit.

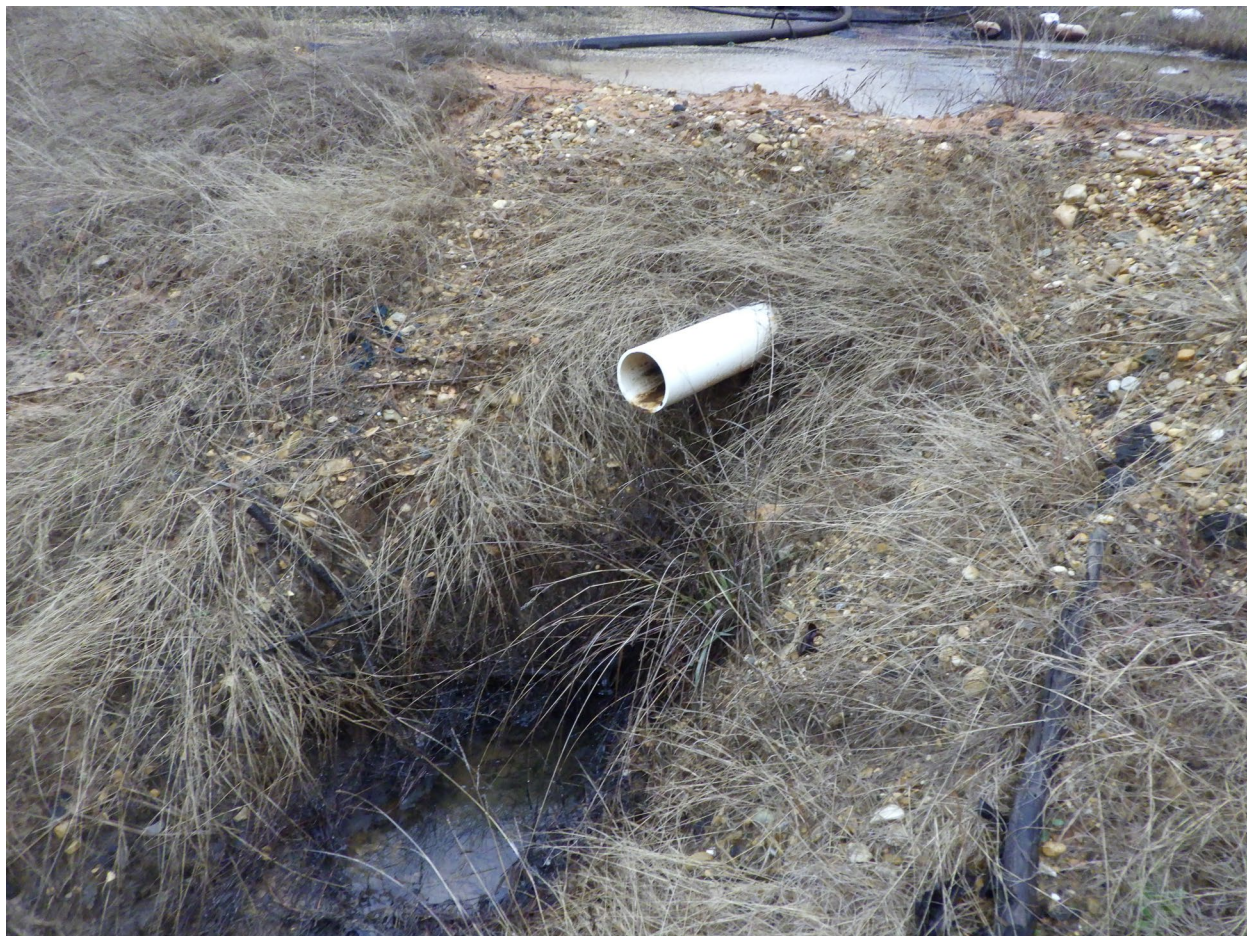
Photo No. 12

**Description:** Looking NNE, this photo shows the open drainpipe for the tank battery directed to the pit.

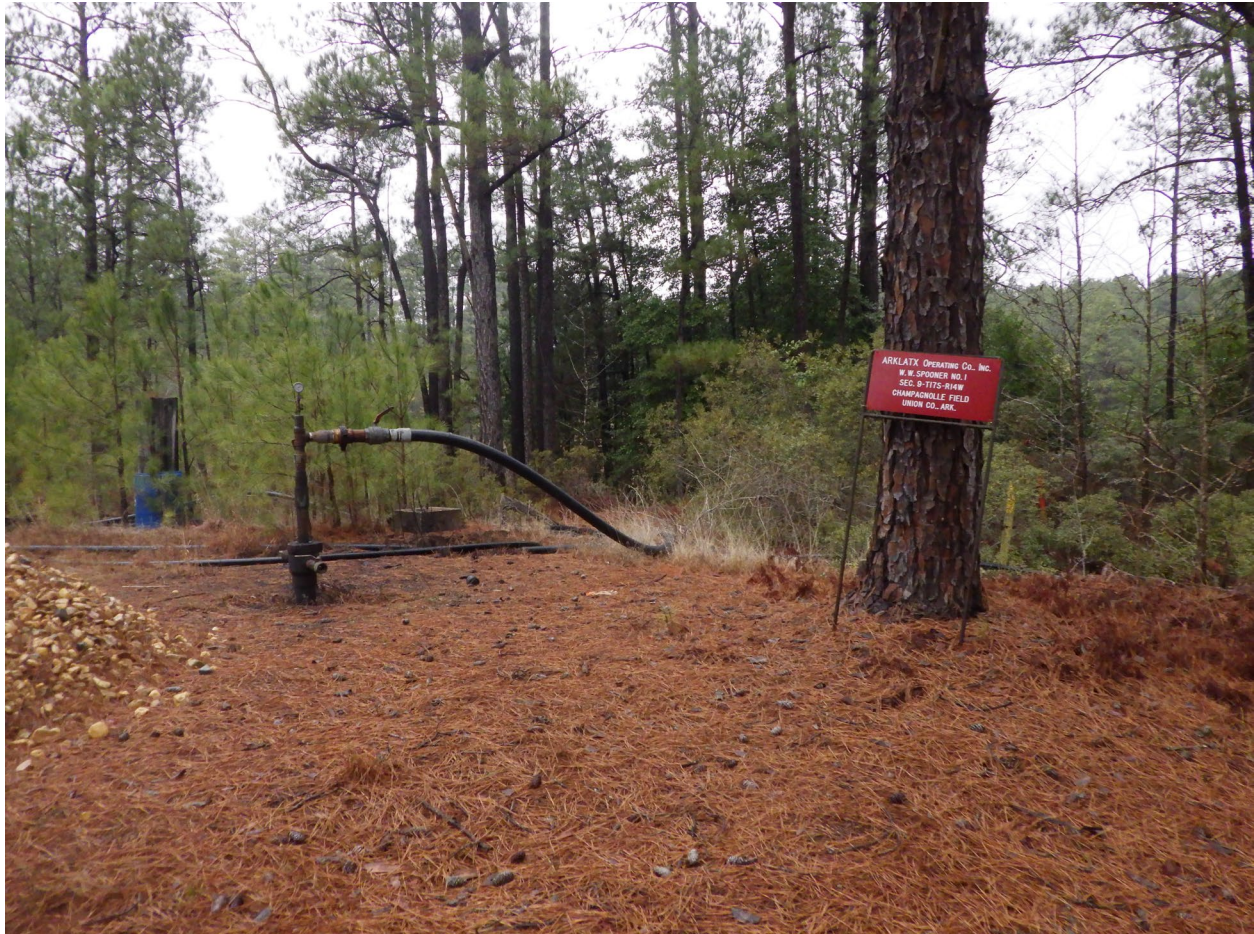
Photo No. 13

**Description:** Looking NNE, this photo shows the signage and an overview of the saltwater disposal (SWD) injection well adjacent to the tank battery.

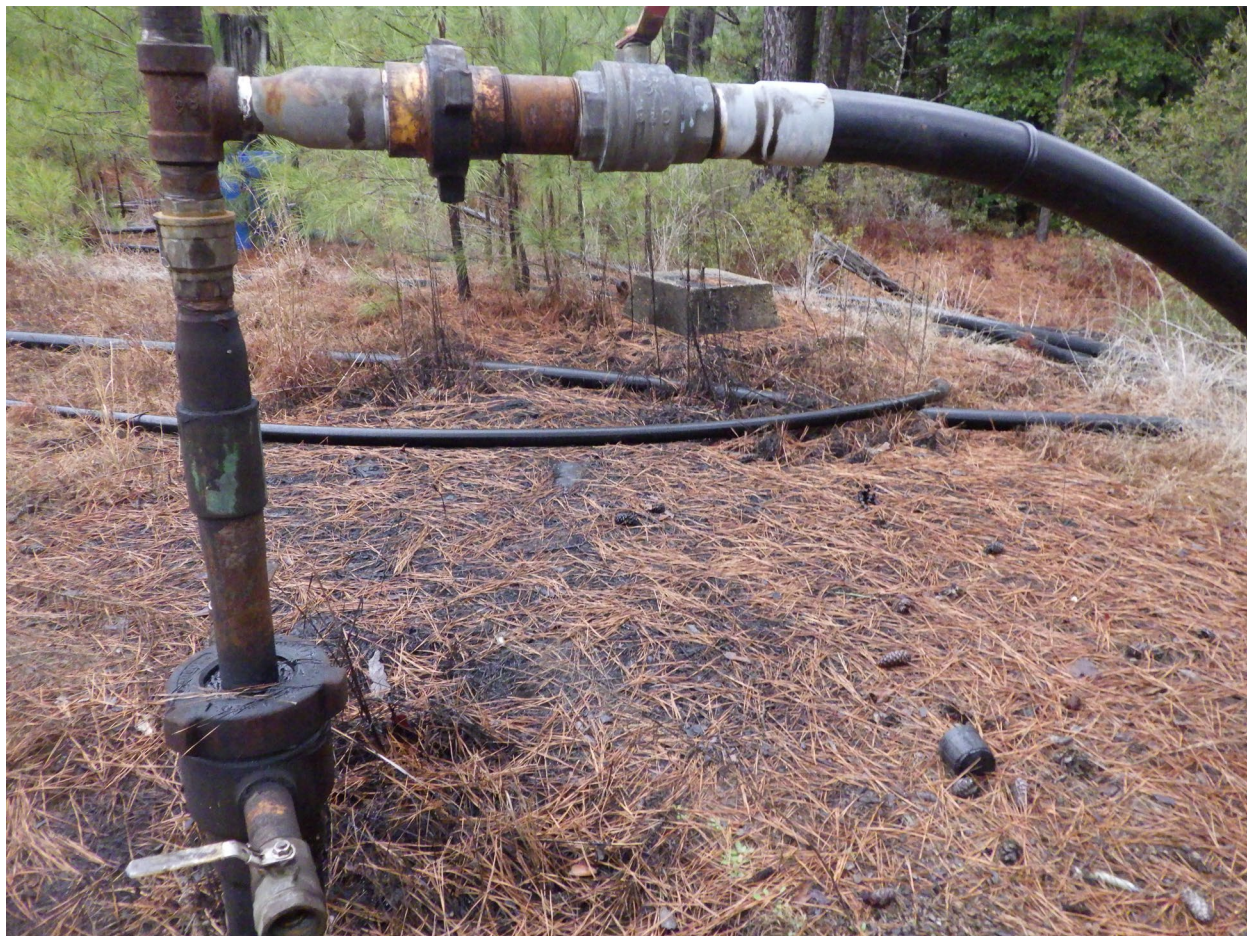
Photo No. 14

I observed the SWD injection well located onsite with residual crude oil noted on the ground, see Photo No. 13 and No. 14.

**Description:** Looking N, this photo shows residual, loose oil on the ground around the SWD injection well.

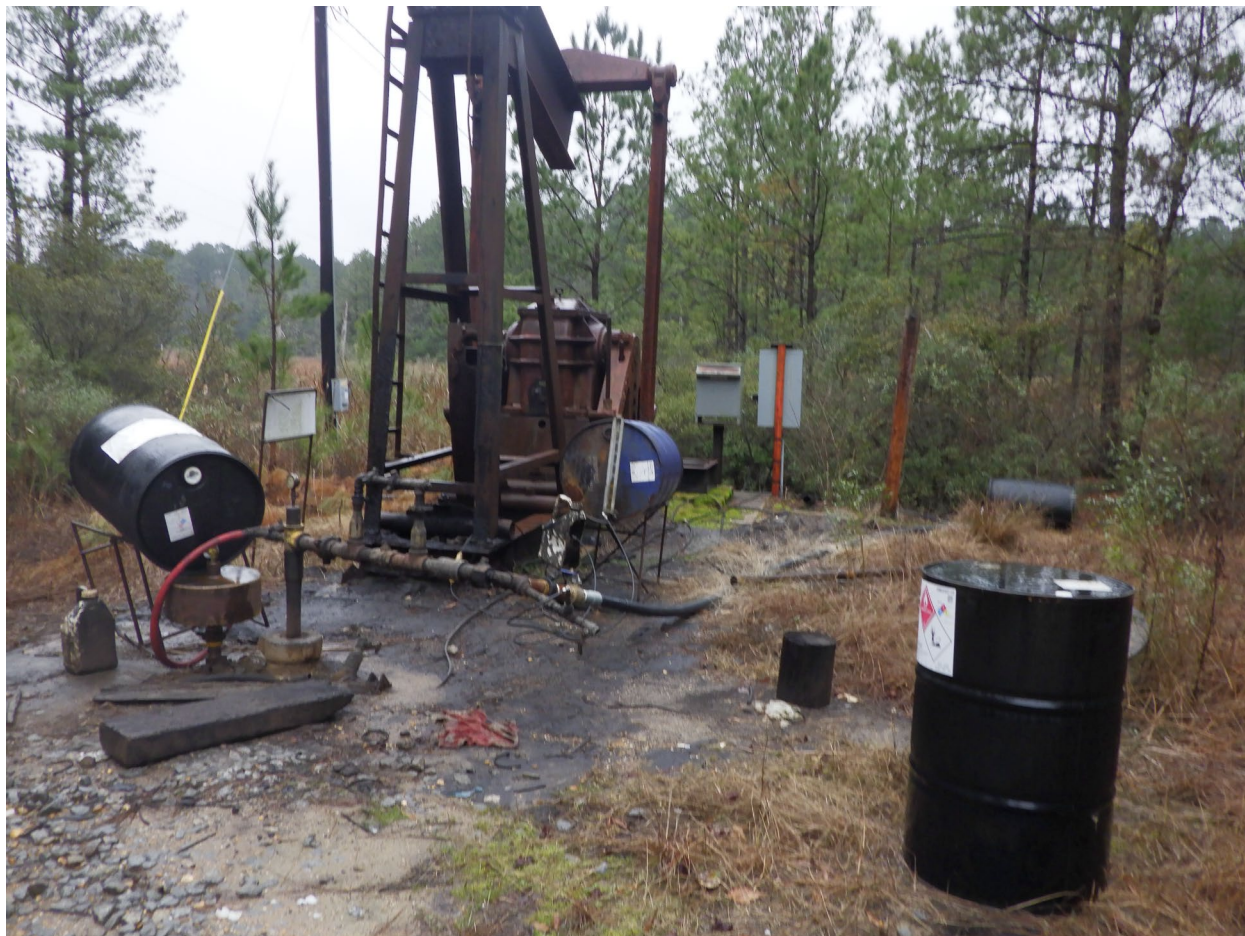
Photo No. 15

**Description:** Looking SE, this photo shows residual, loose oil on the ground around a nearby production well.

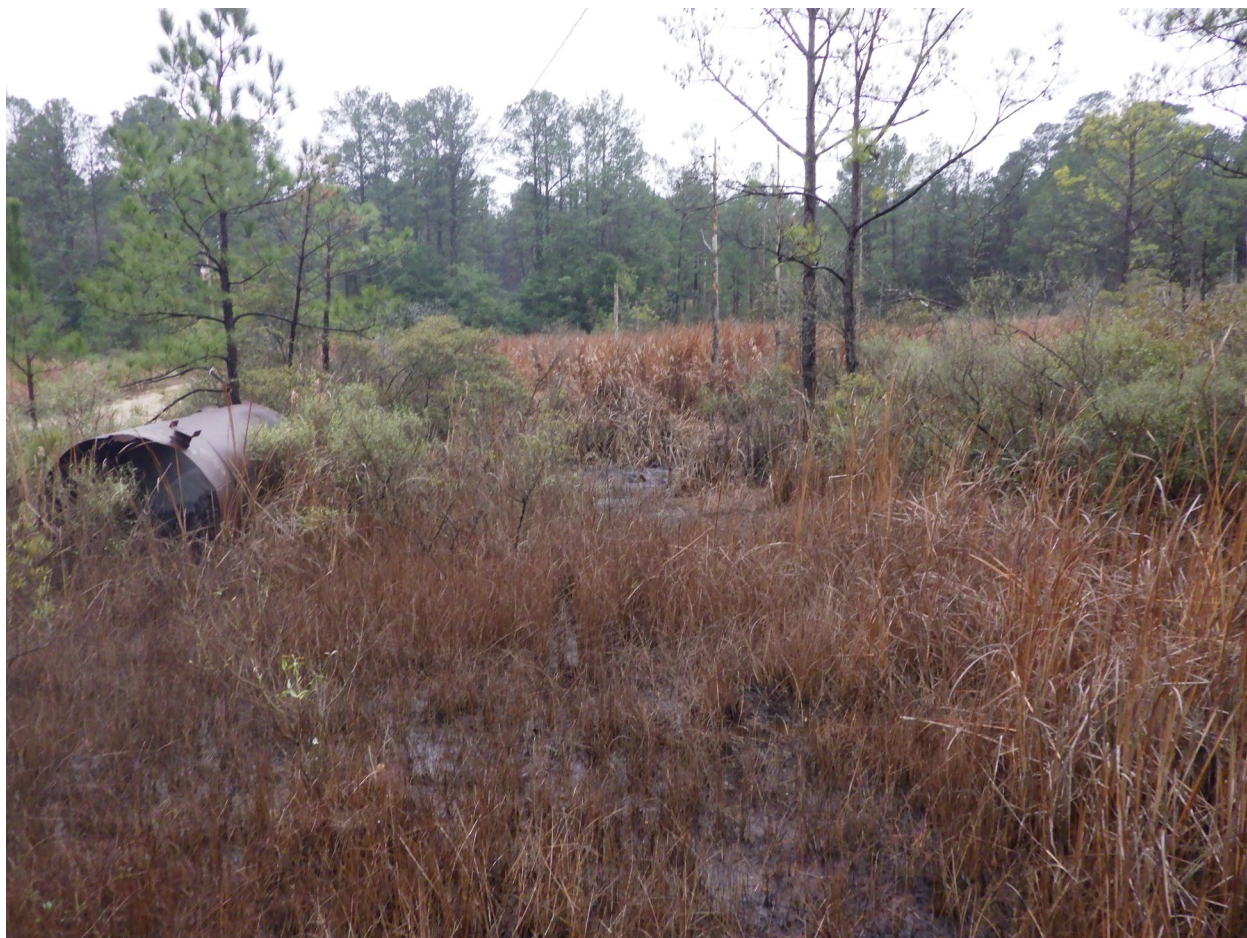
Photo No. 16

**Description:** Looking S, this photo shows a flowpath through a wetland adjacent to the production well.

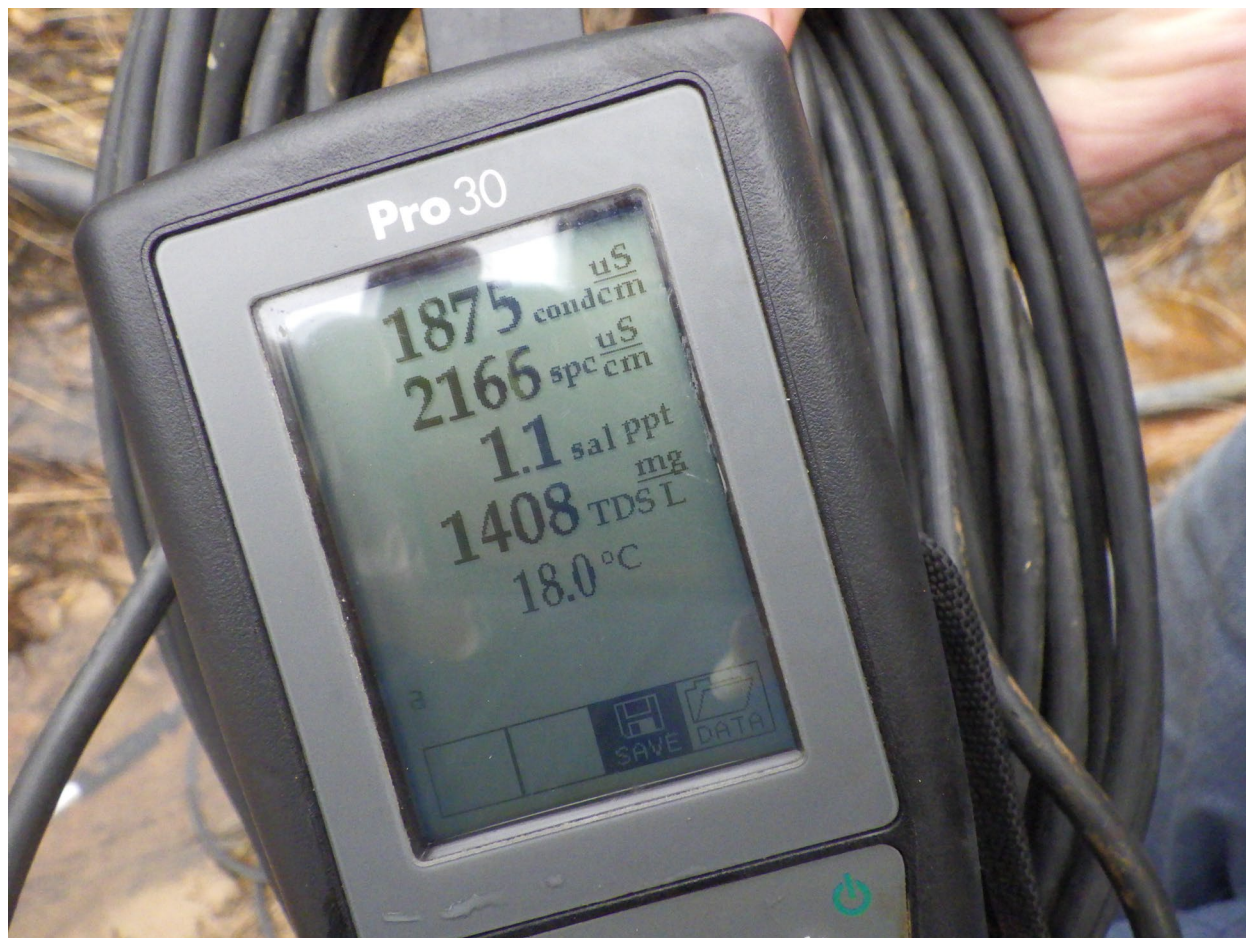
I observed a TDS reading of 1,408 mg/L in the drainage from the production well, see Photo No. 17 through No. 19.

**Description:** Looking N, this photo shows a Total Dissolved Solids (TDS) reading of 1,408 mg/L for the water in the drainage from the production well area.

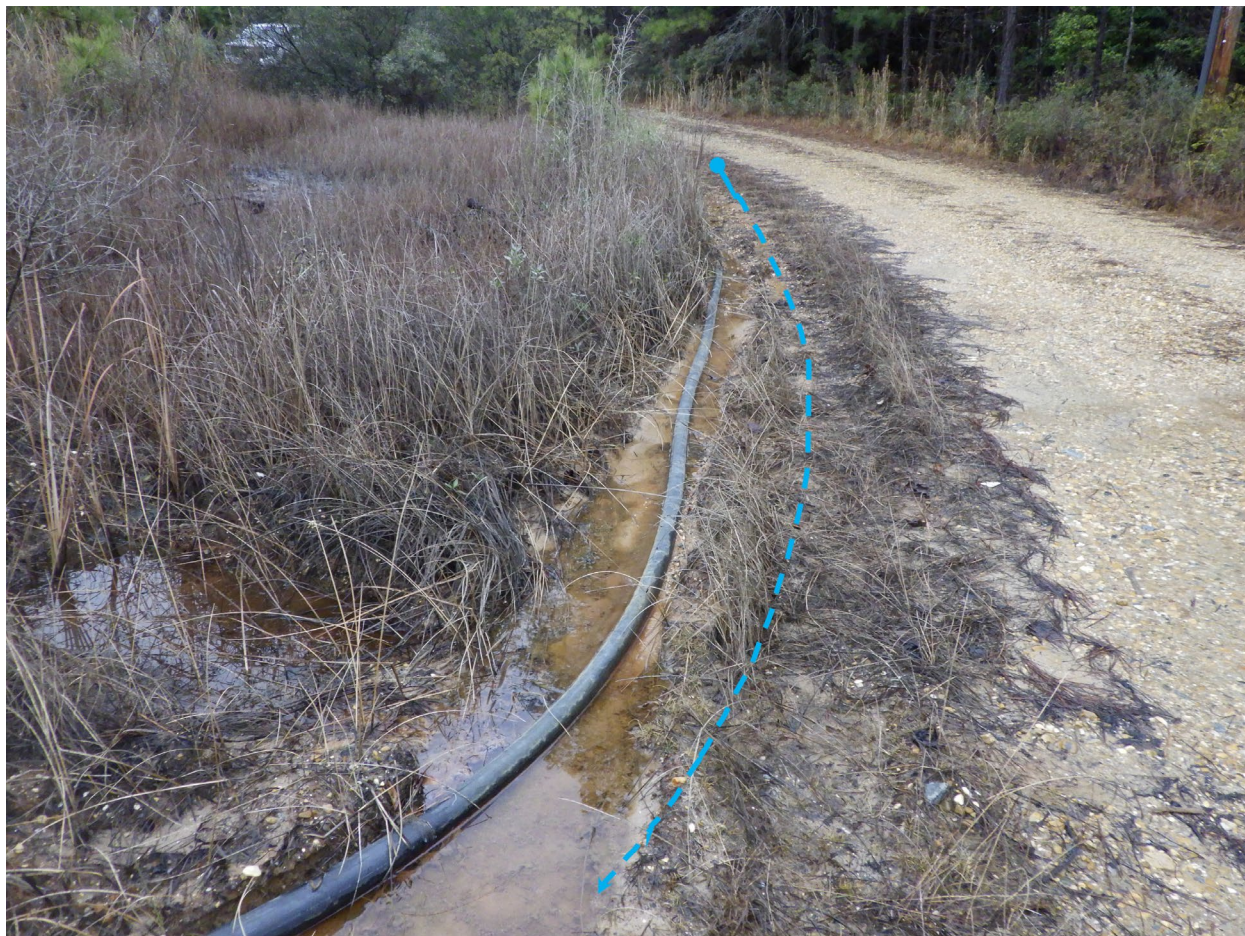
Photo No. 18

**Description:** Looking NNE, this photo shows the upstream view of the drainage from Photo No. 17. Flow direction line added for clarity.

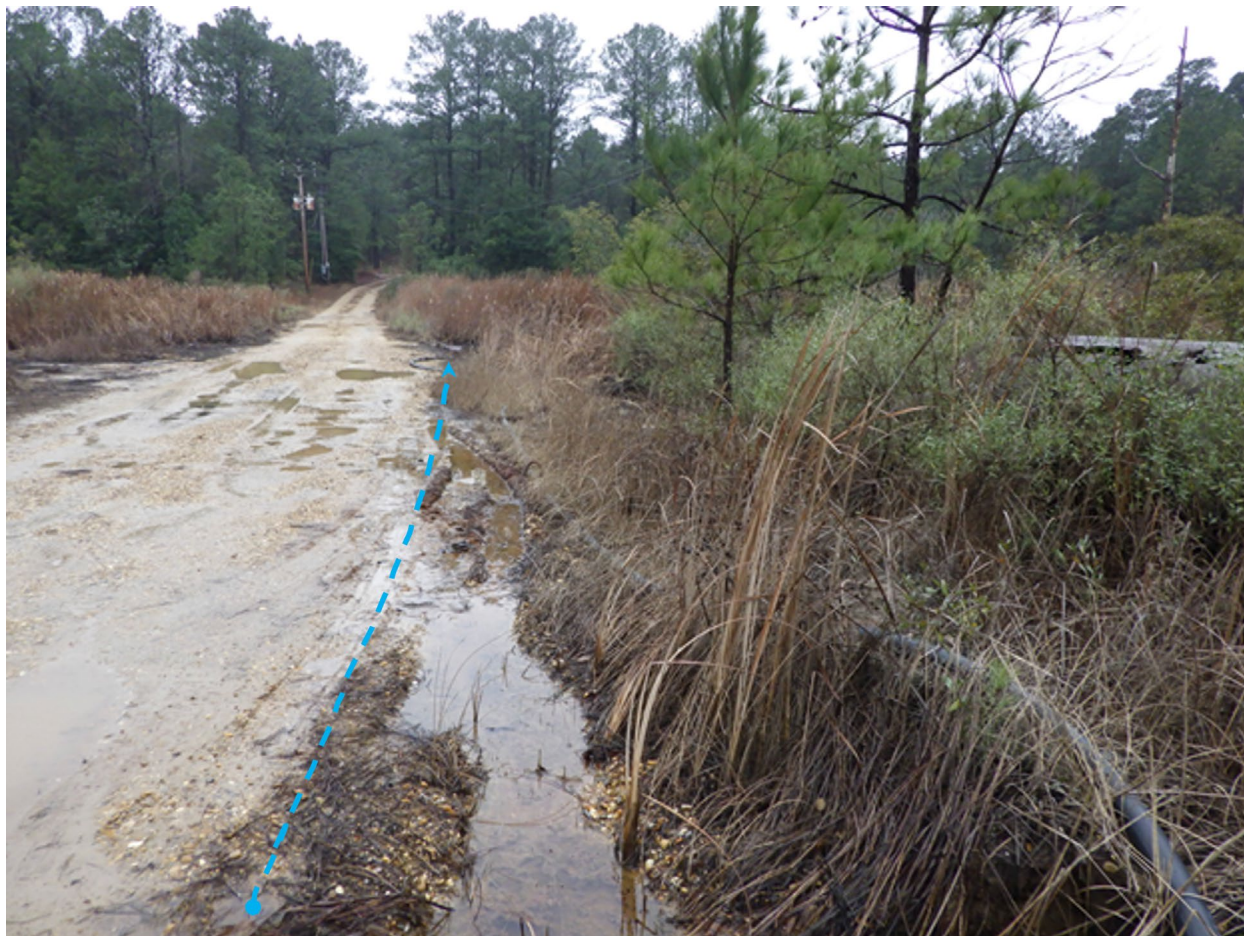
Photo No. 19

**Description:** Looking SSE, this photo shows the downstream view of the drainage from Photo No. 17. Flow direction line added for clarity.
