**Region 6 - Enforcement & Compliance Assurance Division**  
**INSPECTION REPORT**

| Inspection Date(s): | 01/30/2025 | |
| Company Name: | <b>ArklaTx Operating Co., Inc.</b> | |
| Facility Name: | <b>Spooner, WW Lease Tank Battery</b> | |

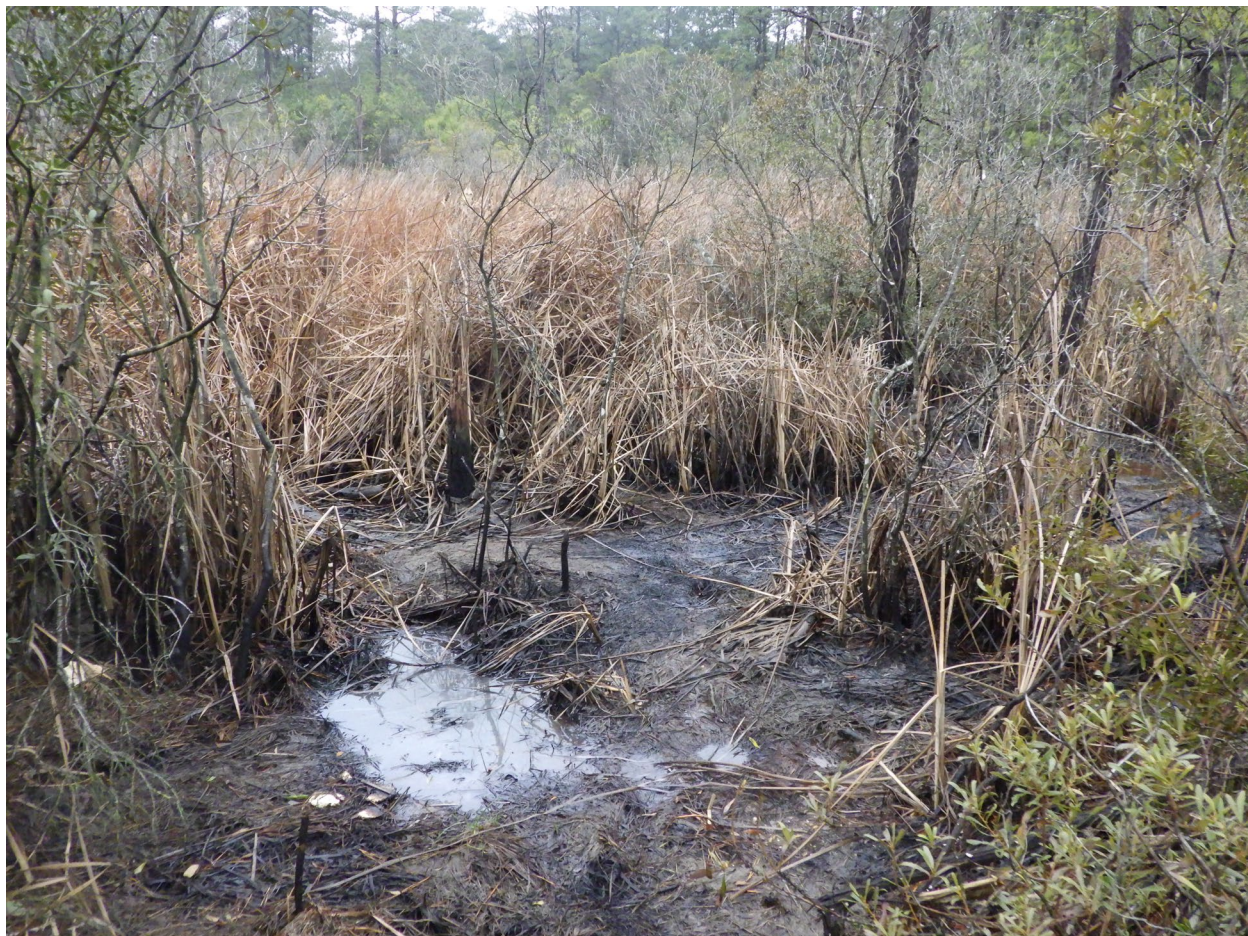
Photo No. 20

I observed dead vegetation and oil staining in the wetland, see Photo No. 20.

**Description:** Looking NNW, this photo shows dead vegetation and oil staining in the wetland.

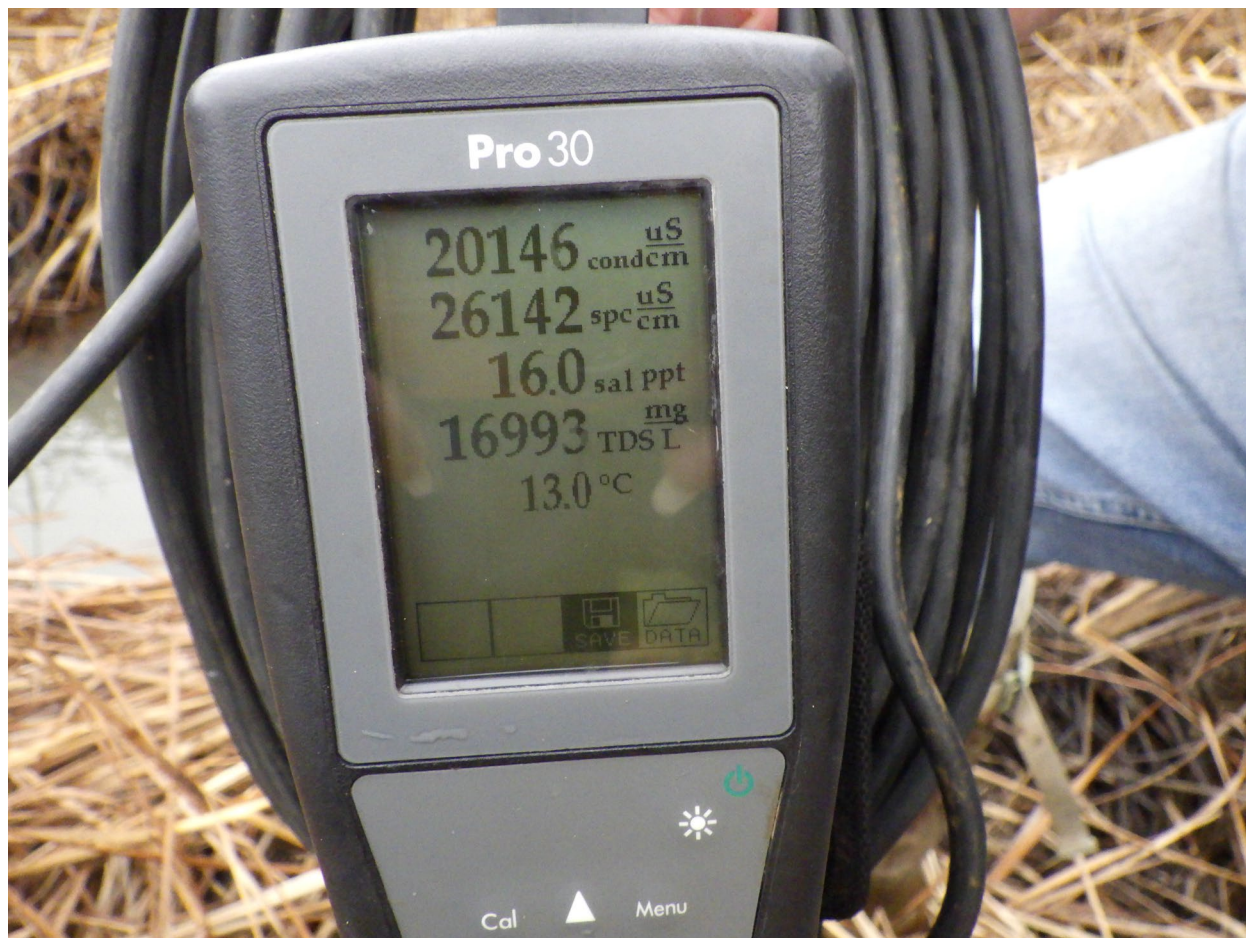
I observed an elevated TDS reading of 16,993 mg/L in a pool of water in the wetland, see Photo No. 21 through No. 23.

**Description:** Looking N, this photo shows the TDS reading of 16,993 mg/L in a pool of water in the wetland downstream of the drainage from the production well.

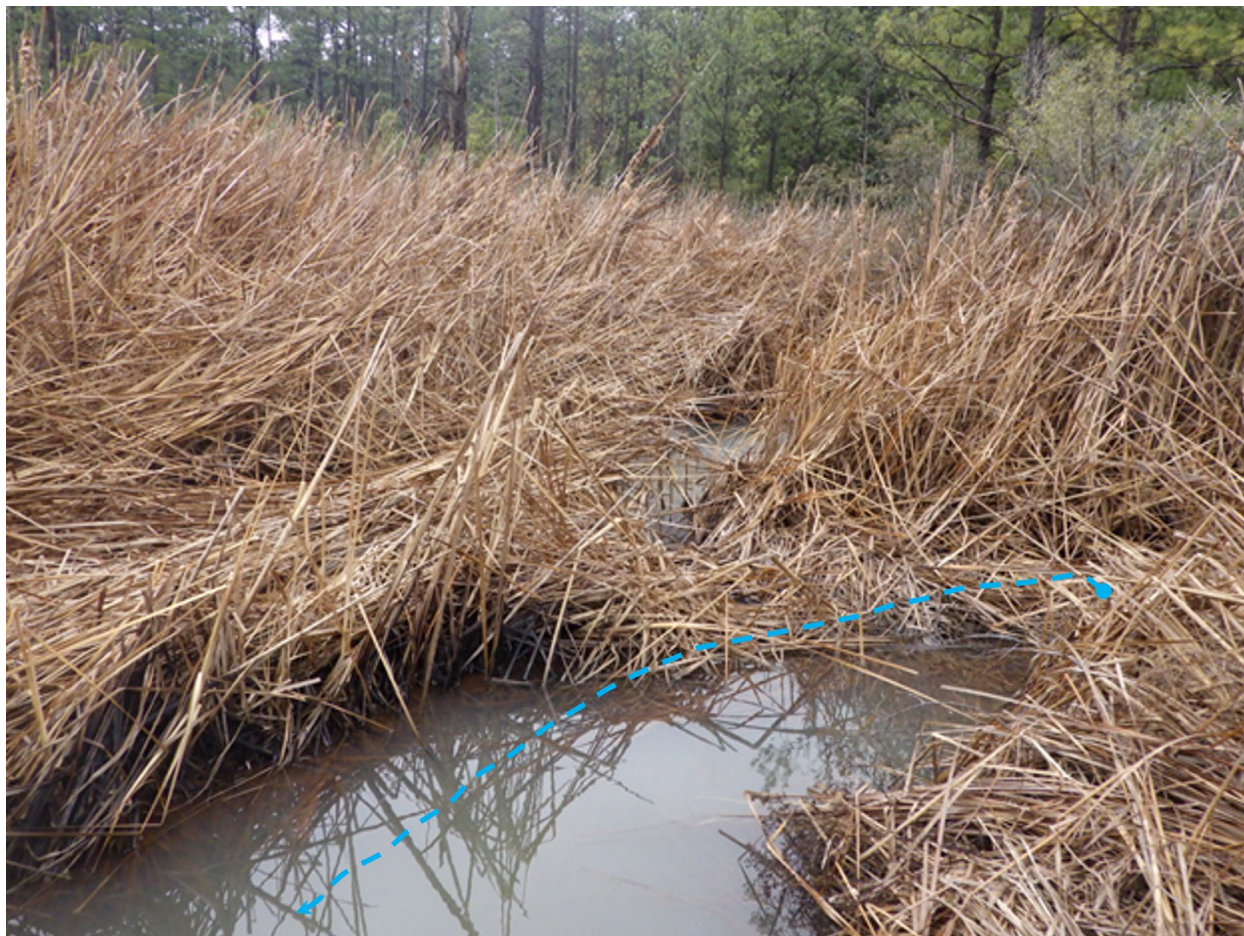
Photo No. 22

**Description:** Looking N, this photo shows the upstream view of the pool of water in the wetland from Photo No. 21. Flow direction line added for clarity.

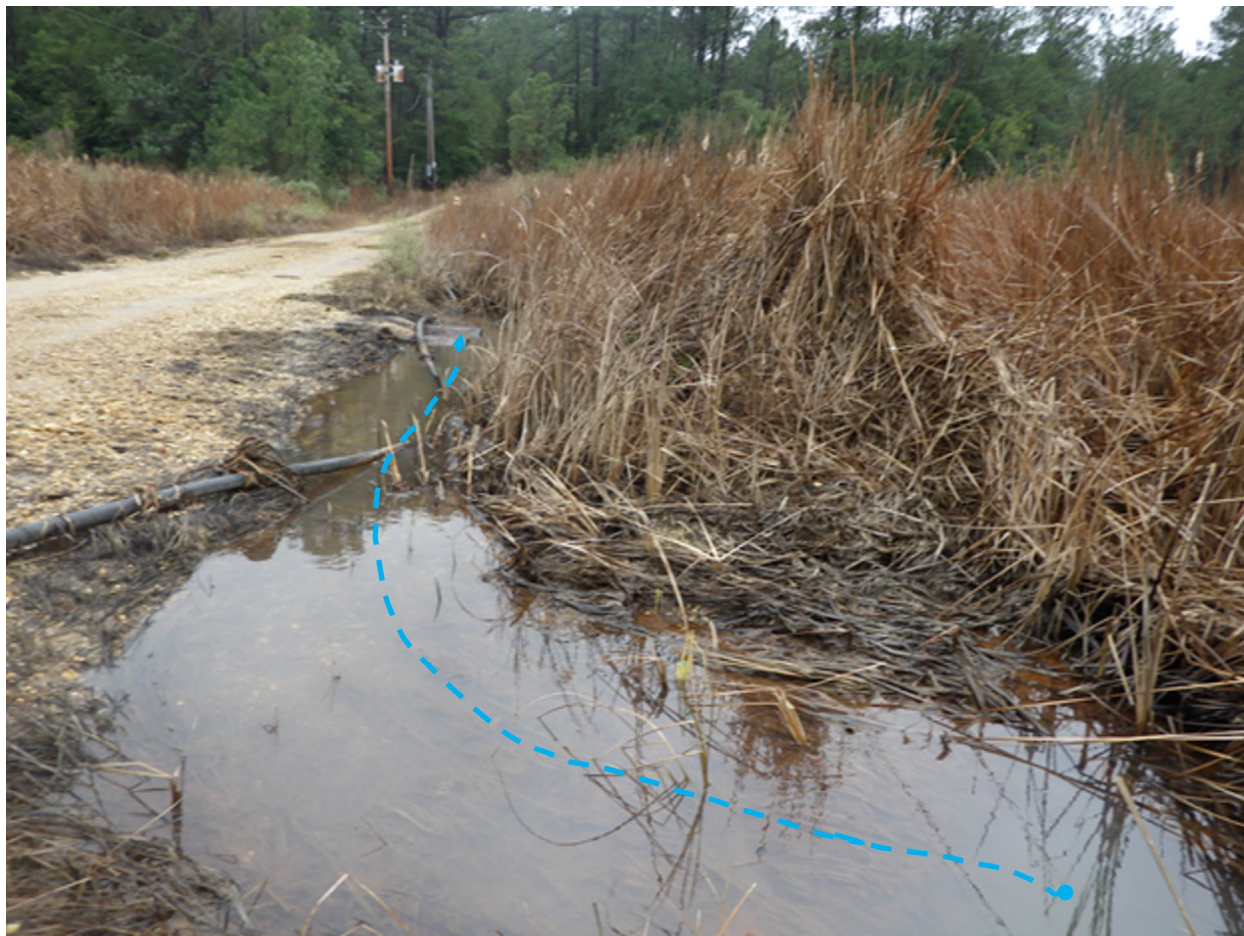
Photo No. 23

**Description:** Looking SSE, this photo shows the downstream view of the pool of water in the wetland from Photo No. 21. Flow direction lined added for clarity.

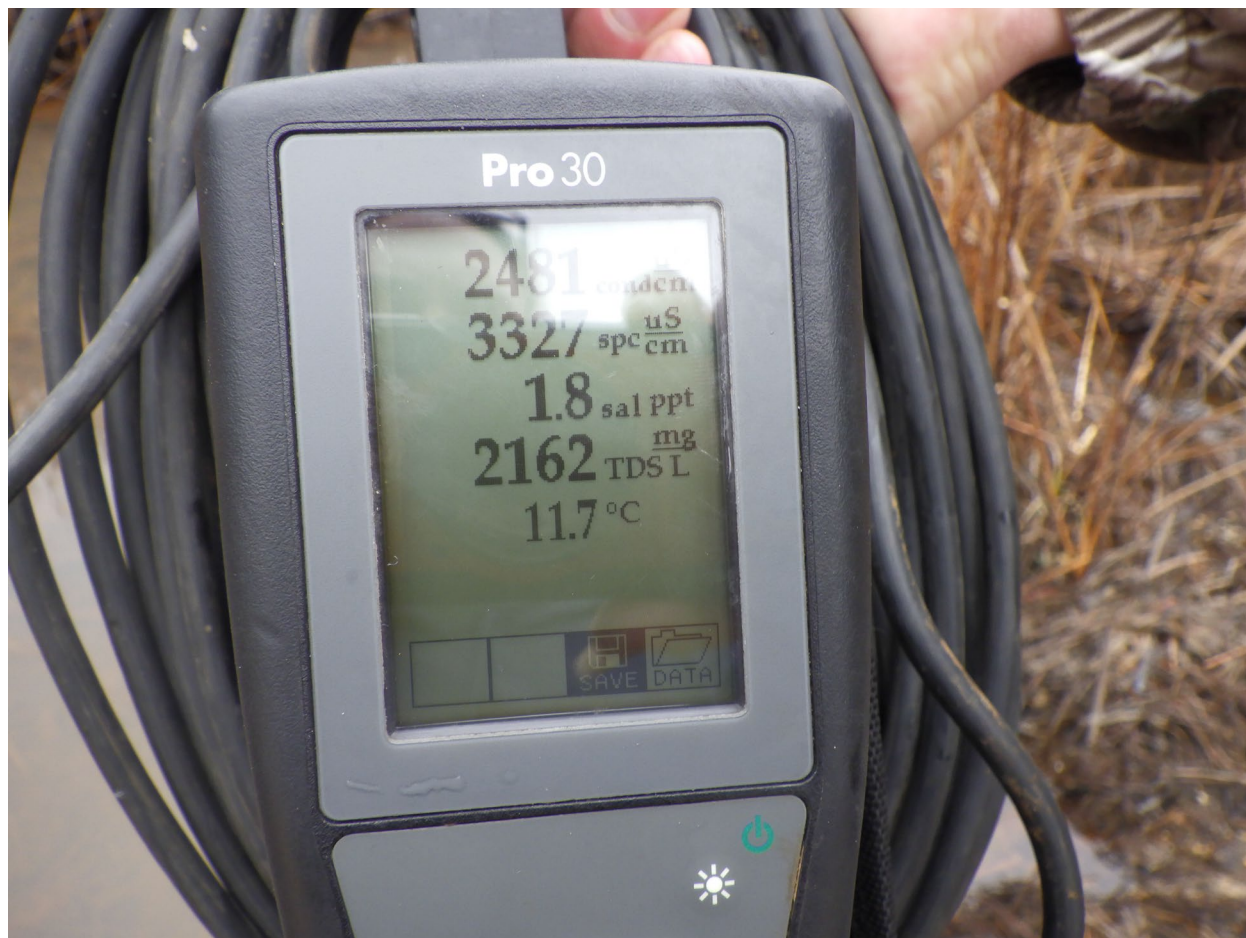
I observed a TDS reading of 2,162 mg/L at a series of culverts under a lease road in the wetland downstream from the elevated TDS reading referenced above, see Photo No. 24 through No. 27.

**Description:** Looking E, this photo shows the TDS reading of 2,162 mg/L at a series of culverts under the lease road in the wetland downstream of the pool of water in Photo No. 22.

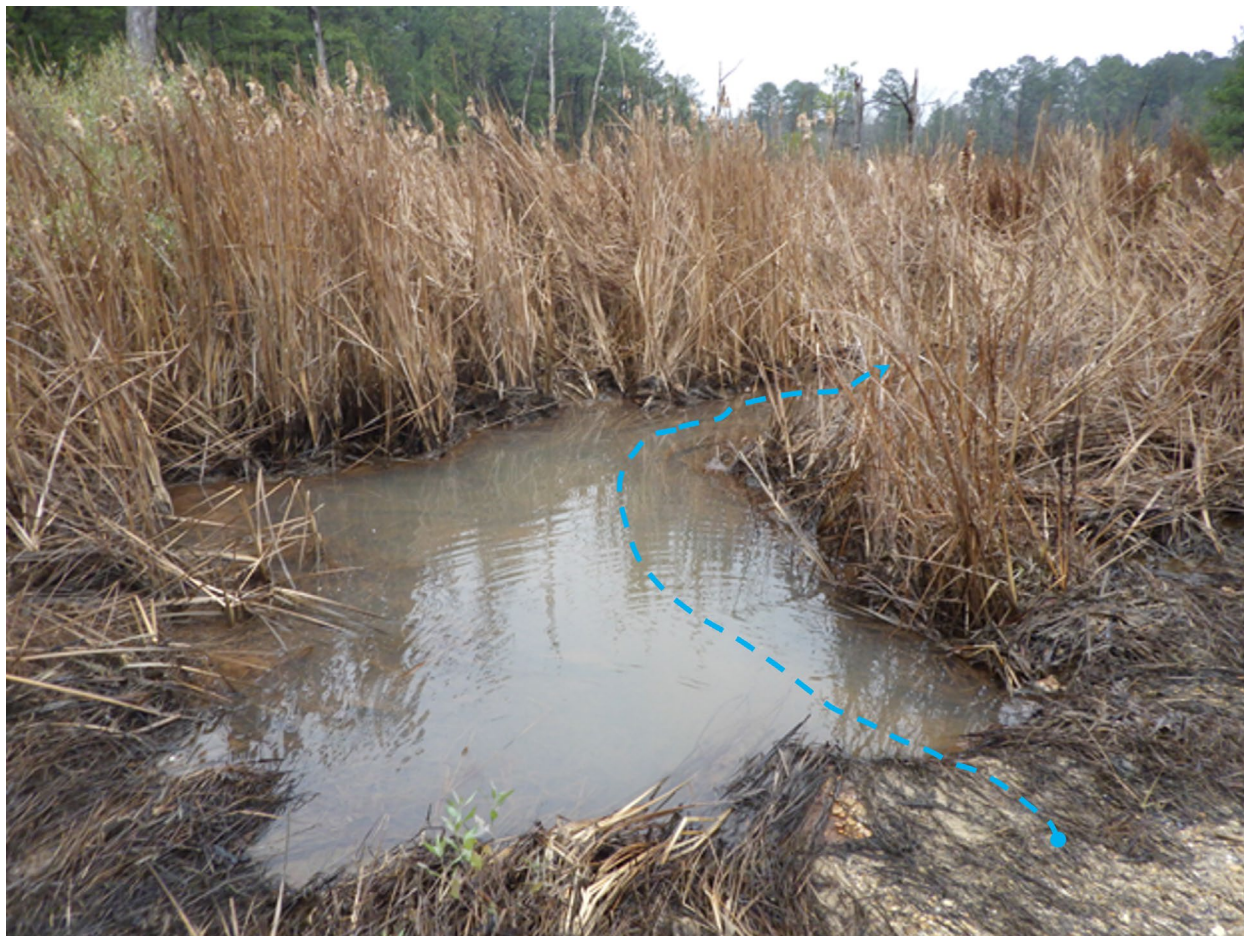
Photo No. 26

**Description:** Looking E, this photo shows the downstream view of the culvert area in the wetland from Photo No. 24. Flow direction line added for clarity.

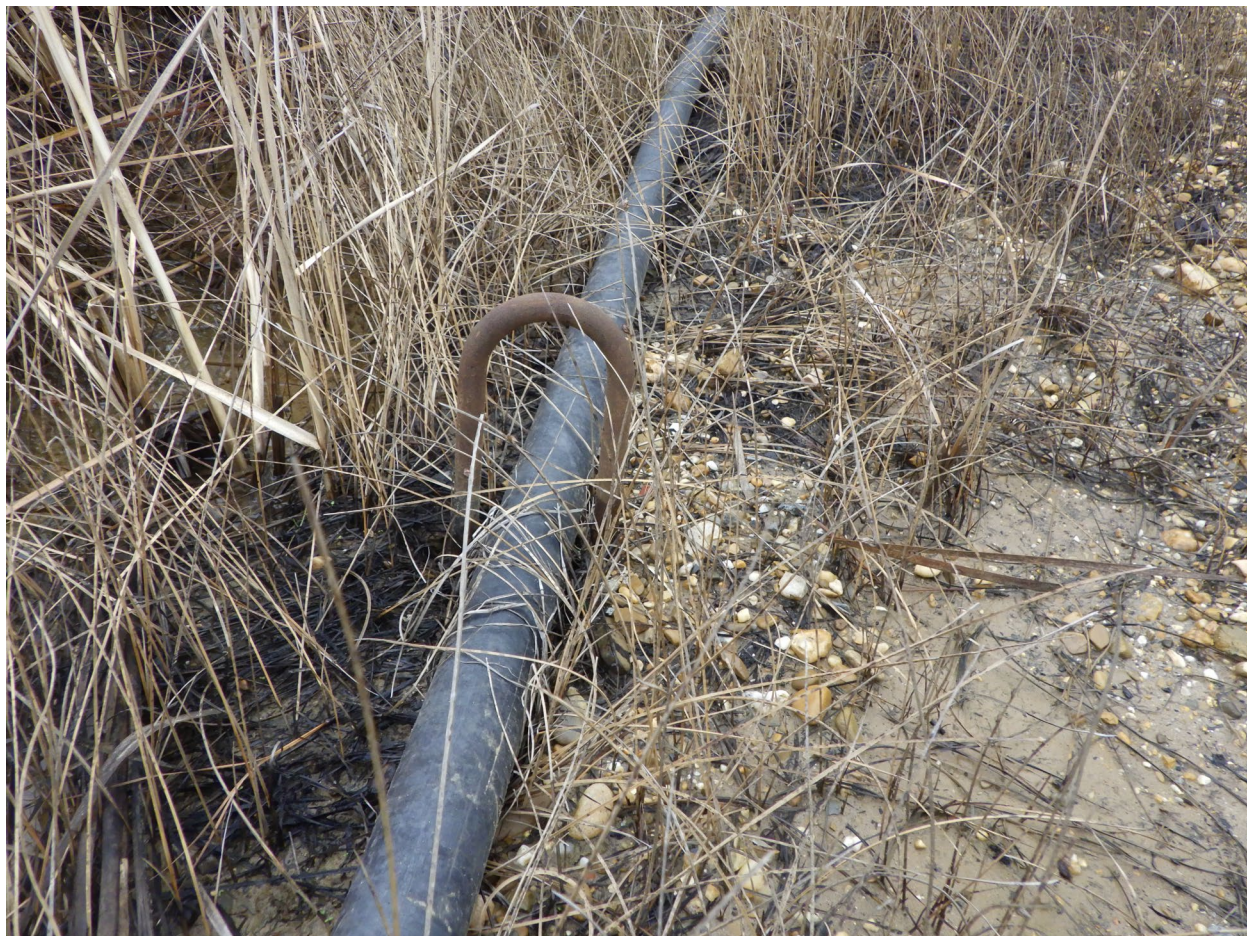
Photo No. 28

I observed a flowline parallel to the lease road, see Photo No. 28.
