## **RCRA Compliance Evaluation Inspection Report**

Triumvirate Environmental Services Inc.  
10100 Rocket Blvd  
Orlando, Florida 32824-8565  
County: Orange  
EPA ID Number: FLD980559728  
NAIC: 562211 – Hazardous Waste Treatment and Disposal

April 6, 2021 09:15 a.m.

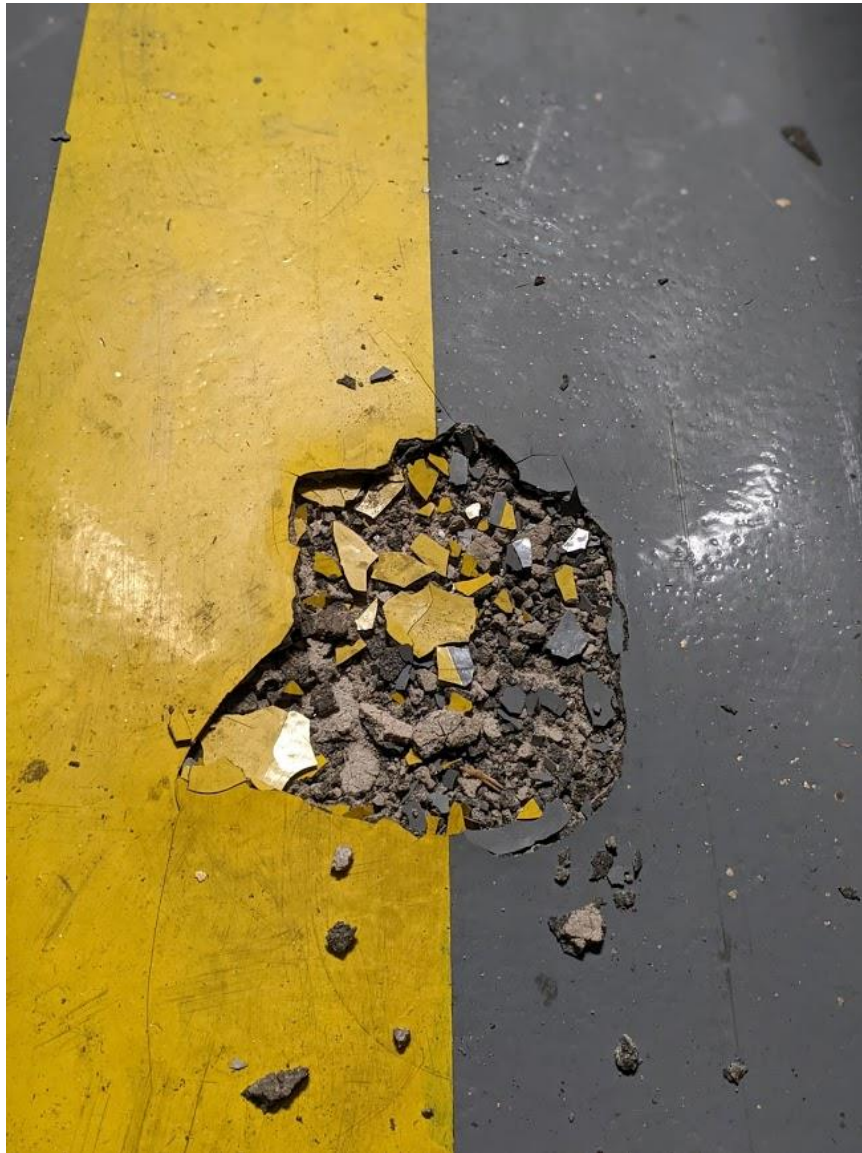
At the time of the inspection, Triumvirate was storing approximately 163 cubic yards of hazardous waste. The facility is permitted to store up to 224 cubic yards of hazardous and non-hazardous waste. Hazardous waste accepted by the facility is stored in its warehouse for up to a year before being shipped to an off-site treatment or disposal facility. At the time of the inspection, no containers were stored beyond a year. Hazardous and non-hazardous wastes are segregated at the facility according to compatibility groups as outlined in the permit. Storage areas have secondary containment to minimize and prevent possible releases to the environment. At the time of the inspection, there was a crack, or gap in the liner of the secondary containment (Photograph 1 of 1).

Photograph 1 of 1: Secondary Liner in Hazardous Waste Storage Area

**Pursuant to the RCRA Permit 26916-009-HO, Part II Subpart B.2 – Container Storage Unit [40 C.F.R. § 264.193(e)(1)(iii)], the Permittee shall inspect the integrity of the containment area to insure that it is free of cracks or gaps, and the concrete sealant remains impervious to leaks.**
