## RCRA Compliance Evaluation Inspection Report

Newell Office Products (Newell Brands Maryville Operations)  
EPA ID Number: TND987782943  
NAICS Code: 325998, 326199

June 7, 2022, 9:00 a.m.

**Attachment A**

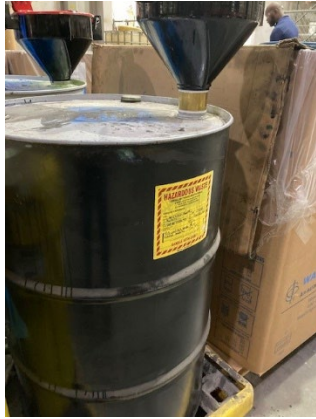
Adjacent to the universal waste storage area, the facility primarily uses the main accumulation point to collect waste and recyclables generated from maintenance activities. Inspectors observed one 55-gallon satellite container of liquid waste paint (D001, F003 and F005) (WS #19), one 55-gallon container of spent aerosol can residue (WS #19), and one 55-gallon satellite container of inkjet cartridges (WS #19). All containers were labeled “hazardous waste” and closed. However, the inspectors observed only two of the three satellite containers with a hazard indication. The inkjet satellite container did not have a hazard indication marking (Photo 1).

Photo-1 Main Accumulation Point, Failure to provide hazard indication on 1 55-gallon SAA container of inkjet cartridge

**Pursuant to Tenn. Comp. R. & Regs. 0400-12-01-.03(1)(f)1(v)(II) [40 C.F.R. § 262.15(a)(5)], which is a condition of the SAA Permit Exemption, a generator is required to mark or label its containers (i) with the words “Hazardous Waste” and (ii) with an indication of the hazards of the contents.**

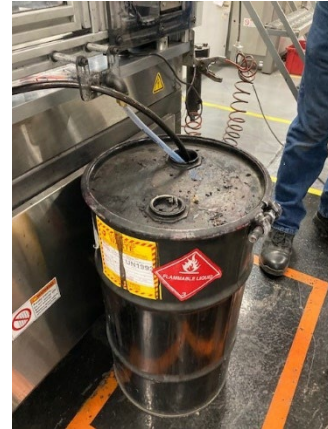
Hazardous waste gets generated in this area from flushing and purging ink lines during color changes. At each marker station, Newell manages a satellite accumulation container (either 30-gallon or 55-gallon) to receive ink-contaminated solvent waste (WS #10 and WS #11). Inspectors observed one 30-gallon satellite container at Sharpie Fine #13 and one 30-gallon container at Expo Marker Line #11. Both containers were labeled and marked with a hazard indication; however, both containers were not closed (Photos 3 and 4). While the flush and purge lines feed directly into the drum through the bung opening, the facility does not have a closure method for both the containers. ***Inspectors recommended the facility to audit all satellite storage areas in the marker***

Photo-4 Expo Marker Line #11, 1 30-gallon SAA open container containing flammable spent solvent waste

*production area and ensure a proper container closure gets implemented immediately.*

**Pursuant to Tenn. Comp. R. & Regs. 0400-12-01-.03(1)(f)1(iv) [40 C.F.R. § 262.15(a)(4)], which is a condition of the SAA Permit Exemption, a generator is required to keep containers of hazardous waste closed at all times during accumulation, except when adding, removing, or consolidating waste; or when temporary venting of a container is necessary for the proper operation of equipment, or to prevent dangerous situations, such as build-up of extreme pressure.**

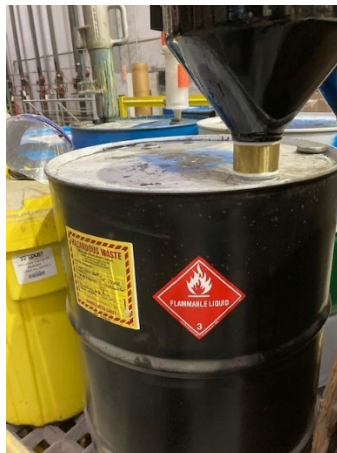
Upon identification, Mr. Buchholz promptly applied a “flammable liquid” hazard indication marking to the inkjet satellite container (Photo 2). Spill equipment, a fire extinguisher, and access to emergency communication were available in this satellite area. Inspectors also observed several containers of material for recycling (e.g., used oil filters, punctured aerosol cans, e-waste, alkaline batteries, toner cartridges, and capacitors) and several non-hazardous waste containers (e.g., glue, glue bottles, plastic pellet filters). All containers were marked to indicate the container contents.

Photo-2 Main Accumulation Point, 1 55-gallon SAA container marked with hazard indication

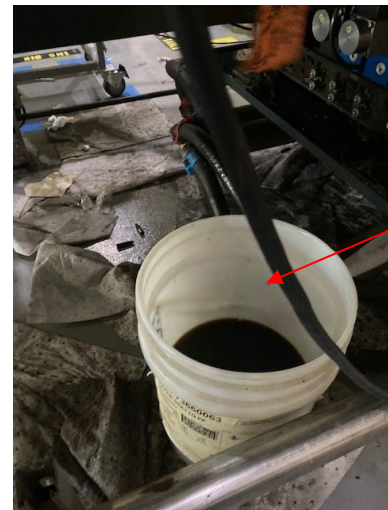
Barrels and caps for Sharpie and Expo-brand markers are produced in this area by injection molding. Plastic pellets get fed into one of thirty machines where they are heated, molded into marker parts, cooled, and boxed for the assembly production line. Inspectors observed three 5-gallon unlabeled used oil containers at molding presses 225/226 and 227/228 (Photo 5 and Photo 6).

Photo-5 Molding Press 225/226 Open 5-gallon Used Oil Container

**Pursuant to Tenn. Comp. R. & Regs. 0400-12-01-.11(3)(c)3(i) [40 C.F.R. § 279.22(c)(1)], containers and aboveground tanks used to store used oil at generator facilities must be labeled or marked clearly with the words “Used Oil.”**

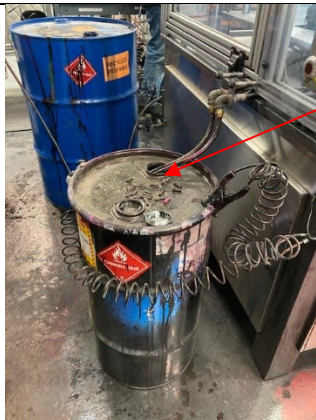
Photo-3 Sharpie Fine #13, 1 30-gallon SAA open container containing flammable spent solvent waste

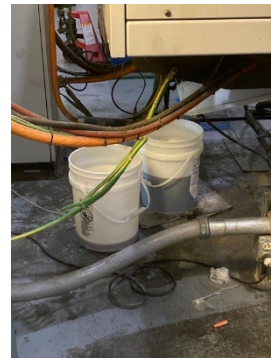
Photo-6 Molding Press 227/228 Open two 5-gallon Used Oil Container

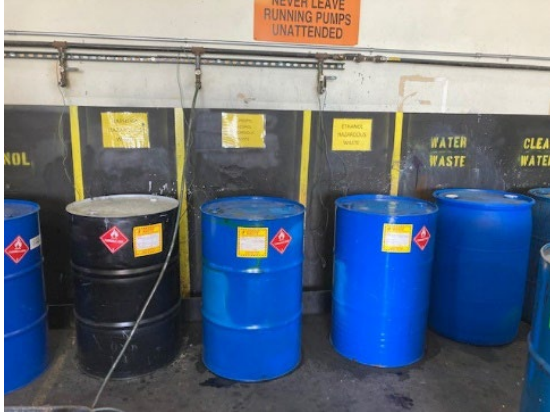
Upon entering the building, inspectors first observed the ink consolidation process. During production, containers of ink products used to fill markers are only partially used due to the pumping constraints of the assembly machine. As a result, any remaining ink in the product drums gets consolidated in this portion of the building. Using a pump, the facility transfers the ink from the partial full drums for consolidation. When the facility completes the ink transfer, personnel flush the pump with a solvent, and waste ink-contaminated solvent (WS #10 and WS #11) gets accumulated in a 55-gallon storage drum. During the inspection, inspectors observed three 55-gallon containers (one for waste naphtha, one for waste n-propyl, and one for waste ethanol) managed as satellite containers for each waste solvent type. However, Mr. Buchholz explained Newell’s practice was also to consolidate waste solvent generated at the marker production area into one of the three satellite containers mentioned above. Inspectors explained that the regulations do not allow the consolidation of satellite containers from other generation points. Therefore, the facility must manage the three 55-gallon containers under the 90-day regulations rather than SAA regulations. Inspectors observed the three 55-gallon storage containers (WS #10 and WS #11) labeled “hazardous waste,” closed, and marked with a hazard indication. However, the three 55-gallon containers of consolidated waste ink-contaminated solvent did not have an accumulation start date (Photo 7).

Photo-7 Ink Consolidation Room, 3-containers received solvent waste for consolidation from Satellite areas in the production area. The containers shall be managed as 90-day containers and require an accumulation start dates on all the three containers

**Pursuant to Tenn. Comp. R. & Regs. 0400-12-01-.03(1)(h)1(v)(I)(III) [40 C.F.R. § 262.17(a)(5)(i)], which is a condition of the LQG Permit Exemption, a generator must mark the date upon which each period of accumulation begins clearly visible for inspection**

**on each container.**
