## Clean Water Act Section 404: Site Visit/Case Development

| Site Name | Neal Oehme Property | | | | |

| Inspection Purpose | Initial site visit | | |

CWA 404 Inspection  
Neal Oehme Property  
139 Mill Street, Wallkill, NY

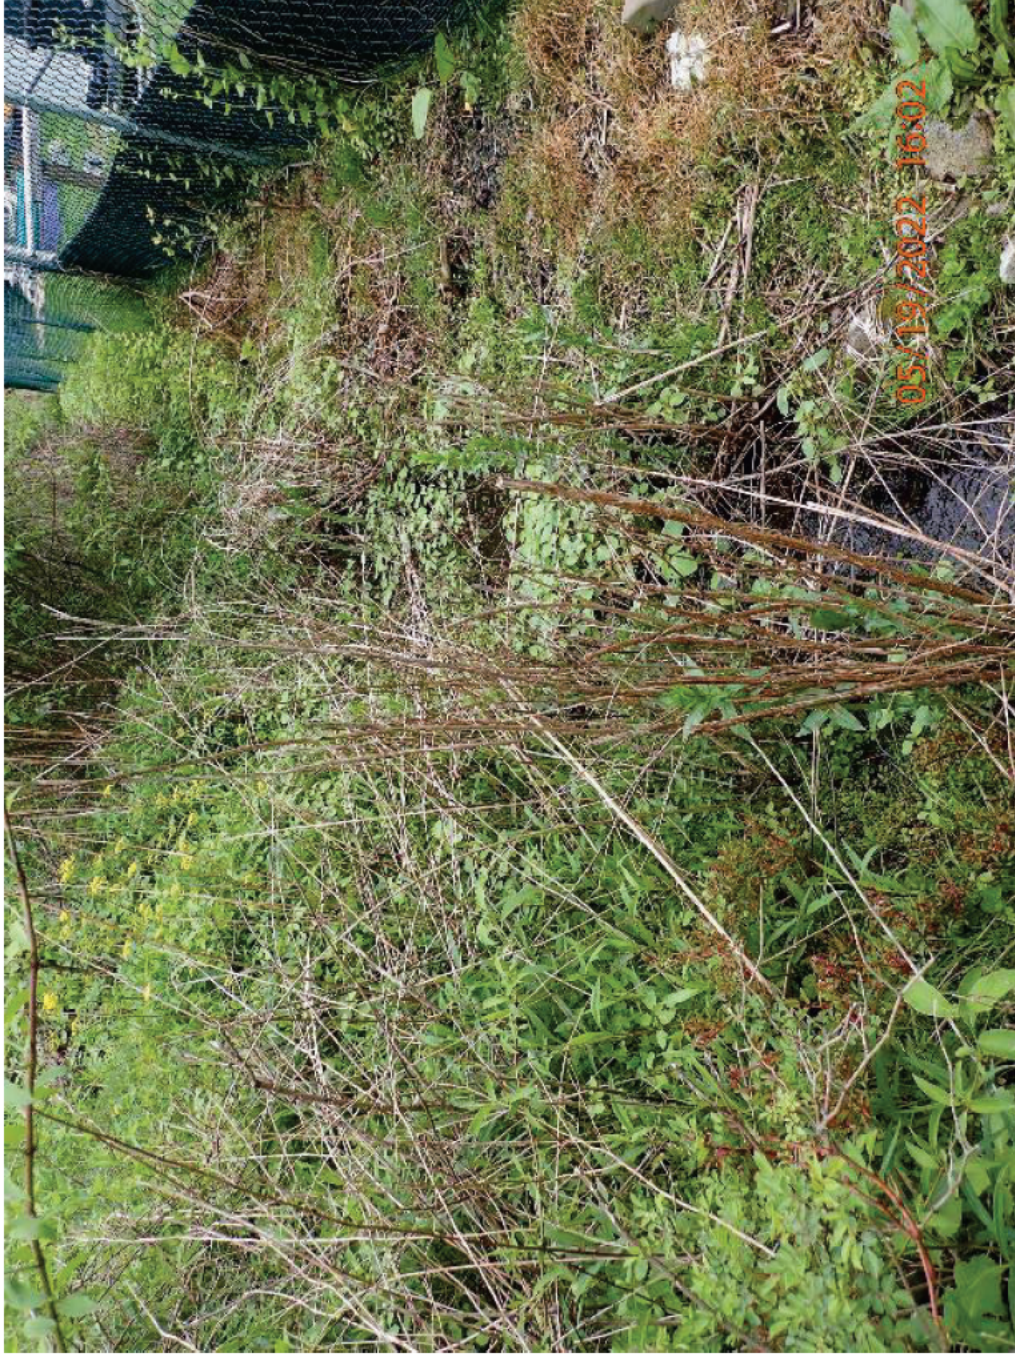
**Date:** 5/19/2022  
**Time:** 4:02 PM  
**Photographer:** SSA  
**Photo ID:** 1 – P5190347

Watercourse that runs along eastern edge of property between fenced backyard and property boundary

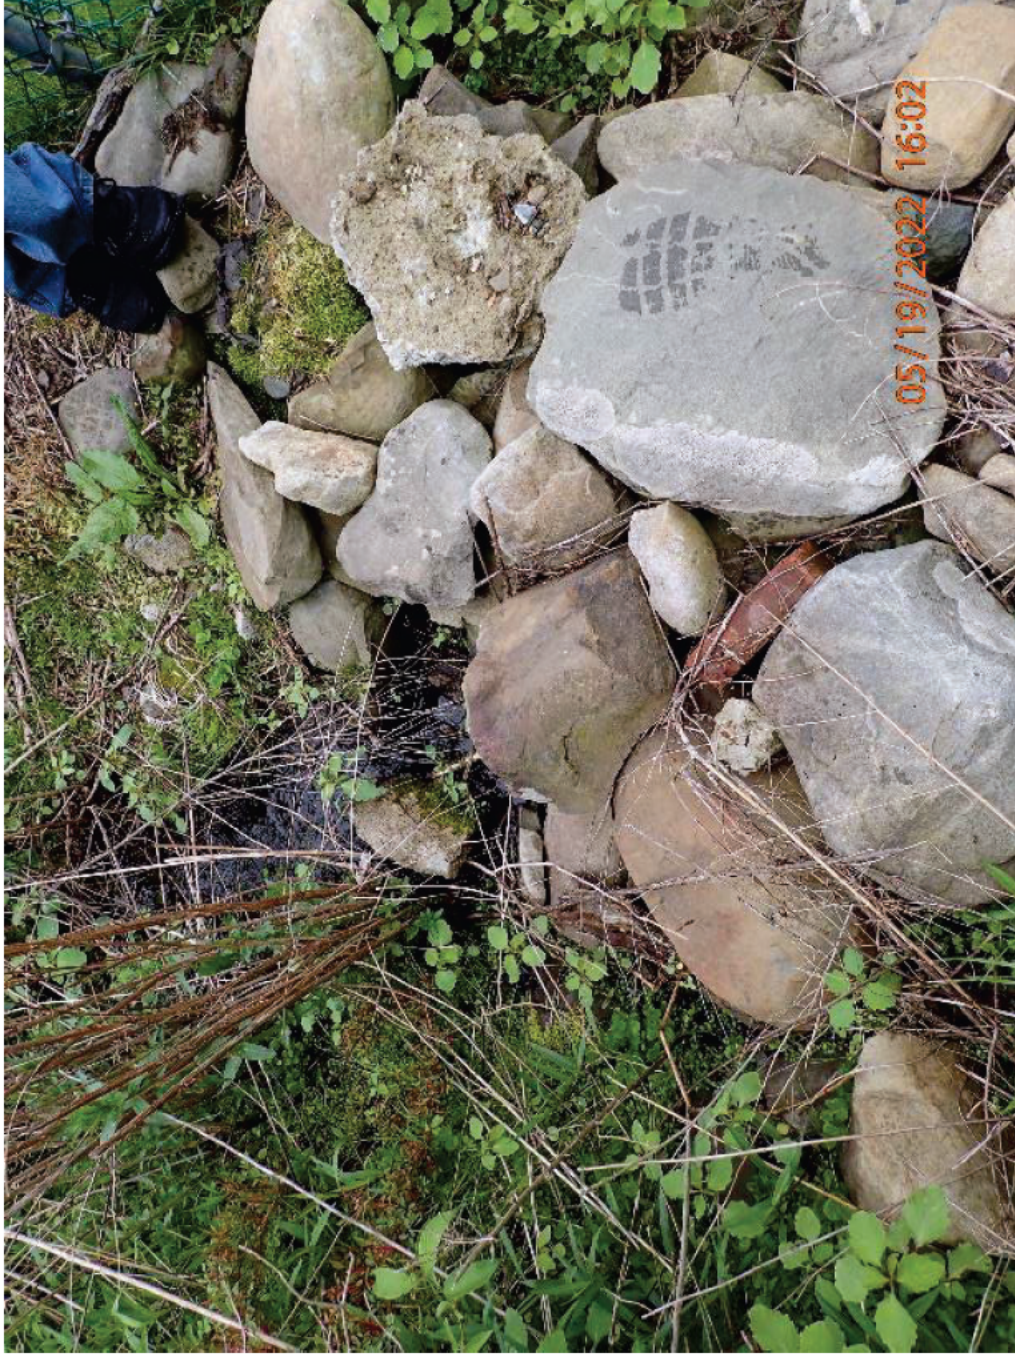
**Date:** 5/19/2022  
**Time:** 4:02 PM  
**Photographer:** SSA  
**Photo ID:** 2 – P5190348

**Description:**  
Watercourse that runs along  
eastern edge of property  
between fenced backyard and  
property boundary

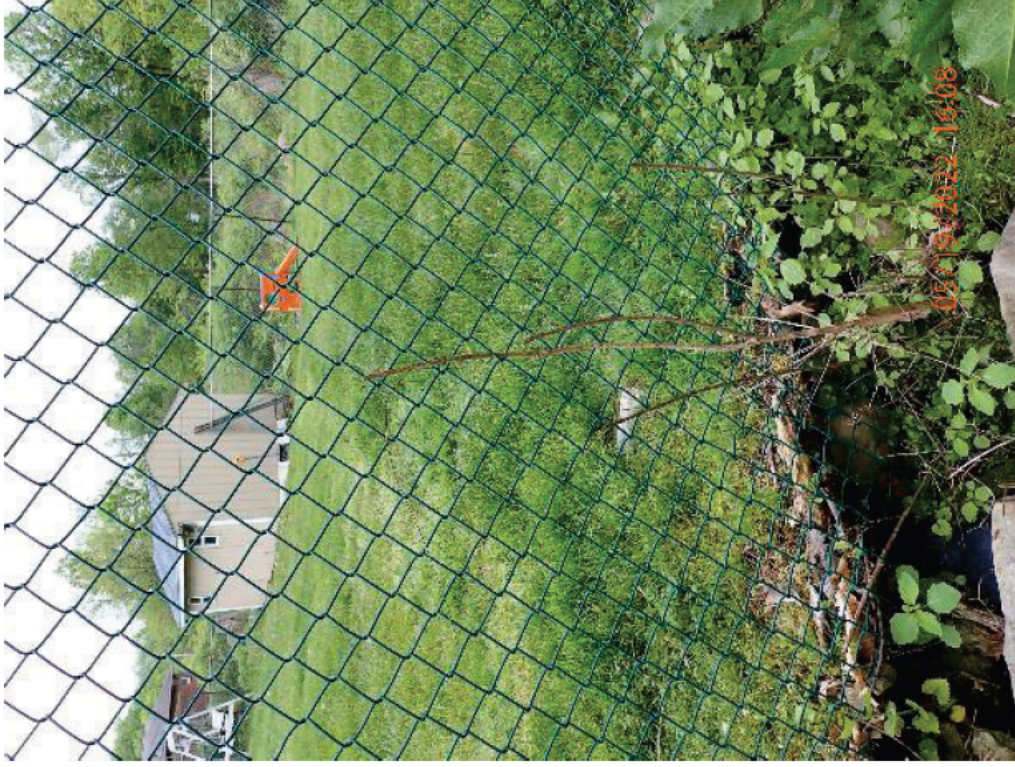
**Date:** 5/19/2022  
**Time:** 4:08 PM  
**Photographer:** SSA  
**Photo ID:** 4 – P5190350

**Description:**  
Path of pipe under fenced  
backyard

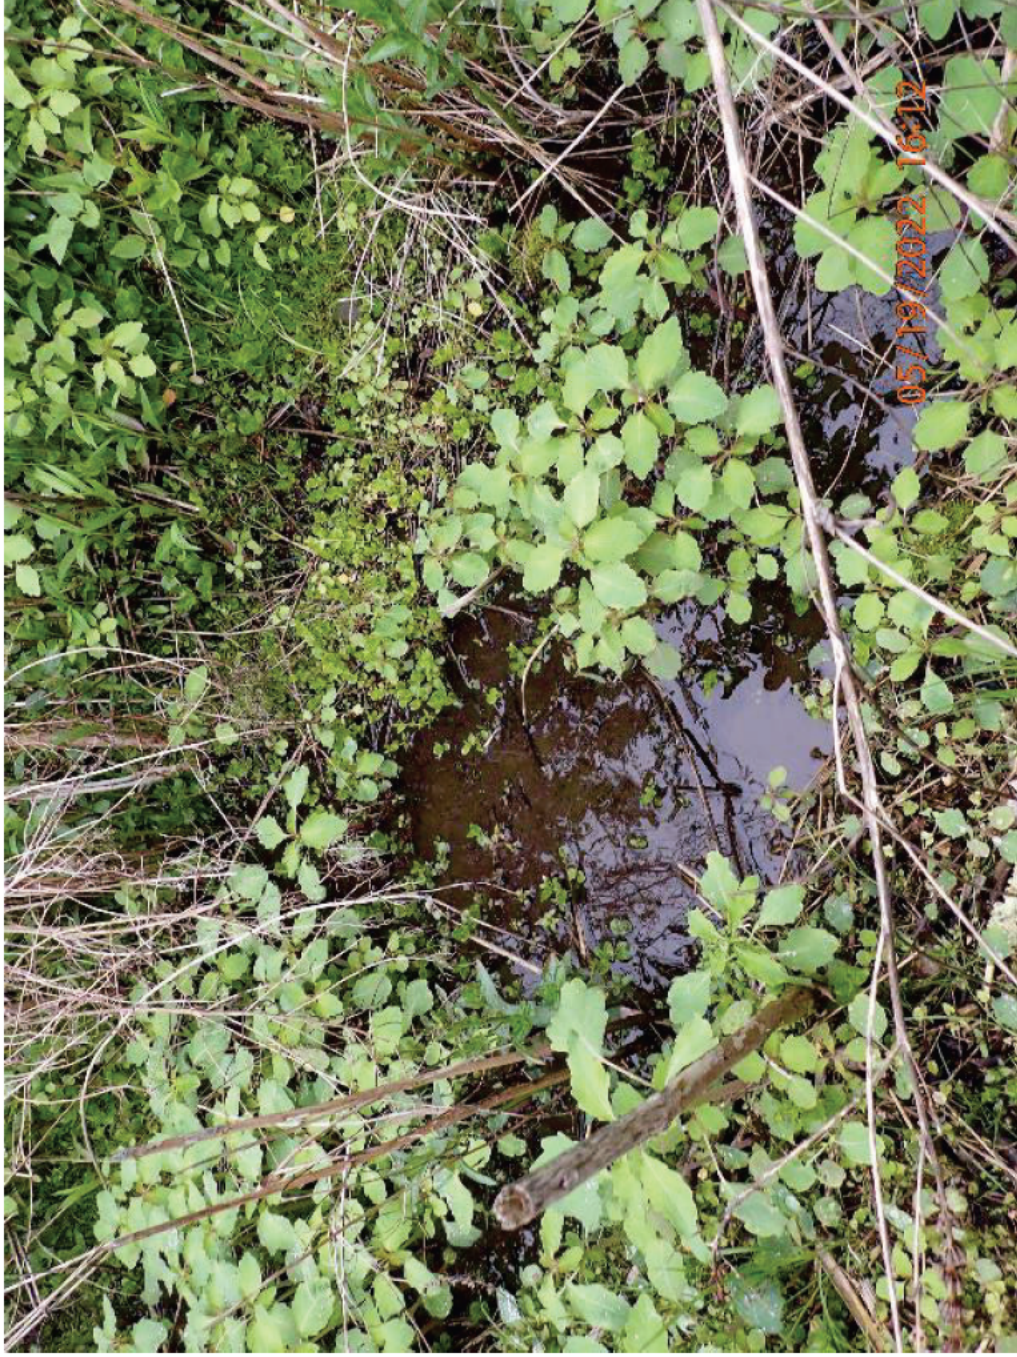
**Date:** 5/19/2022  
**Time:** 4:12 PM  
**Photographer:** SSA  
**Photo ID:** 5 – P5190351

Watercourse that runs along eastern edge of property between fenced backyard and property boundary

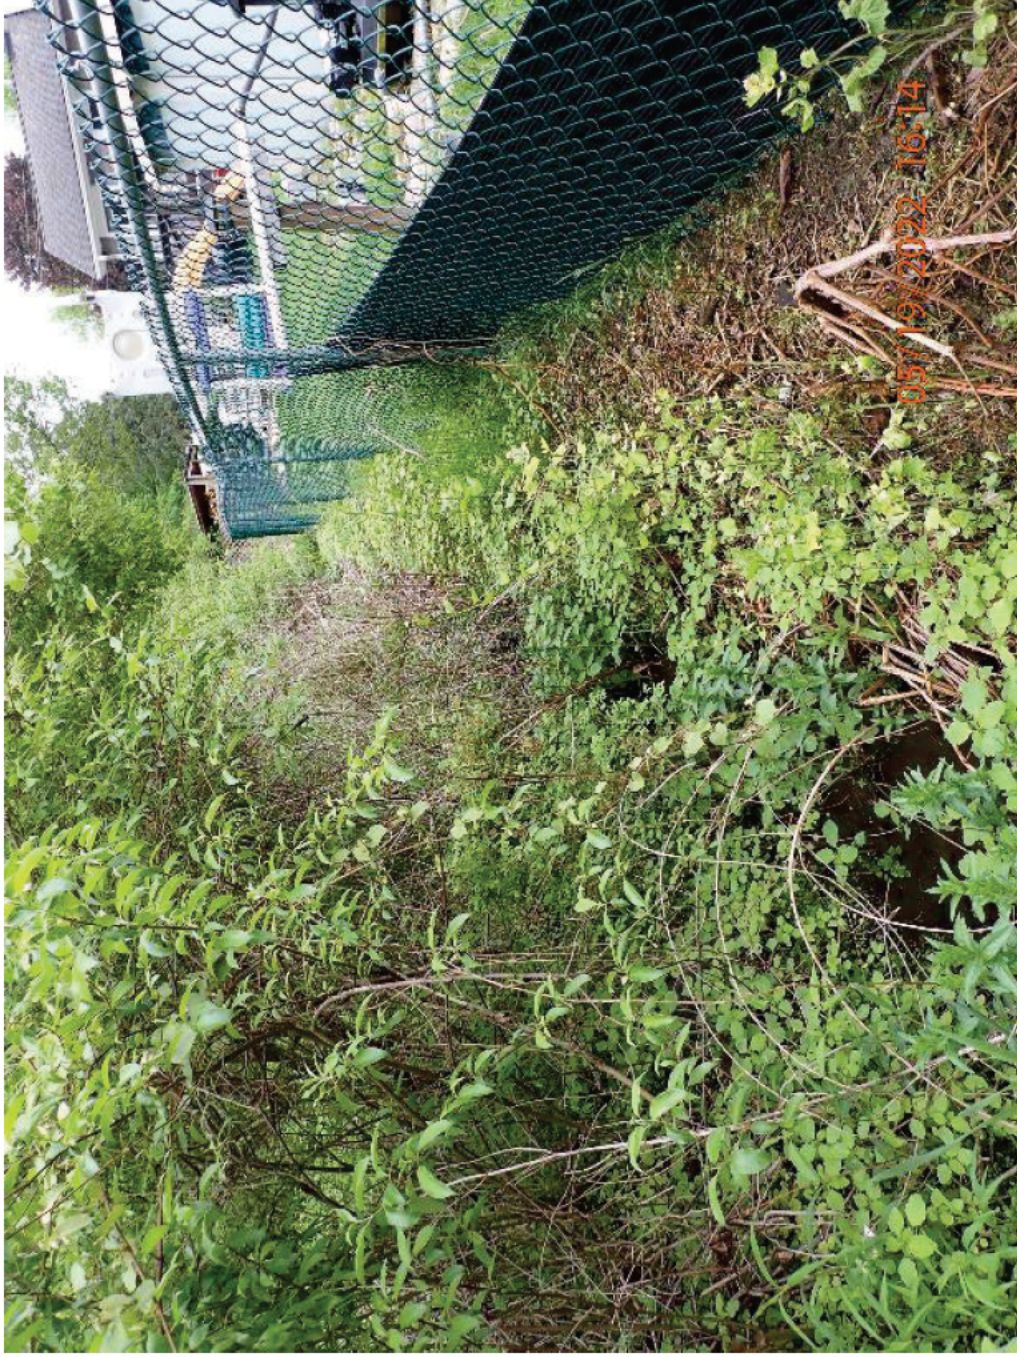
**Date:** 5/19/2022  
**Time:** 4:14 PM  
**Photographer:** SSA  
**Photo ID:** 6 – P5190352

Watercourse that runs along eastern edge of property between fenced backyard and property boundary

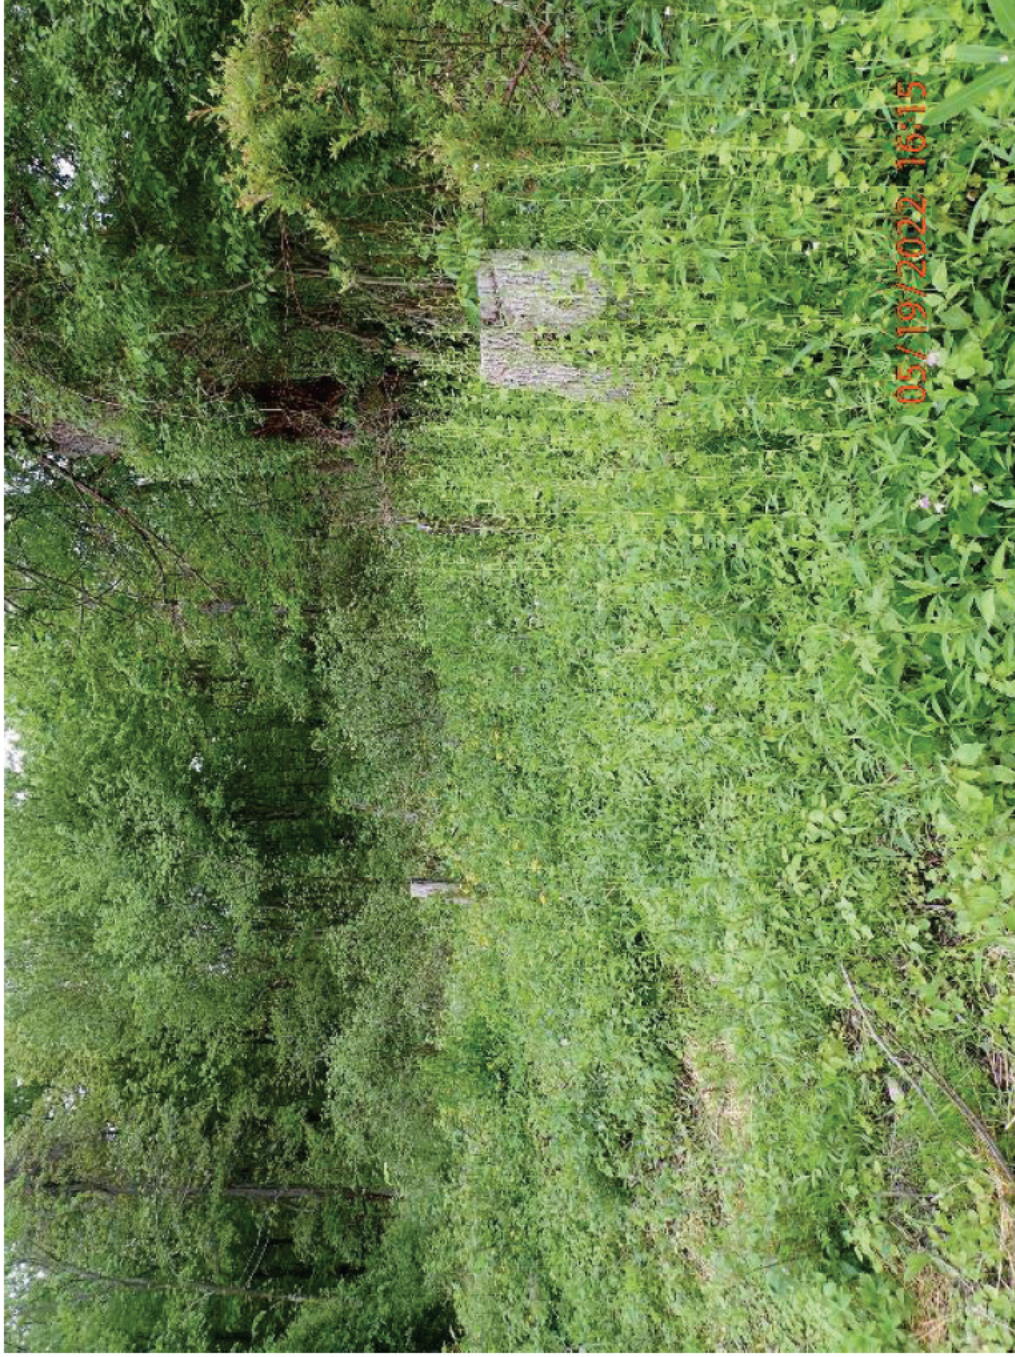
**Date:** 5/19/2022  
**Time:** 4:15 PM  
**Photographer:** SSA  
**Photo ID:** 7 – P5190353

Cleared area behind (north of)  
backyard

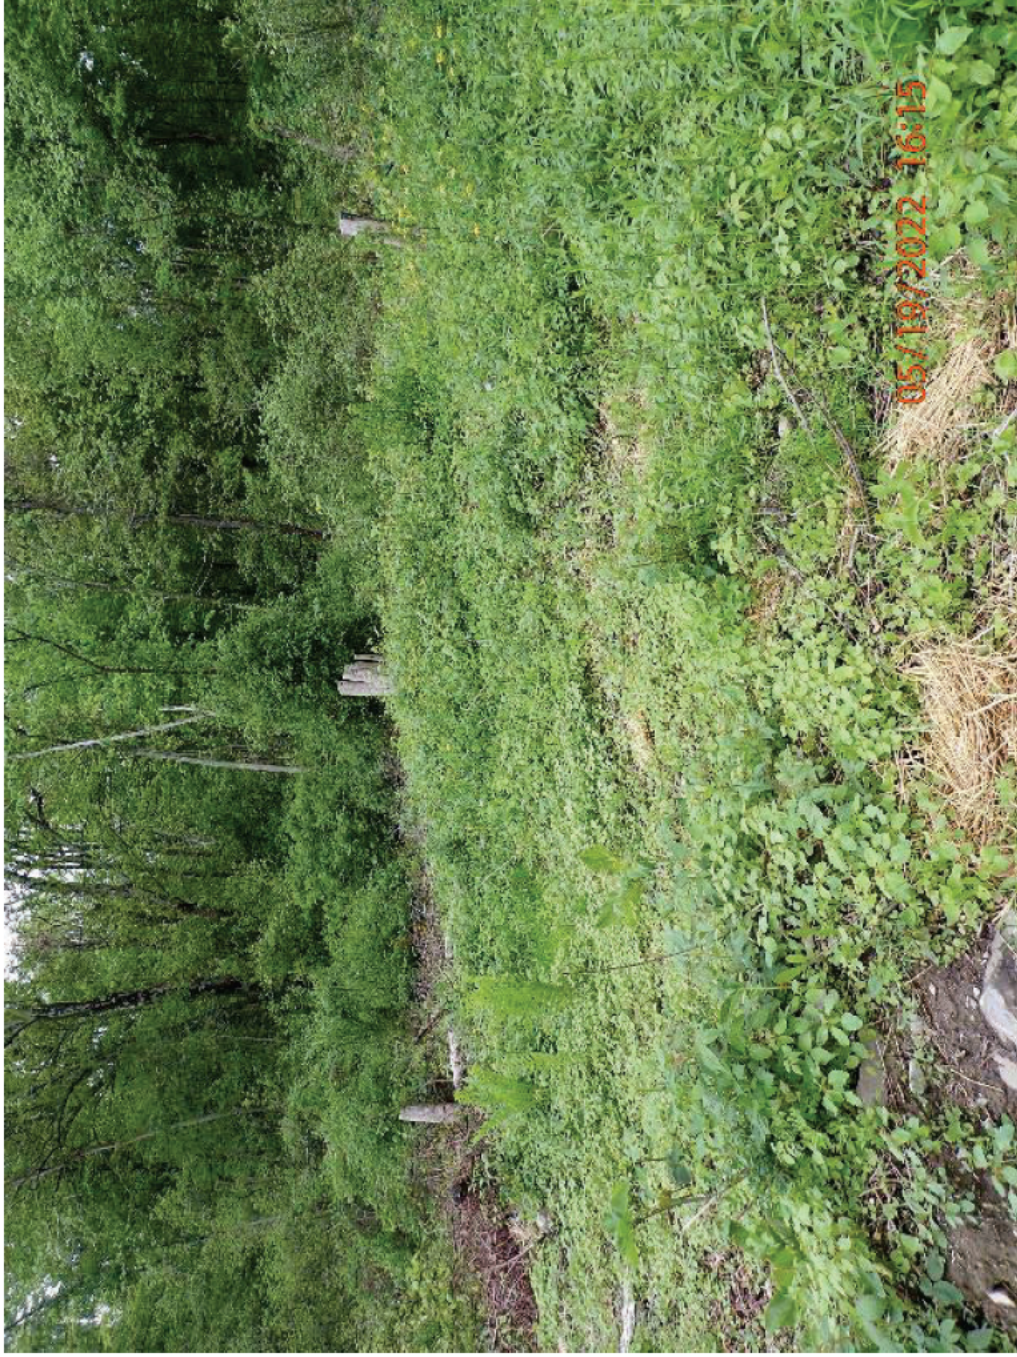
**Date:** 5/19/2022  
**Time:** 4:15 PM  
**Photographer:** SSA  
**Photo ID:** 8 – P5190354

**Description:**  
Cleared area behind (north of)  
backyard

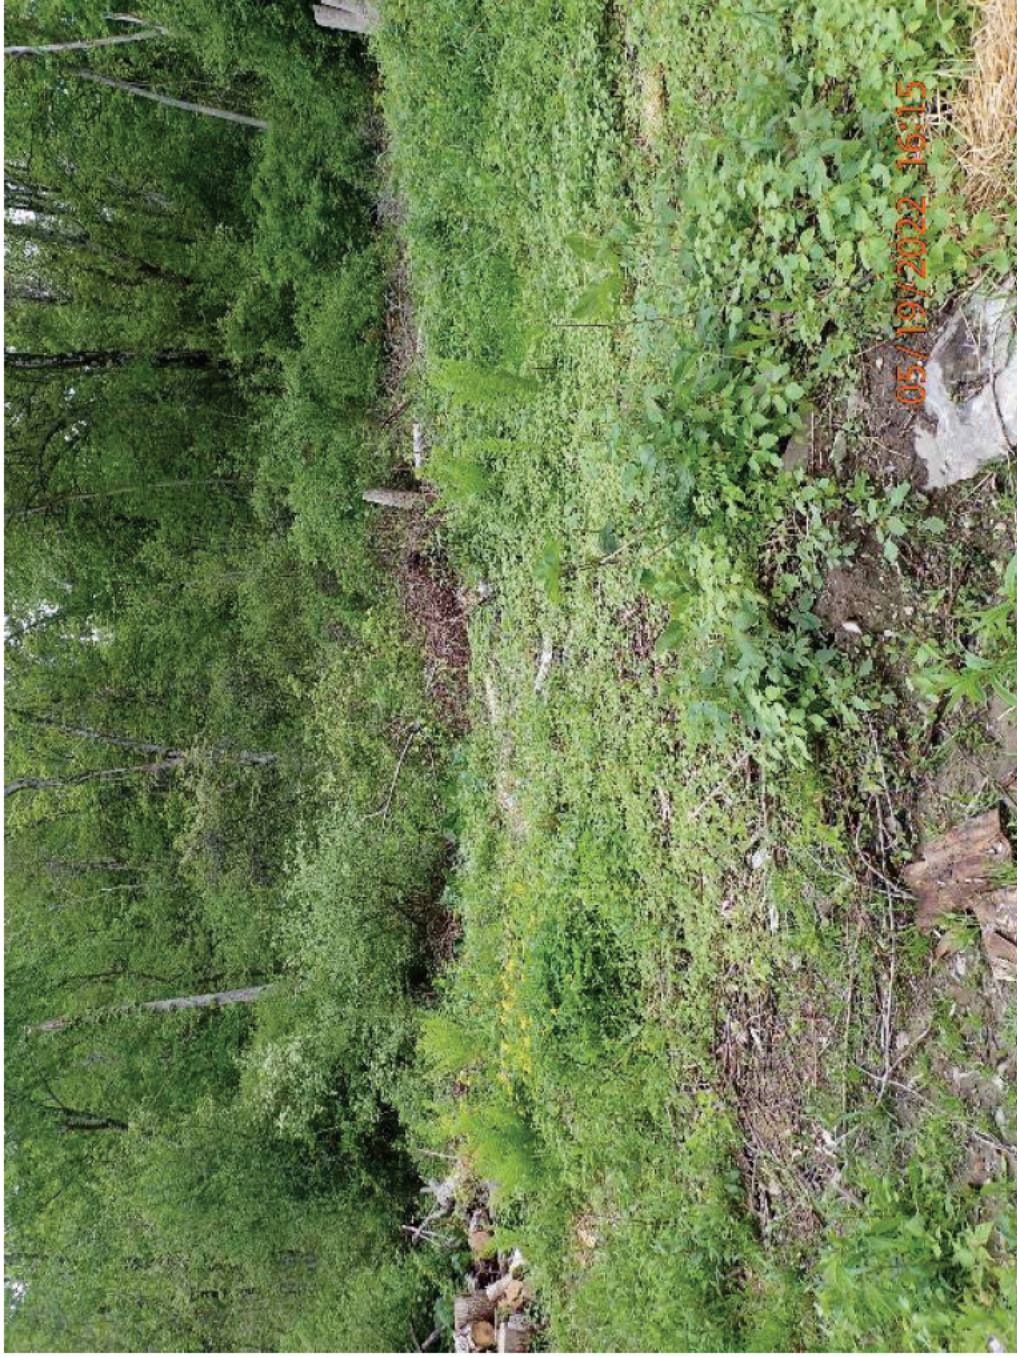
**Date:** 5/19/2022  
**Time:** 4:15 PM  
**Photographer:** SSA  
**Photo ID:** 9 – P5190355

**Description:**  
Cleared area behind (north of)  
backyard

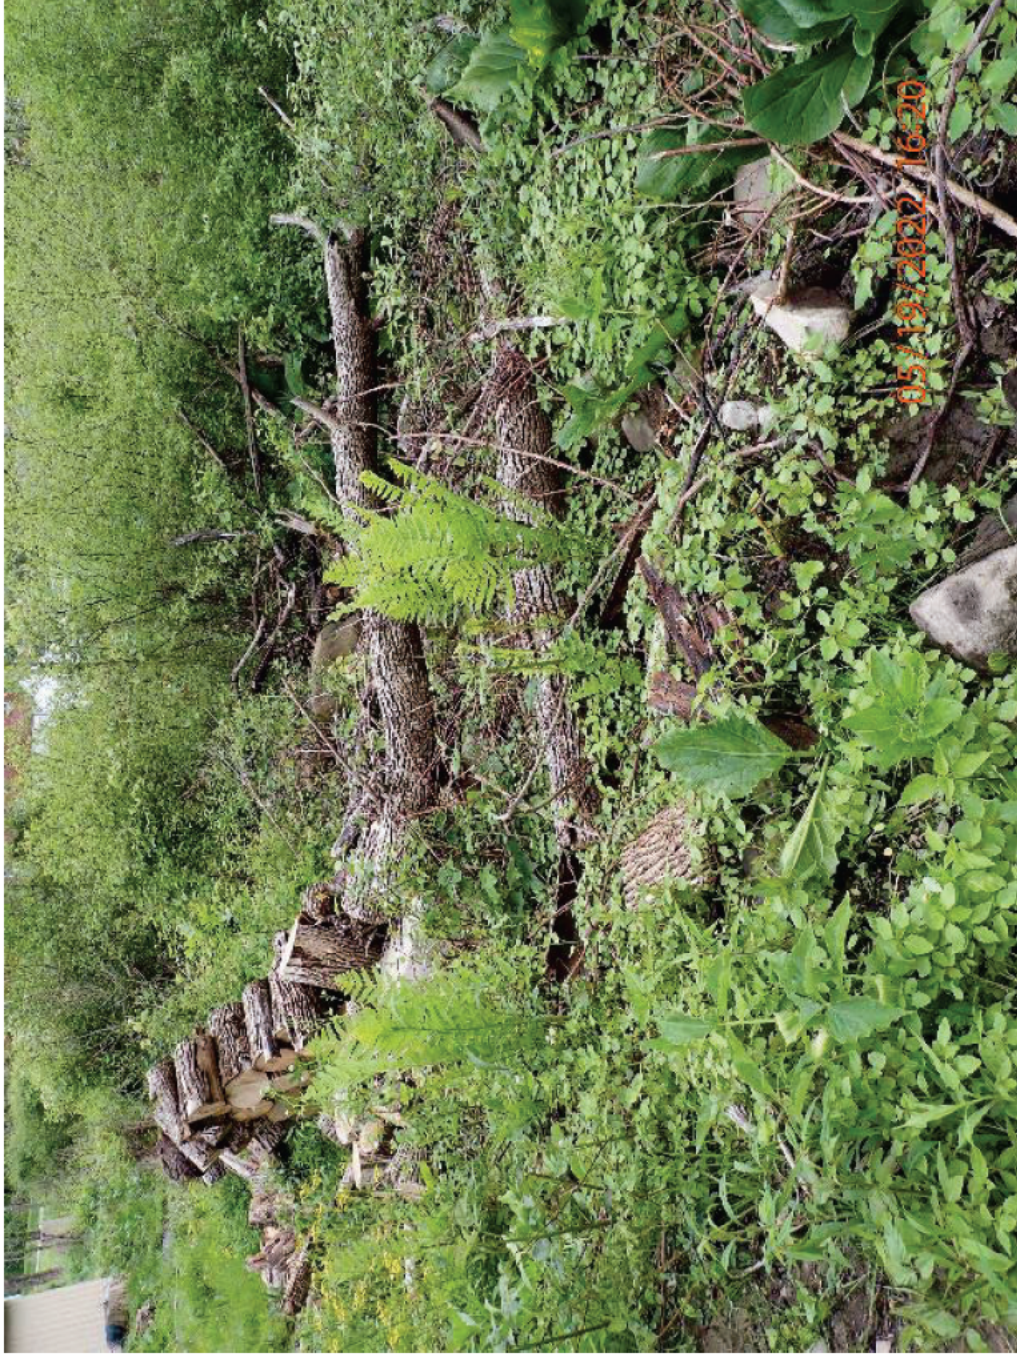
**Date:** 5/19/2022  
**Time:** 4:20 PM  
**Photographer:** SSA  
**Photo ID:** 10 – P5190356

| EPA relayed to Mr. Oehme that woody debris was being stored in areas that were likely wetlands. It also appeared that dirt and rock had also been pushed into this presumed wetland area. | | | |

Woody debris and storage of logs on property in and adjacent to presumed wetland

| Mr. Oehme stated that he would voluntarily remove the woody debris and dirt from the likely wetlands and restore this area to pre-disturbance grade. | | | |

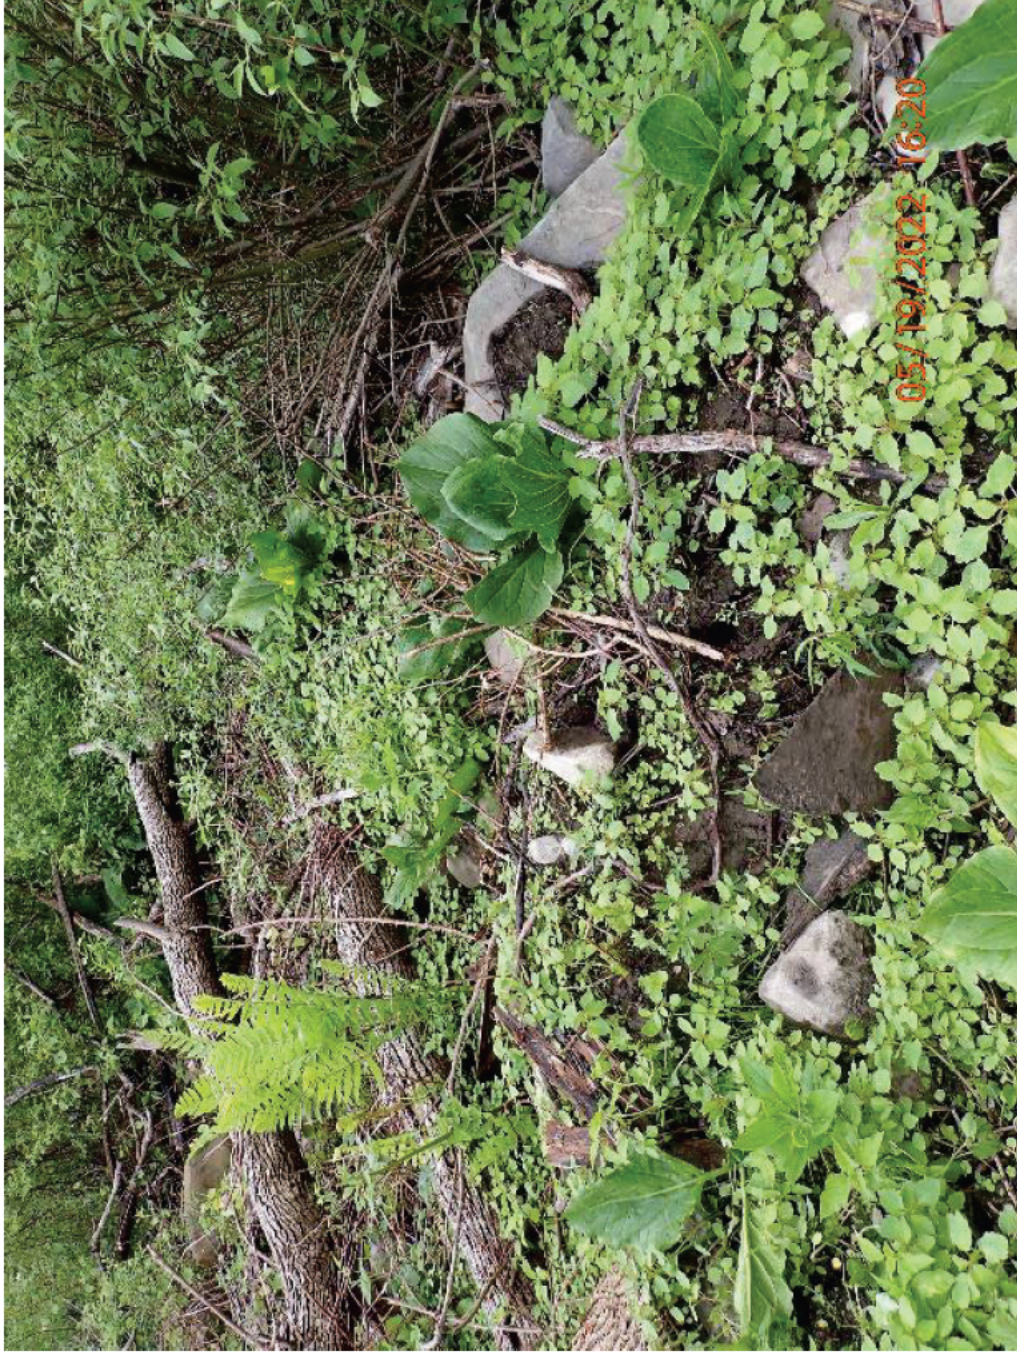
**Date:** 5/19/2022  
**Time:** 4:20 PM  
**Photographer:** SSA  
**Photo ID:** 11 – P5190357

| Woody debris, dirt, and rock had been potentially discharged to an area that was likely wetlands. | | | |

Woody debris, dirt, and rock placed/pushed into presumed wetland  
Vegetation dominated by skunk cabbage and jewelweed

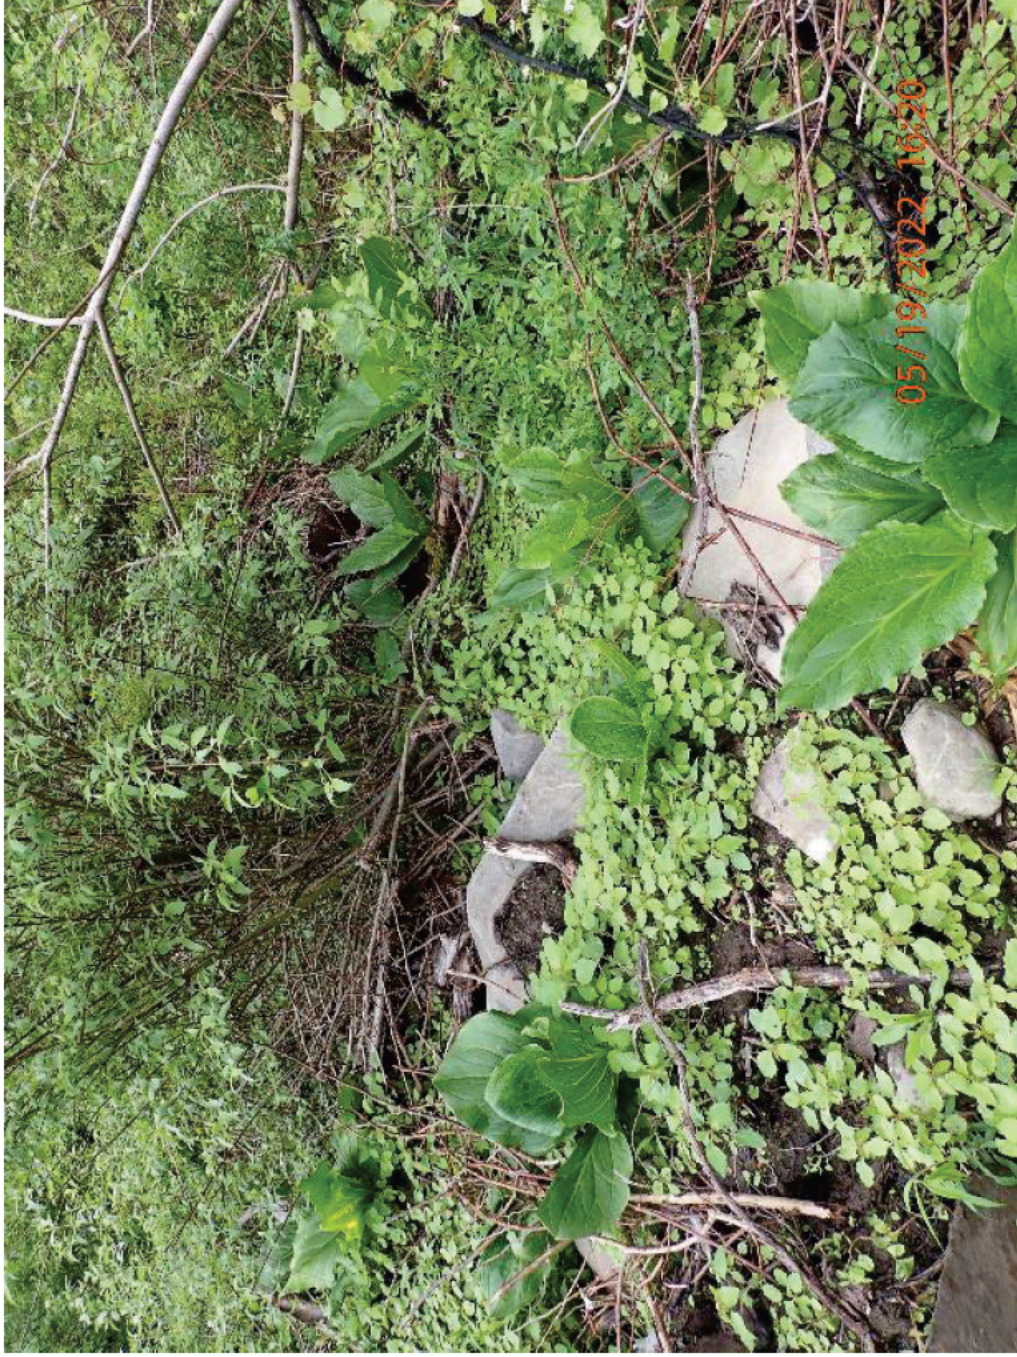
**Date:** 5/19/2022  
**Time:** 4:20 PM  
**Photographer:** SSA  
**Photo ID:** 12 – P5190358

Dirt and rock placed/pushed  
into presumed wetland

Vegetation dominated by skunk  
cabbage and jewelweed

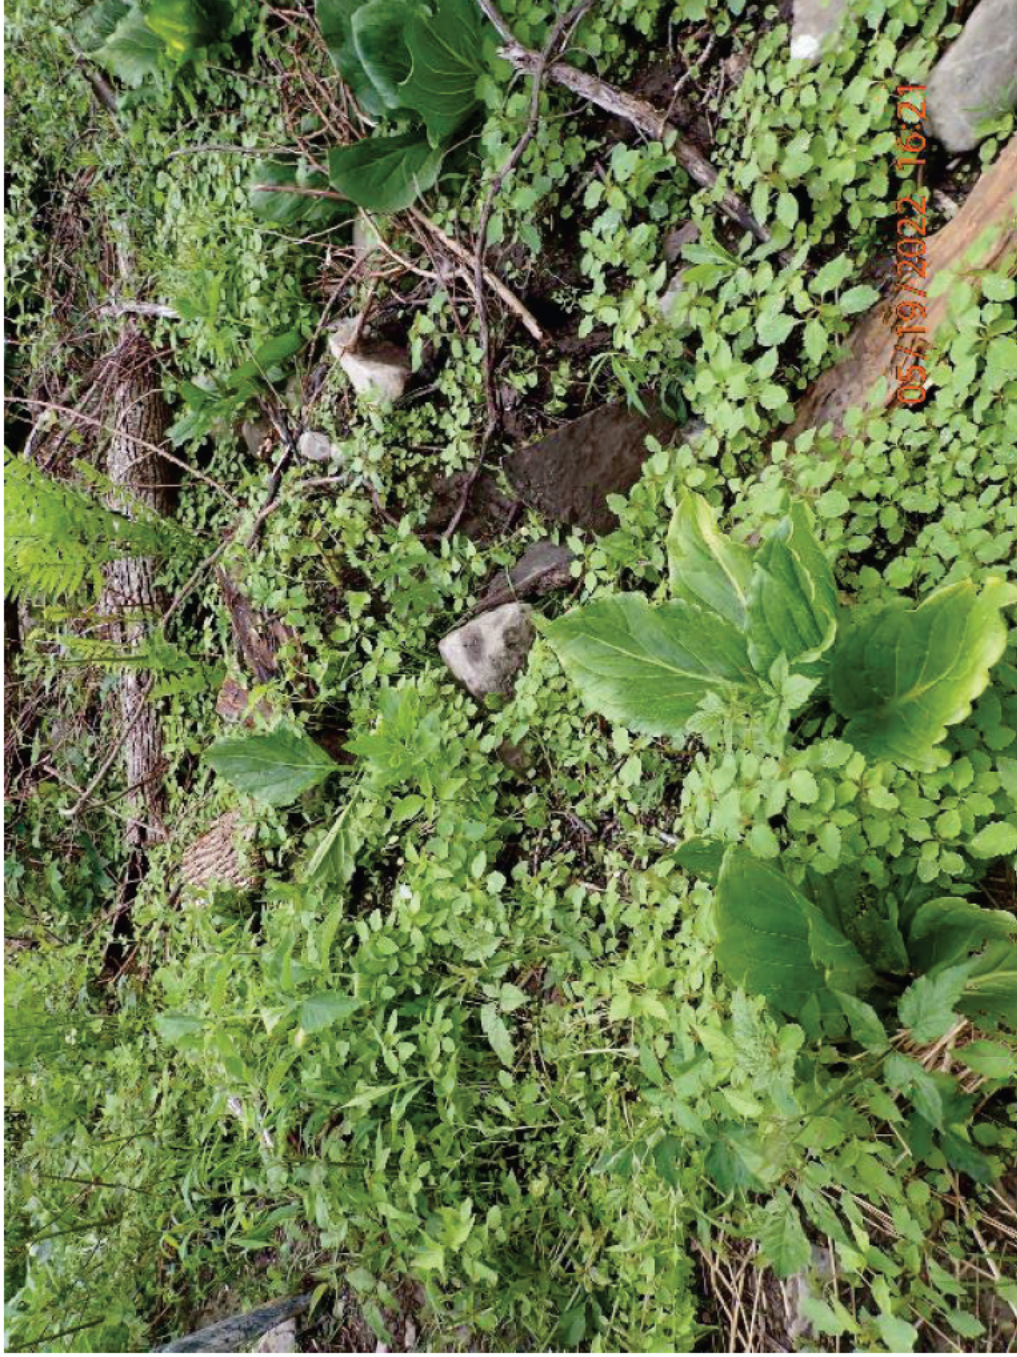
**Date:** 5/19/2022  
**Time:** 4:21 PM  
**Photographer:** SSA  
**Photo ID:** 13 – P5190359

Dirt and rock placed/pushed  
into presumed wetland  
Vegetation dominated by skunk  
cabbage and jewelweed

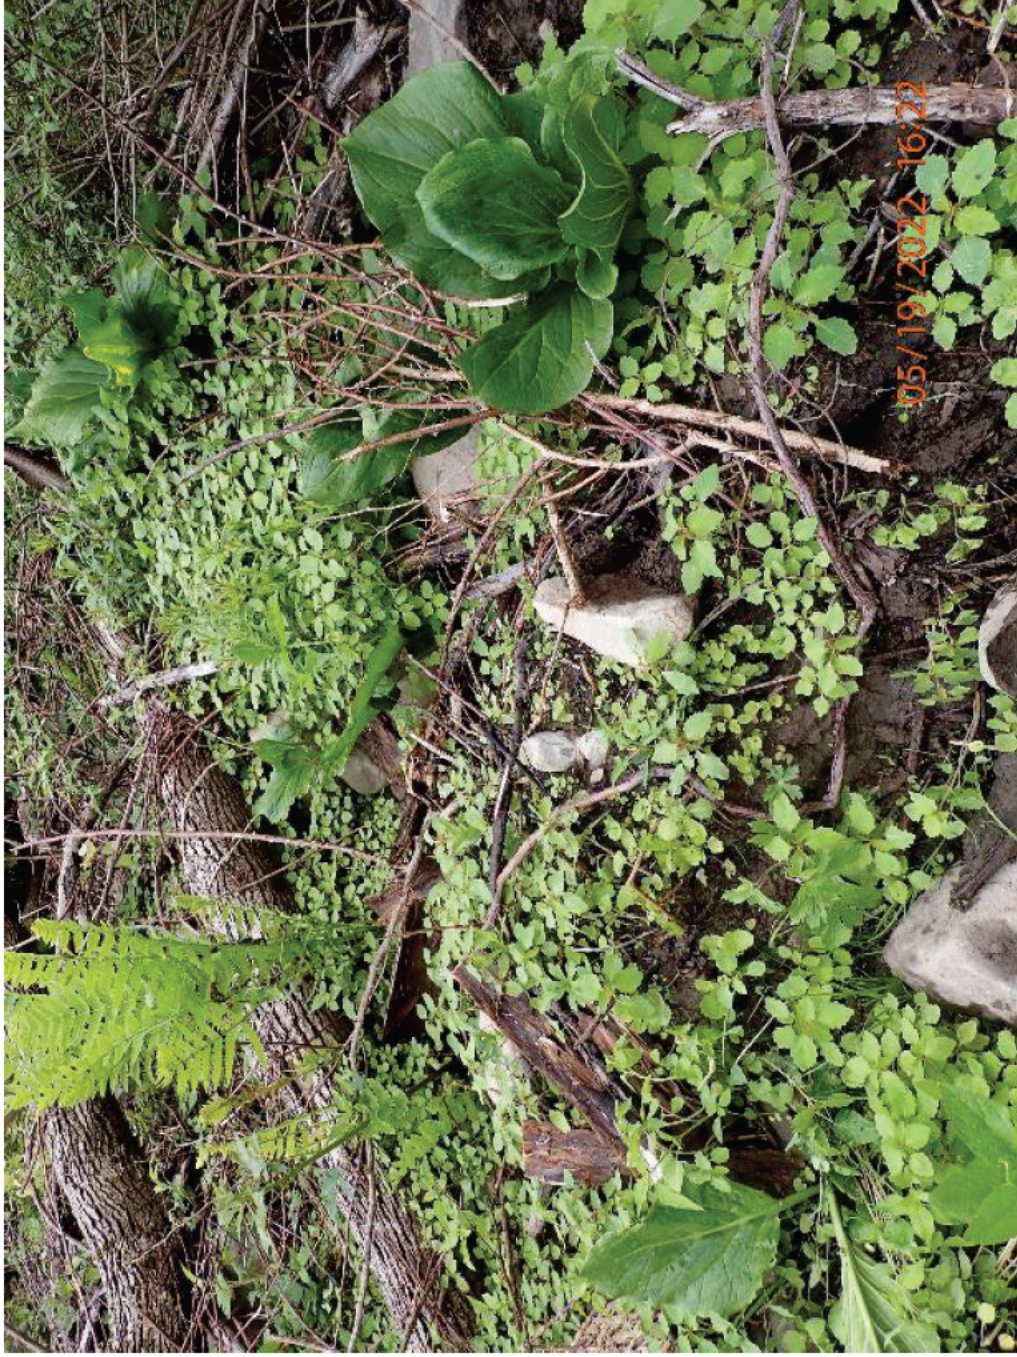
**Date:** 5/19/2022  
**Time:** 4:22 PM  
**Photographer:** SSA  
**Photo ID:** 14 – P5190360

Logs, dirt, and rock in presumed wetland area

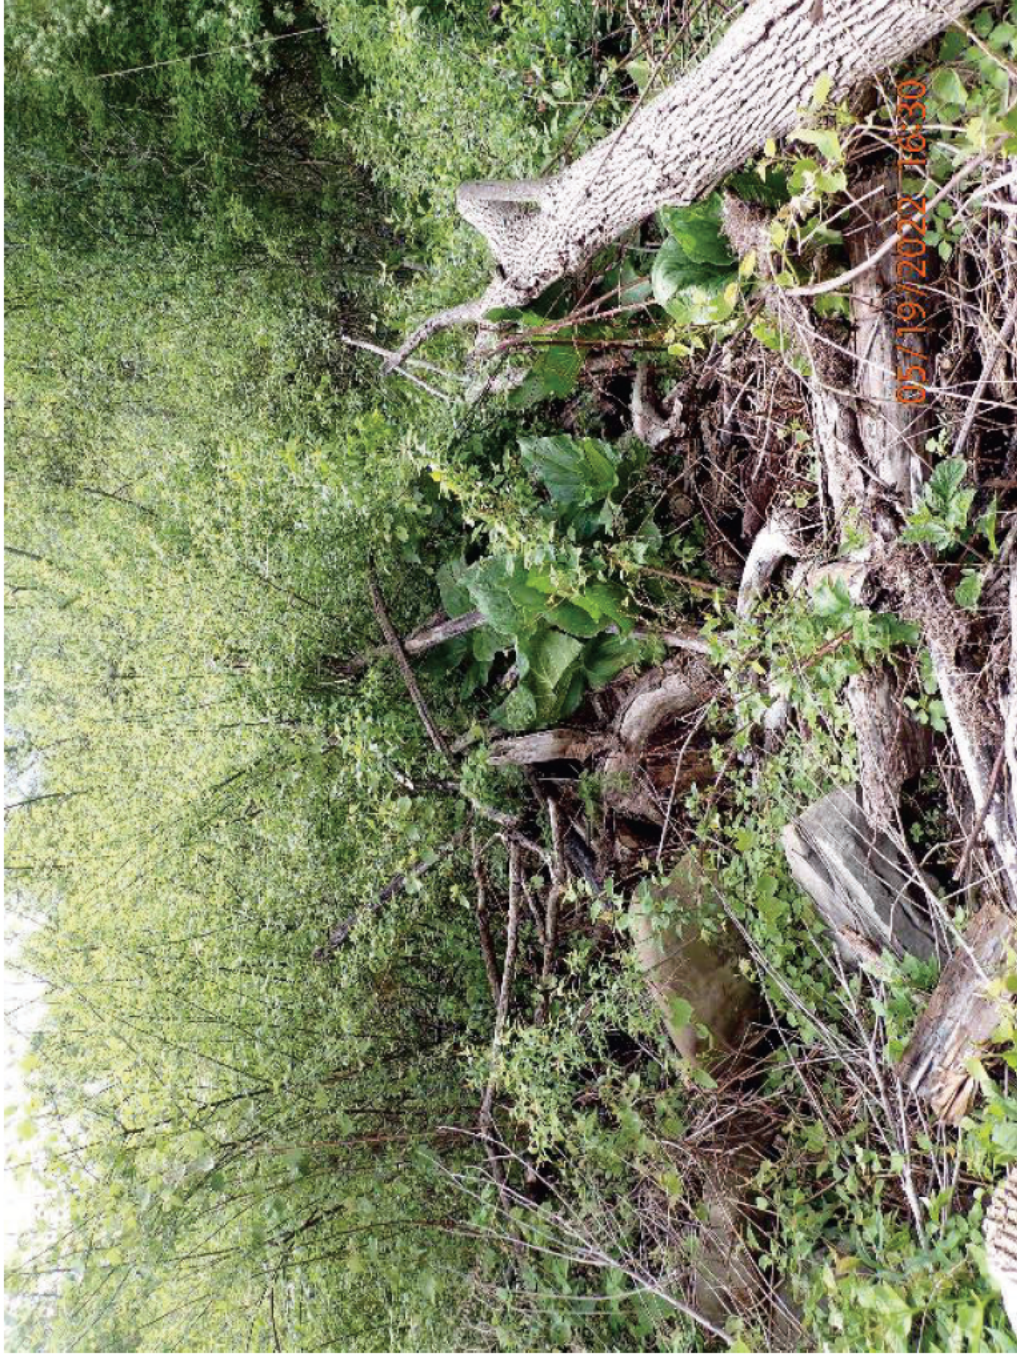
**Date:** 5/19/2022  
**Time:** 4:30 PM  
**Photographer:** SSA  
**Photo ID:** 15 – P5190361

**Description:**  
Presumed wetland area

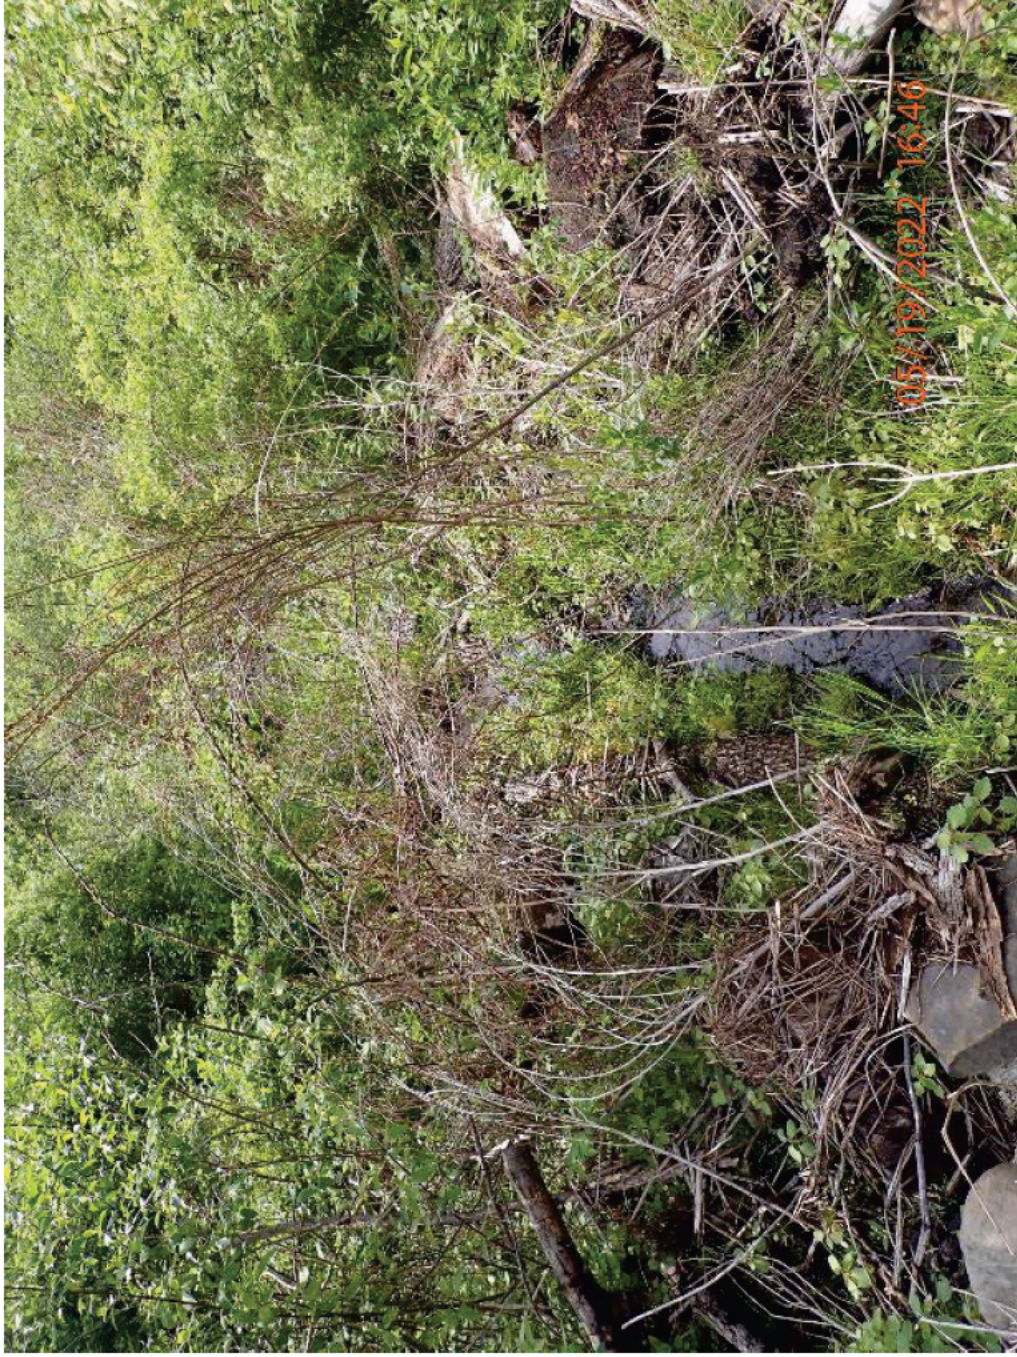
**Date:** 5/19/2022  
**Time:** 4:46 PM  
**Photographer:** SSA  
**Photo ID:** 16 – P5190362

Watercourse that flows north  
along eastern edge of property

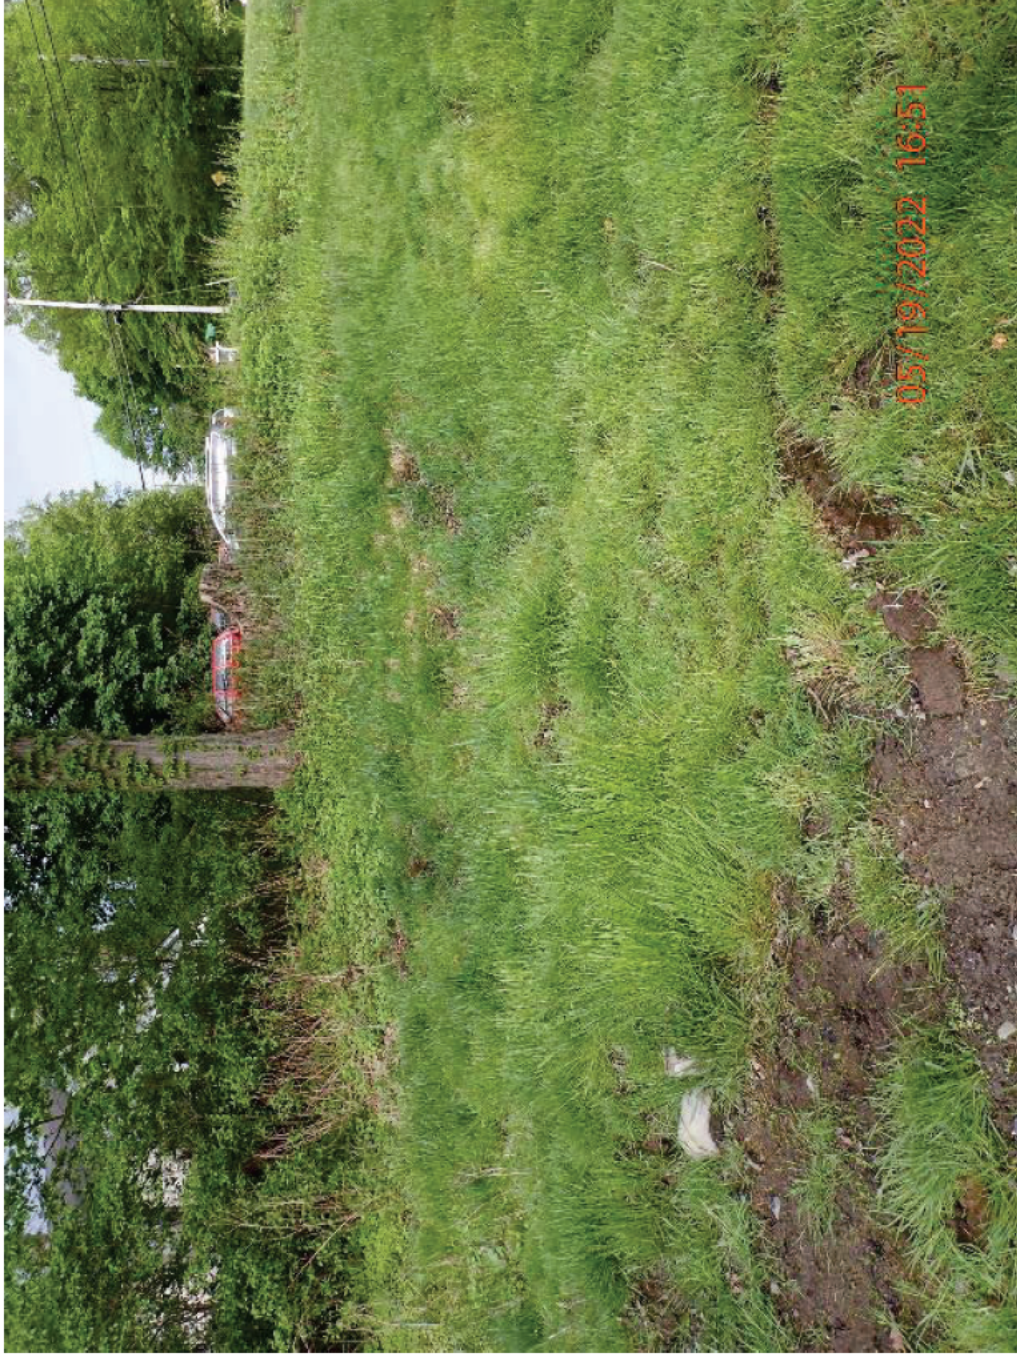
**Date:** 5/19/2022  
**Time:** 4:51 PM  
**Photographer:** SSA  
**Photo ID:** 17 – P5190363

Water seeping from hillside
