## Clean Water Act Section 404: Site Visit/Case Development

| Site Name | Neal Oehme Property | | | | |

| Inspection Purpose | Initial site visit | | |

CWA 404 Inspection  
Neal Oehme Property  
139 Mill Street, Wallkill, NY

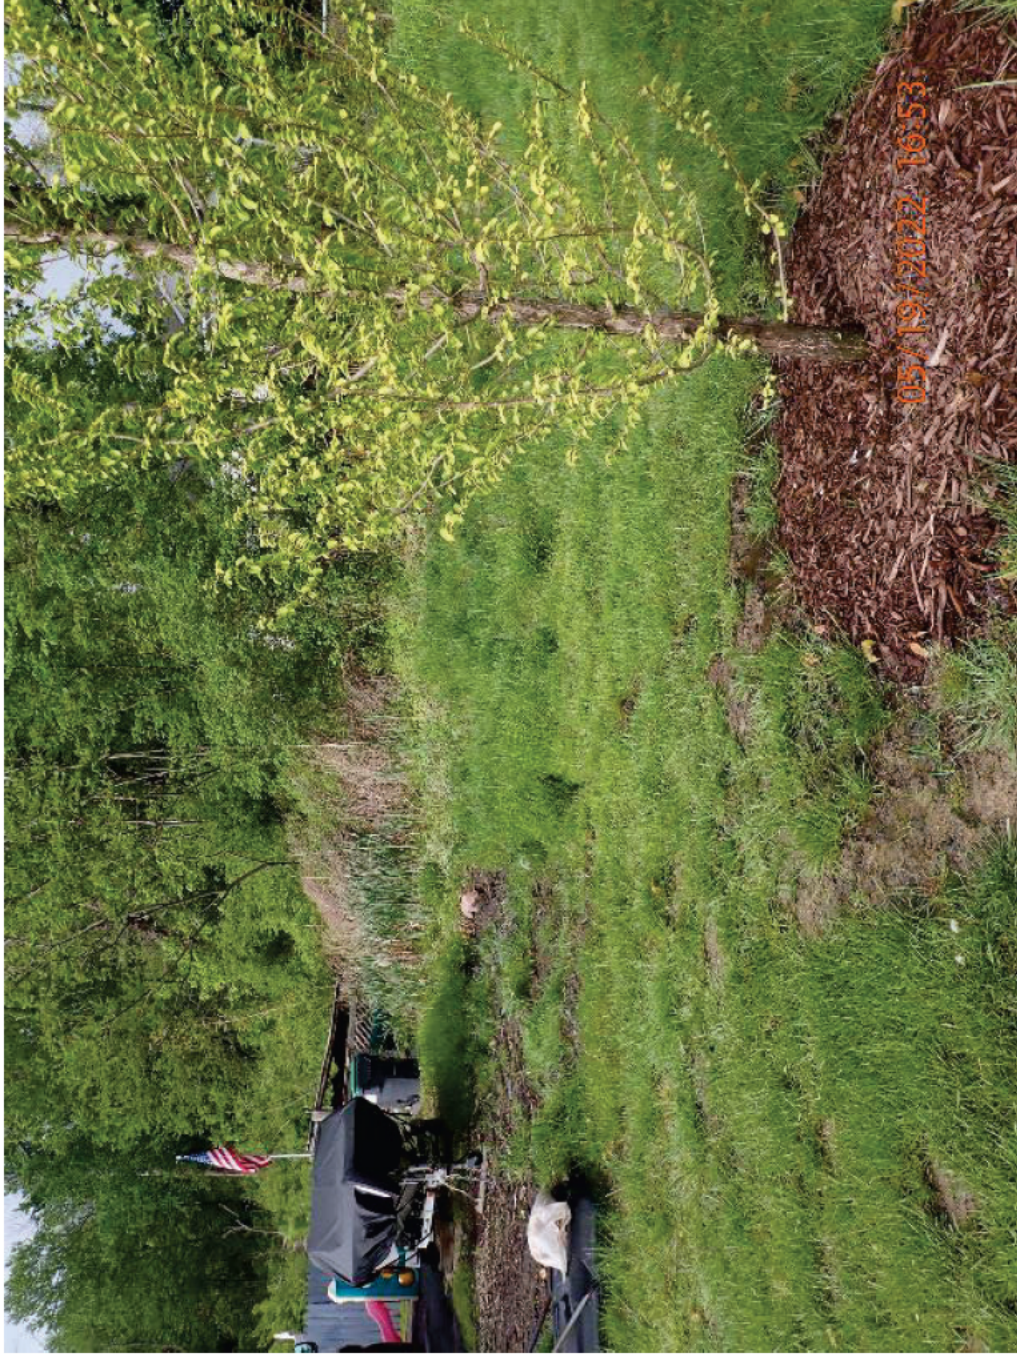
**Date:** 5/19/2022  
**Time:** 4:53 PM  
**Photographer:** SSA  
**Photo ID:** 18 – P5190364

**Description:**  
Hillside seep area
