Multi-Media Inspection Report  
Federal Aviation Administration  
William J. Hughes Technical Center  
Egg Harbor Township, New Jersey  
November 2021

## MULTI-MEDIA INSPECTION REPORT

Facility Name: FAA William J. Hughes Technical Center  
Facility Address: Atlantic City International Airport, Egg Harbor Township, NJ 08405  
Latitude & Longitude: 39.444401, -74.562881

Date of Inspection: November 9, 2021  
Inspector(s): Erin Floto & Carlos Colombani

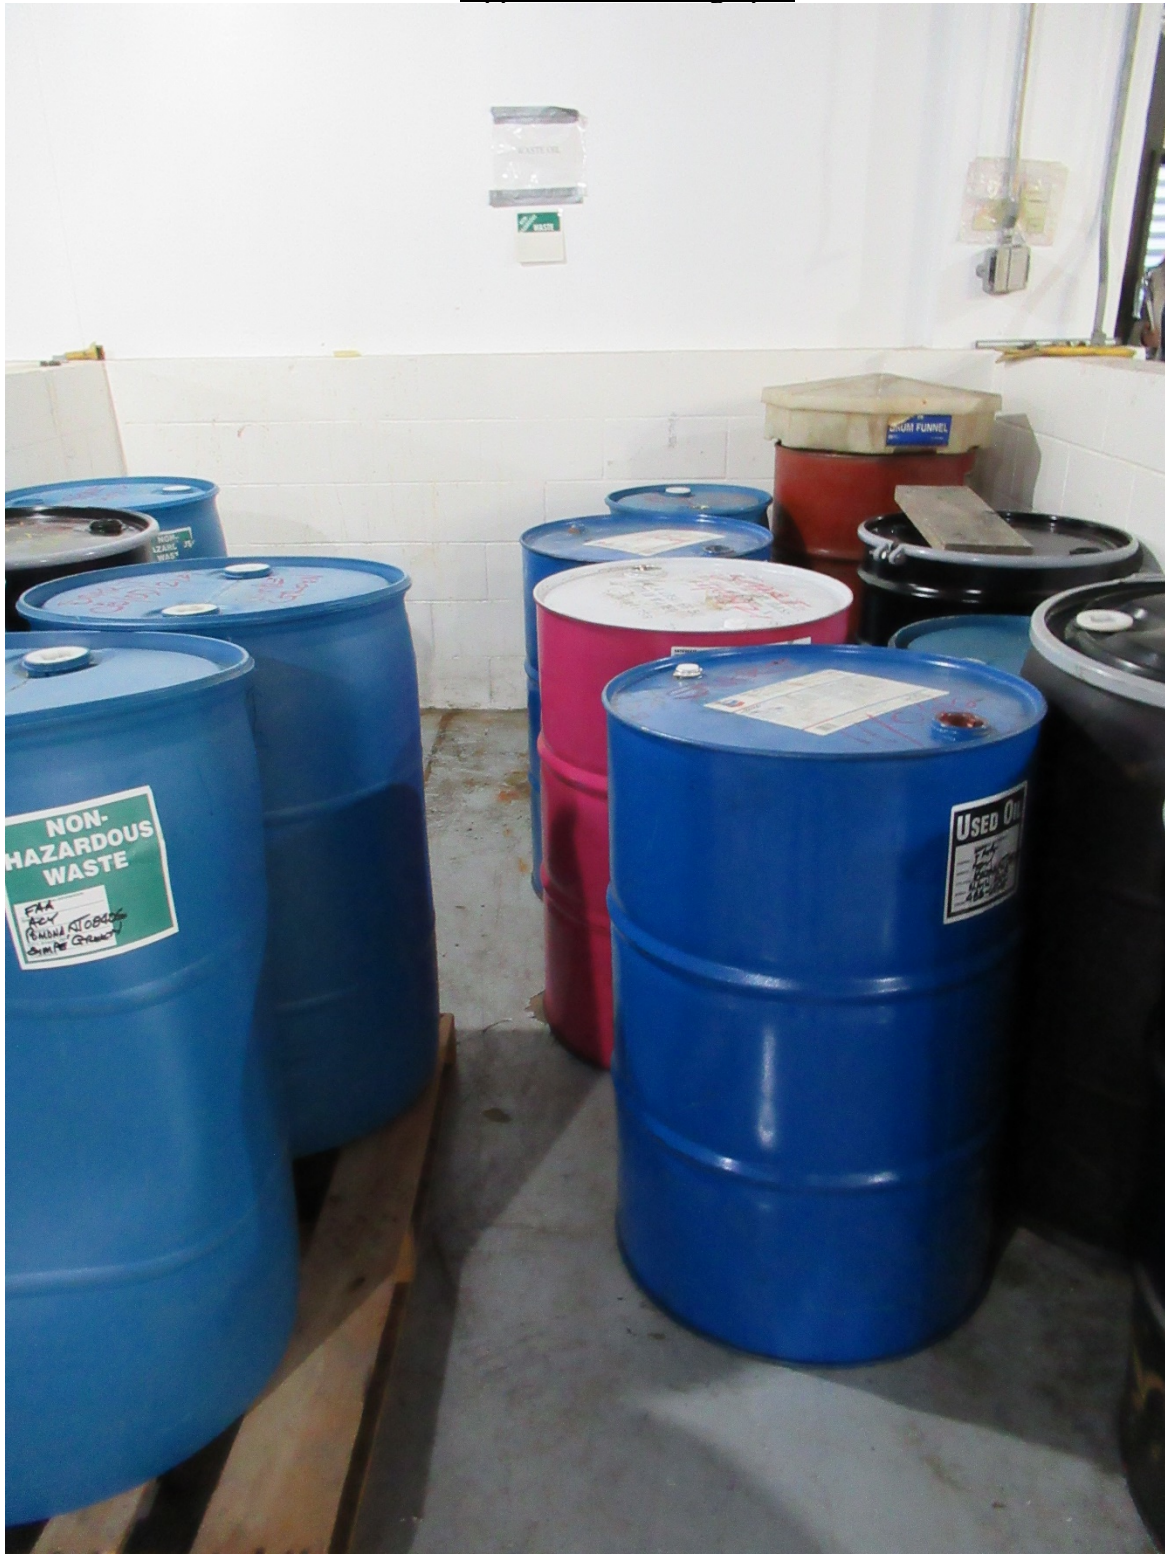
At Building 56, the CAA, Mr. Bill Wills serves as the hazardous waste manager. There were three 55-gallon containers of used oil (Appendix A, IMG\_0282) and one 55-gallon container of flammable liquids labeled March 18, 2021. There were also about four 55-gallon drums storing non-hazardous waste, of which one appeared to not be in adequate condition to hold the product (slight suction inwards). Additionally, there were at least seventeen (17) open containers of used lamps and one stack of approximately twelve (12) used lamps fully uncovered (Appendix A, IMG\_0283). The building structure acts as a secondary containment in case of any spills. There were proper spill containments kits, fire extinguishers, a fire suppression system and telephones readily available in case of an emergency.

IMG\_0282 Used Oil Containers at CAA.

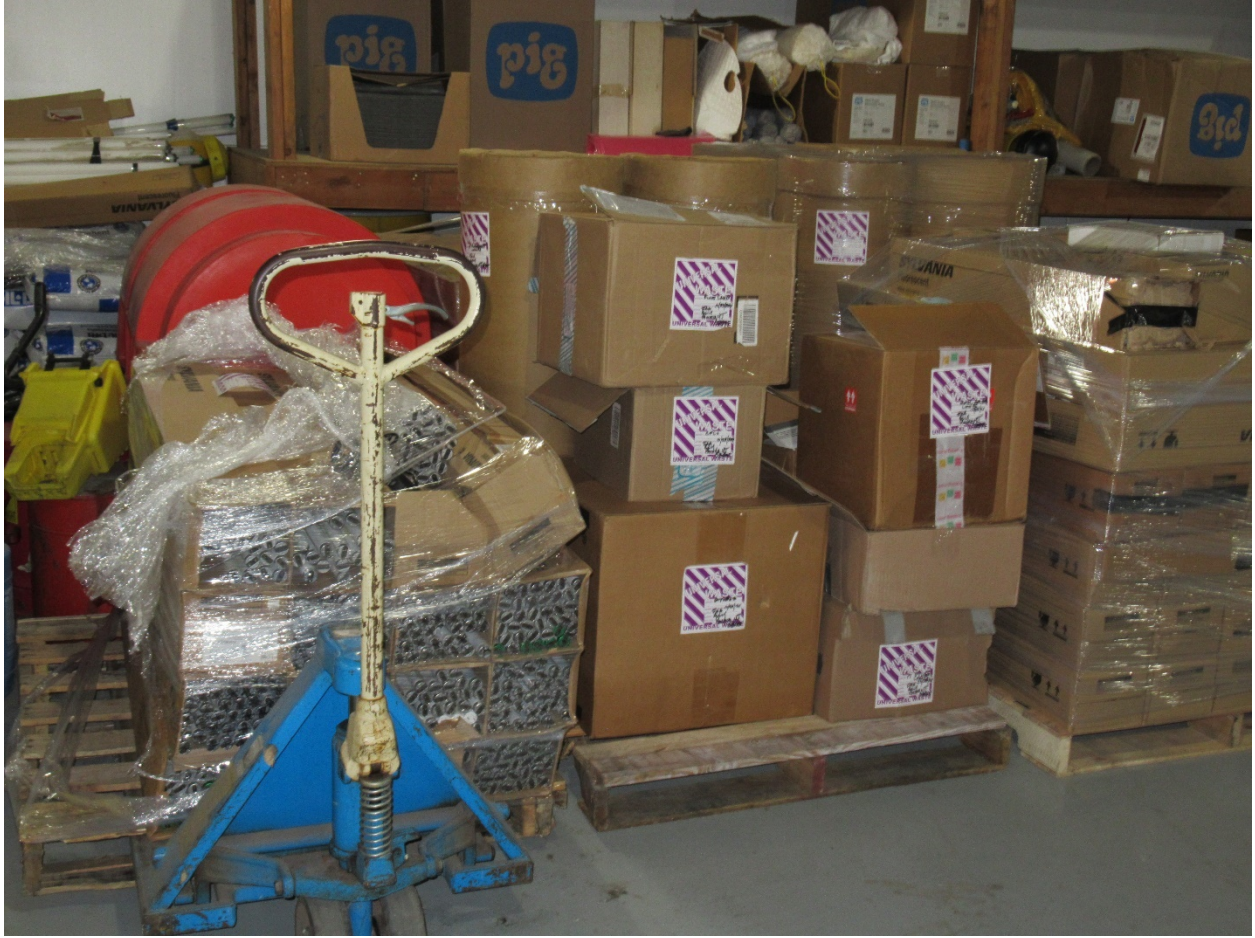
IMG\_0283: Uncovered universal waste.

| REGULATORY, STATUTORY OR PERMIT REFERENCE | FIELD OBSERVATION |
|---|---|
| <p>In accordance with 40 C.F.R. § Part 273.13(d)(1), as incorporated by reference at N.J.A.C. § 7:26A-7.1, a small quantity handler of universal waste must contain any lamp in containers or packages that are structurally sound, adequate to prevent breakage, and compatible with the contents of the lamps. Such containers and packages must remain closed and must lack evidence of leakage, spillage or damage that could cause leakage under reasonably foreseeable conditions.</p> | <p>At the Central Accumulation Area (CAA) Building 56, there were at least 17 open boxes of used lamps and 1 stack of approximately 12 used lamps fully uncovered (Appendix A, IMG_0283).</p> <p><u>Corrective Action:</u> On December 13, 2021, the Facility provided a photograph that demonstrated proper closure of the opened universal waste containers.</p> |

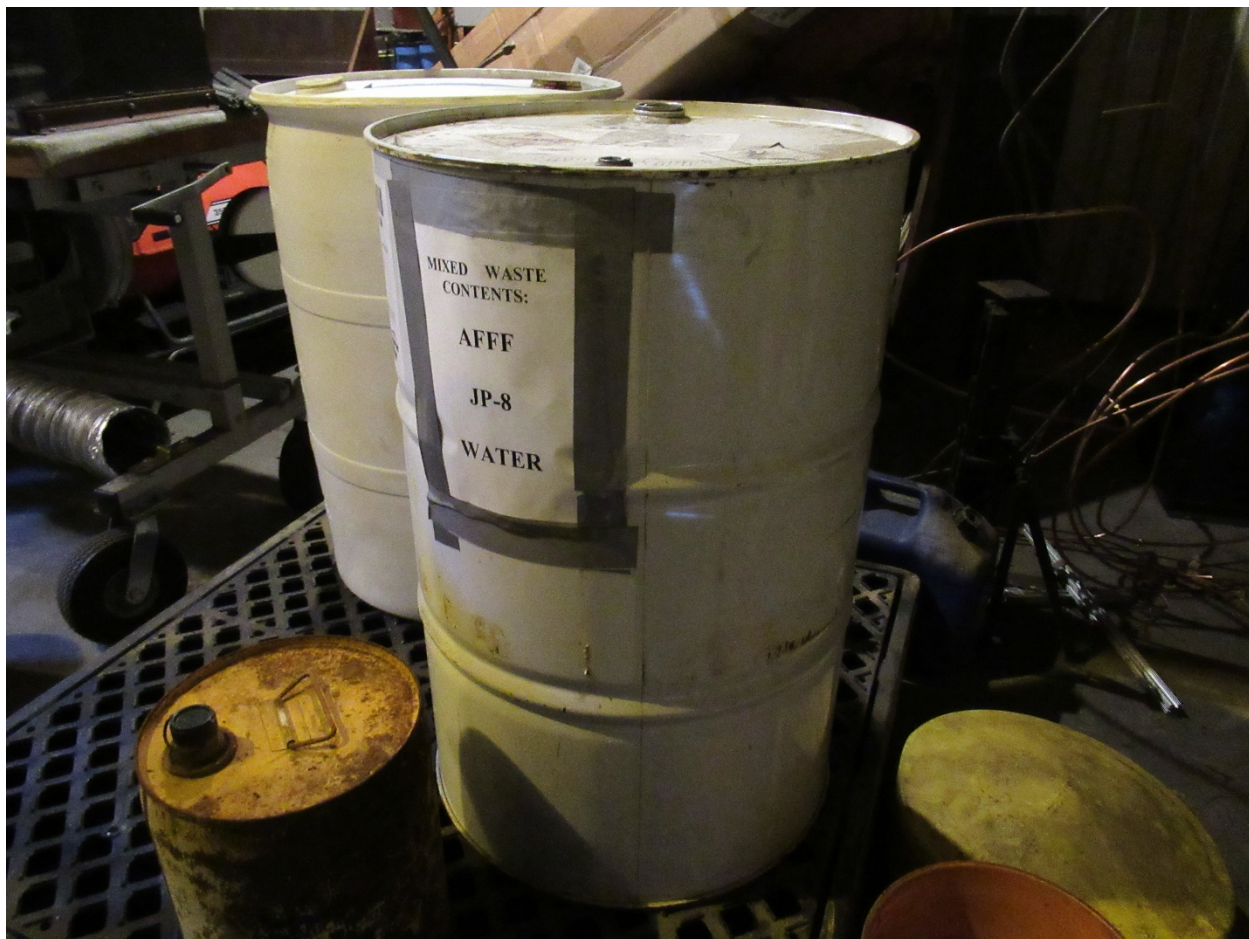
At Building 275, the Fire Test Facility, the SAA was storing a 55-gallon drum of used oil; a 55-gallon drum of mixed waste consisting of jet-fuel, aqueous film foaming foam (AFFF) and water (Appendix A, IMG\_0284); and a corroded 10-gallon petroleum-based product, which appeared to have manufacturing date of May 1983 (Appendix A, IMG\_0286). Mr. Colombani informed the facility that the product should be shipped offsite. There was secondary containment for all the containers.

IMG\_0284 AFFF, Jet Fuel and Water (Mixed Waste).

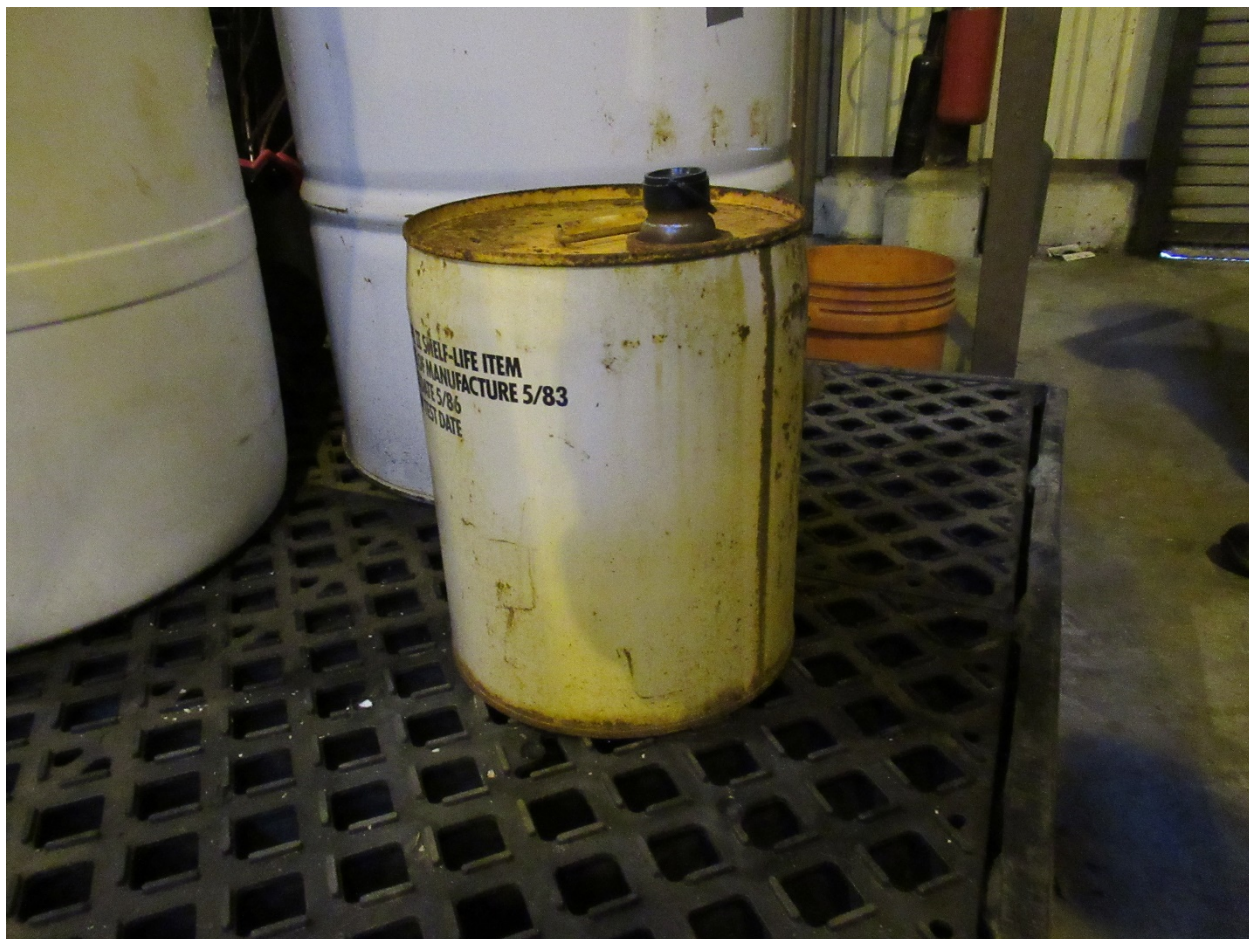
IMG\_0286 Corroded container. Old product.

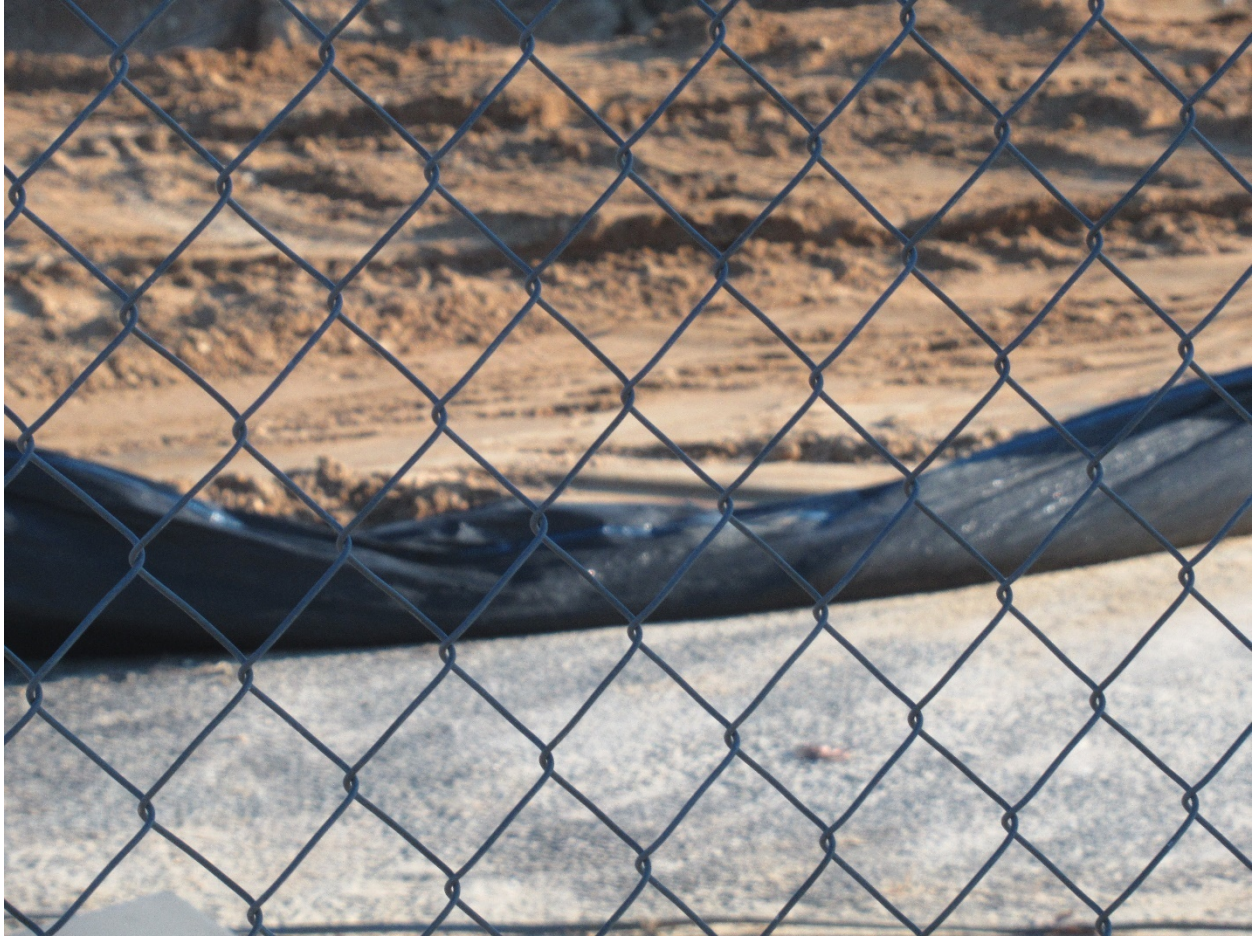
At the Priority One Consolidation and Parking Lot construction project, the silt fence for the boundary of the project was compromised. There was an area of the silt fence that needed replacement to prevent sediment and erosion from being tracked offsite (Appendix A, IMG\_0287). The downgradient stormwater drains were covered with sediment drain filters to increase sediment and erosion controls surrounding the project.

IMG\_0287: Silt fence needing replacement.

| REGULATORY, STATUTORY OR PERMIT REFERENCE | FIELD OBSERVATION |
|---|---|
| <u>NJPDES 5G3 – Construction Activity Stormwater General Permit (NJ0088323)</u><br><br>Sediment & Erosion Control | At the Priority One Consolidation and Parking Lot construction site, the silt fence for the boundary of the project was compromised. There was an area of the silt fence that needed replacement to prevent sediment and erosion from tracking offsite (Appendix A, IMG_0287).<br><br><u>Corrective Action:</u> On December 13, 2021, the facility provided photographs demonstrating that the silt fence was replaced. |
