## **RCRA Inspection Report**

Polychemie, Inc.  
Port Bienville Industrial Park, Road D  
Pearlington, Mississippi 39572

February 23 & 25, 2021

**COMPLIANCE EVALUATION Inspection**

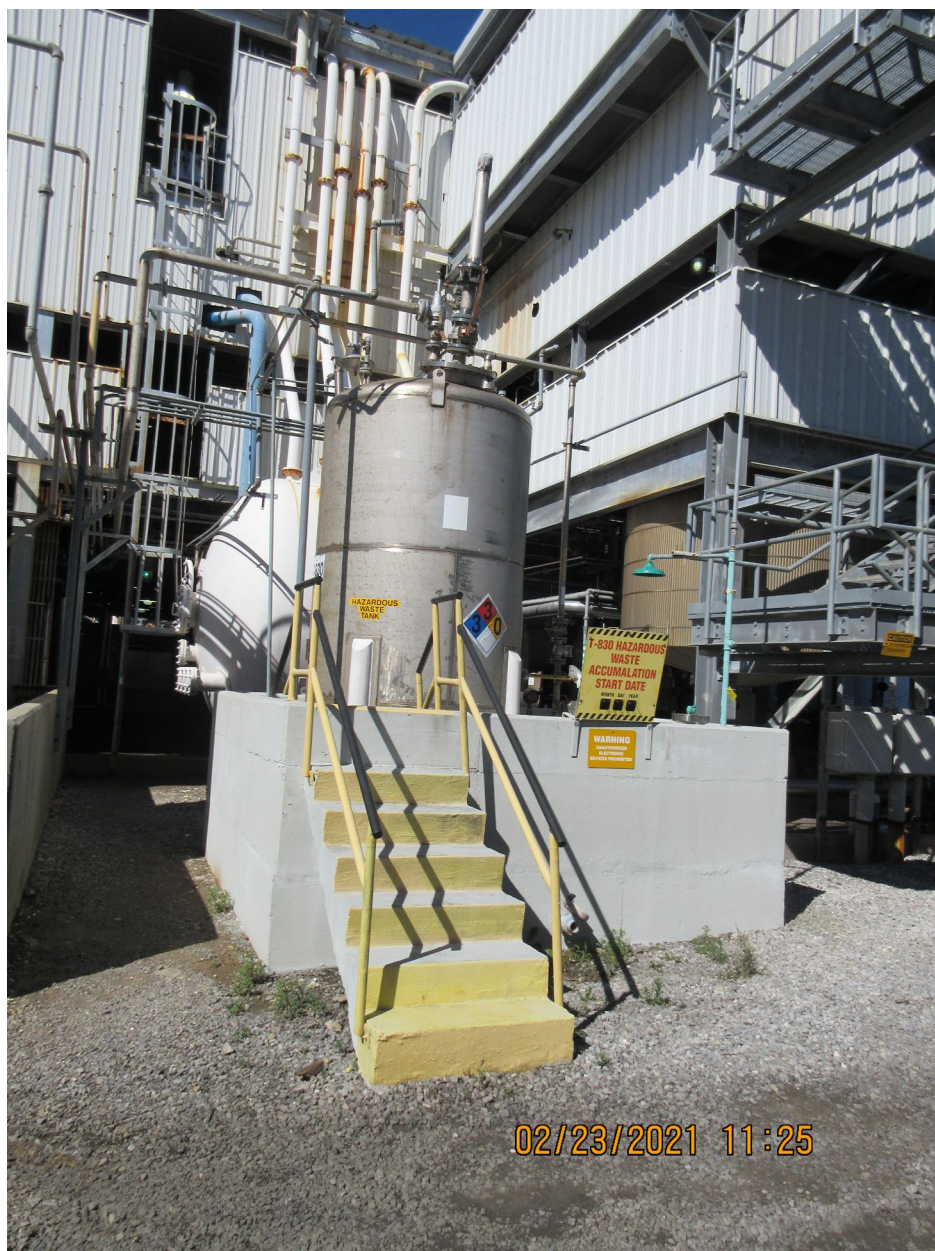
Tank-830 is an 1800-gallon tank (Photo 1) used by the facility to accumulate ignitable hazardous waste generated from the facility's DADMAC polymer production process. At the time of the inspection, the tank was stated to be empty, having been emptied on February 22, 2021. The tank was labeled with the words "Hazardous Waste" and a placard indicating the hazard of its

Photo 1 – 1800 gallon Tank-830

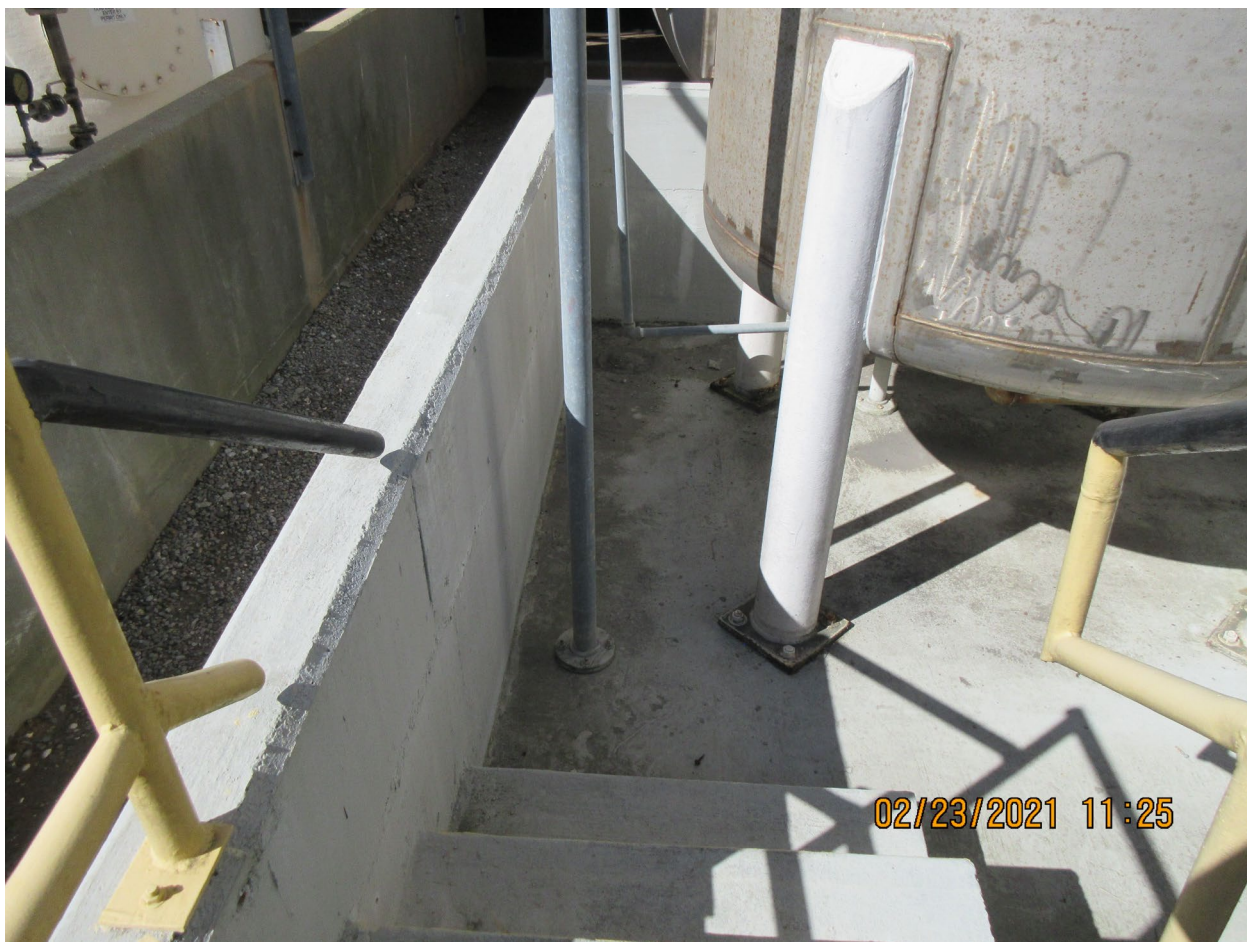
At the time of the inspection, the tanks secondary containment system for Tank-830 was observed to be sealed and free of any cracks and gaps (Photos 2, 3 & 4). The tank was observed to be closed at the time of the inspection. Facility personnel indicated that twelve pieces of ancillary equipment to the tank used to transfer the waste to outgoing tanker trucks were in service for greater than 300 hours per year. Pumps and valves which were part of this line were labeled and tagged at the time of the inspection (Photo 4).

Photo 2 – Secondary Containment for Tank-830

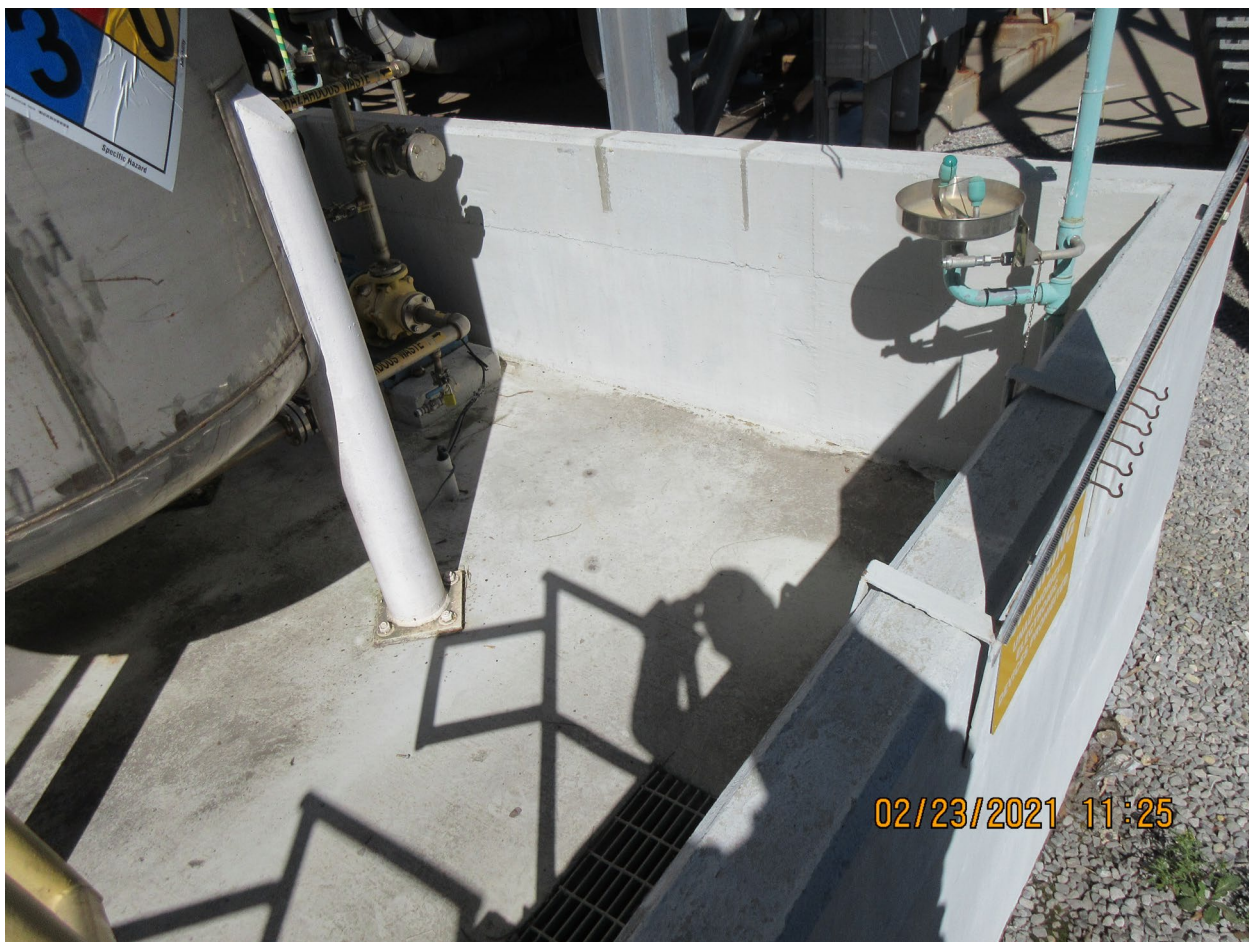
Photo 3 – Secondary containment for Tank-830

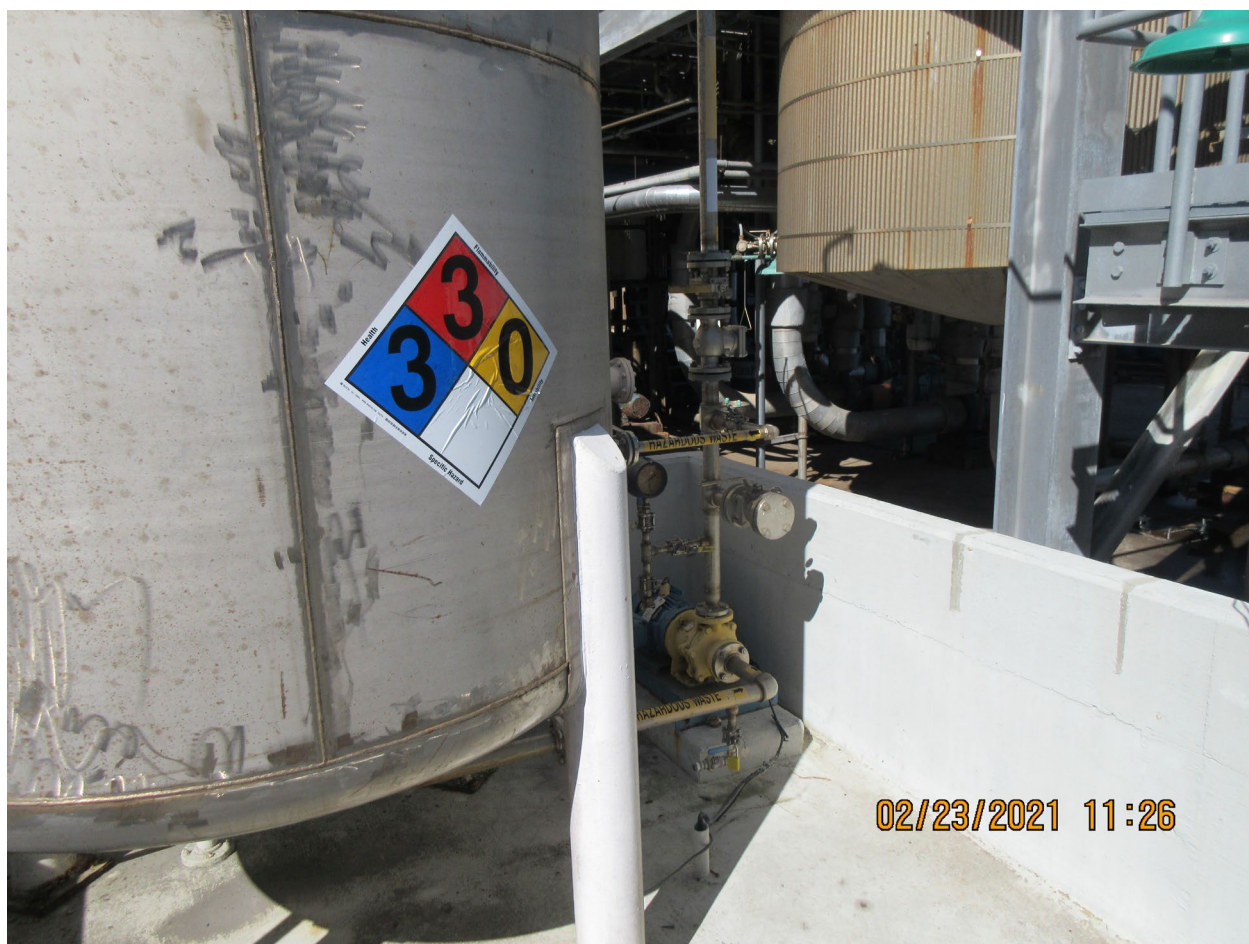
Photo 4 – Ancillary equipment for Tank-830

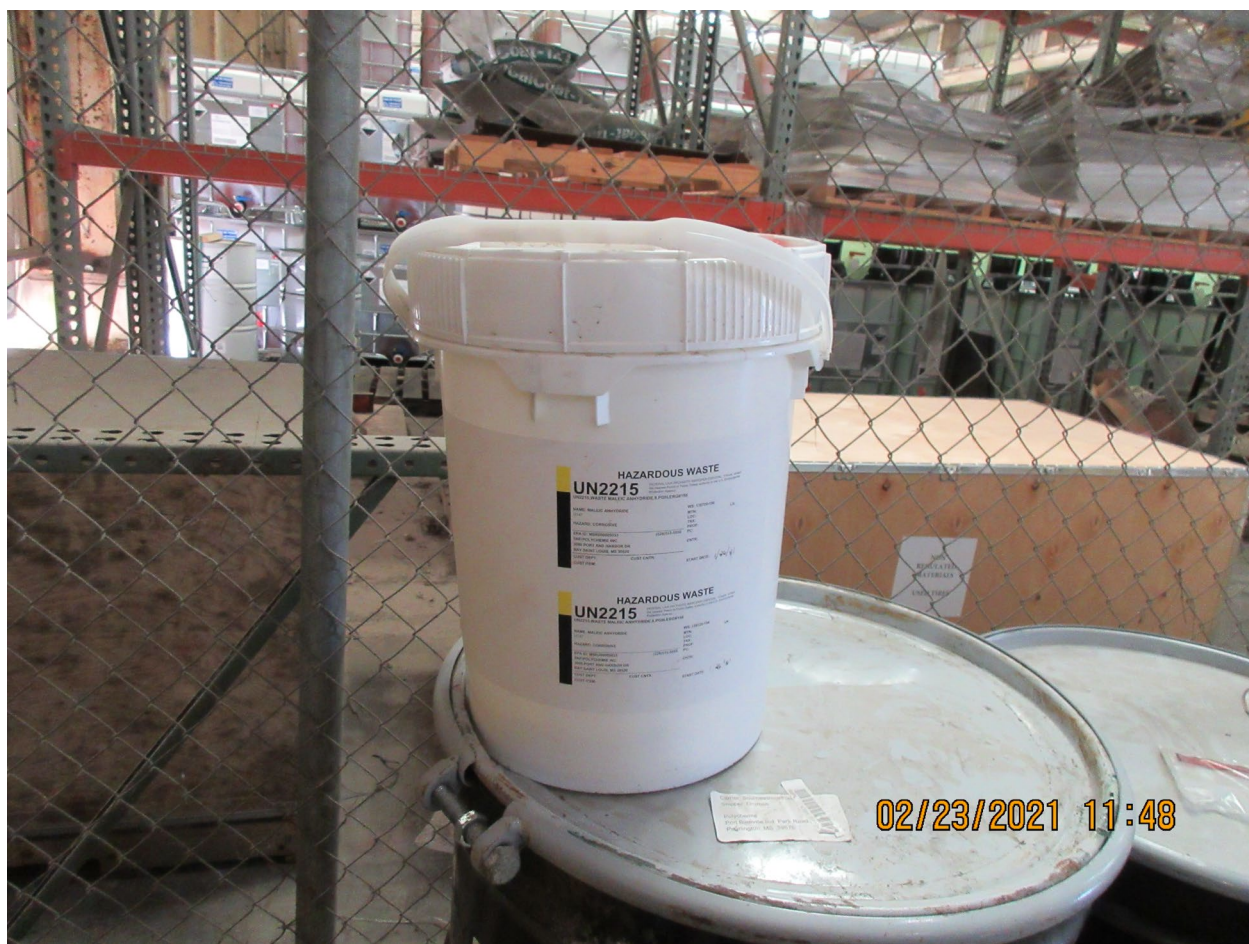
One 5-gallon container of hazardous waste maleic anhydride sulfate was observed to be labeled with the words “Hazardous Waste” and an accumulation start date of less than 90-days. The container was not labeled with an indication of the hazard contents of the container at the time of the inspection (Photo 5).

**Pursuant to 11 Miss. Admin. Code Pt. 3, R. 1.1 [40 C.F.R. § 262.17(a)(5)(i)], which is a condition of the LQG Permit Exemption, a generator must mark or label its containers with the following: the words “Hazardous Waste”; an indication of the hazards of the contents; and the date upon which each period of accumulation begins clearly visible for**

Photo 5 – 5-gallon container of hazardous waste within 90-day accumulation area missing an indication of the hazard within the container.

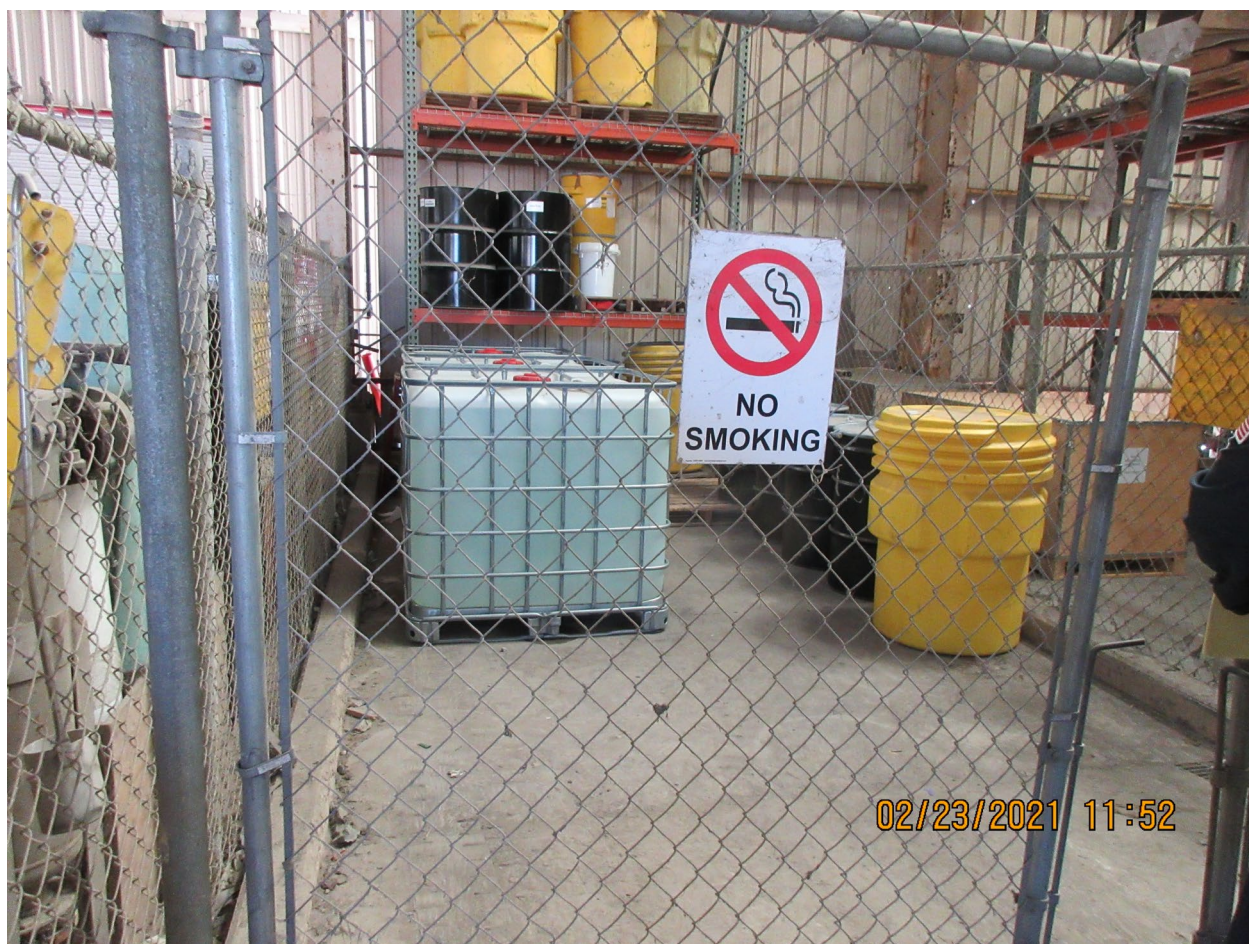
This area was a fenced area with a concrete berm located within a larger metal building (Photo 6). Three 275-gallon plastic totes (within metal cages) were observed to contain hazardous wastes including ammonium persulfate (two containers) and maleic acid (one container). Each of the containers were labeled with the words “Hazardous Waste,” an indication of the hazard within the containers and an accumulation start date of less than 90-days. Each of the containers were closed at the time of the inspection.

This area was equipped with a “No Smoking” sign on the gated door to the area (Photo 6).

Photo 6 – 90-day Hazardous Waste Accumulation Area

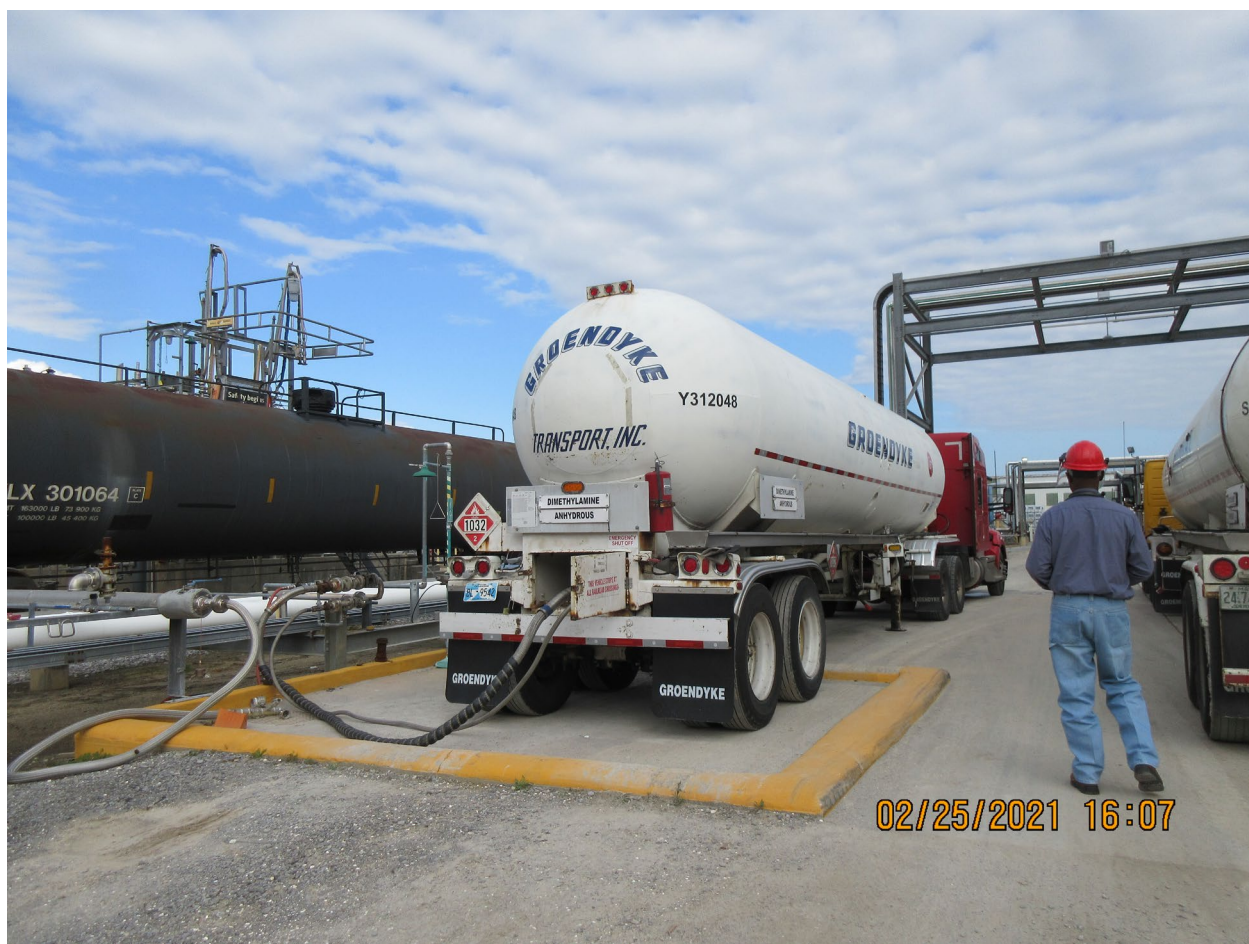
At 2:30 pm on February 25, 2021, Daryl Himes returned to Polychemie, Inc. to further inspect Tanker Truck Loading Station Number 6 (Photos 5 & 6). Heather Flowers stated that this location would have been used for the accumulation area for any tankers managing hazardous waste from the DADMAC process that were previously managed in tank T-830.

A small bermed area was located on the rear of Loading Station 6 which would have been beneath the loading ports of any tanker truck managed at this location. Facility personnel and contract drivers populated this area at the time of the inspection on February 25, 2021.

Photo 7 – Tanker Truck Loading Area #6

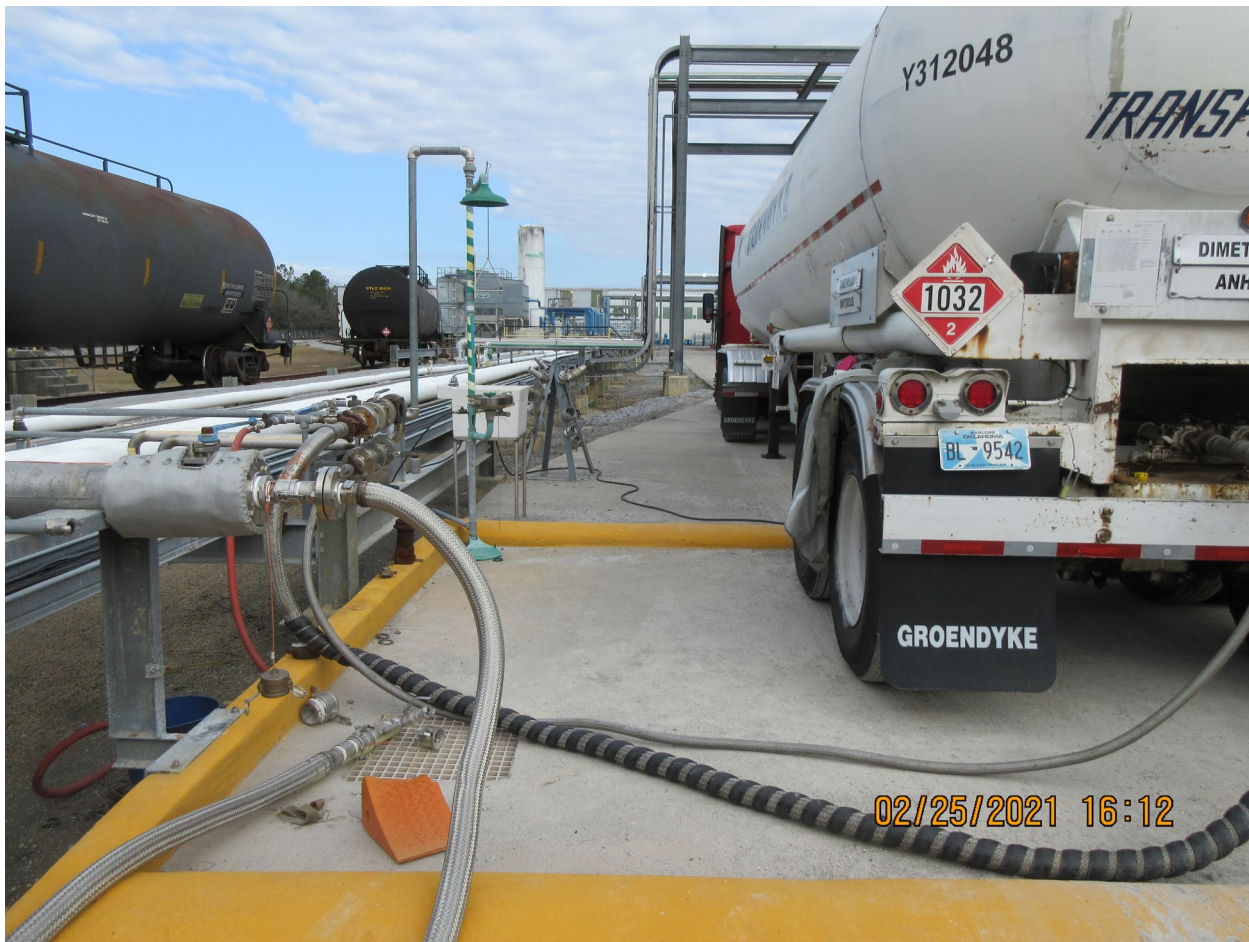
Photo 8 – Tanker Truck Loading Area #6
