## EPA Region 10 Enforcement Division

### INSPECTION REPORT

| Company Name | Collins Aerospace | |
| Facility or Site Name | Goodrich Corporation Carbon Products | |

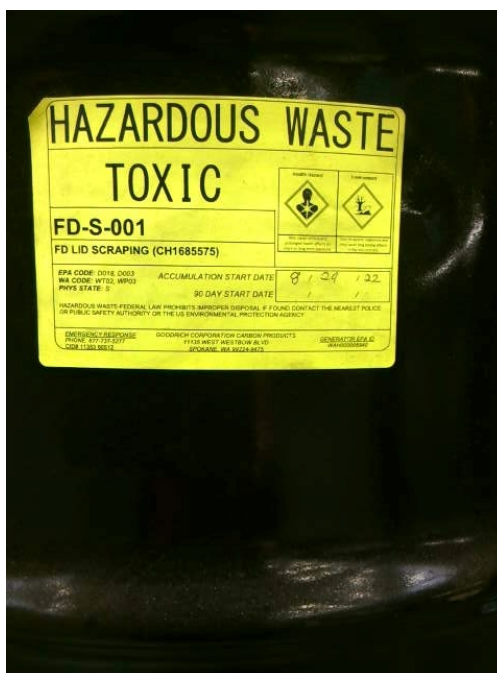
| Furnace Deck SAA | No CBI | No PII |

| <p>While inspecting the satellite accumulation area on the furnace deck, I observed two 55-gallon drum containers. Both were closed and labeled as hazardous waste. On each label were D003 reactive waste codes. The hazard indicators listed health hazard and environmental hazard. One container was labeled as, "FD Lid Scrapings," the other was labeled as, "FD Vertical Heat Exchanger Cleanout Condensers, Demister Pads."</p> | | | |

| Waste codes indicated reactive waste; hazard indicators were for toxic waste. | <b>Citations:</b> WAC 173-303 | |

| Label with "Toxic" indicator and D003 code | IMG-202209071137213721168984.jpg | |

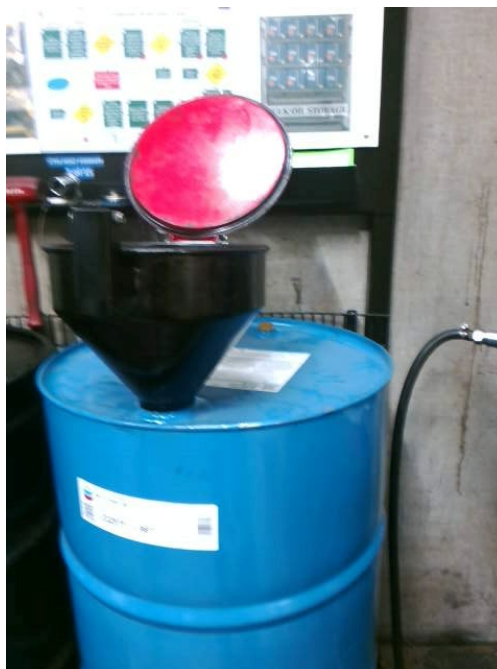
| Machine Shop/SAA | No CBI | No PII |

| <p>While also inspecting the Machine Shop, I observed one 55-gallon drum container. The container had a funnel lid that was open. I was told this container was used oil. During the inspection a facility representative closed the funnel and attached a label to the container with the words "Used Oil."</p> | | | |

| One container of used oil not closed, not labeled as "Used Oil." | <b>Citations:</b> WAC 173-303 | |

| Open funnel on used oil container; no label | IMG-20220907120454454189177.jpg | |

I observed Chris Matuszak close the funnel and label the used oil container in the Machine Shop SAA.

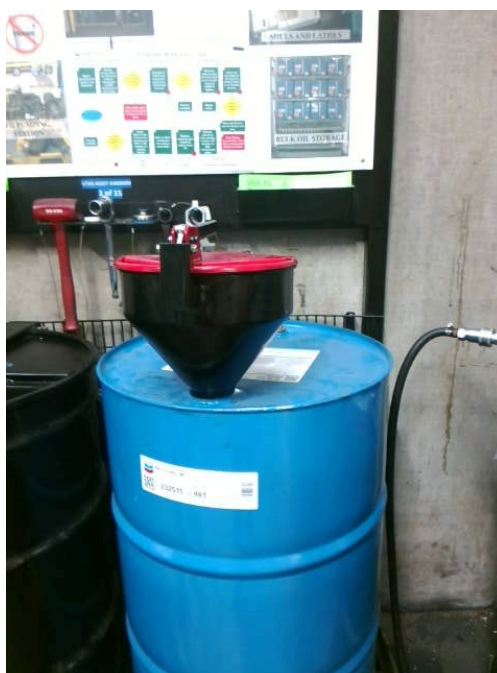
| Machine Shop/SAA | No CBI | No PII |

| Chris M. closed funnel on used oil container | IMG-2022090712050858202209.jpg | |

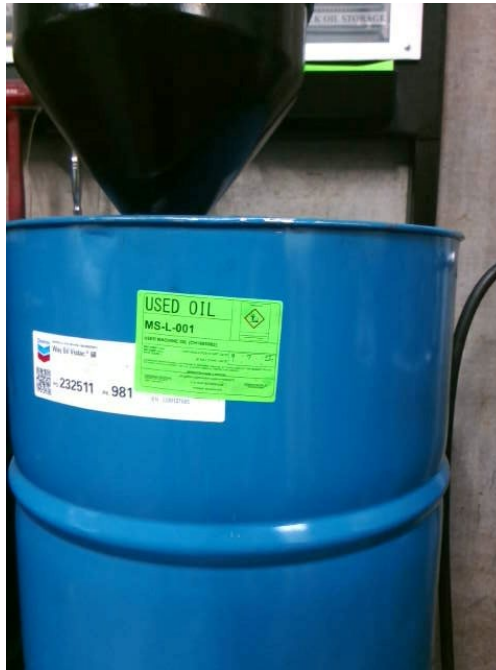
| Machine Shop/SAA | No CBI | No PII |

| Chris M. placed "Used Oil" label on container | IMG-20220907120536536160128.jpg | |

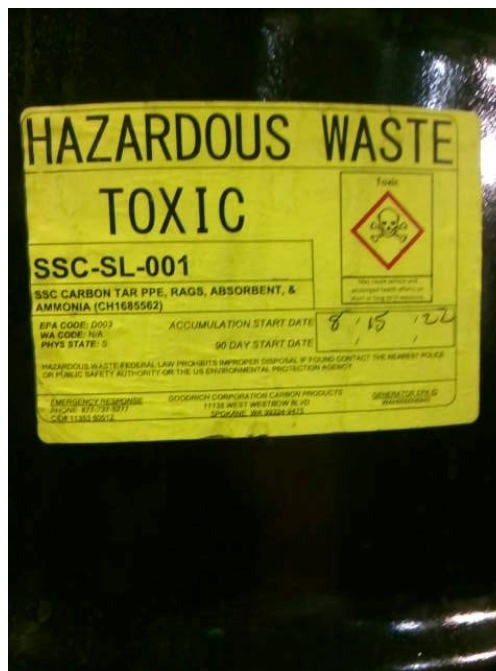
| SSC/Basement | No CBI | No PII |

| <p>While inspecting the single step carbonization process in the basement, I observed four 55-gallon drum container, each labeled as hazardous waste. All four containers were closed and had accumulation start dates and hazard indicators. Two of the containers in this area had labels listing the waste as D003 reactive waste but had toxic hazard indicators. One container was labeled as, "SSC Carbon Tar PPE, Rags, Absorbent, &amp; Ammonia," the other was labeled "SSC Acid Filters."</p> | | | |

| Waste codes were for D018 and D003. Hazard indicators were for health hazard and environmental hazard. | <b>Citations:</b> WAC 173-303 | |

| Label with "Toxic" indicator and D003 code | IMG-202209071129432943190550.jpg | |

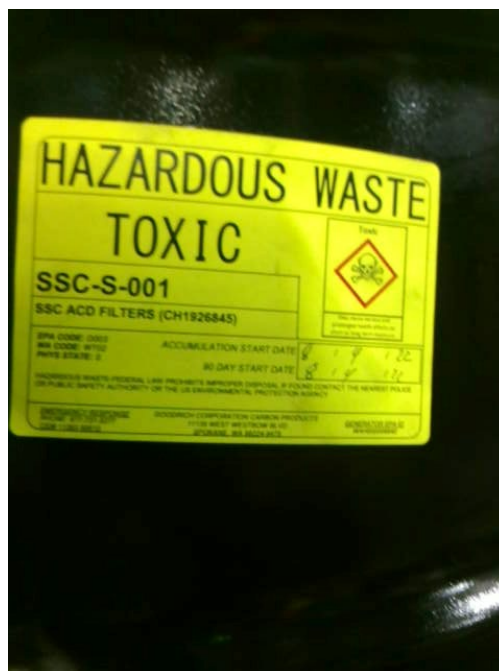
| SSC/Basement | No CBI | No PII |

| Label with "Toxic" indicator and D003 code | IMG-202209071130193019158098.jpg | |

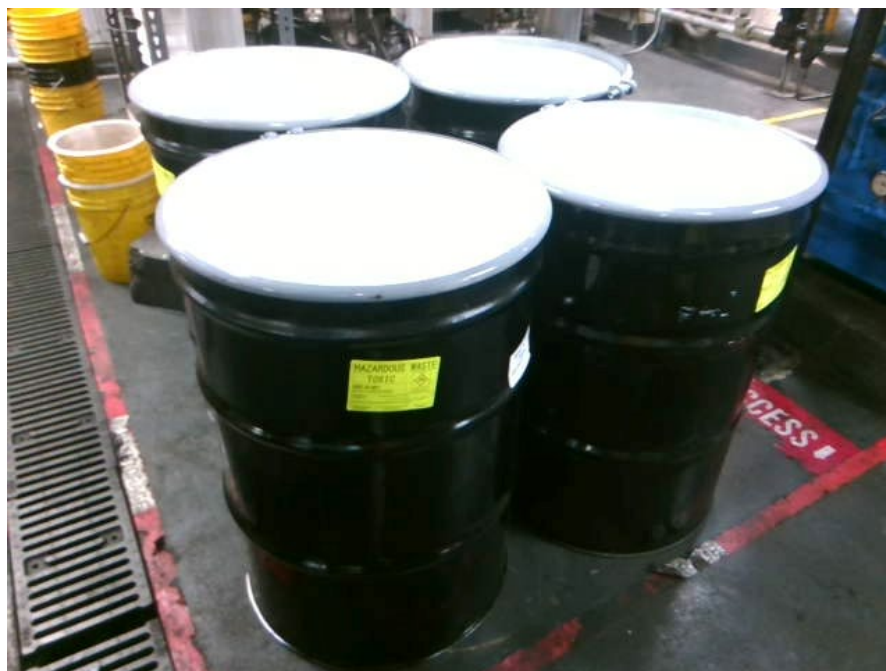
| SSC/Basement | No CBI | No PII |

| Backup view of labels with "Toxic" indicator | IMG-202209071130323032179667.jpg | |
