## **RCRA Inspection Report**

Centers for Disease Control and  
Prevention (CDC)  
4770 Bufford Highway  
Atlanta, Georgia 30341

December 18, 2024, 9:05 AM

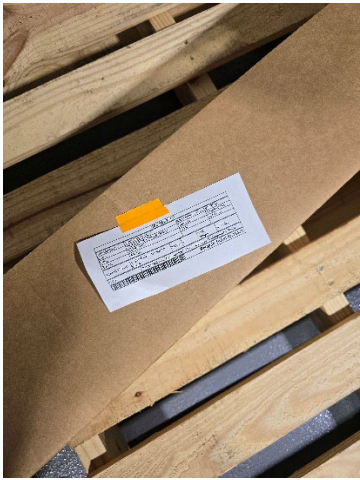
| | <p>Photo D: Building 110, Room 1208—Universal waste lamps – containerized after inspection</p> |

Facility personnel corrected these issues by cleaning up the broken lamp (bulbs and fixture). It was placed into a closed container, labeled, with the words “Hazardous Waste”, “Toxic”, and “D009” (Photo F). The container was taken to the central accumulation area (CAA) in building/room 112a. Also, the eight UV lamps were placed in a container and labeled “Universal waste UV lamps” (Photo D).

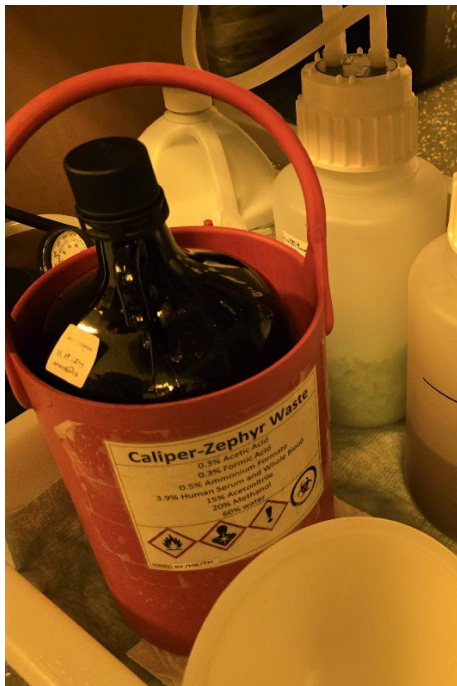
In this lab, the inspectors noticed three containers for caliper zephyr waste. One 4-5L amber glass bottle (Photo G), one 5L plastic container, and a condensation bottle with absorbent material. These bottles were labeled with flammable, harmful, health, and biohazard indications but were not labeled with the words “Hazardous Waste”. According to profile documentation received on 1/23/25 from CDC, the Caliper Zephyr Waste was identified with EPA waste codes D001 and F003.

Photo G: Building 110, Lab 1201—Caliper-Zephyr Waste

Pursuant to Ga. Comp. R. and Regs. 391-3-11-.08(1) [40 C.F.R. § 262.15(a)(5)(i)], which is a condition of the SAA Permit Exemption, a generator is required to mark or label its containers with the words “Hazardous Waste”.

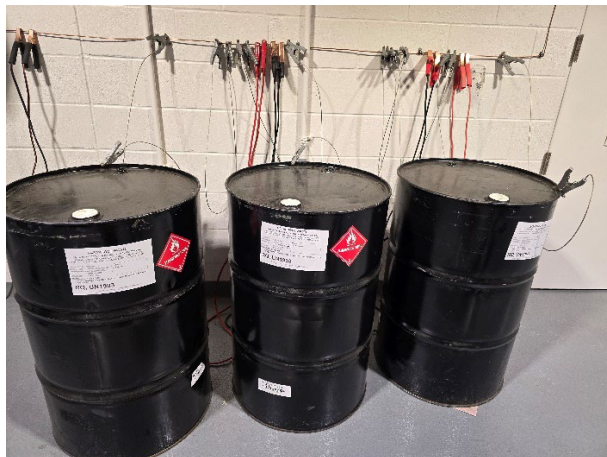
The inspectors observed six 55-gallon containers along the back left wall (Photos H & I).

- One 55-gallon plastic container was labeled as non-hazardous sodium citrate hydrochloride. The container was closed and was dated 10/7/24.
- Three 55-gallon containers of methanol and toluene were labeled with the EPA codes D001, F002, F003, and F005. Each container was closed and had a flammable DOT sticker. Two containers were dated 12/6/24 and one was dated 12/17/24. All three containers were labeled with the words “Hazardous Waste”. One container was constructed of plastic material and not grounded. Two containers were metal and grounded. The plastic container appeared to be in good condition and not leaking; however, the inspectors would caution that Toluene and methanol mixtures are generally not compatible with most plastic containers and should be grounded.

- One 55-gallon plastic container was labeled with the words “used oil”, closed, and dated 12/9/24.
- One 55-gallon metal container was labeled as acetonitrile and methanol. The container was closed, grounded, and dated 12/6/24. The container had the words “Hazardous Waste”, a flammable DOT sticker, and EPA waste codes of D001, F003, and F005.

Photo H: CAA – Hazardous waste containers

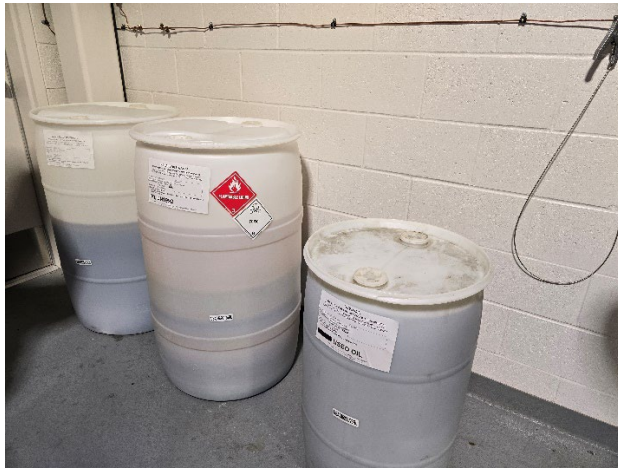
Photo I: CAA – Hazardous waste (toluene and methanol), non-hazardous waste, and used oil containers
