**Region 6 - Enforcement & Compliance Assurance Division**  
**INSPECTION REPORT**

| Company Name: | <b>Village of Reserve</b> | |
| Facility Name: | <b>Reserve Wastewater Treatment Plant</b> | |
| Identification/Permit Number: | NM0024163 | |

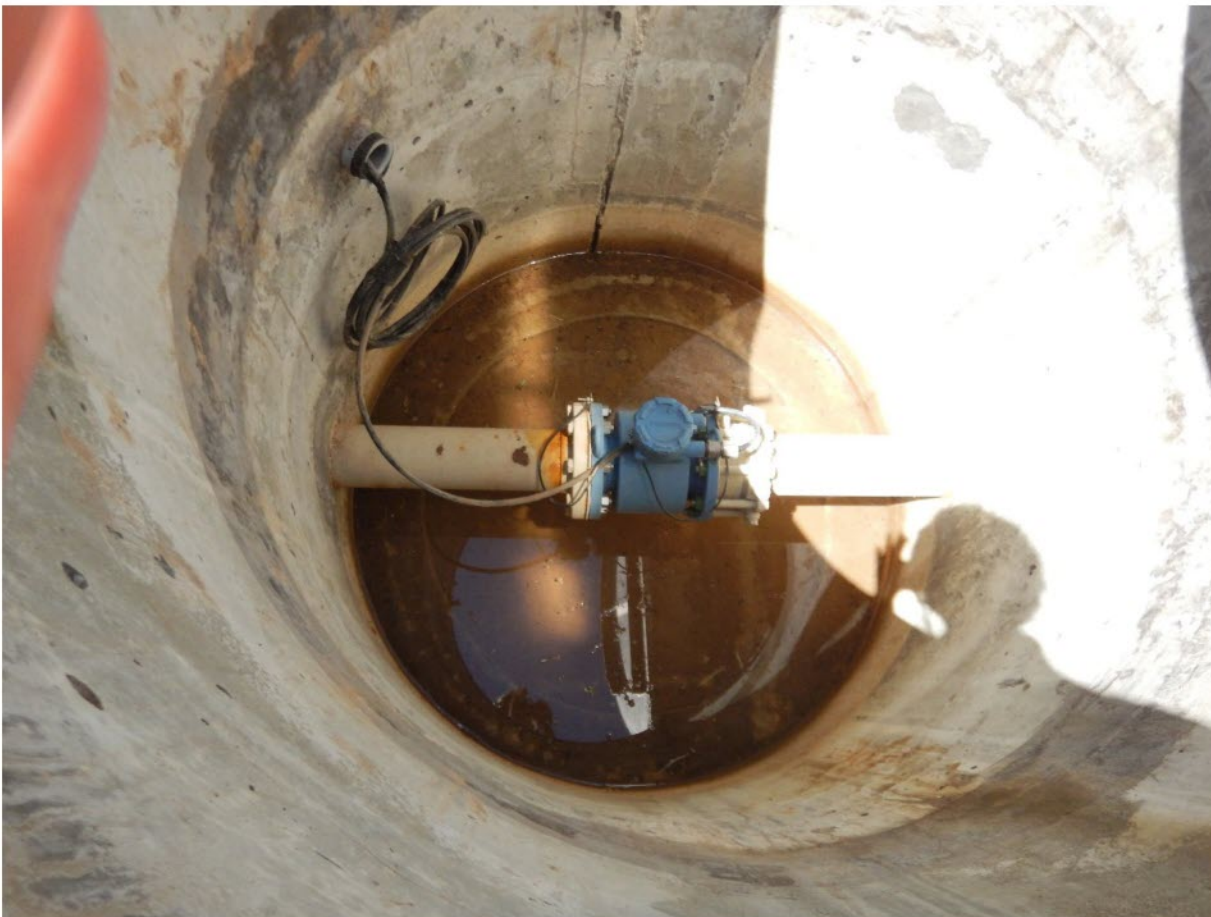
Photo No. 1

Description: View down manhole of influent closed-pipe mag-meter.

Flow measurement devices for both influent and effluent are closed-pipe mag-meters. These meters require full-pipe flow in order to function correctly. The permittee does have records showing that the meters have been professionally calibrated within the last year, however due to the nature and location

of the flow meters, there is no way for facility personnel to easily verify that flow rates are within 10% accuracy.

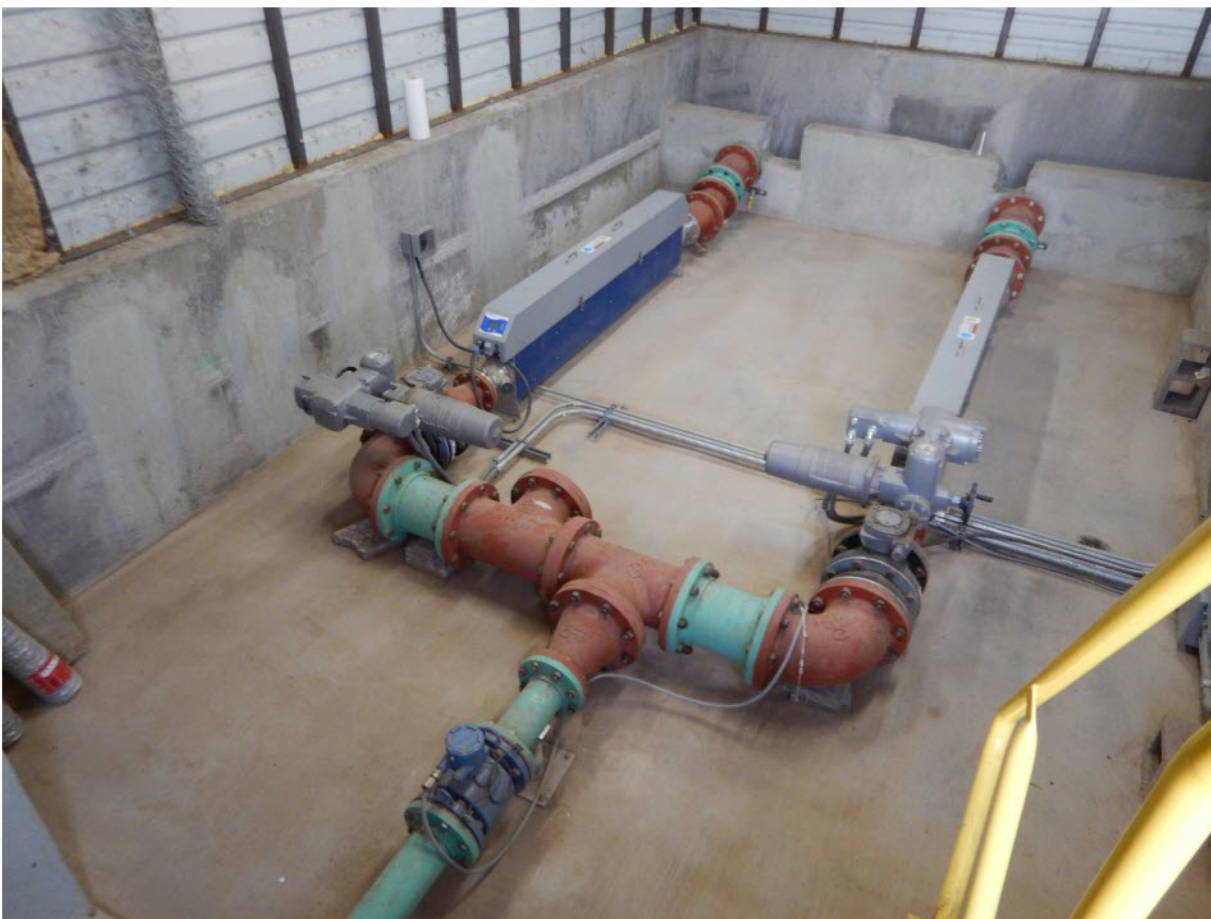
Photo No. 2

Description: View into UV disinfection room which used to be serpentine chlorine contact chamber. The effluent closed-pipe mag-meter is shown on the pipe at the bottom of the picture, prior to the pipe splitting to the UV banks. The wet well trough is in the upper right corner of the photo, behind the concrete baffle.

The effluent flow meter is located prior to the ultraviolet disinfection banks and the wet-well where the wastewater flow can be diverted to the drying beds. If the flow is diverted to the drying beds, then the flow rate measured by the effluent flow meter located prior to the UV banks will not accurately represent the actual flow to the river through the outfall.

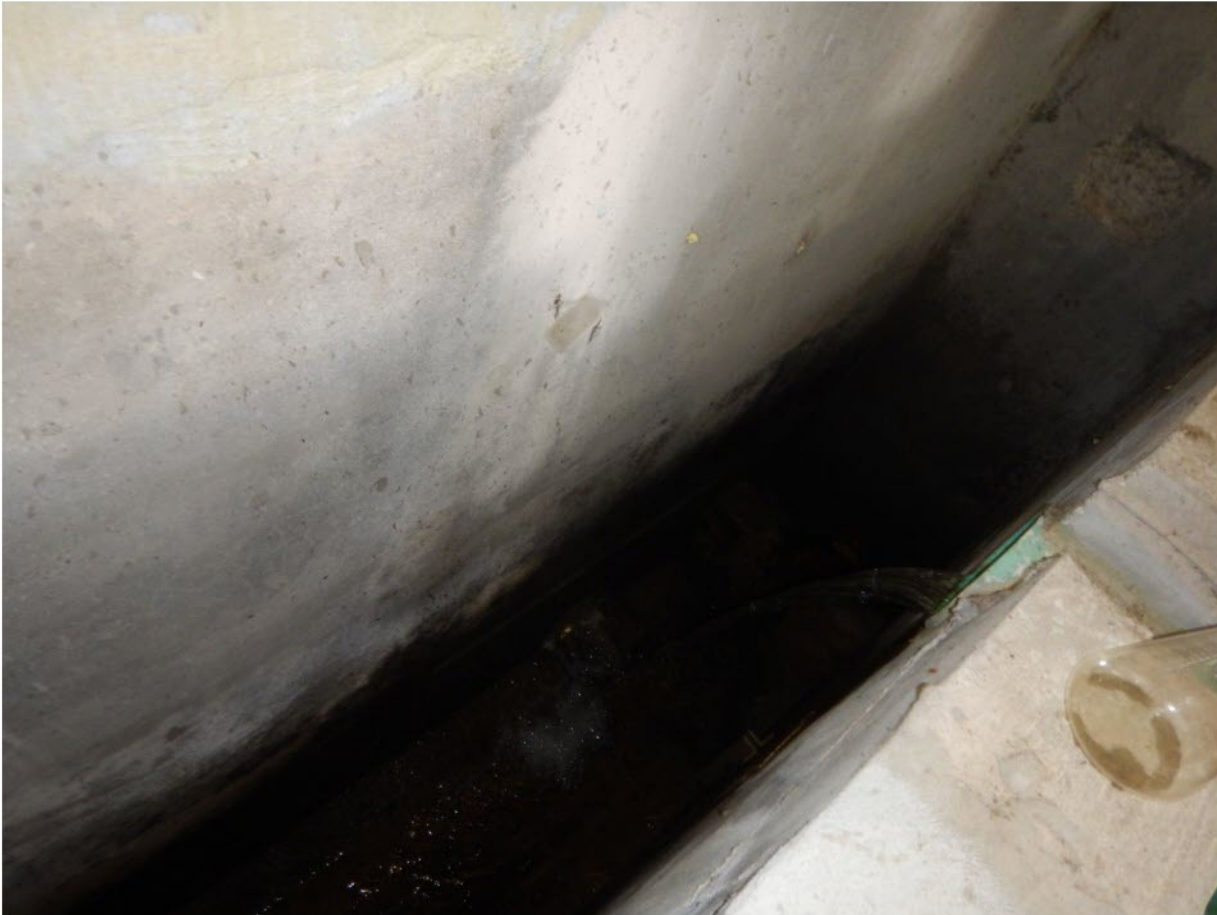
Photo No. 3

Description: View into wet well trough after the UV banks.
