# **NPDES Compliance Inspection Report**

## **Makah National Fish Hatchery**

**Neah Bay, WA**

**Inspection Date: 09/07/2022**

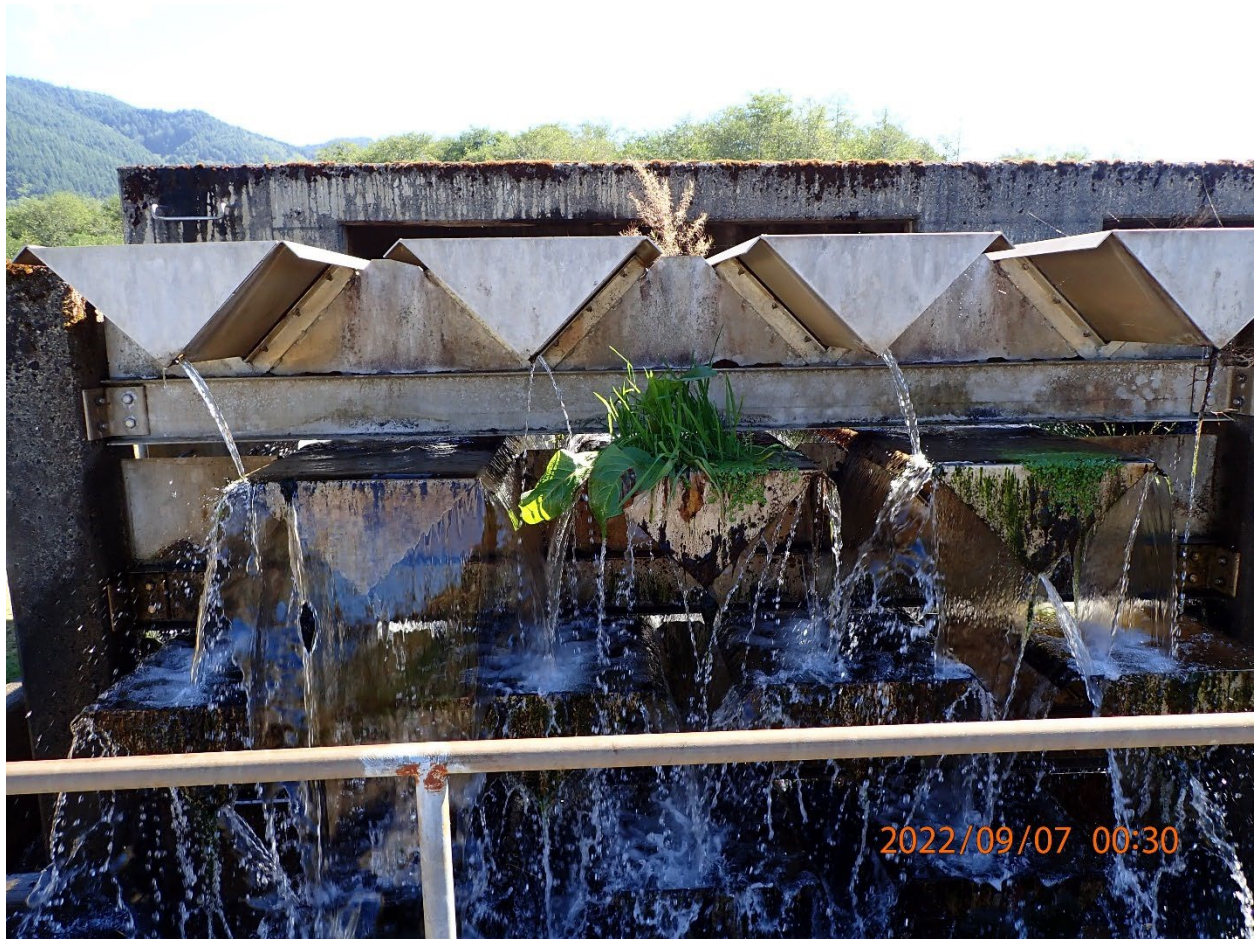
*Photo 1/ P9060052 - Degassing area*

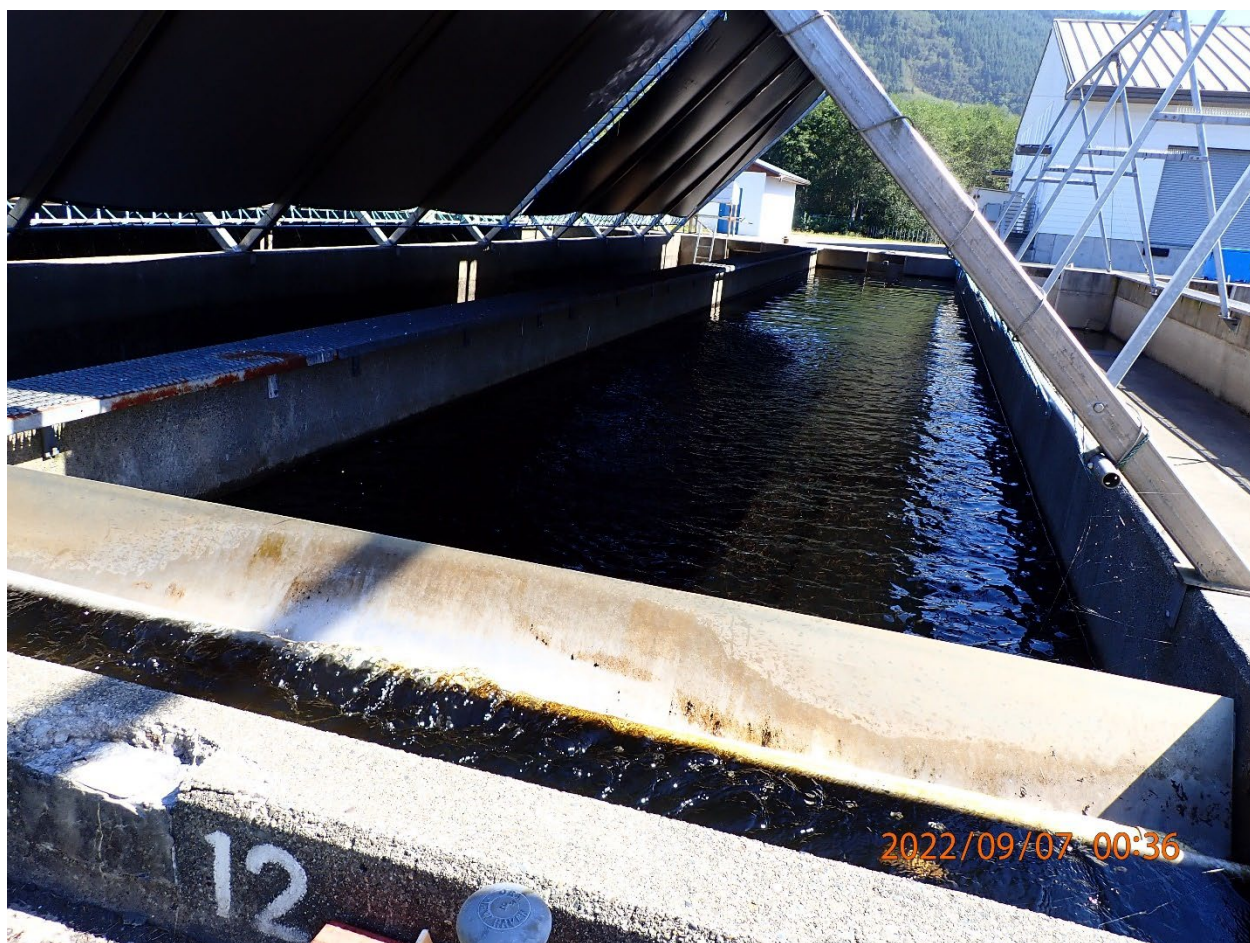
Photo 2/ P9060054 - Raceway for steelhead

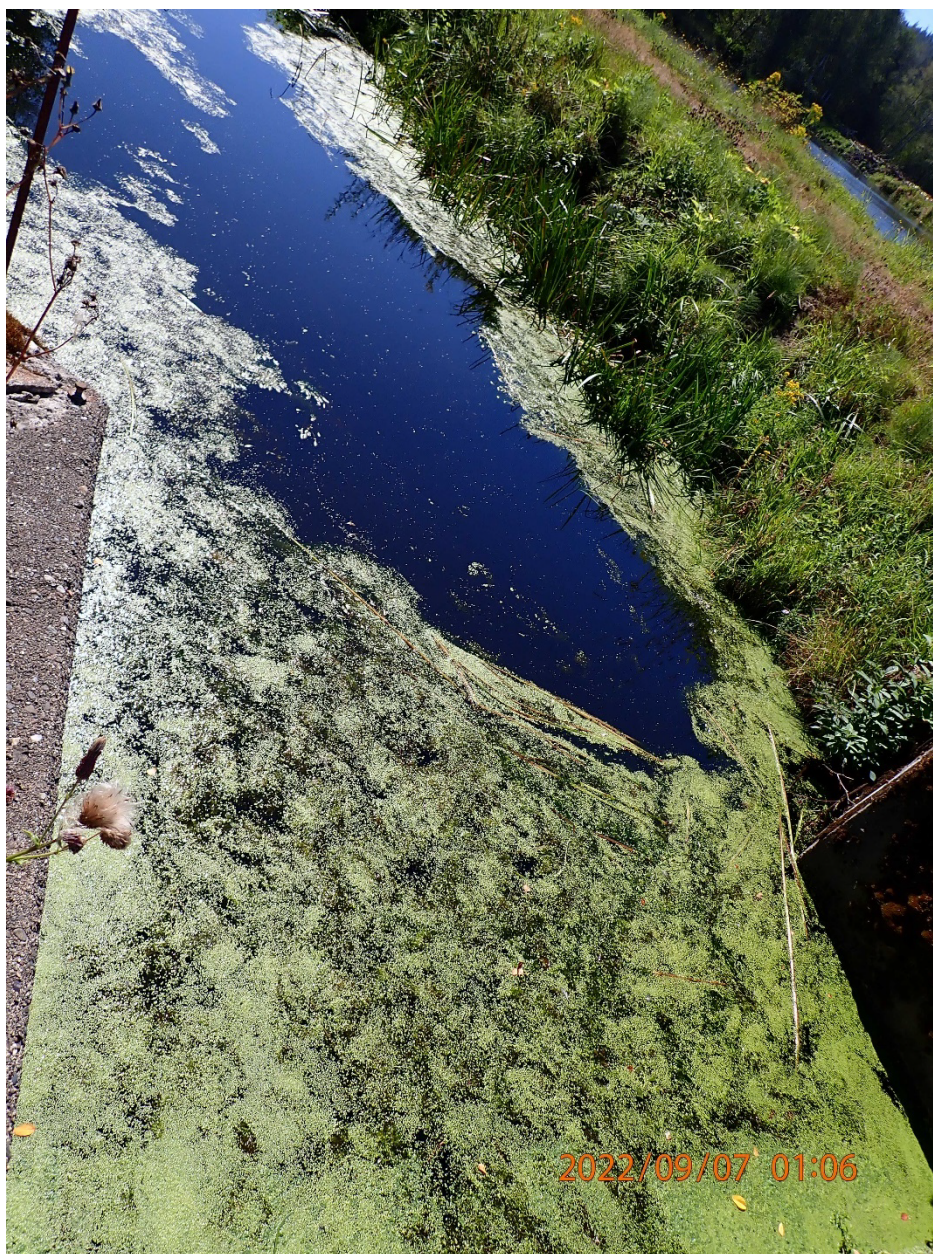
The influent sampling point is right before the pumphouse and the effluent sampling point is towards the end of the effluent channel. Their effluent sampling point isn’t at the nearest possible point before discharge. It’s possible that some algae at their current effluent sampling point is contributing to their settleable solids limit exceedances.

*Photo 3/ P9060062 - Effluent sampling area*

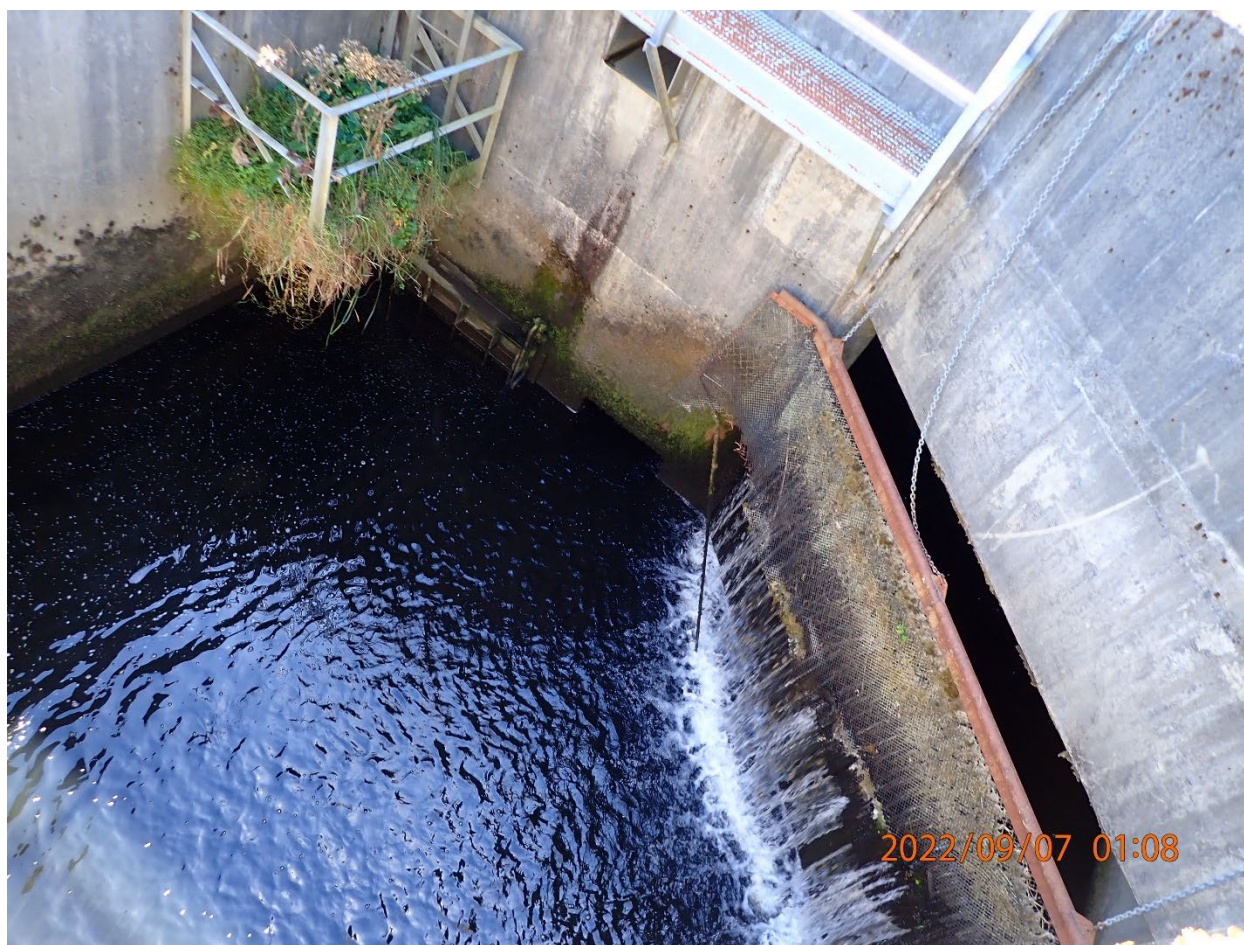
*Photo 4/ P9060063 - Effluent waterfall*

We first started off at the receiving water, the Tsoo-Yess River. The facility’s influent sampling point is right before the pumphouse. Their monthly composite samples are taken four times per day towards the beginning and ends of each month. We then entered the pumphouse where I visually inspected the six water pumps. Each water pump has a different flow rate and all six pumps are running at their maximum capacity. I then visually inspected their degassing area. The hatchery uses an older gravity fed system (**Photo 1**) to degas. The intake pond and raceways (**Photo 2**) were also visually inspected. A UV light system is utilized for sockeye salmon. Chorine is used in the sockeye isolation building. Chloramine-T is used for the sockeye eggs. The facility also utilizes florfenicol as a preventative from bacterial coldwater disease. Oxytetracycline is also used for bacterial coldwater disease. I next visually inspected their sand filters and diesel generators. Their effluent samples are taken towards the end of the effluent channel (**Photo 3**). I mentioned to Ms. Bates that a more representative effluent sample could be taken at the effluent waterfall (**Photo 4**).
