### INSPECTION REPORT

| Inspection Date(s): | 03/05/2025 | |
| Company Name: | <b>Smith, Roger G</b> | |
| Facility Name: | <b>Troy Tokio Unit Tank Battery</b> | |

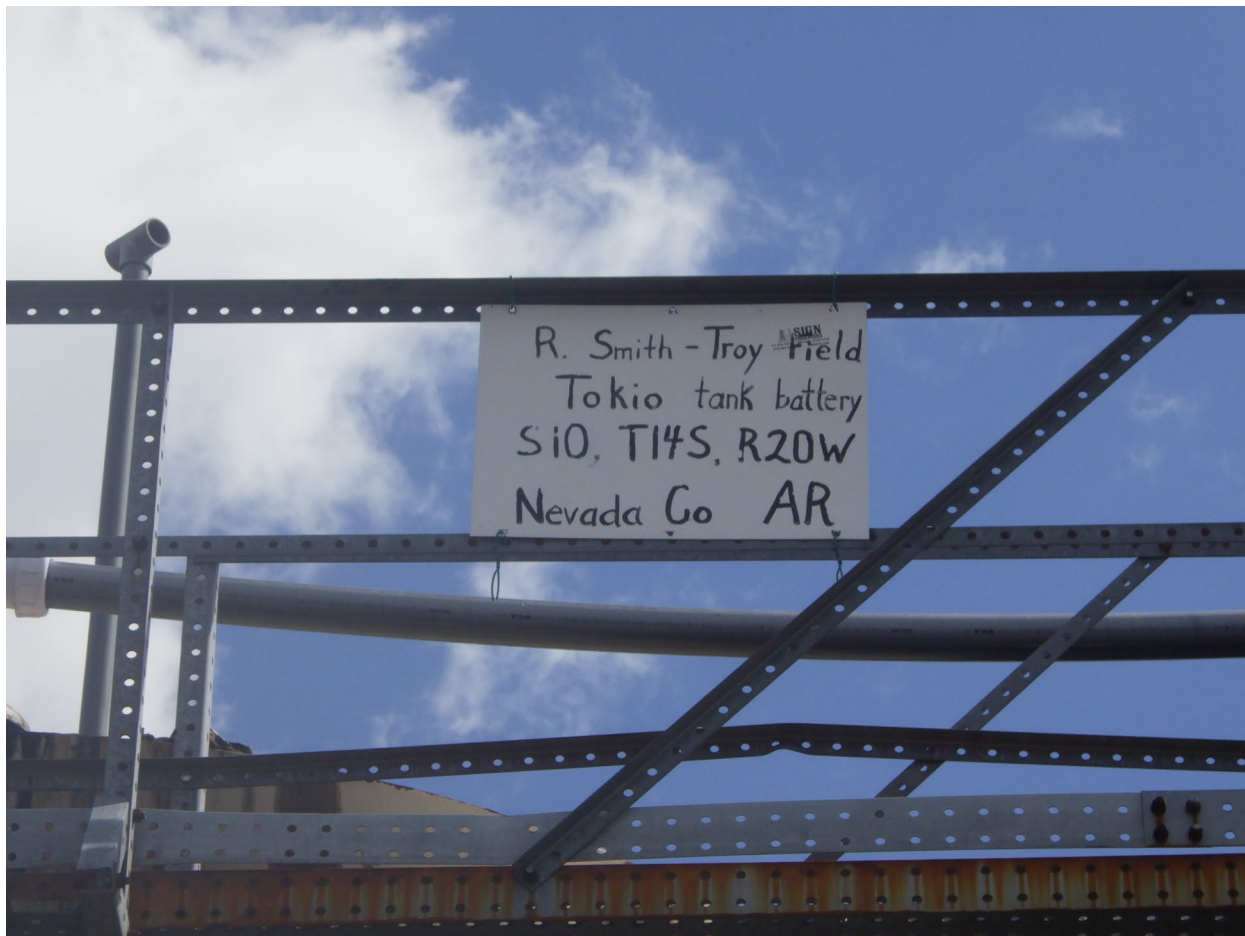
Photo No. 1

**Description:** Looking SE, this photo shows the signage for the Troy Tokio Unit Tank Battery ("facility").

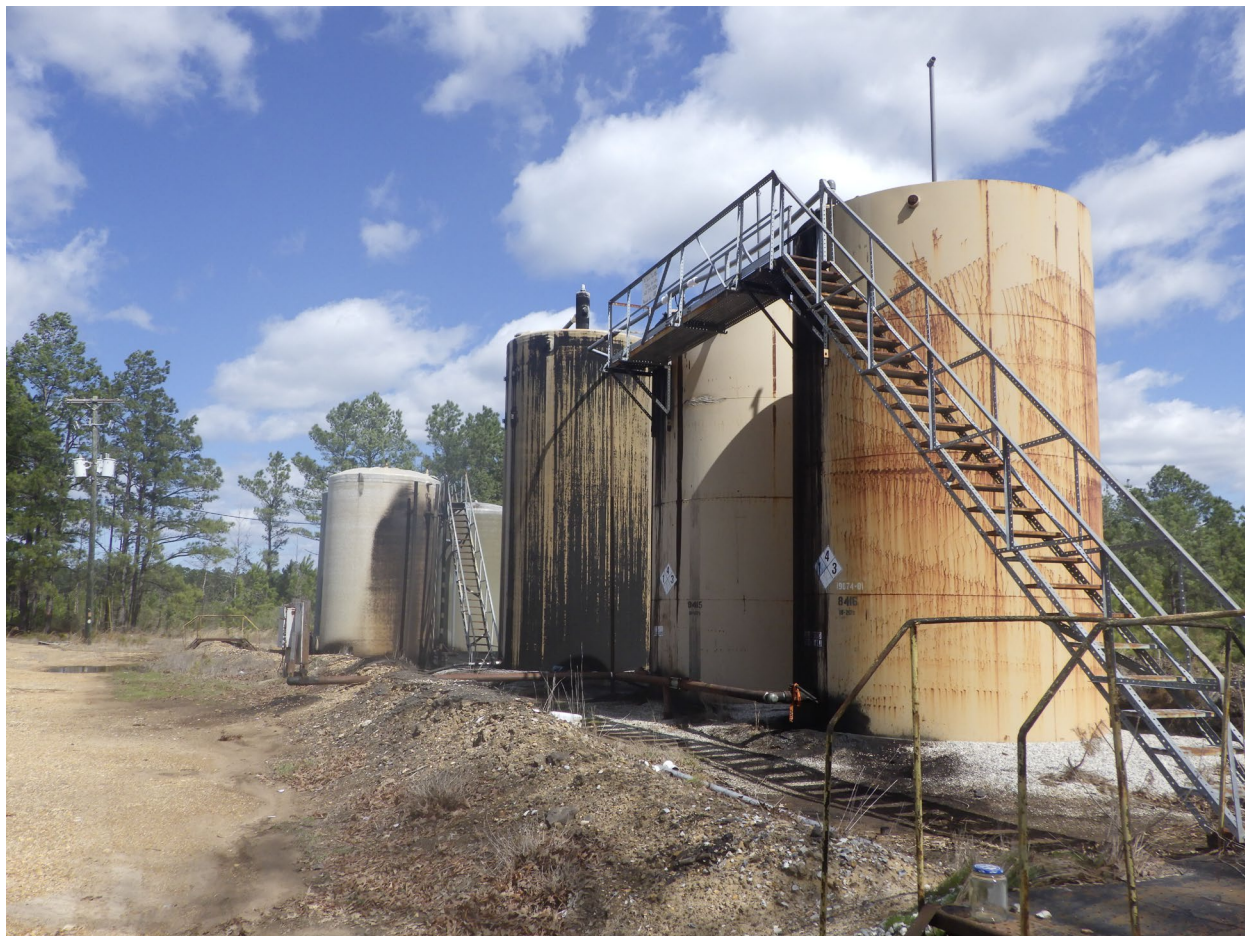
Photo No. 2

I observed product transfer lines outside secondary containment without catchment buckets, see Photos No. 2 and No. 3.

- Product transfer lines outside secondary containment without catchment buckets (Photos No. 2 and No. 3),
- Loose and residual crude oil and saltwater inside secondary containment (Photos No. 4, No. 7 and No. 8),
- The drainpipe for secondary containment without a cap (Photo No. 6),
- A low area in the berm for the secondary containment (Photo No. 9),
- An active leak of crude oil from a tank inside secondary containment (Photos No. 10 and No. 11),
- Bare, erodible soils and dead vegetation from a potential saltwater release (Photos No. 12 through No. 15), and
- Miscellaneous tanks outside secondary containment that appear to be out of service and not properly labeled (Photos No. 16 and No. 17).

**Description:** Looking ENE, this photo shows an overview of the facility.

Inspector will conduct follow-up phone calls with the company representative(s) over the coming weeks and months to ensure areas of concern are properly addressed.

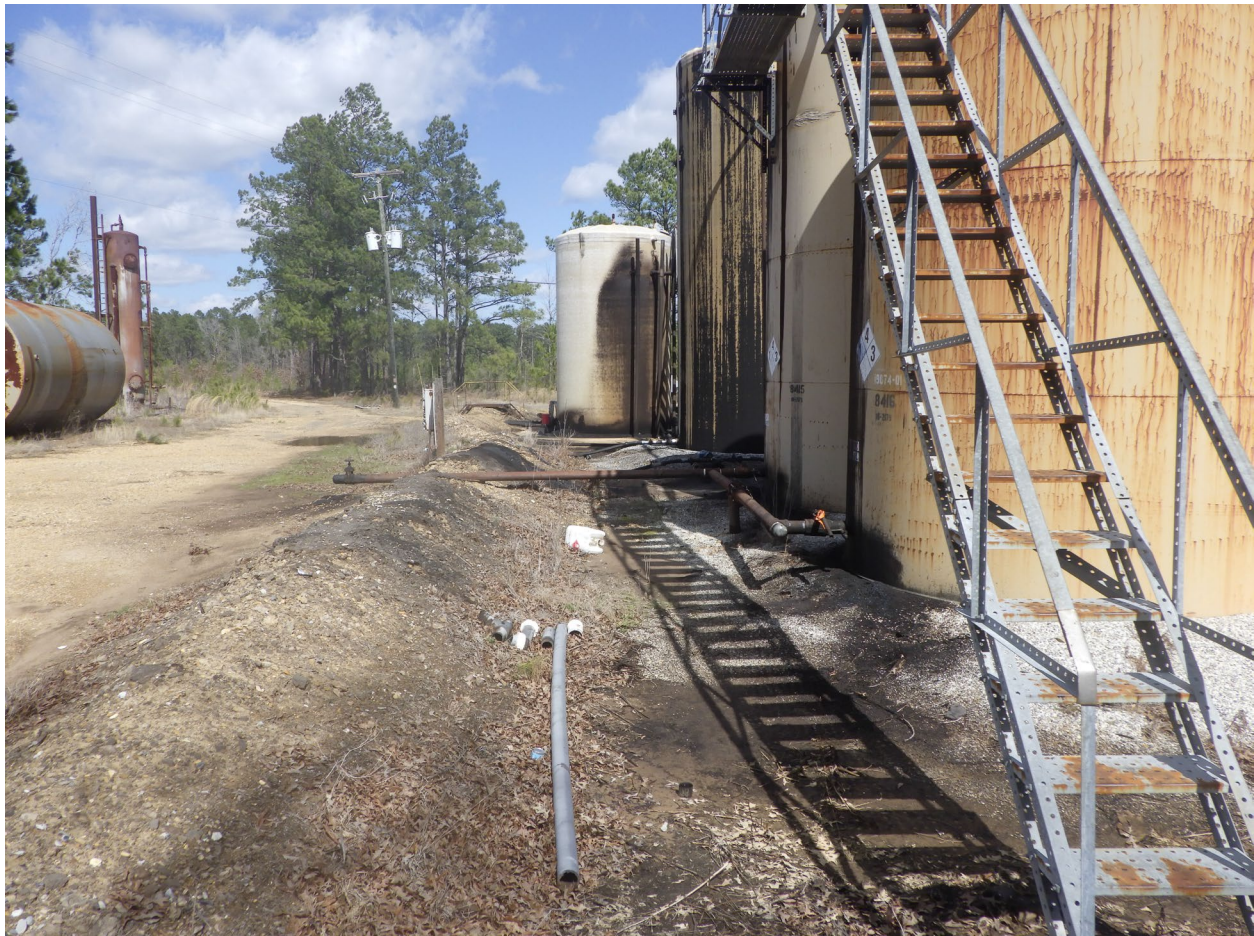
Photo No. 3

**Description:** Looking NE, this photo shows a side view of the inside of the secondary containment.

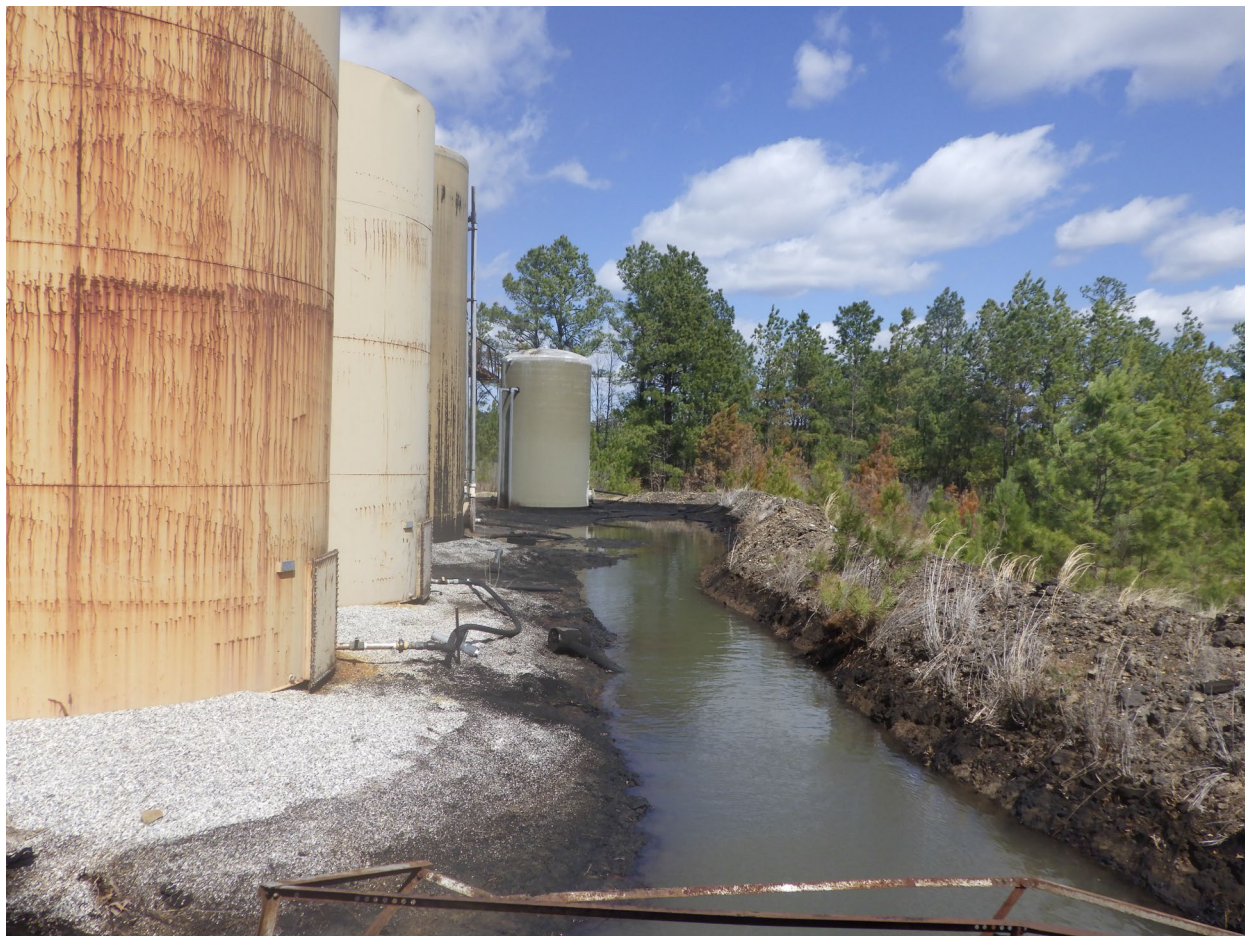
Photo No. 4

I observed the sump area, the drainpipe, and a pump for the secondary containment, see Photos No. 4 through No. 6.

**Description:** Looking NE, this photo shows a view of the backside and the sump area inside the secondary containment.

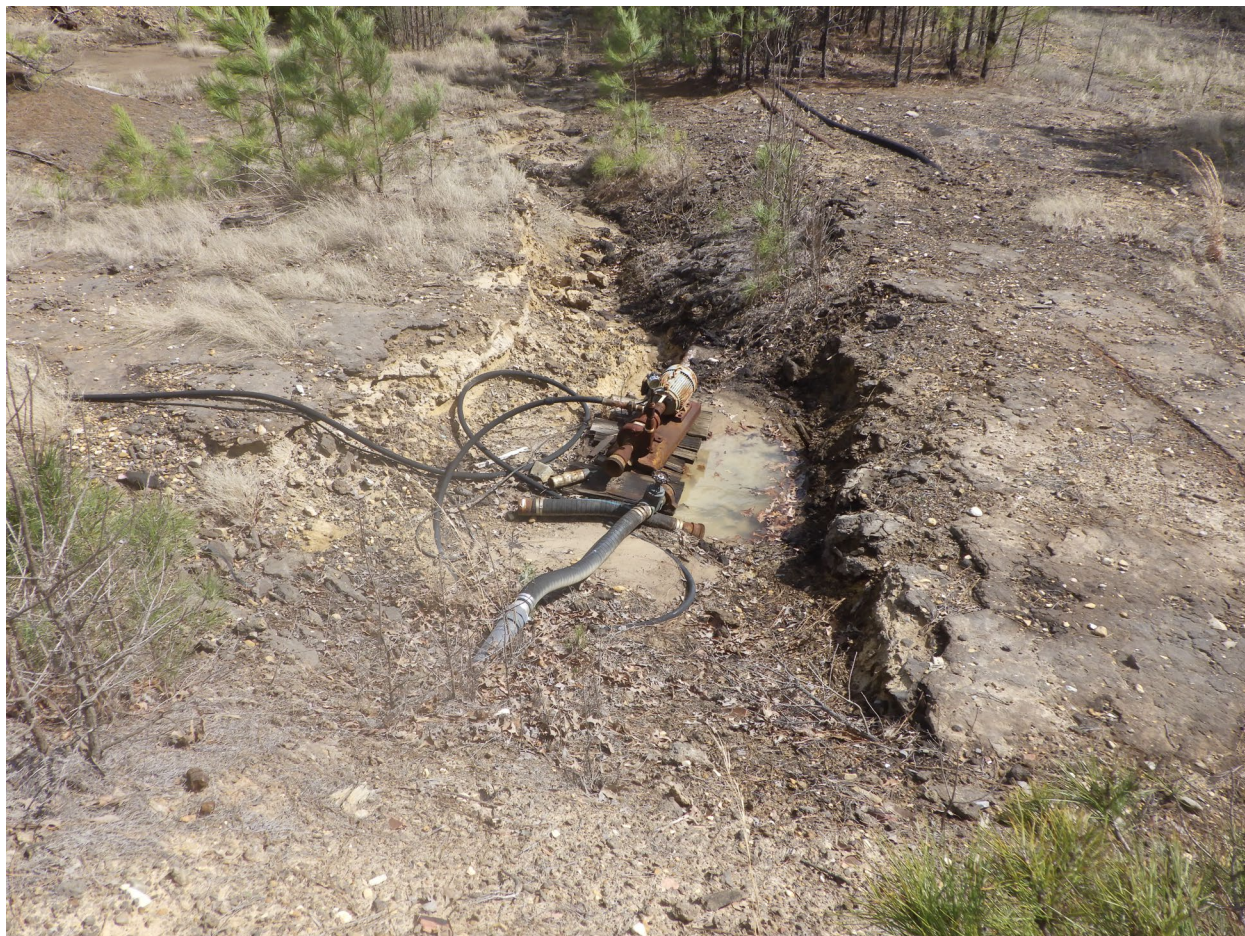
Photo No. 5

**Description:** Looking ENE, this photo shows a pump used at the drainpipe for the sump area of the secondary containment.

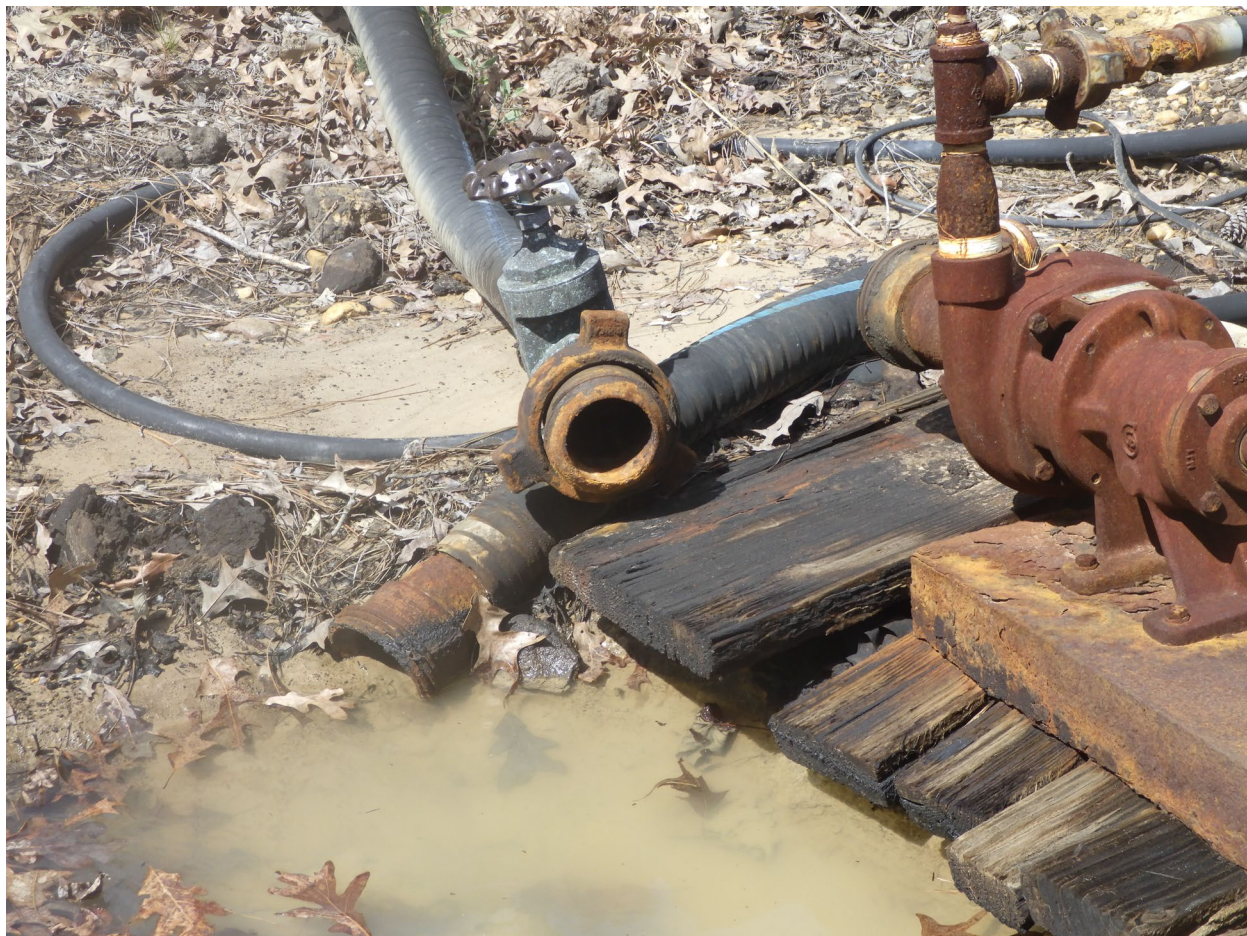
Photo No. 6

**Description:** Looking N, this photo shows the drainpipe for secondary containment with a closed valve and no cap.

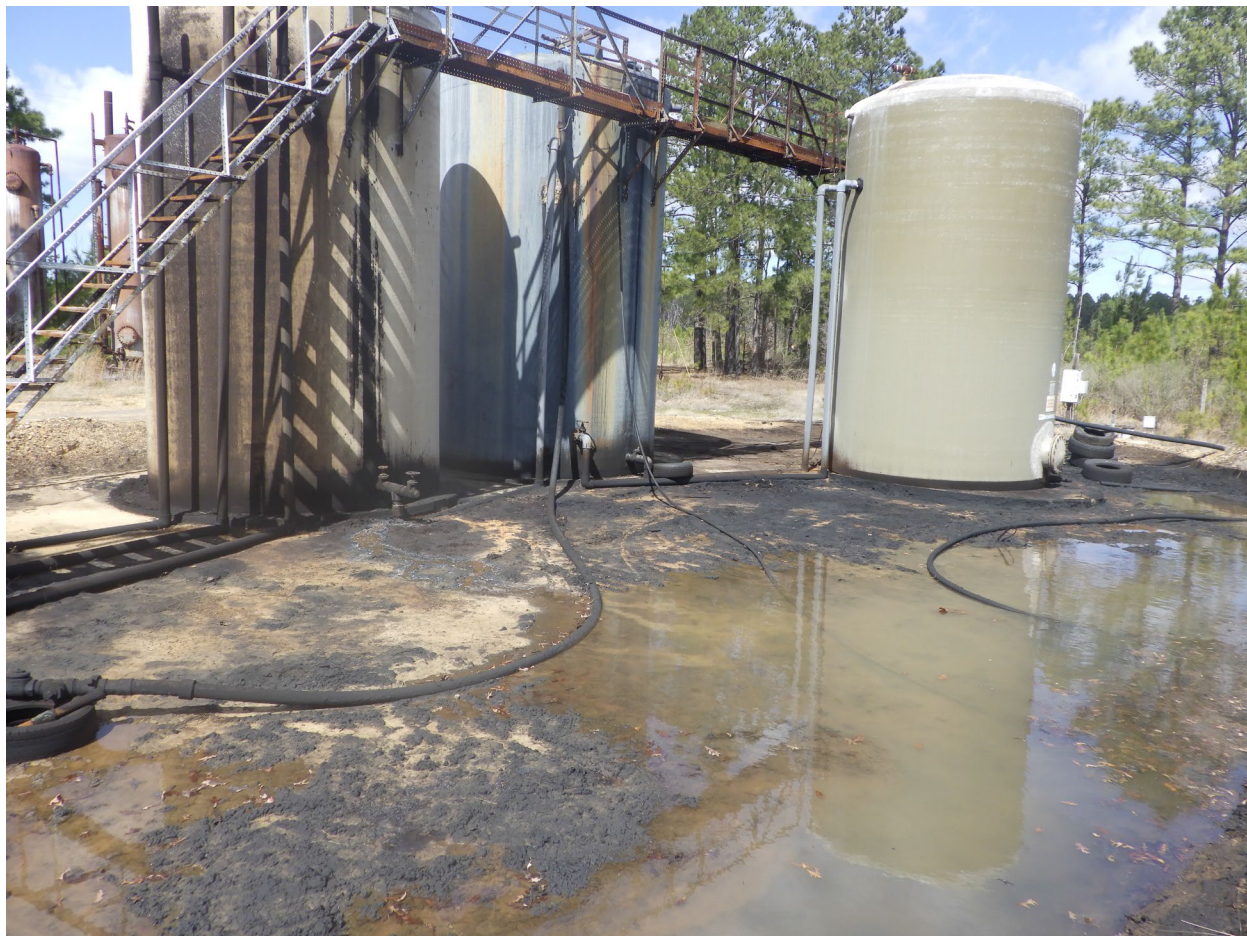
Photo No. 7

I observed loose crude oil and salt water inside secondary containment, see Photos No. 7 and No. 8.

**Description:** Looking NNE, this photo shows loose crude oil and saltwater inside the secondary containment.

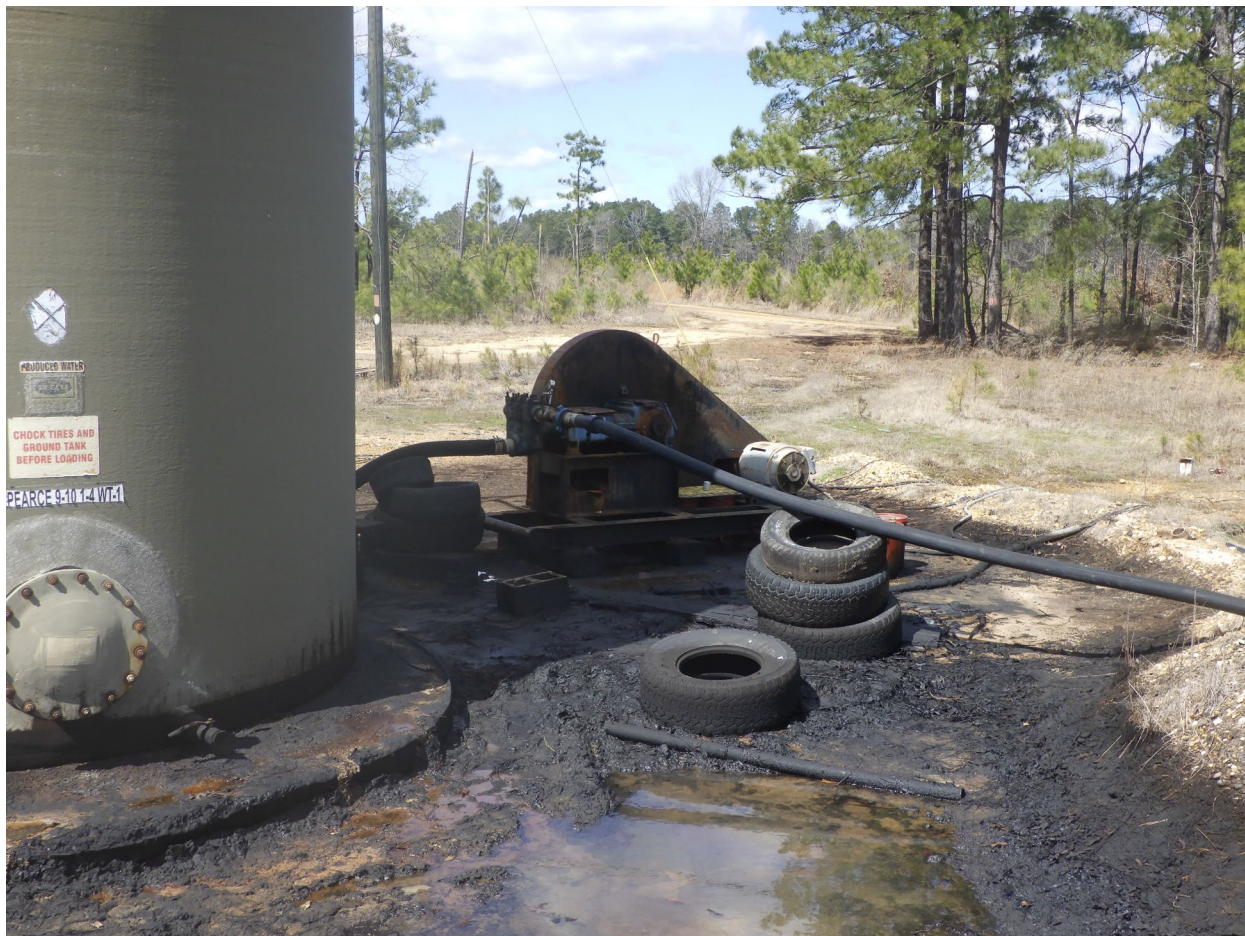
Photo No. 8

**Description:** Looking N, this photo shows the pump used for the saltwater disposal (SWD) injection well.

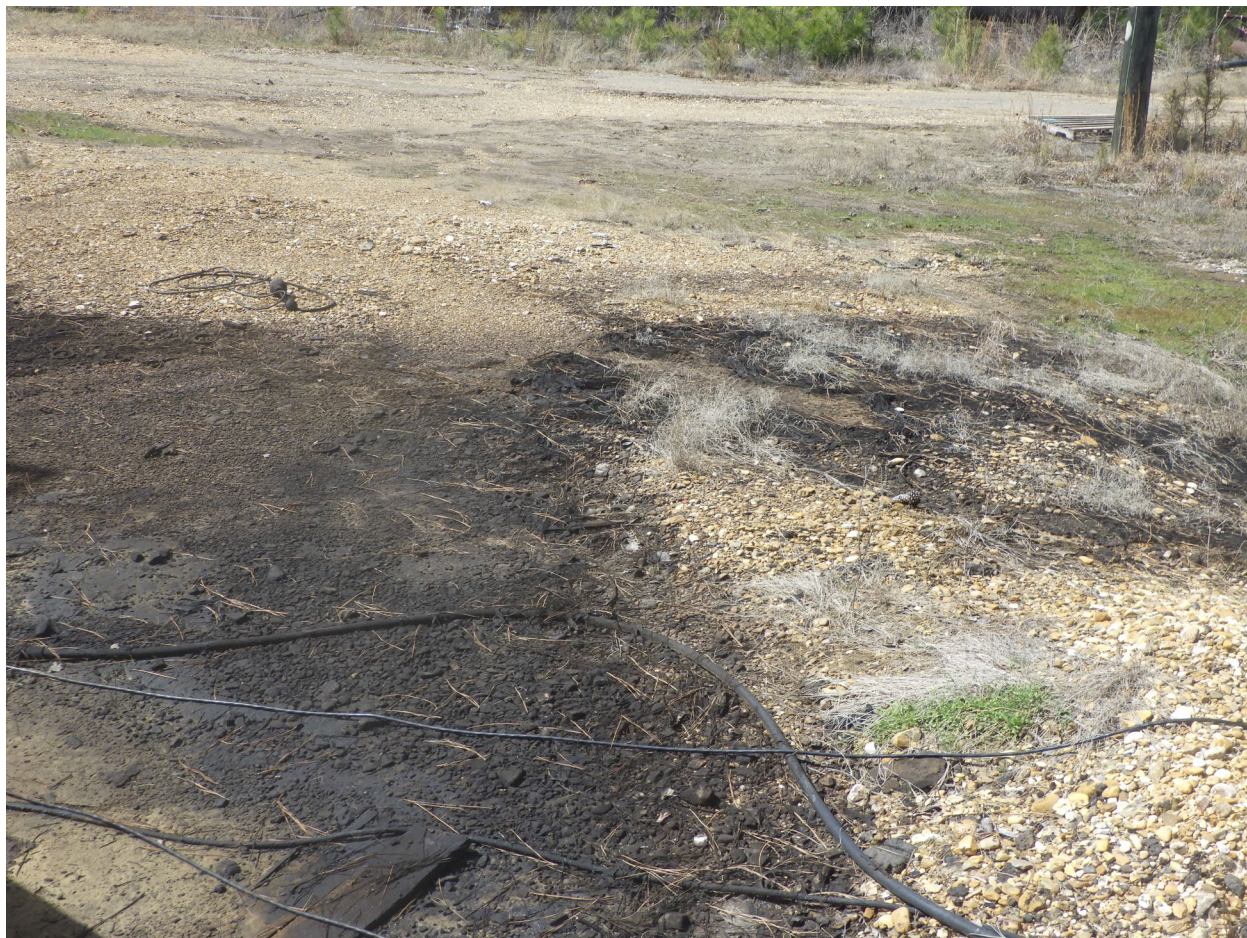
Photo No. 9

I observed a low area in the berm of the secondary containment, see Photo No. 9.

**Description:** Looking NW, this photo shows a low area in the berm for the secondary containment.

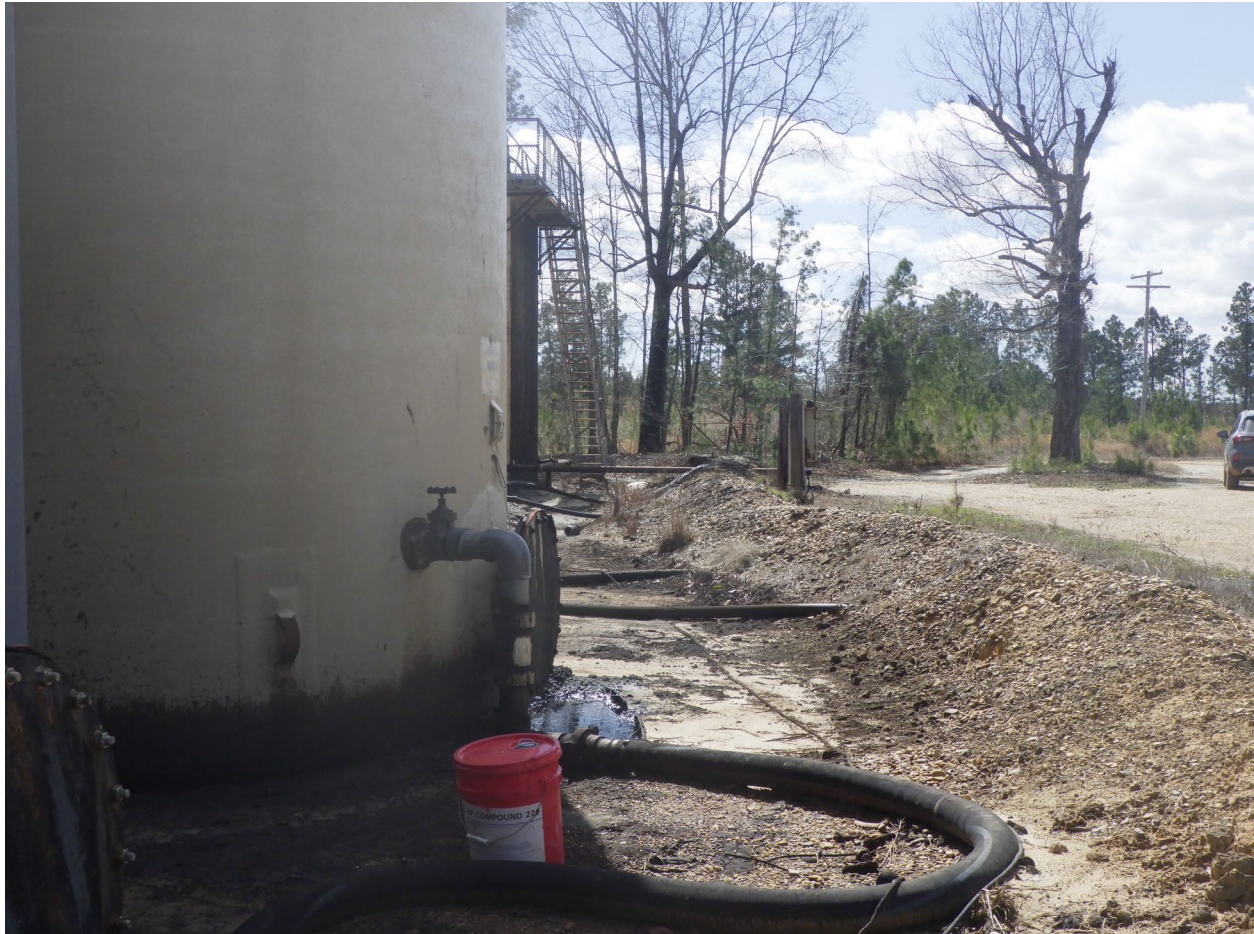
Photo No. 10

I observed an active leak of crude oil from one of the tanks inside secondary containment, see Photos No. 10 and No. 11.

**Description:** Looking S, this photo shows a frontside view inside the secondary containment with an active crude oil leak.

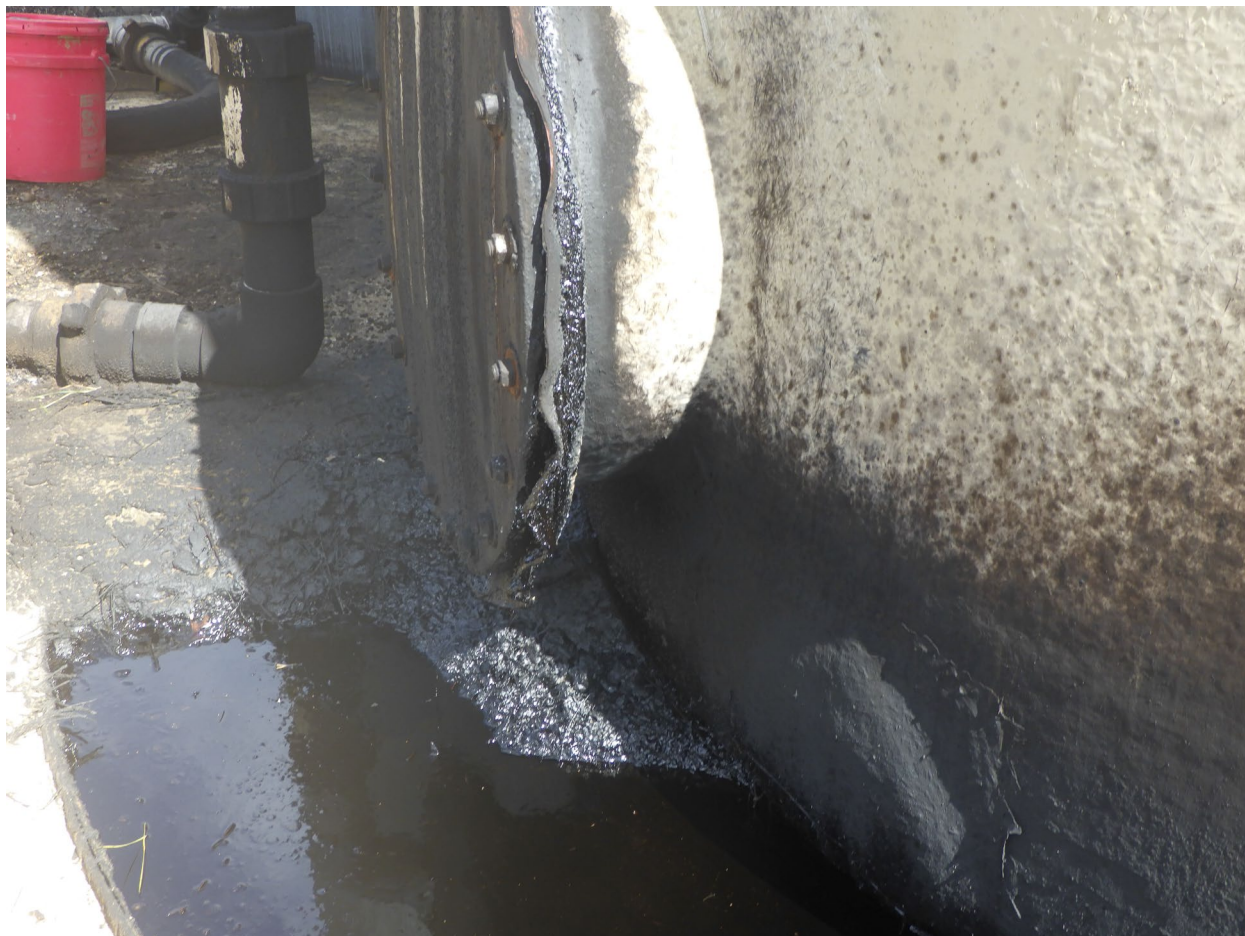
Photo No. 11

**Description:** Looking NE, this photo shows a closeup of the active crude oil leak from Photo No. 10.

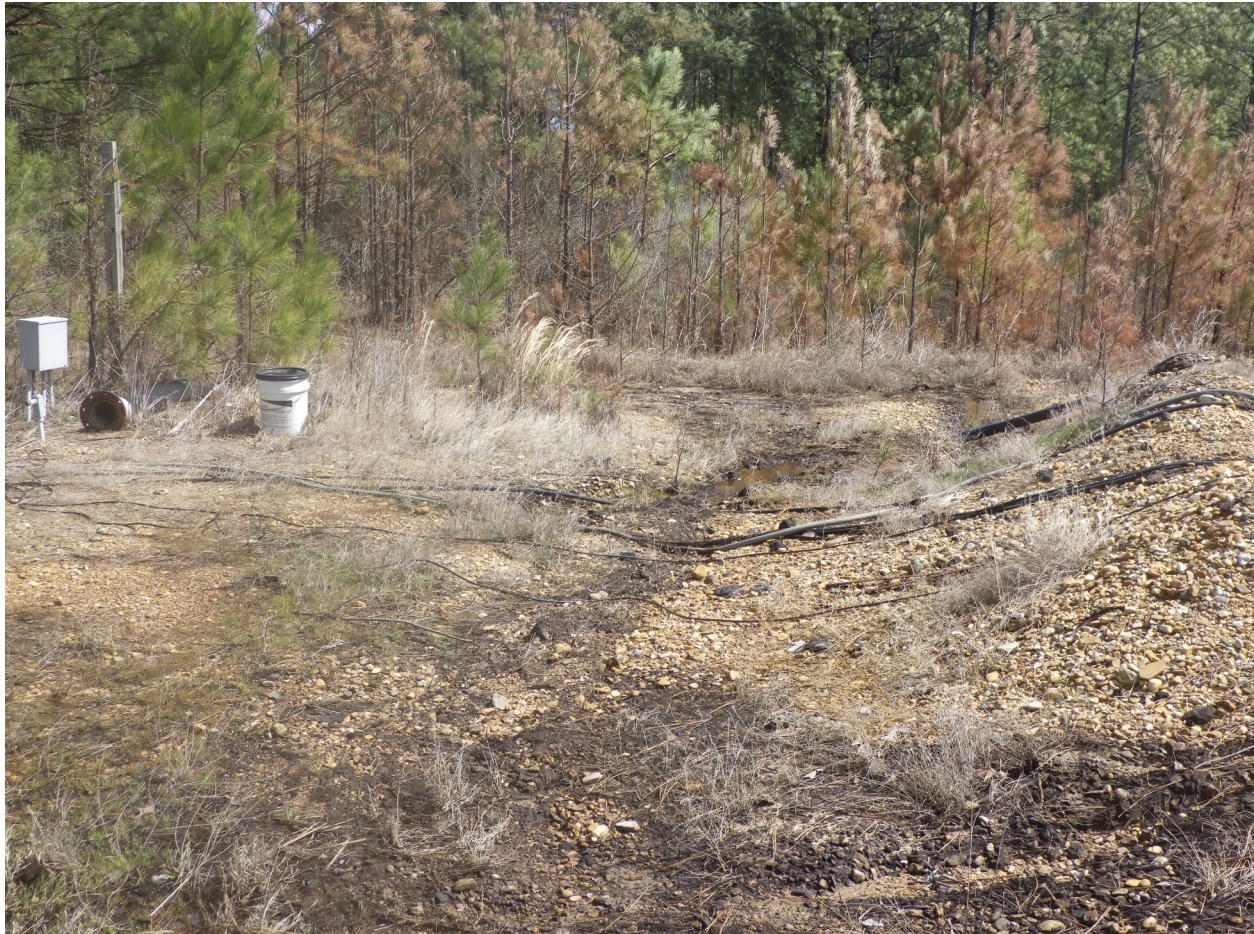
Photo No. 12

I observed the drainage area around the secondary containment, flowlines directed toward the saltwater disposal (SWD) well, and bare soil and dead vegetation from a potential saltwater release, see Photos No. 12 through No. 15.

**Description:** Looking E, this photo shows the drainage area around the tank battery with dead vegetation in the background.

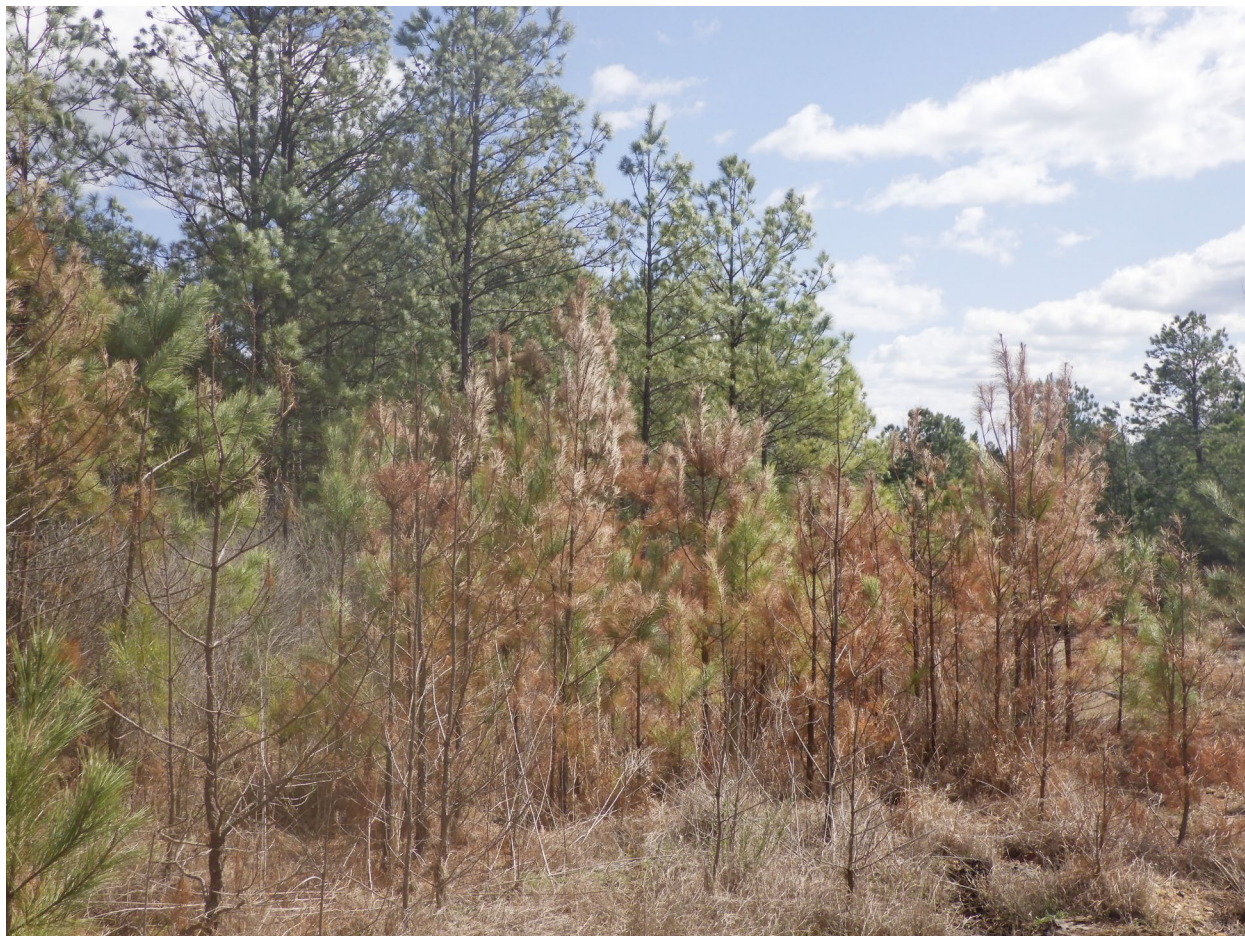
Photo No. 13

**Description:** Looking ESE, this photo shows a closeup view of the dead vegetation from Photo No. 12.

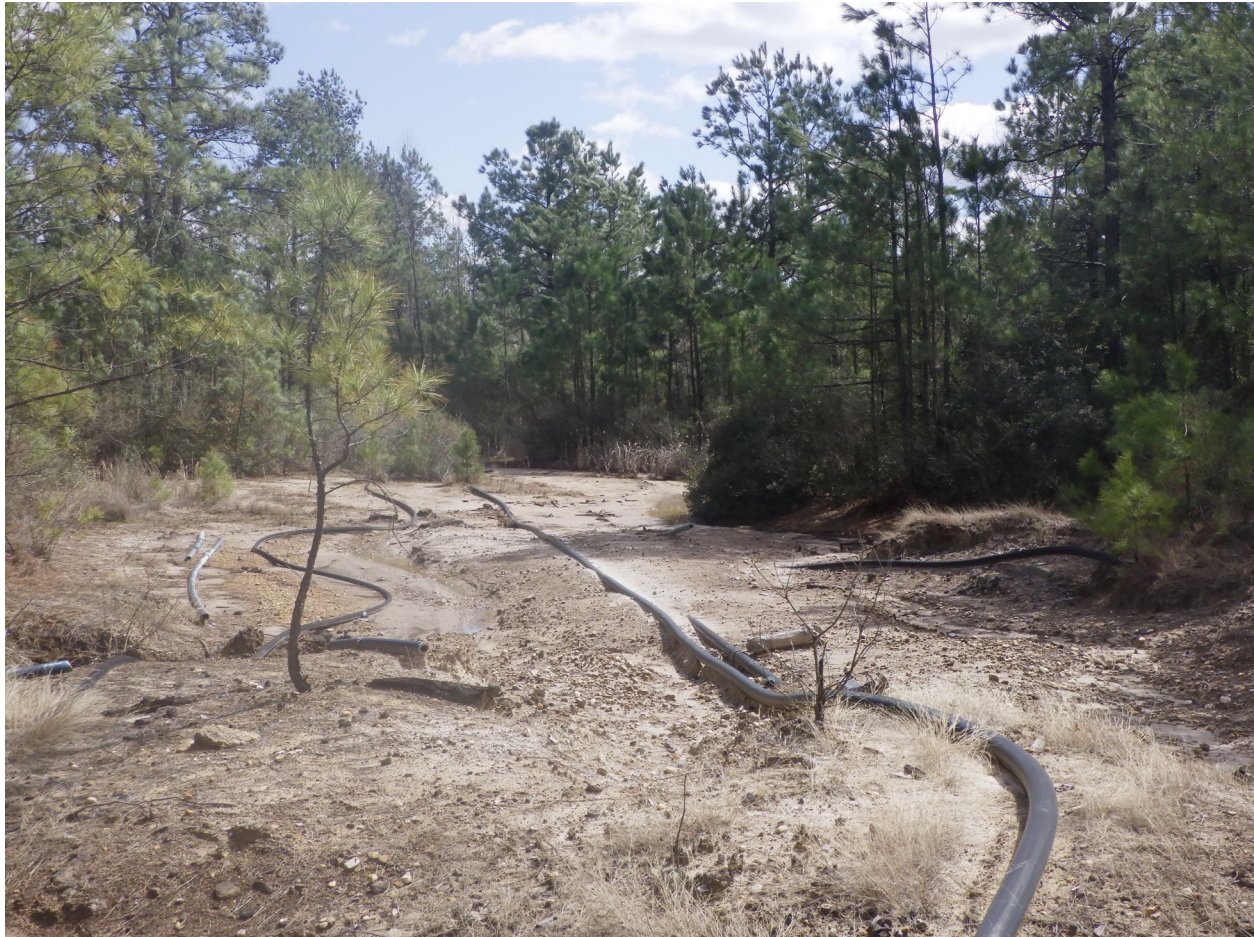
Photo No. 14

**Description:** Looking ESE, this photo shows a historic saltwater release within the flowline area for the SWD injection well.

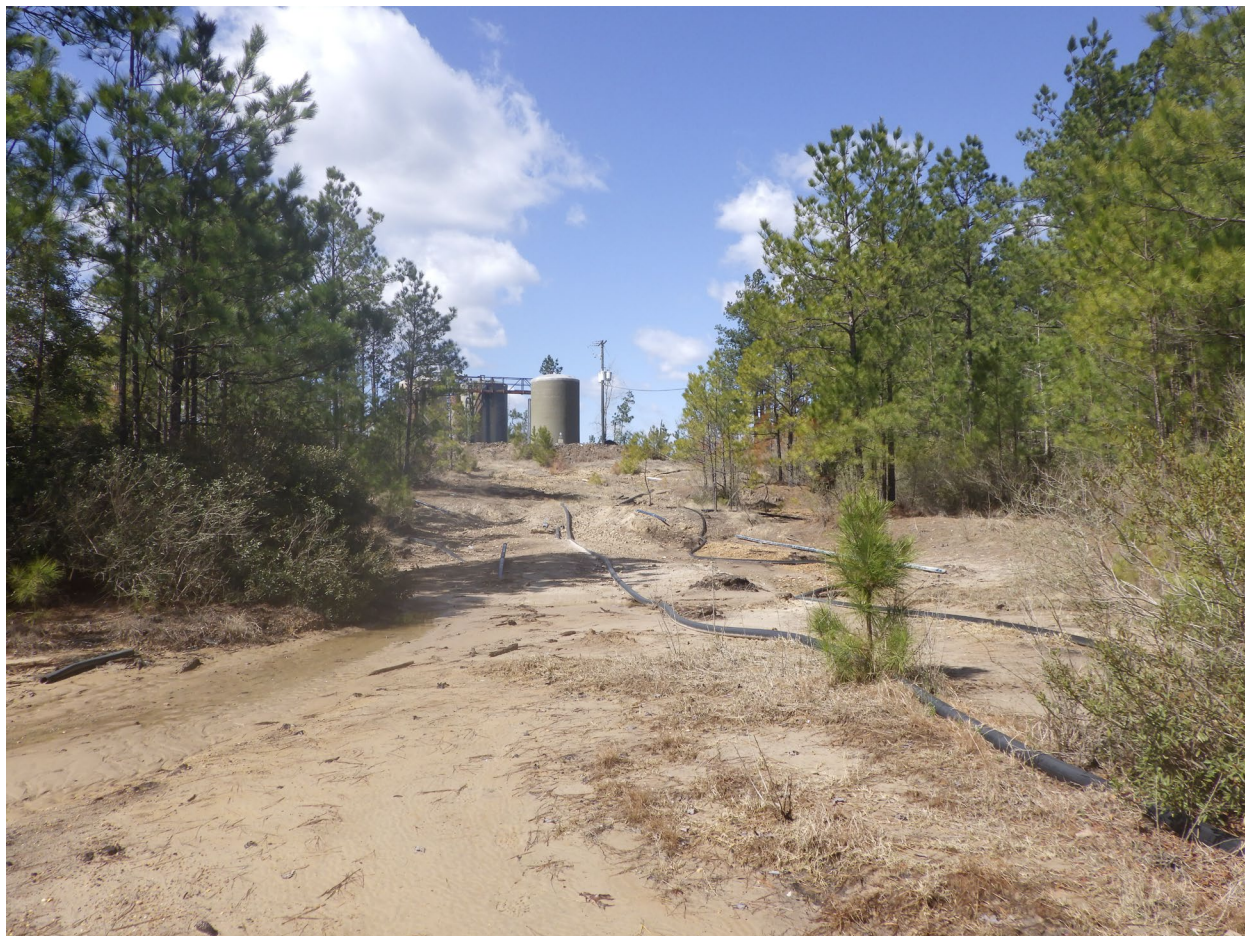
Photo No. 15

**Description:** Looking NNW, this photo shows an additional view of the drainage area and the historic saltwater release from Photo No. 14.

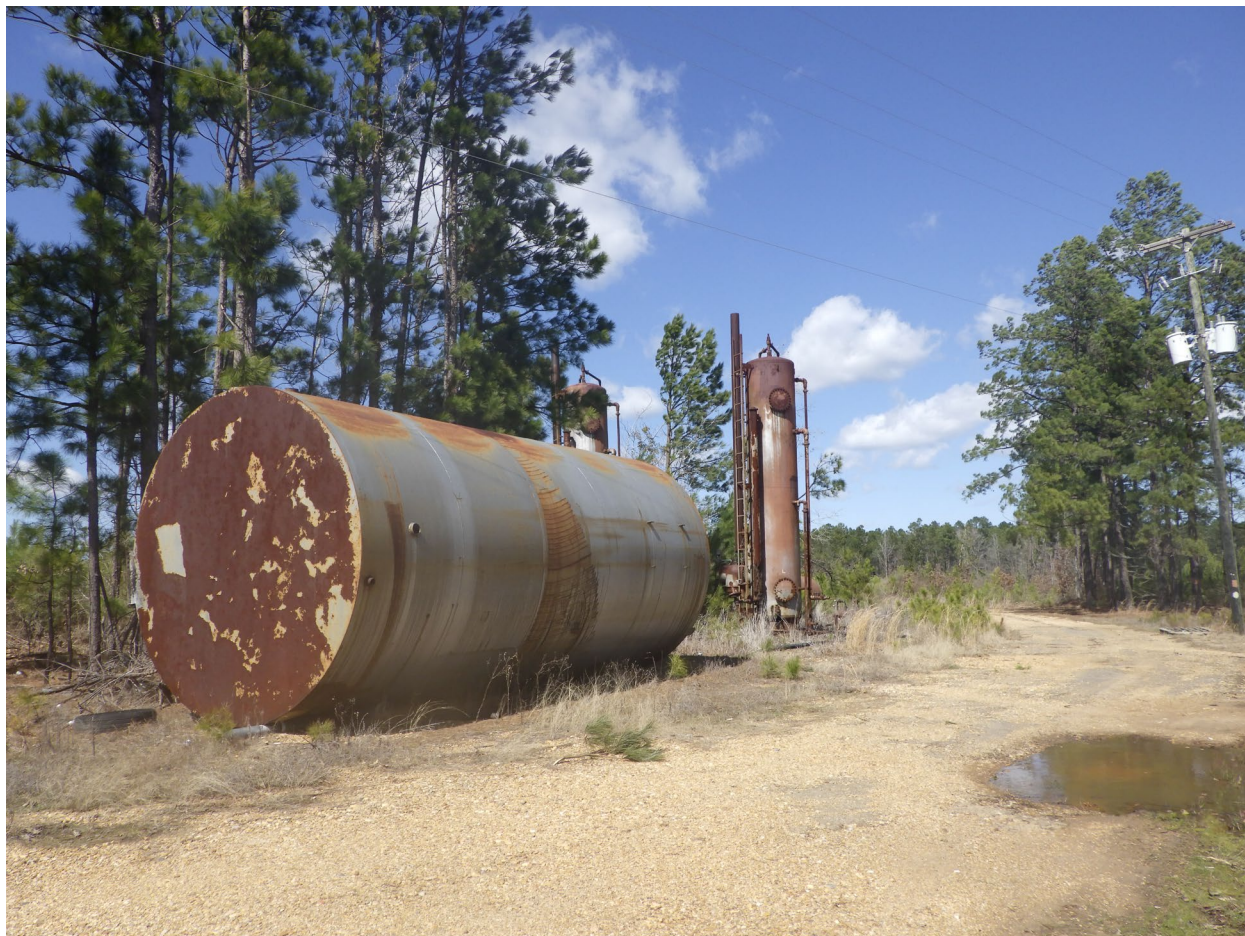
Photo No. 16

I observed five (5) miscellaneous tanks outside secondary containment that appeared to be out of service, see Photos No. 16 and No. 17.

**Description:** Looking NNE, this photo shows two (2) treaters and a storage tank that appear to be out of service.

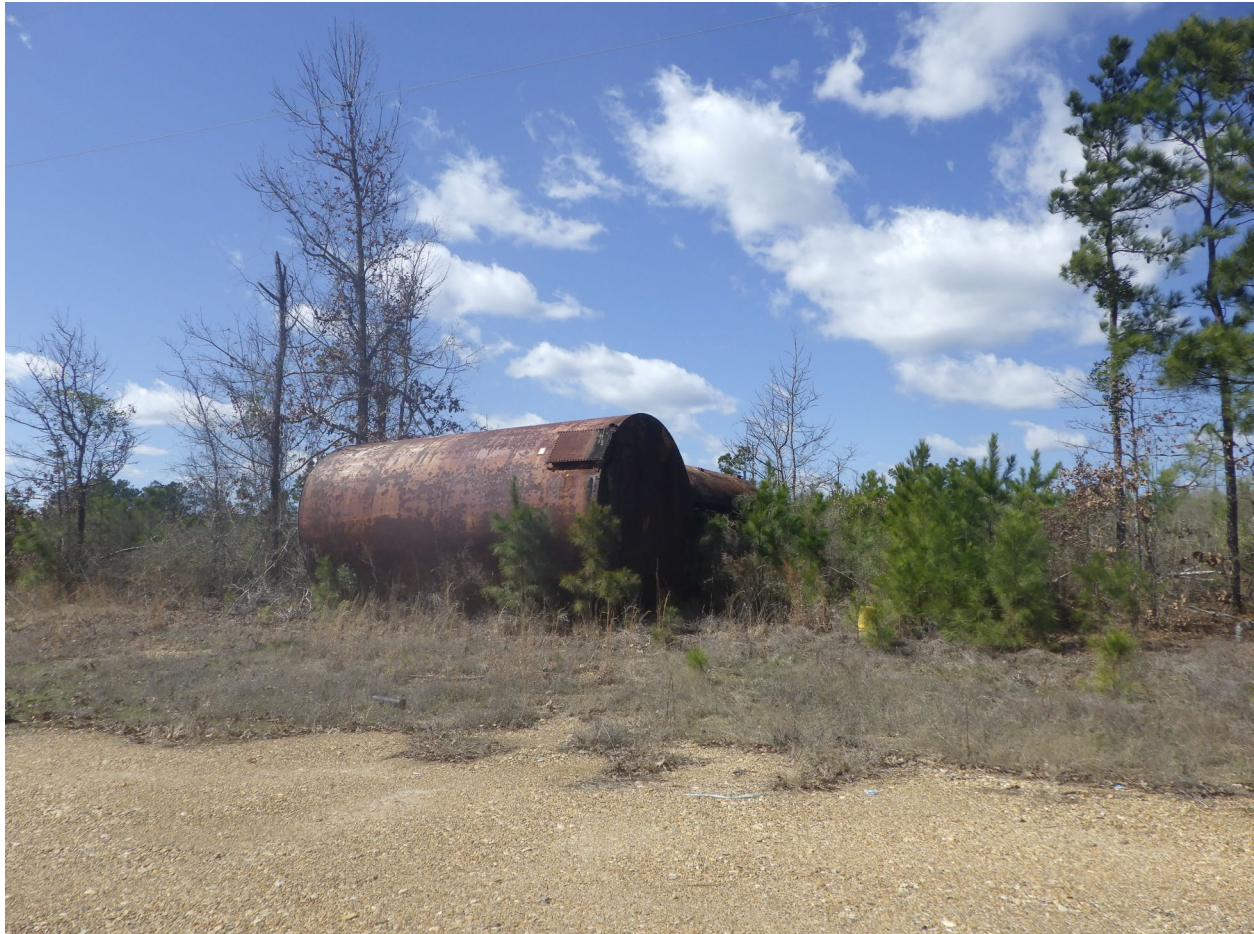
Photo No. 17

**Description:** Looking W, this photo shows an additional two (2) storage tanks outside secondary containment that appear to be out of service.
