ENVIRONMENTAL RESEARCH 12, 110-128 (1976)

## Asbestos Exposure during Brake Lining Maintenance and Repair<sup>1</sup>

ARTHUR N. ROHL, ARTHUR M. LANGER, MARY S. WOLFF, AND  
IRVING WEISMAN

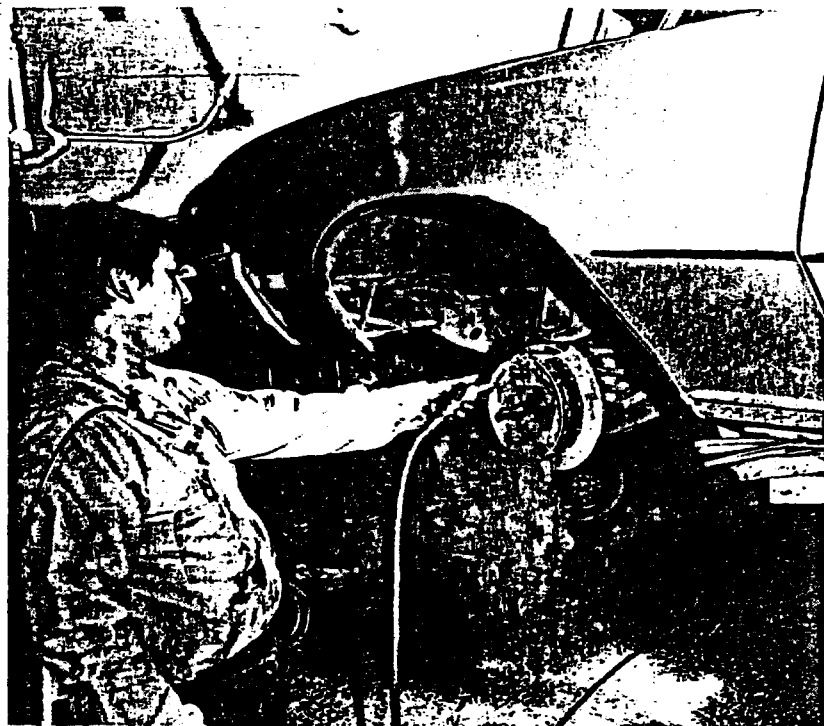
FIG. 4. Removal of dust from brake drum and back plate by pneumatic air blowing at automobile garage.

When a vehicle is brought into a repair shop for brake lining inspection or replacement, the wheel is removed and loose dust is removed from the drums and back plates, generally by means of a compressed air jet. A recent survey of brake repair establishments in Baltimore and Washington revealed that this is the standard method in those cities (Castleman *et al.*, 1975). A similar situation exists in New York City. The cloud of dust that is produced is visible for several minutes afterwards (Fig. 4). Table 3 shows that fiber concentrations are high in the operator's area under these conditions (an average concentration of 16 fibers/ml), and that there are significant concentrations at least 20 ft away. Background or area sampling during the same operation shows that, at least 14 minutes after jet air blowing and up to 75 ft away, asbestos concentrations are still measurable even by optical microscopy. The data in Table 3 indicate that an asbestos concentration gradient, dependent on distance and time, is associated with this operation. It is evident that any person 65-75 ft away can be exposed. Current (interim) regulations of OSHA prohibit concentrations of 5 fibers/ml or more, longer than 5  $\mu$ m, as

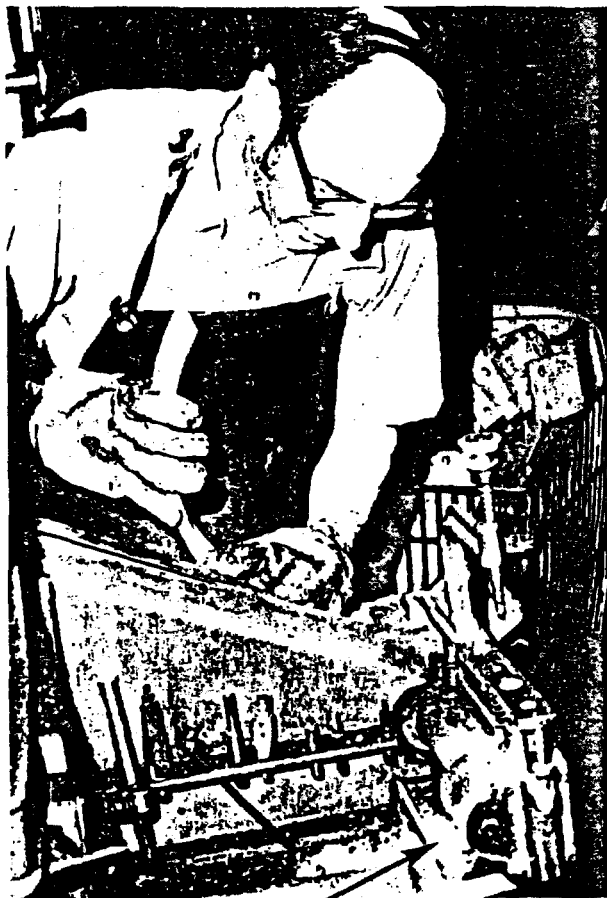
FIG. 5. Beveling of truck brake linings at municipal garage. Arrow indicates accumulation of asbestos dust.

Personal air sampling was also conducted at the New York Department of Sanitation truck repair shop, where various kinds of brake application and repair work are performed. Used truck brake linings are salvaged by grinding the surface to remove grease and dirt, and new linings are ground to expedite break-in. The edges of new linings are beveled on a grinding wheel or arcing machine to avoid noise problems. (Fig. 5). Holes are drilled or punched into the brake lining, which

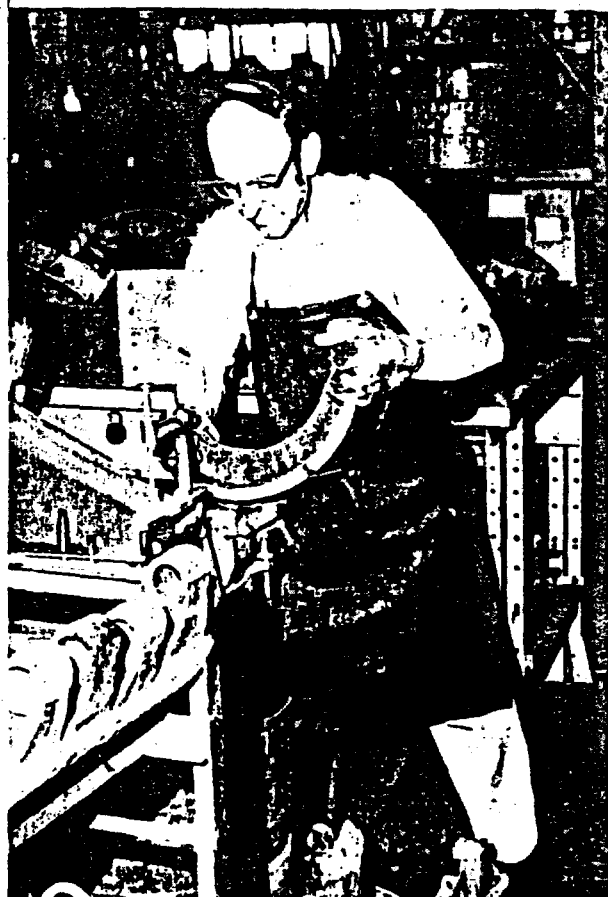
FIG. 6. Renewing of municipal truck brake linings by light grinding to remove grease and dirt.
