## **RCRA Inspection Report**

University of South Alabama  
307 University Boulevard North  
Mobile, Alabama 36688

EPA ID#: ALD079474037  
NAICS #: 61131- Colleges, Universities, and  
Professional Schools

November 19, 2024, 1:00pm CST-7:00pm CST

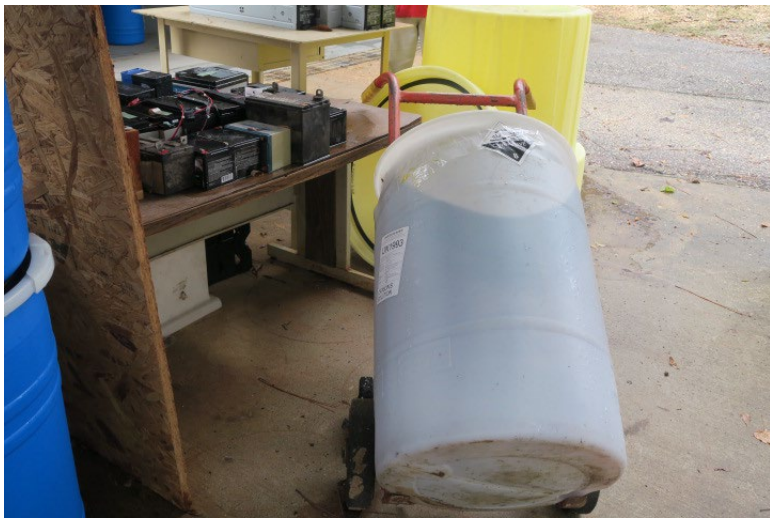
In front of the TSD Building is a staging area which contained 15 empty drums and approximately 25 used lead acid batteries for recycling. The inspectors also observed one 30-gallon drum of hazardous waste on a dolly in the outdoor staging area. University personnel identified the contents of the container as Carson’s Solution (Photo 1). The container was labeled with hazard indicators “Corrosive” and “Flammable Liquids,” with EPA waste codes D001 and F003, and with the words “Hazardous Waste” (Photo 2). Cedric Crawley stated that one hazardous waste label with an accumulation start date of September 14, 2023, was an inaccurate label, and he removed it at the time of the inspection. A second hazardous waste label which remained on the drum had an accumulation start date of November 4, 2024 (Photo 2). Inspectors requested documentation clarifying the accumulation start date for the drum. In an email dated December 2, 2024, William Guess provided documentation detailing the volume of Carson’s Solution that was added to the 30-gallon drum and the date(s) it was accumulated. The document states that Carson’s Solution was first added to the drum on January 25, 2024, and that hazardous waste was most recently added to the container on October 14, 2024.

Photo 1: 30-gallon drum of hazardous waste labeled Carson's Solution in the TSD Building outdoor staging area.

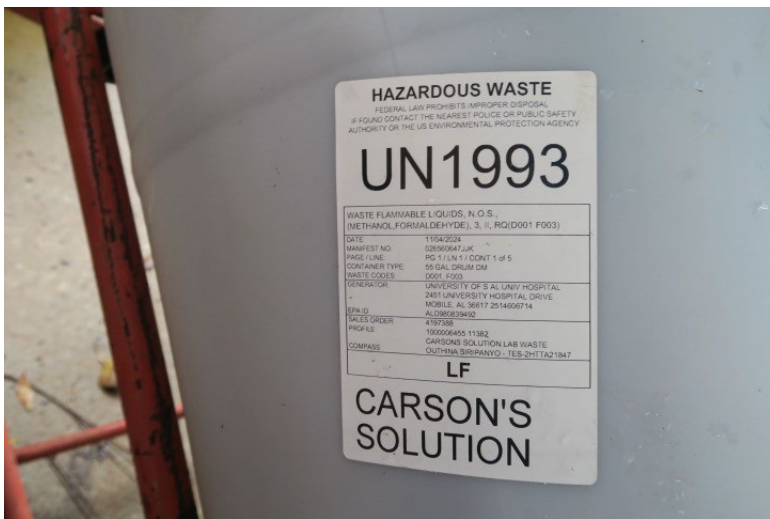
Photo 2: Hazardous waste label on the 30-gallon drum of hazardous waste labeled Carson's Solution in the TSD Building outdoor staging area

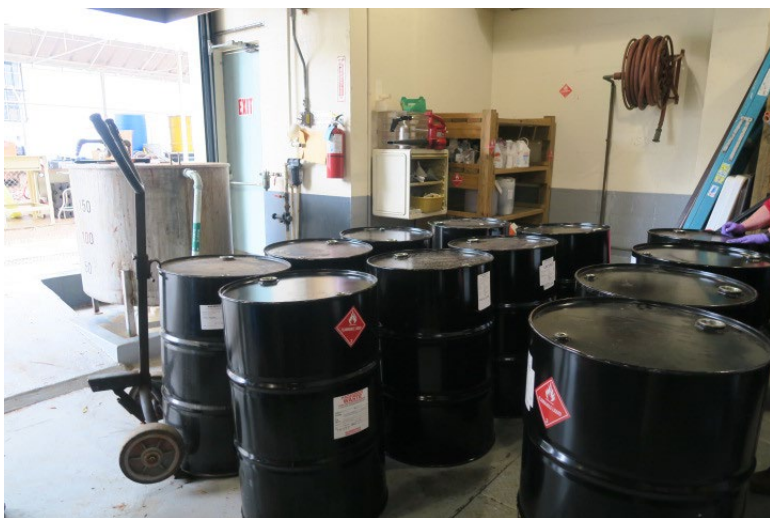
In the processing area of the TSD building, the inspectors observed 12 55-gallon drums lined up in three rows of four (Photo 3). Facility personnel stated that waste containers in the TSD building are typically labeled in accordance with the permit requirements when they are in storage. Before the transporter arrives, hazardous waste drums are lined up in the process area to prepare for shipment. Regarding these 12 hazardous waste drums, the containers were originally scheduled to be transported off-site, but the waste pick-up was cancelled due to USA's concerns about the transporter employee's training, qualifications, and job performance. Typically, when the transporter comes to pick up the waste, they relabel them with the transporter's hazardous waste labels for transportation and the DOT toxic hazard stickers are removed from the containers of hazardous waste solvent that are considered toxic under RCRA, but not under DOT. The original transporter had processed some, but not all, of the twelve containers that were to be included in the waste pick-up, removing the facility's labels and toxic indicators.

As such, inspectors observed eleven containers labeled with the words "hazardous waste," and one container labeled non-regulated DAB solution. Containers of hazardous waste were also labeled with waste codes D001, F003, and F005. There were three hazardous waste drums of Carson's Solution, one drum of non-regulated DAB solution, six hazardous waste drums of xylene and mixed alcohol, and two hazardous waste drums of xylene and toluene. Nine of the 12 drums were labeled with an accumulation start date; the dates observed were November 1, 2024, November 4, 2024, and November 14, 2024. Three of the drums were not labelled with accumulation start dates.

Photo 3: Twelve 55-gallon hazardous waste drums in the processing area of the TSD building.

**Pursuant to Hazardous Waste Permit No. ALD079474037, Permit Condition Part III.G.1, the Permittee shall manage containers as required by ADEM Admin. Code r. 335- 14- 5-.09(4) and Part D- 1c of the permit application. Specifically, Part D-1c of the permit application states that all containers receive an in-house laminated manifest card (with individual tracking number) used for identification and allows for computerized tracking of all waste materials. This tracking method includes a receiving date that allows for disposal within the allotted time frame called for in this permit.**

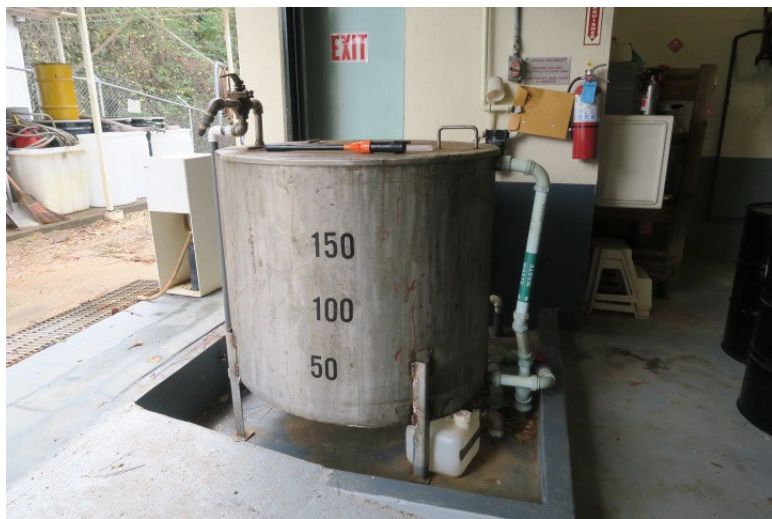
The inspectors observed a neutralization tank which appeared to be in good condition and was empty at the time of the inspection (Photo 5). According to the neutralization log, which is kept in the TSD building, it was last used to neutralize Hier Solution on October 14, 2024.

Photo 5: Neutralization tank in the TSD building.

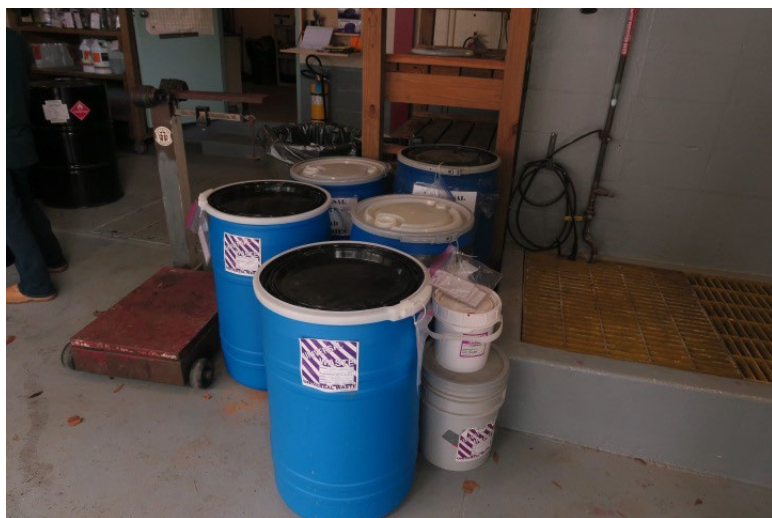
The inspectors observed 7 containers of universal waste batteries (five 30-gallon drums, one 5-gallon bucket, one small <5-gallon bucket) (Photo 6). The contents include two containers of used lithium batteries, two containers of used alkaline batteries, one container of used Ni-Cd batteries, one container of used zinc batteries, and one container labeled “odd group of dead batteries”. Each container was tagged with the facility’s internal manifest system tag and a universal waste label. The inspectors observed accumulation start dates of November 6, 2024, and September 9, 2024, on the containers.

Photo 6: Seven containers of universal waste batteries in the TSD building.

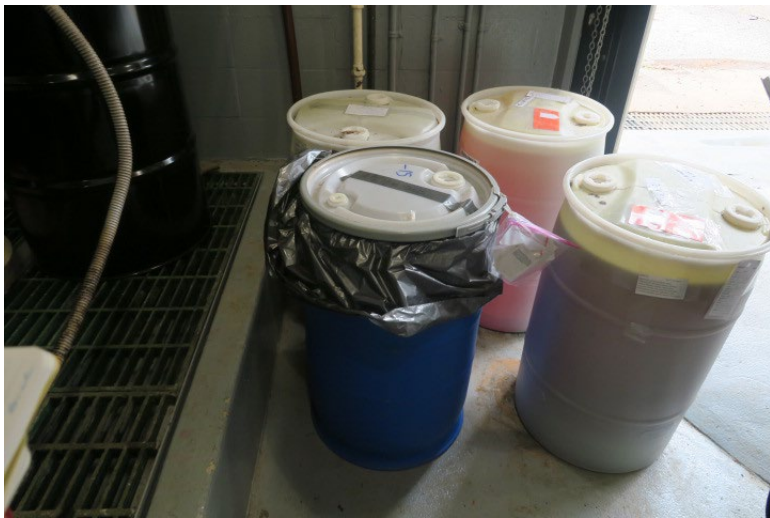
To the right of the entrance, inspectors observed four 30-gallon hazardous waste drums (Photo 7). Drum 1 was closed, in good condition, labeled with the words “hazardous waste,” flammable and toxic indicators, and an accumulation start date. Drum 2 was closed, in good condition, labeled with the words “hazardous waste,” flammable and toxic indicators, and an accumulation start date. Drum 3 contained ethidium bromide gels (non-RCRA regulated but the facility is managing it as hazardous waste), it was closed, in good condition, labeled with the words “hazardous waste,” an accumulation start date, but was not labeled with a hazard indicator. A poison hazard indicator was added by facility personnel at the time of the inspection. Drum 4 contained acetone, ethanol, and other toxic chemicals. It was closed, in good condition, labeled with the words “hazardous waste,” and an accumulation start date, but was not labeled with an indication of the hazards of the contents. Flammable and toxic hazard indicators were added by facility personnel at the time of the inspection.

Photo 7: Four 30-gallon drums of hazardous waste in the TSD building, to the right of the entrance.

**Pursuant to Hazardous Waste Facility Permit No. ALD079474037, Permit Condition Part II.L.1 of, the Permittee shall maintain compliance with the requirements of 40 CFR 268 as adopted in ADEM Admin. Code r. 335- 14- 9. Specifically 40 CFR 268.50(a)(2)(i)(C) as adopted in ADEM Admin. Code r. 335- 14- 9, requires each container of hazardous waste restricted from land disposal to be clearly marked to identify its contents and with an indication of the hazards of**

the contents (examples include, but are not limited to, the applicable hazardous waste characteristic(s) (i.e., ignitable, corrosive, reactive, toxic); hazard communication consistent with the Department of Transportation requirements at 49 CFR part 172 subpart E (labeling) or subpart F (placarding); a hazard statement or pictogram consistent with the Occupational Safety and Health Administration Hazard Communication Standard at 29 CFR 1910.1200; or a chemical hazard label consistent with the National Fire Protection Association code 704).

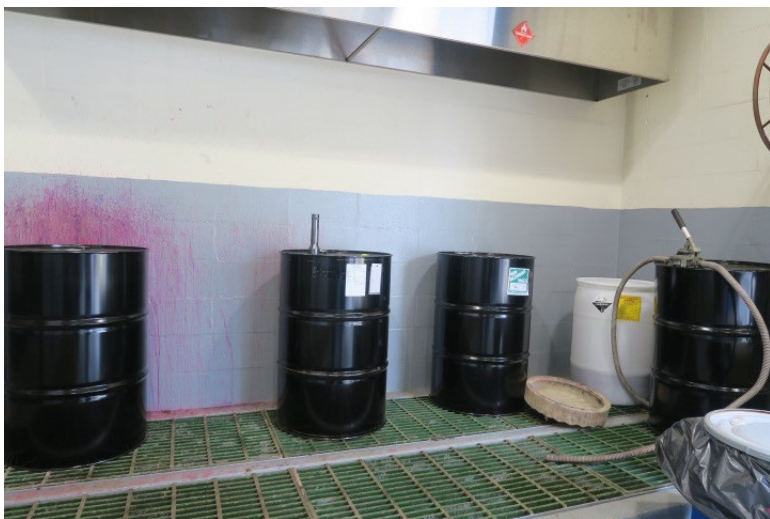
The inspectors also observed 5 containers (one 30-gallon and four 55-gallon drums) on top of a catch basin (Photo 8). Container 1, a 55-gallon drum, was empty and labeled for storing hazardous waste containing xylene. Container 2, a 55-gallon drum, was labeled as non-regulated material (313 Diaminobenzidine). Container 3, a 55-gallon drum, was labeled as non-hazardous waste.

Container 4, a 55-gallon drum containing hazardous waste Carson's Solution, was unlabeled (no hazardous waste label, hazard indicators, or waste codes) with a hose attachment connected.

Container 5, a 30-gallon drum, was labeled with a hazardous waste label and corrosive indicator, but it did not have an accumulation start date. Cedric Crawley described that he was in the process of adding excess Carson's Solution from the 55-gallon unlabeled drum to the 30-gallon consolidation drum when inspectors arrived to view the facility. He stated he planned to add an accumulation start date of November 19, 2024, to the 30-gallon drum.

Photo 8: Five containers (four 55-gallon and one 30-gallon drum) on a catch basin in the TSD building. The 30-gallon drum and 55-gallon drum with the hose attachment contained hazardous waste (Carson's solution). The other containers were empty, contained non-hazardous waste, and non-regulated material.

**Pursuant to Hazardous Waste Permit No. ALD079474037, Permit Condition Part II.L.1, the Permittee shall maintain compliance with the requirements of 40 CFR 268 as adopted in ADEM Admin. Code r. 335- 14- 9. Specifically, 40 CFR 268.50(a)(2)(i)(a-d) as adopted in ADEM Admin. Code r. 335- 14- 9, requires each container of hazardous waste restricted from land disposal to be clearly marked to identify its contents and with the words "hazardous waste," the applicable EPA hazardous waste number(s) (EPA hazardous waste codes) in subparts C and D of part 261 of this chapter; or use a nationally recognized electronic system, such as bar coding, to identify the EPA hazardous waste number(s), an indication of the hazards of the contents (examples include, but are not limited to, the applicable hazardous waste characteristic(s) (i.e., ignitable, corrosive, reactive, toxic); hazard communication consistent with the Department of Transportation requirements at 49 CFR part 172 subpart E (labeling) or subpart F (placarding); a hazard statement or pictogram consistent with the Occupational Safety and Health Administration Hazard Communication Standard at 29 CFR 1910.1200; or a chemical hazard label consistent with the National Fire Protection Association code 704), and the date each period of accumulation begins.**

**Pursuant to Hazardous Waste Permit No. ALD079474037, Permit Condition Part III.G.1, The Permittee shall manage containers as required by ADEM Admin. Code r. 335- 14- 5-.09(4) and Part D- 1c of the permit application. Specifically, Part D-1c of the permit application states that all containers receive an in-house laminated manifest card (with individual tracking number) used for identification and allows for computerized tracking of all waste materials. This tracking method includes a receiving date that allows for disposal within the allotted time frame called for in this permit.**

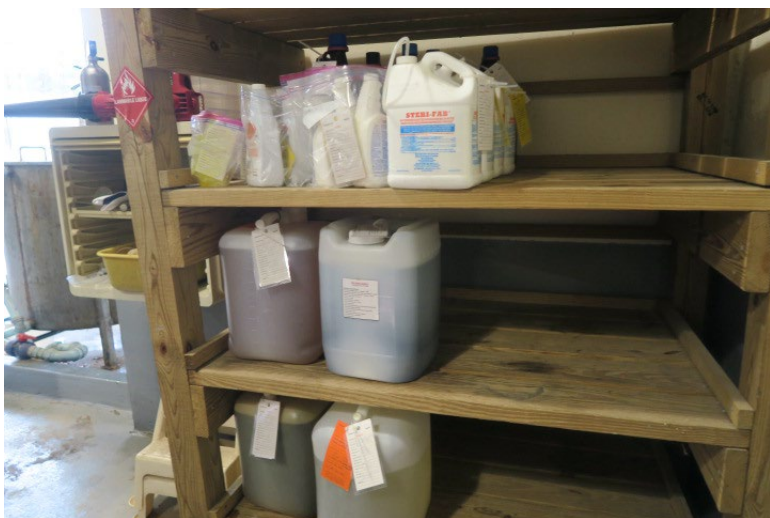
The TSD building also contains several wooden shelving units for additional hazardous waste materials: shelving unit one for flammable materials held approximately 25 containers (Photo 9). Shelving unit two for toxic chemicals held ~20 containers (Photo 10). Shelving unit three for acids held ~ 40 containers (Photo 11). Shelving units four and five combined contained ~30 5-gallon buckets all containing the same material from a shipment on November 11, 2024 (Photo 12 and 13). Shelving unit six, for toxic solids or liquids, held ~15 containers (Photo 14). For the containers on all wooden storage shelves, all were tagged with the facility's internal manifest tracking system labels, accumulation dates were less than a year, containers were in good condition, and shelves and/or labels included indication of hazards. In addition, near the toxic chemical shelf, inspectors observed one 30-gallon hazardous waste drum in good condition, labeled with the words "hazardous waste," corrosive indication of hazard, waste codes, and an accumulation start date (Photo 15).

Photo 9: Waste containers on the wooden shelves at the incoming waste processing area in the TSD Building, shelf labeled with flammable liquid hazard indicator, for flammable waste storage.

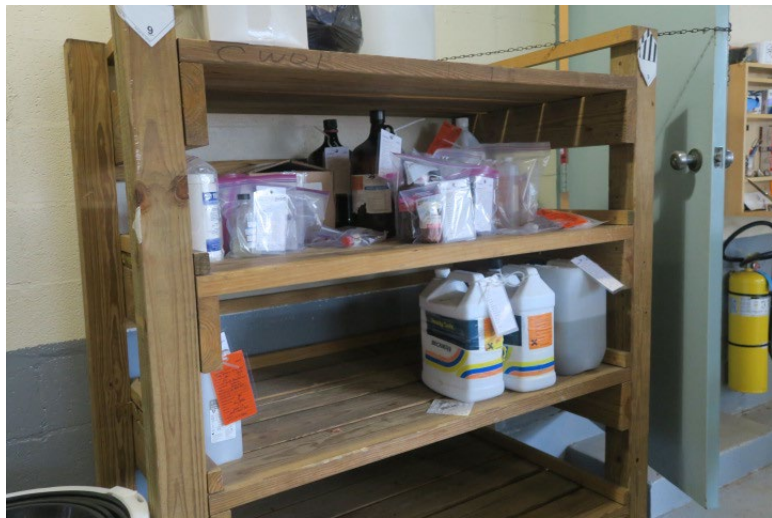
Photo 10: Waste containers on the wooden shelves at the incoming waste processing area in the TSD Building, shelf labeled with Toxic hazard indicator for miscellaneous toxic waste storage.

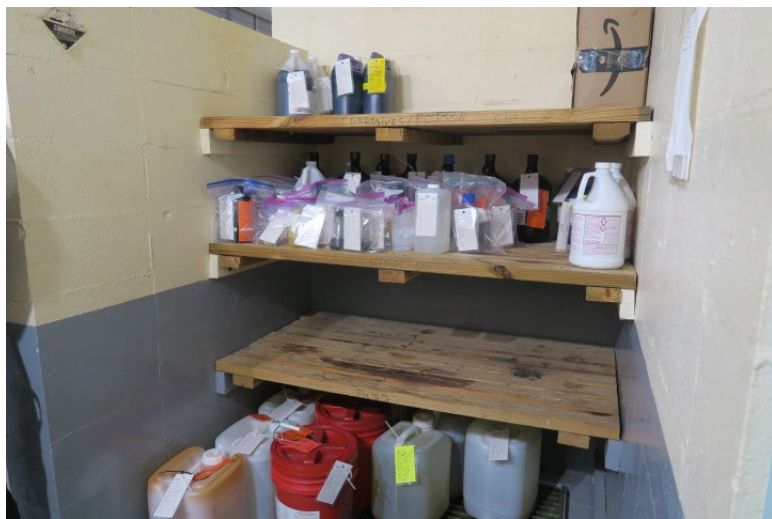
Photo 11: Waste containers on the wooden shelves in the TSD Building, shelf labeled with corrosive hazard indicator for acid waste storage.

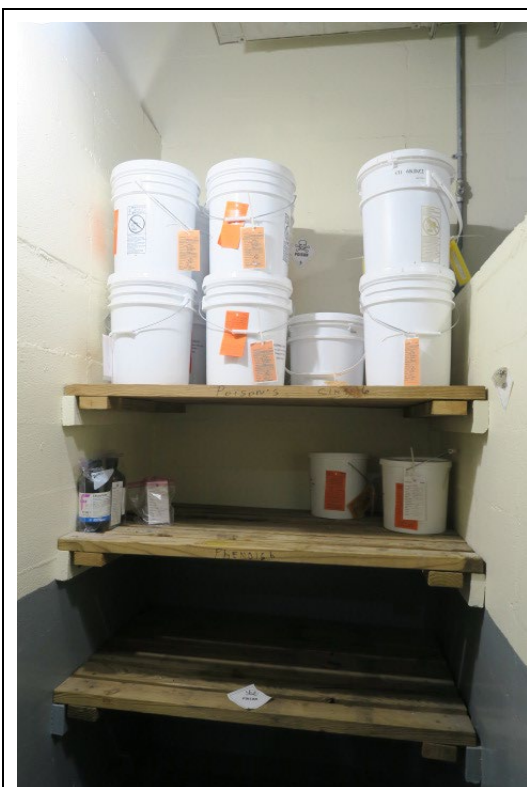
Photo 12: Waste containers on the wooden shelves in the TSD Building, shelf labeled with poison hazard indicator.

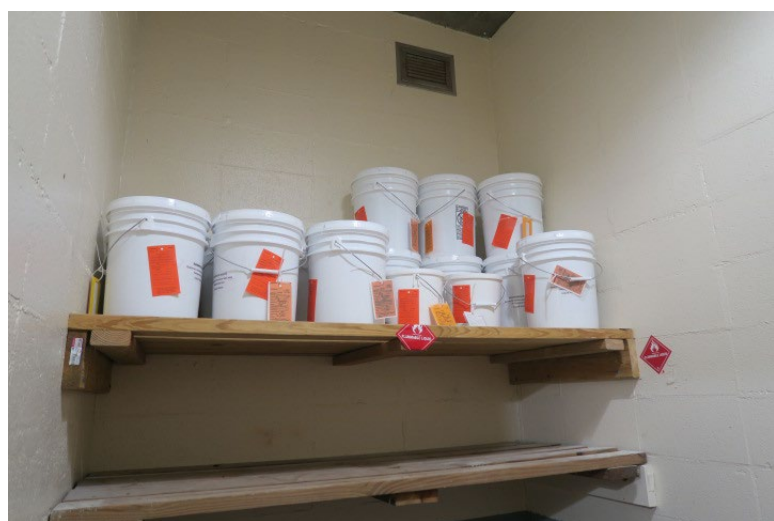
Photo 13: Waste containers on the wooden shelves in the TSD Building, shelf labeled with flammable hazard indicator.

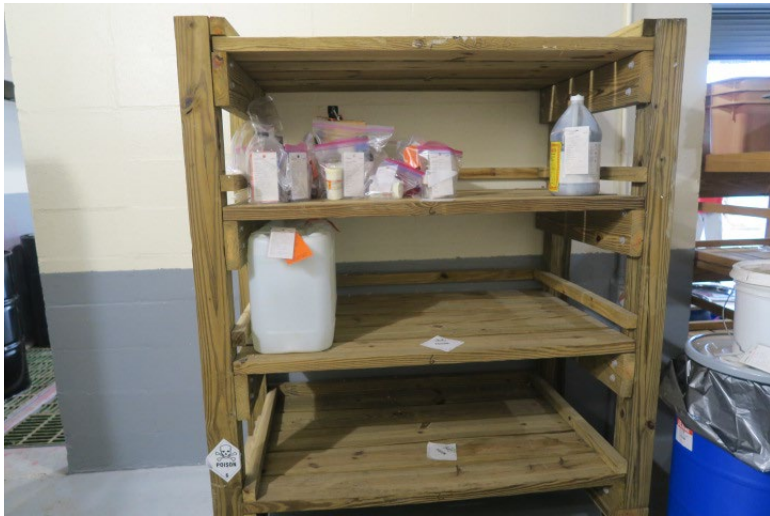
Photo 14: Waste containers on the wooden shelves in the TSD Building, shelf labeled with poison hazard indicator, for toxic solids or liquids.

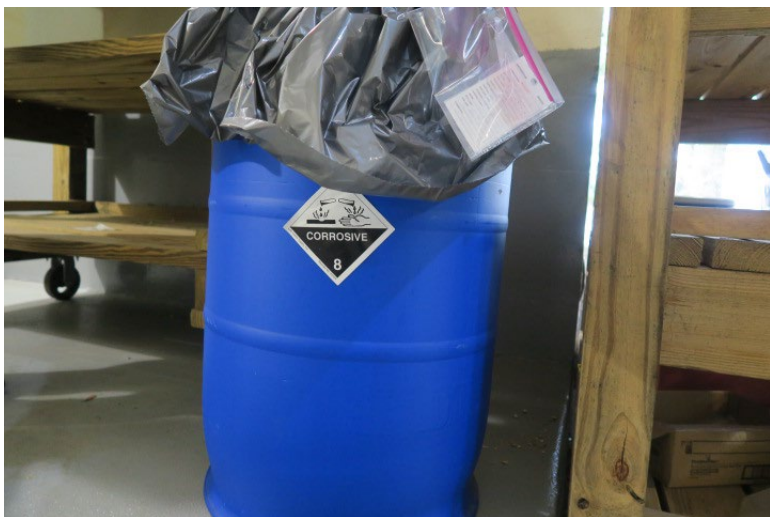
Photo 15: One 30-gallon hazardous waste drum labeled with the words "hazardous waste," corrosive hazard indicator, waste codes, and accumulation start date. Located next to the wooden shelf for toxic waste (reference Photo 14).

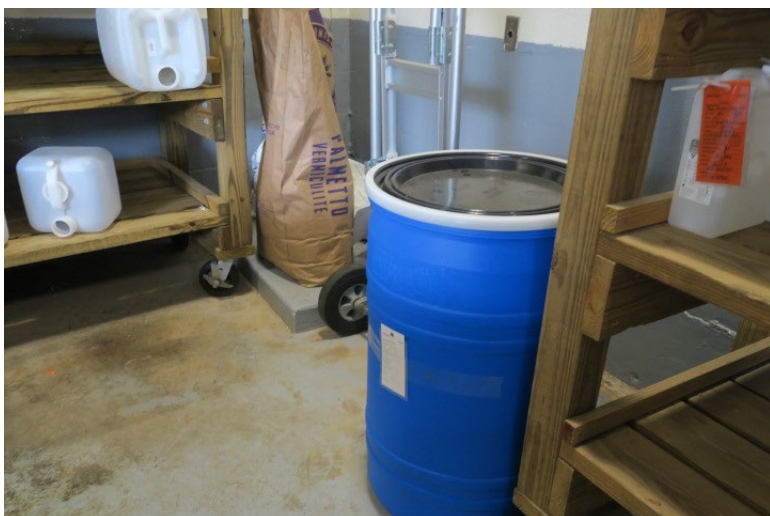
Next to shelving unit two, the inspectors observed one 30-gallon drum containing lead vests that was labeled with waste code D008, an accumulation start date, and a hazardous waste label. The container was not marked with an indication of the hazards of the contents (Photo 16). A Toxic indicator label was added at the time of the inspection.

Photo 16: one 30-gallon drum containing lead vests, that was labeled with waste code D008, an accumulation start date, and a hazardous waste label. The container did not have an indication of hazard label. Located next to the wooden shelf for toxic waste (reference photo 10).

**Pursuant to Hazardous Waste Permit No. ALD079474037, Permit Condition Part II.L.1 of the, the Permittee shall maintain compliance with the requirements of 40 CFR 268 as adopted in ADEM Admin. Code r. 335- 14- 9. Specifically, 40 CFR 268.50(a)(2)(i)(C) as adopted in ADEM Admin. Code r. 335- 14- 9, requires each container of hazardous waste restricted from land disposal to be clearly marked to identify its contents and with an indication of the hazards of the contents (examples include, but are not limited to, the applicable hazardous waste characteristic(s) (i.e., ignitable, corrosive, reactive, toxic); hazard communication consistent with the Department of Transportation requirements at 49 CFR part 172 subpart E (labeling) or subpart F (placarding); a hazard statement or pictogram consistent with the Occupational Safety and Health Administration Hazard Communication Standard at 29 CFR 1910.1200; or a chemical hazard label consistent with the National Fire Protection Association code 704).**

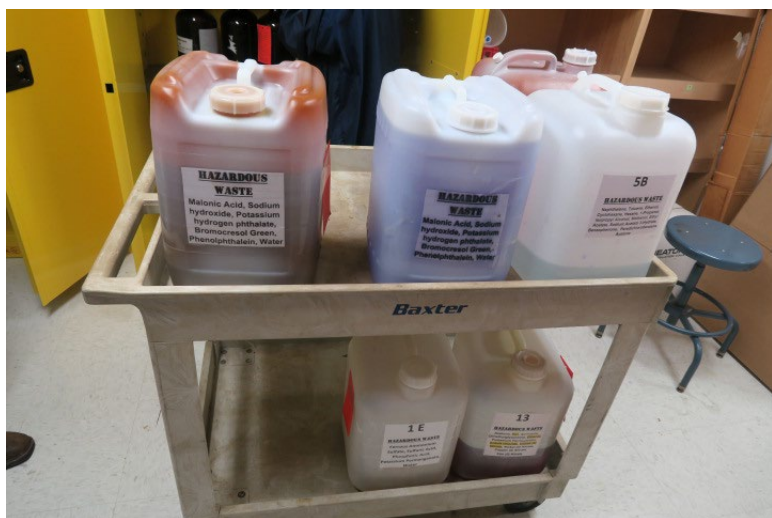
The inspectors observed the Chemistry Stockroom which contained a mobile cart containing 6 carboys containing hazardous waste such as Malonic Acid, Sodium hydroxide, and Bromocresol Green Phenolphthalein (Photo 17). There were two flammable cabinets with hazardous waste: 101 Waste Cabinet held two ~2L bottles and one small plastic container (Photo 18), 131/132

Photo 17: Mobile cart holding six 5-gallon carboy containers of hazardous waste in the Chemical Stockroom SAA located in the Science Laboratory Building.

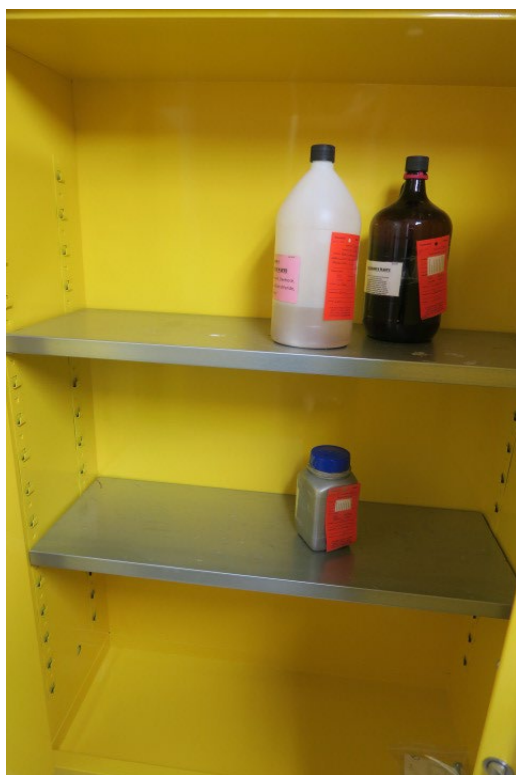
Photo 18: Three containers of hazardous waste in the flammable waste cabinet (labeled 101) in the Chemical Stockroom SAA located in the Science Laboratory Building.

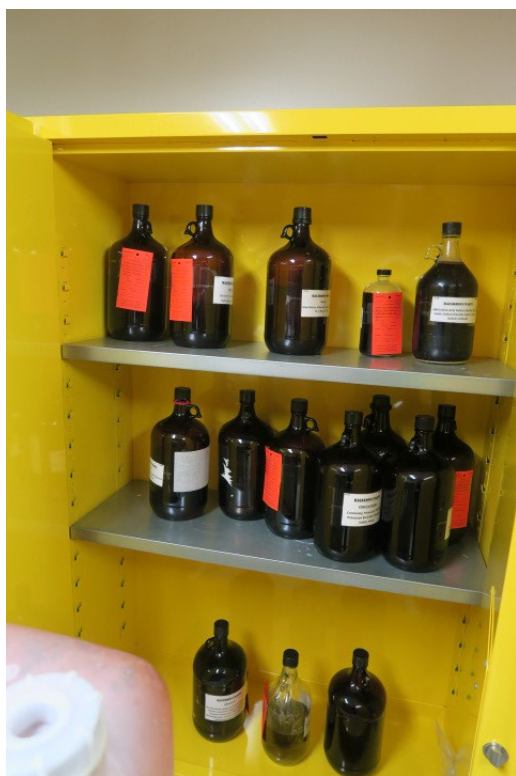
Waste Cabinet held thirteen ~ 2L glass bottles and two small glass bottles (Photo 19) for a total of 18 hazardous waste containers between both cabinets. Each container in the stockroom was closed, labeled with the words “hazardous waste,” and marked with an indication of the hazards of its contents. The inspectors also reviewed the inventory log for the current academic semester (Start: August 16, 2024 & End: December 12, 2024). According to the inspectors’ observations and the inventory log, the Science Laboratory Building was storing approximately 30-gallons of hazardous waste that was accumulated over the course of this semester.

Photo 19: 15 containers of hazardous waste in the flammable waste cabinet (labeled 131/132) in the Chemical Stockroom SAA located in the Science Laboratory Building.

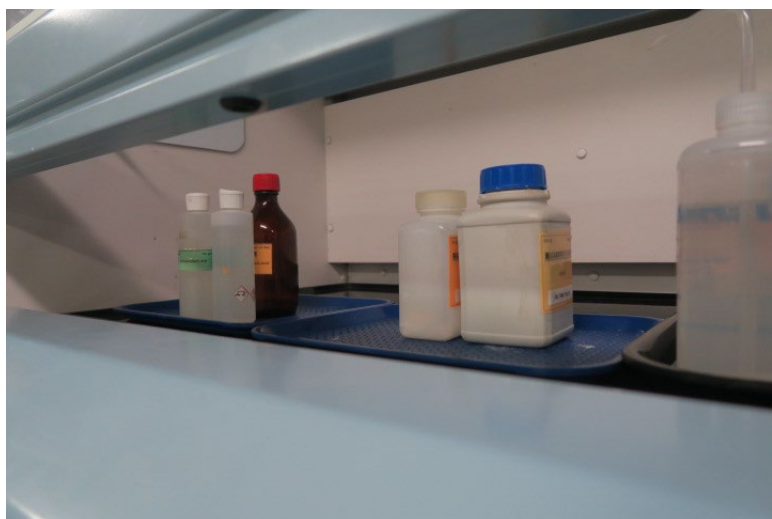
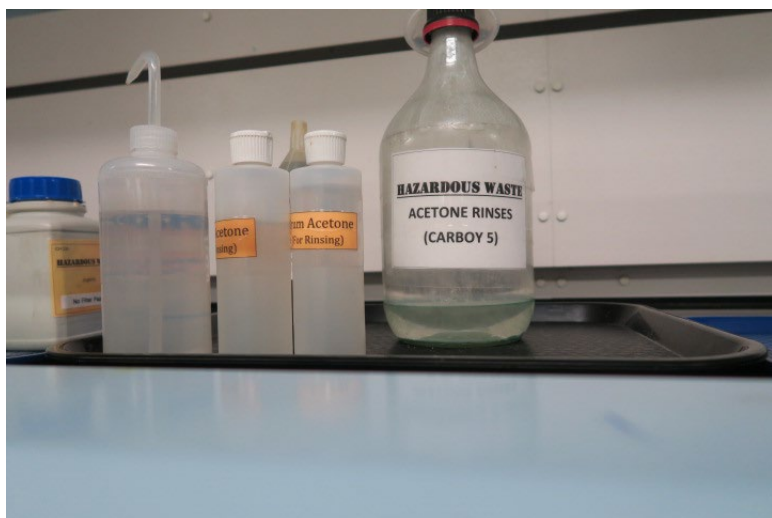
The inspectors also observed a teaching laboratory where hazardous waste is generated in the lab and then stored in fume hoods until transfer to the Chemistry Stockroom, typically once the container is full. The University considers the hazardous waste in fume hoods part of the Chemistry Stockroom Satellite Accumulation Area. The inspectors observed nine small hazardous waste containers (~ 1L or less, both glass and plastic containers) in the fume hoods containing hazardous waste such as Sodium Bicarbonate, Hydrochloric Acid, and Acetone. All nine containers were labeled with the words “Hazardous Waste” however none of the waste containers were marked with an indication of the hazard of its contents (Photo 20 and 21).

Photo 20: Hazardous waste containers in the fume hood of a chemistry lab in the Science laboratory building SAA. Containers were labeled with the words hazardous waste but did not contain indications of hazard.

Photo 21: Hazardous waste containers in the fume hood of a chemistry lab in the Science laboratory building SAA. Containers were labeled with the words hazardous waste but did not contain indications of hazard.

**Pursuant to ADEM Admin. Code r. 335-14-3-.01(5)(ii) [40 C.F.R. § 262.15(a)(5)(ii)], which is a condition of the SAA Permit Exemption, a generator is required to mark or label its containers with an indication of the hazards of the contents.**

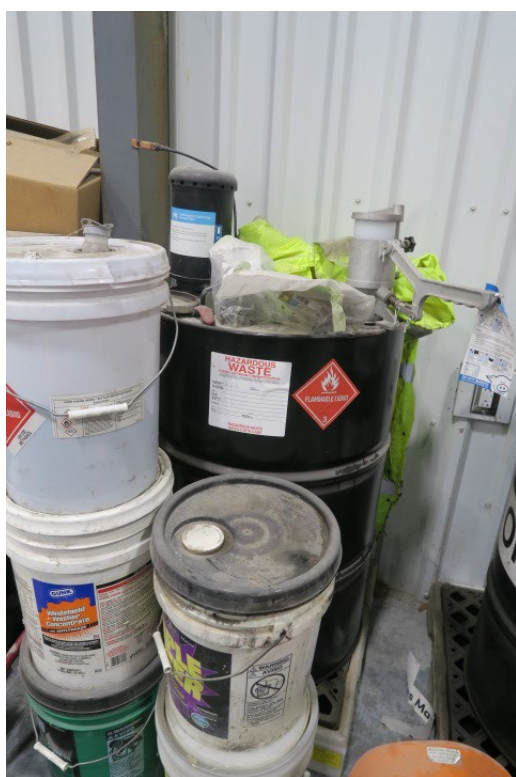
Photo 22: One 55-gallon drum containing hazardous waste (paint waste), with an indication of hazard (flammable), the words "hazardous waste," and an accumulation start date. Located in the Grounds/Transportation Maintenance Area SAA.

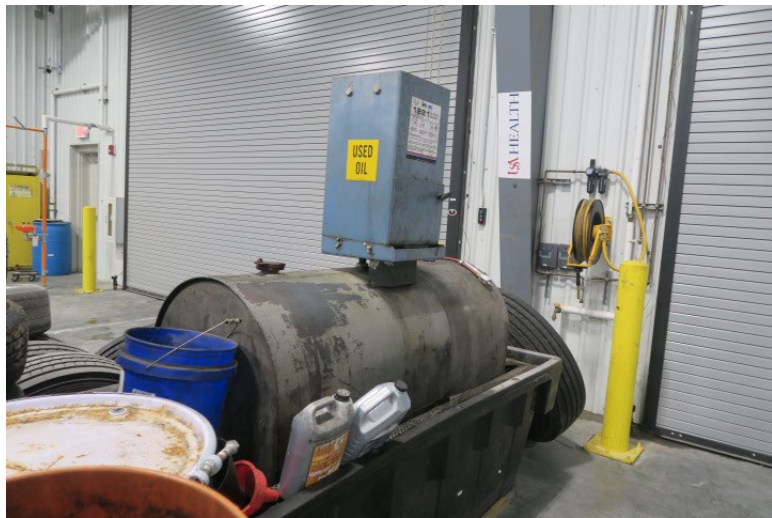
Photo 23: 200-gallon tank in the Grounds/Transportation building labeled "used oil". Located in the Grounds/Transportation Maintenance Area.

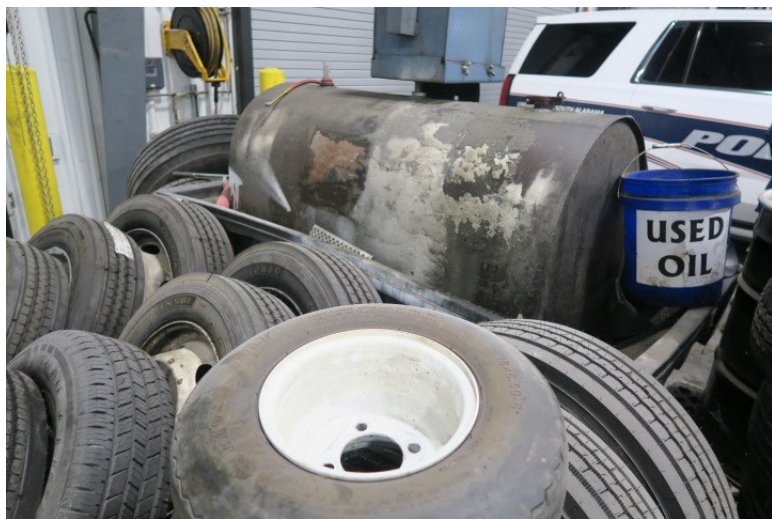
Photo 24: one 5-gallon bucket of used oil contaminated materials labeled "used oil", in the Grounds/Transportation Maintenance Area.

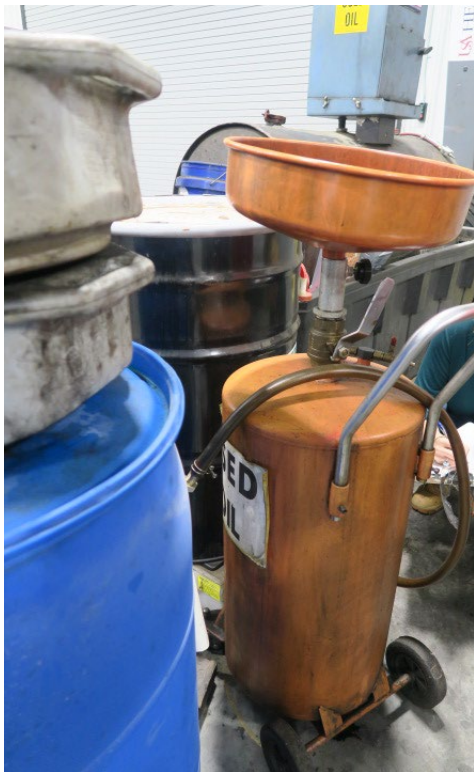
Photo 25: Container used to transfer used oil with funnel attached (valve in the open position), labeled used oil. Located in the Grounds/Transportation Maintenance Area.

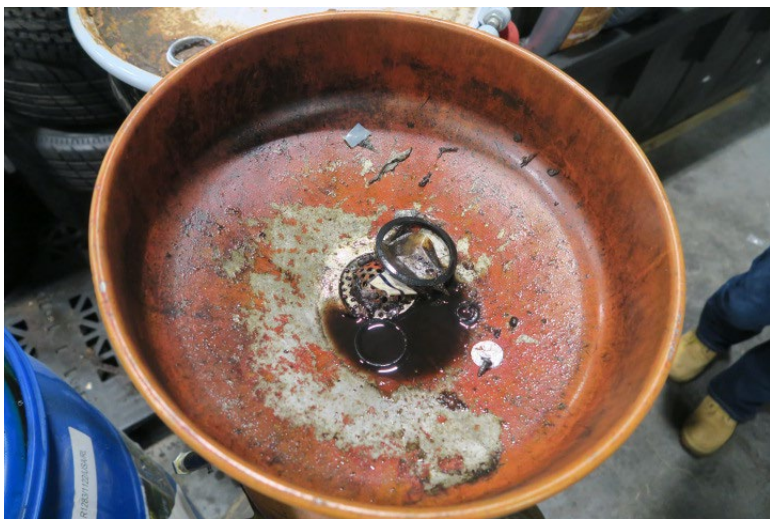
Photo 26: Oil residue in the funnel of the container used to transfer used oil. Located in the Grounds/Transportation Maintenance Area.

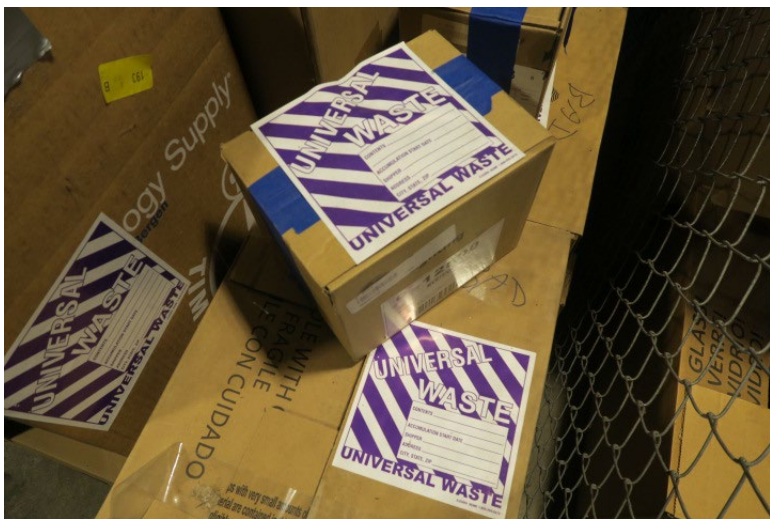
Photo 28: Three cardboard containers with blank universal waste labels on the pallet in front of the caged universal waste area in the Maintenance Division.

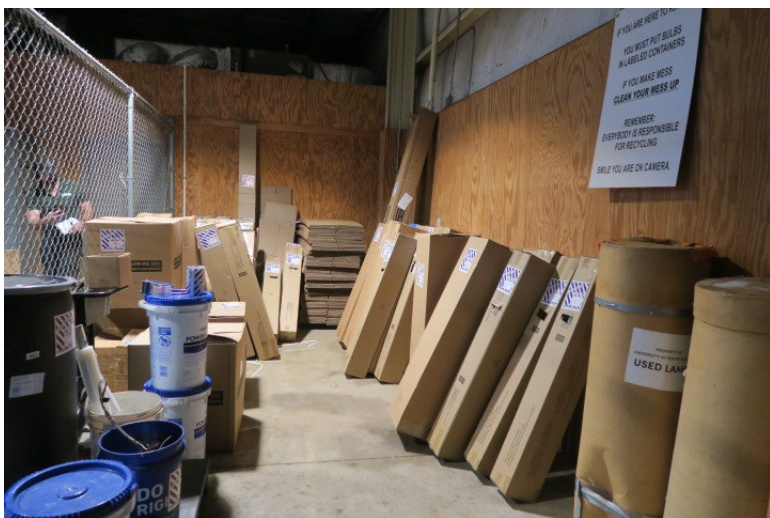
Photo 29: Approximately 75 containers of universal waste lamps and batteries in the caged universal waste area in the Maintenance Division.

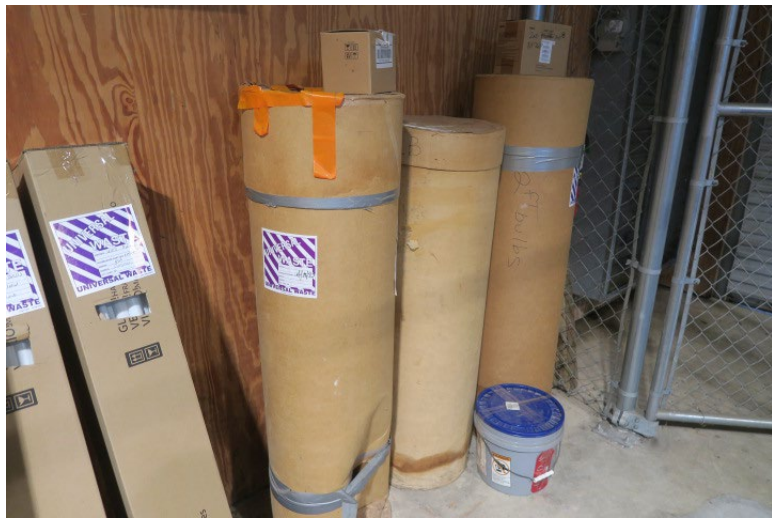
Photo 30: 2-foot cardboard cylinder wrapped in orange and silver duct tape containing universal waste lamps that was marked with a universal waste label and accumulation start date but was damaged and not structurally sound. Located in the caged universal waste area of the Maintenance Division.

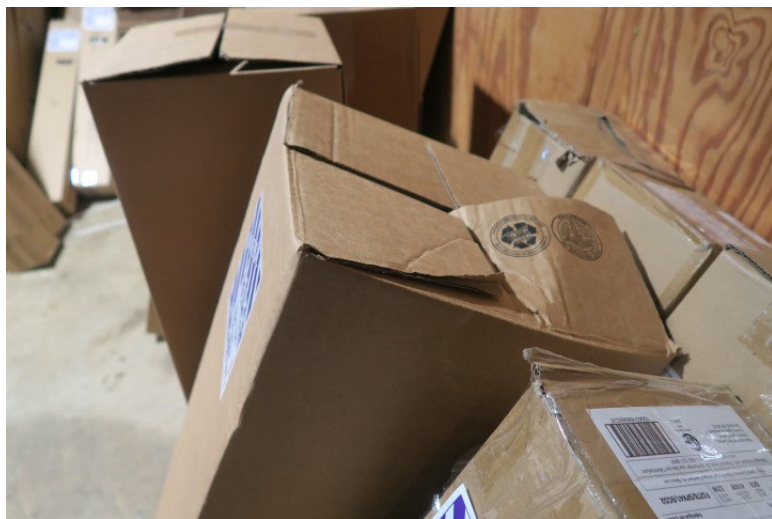
Photo 31: One open 4-foot container of waste lamps in the caged universal waste area of the Maintenance Division. \*The flaps were closed by facility personnel during the inspection as pictured here, but not secured with tape. Reference Photo 27 shows this container open before the flaps were closed (see 4<sup>th</sup> box from the right along the back wall).

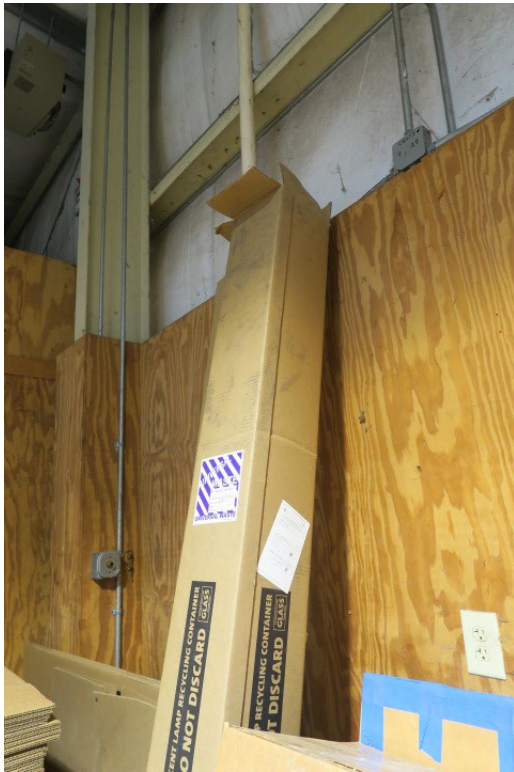
Photo 32: One open 8-foot container of waste lamps in the caged universal waste area of the Maintenance Division.

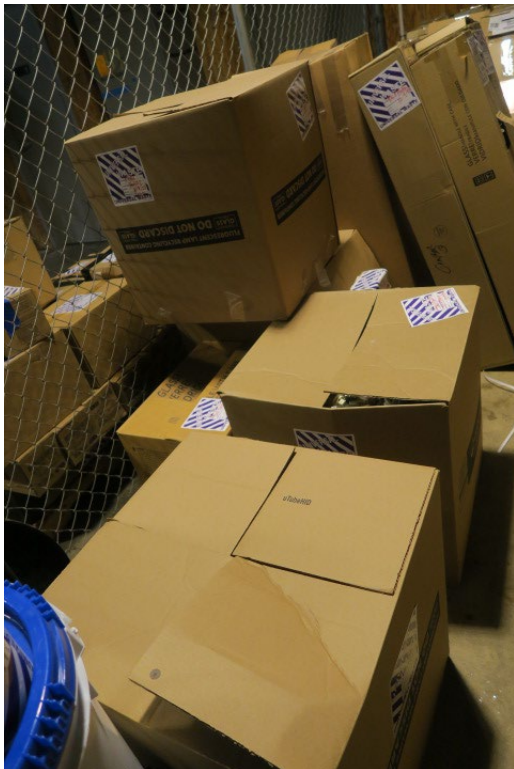
Photo 33: Three open cardboard boxes of waste lamps, flaps were folded together by facility personnel but are not secured with tape. Located in the in the caged universal waste area of the Maintenance Division.

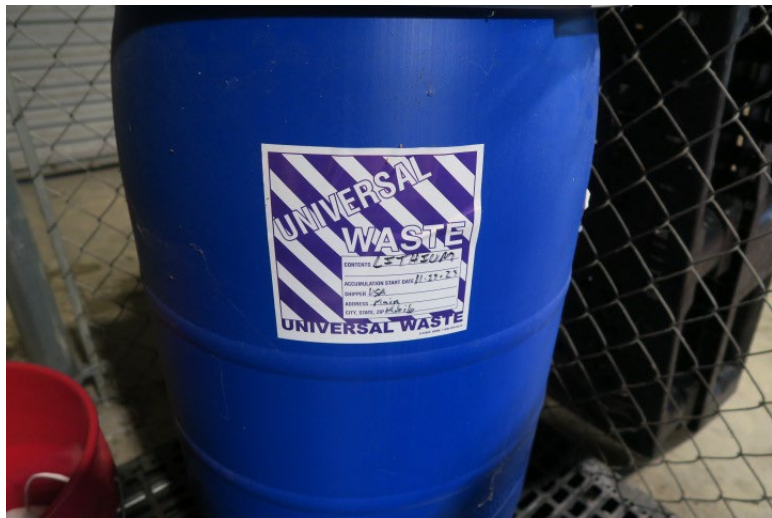
Photo 34: one 30-gallon drum of universal waste lithium batteries with an accumulation start date of 11/27/23, located in the caged universal waste area of the Maintenance Division.

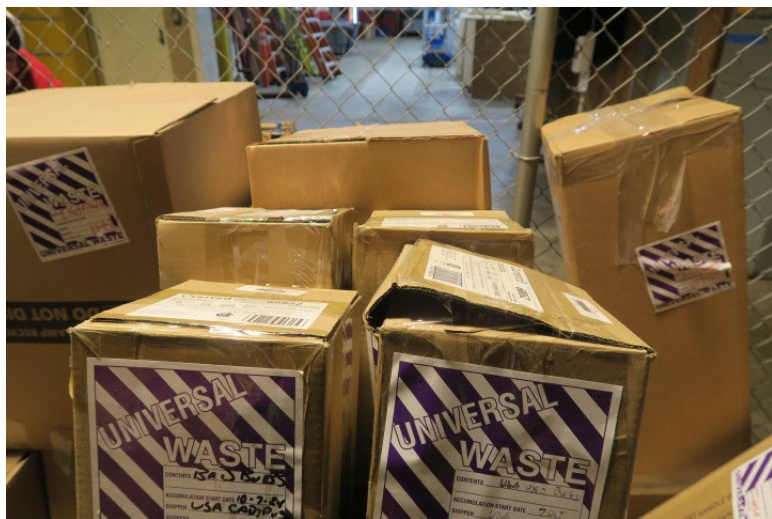
Photo 35: Container of universal waste identifying contents with the phrase "bad bulbs" and "used bulbs", located in the caged universal waste area of the Maintenance Division.
