**SUBJECT:** CLEAN AIR ACT INSPECTION REPORT  
Earthmovers Landfill, LLC, Elkhart, Indiana

**Date of Inspection:** July 19, 2021

**Facility Type:** Municipal solid waste landfill

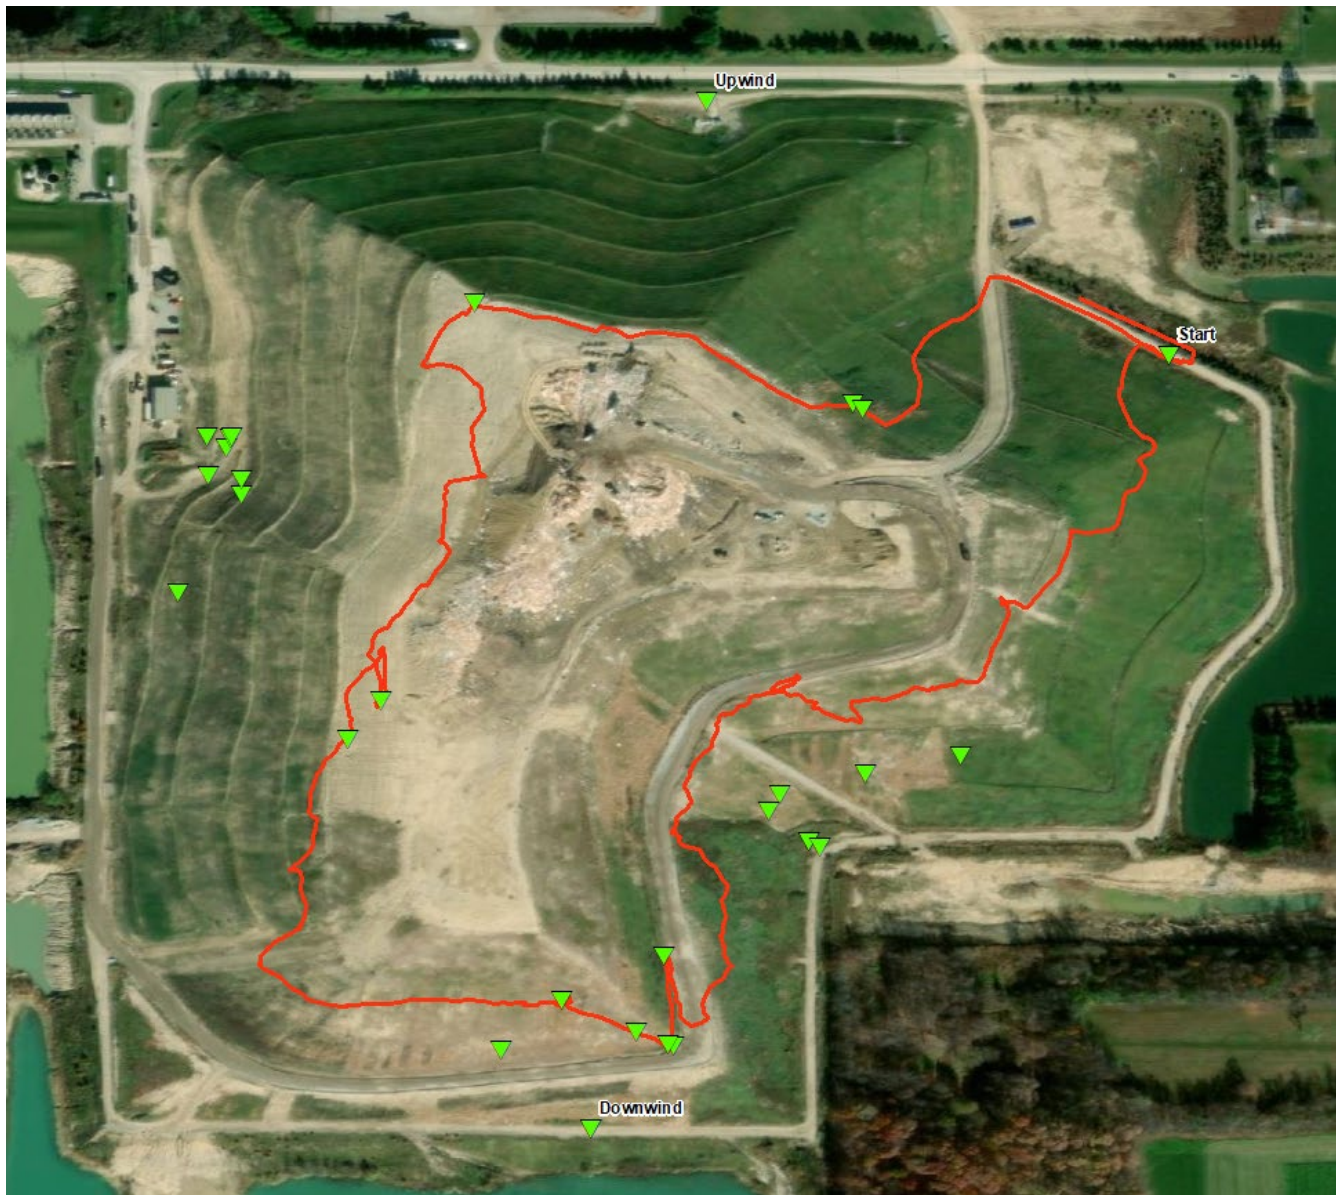
### Map of GPS Path, Exceedances, and Follow-up Points

Inspectors found and verified 20 locations on the surface of the landfill that exceeded 500 ppm methane. Approximately half of these exceedances were in areas with final cover or pending closure certification, and less than half of these exceedances were at wells.

The red path was taken by Emma Leeds. Karina Kuc's path ran in a similar loop but further downslope and closer to the perimeter of the landfill. Unlabeled green arrows indicate locations with TVA readings that exceeded 500 ppm methane, and six additional follow-up points.

Inspectors noted the above 6 locations to likely be leaking significant amounts of methane. Via email after the inspection, Earthmovers personnel confirmed that they would re-monitor at these follow-up points and correct any exceedances found as needed.
