**Region 6 - Enforcement & Compliance Assurance Division**  
**INSPECTION REPORT**

| Regulatory Program(s) | NPDES Stormwater/ CWA 402 | |
| Company Name: | <b>Riverside Homebuilders, Ltd. (RHLTD)</b> | |
| Facility Name: | <b>Lakeview Heights</b> | |

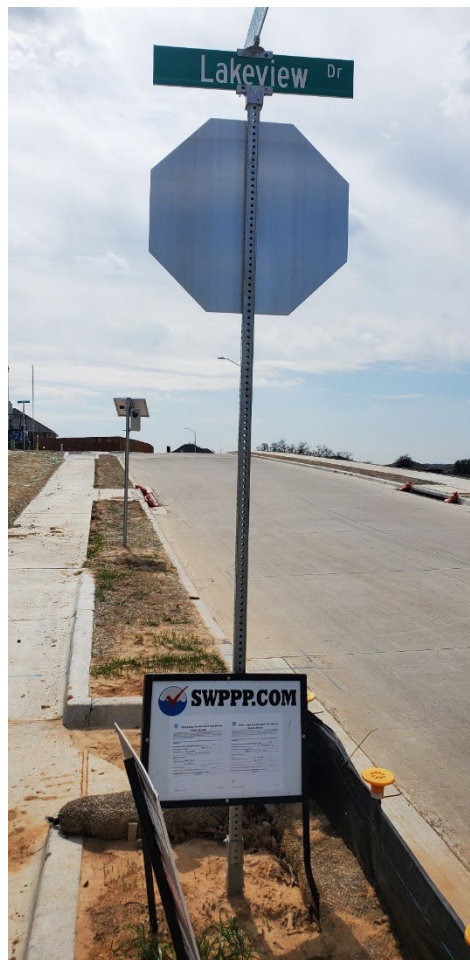
Photo no. 1

- We observed the Large Construction Site Notice (CSN) (TXR1557OE) posted at the intersection of Lakeview Drive and Gateway Street. The CSN was issued by the Texas Commission on Environmental Quality (TCEQ) with an effective date of September 15, 2023, for coverage under the Construction General Permit (CGP), with a subsequent expiration date of September 15, 2026 (**Appendix 1, Photos 1-2**).

Description: Large Construction Site Notice (CSN) posted at the intersection of Lakeview Drive and Gateway Street.

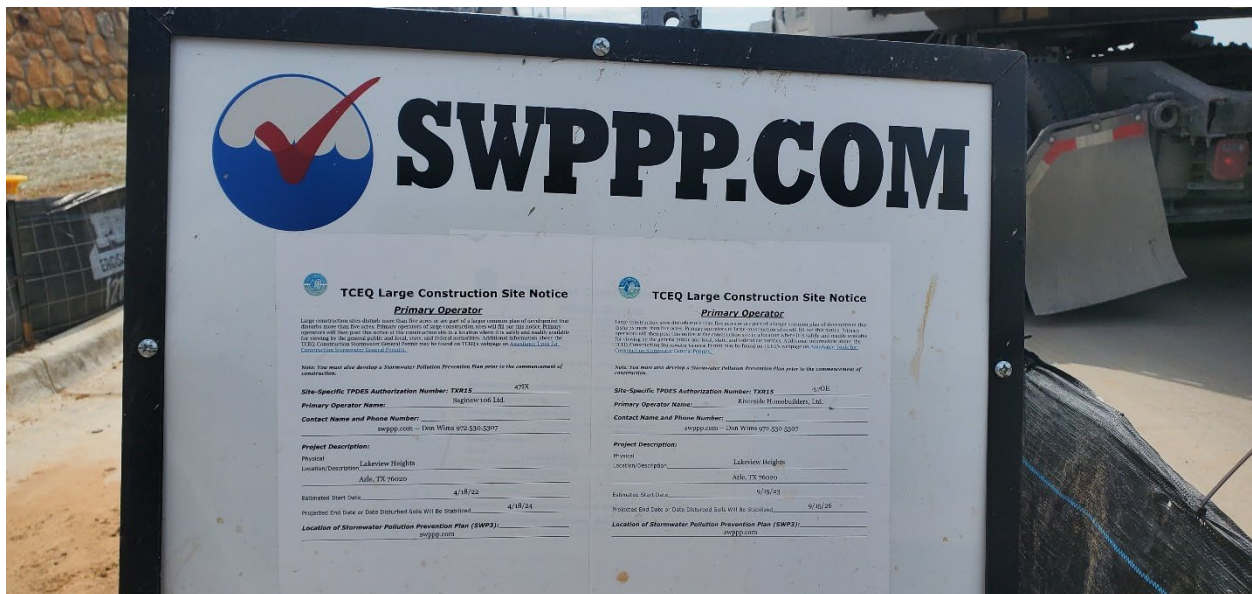
Photo no. 2

Description: Up close photo of the Construction Site Notice (CSN) posted at the intersection of Lakeview Drive and Gateway Street.

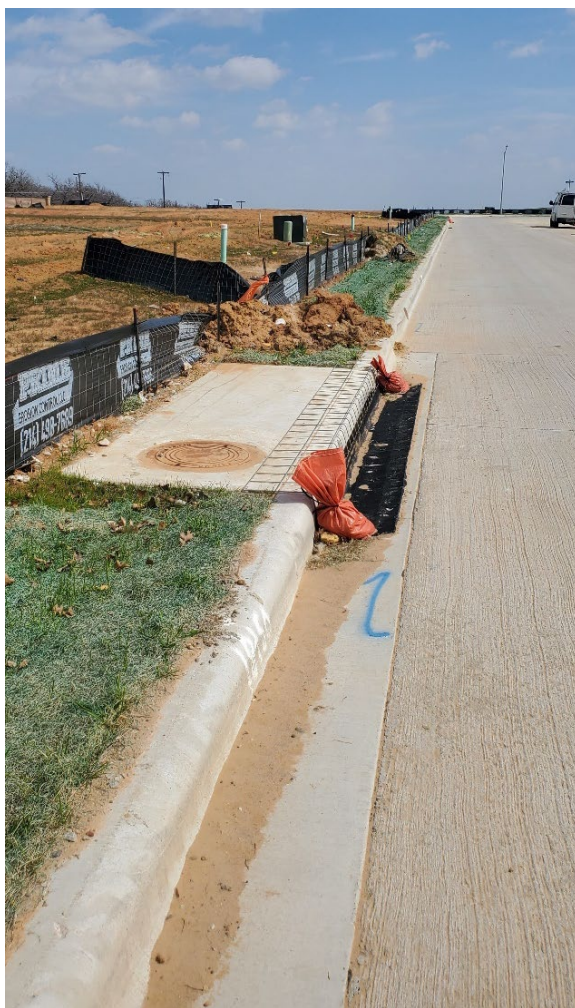
Photo no. 3

- We observed stockpiles (i.e. sand and dirt stockpiles) not properly contained by BMPs (**Appendix 1, Photo 3**).

Description: Uncontained stockpiles and sediment along the curb on Cedar Trail.

Description: Photo demonstrating that the uncontained stockpiles observed on 3/4/2024 have been removed and lots are stabilized. The text on the photo was added by a Lakeview Heights representative.

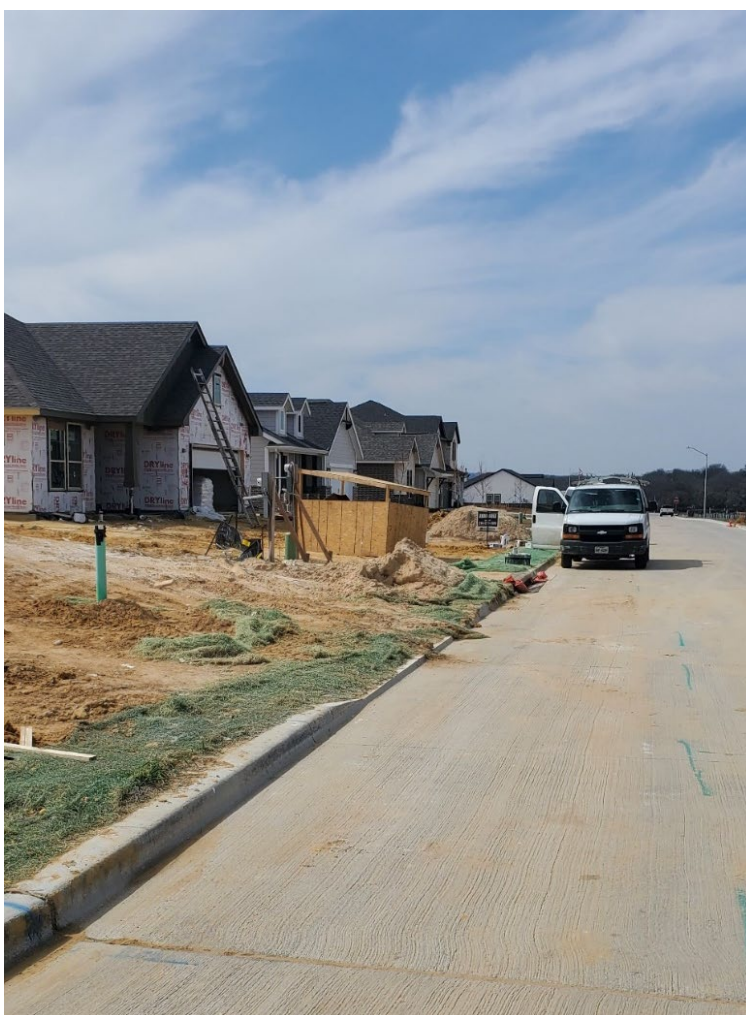
Photo no. 4

- We observed sections of worn erosion control blankets along the front of some residential lots, causing exposed sediment along the curbs (**Appendix 1, Photo 4**).

Description: Damaged erosion control blanket, leaving exposed sediment and sand piles along the lots on Cedar Trail.

Description: New erosion control blanket was installed along the lot of 1404 Cedar Trail. The text on the photo was added by a Lakeview Heights representative.

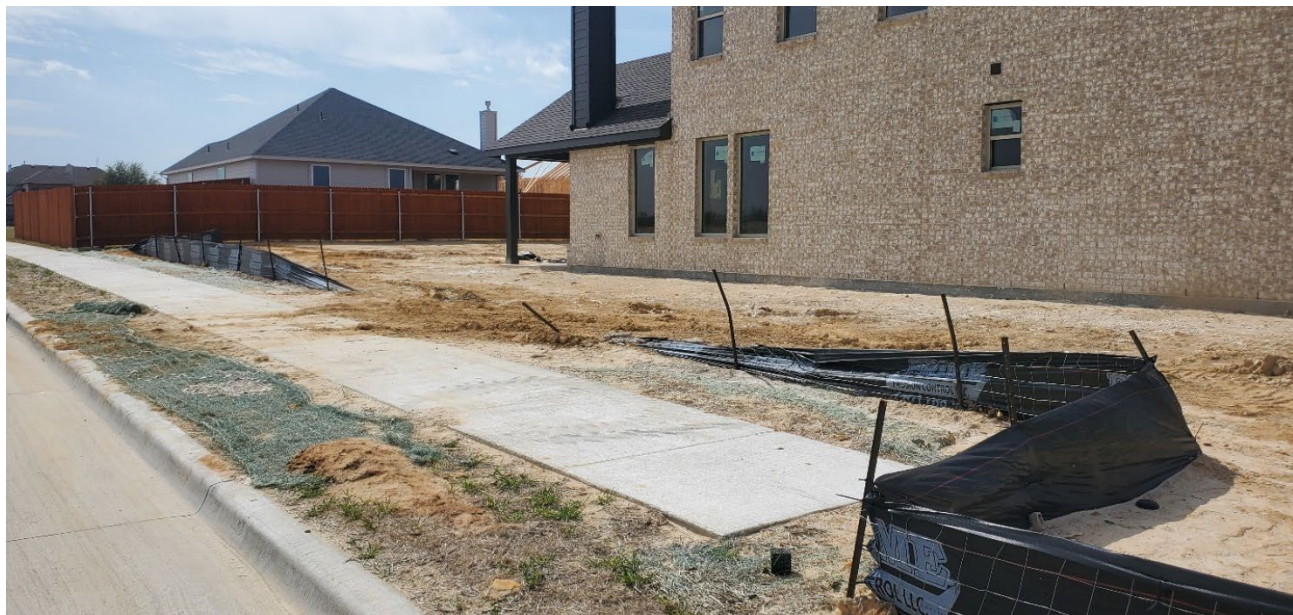
Photo no. 5

- We observed a portion of the silt fence and erosion control blanket near the intersection of Bristol Lane and Cedar Trail that appears to have been driven over (**Appendix 1, Photo 5**).

Description: Damaged silt fence and erosion control blanket near the intersection of Bristol Lane and Cedar Trail.

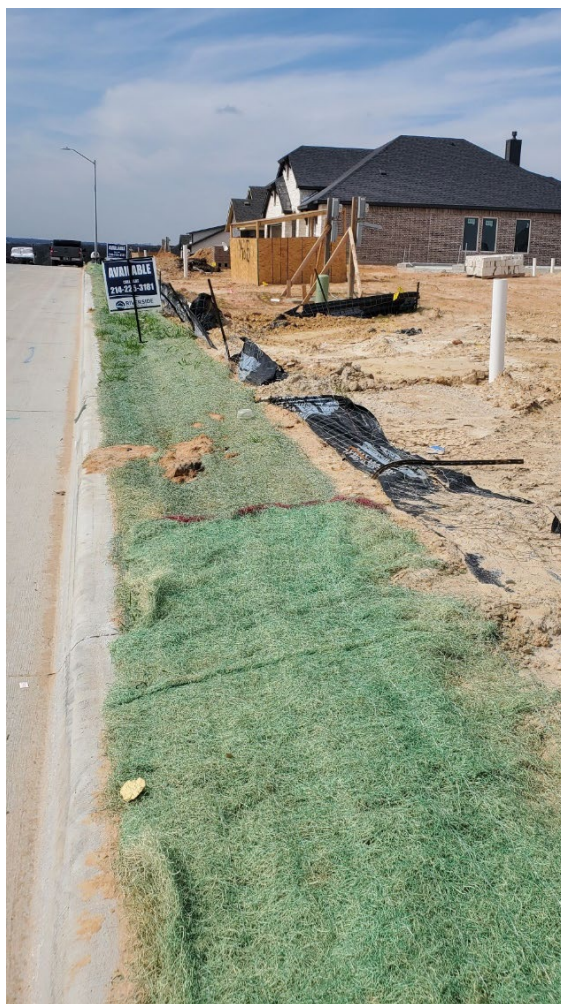
Photo no. 6

- We observed sections of damaged silt fence along the front of some lots that also had other BMPs installed. The silt fence needs to be properly maintained, or removed, along lots that have other effective BMPs present (**Appendix 1, Photo 6**).
- We observed sections of worn erosion control blankets along the residential lots (**Appendix 1, Photo 7**).
- We observed stockpiles not properly contained by BMPs (**Appendix 1, Photo 8**).
- We observed mortar being washed directly onto the lot between 1417 and 1421 Whitetail Lane (**Appendix 1, Photos 9-11**). Mortar is to be disposed of at the designated washout on-site.

Description: Damaged silt fence along Whitetail Lane.

Description: Silt fence and erosion control blanket installed along 1405 Whitetail Lane. The text on the photo was added by a Lakeview Heights representative.

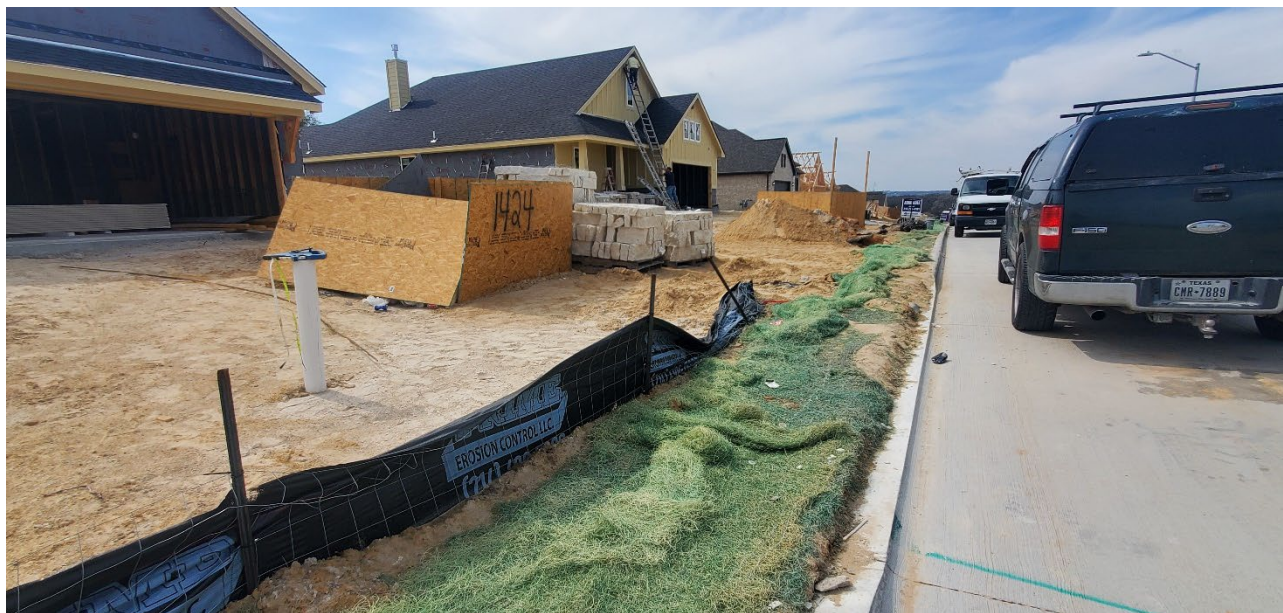
Photo no. 7

Description: Damaged erosion control blankets along the residential lots on Whitetail Lane.

Description: Erosion control blanket and silt fence installed along 1404 Whitetail Lane. The text on the photo was added by a Lakeview Heights representative.

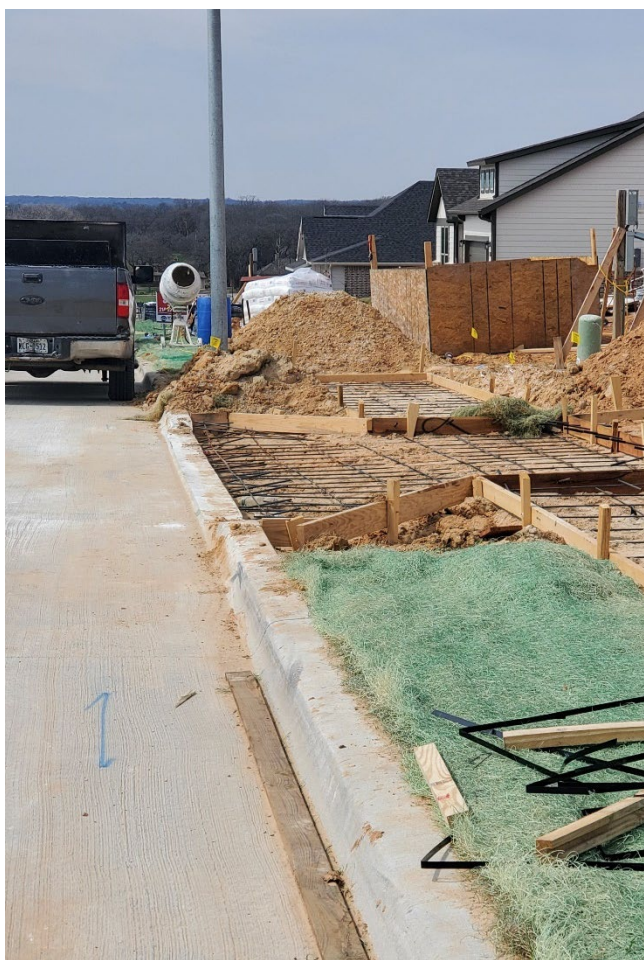
Photo no. 8

Description: Stockpiles not properly contained on Whitetail Lane.

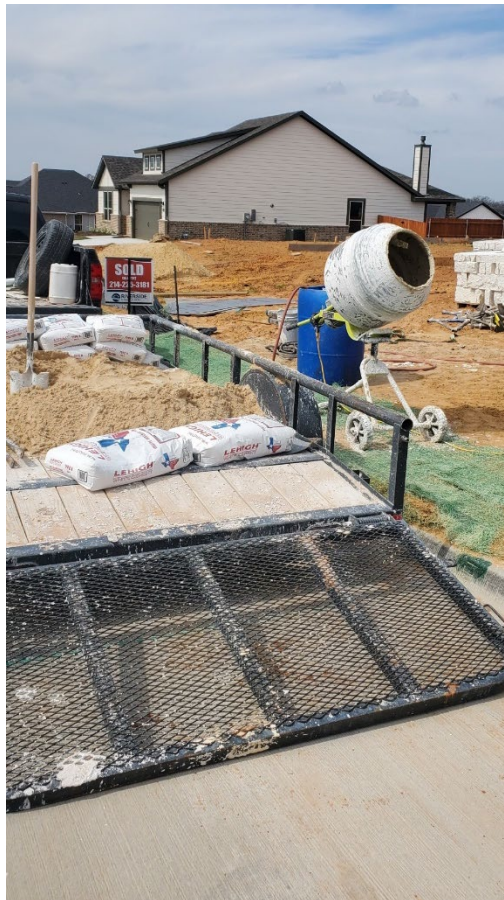
Photo no. 9

Description: Portable concrete mixing machine near the lot curb on Whitetail Lane.

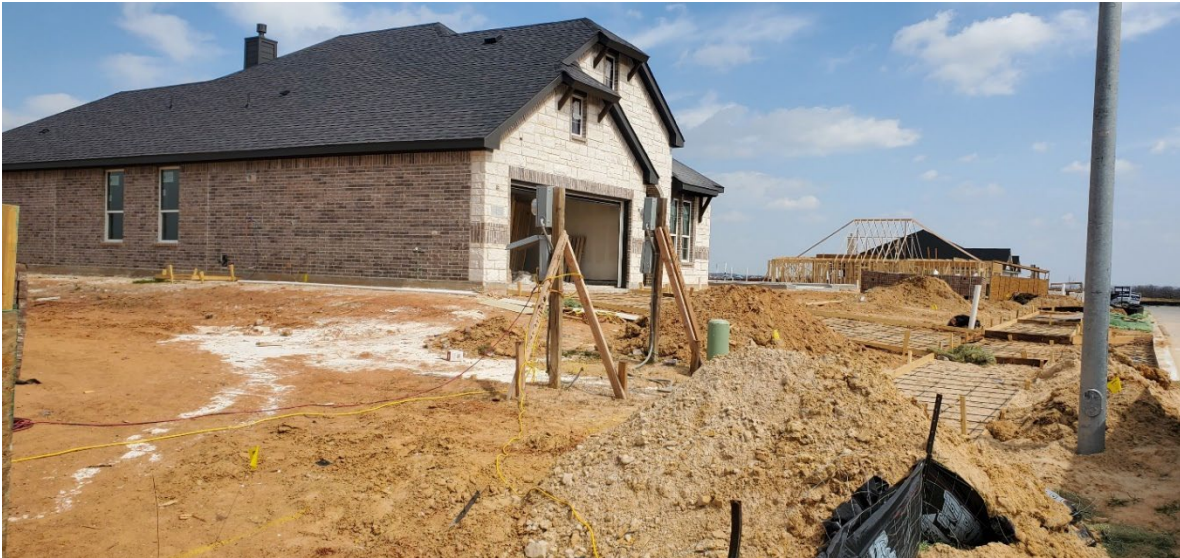
Photo no. 10

Description: Mortar mix washout disposed of directly on the lot between 1417 and 1421 Whitetail Lane.

Description: Photo demonstrating that the mortar mix has been cleaned up between 1417 and 1421 Whitetail Lane.

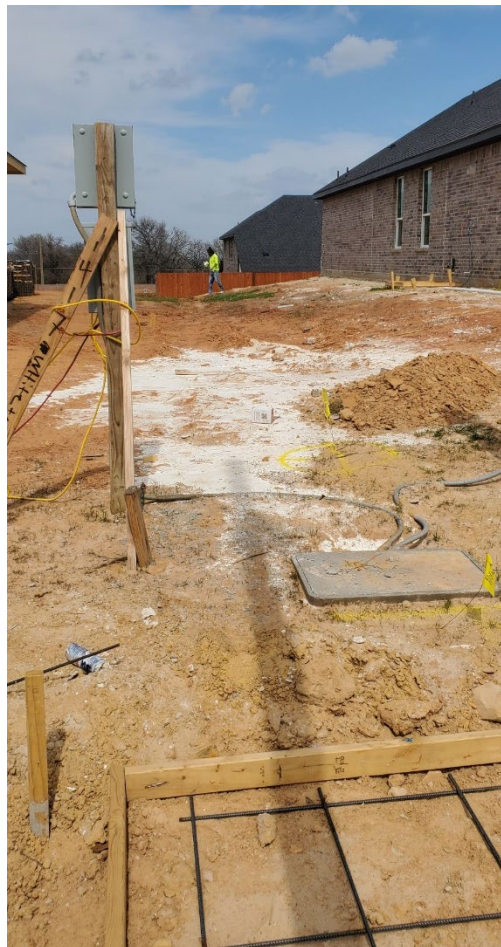
Photo no. 11

Description: Second angle of mortar mix washout being disposed of directly on the lot (between 1417 and 1421 Whitetail Lane).

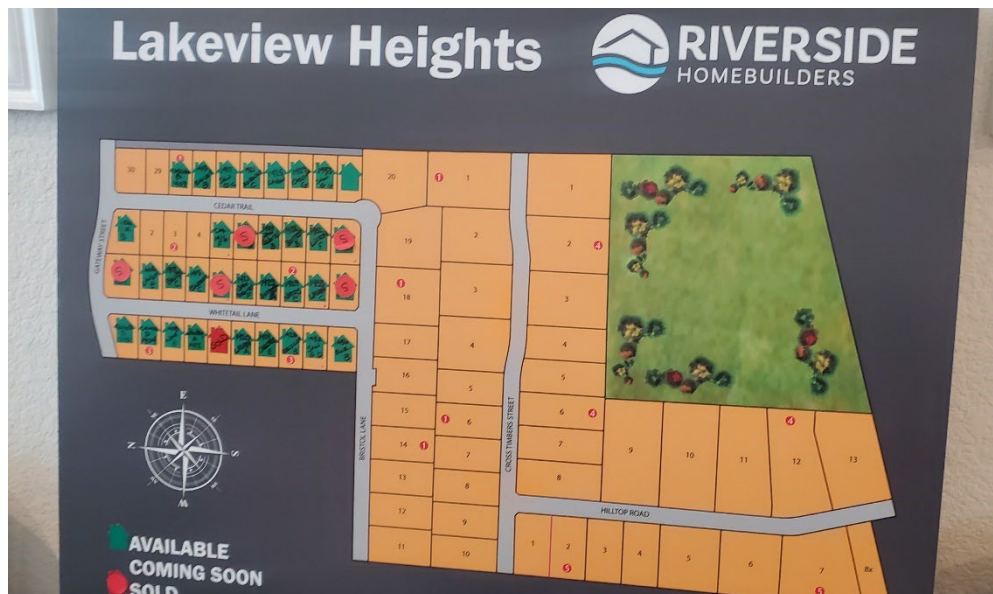
Description: Map of Lakeview Heights. Photo was taken during our meeting with the construction manager, Dylan Cutler, in the model home at the intersection of Gateway Street and Cedar Trail (Lot 1 Block 2).

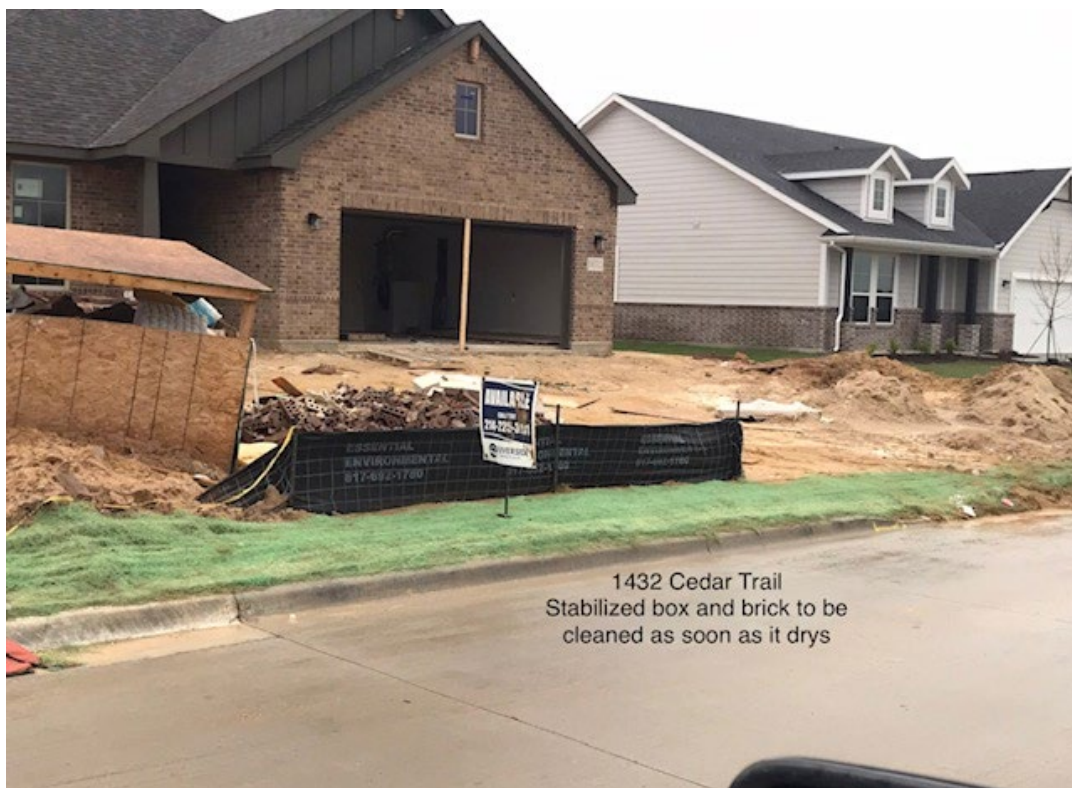
Photo no. 2

Description: Sediment and construction materials are being contained at 1432 Cedar Trail. The text on the photo was added by a Lakeview Heights representative.

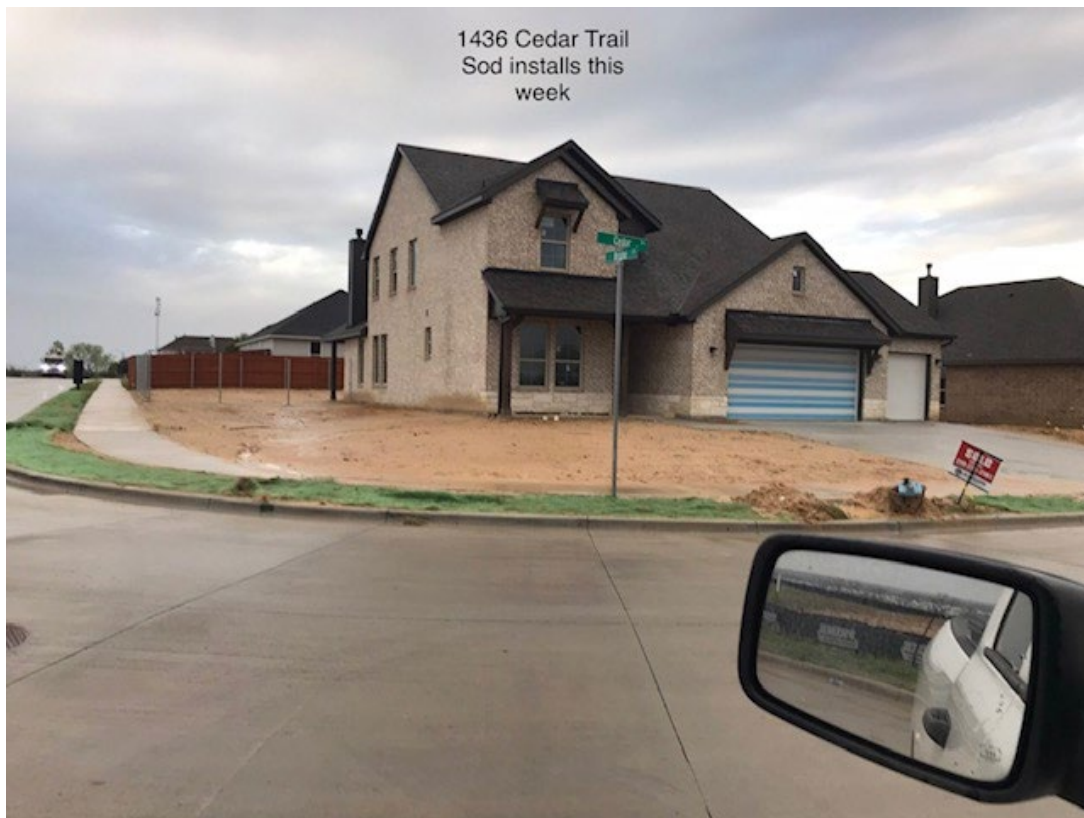
Photo no. 3

Description: Erosion control blankets along the lot of 1436 Cedar Trail. The text on the photo was added by a Lakeview Heights representative.

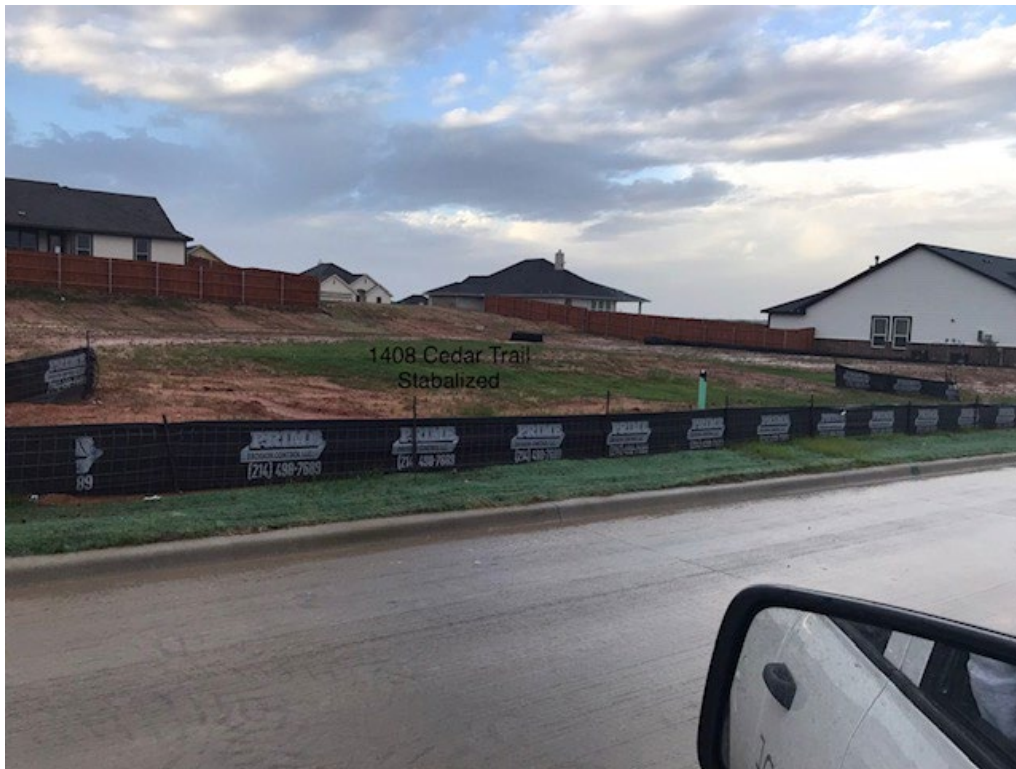
Photo no. 5

Description: New erosion control blanket was installed along the lot of 1408 Cedar Trail. The text on the photo was added by a Lakeview Heights representative.

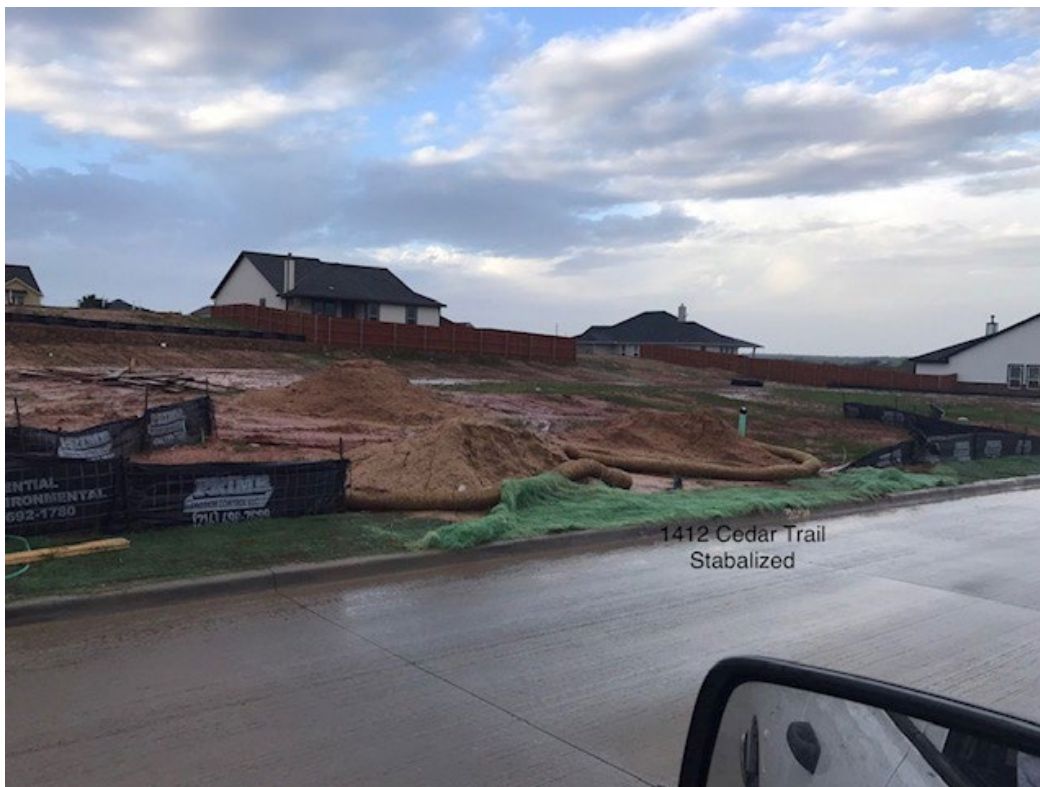
Photo no. 6

Description: Stockpiles contained by straw wattle and erosion control blanket on the lot of 1412 Cedar Trail. The text on the photo was added by a Lakeview Heights representative.

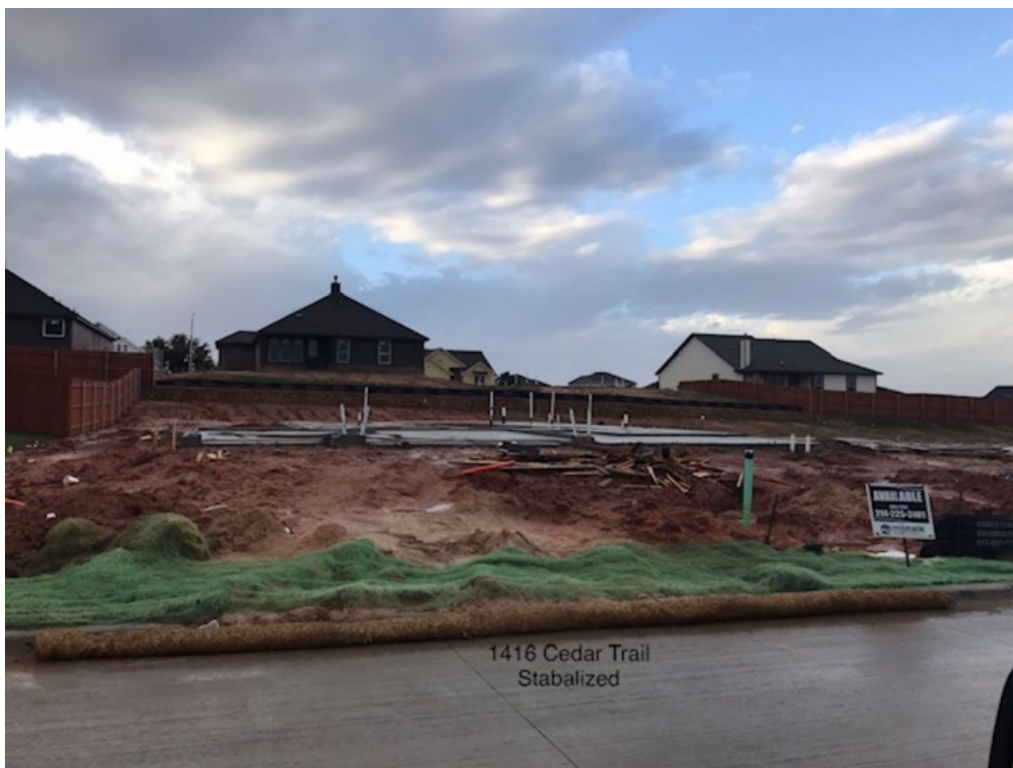
Photo no. 7

Description: Erosion control blanket and straw wattle installed along the lot of 1416 Cedar Trail. The text on the photo was added by a Lakeview Heights representative.

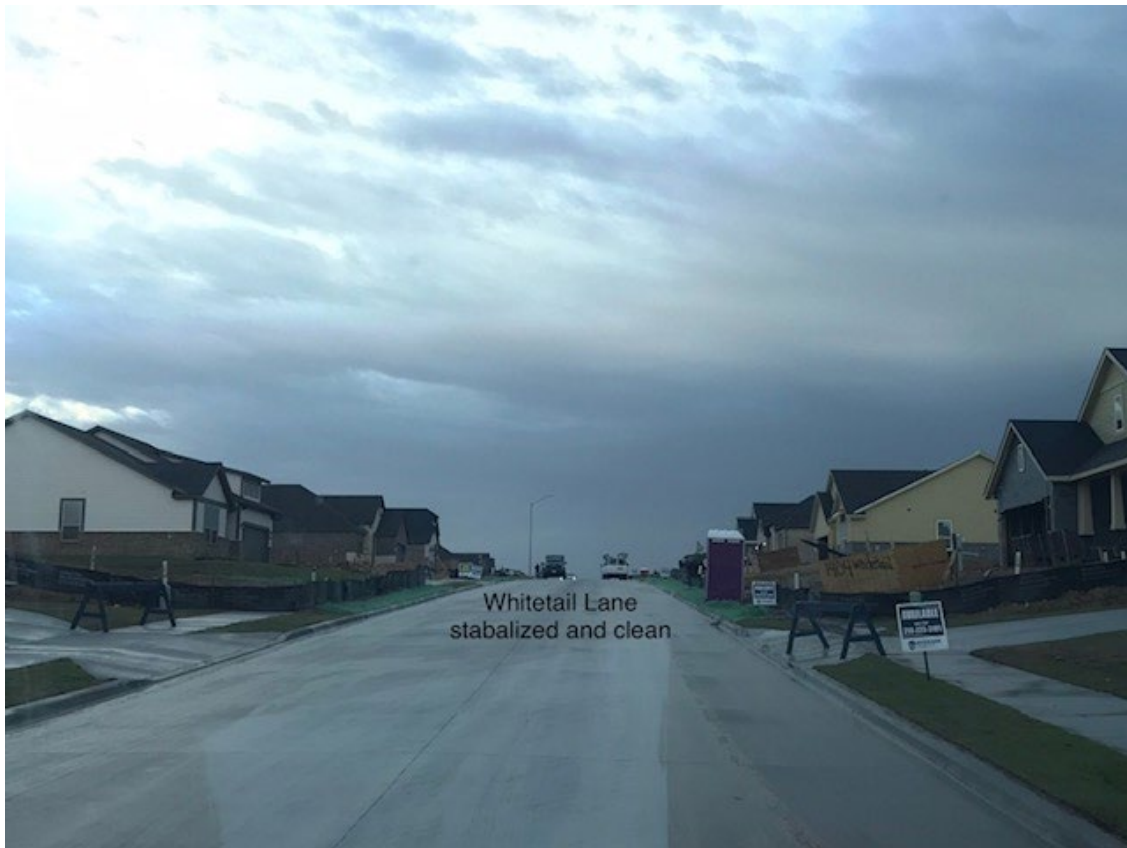
Photo no. 8

Description: Street view of Whitetail Lane, demonstrating that the street has been swept and stabilized.

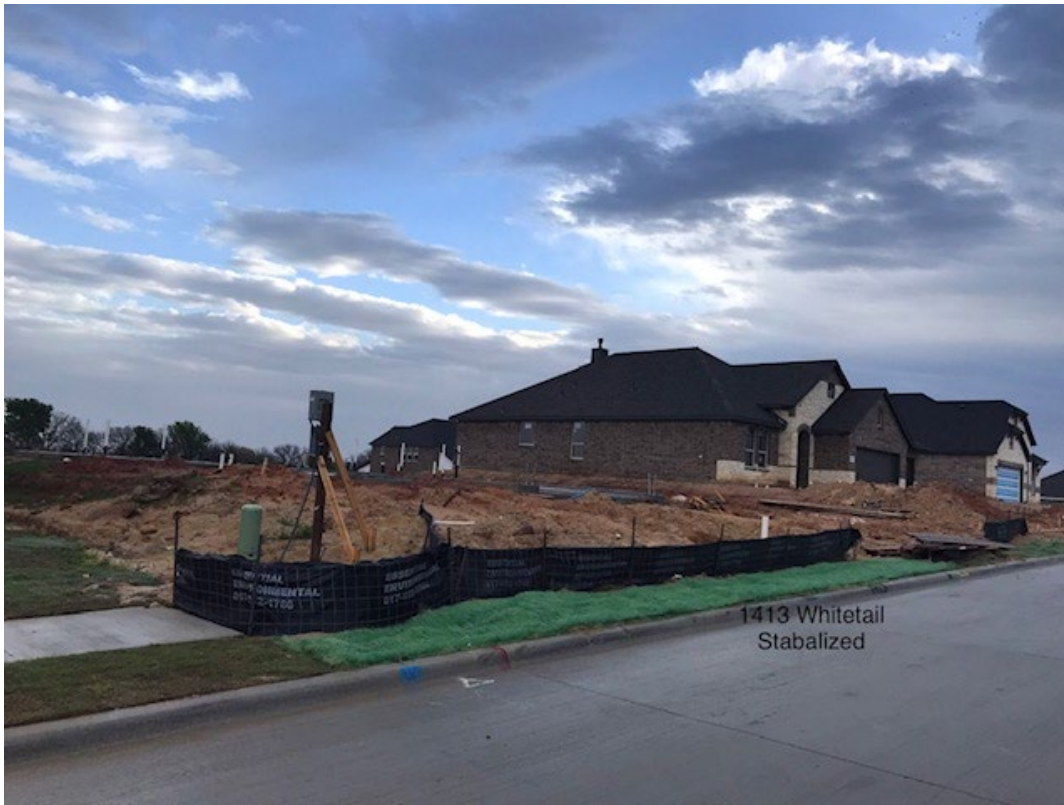
Photo no. 12

Description: Erosion control blanket and silt fence installed along 1413 Whitetail Lane. The text on the photo was added by a Lakeview Heights representative.

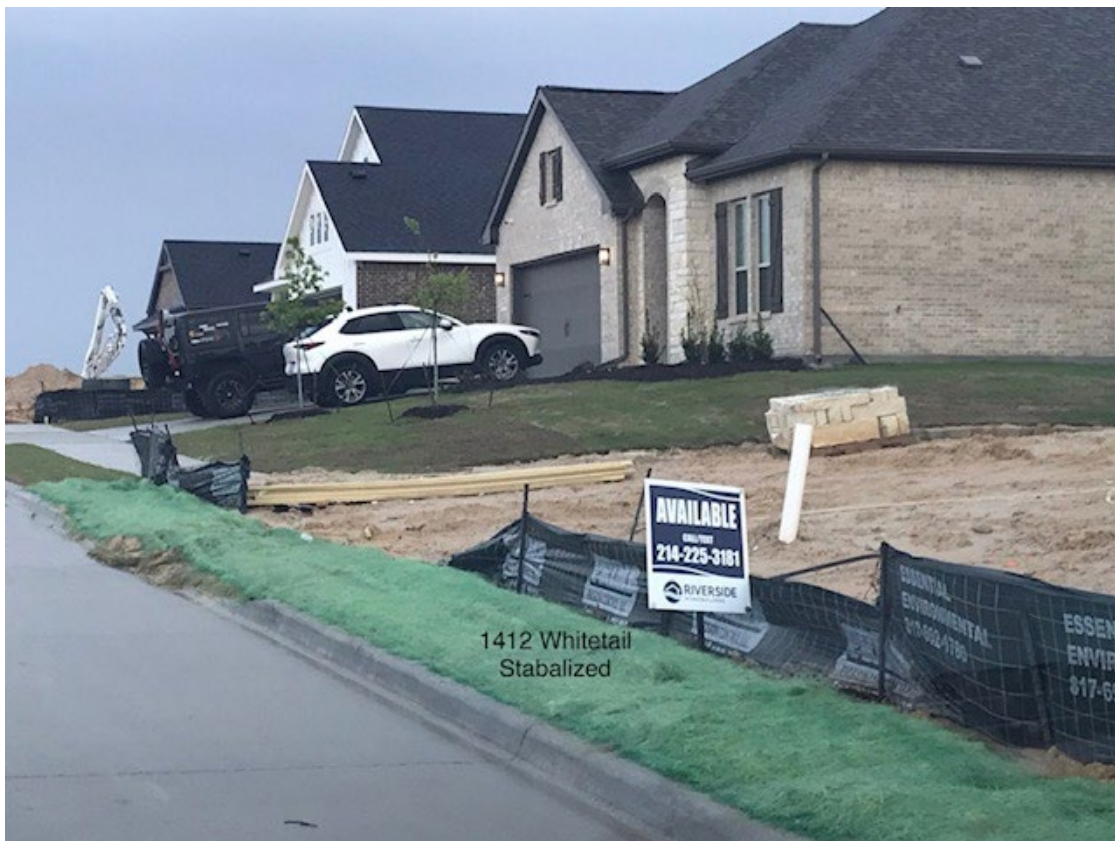
Photo no. 13

Description: Erosion control blanket and silt fence installed along 1412 Whitetail Lane. The text on the photo was added by a Lakeview Heights representative.

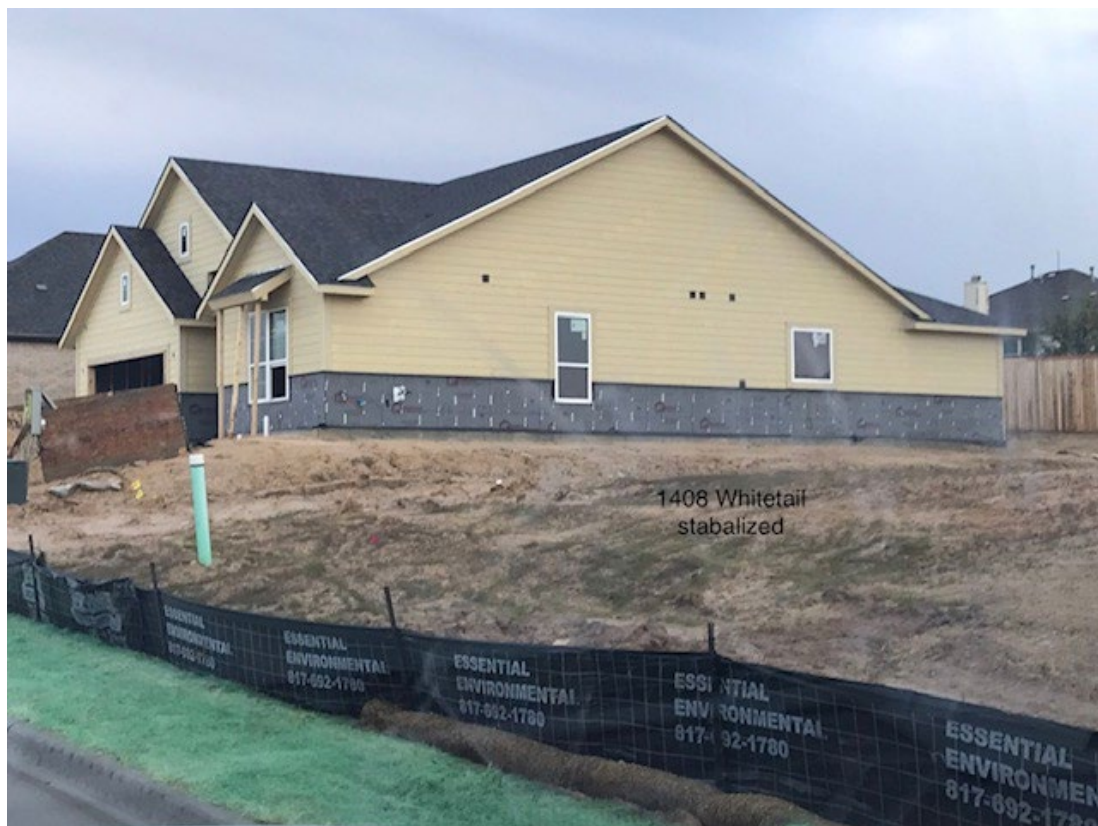
Photo no. 14

Description: Erosion control blanket, silt fence, and straw wattle along 1408 Whitetail Lane. The text on the photo was added by a Lakeview Heights representative.

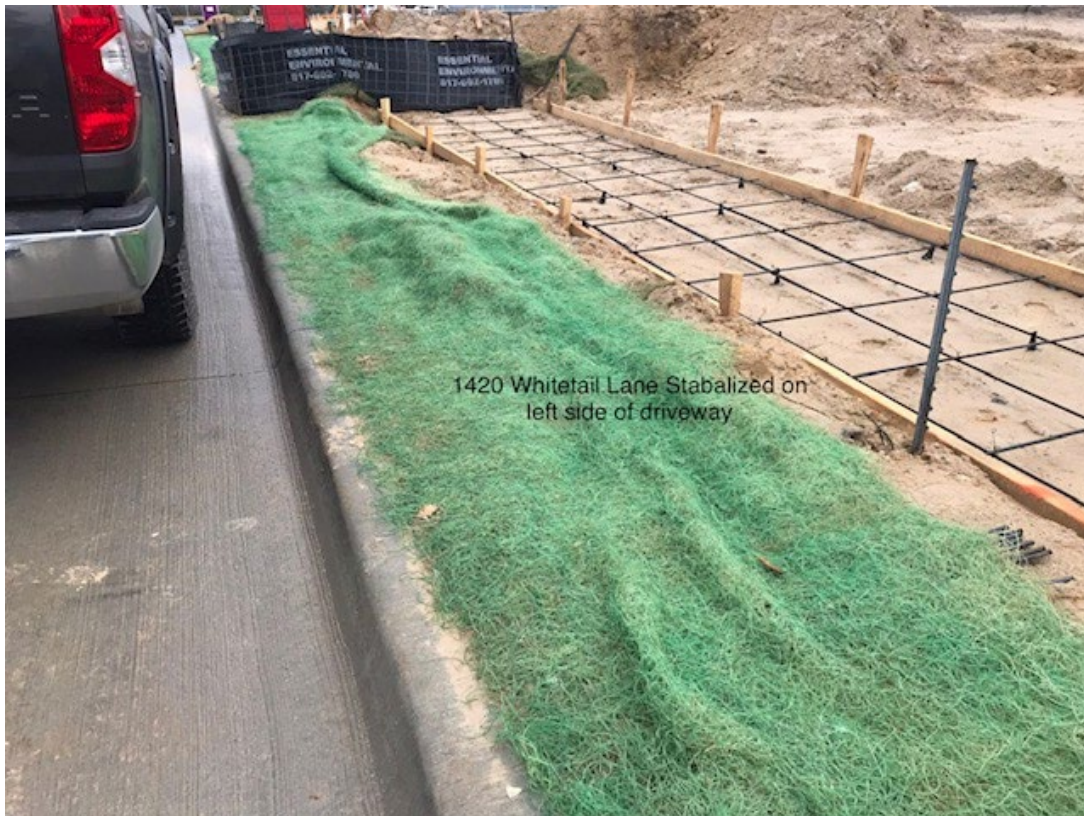
Photo no. 15

Description: Erosion control blanket along 1420 Whitetail Lane. The text on the photo was added by a Lakeview Heights representative.

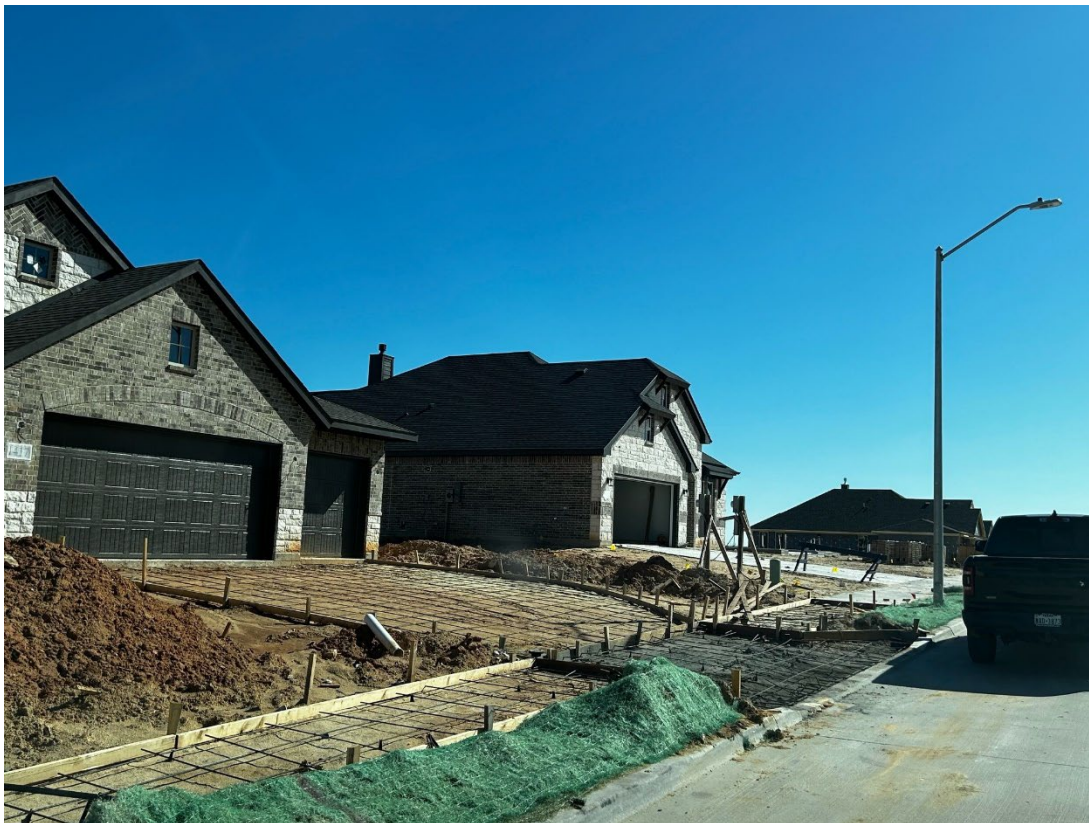
Photo no. 16

Description: Newly installed erosion control blanket.
