### INSPECTION REPORT

| Media Program: | RCRA Compliance Evaluation Inspection | |
| Company Name: | <b>The Sherwin-Williams Company</b> | |
| Facility Name: | <b>Sherwin-Williams W Miller Road</b> | |

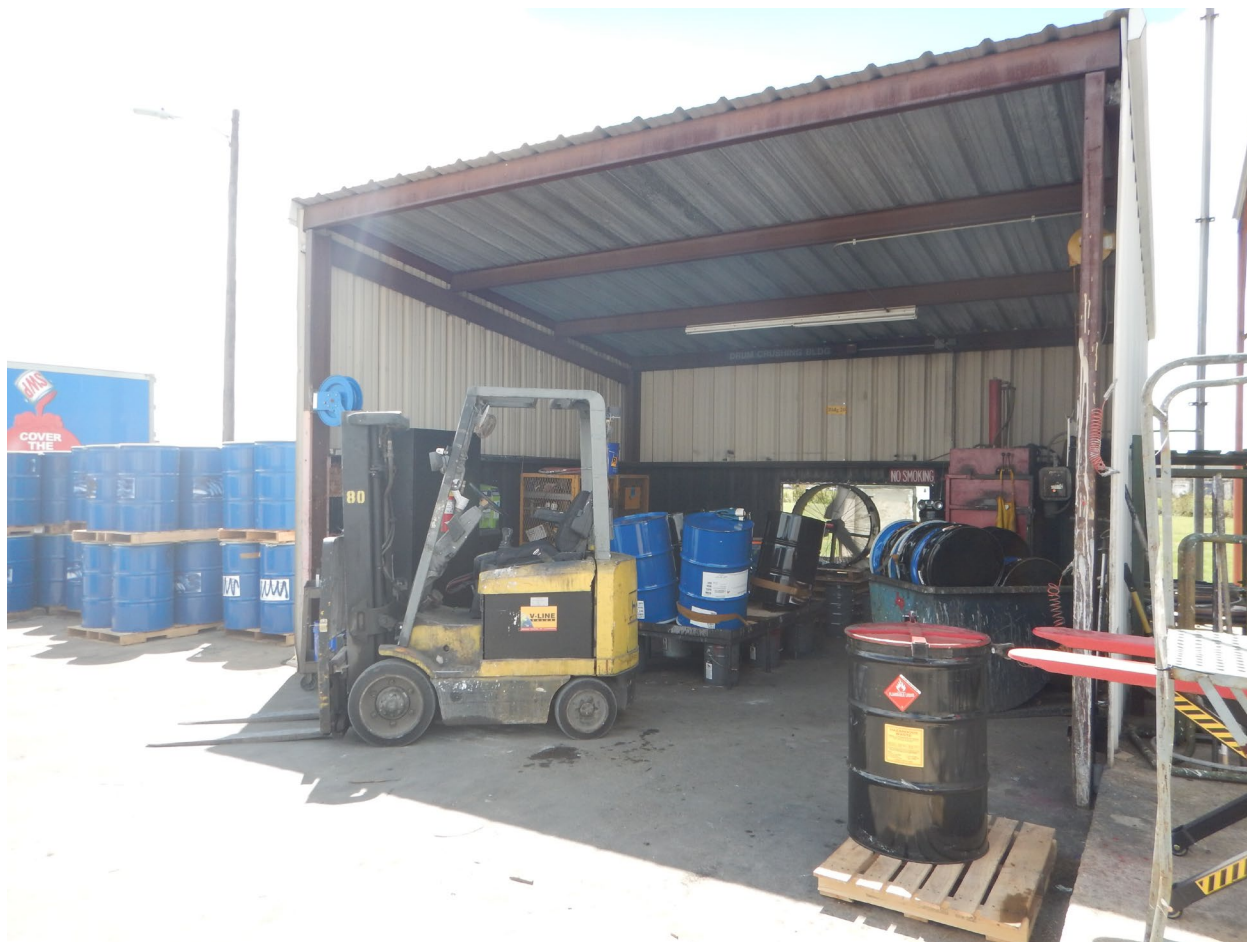
Photo No. 1

| Description:<br>Overview of the container draining and compacting area. Secured and labeled satellite accumulation drum located in the foreground on a pallet. | | |

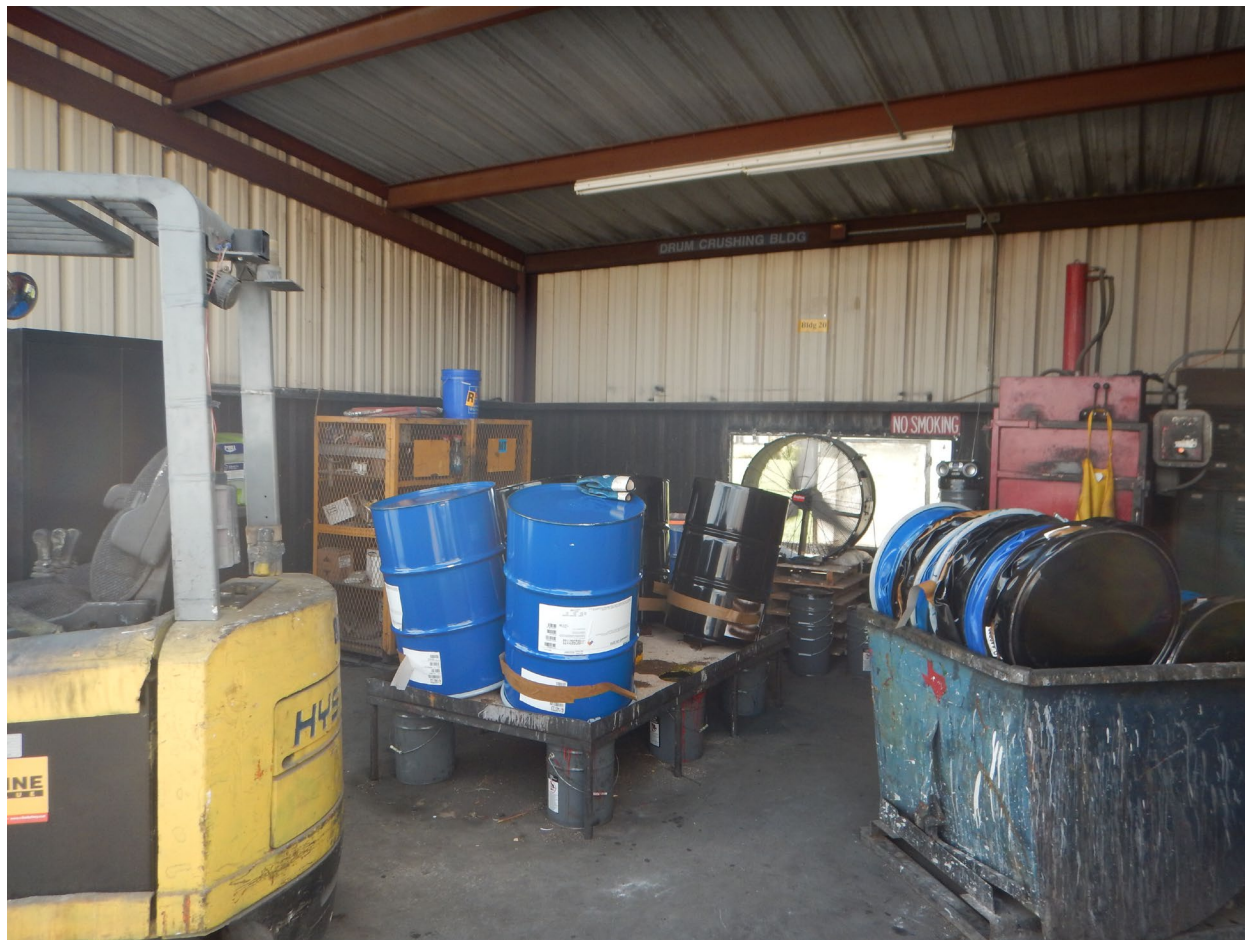
Photo No. 2

At the time of the inspection, I noticed five containers were open and tipped to drain. However, the area was unattended, and the containers had already finished draining. I requested an SOP describing operations in this area (see 40 CFR 265.1087(c)(3)(ii)).

| <b>Description:</b><br>Closer view of draining and compacting area. Five containers are open and tipped over open 5-gallon buckets, but have finished draining. | | |

- One drum containing solvent rags was missing a bung and was instead covered by a paper cup.
- In the satellite accumulation area, open, unattended containers were present after drums had been tipped and emptied. Facility to provide SOPs.

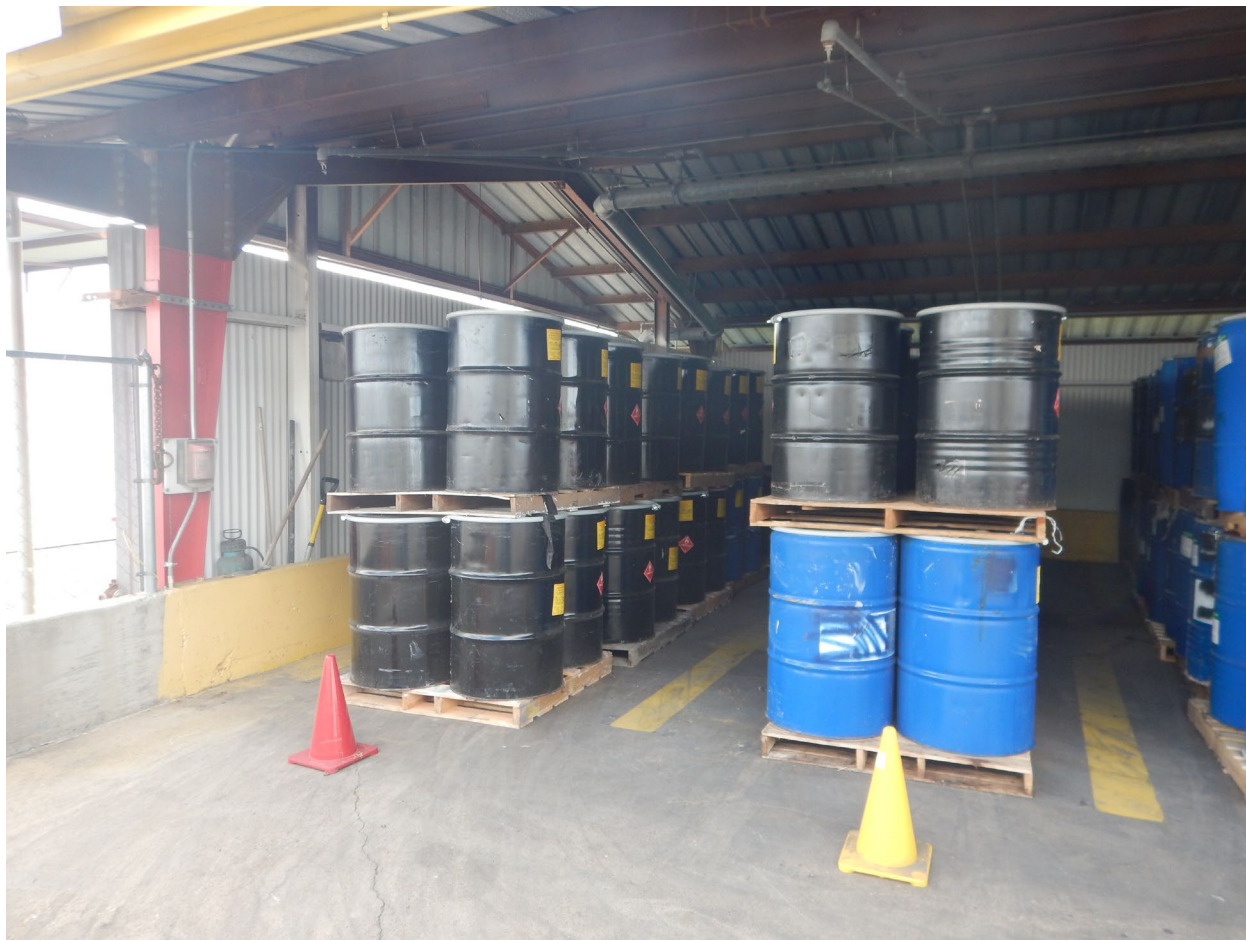
Photo No. 4

| Description:<br>View of aisle spacing in central accumulation area. | | |

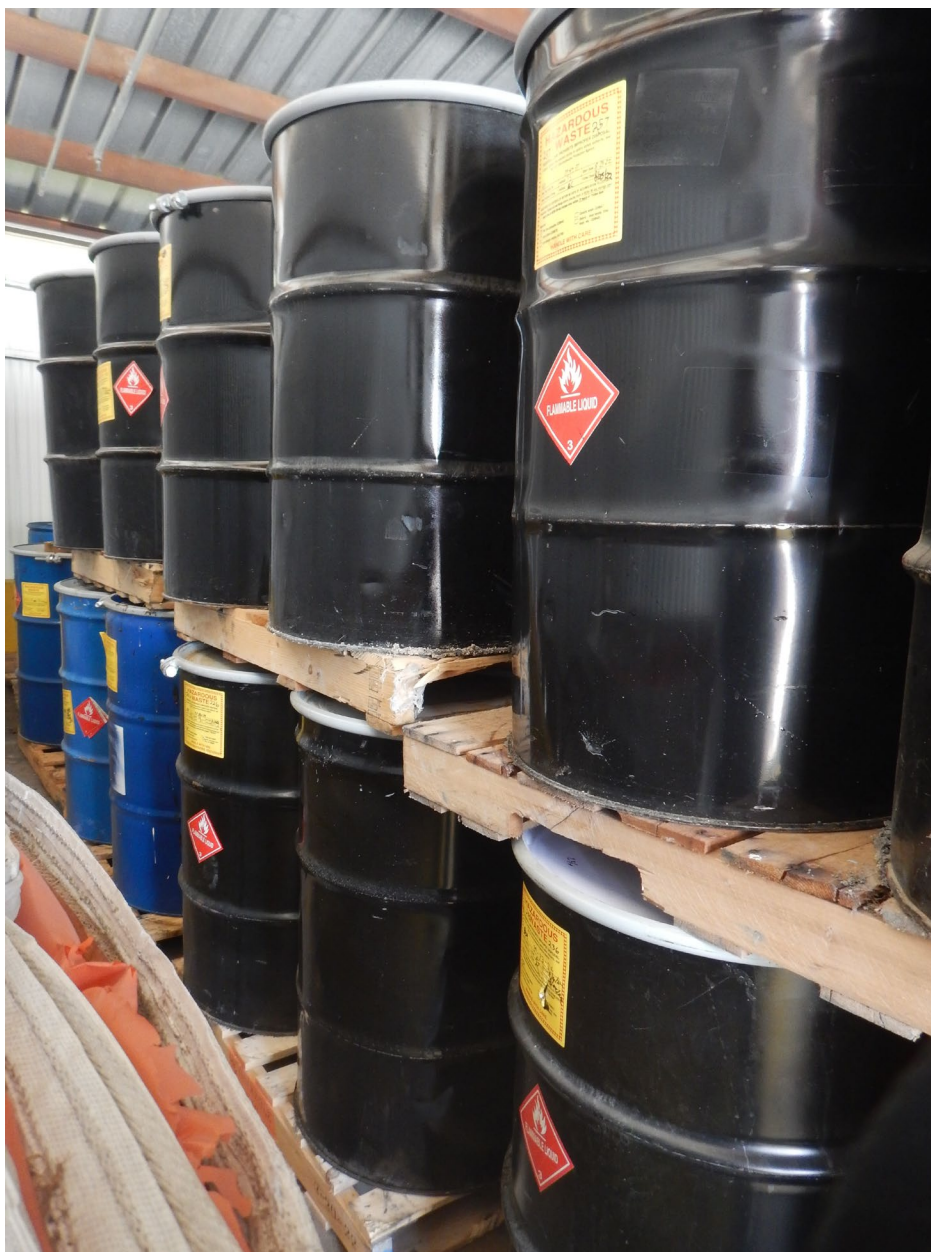
Photo No. 5

| Description:<br>Two containers in central accumulation area without easily visible labels. | | |

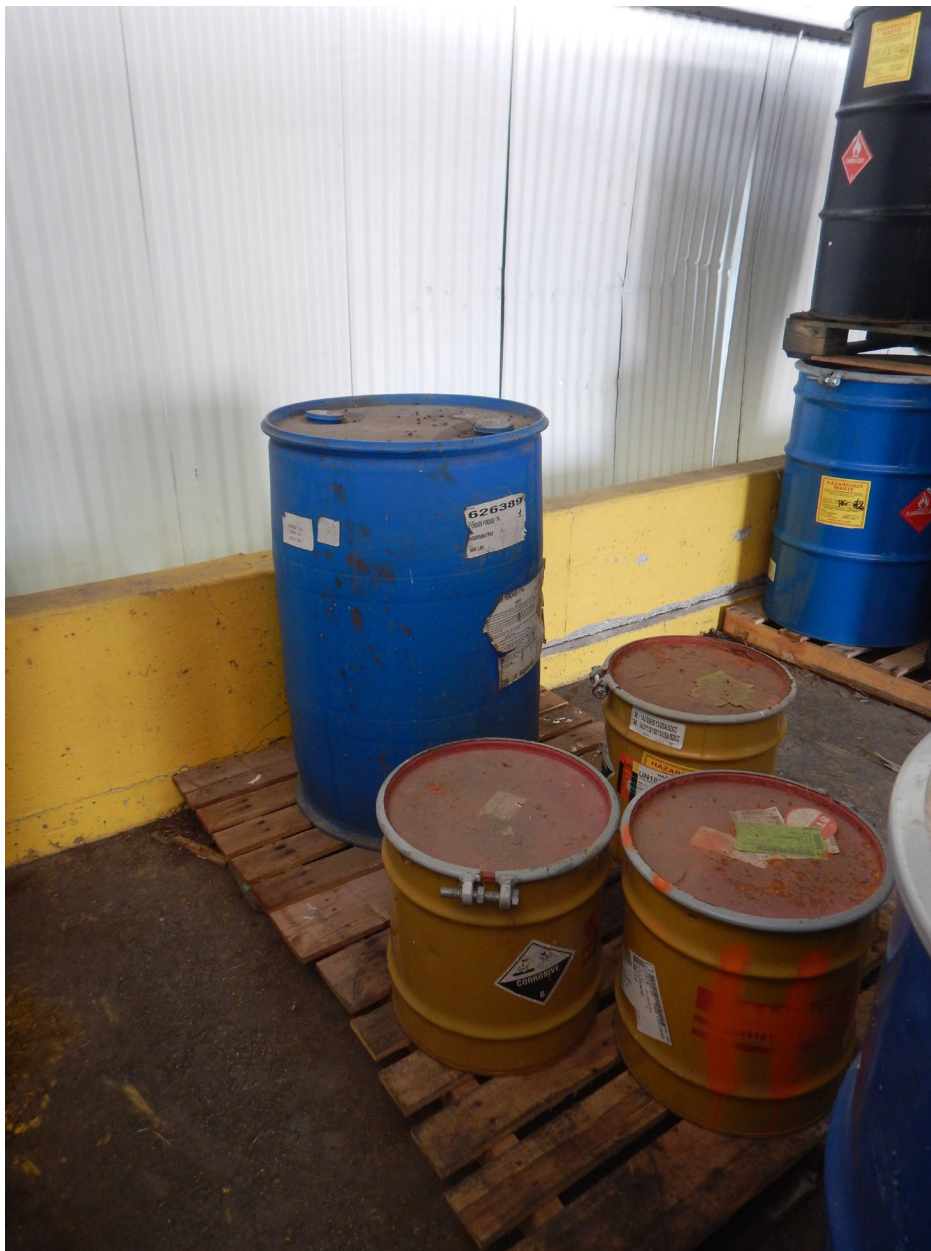
Photo No. 6

I identified a container of hydrogen peroxide, an oxidizer, in the southeast corner of the shelter. This material is incompatible with the flammable wastes also stored in this area (see 40 CFR 262.17(a)(1)(vii)(C)).

- An incompatible waste (oxidizer) was stored in the Central Waste Accumulation Area adjacent to containers of flammable wastes. These wastes are incompatible and were stored on the same pallet with no dividing structure between them.

| Description:<br>A container of hydrogen peroxide, an oxidizer, stored in the same area as ignitable hazardous waste without any barrier between the two types of hazardous waste. | | |

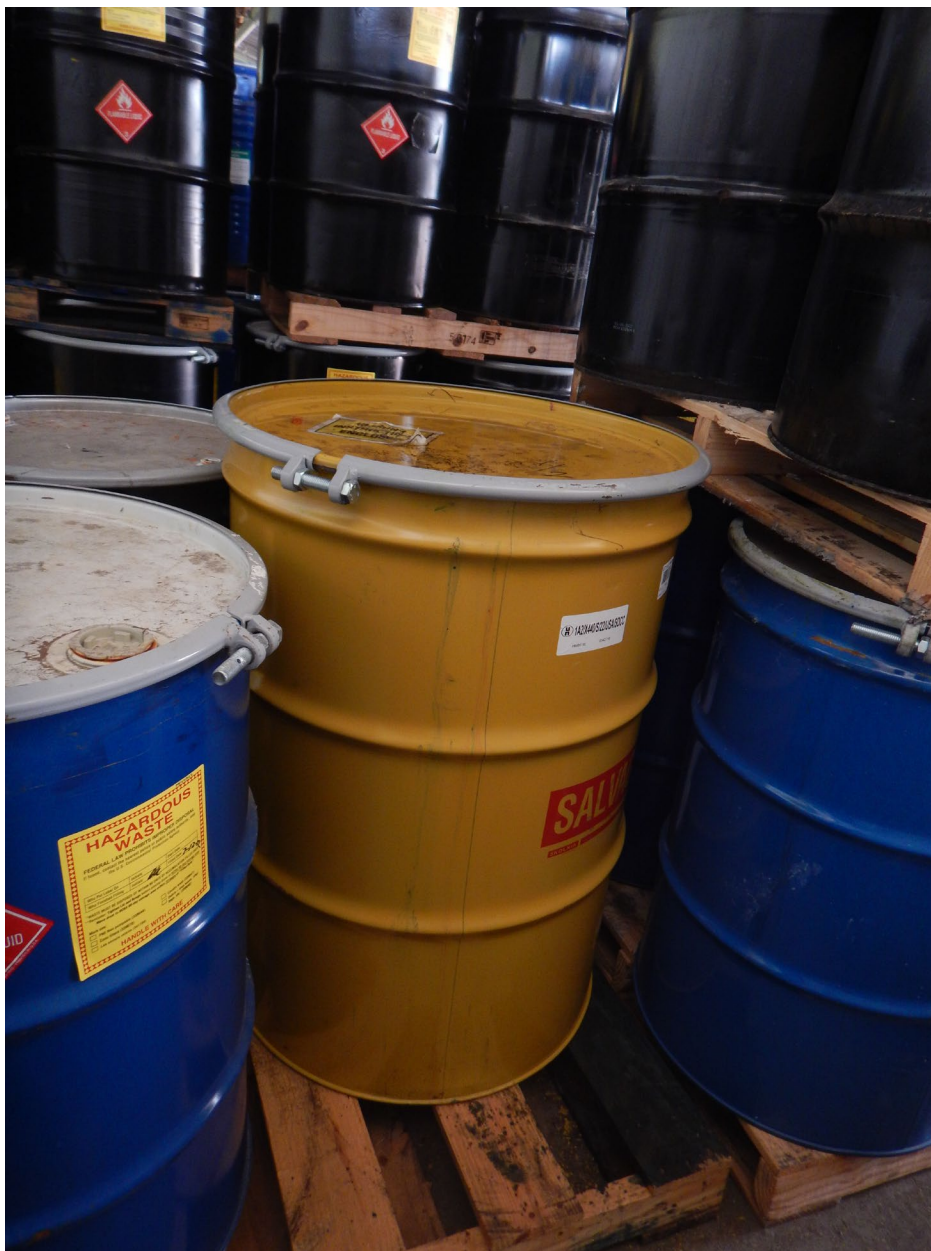
Photo No. 7

- One overpack drum in the Central Waste Accumulation Area was unlabeled.
- Training records for RCRA-applicable employees will be reviewed and assessed for their completeness and compliance with LQG training and recordkeeping requirements.

| Description:<br>Unlabeled overpack drum in central accumulation area. | | |

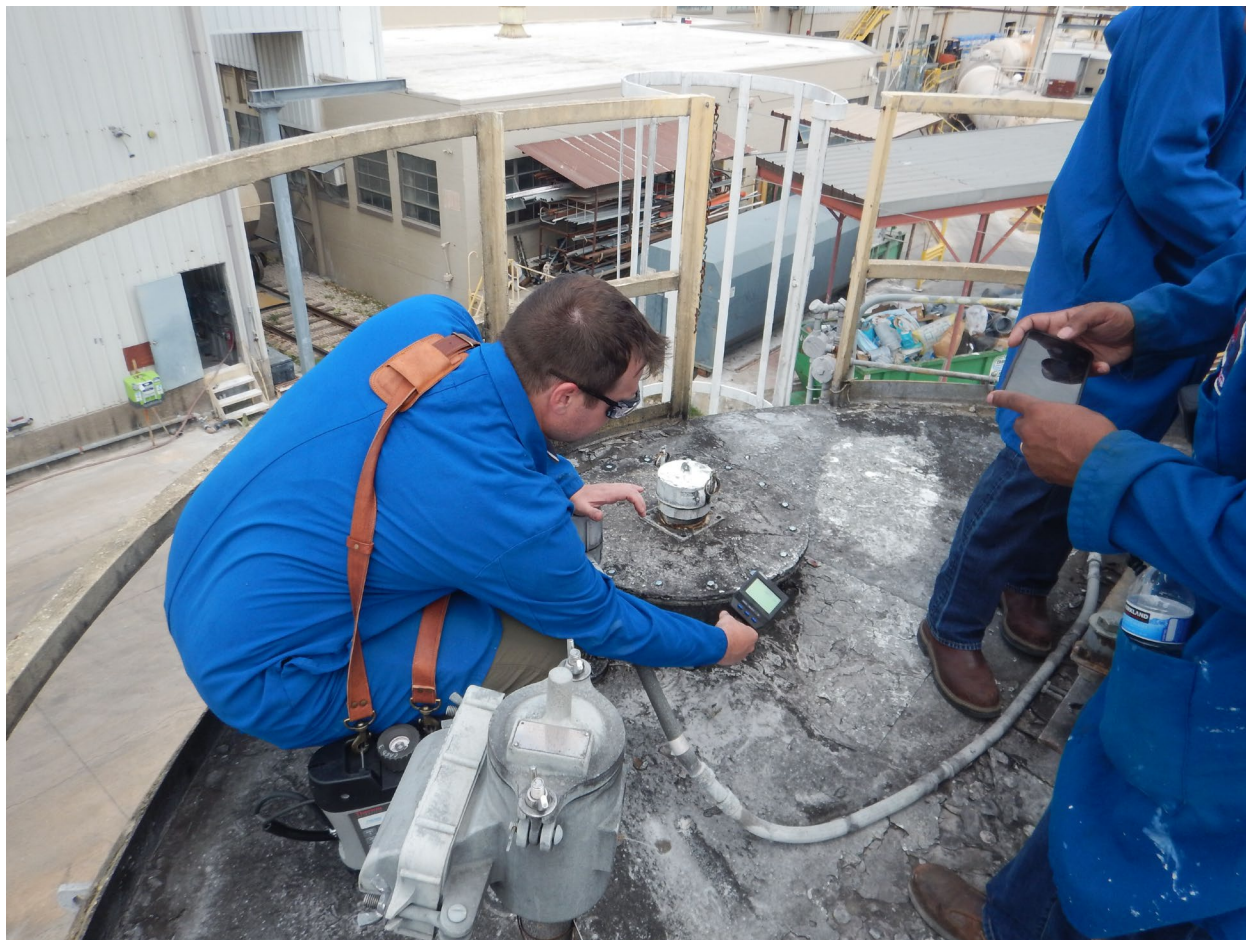
Photo No. 8

- Based on EPA's monitoring, an emissions leak from the manway hatch of Tank S-13 was detected with a reading of 16,000 ppm, more than the 500 ppm regulatory limit for access ports. Inspection and operation records for tanks S-13 and T-5 will be reviewed to confirm <90-day thruputs.

| Description:<br>Manway hatch at the top of tank S-13 secured with incorrect bolts. The inspection team determined there was a leak here of 16,000 ppm using Method 21 monitoring. | | |

- Tank S-13
    - Replacement of bolts and seal on manway being replaced. Photos will be uploaded when complete.
- Review of Emergency Response Plan incorporating the RCRA Contingency Plan

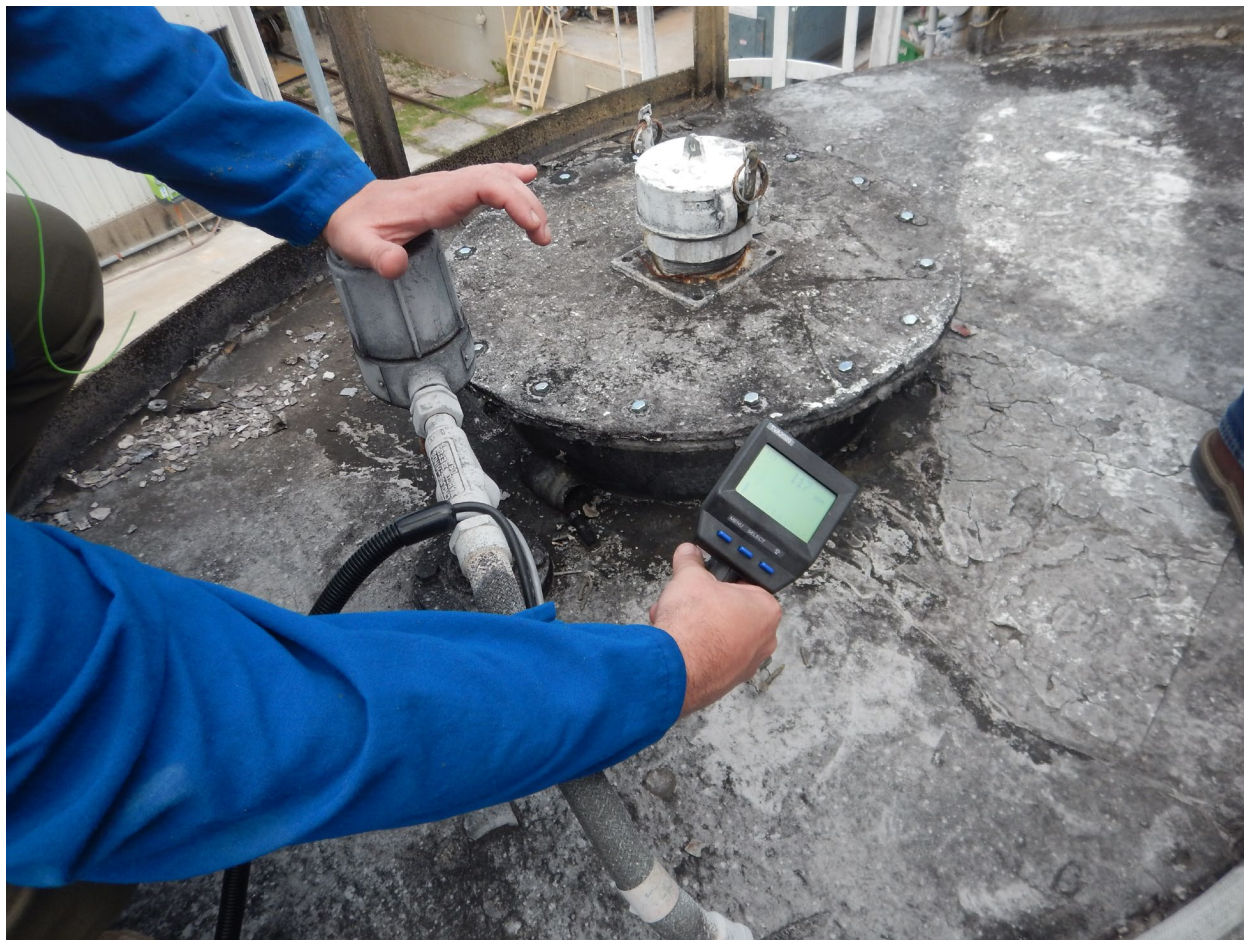
Photo No. 9

| Description:<br>Closeup of TVA monitoring process. Measurements ranged from 100 ppm to 16,000 ppm around the manway hatch. | | |

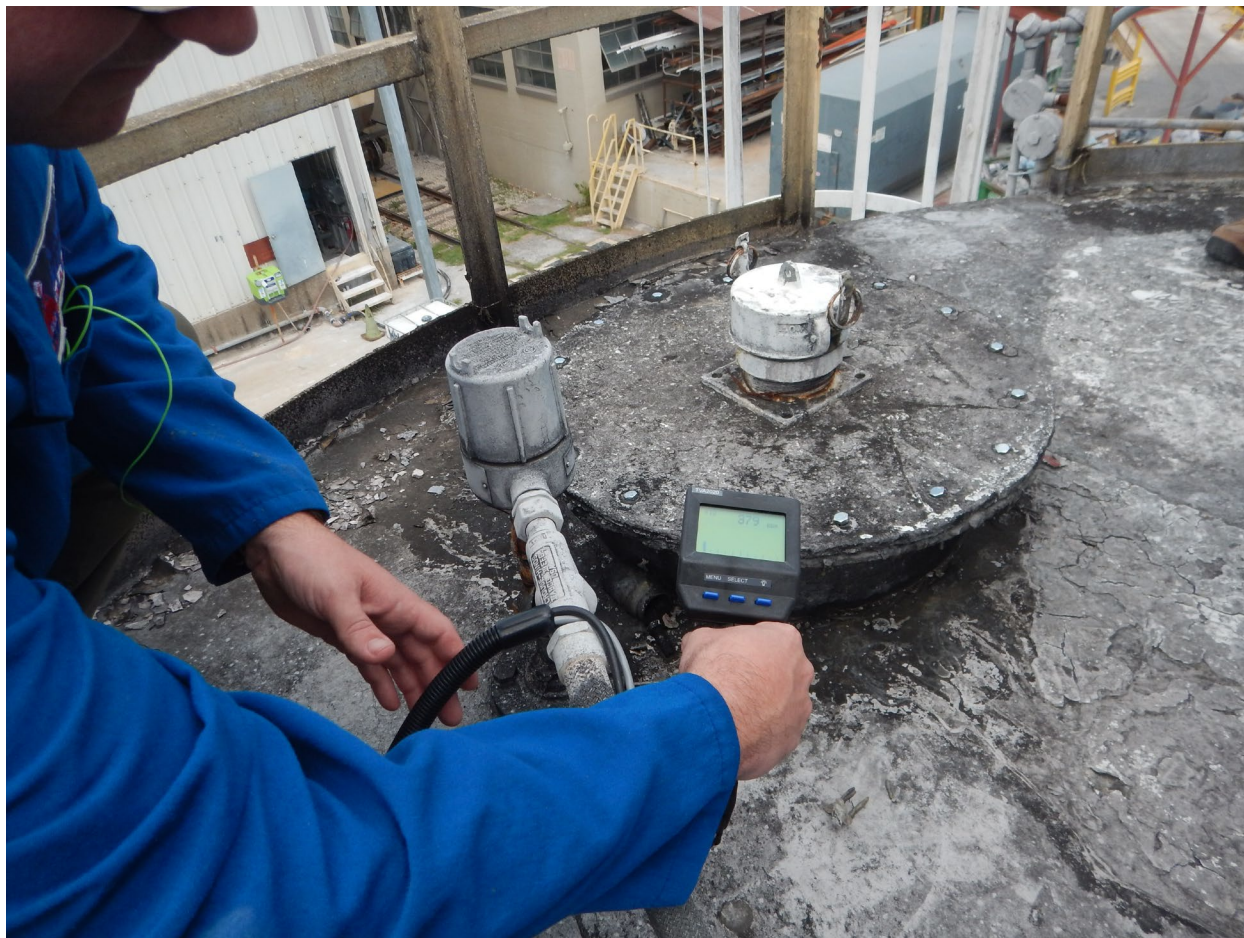
Photo No. 10

| Description:<br>Closeup of TVA monitoring process. Measurements ranged from 100 ppm to 16,000 ppm around the manway hatch. | | |
