**Report of Results: MVA9214**

**Examination of a SQUARE D  
Enclosed Switch Box  
Exhibit D (Beach Case)**

### **Examination of a SQUARE D Enclosed Switch Box Exhibit D (Robert Beach Case)**

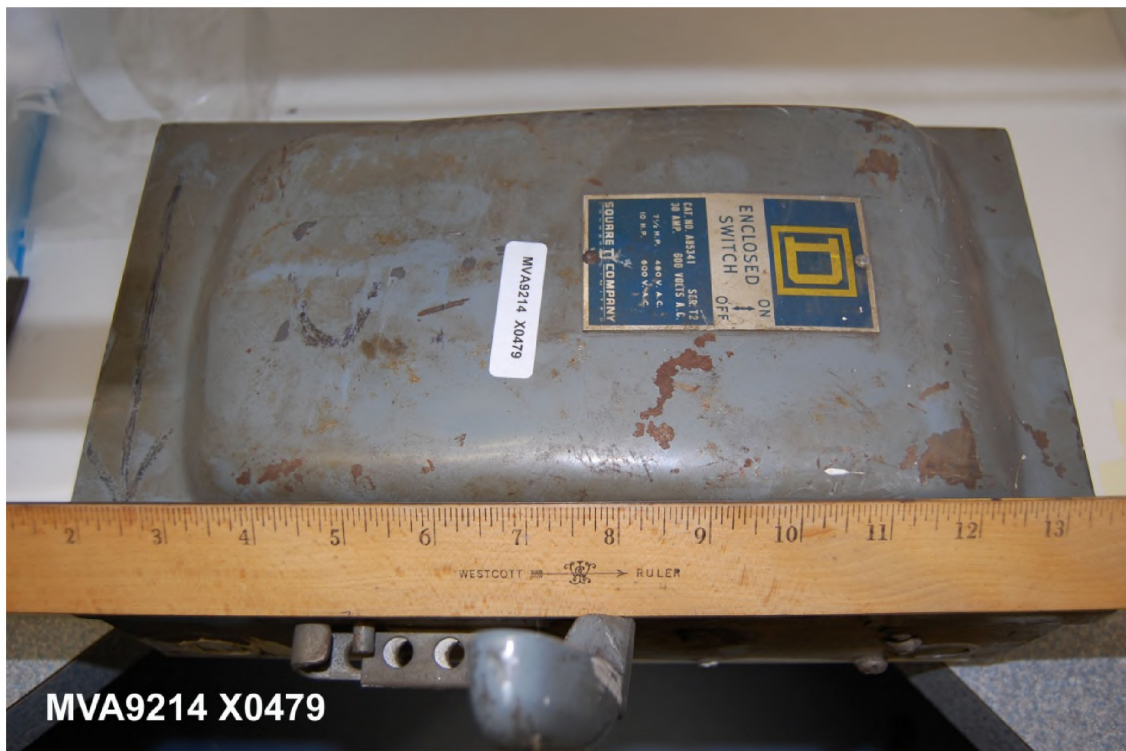
**Figure 2.** Cover on Sample X0479 (SQUARE D electrical control unit).  
Label: Enclosed Switch, Cat. No. A85341, SER. T2, 30 AMP, 600 Volts A.C.

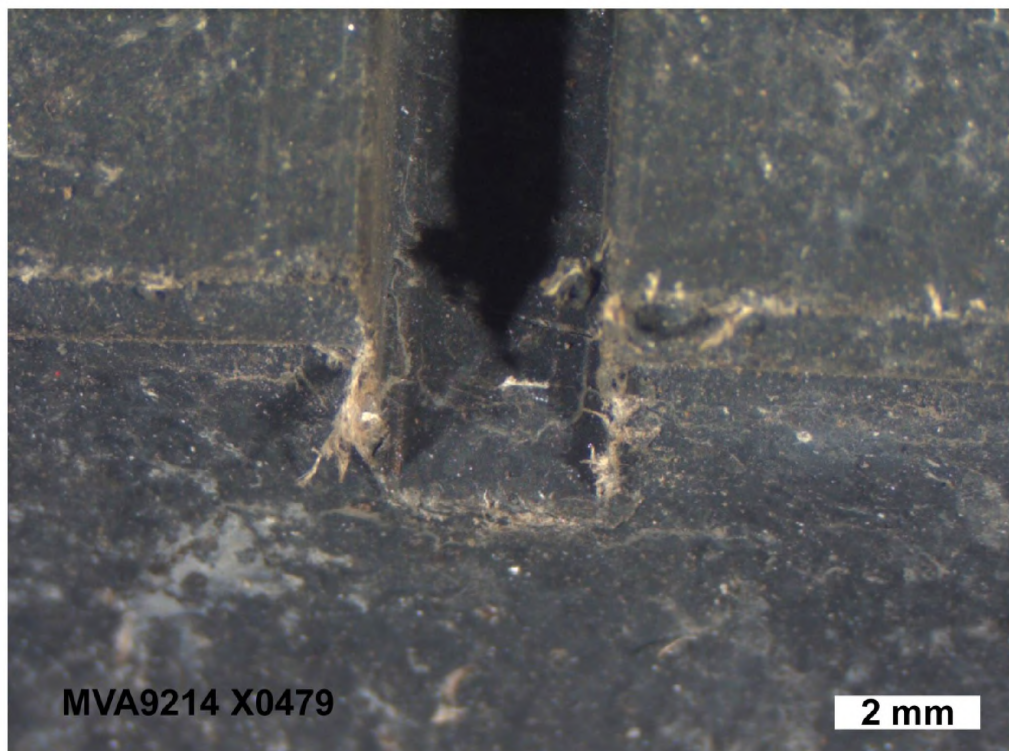
**Figure 4.** Asbestos fibers are protruding from the surface of Sample X0479A.
