Clean Water Act Section 404: Site Visit/Case Development

Site Name	Lawngevity Landscape and Garden Gate Nursery	Start Date	October 20, 2022
		End Date	October 20, 2022
Inspection Purpose	Initial site visit		
Opening Conference			
<input checked="" type="checkbox"/> Presentation of Inspector Credentials			
Name and Title (Use N/A if owner/operator not available to join the inspection)			
Credentials were presented to Mr. Paul Elfers (president of Lawngevity)			
<input checked="" type="checkbox"/> Opening Conference			
Name of person authorizing access if applicable			
I spoke with a representative of Lawngevity over the phone to arrange the inspection and authorize access. Representatives of Lawngevity met EPA for the inspection.			
Notes from Opening Conference			
We explained the reason for the inspection and the pointed out the area that we were interested in inspecting.			
<input checked="" type="checkbox"/> Access Issues if Any			
Describe			
Note: At the start of the inspection, EPA was unaware the that property was not owned by Lawngevity/Mr. Elfers. Lawngevity representatives informed EPA that they were leasing the property.

Lawgevity Landscaping Site Chester, Orange Count

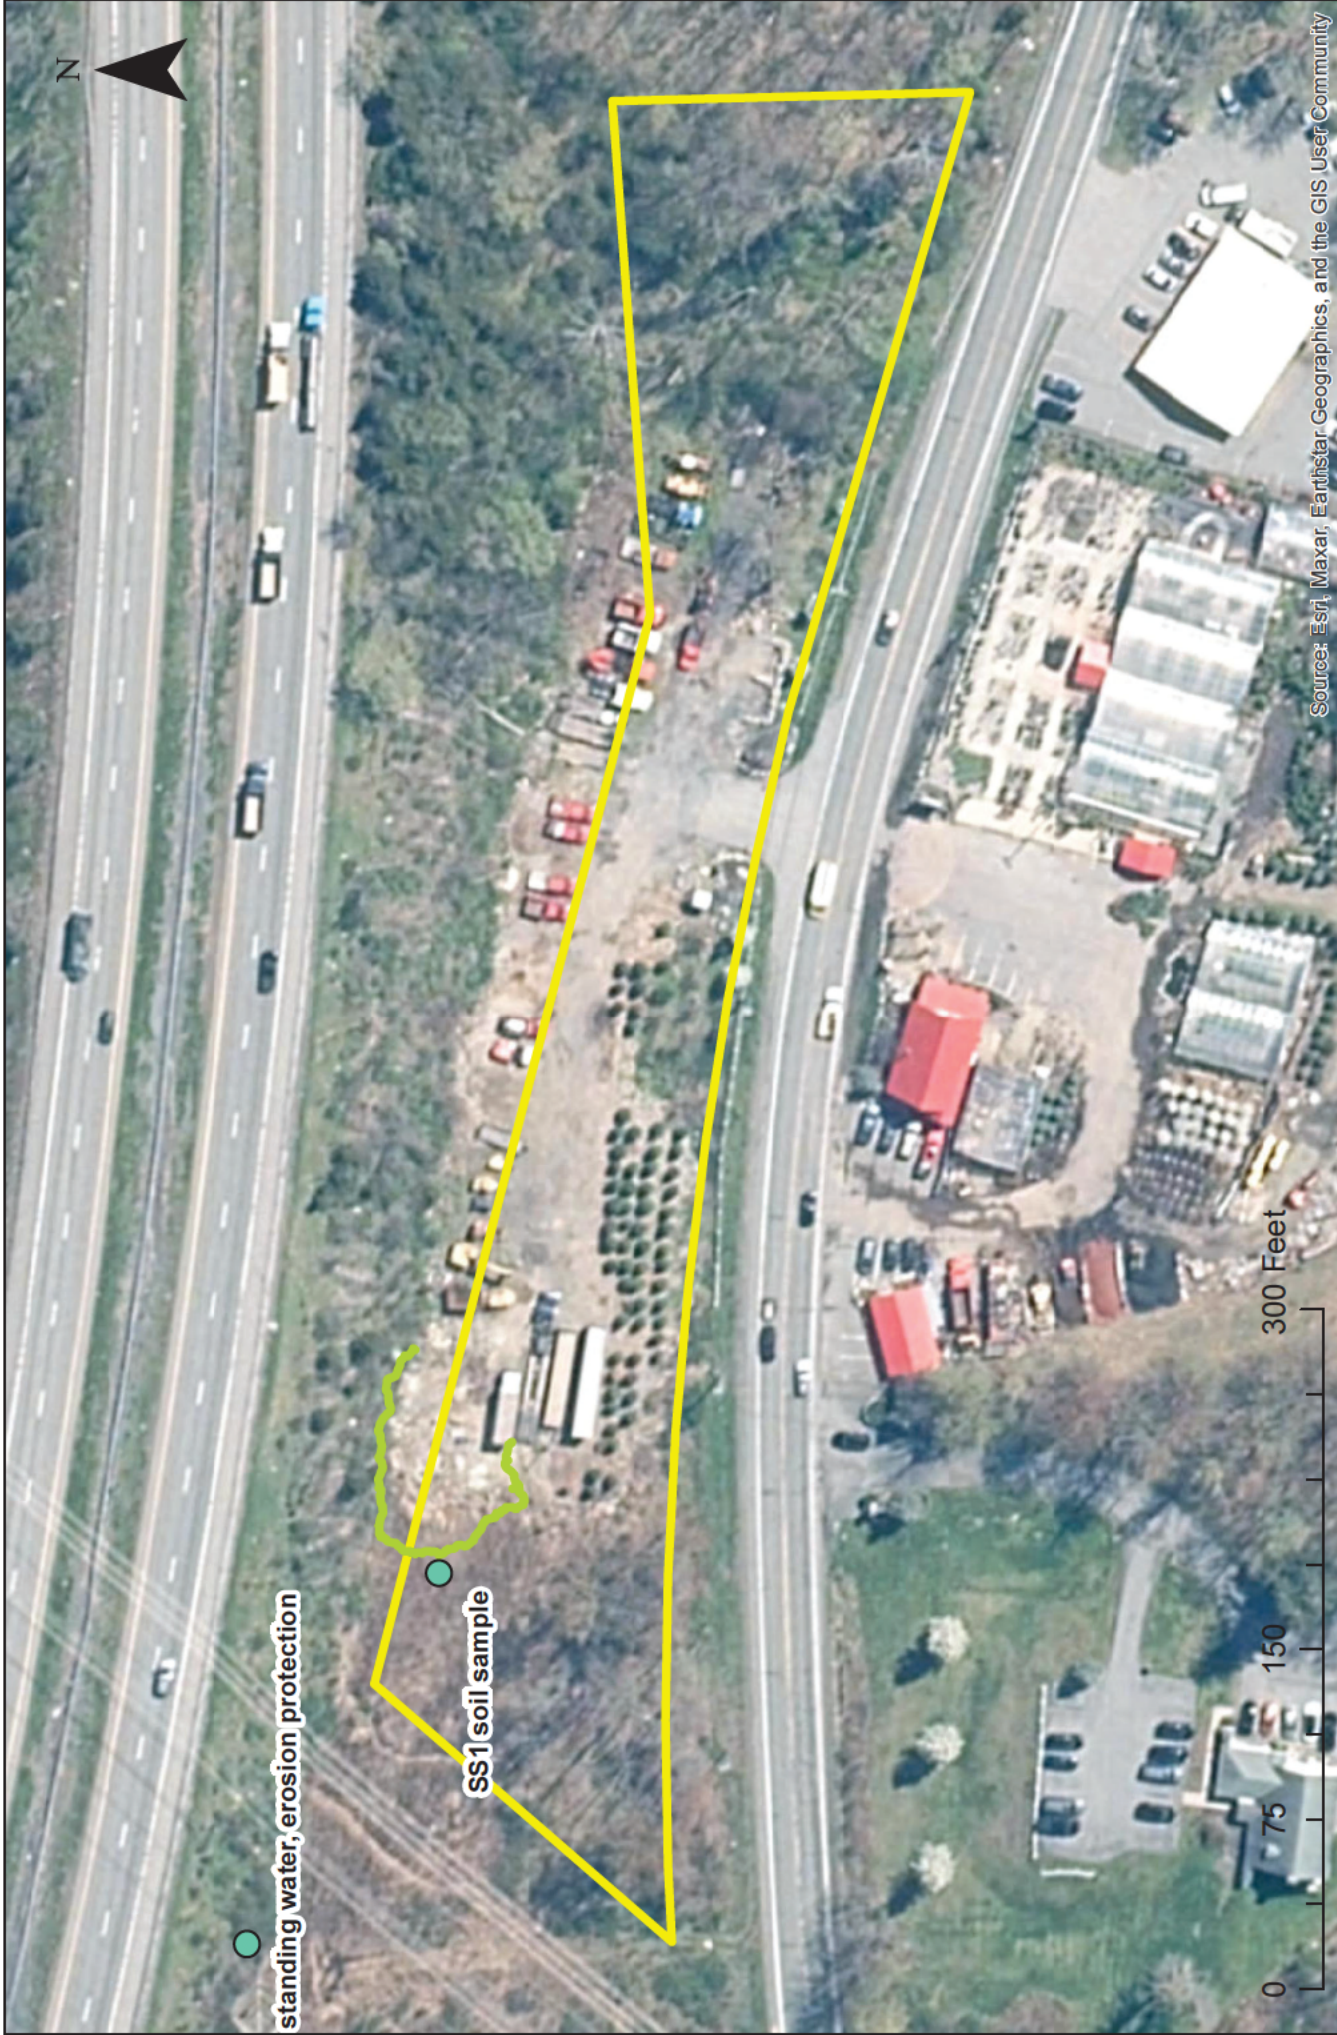
Source: Esri, Maxar, Earthstar Geographics, and the GIS User Community

- EPA 10/20/2022 GPS Point
- EPA 10/20/2022 GPS Disturbance Limit
- Approximate Parcel Boundary

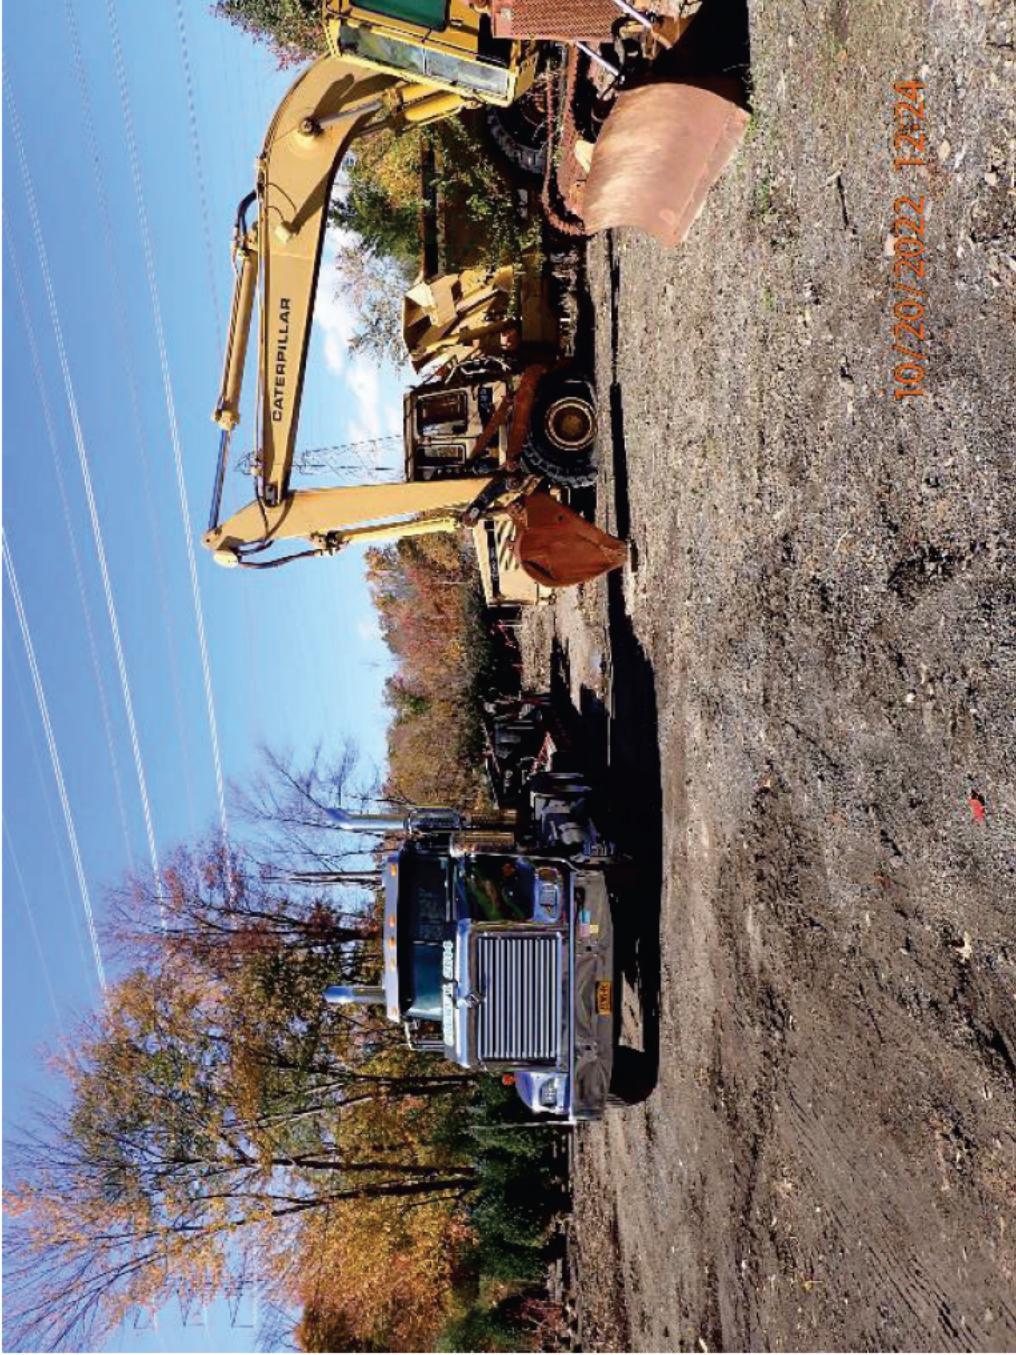
Date: 10/20/2022
Time: 12:24 PM
Photographer: S. Robinson
Photo ID: 1 – PA200506

Description:
Machinery parking near recent fill area

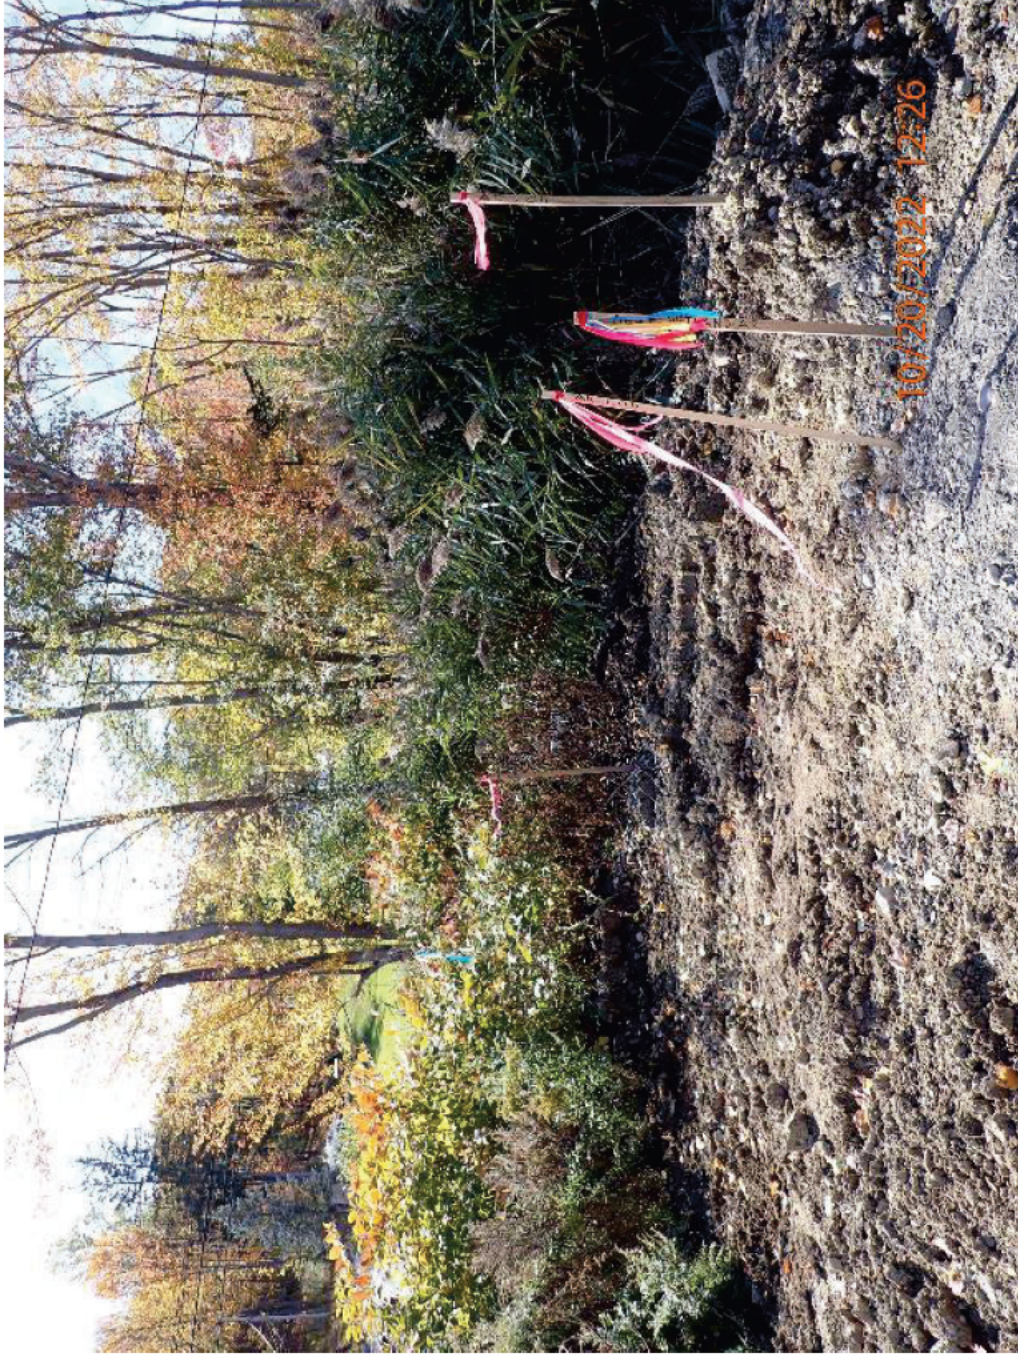
Date: 10/20/2022
Time: 12:26 PM
Photographer: S. Robinson
Photo ID: 3 – PA200508

EPA met with representatives from Lawngevity at their property located at 1147 NY Route 17M and then proceeded across Route 17M to the Site. EPA observed that fill material had recently been spread to expand the storage/parking area to the west. Fill material consisted of dirt, rock, and concrete; and measured one- to two-feet high near the edge of disturbance. EPA took a GPS line recording of the limit of disturbance. Mr. Elfers stated that Transco had arrived that morning to flag/stake their access route to their transmission lines through the property.

Recent fill area with Transco flagging and stakes indicating access route through property

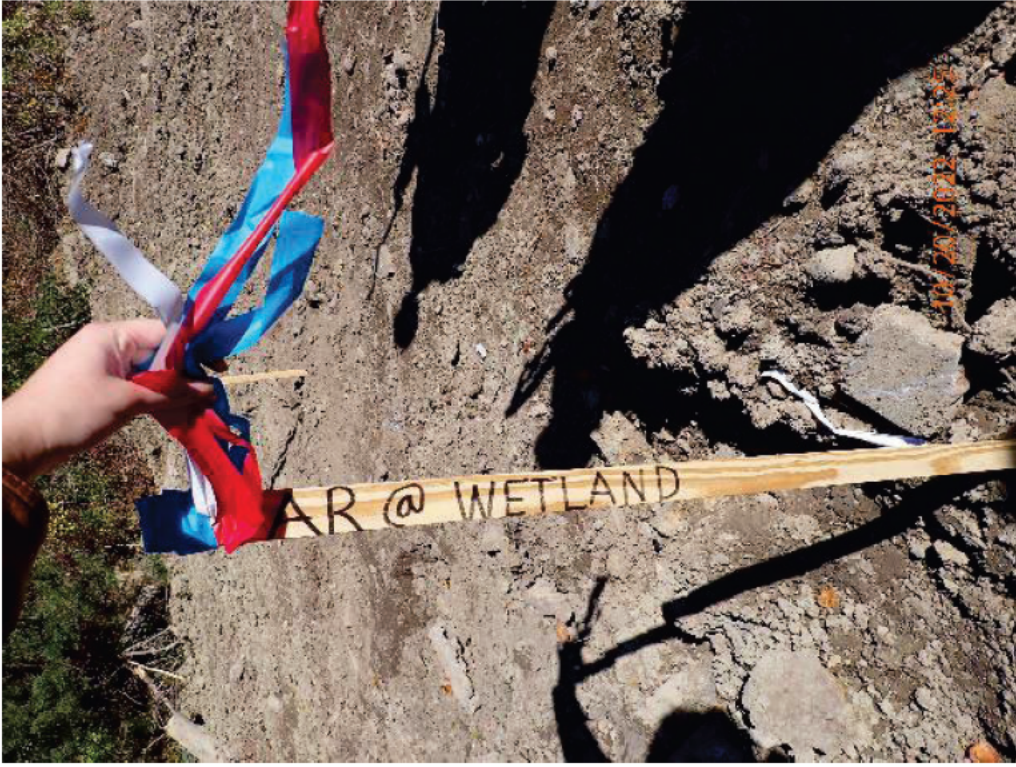
Date: 10/20/2022
Time: 12:24 PM
Photographer: S. Robinson
Photo ID: 2 – PA200507

Transco flagging within recent fill area indicating access route through property

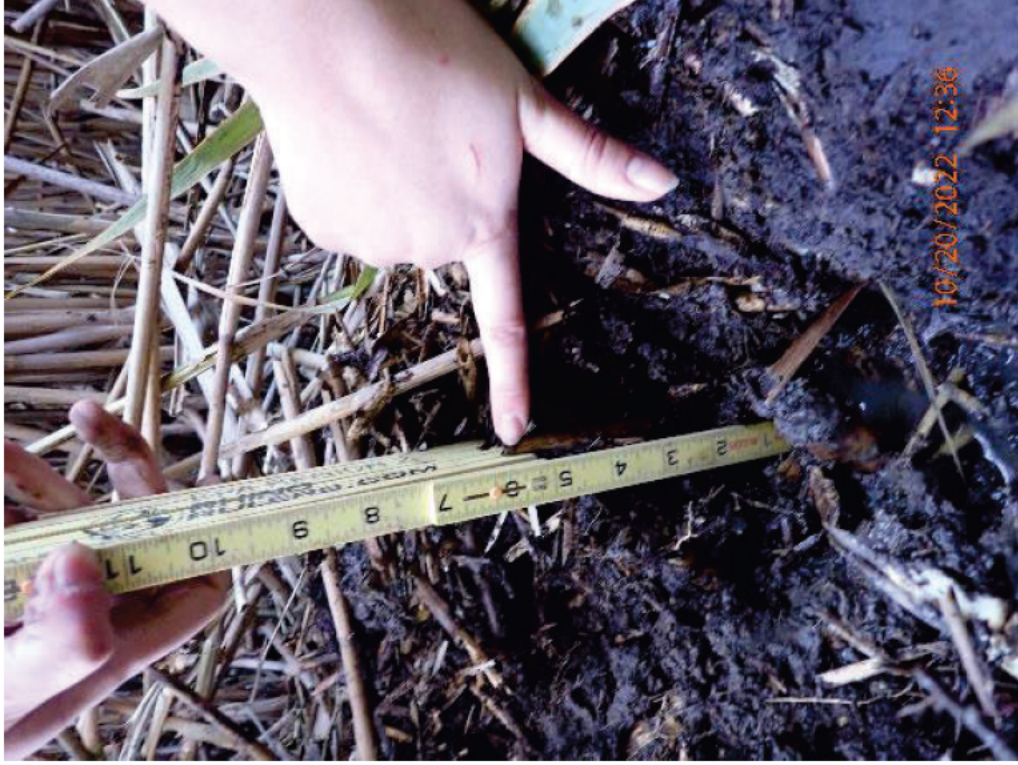
Date: 10/20/2022
Time: 12:36 PM
Photographer: S. Robinson
Photo ID: 5 – PA200510

EPA took a soil sample west of and adjacent to the recent fill material and confirmed that the area was an emergent wetland due to the presence of hydrophytic (wetland) vegetation, hydric soils, and wetland hydrology. This area had 100% absolute areal coverage of common reed (*Phragmites australis*). Shovel refusal was at 5" due to common reed rhizomes; auger refusal was at 10". Vegetation in other areas included purple loosestrife (*Lythrum salicaria*) and Canada goldenrod (*Solidago canadensis*). See attached wetland datasheet.

Description:
Soil pit showing water table 6
inches below surface

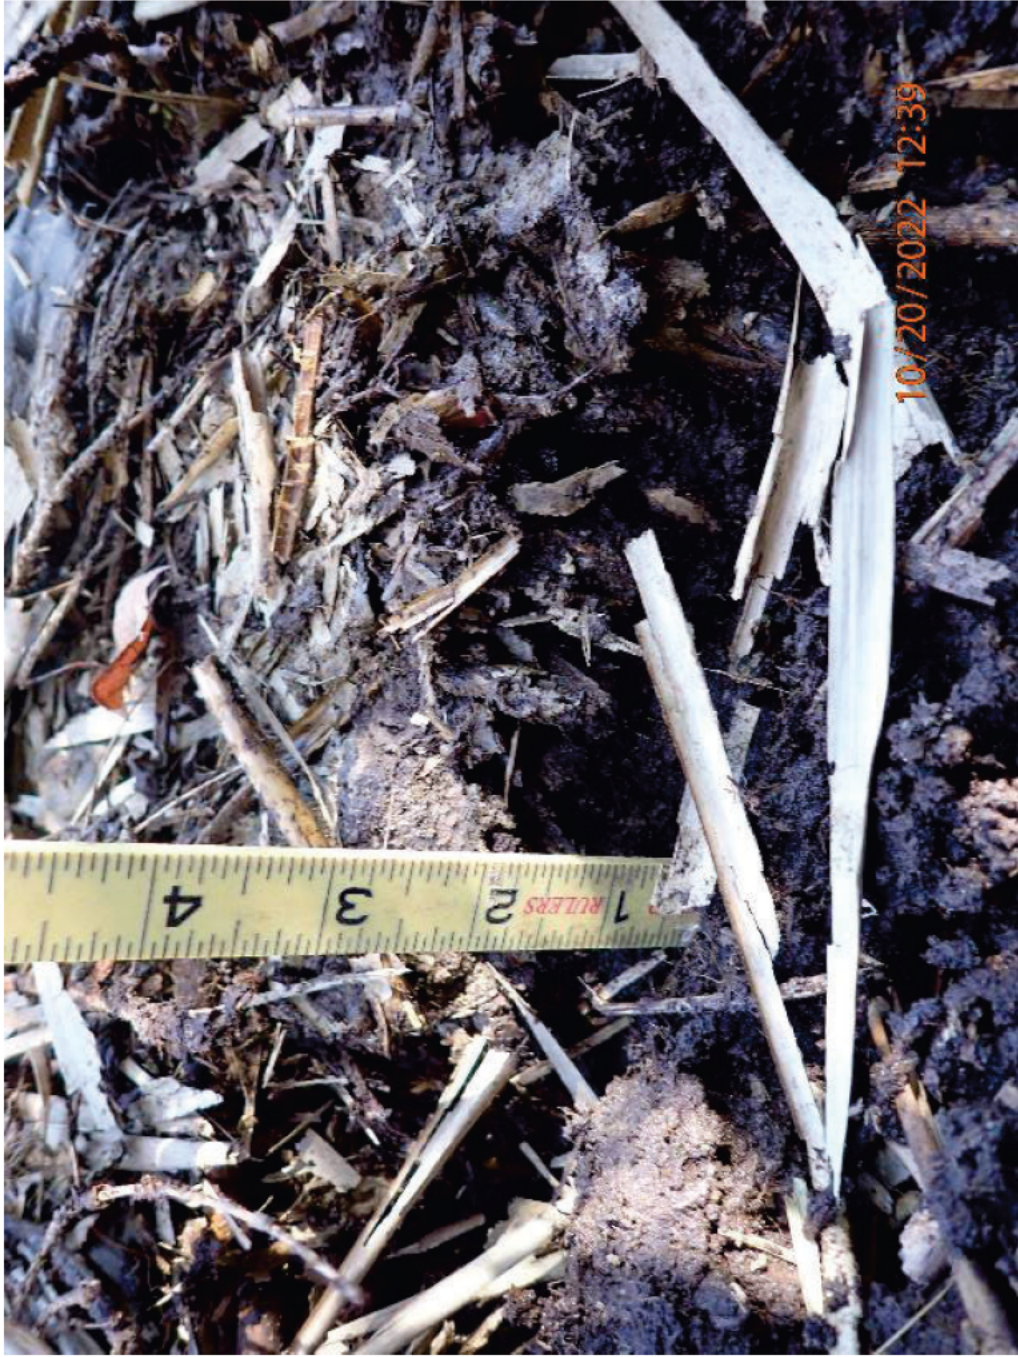
Date: 10/20/2022
Time: 12:39 PM
Photographer: S. Robinson
Photo ID: 6 – PA200511

Soil pit – observation of saturated soil, high water table, depleted soils, and redox features

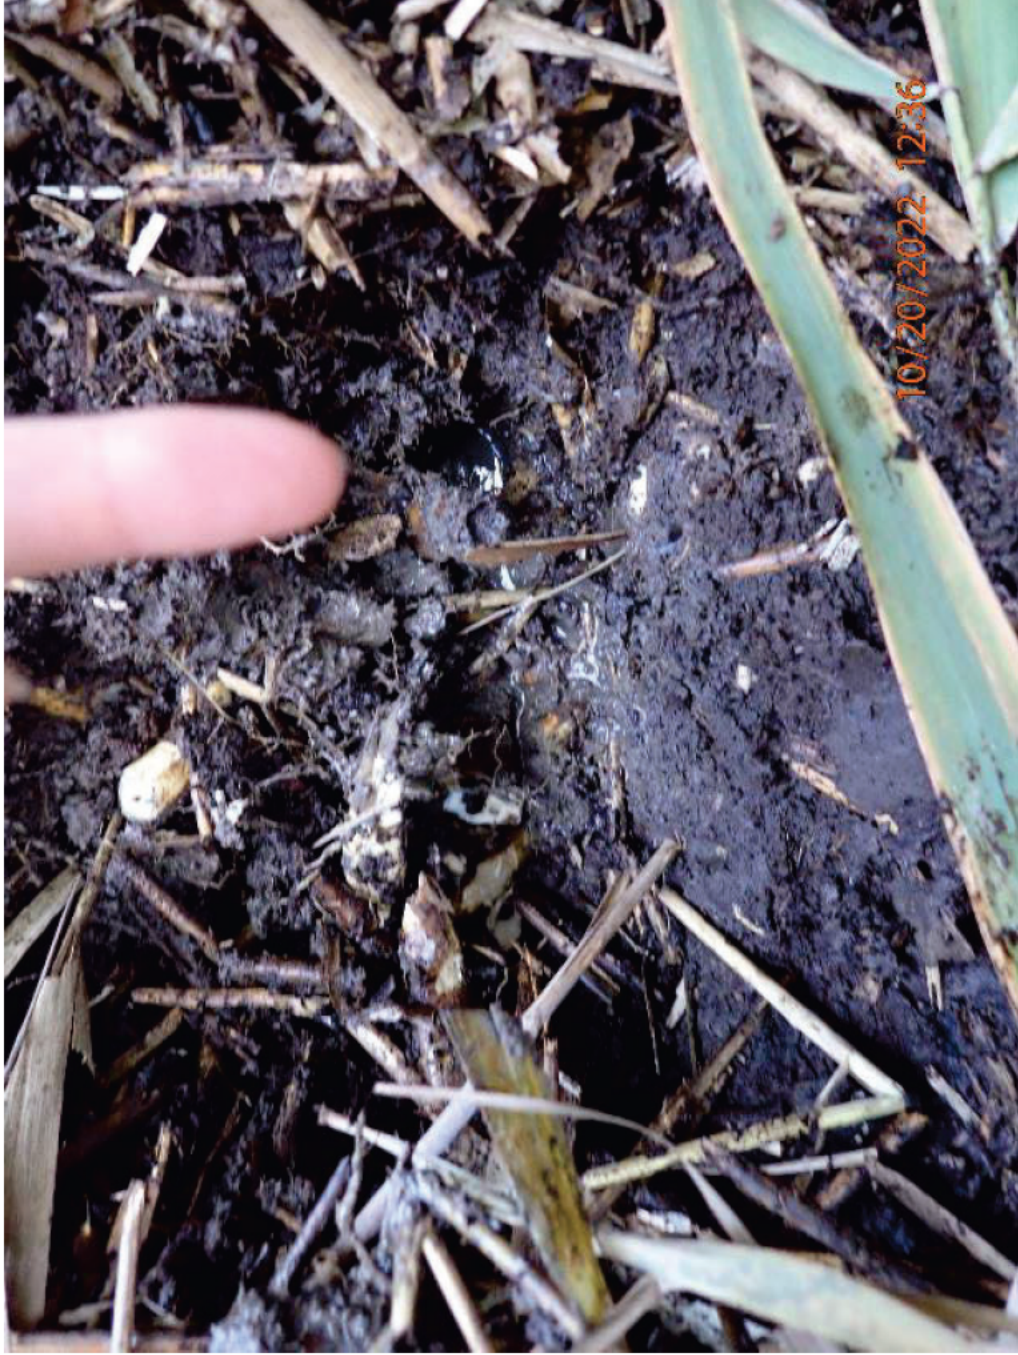
Date: 10/20/2022
Time: 12:36 PM
Photographer: S. Robinson
Photo ID: 4 – PA200509

Soil pit – observation of saturated soil, high water table, depleted soils, and redox features

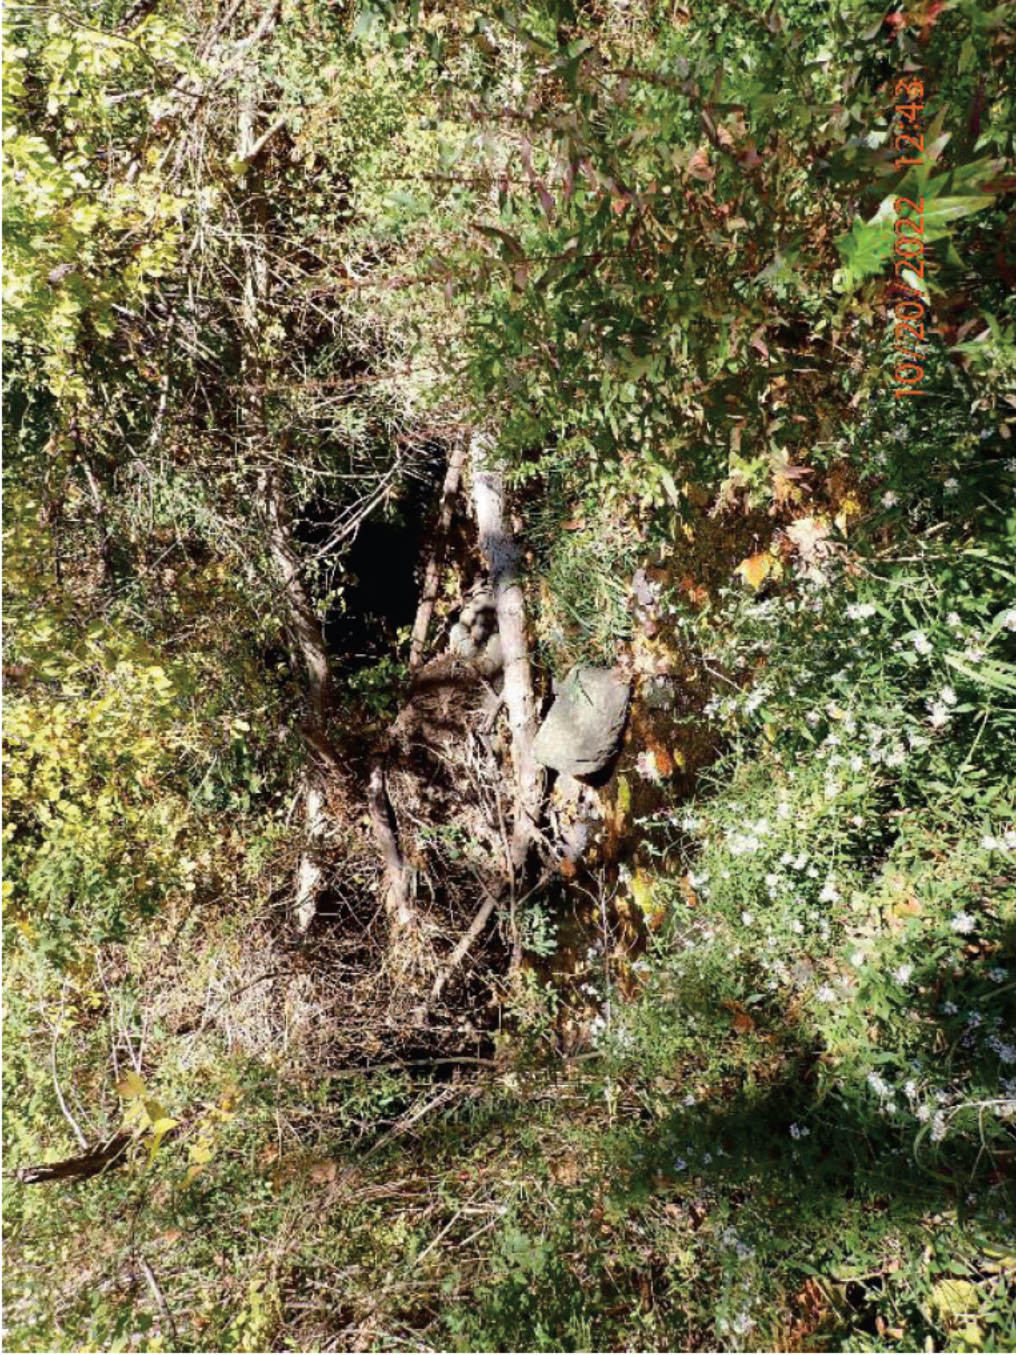
Date: 10/20/2022
Time: 12:43 PM
Photographer: S. Robinson
Photo ID: 7 – PA200511

EPA then walked to the east side of the property to observe Youngs Brook, a USGS-mapped perennial stream which flows from south to north through the eastern half of the property. At the time of the inspection, the stream was flowing, approximately 4-5 feet wide and several inches deep. EPA observed a defined bed and banks, and substrate sorting in the stream channel and cattails (*Typha* sp.) adjacent to the stream channel.

Actively flowing stream, Youngs Brook, located east of the disturbed portion of the parcel

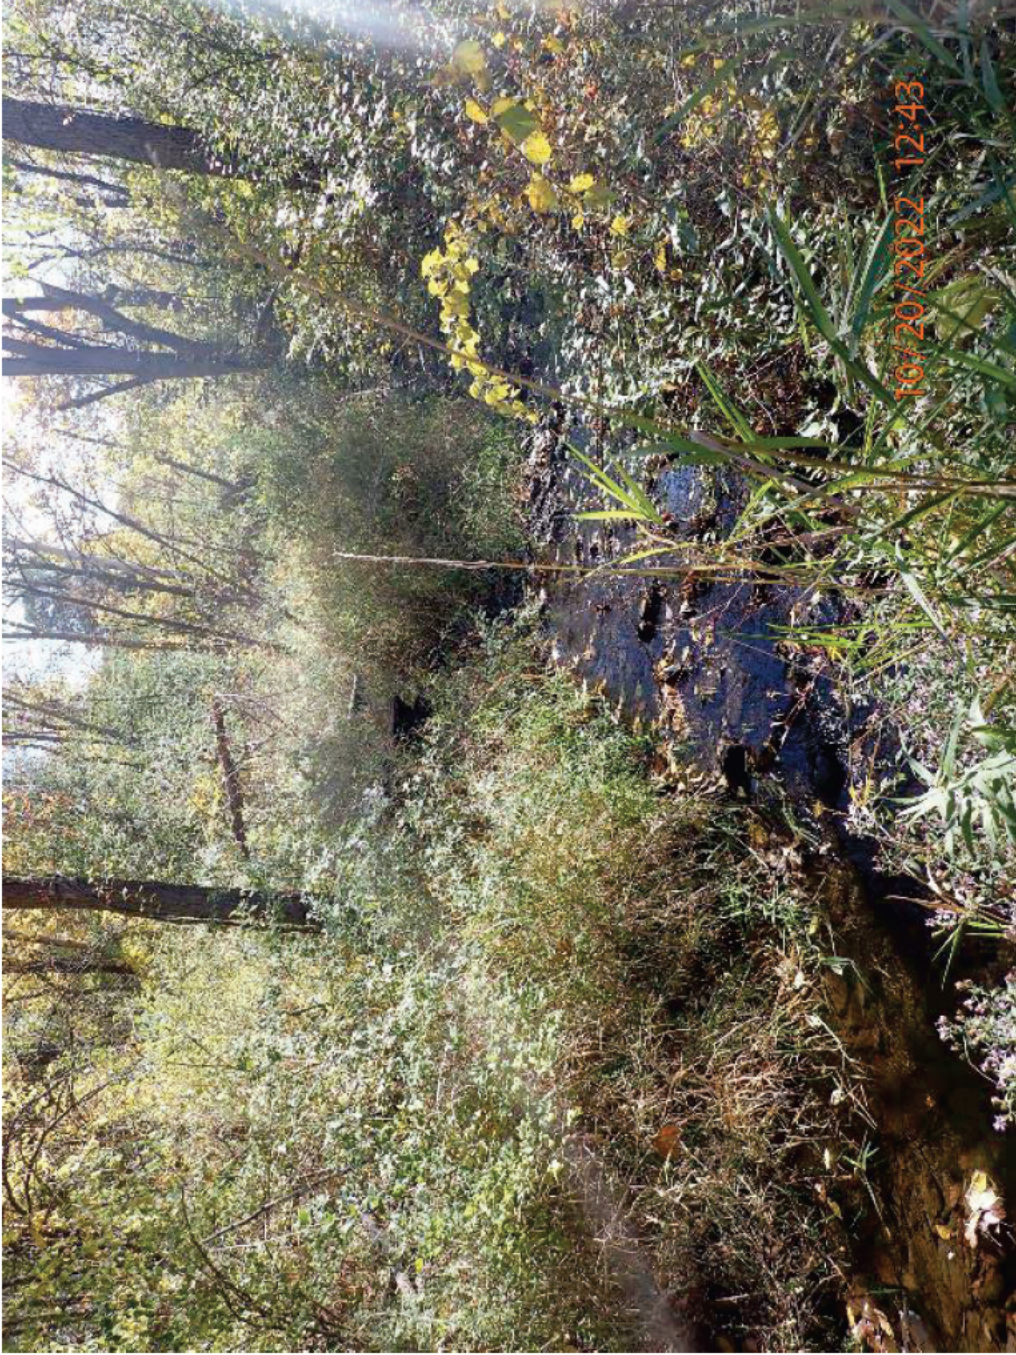
Date: 10/20/2022
Time: 12:43 PM
Photographer: S. Robinson
Photo ID: 8 – PA200513

Actively flowing stream, Youngs Brook, located east of the disturbed portion of the parcel

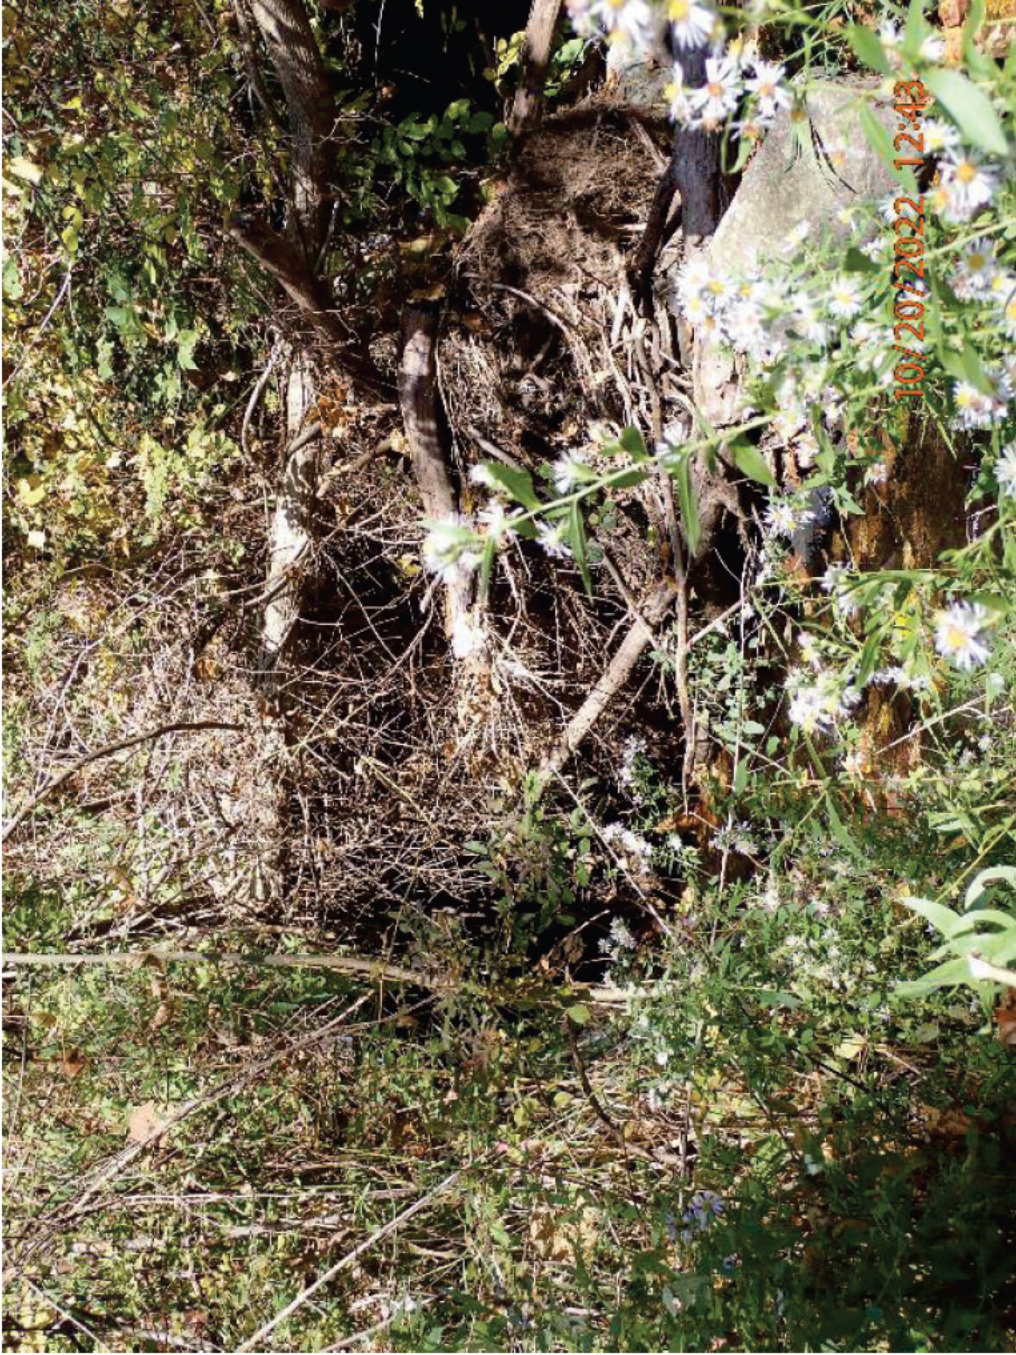
Date: 10/20/2022
Time: 12:43 PM
Photographer: S. Robinson
Photo ID: 9 – PA200514

Actively flowing stream, Youngs Brook, located east of the disturbed portion of the parcel

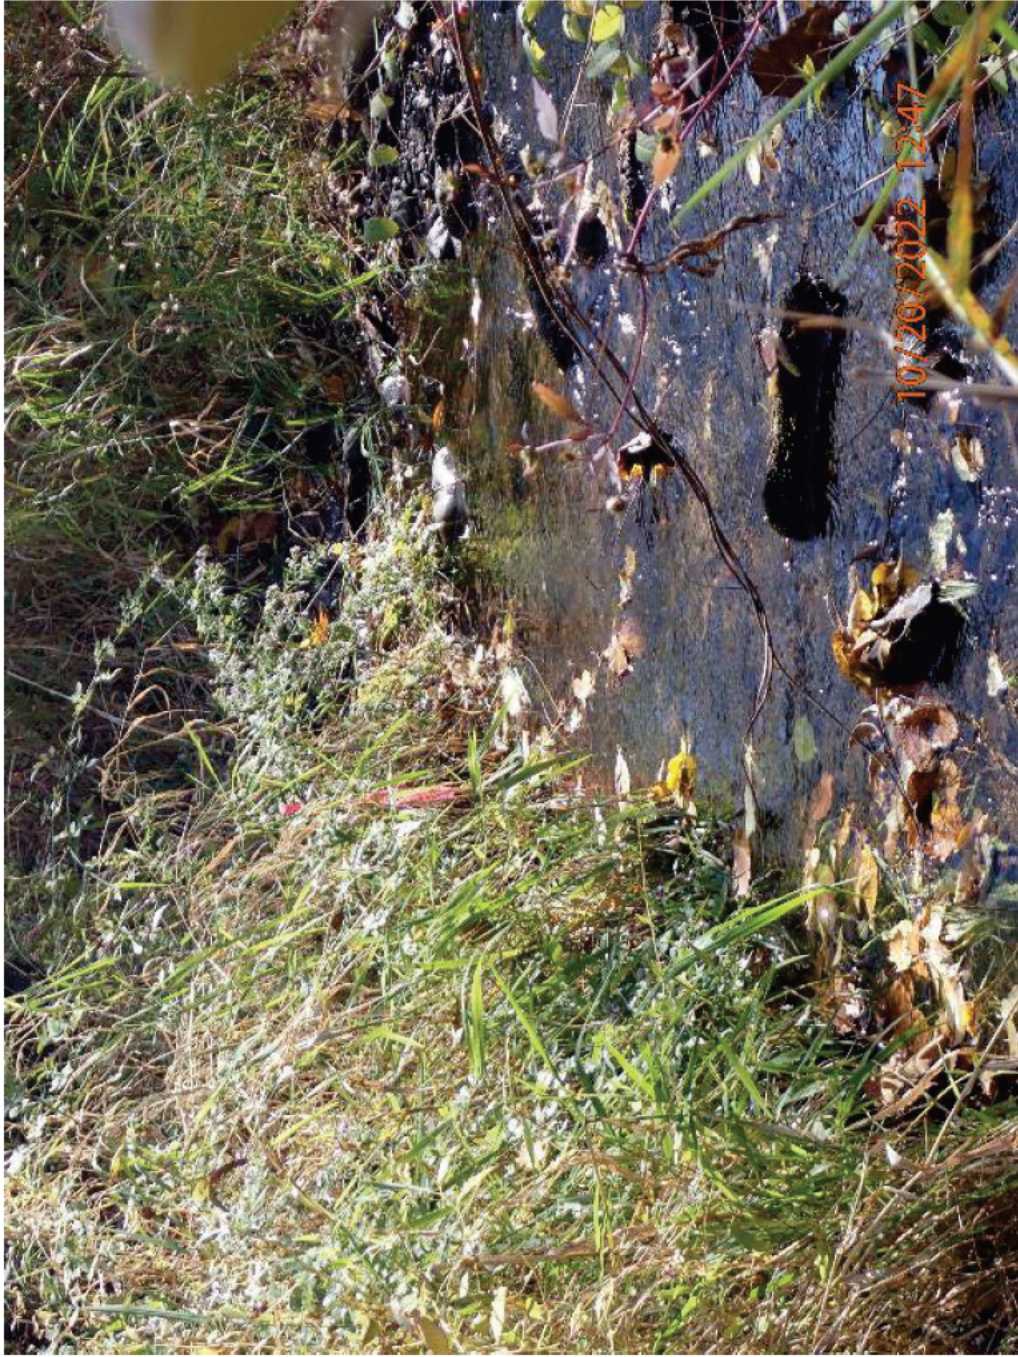
Date: 10/20/2022
Time: 12:47 PM
Photographer: S. Robinson
Photo ID: 11 – PA200516

Actively flowing stream, Youngs Brook, located east of the disturbed portion of the parcel

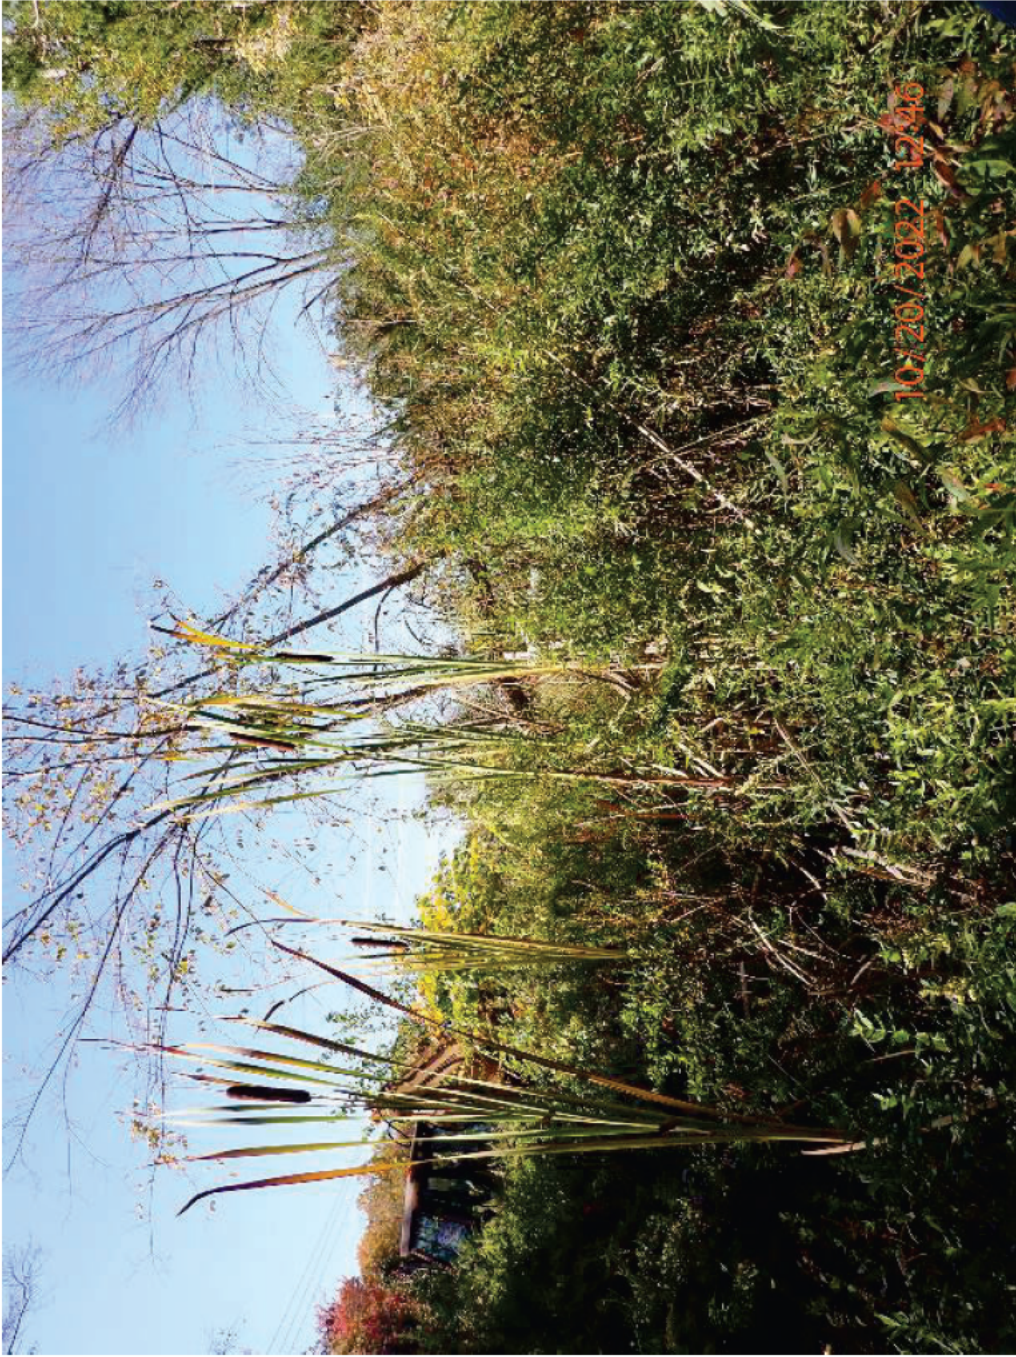
Date: 10/20/2022
Time: 12:46 PM
Photographer: S. Robinson
Photo ID: 10 – PA200515

Cattail vegetation adjacent to
Youngs Brook

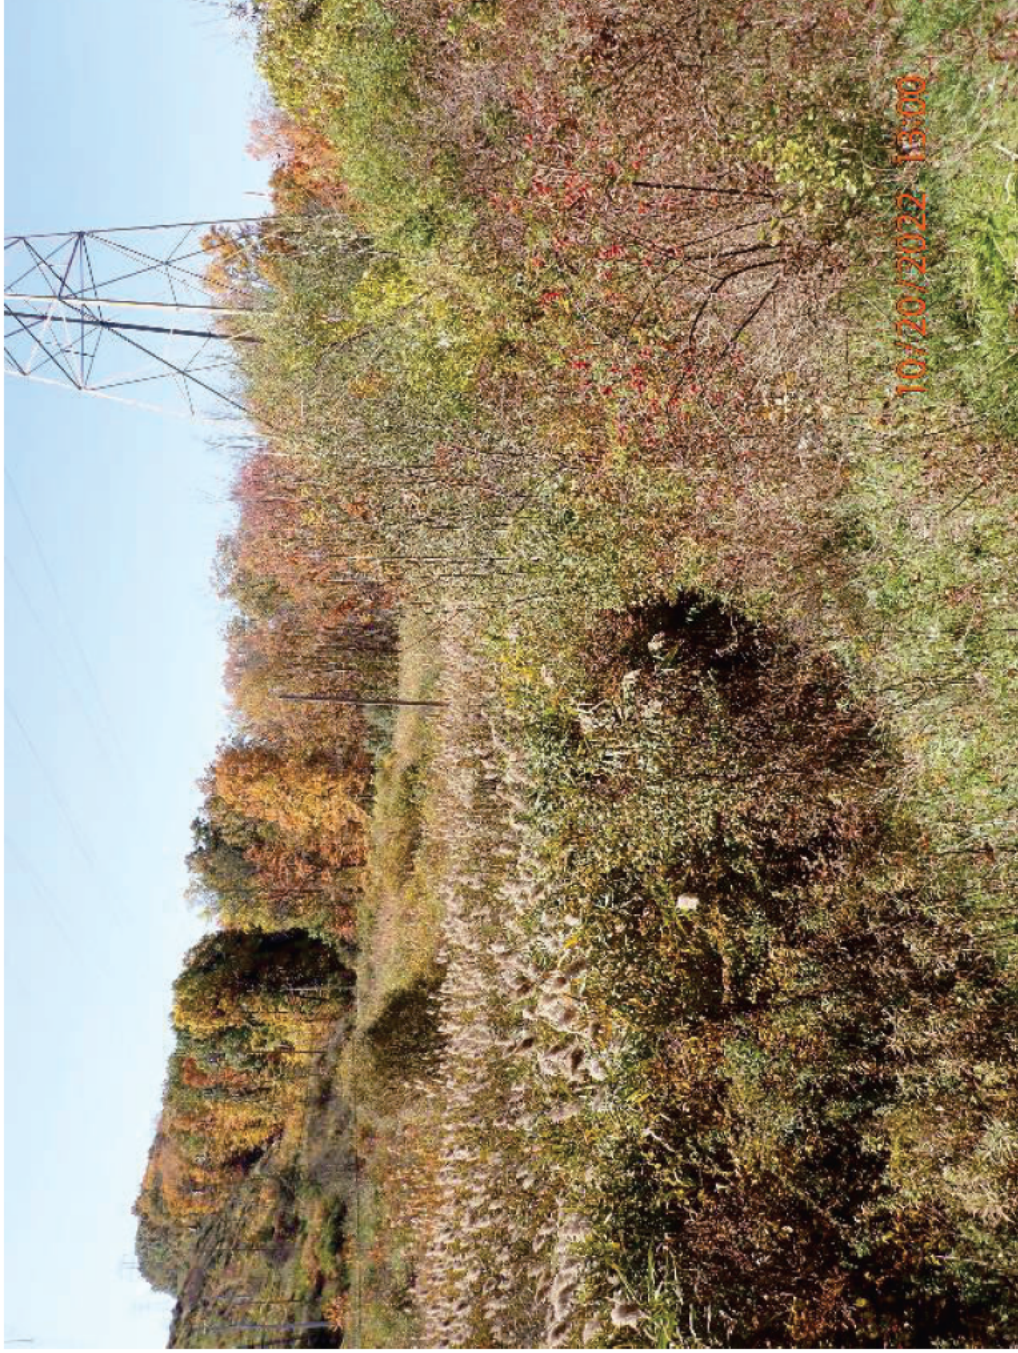
Date: 10/20/2022
Time: 1:00 PM
Photographer: S. Robinson
Photo ID: 14 – PA200519

Panorama of the *Phragmites* located in the northwest corner of the site

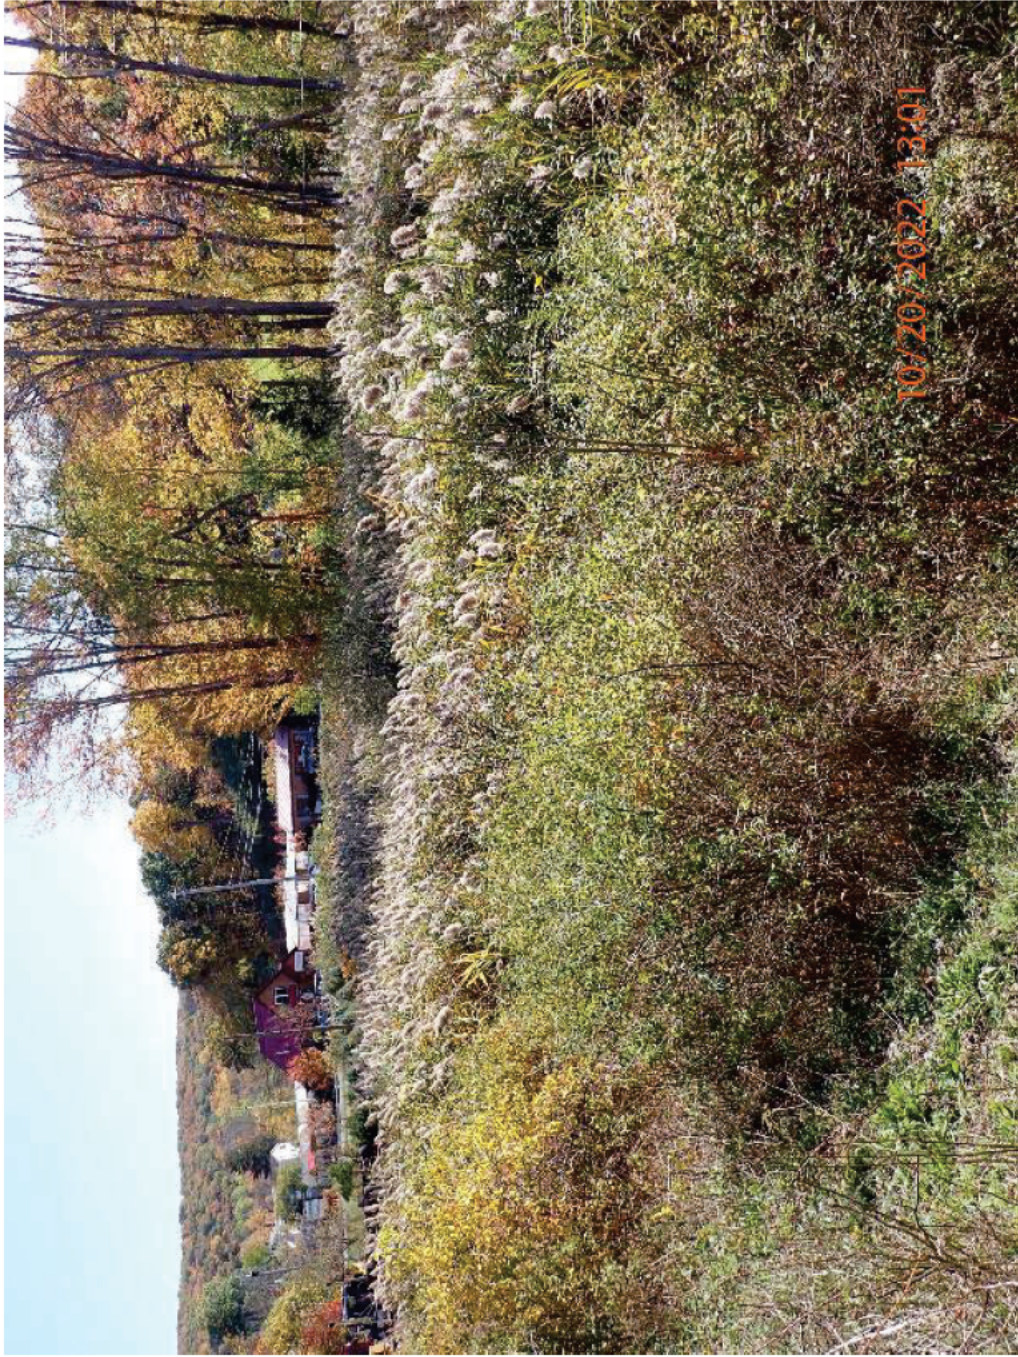
Date: 10/20/2022
Time: 1:01 PM
Photographer: SSA
Photo ID: 15 – PA200520

Panorama of the *Phragmites* located in the northwest corner of the site

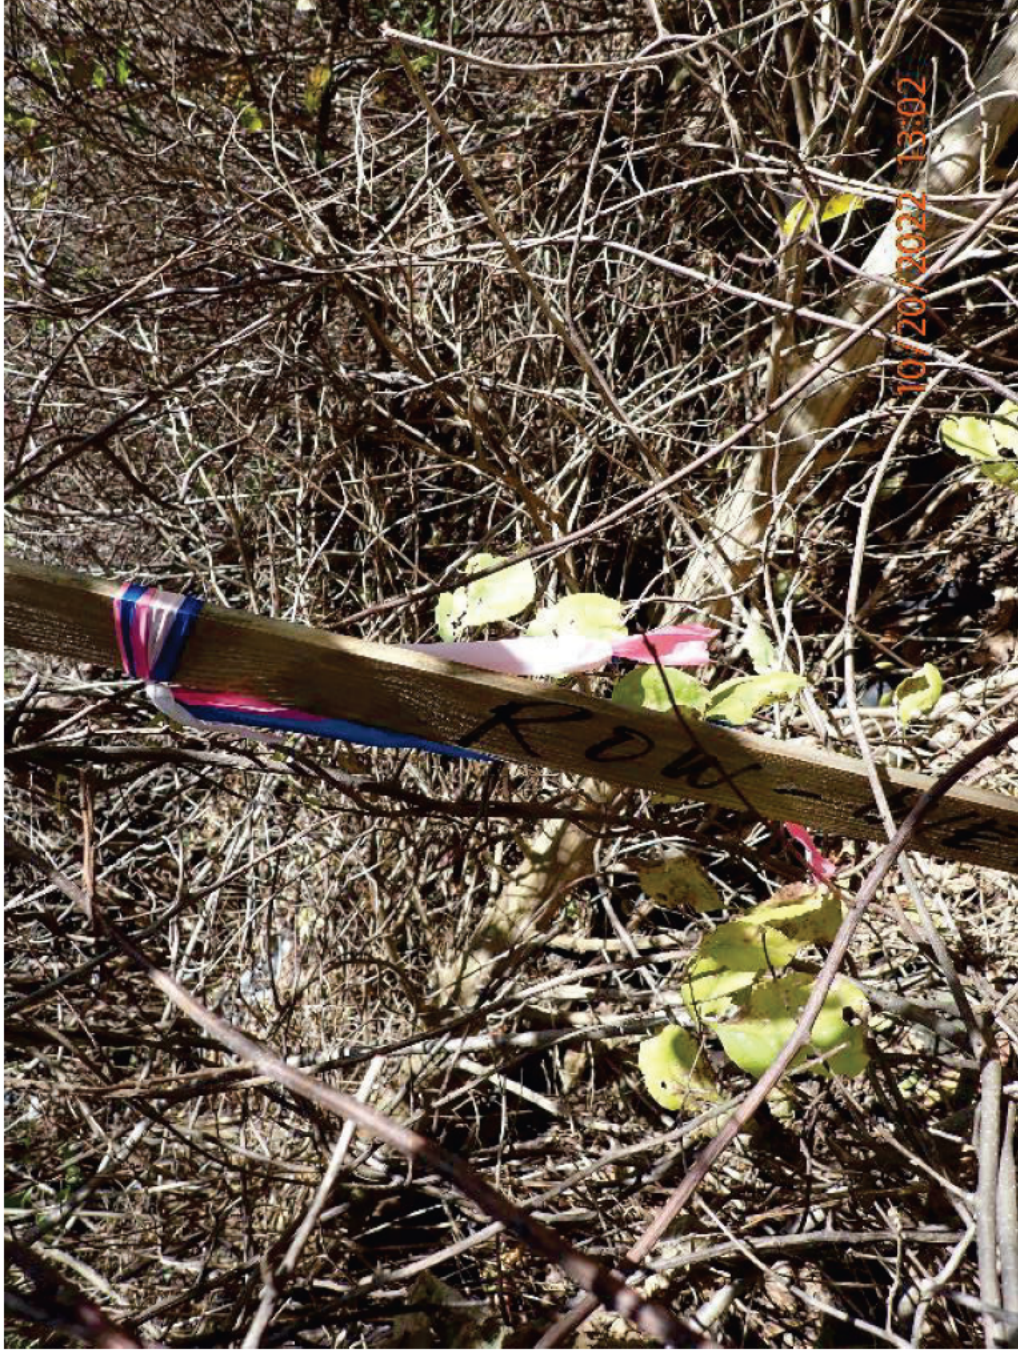
Date: 10/20/2022
Time: 1:02 PM
Photographer: SSA
Photo ID: 16 – PA200521

Transco right-of-way flag marker found within the *Phragmites* on the site
