Clean Water Act Section 404: Site Visit/Case Development

Site Name	Lawngevity Landscape and Garden Gate Nursery	Start Date	October 20, 2022
		End Date	October 20, 2022
Inspection Purpose	Initial site visit		
Opening Conference			
<input checked="" type="checkbox"/> Presentation of Inspector Credentials			
Name and Title (Use N/A if owner/operator not available to join the inspection)			
Credentials were presented to Mr. Paul Elfers (president of Lawngevity)			
<input checked="" type="checkbox"/> Opening Conference			
Name of person authorizing access if applicable			
I spoke with a representative of Lawngevity over the phone to arrange the inspection and authorize access. Representatives of Lawngevity met EPA for the inspection.			
Notes from Opening Conference			
We explained the reason for the inspection and the pointed out the area that we were interested in inspecting.			
<input checked="" type="checkbox"/> Access Issues if Any			
Describe			
Note: At the start of the inspection, EPA was unaware the that property was not owned by Lawngevity/Mr. Elfers. Lawngevity representatives informed EPA that they were leasing the property.

Lawgevity Landscaping Site Chester, Orange Count

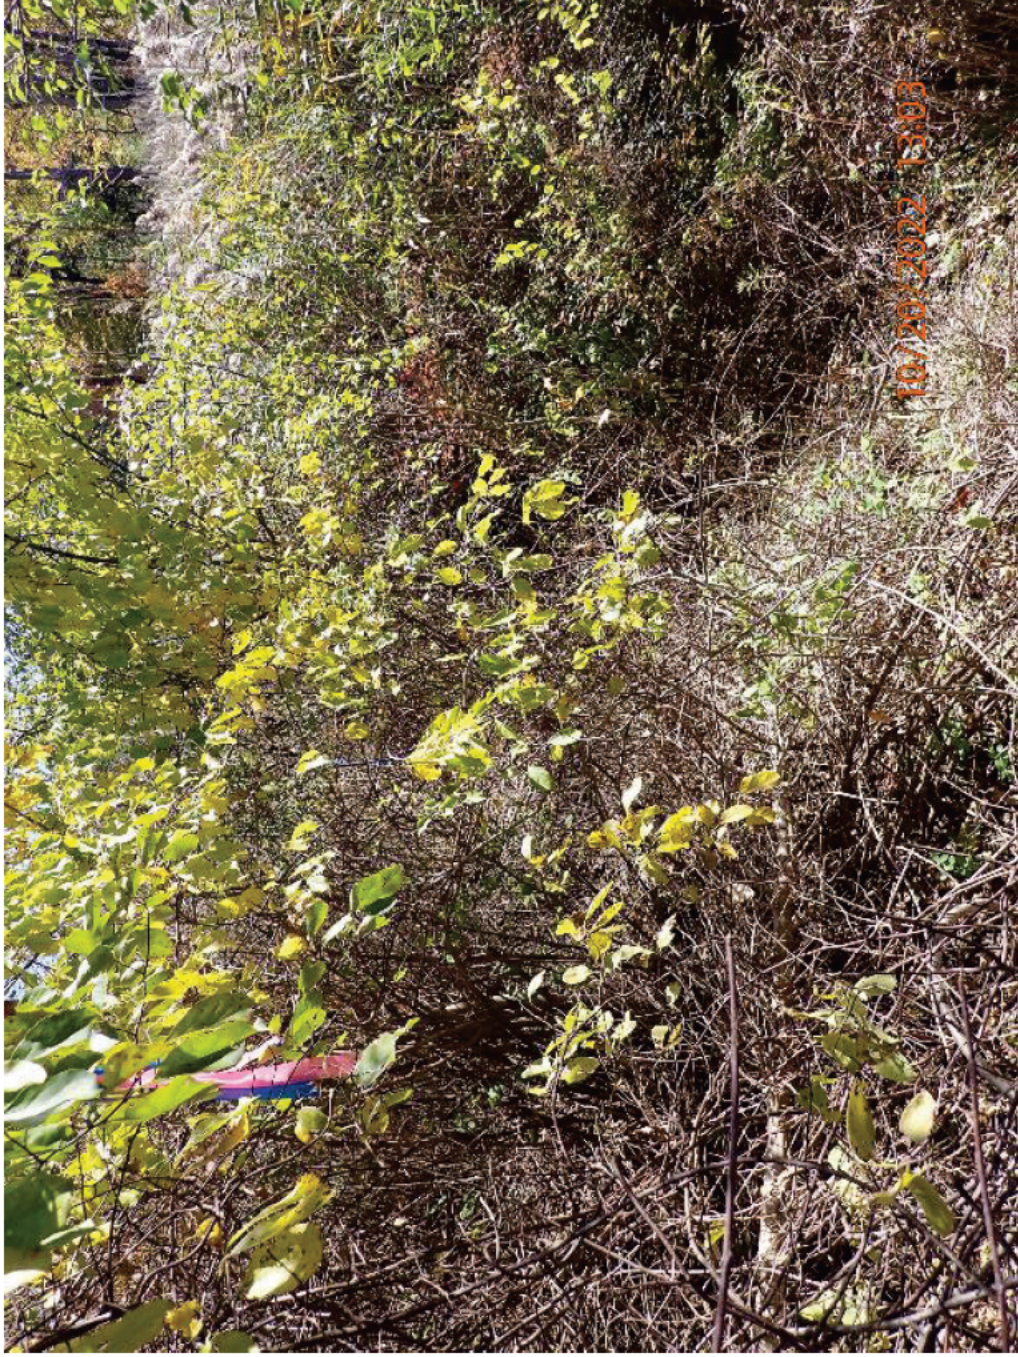
Date: 10/20/2022
Time: 1:03 PM
Photographer: S. Robinson
Photo ID: 17 – PA200522

Transco flags, including one labeled “wetland”, was found in the northwest corner of the property

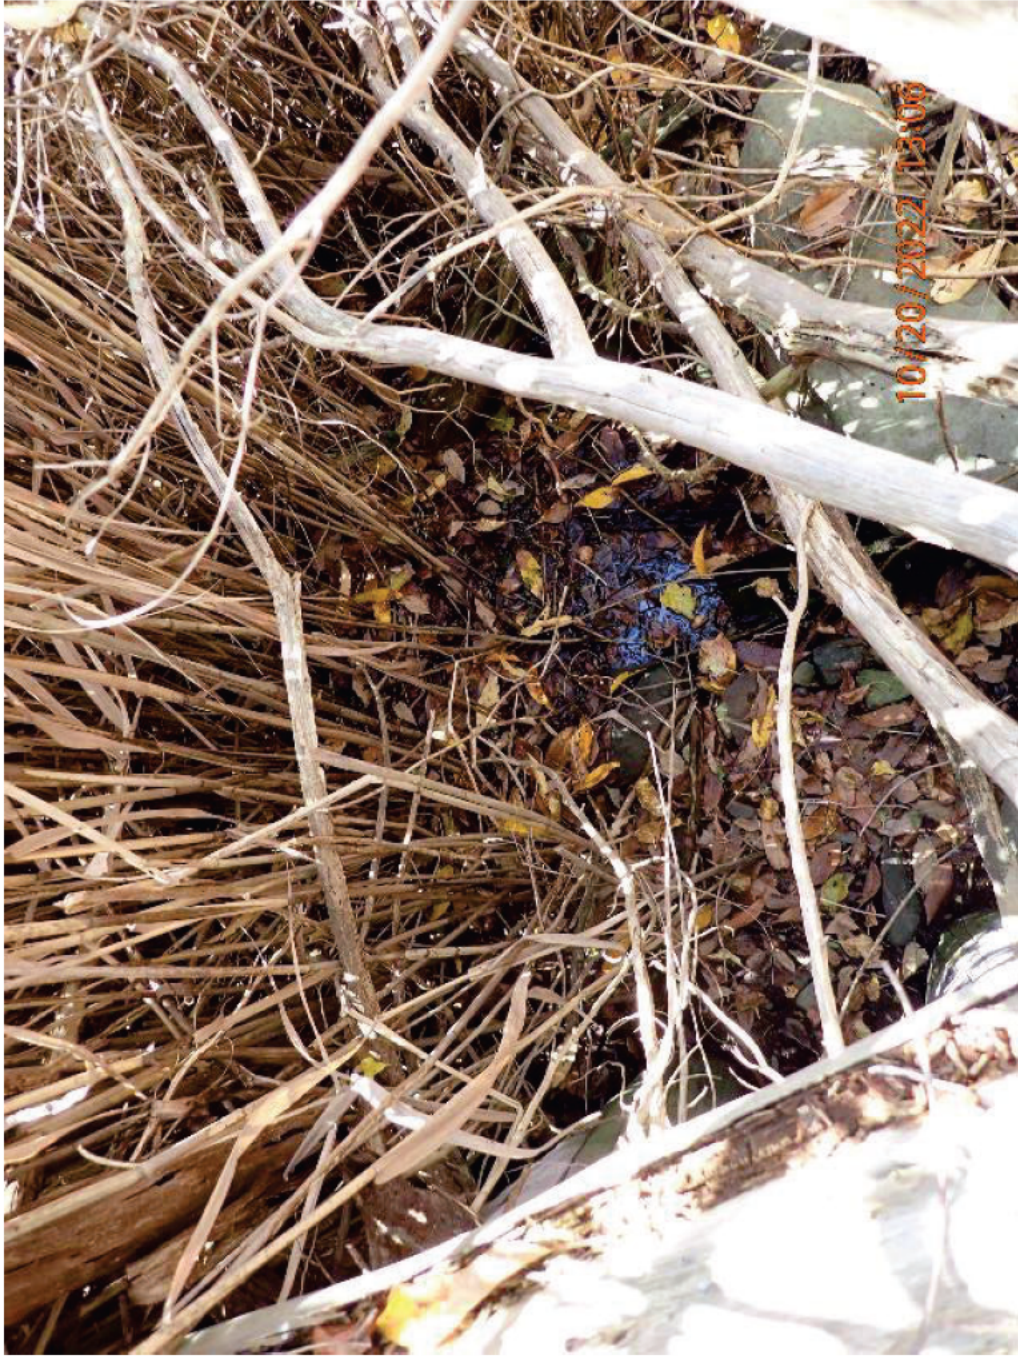
Date: 10/20/2022
Time: 1:06 PM
Photographer: S. Robinson
Photo ID: 18 – PA200523

Low profile bulkhead and standing surface water found near the base of the utility line structure

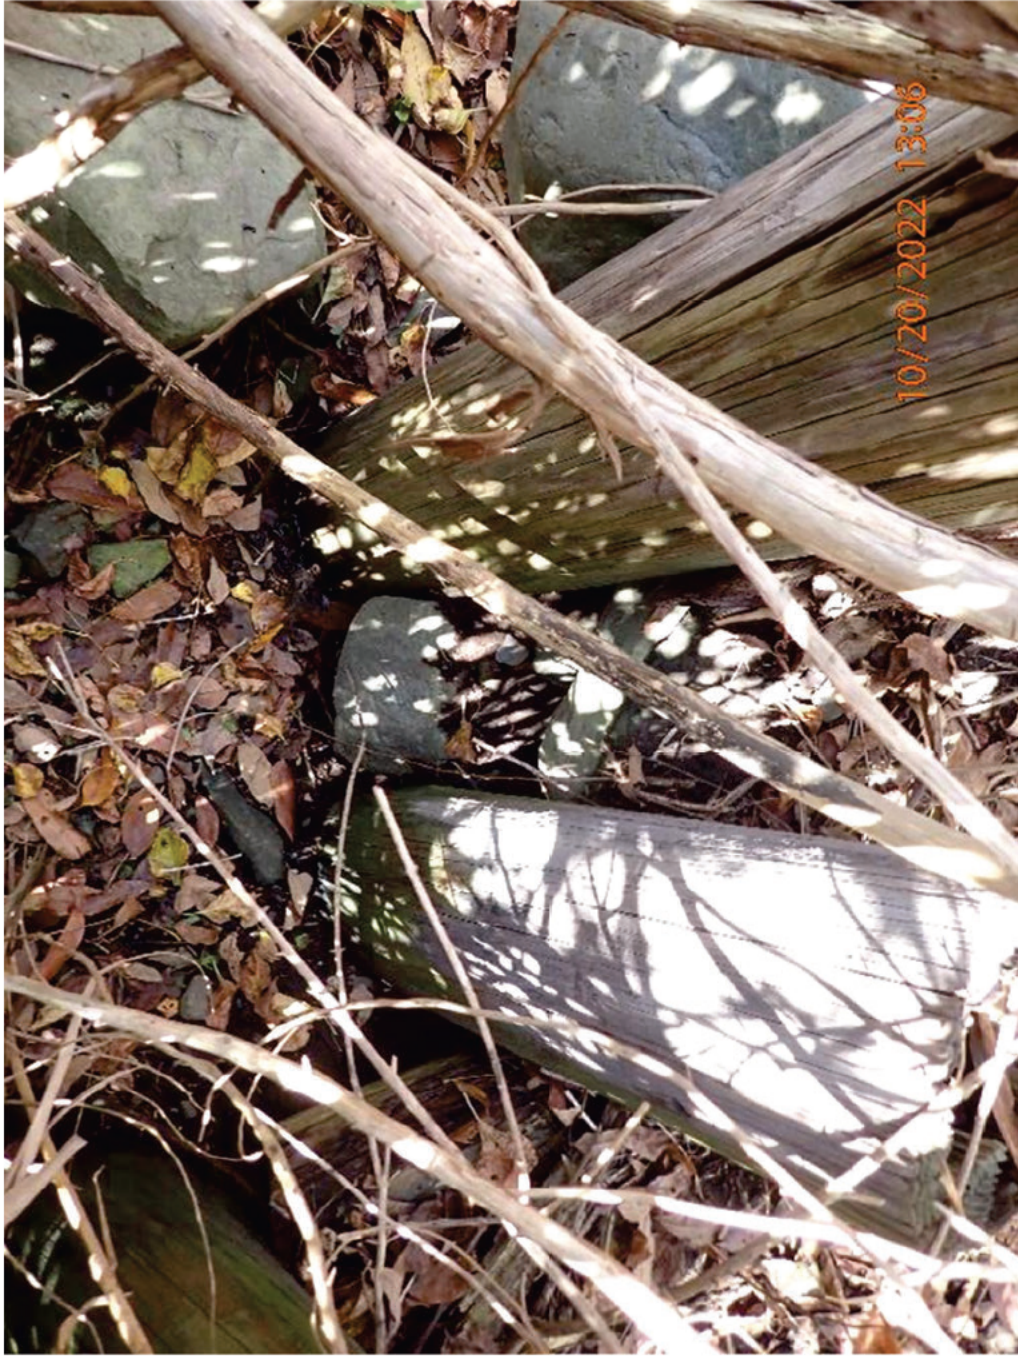
Date: 10/20/2022
Time: 1:06 PM
Photographer: S. Robinson
Photo ID: 19 – PA200524

Low profile bulkhead found near the base of the utility line structure.
