# RCRA Compliance Evaluation Inspection Report

Sandvik Palm Coast (SPC)  
1 Commerce Boulevard  
Palm Coast, Florida 32164-7961  
County: Flagler  
Latitude: 29.551731  
Longitude: -81.263176  
EPA ID Number: FLD984229716

On December 14, 2021, Luke Lewis and Emma Sacchitello of FDEP, and Daryl Himes, EPA, conducted a routine compliance evaluation inspection of Sandvik Palm Coast to determine the facility's compliance with state and federal hazardous waste regulations. This was an EPA lead inspection.

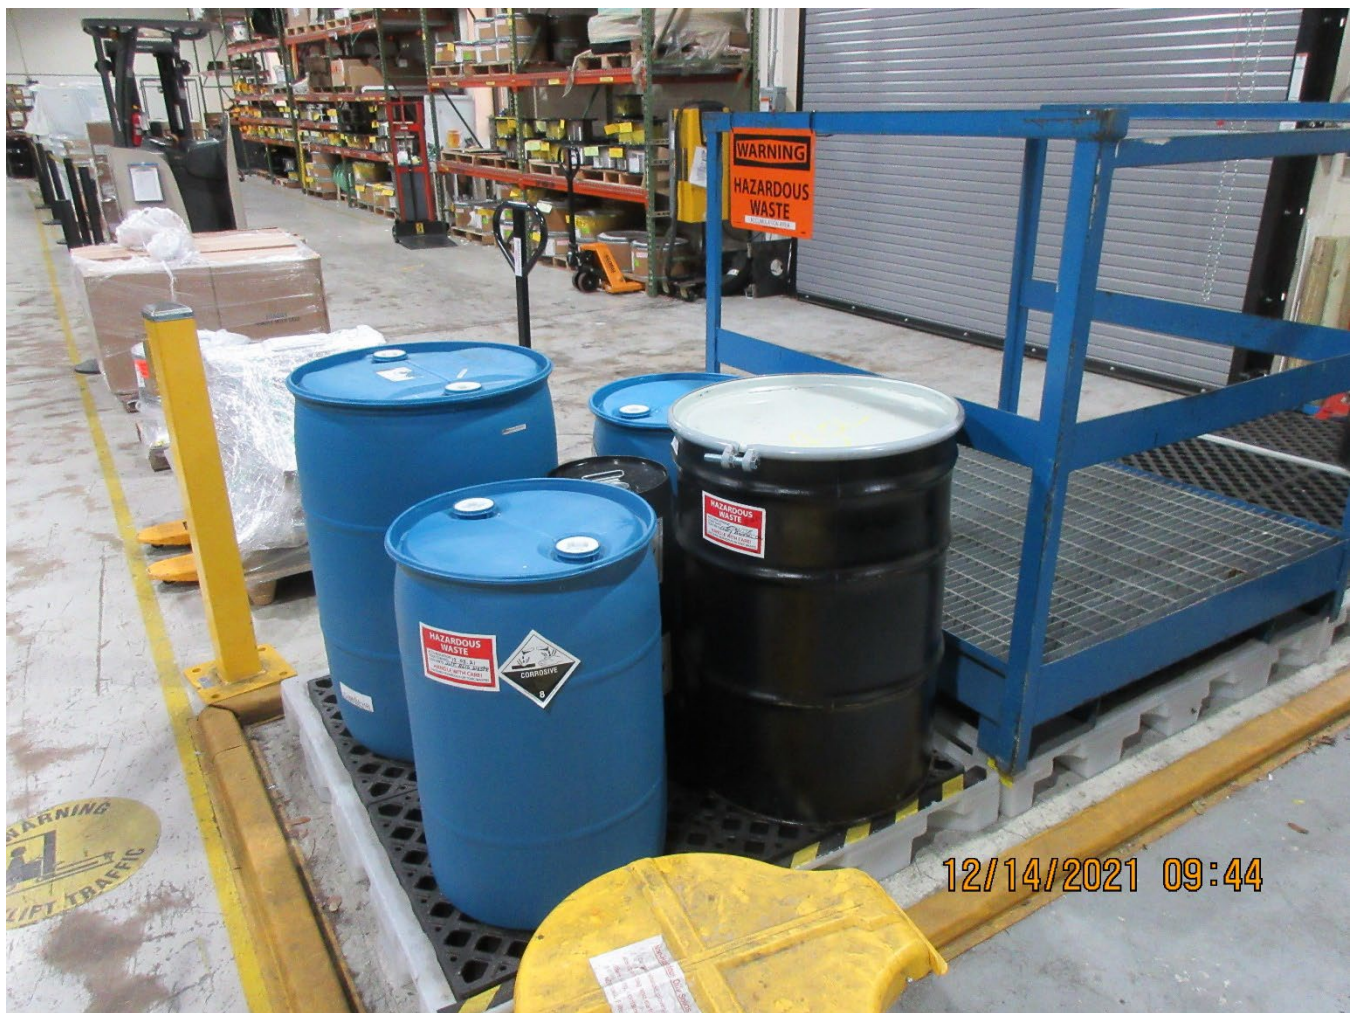
One 55-gallon container of hazardous waste aerosol cans, one 30-gallon container of spent sulfuric acid and one 30-gallon container of ignitable hazardous waste were observed in this area (Photo 1).

Photo 1 – Commerce 3 90-Day Accumulation Area in Corner of Main Room

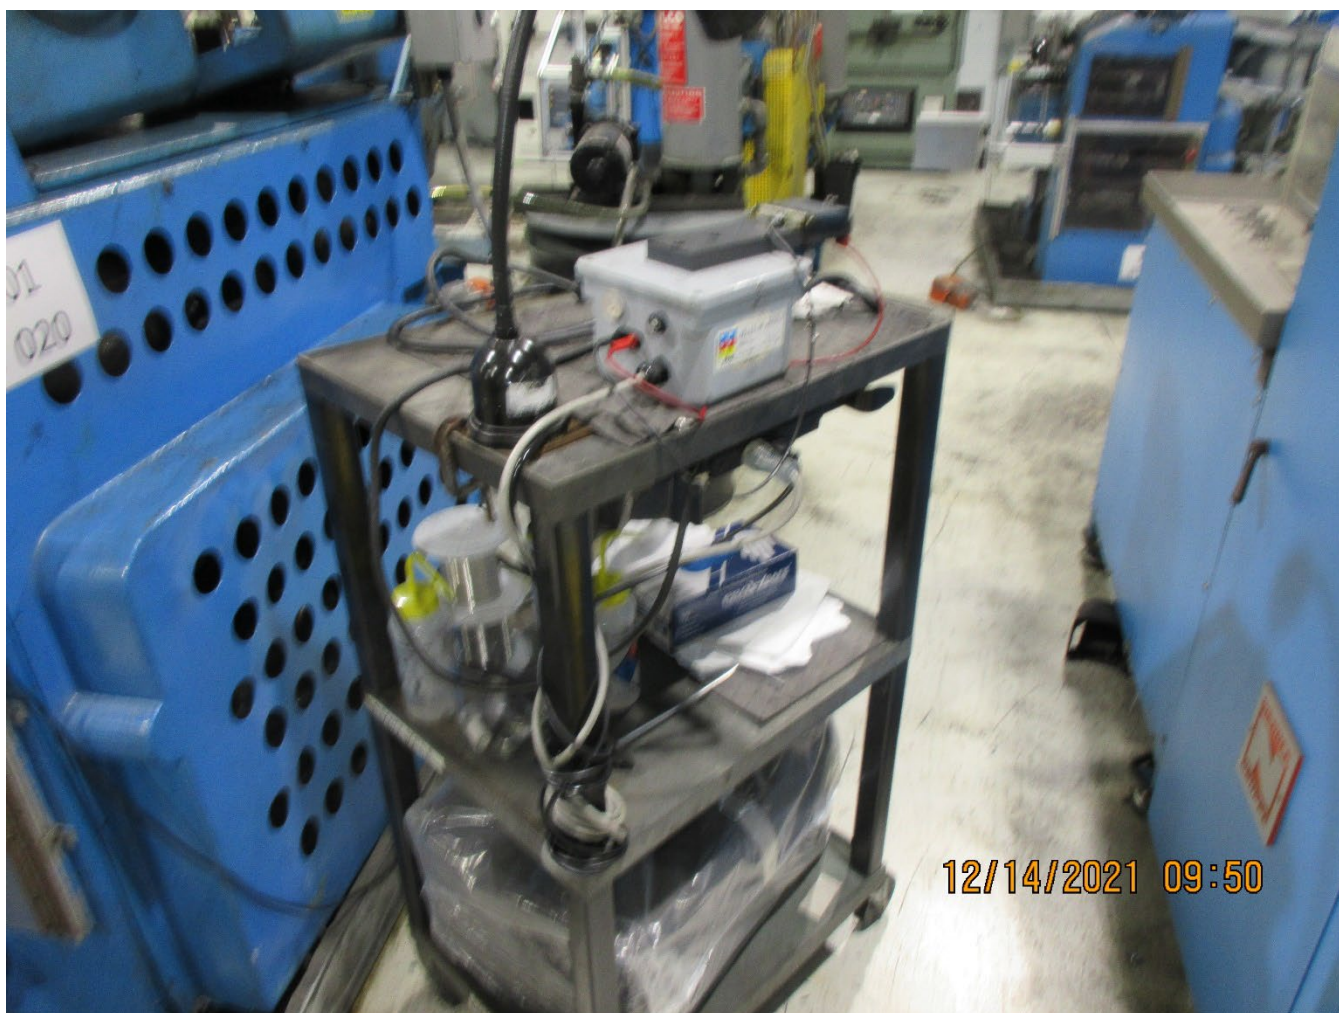
Various types of equipment used for the shaping of SPDW and the cleaning of equipment were observed in this area. Acid pots (Photo 2) and ultrasonic machines (Photo 3) were observed in various locations in this area. The acid pots were typically observed on top of a portable cart as shown in Photo 2. When the acid and solvent from their respective storage vessels becomes unusable, it is placed into a hazardous waste container within a SAA or a 90-day accumulation area.

Photo 2 - Commerce 3 Acid Pot on Cart in Main Room

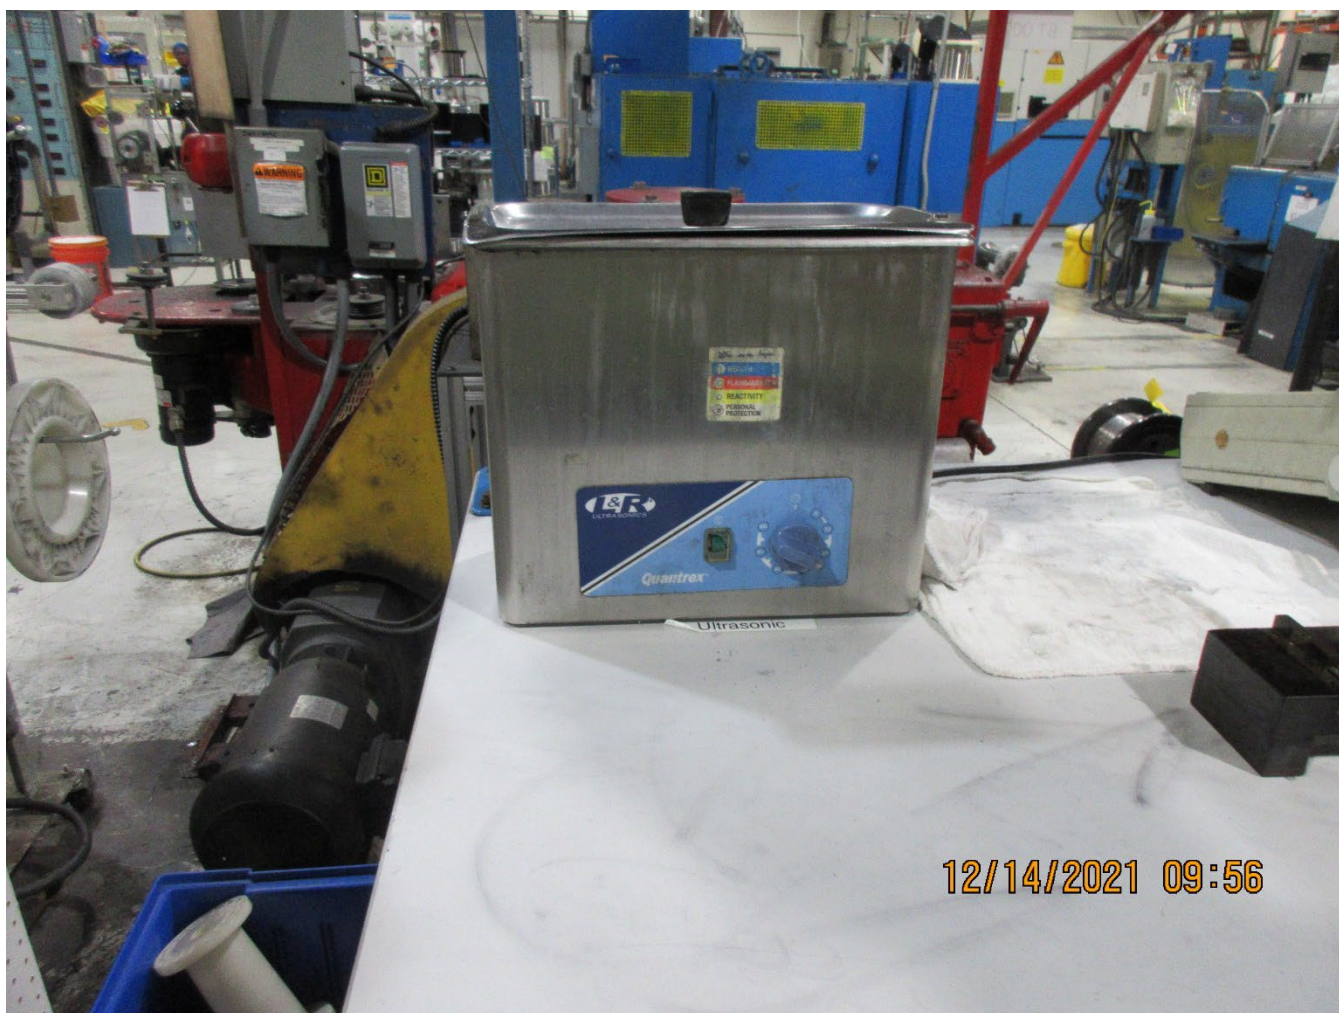
Photo 3 - Commerce 3 Ultrasonic Machine in Main Room

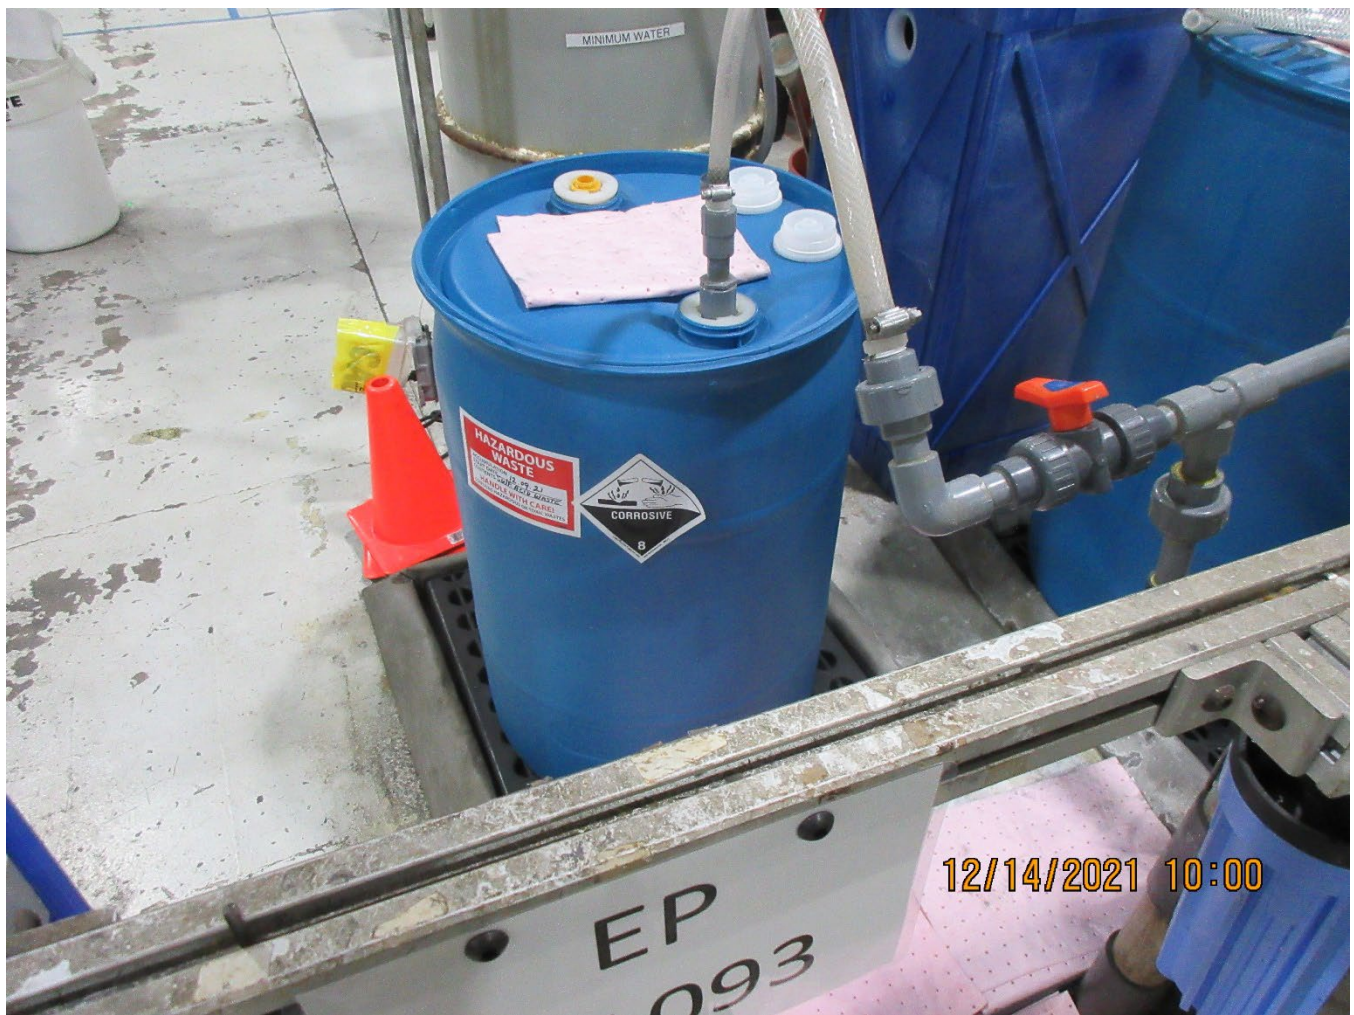
The electro-polishing line located in the middle of this area was comprised of baths of sulfuric acid and sodium hydroxide. SPDW is passed through these baths and then through baths of deionized water rinses and re-spooled. The sulfuric acid solution, sludge and spent filters which are generated as part of this operation are changed every 24 hours or at the end of a production run. The sodium hydroxide solution is changed less frequently and is dependent on use. Spent sulfuric acid from the electro-polishing line was being placed into a 30-gallon container within a SAA in the area of the machine (Photo 4).

Photo 4 – Commerce 3 30-gallon drum for spent acid from the electropolishing line in the Main Room

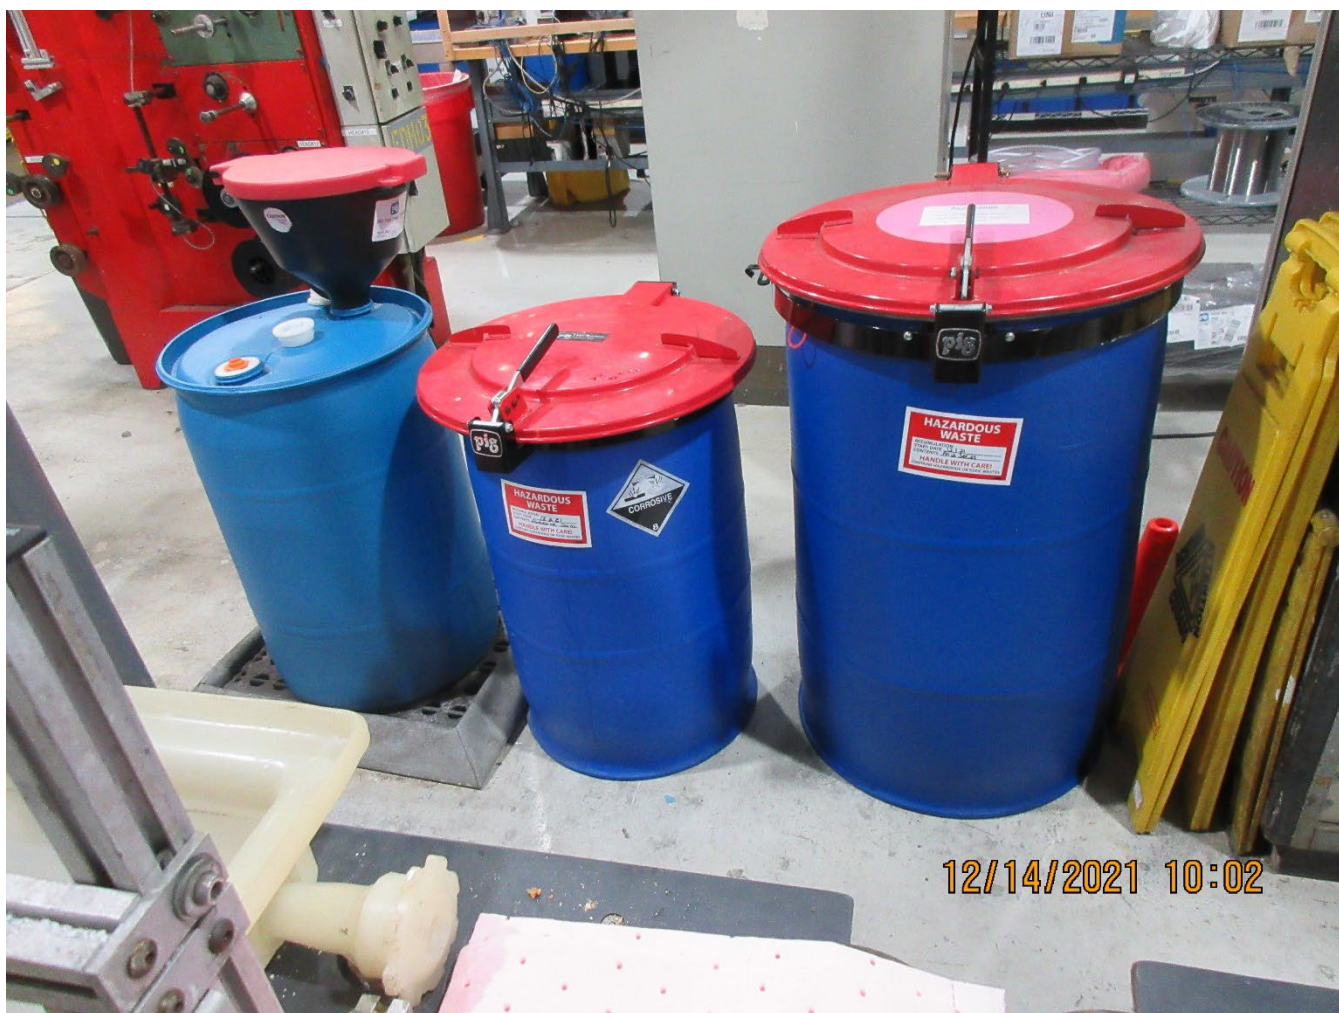
Hazardous wastes observed in this area included one 55-gallon container of acid solids, one 30-gallon container of alkaline solids, and one 30-gallon container of alkaline liquids were observed in this area (Photo 5). The 55-gallon container of hazardous waste acid solids was not labeled with an indication of the hazard contents of the container.

Photo 5 - Commerce 3 90-Day Accumulation Area in central area of Main Room

**Pursuant to Fla. Admin. Code Ann. r. 62-730.160(1) [40 C.F.R. § 262.17(a)(5)(i)(B)], which is a condition of the LQG Permit Exemption, a generator must mark or label its containers with an indication of the hazards of the contents.**

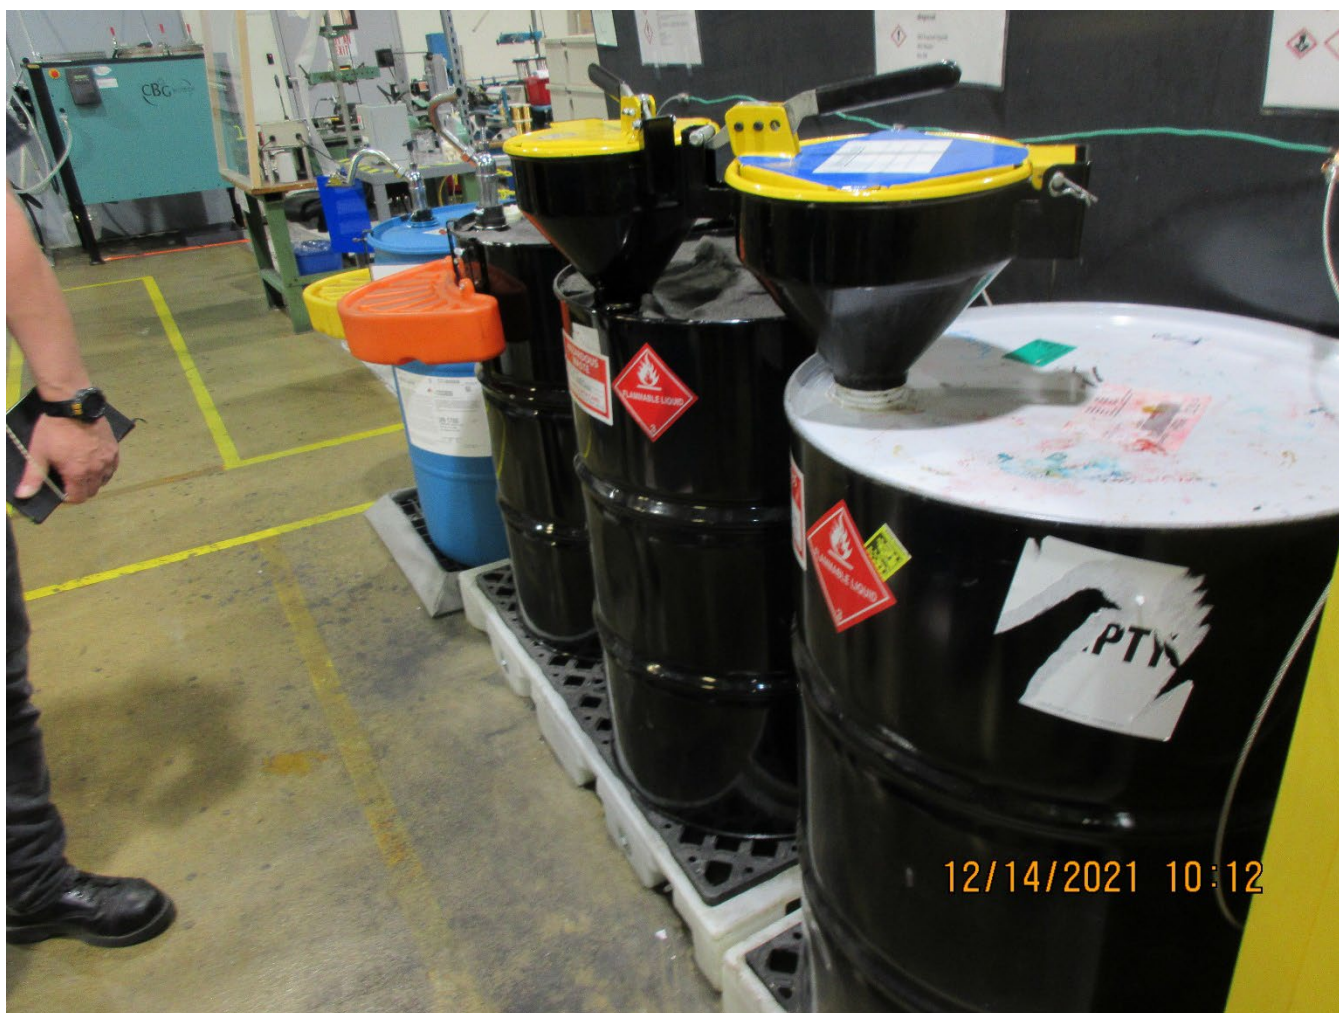
A 90-day hazardous waste accumulation area was maintained at the time of the inspection in the Medical Area (3 of 3 in the 3 Commerce Boulevard Building). Two 55-gallon drums of hazardous waste were observed in this area at the time of the inspection (Photo 6).

Photo 6 - Commerce 3 90-Day Accumulation Area in Medical Area

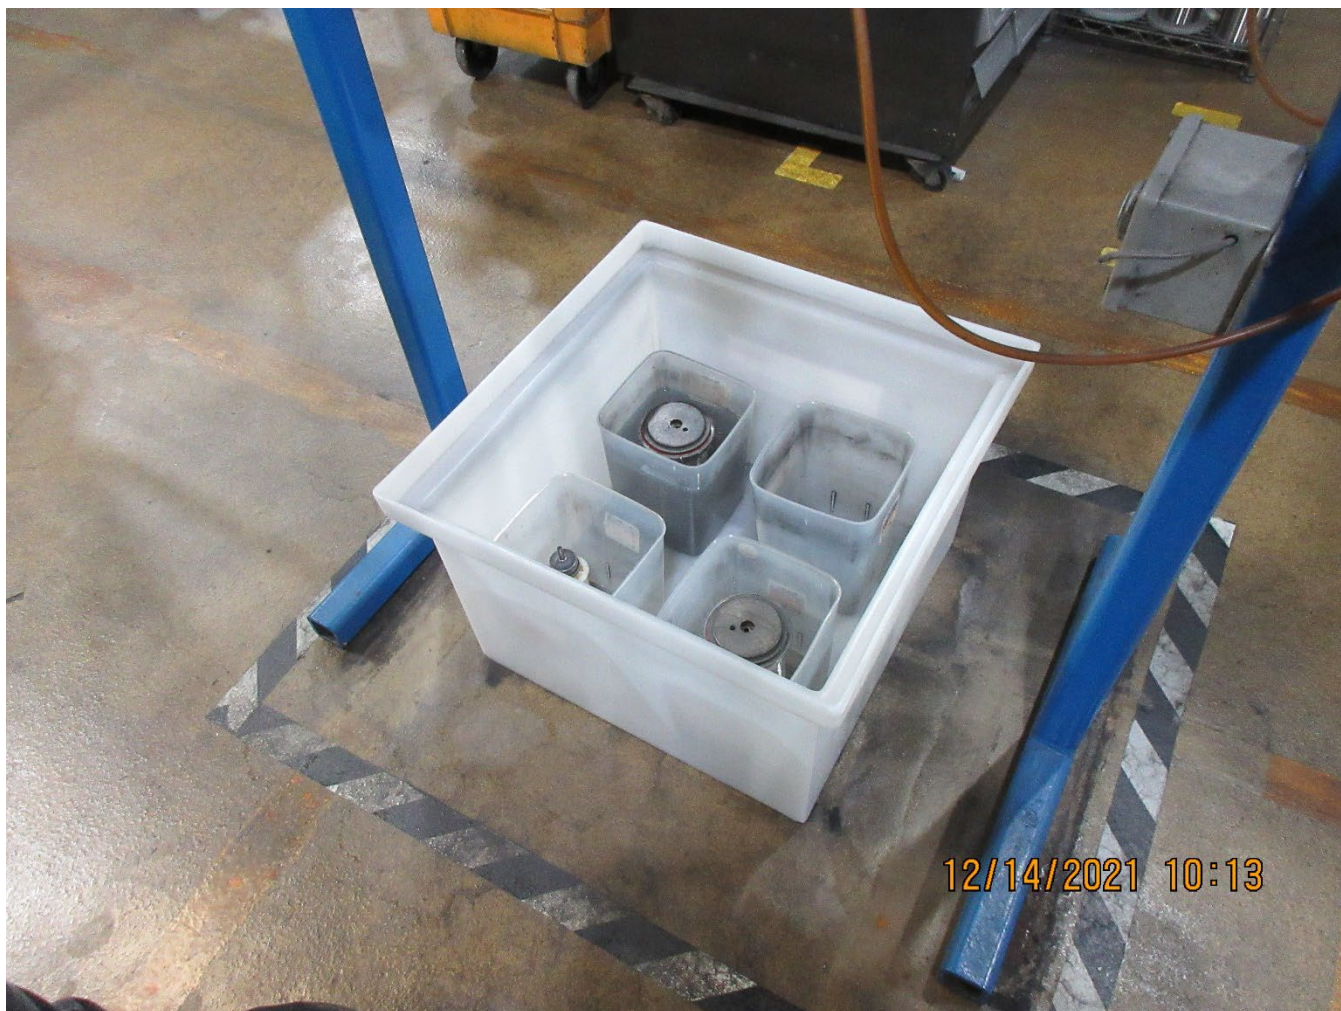
Several dies for drawing wire were observed within containers of alcohol within the Medical Area at the time of the inspection for die cleaning purposes (Photo 7). When the alcohol becomes spent, it is transferred to a hazardous waste container in a SAA or 90-day hazardous waste accumulation area.

Photo 7 – Commerce 3 Alcohol Baths used for die cleaning within the Medical Area

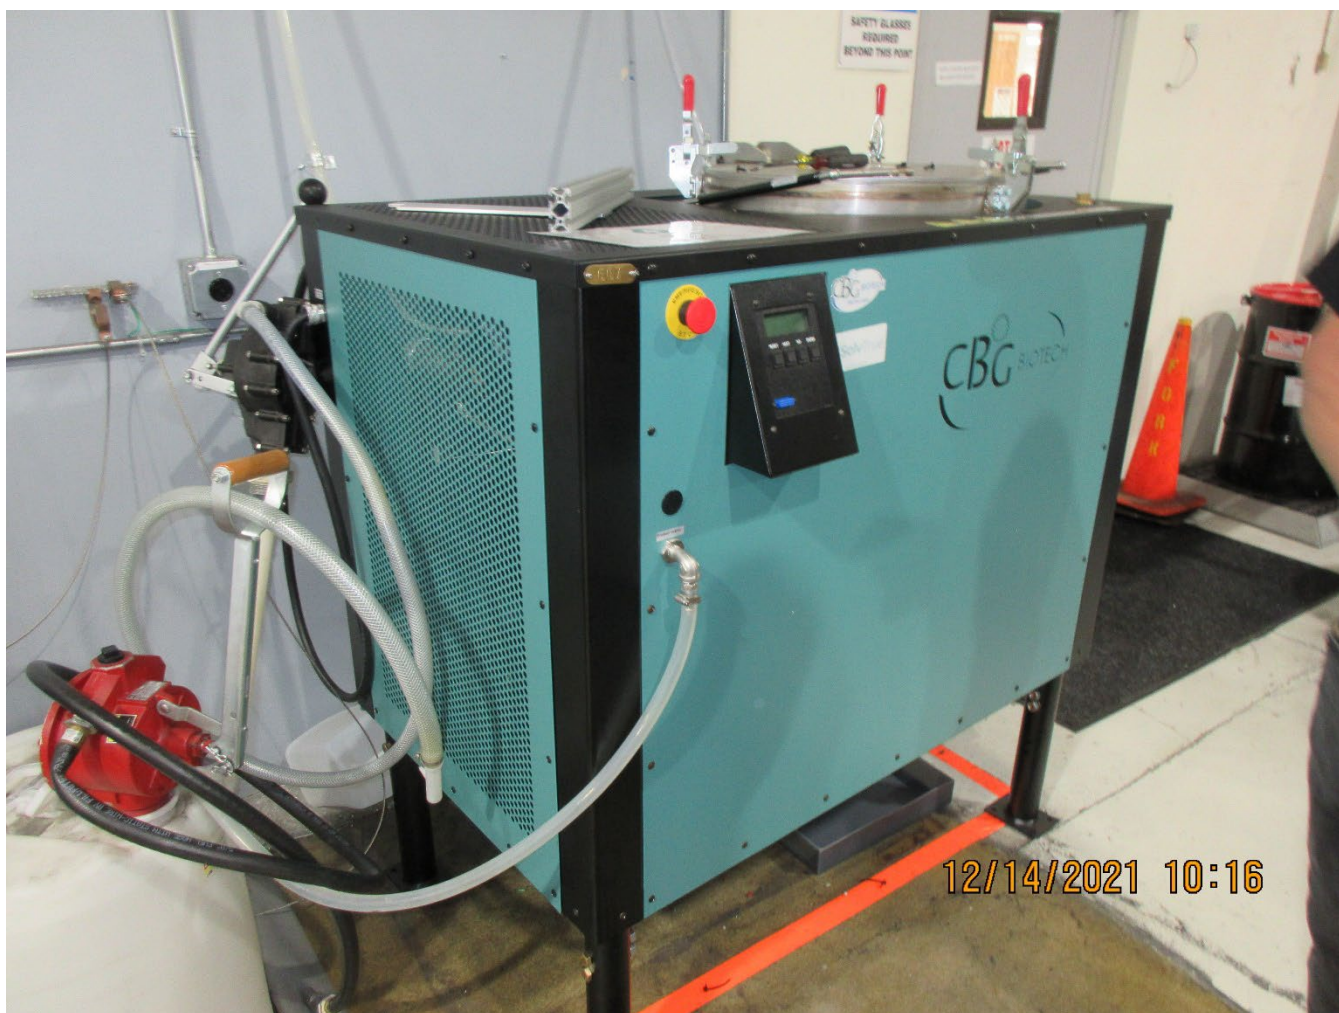
A still used for the reclamation of isopropyl alcohol (IPA) was observed in this area (Photo 8). According to Mr. Bateman, the still observed at the time of the inspection was recently purchased and was not currently in use.

Photo 8 – Commerce 3 IPA Still within the Medical Area

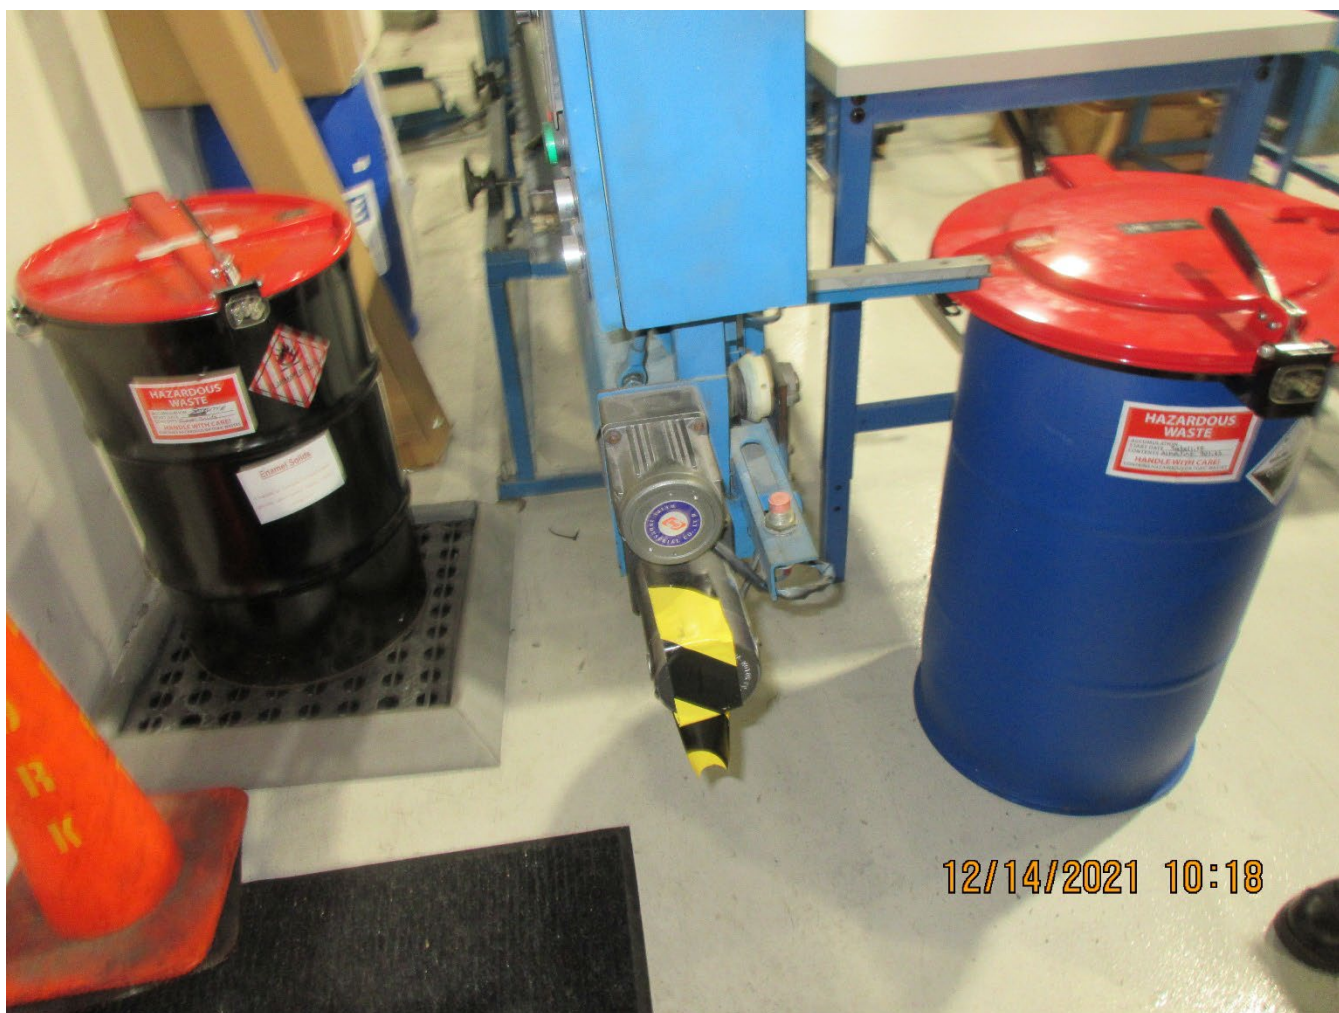
SAA's within the Medical Area were observed to have a 55-gallon container of alkaline solids and a 55-gallon container of enamel solids (Photo 9). The alkaline solids were generated from an alkaline dip pot maintained within a Components Room located adjacent to the Medical Area for the removal of coatings from the surface of wires.

Photo 9 – Commerce 3 Satellite Accumulation Areas for Alkaline Liquids (on left) and Alkaline Solids (on Left) in Medical Area

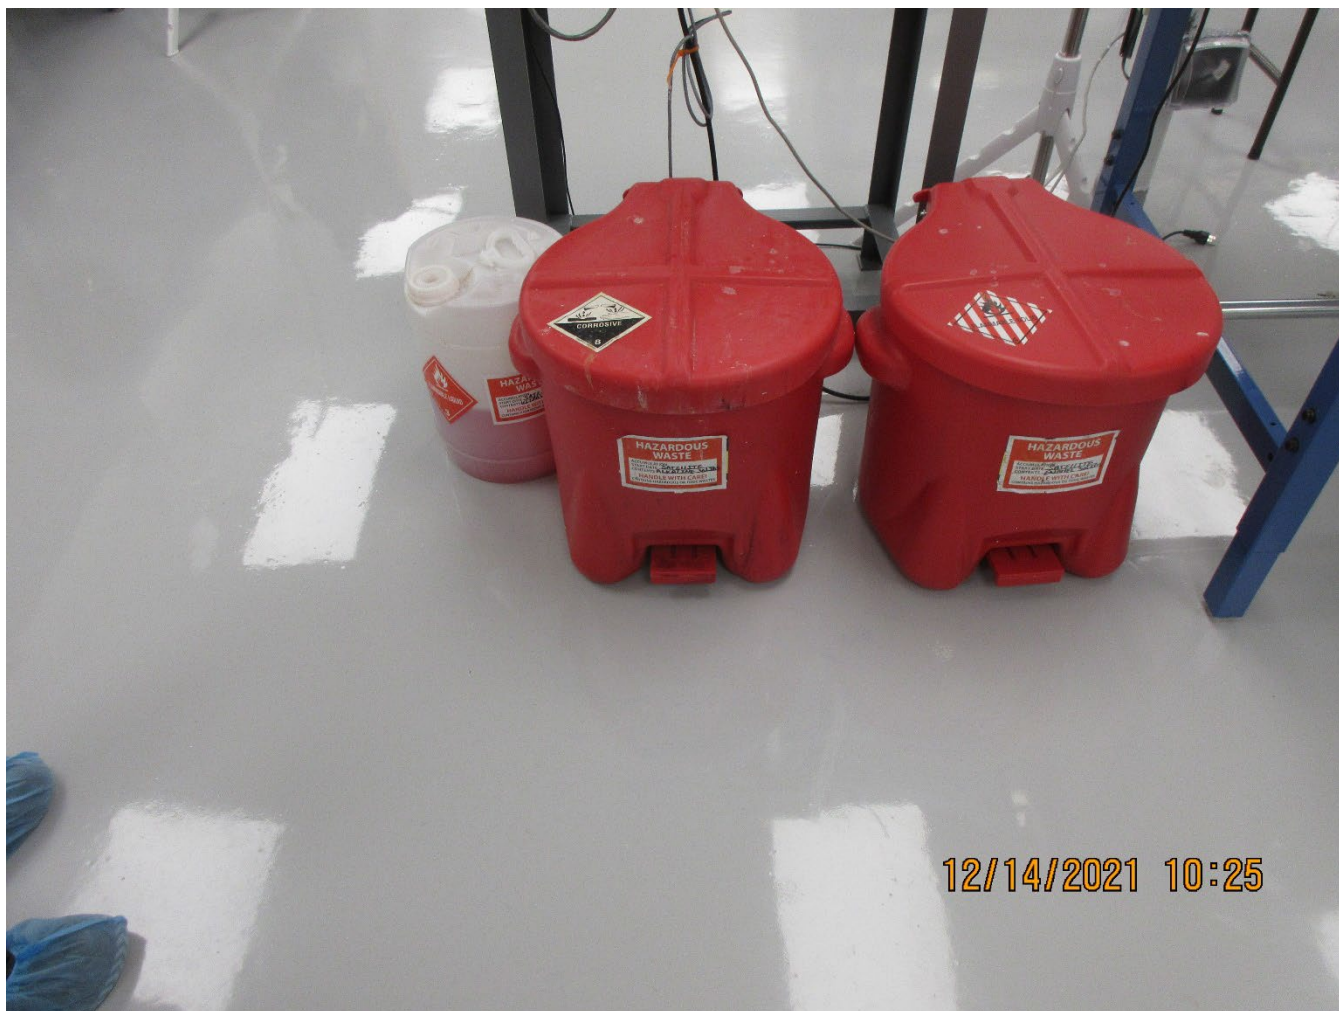
Two 10-gallon, one 5-gallon and two 1-gallon containers of hazardous waste were observed in this area (Photo 10).

Photo 10 – Commerce 3 Satellite Accumulation Area within Components Room

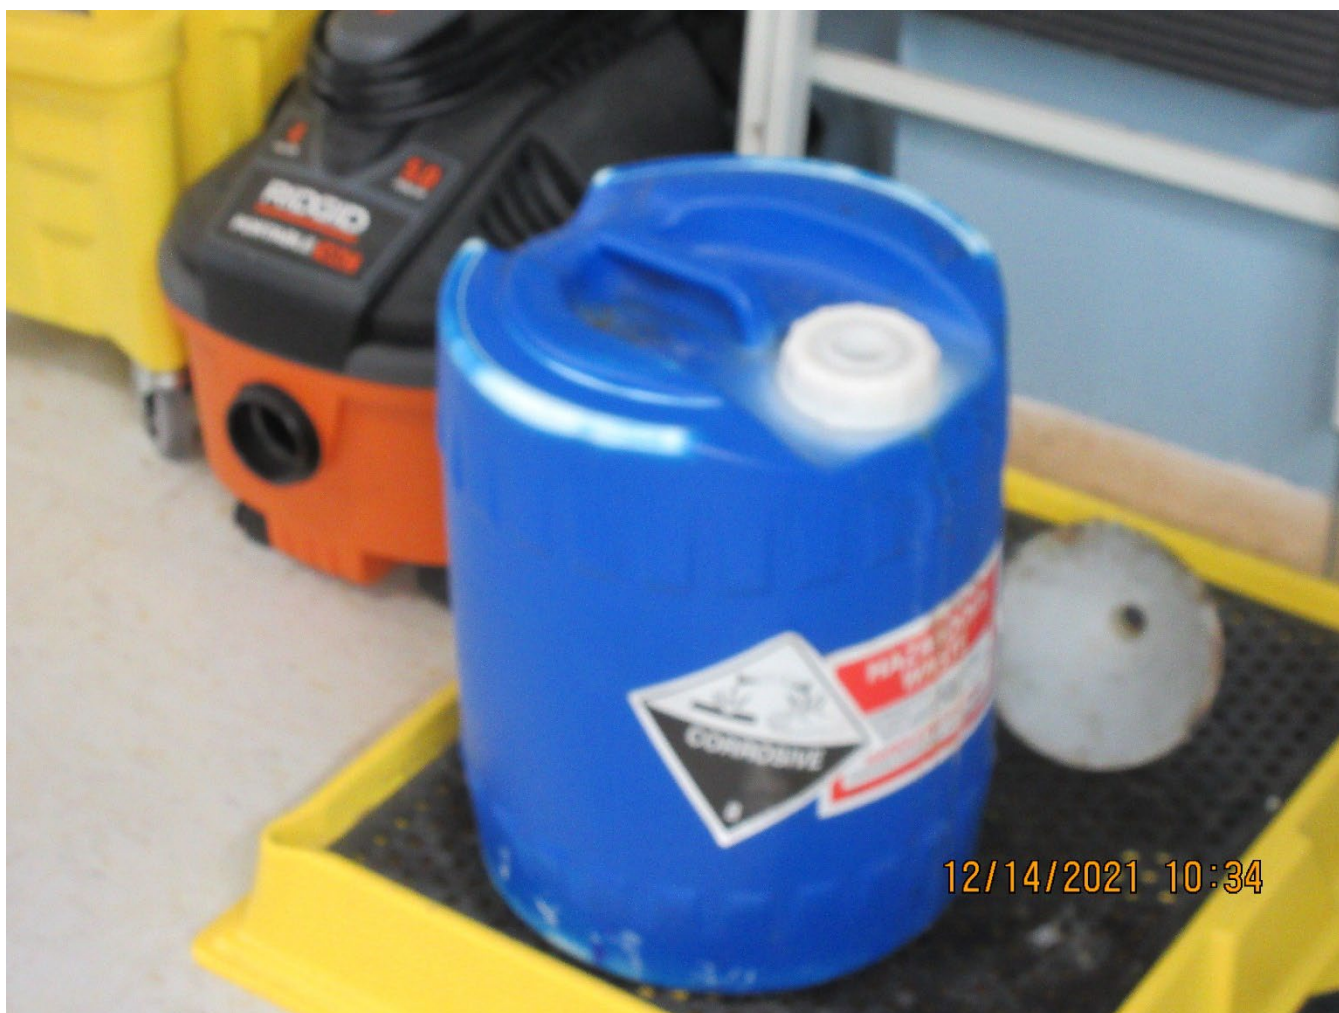
The Die Room is used for the resurfacing and resizing of diamond dies. Nitric acid in two 4-ounce jars is used to burn-off the ends of the tungsten wire used for re-alignment and polishing of dies. Two such jars were observed in this area. This process generates a liquid hazardous waste that was being accumulated in a 5-gallon satellite container (Photo 11).

Photo 11 – Commerce 3 5-gallon container of spent nitric acid from pointing in Die area

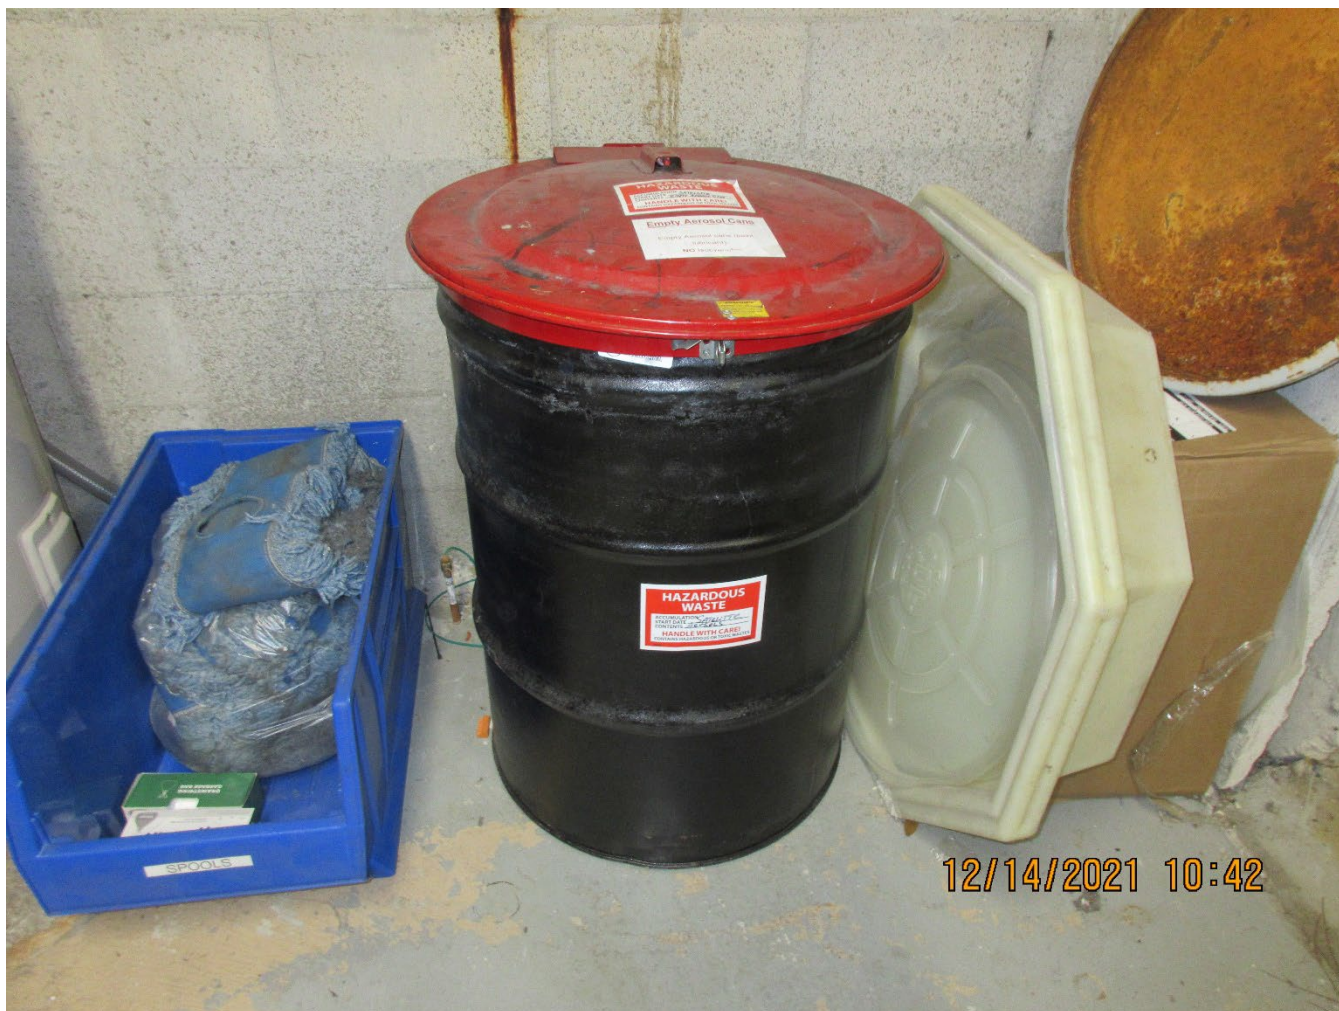
One 55-gallon container of hazardous waste aerosol cans was observed in this area (Photo 13). The container was not labeled with an indication of the hazard contents of the container.

Photo 13 - Commerce 3 One drum of hazardous waste aerosol cans in the vicinity of the Universal Waste Area

**Pursuant to Fla. Admin. Code Ann. r. 62-730.160(1) [40 C.F.R. § 262.15(a)(5)(ii)], which is a condition of the SAA Permit Exemption, a generator is required to mark or label its container with an indication of the hazards of the contents.**

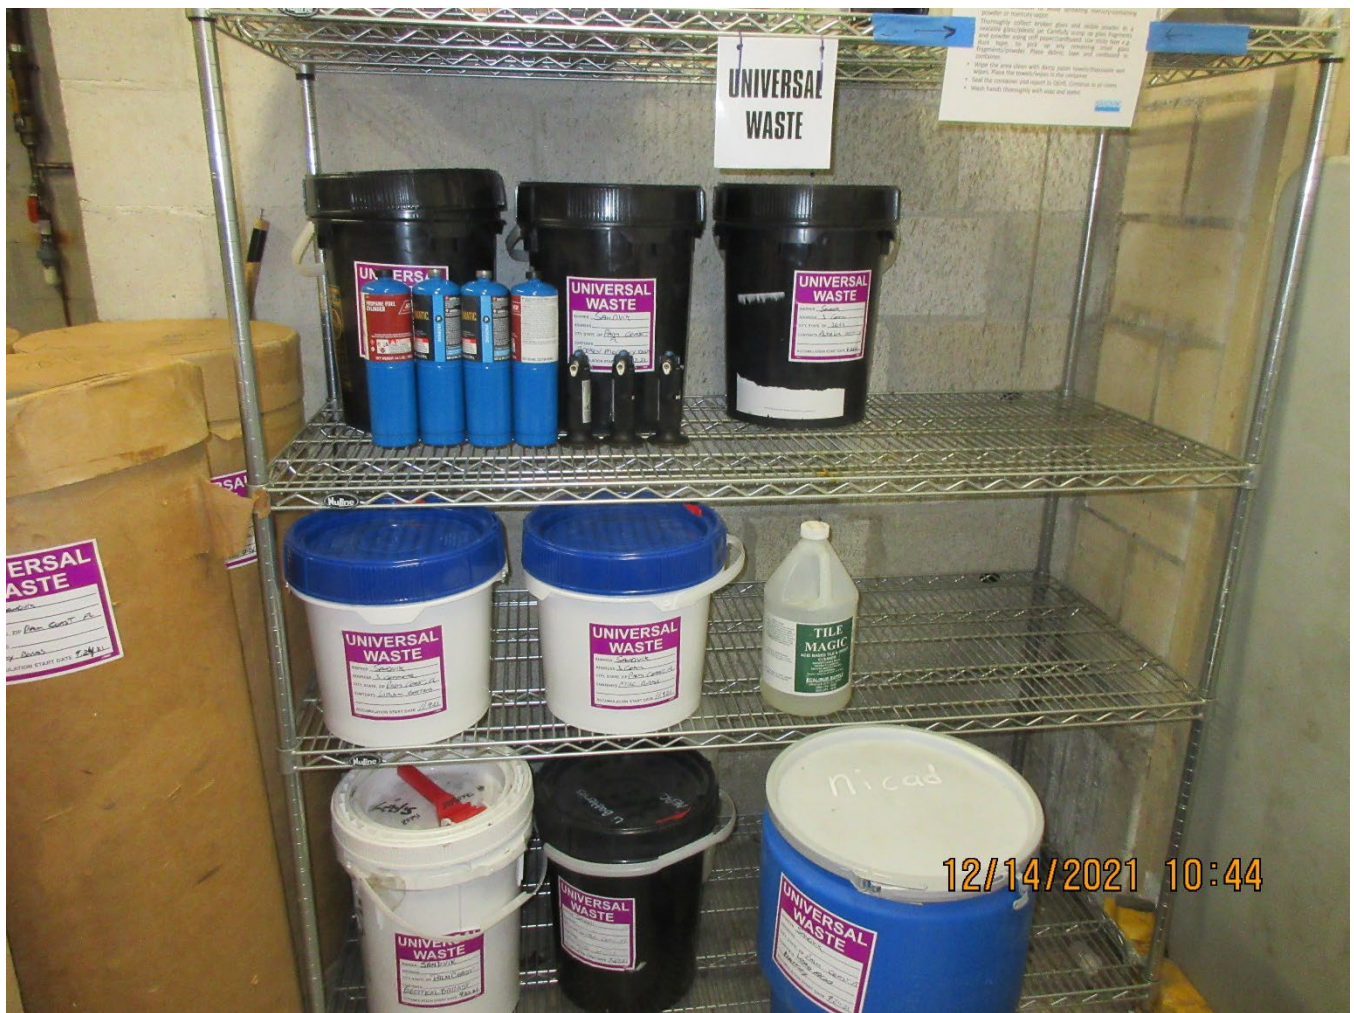
Eight containers of universal waste batteries and fluorescent bulbs were also observed in this area. One of the containers was labeled as broken bulbs (Photo 14). The EPA and FDEP inspectors informed Mr. Bateman that broken bulbs are not Universal Wastes and must be managed as hazardous wastes.

Photo 14 - Commerce 3      Eight containers of universal waste batteries and bulbs and broken bulbs in Universal Waste Area

**Pursuant to Fla. Admin. Code Ann. r. 62-730.160(1) [40 C.F.R. § 262.15(a)(5)], which is a condition of the SAA Permit Exemption, a generator is required to mark or label its containers (i) with the words “Hazardous Waste” and (ii) with an indication of the hazards of the contents.**

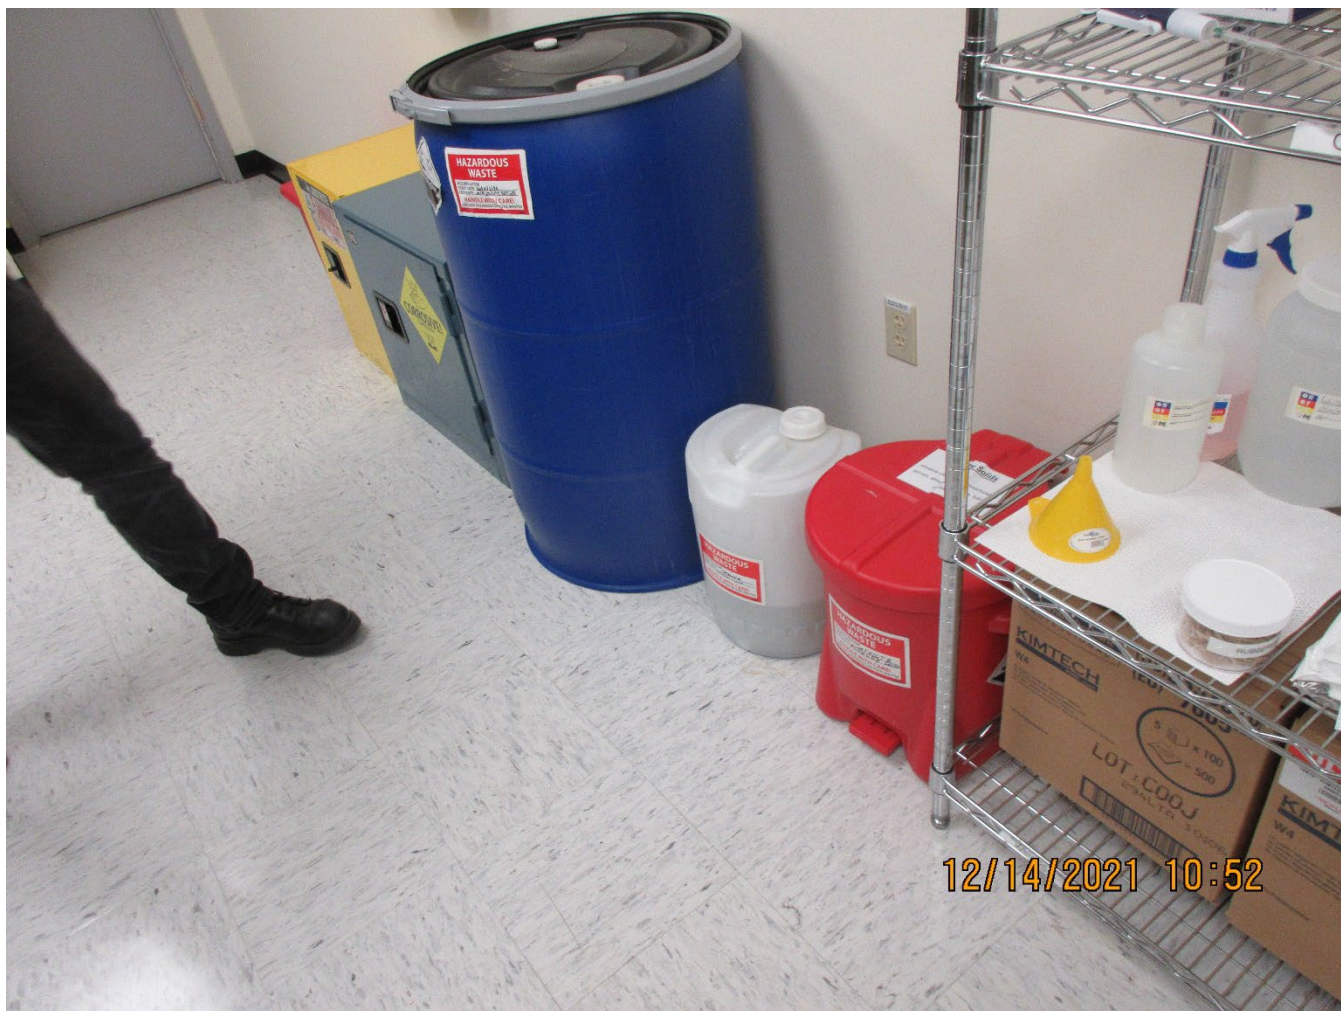
Wire undergoes a process called stiffening in this room. The stiffening process involves wire grinding, polishing, de-burring and rinsing. The grinding process roughens up the wire surface for polishing. Polishing removes most dirt and corrosion on the wire prior to de-burring. The de-burring process uses a dip pot of sodium hydroxide to resurface the wire. The last step before re-spooling is a deionized water rinse. The sodium hydroxide solution used in the deburring generates about three to four cups of hazardous waste waste alkaline liquids per day. Hydrochloric acid is used to adjust the pH of the alkaline liquids. The neutralized liquid is then accumulated in a 5-gallon container managed as hazardous waste alkaline liquids. PPE, gloves, shop wipes and solid materials generated from the stiffening process are managed as solid hazardous waste and accumulated in 5-gallon and 55-gallon satellite containers. A 5-gallon container of hazardous waste enamel solids was also observed in this area (Photo 15).

Photo 15 – Commerce 1 Precious Metals Room 8

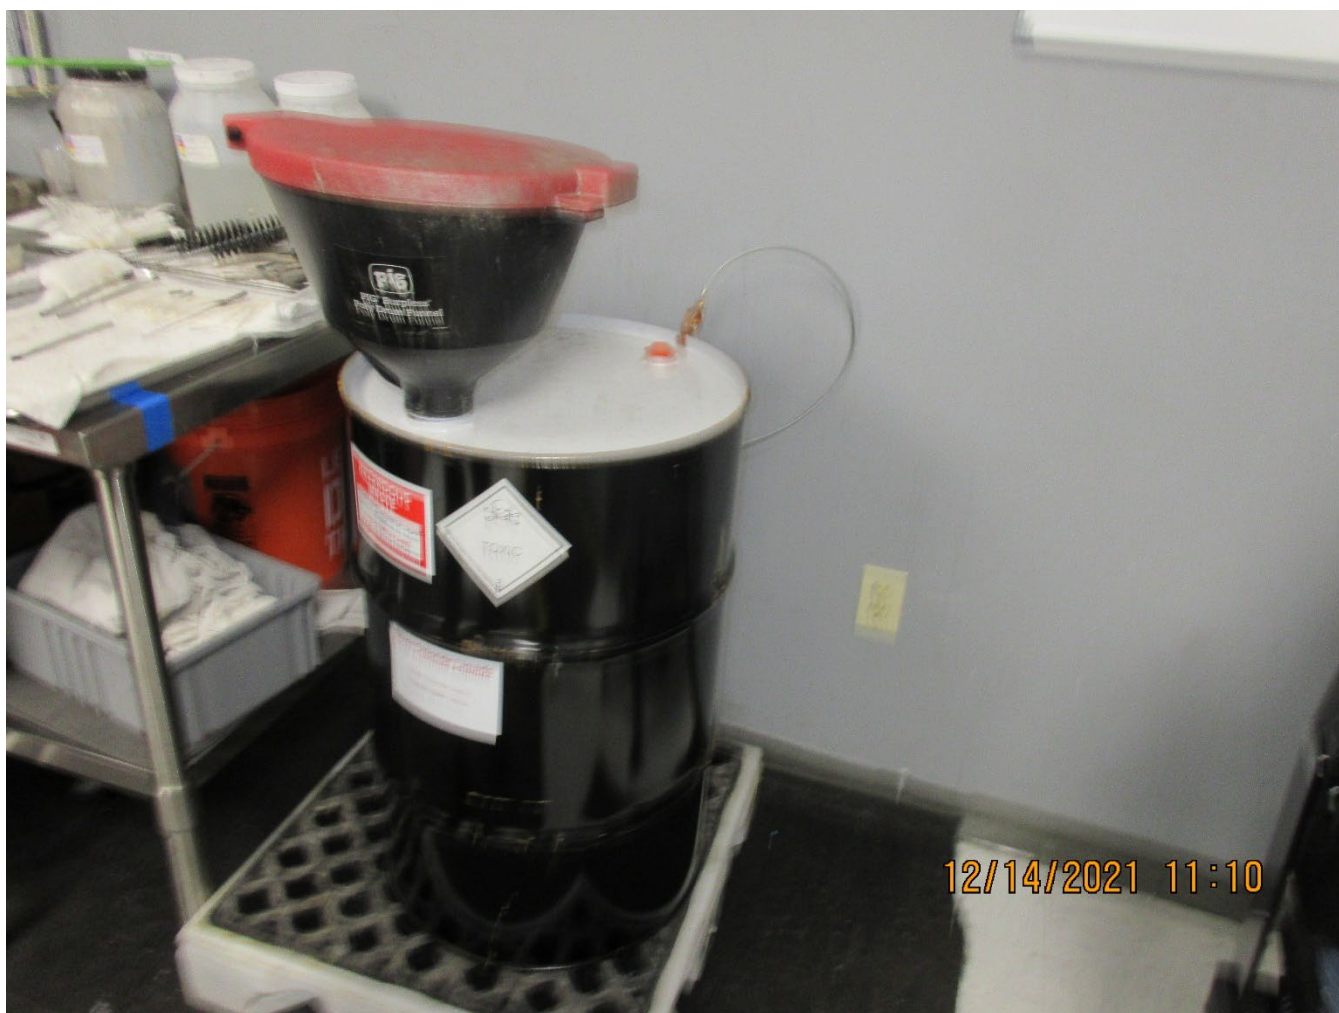
Silver chloride used for wire coating purposes in this area result in hazardous wastes liquids being generated in one 30-gallon container (Photo 16) and one 30-gallon and one 5-gallon container of hazardous waste solids (Photo 17).

Photo 16 – Commerce 1 Met Room Hazardous Waste Liquids
