# RCRA Compliance Evaluation Inspection Report

Sandvik Palm Coast (SPC)  
1 Commerce Boulevard  
Palm Coast, Florida 32164-7961  
County: Flagler  
Latitude: 29.551731  
Longitude: -81.263176  
EPA ID Number: FLD984229716

On December 14, 2021, Luke Lewis and Emma Sacchitello of FDEP, and Daryl Himes, EPA, conducted a routine compliance evaluation inspection of Sandvik Palm Coast to determine the facility's compliance with state and federal hazardous waste regulations. This was an EPA lead inspection.

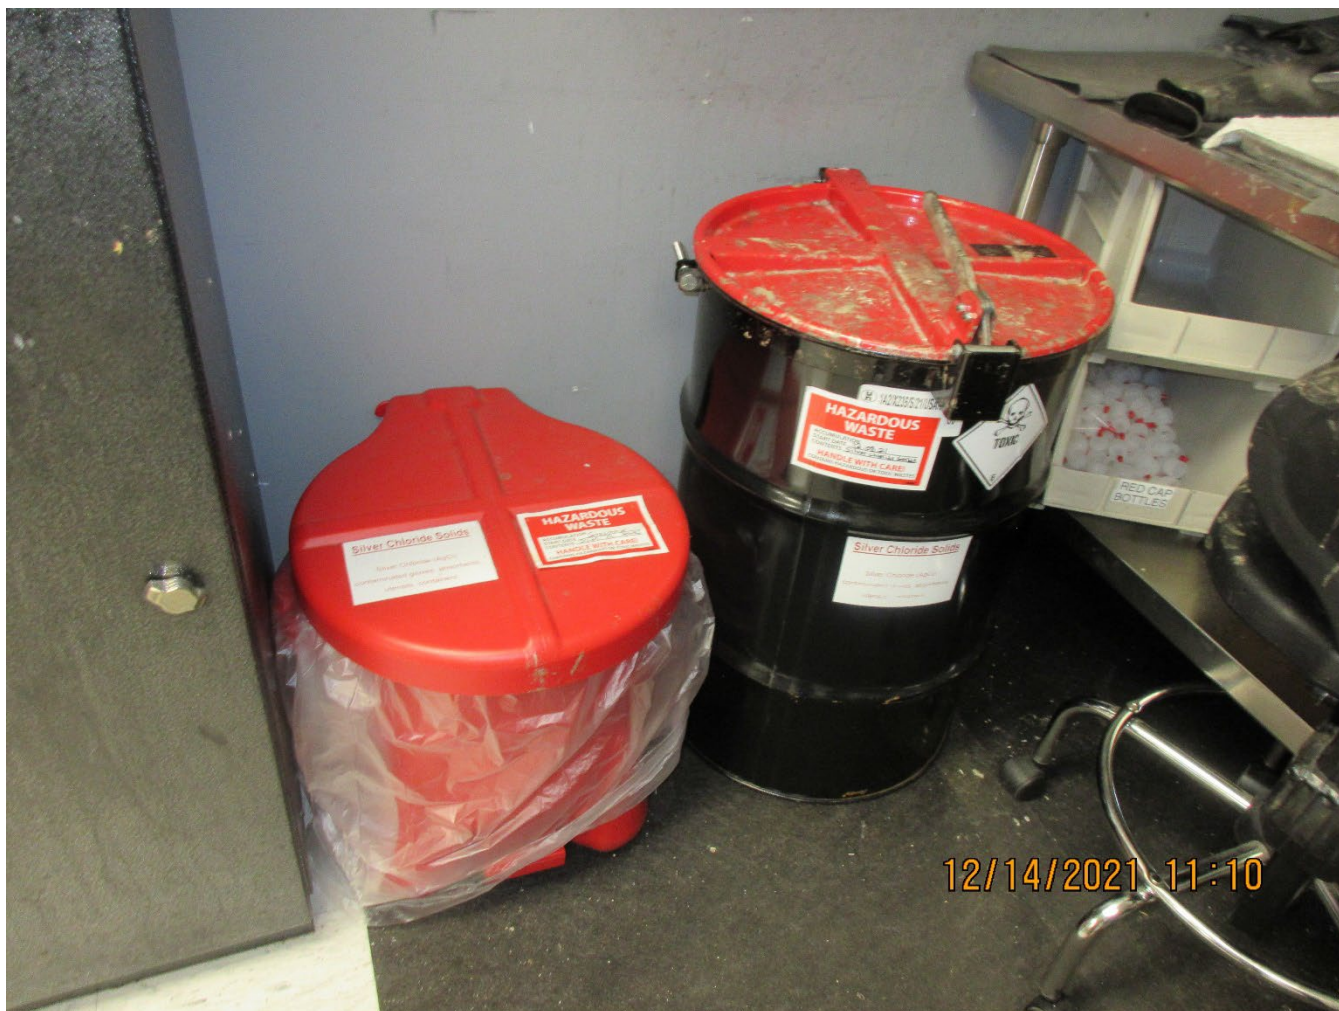
Silver chloride used for wire coating purposes in this area result in hazardous wastes liquids being generated in one 30-gallon container (Photo 16) and one 30-gallon and one 5-gallon container of hazardous waste solids (Photo 17).

Photo 17 – Commerce 1 Met Room Hazardous Waste Solids

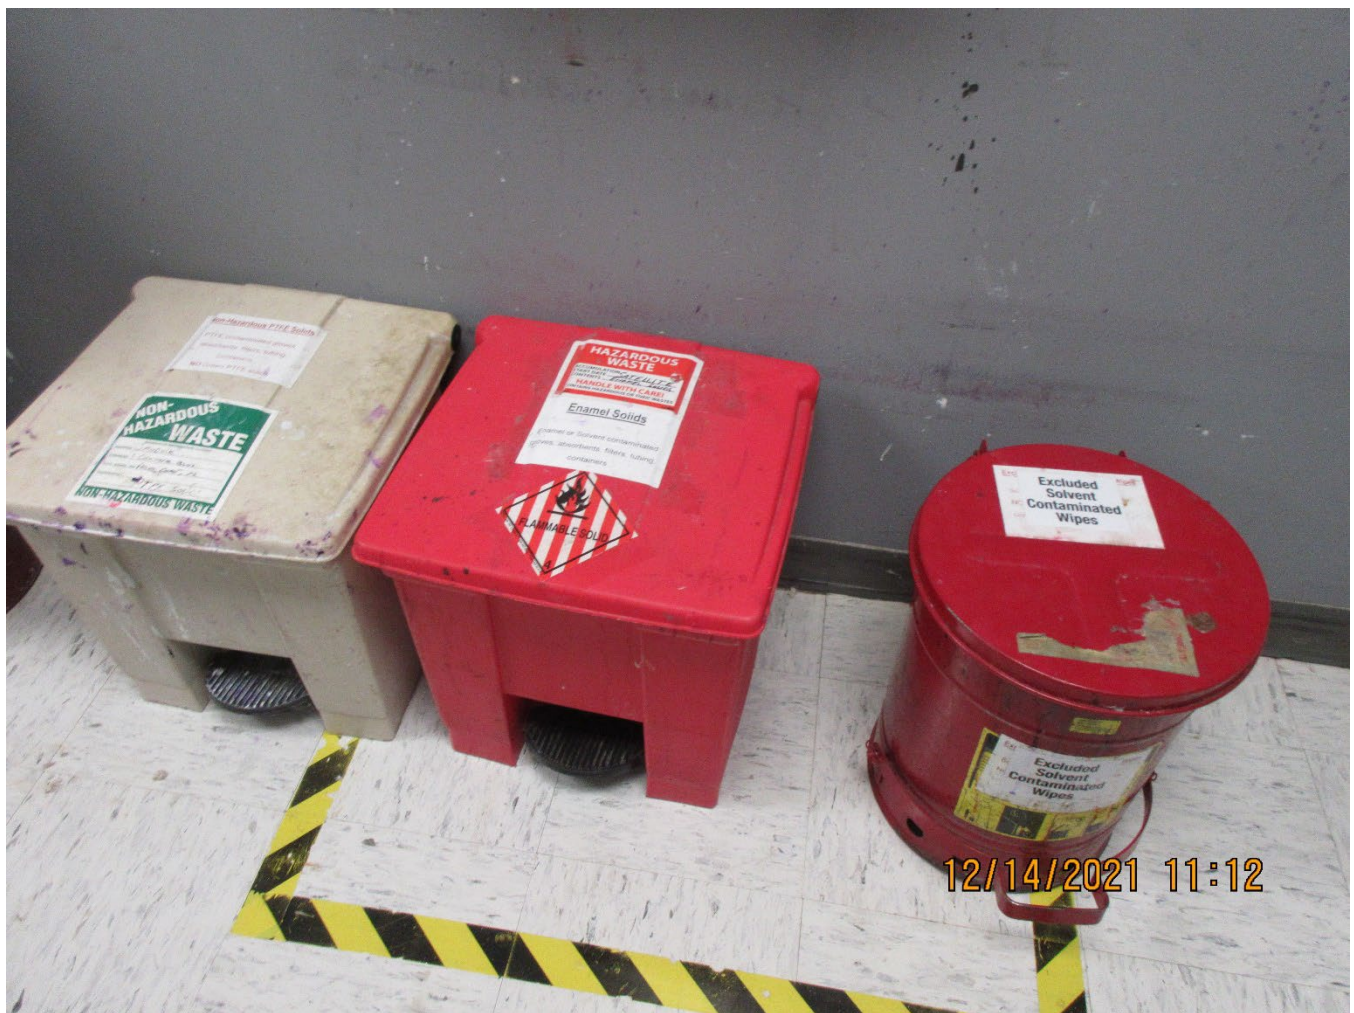
One 5-gallon container of hazardous waste enamel solids was also observed in this area (Photo 18).

Photo 18 - Commerce 1 Met Room Hazardous Waste Enamel Solids

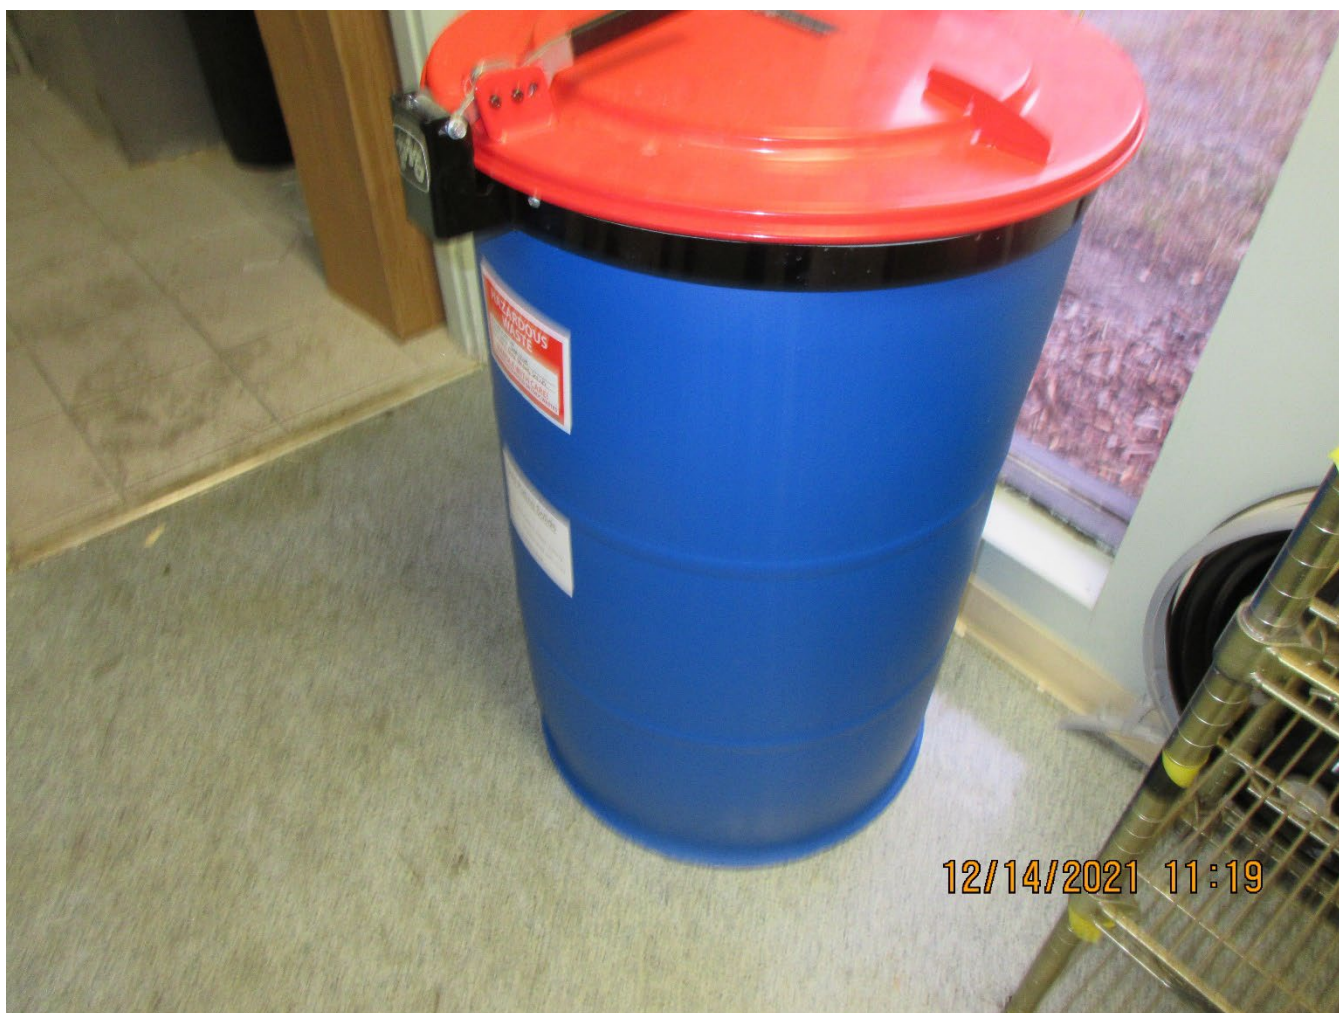
Containers of hazardous waste observed in this area included the following: one 5-gallon container of alkaline solids, one 5-gallon container of acid solids, one 55-gallon solids of nickel sulfamate solids, one 55-gallon container of gold plating solids (Photo 19) and one 55-gallon container of gold plating liquids (Photo 20).

Photo 19 - Commerce 1 Plating Room Gold Plating Solids

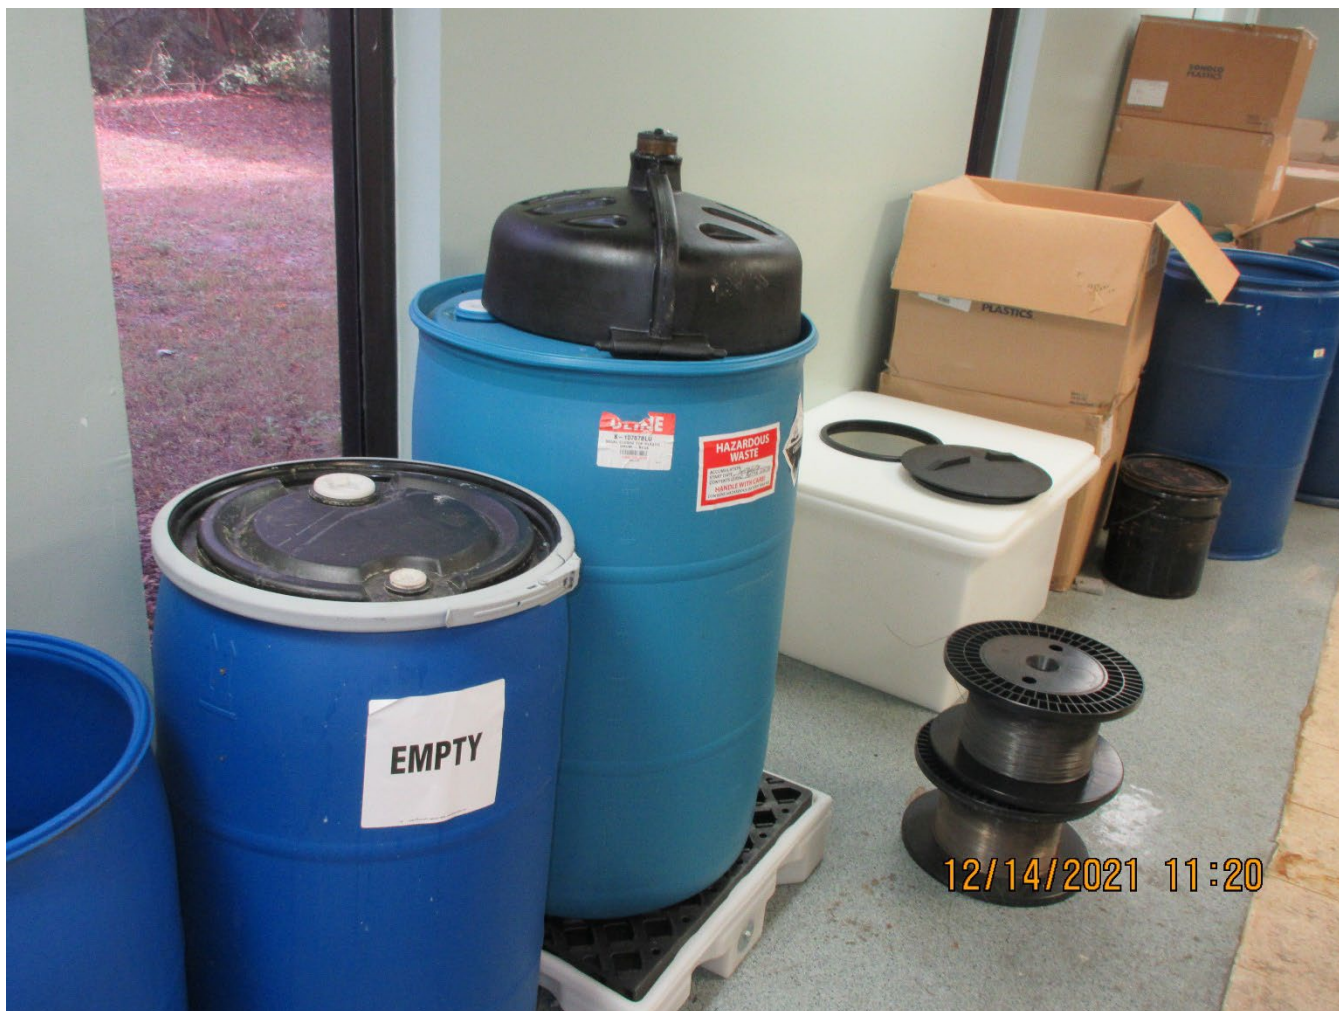
Photo 20 - Commerce 1 Met Room Hazardous Waste Gold Plating Liquids

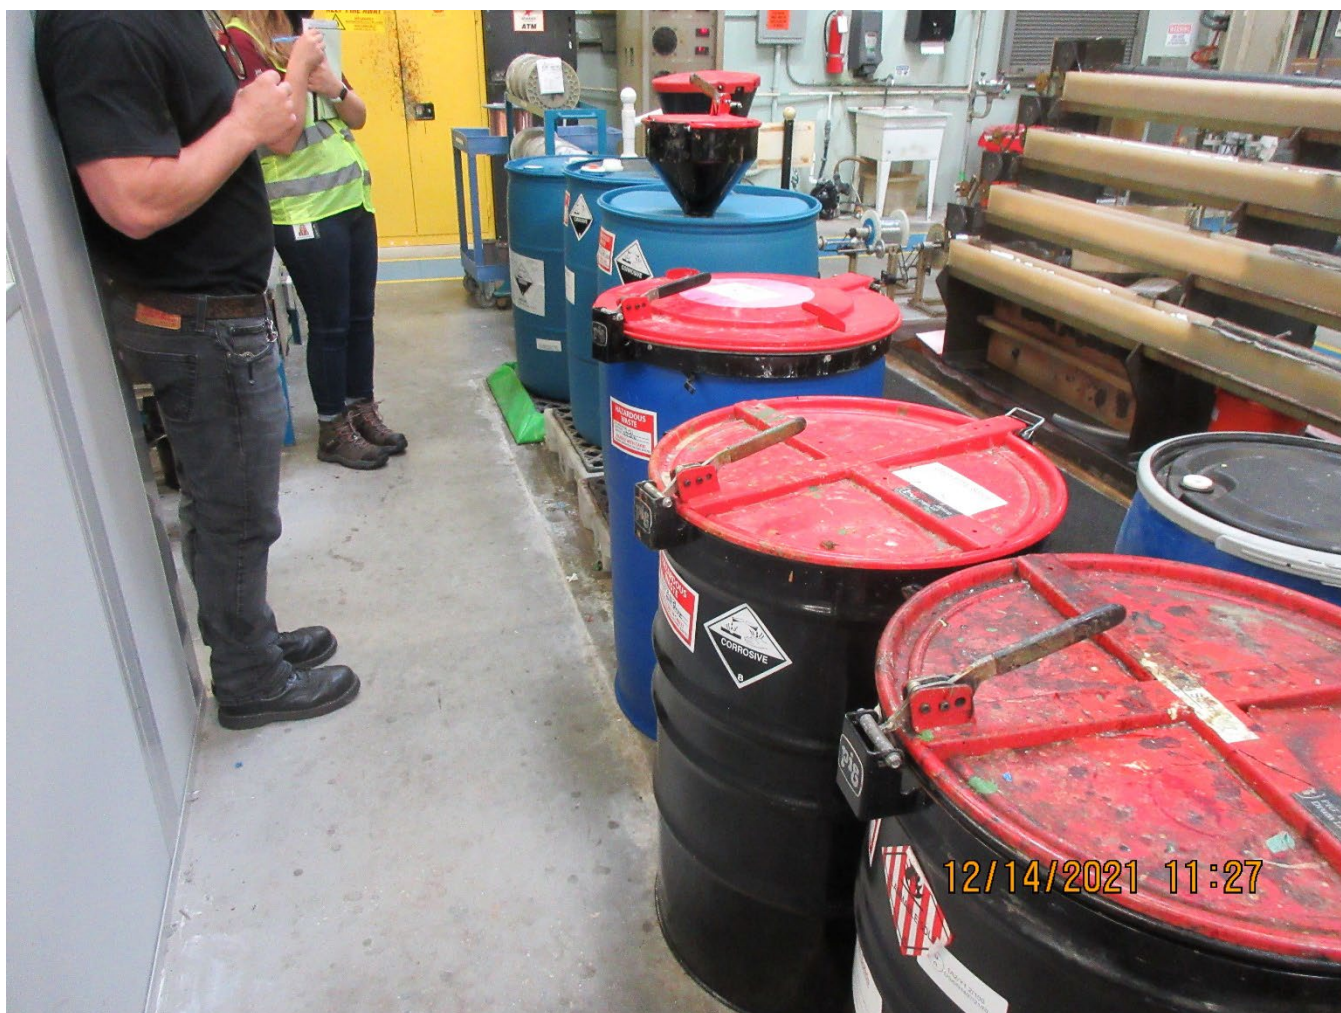
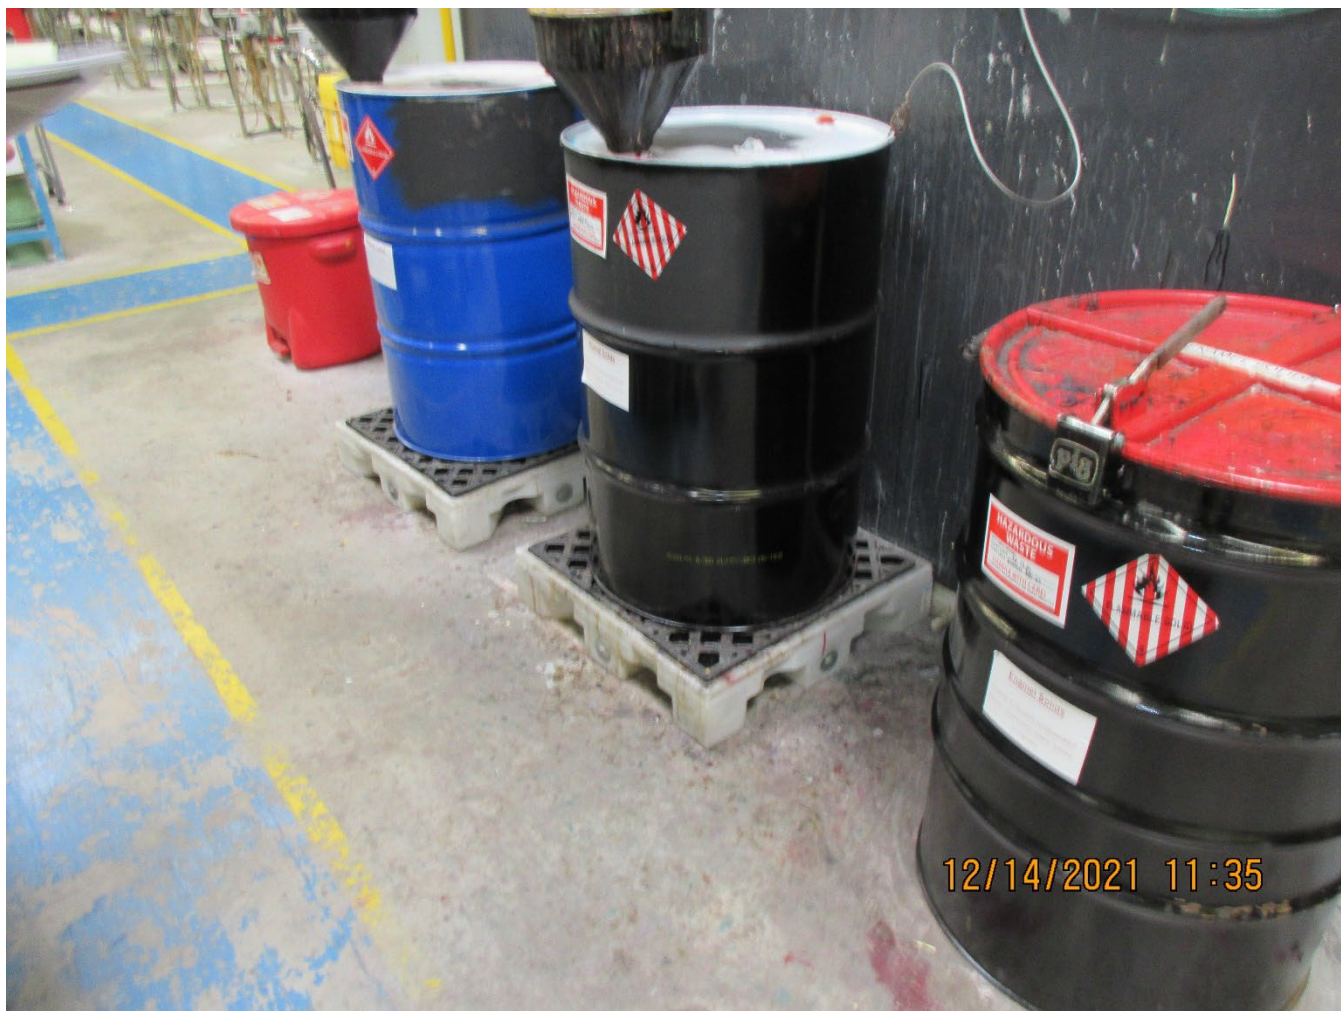
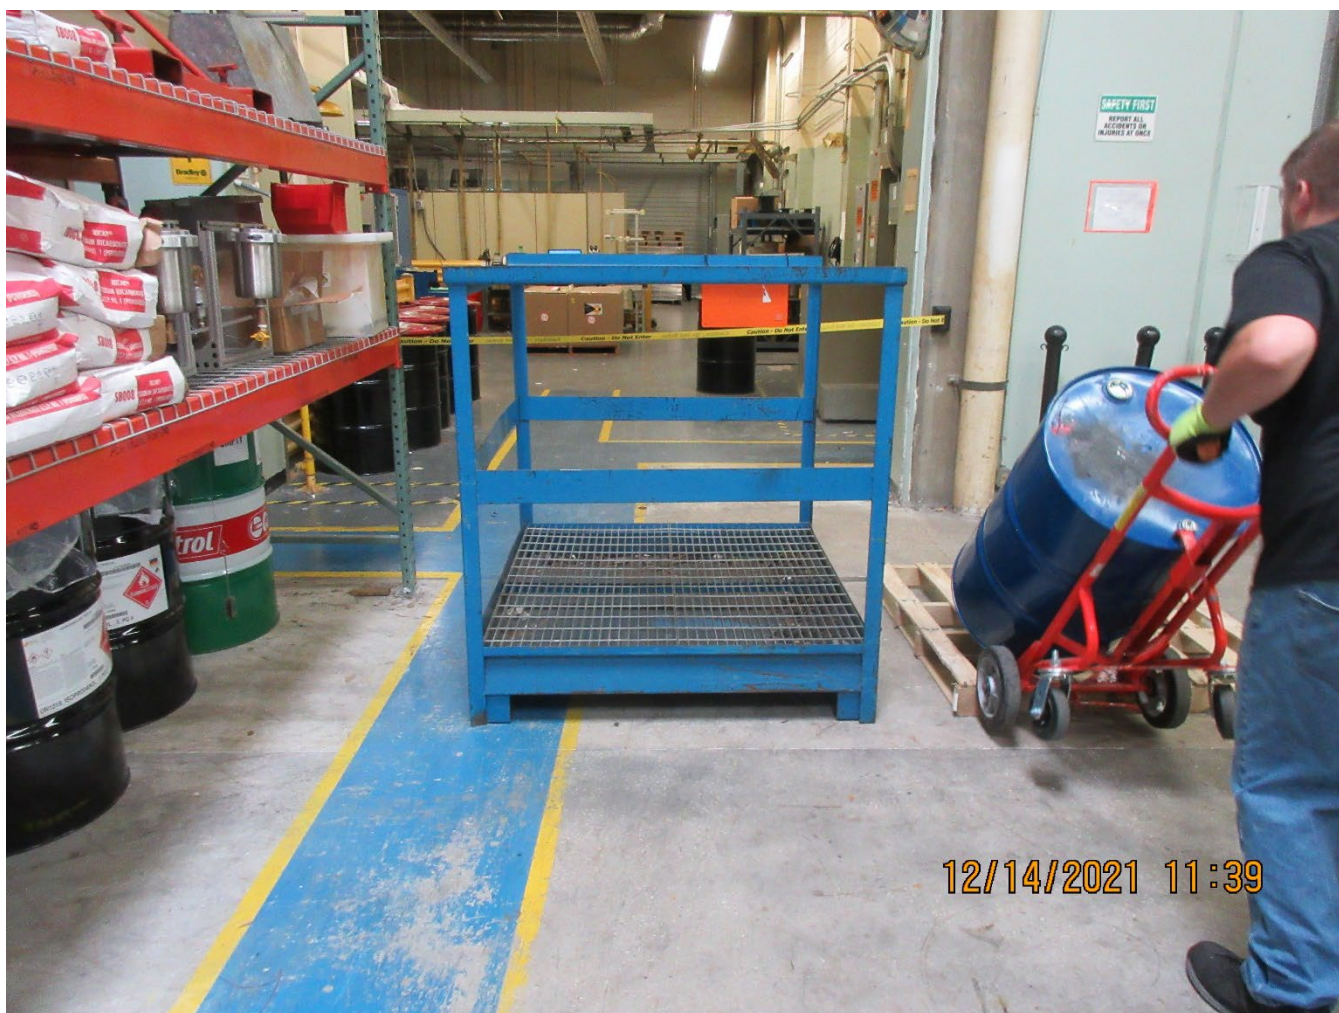
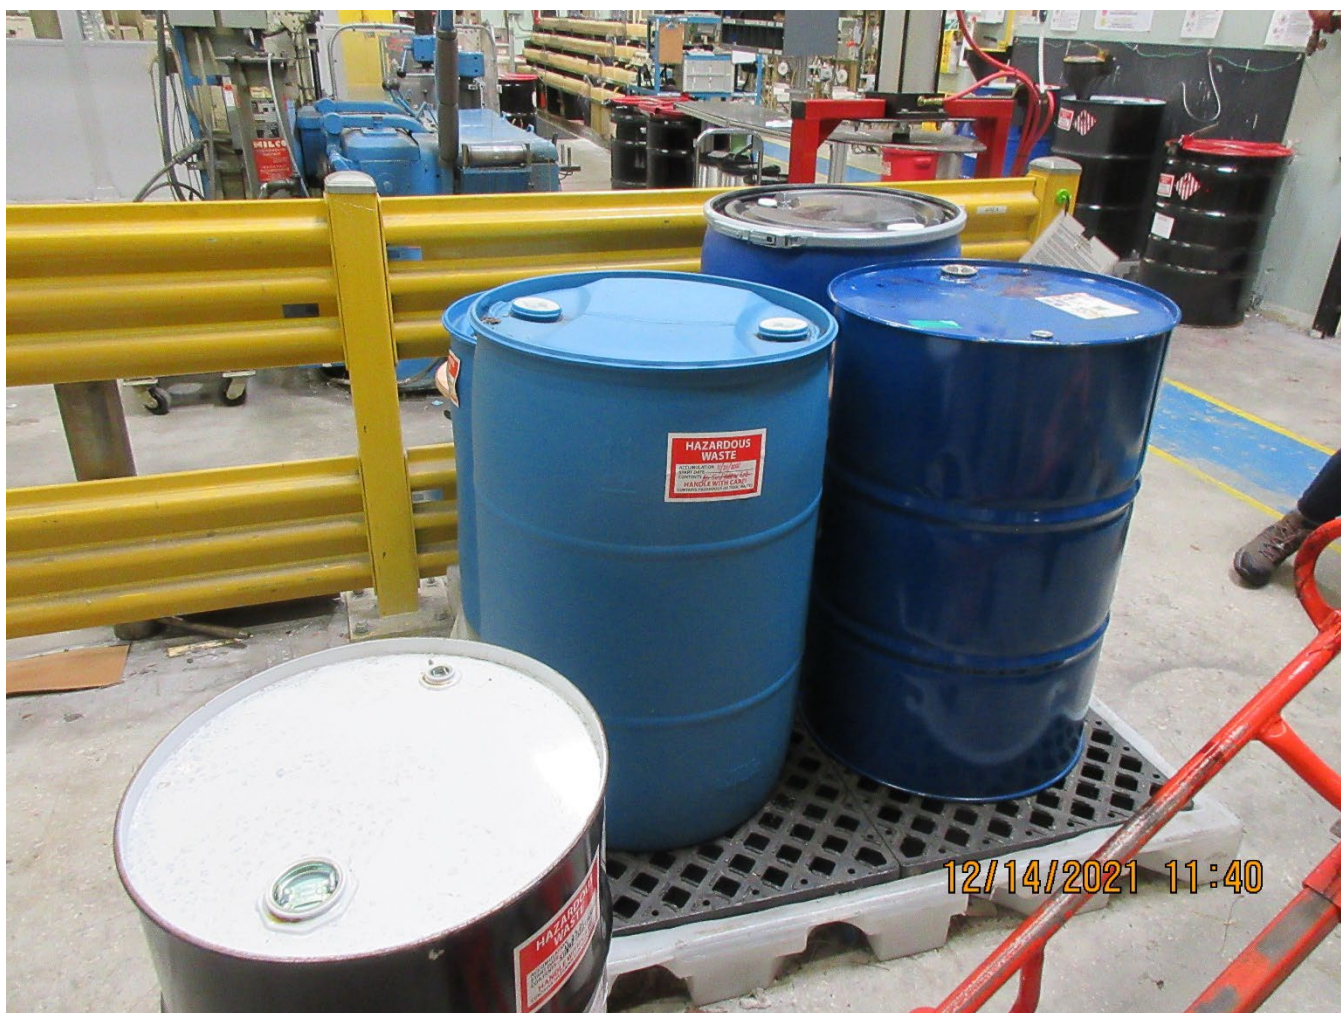
Eight 55-gallon and three 30-gallon containers of hazardous wastes were observed in two separate 90-Day Hazardous Waste Accumulation Areas within the Primary Production Floor. In addition, three 55-gallon and one 5-gallon container of hazardous waste was observed in separate SAAs within the Primary Production Floor (Photos 21 -24).

Photo 21 - Commerce 1 Primary Production Floor 90-Day Hazardous Waste Accumulation Area

Photo 22 - Commerce 1 Primary Production Floor 90-Day Hazardous Waste Accumulation Area

Photo 23 - Commerce 1 Primary Production Floor 90-Day Hazardous Waste Accumulation Area

Photo 24 - Commerce 1      Primary Production Floor    90-Day Hazardous Waste Accumulation Area

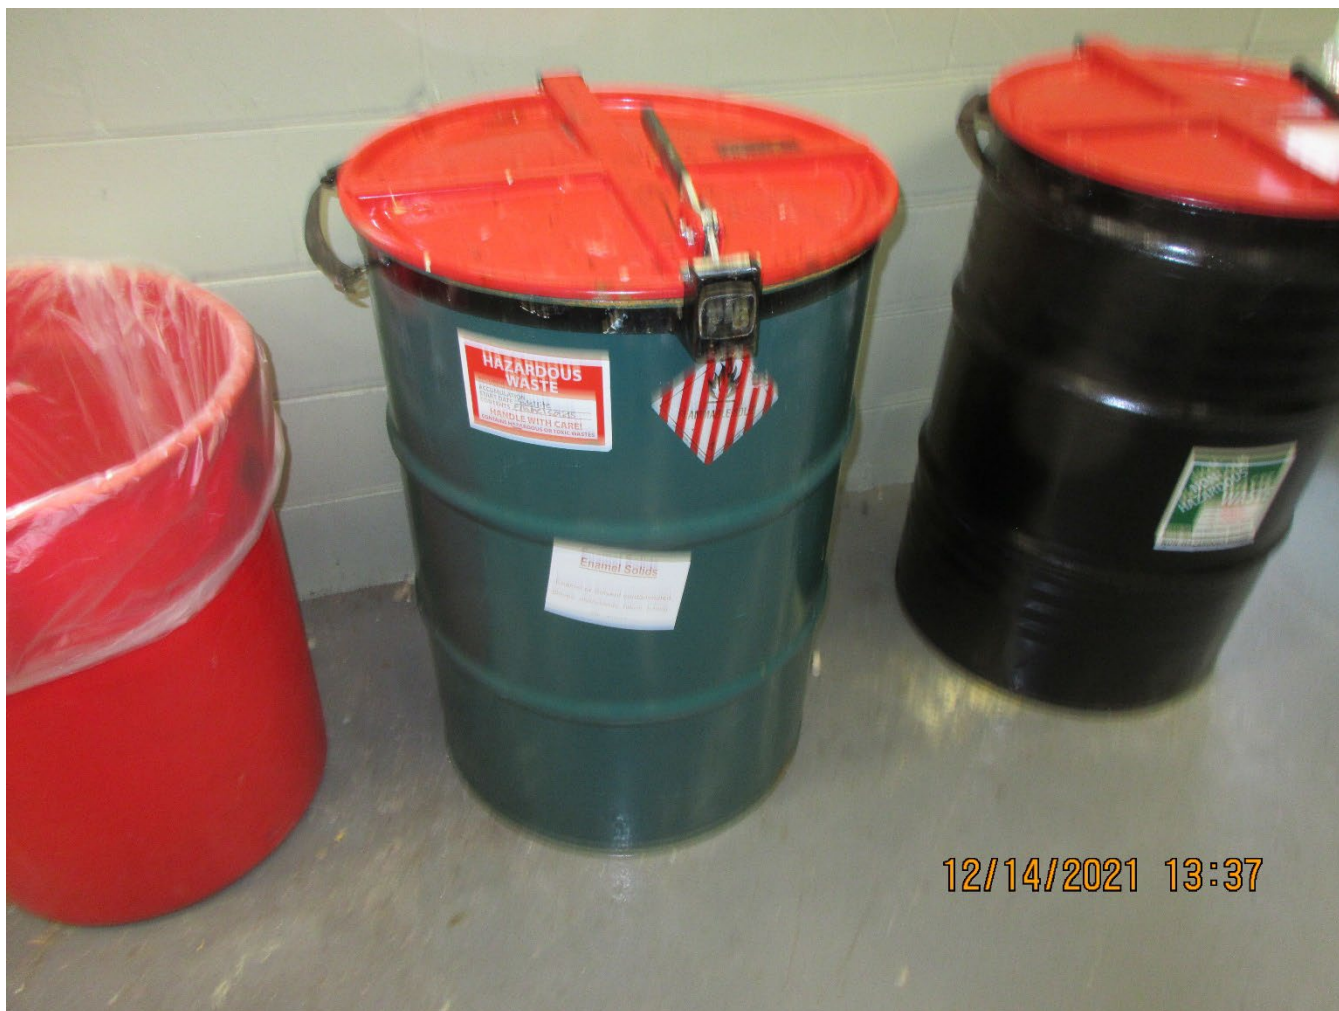
At the time of the inspection, one 55-gallon container of hazardous waste enamel solids was observed within a SAA in this area (Photo 25).

Photo 25 - Commerce 1 Enamel Solids in the Mag Area  
Hazardous Waste Accumulation Area

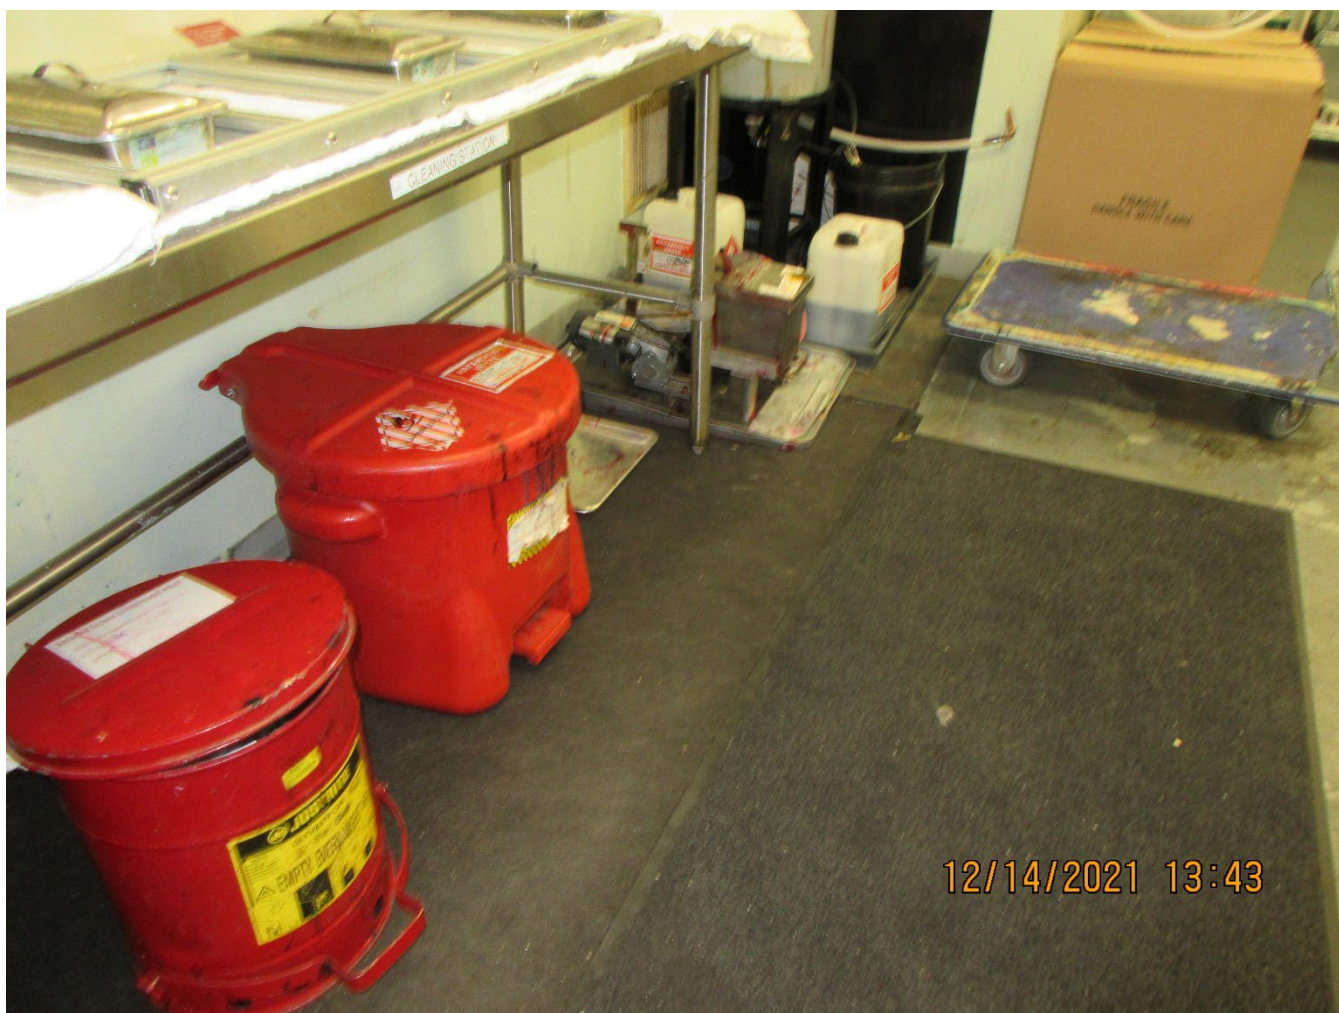
Very fine SPDW is produced in this area. At the time of the inspection, one 5-gallon container of solvent wipes, one 10-gallon container of enamel solids, one 2.5 gallon container of IPA ultrasonic and one 2.5-gallon container of enamel solid hazardous wastes were being accumulated in SAAs in this area. At the time of the inspection, the 5-gallon container of solvent wipes was not labeled with an indication of the hazards contents of the container (Photo 26).

Photo 26 - Commerce 1 SAs in Triple O area

**Pursuant to Fla. Admin. Code Ann. r. 62-730.160(1) [40 C.F.R. § 262.15(a)(5)(ii)], which is a condition of the SAA Permit Exemption, a generator is required to mark or label its container with an indication of the hazards of the contents.**

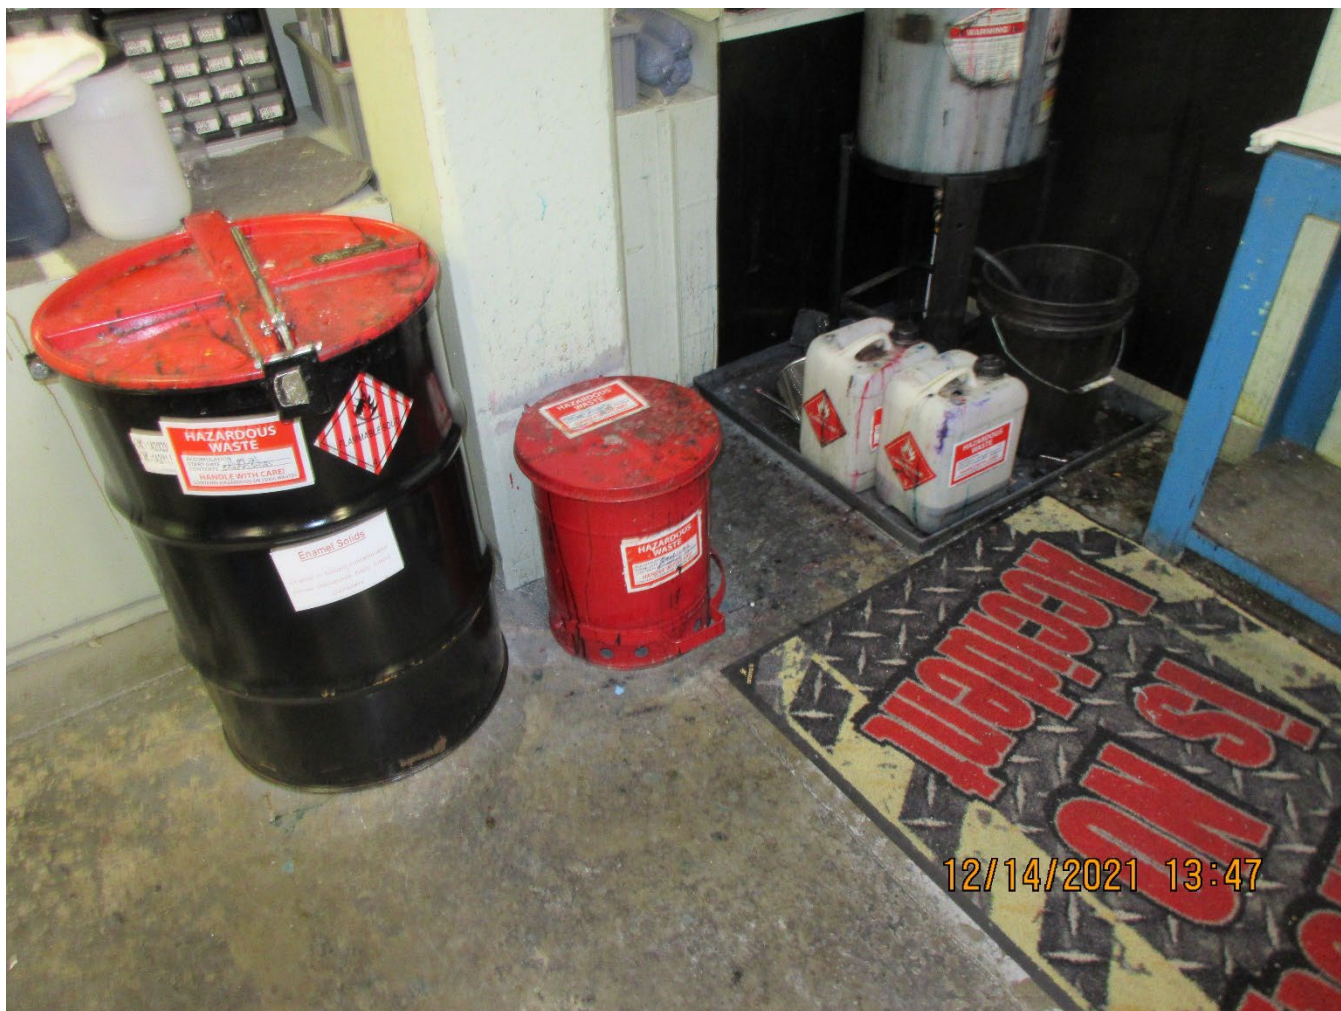
Hazardous wastes observed within SAAs within Precious Metals Room 5 at the time of the inspection included one 30-gallon and one 5-gallon container of enamel solids, one 2.5 gallon container of enamel liquids and one 2.5 gallon container IPA ultrasonic waste (Photo 27). No hazardous wastes were observed within Precious Metals Room 6.

Photo 27 - Commerce 1 SAA in the Precious Metals 5 Room

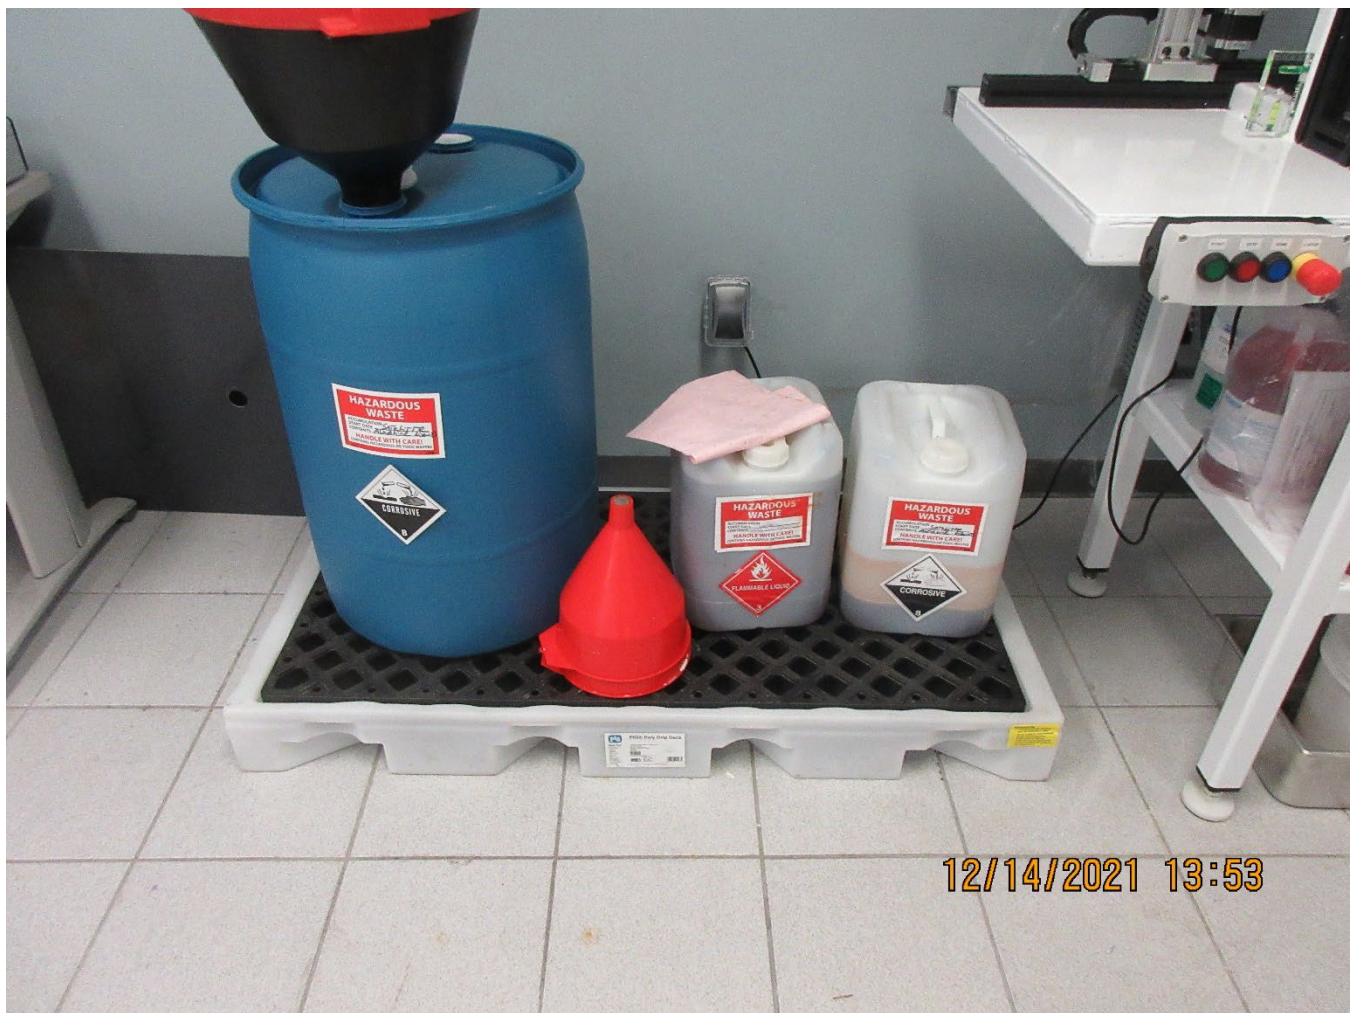
Stranding, chemical stripping, enamelling and testing of SDPW is performed in this area. One 55-gallon and one 5-gallon container of alkaline liquid hazardous waste and one 5-gallon container of ultrasonic IPA hazardous waste was observed in this area (Photo 28).

Photo 28 - Commerce 1 SAA in the Trifilar Area
