**REPORT OF INDUSTRIAL STORMWATER  
COMPLIANCE EVALUATION INSPECTION**

**AT  
Brown Industries LLC  
807 E. 29<sup>th</sup> St.,  
Lawrence, Kansas 66046  
Facility Registry Service ID: 110003146186  
National Pollutant Discharge Elimination System Permit: Not permitted**

**January 23, 2025**

**by U.S. ENVIRONMENTAL PROTECTION AGENCY  
Region 7: Enforcement and Compliance Assurance Division**

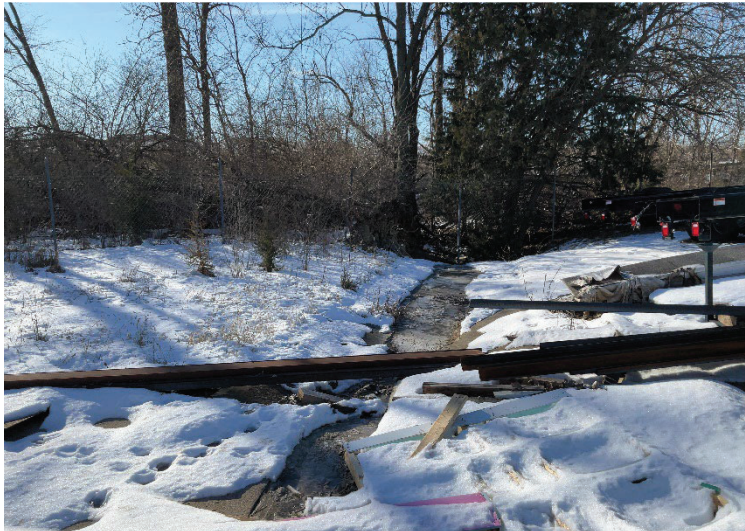
*Figure 4 shows image 19 from the digital image log.*

On the south side of the facility is a concrete channel that drains stormwater to an earthen channel sloping south. Image 19 in Figure 4 and image 28 in Figure 5 show the flow path from the industrial yard to the fence.

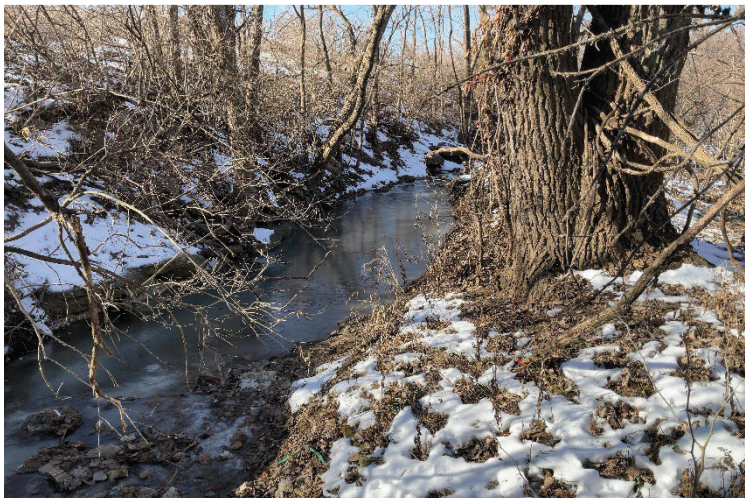
*Figure 6 shows image 26 from the digital image log.*

Images 24 to 27 show the drainage channel to the south of the facility. Figure 6 shows image 26 which is looking west or downstream the channel to the south of the facility.

I saw some materials offsite that were consistent with materials on site, such as cardboard and green strapping seen in images 20 and 21 in the drainage channel near the fence. I saw green strapping in the drainage channel downstream of the industrial yard shown in images 22, 24, and 26. I saw similar green strapping around materials or on the ground in the industrial yard, shown in images 10, 12, and 41.

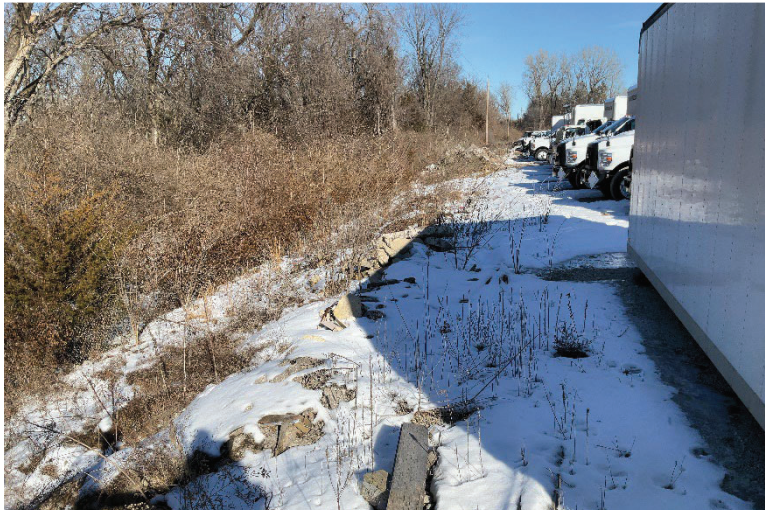
*Figure 7 shows image 35 from the digital image log.*

On the west side of the facility the ground slopes to the west towards a drainage channel and intermittent stream, Haskell Tributary. I saw rills, erosional paths, and flow paths in the embankment conveying stormwater downslope and west. Images 36 to 41 show more detail of the embankment on the west

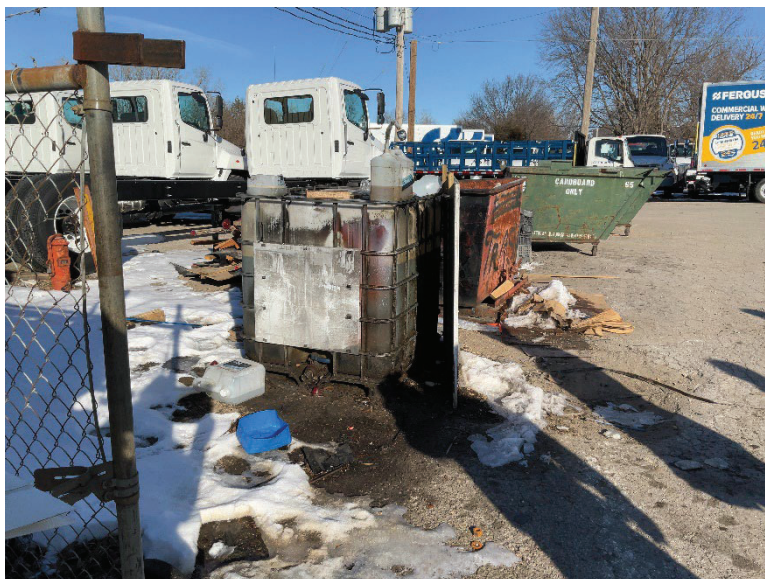
*Figure 10 shows image 3 from the digital image log.*

I saw trash and debris on the ground, shown in images 3, 6, 18 to 21, 33, 34, 38, and 41 to 44. I saw released used oil not contained or cleaned up in a timely manner, shown in images 3, 9, 42 to 45, and 48. I saw used oil in containers and aboveground tanks not clearly marked with the words “Used Oil” shown in images 3 and 4. Based on the oil I saw on the ground, the facility did not contain released used oil and clean up the released used oil. I saw that the used oils containers were stored outside, open, and not under covering when the facility was not actively adding to the container, like images 3 to 5. I saw that these used oil containers did not have secondary containment. Spills and leaks not cleaned up may contaminate stormwater. I saw one of the potential pollutant sources is oil from the customers’ truck chassis, image 48 shows an example. Based on the releases I saw at the truck chassis and the oil collection sites at the facility, this industrial activity needs added structural and nonstructural controls to prevent stormwater pollution.

The facility should consider cleaning up released oils and improving pollution prevention controls. Spills and leaks not cleaned up may contaminate stormwater and discharges not composed of stormwater are not authorized. Standards for the management of used oil may be found in 40 C.F.R. Part 279.
