## **RCRA Inspection Report**

Wilbert Plastic Services  
2930 Greenville Highway  
Easley, Pickens County, South Carolina 29640

EPA ID No. SCD982126146

June 16, 2021

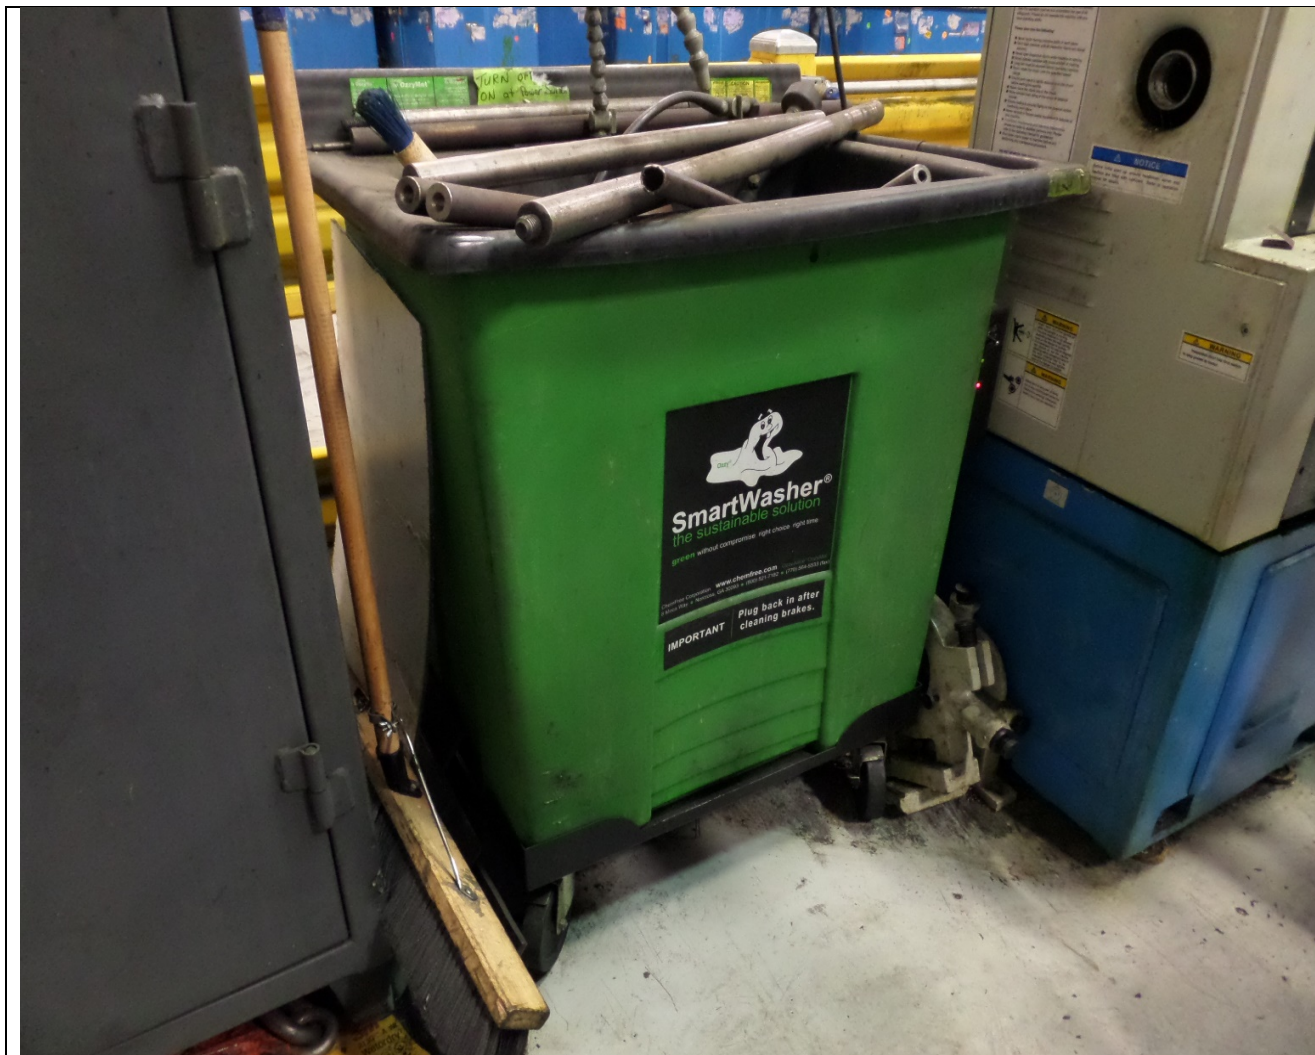
The inspectors observed a part washer ("SmartWasher") in this area (Photograph 1). The part washer uses SW-4 Ozzy Juice Heavy Duty Degreasing Solution.

Wilbert Plastic Services (Wilbert). Maintenance Shop. Part washer. Photograph 1 taken at 10:38 a.m.

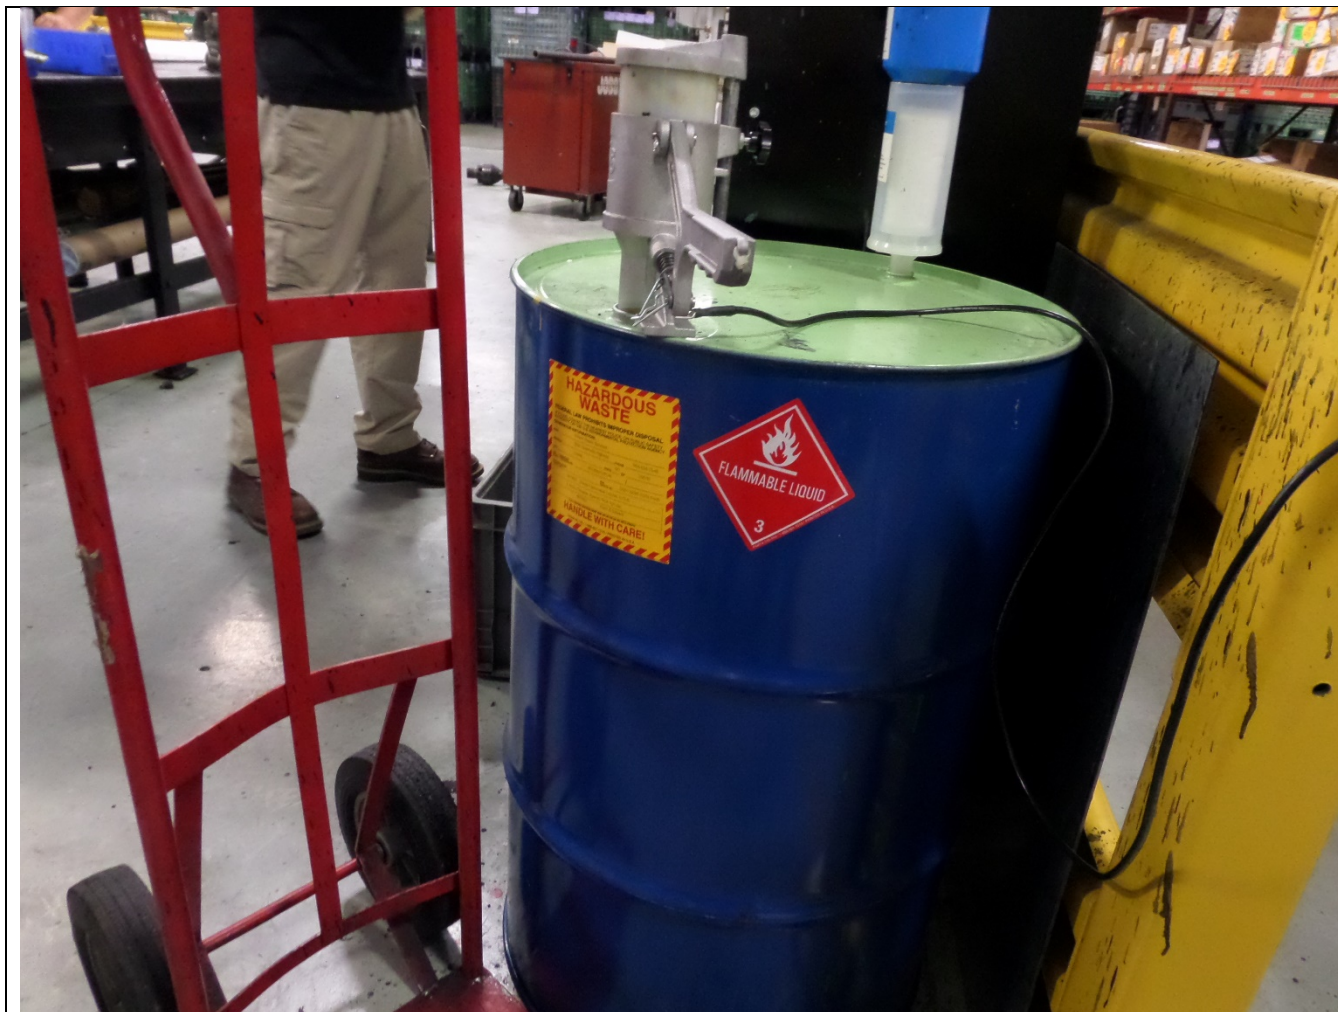
The maintenance shop personnel puncture aerosol cans containing mold release and other aerosols. The inspectors observed an aerosol can puncturing device connected to the top of a 55-gallon container in a Satellite Accumulation Area (SAA) in the maintenance shop. The inspectors observed the container was closed, labeled with the words hazardous waste (flammable liquids NOS (Toluene, Xylene) Paint & Solvent D001/D035/F003/F005 with profile number 660352) and labeled with a flammable hazard indicator. The inspectors observed the hazardous waste label was applied on top of another hazardous waste label with the edge of the bottom label visible (Photograph 2). In order to provide clear hazard communication on

containers accumulating hazardous waste, previous labels should be removed. The inspectors observed two five-gallon containers accumulating universal waste batteries and universal waste mercury containing equipment on a shelf. The containers were labeled with the words universal waste batteries and universal waste mercury containing equipment and dated March 21, 2021 and February 11, 2021, respectively. The inspectors observed the printed universal waste information on the labels were small. The inspectors suggested that the facility apply labels with larger print on the containers.

Wilbert. Maintenance Shop. Aerosol puncturing SAA. The inspectors observed the hazardous waste label was applied on top of another hazardous waste label with the edge of the bottom label visible. Photograph 2 taken at 10:46 a.m.

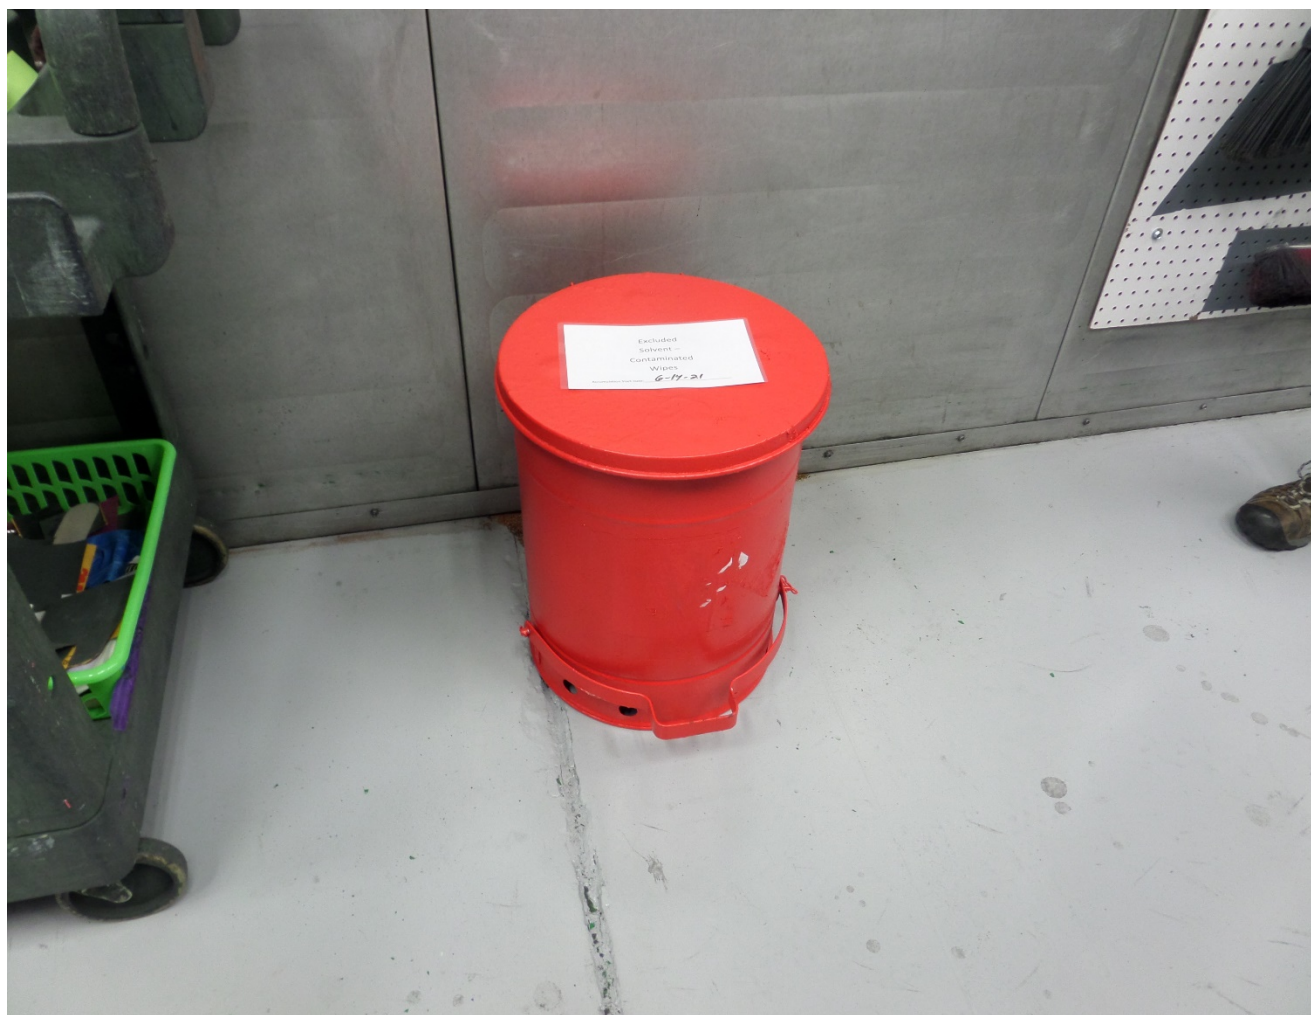
The inspectors observed the facility using isopropyl alcohol (IPA) and methyl ethyl ketone (MEK) dispensed from safety cans with a pump activated sprayer on a wipe to clean the molded parts. The spent wipes are accumulated in a 5-gallon red safety container. The inspectors observed the container closed, labeled with the words “Excluded Solvent Contaminated Wipes” and marked with the date June 14, 2021 (Photograph 3). The inspectors observed that the wipes accumulating in the container appeared to be dry. The facility indicated they are managing the spent wipes in accordance with the Solvent Contaminated Wipes Rule. The spent wipes are disposed in the Pickens County Landfill, 2043 Old Liberty Road, Liberty, South Carolina.

Wilbert. Paint Department. Excluded Solvent Contaminated Wipes. Photograph 3 taken at 10:59 a.m.

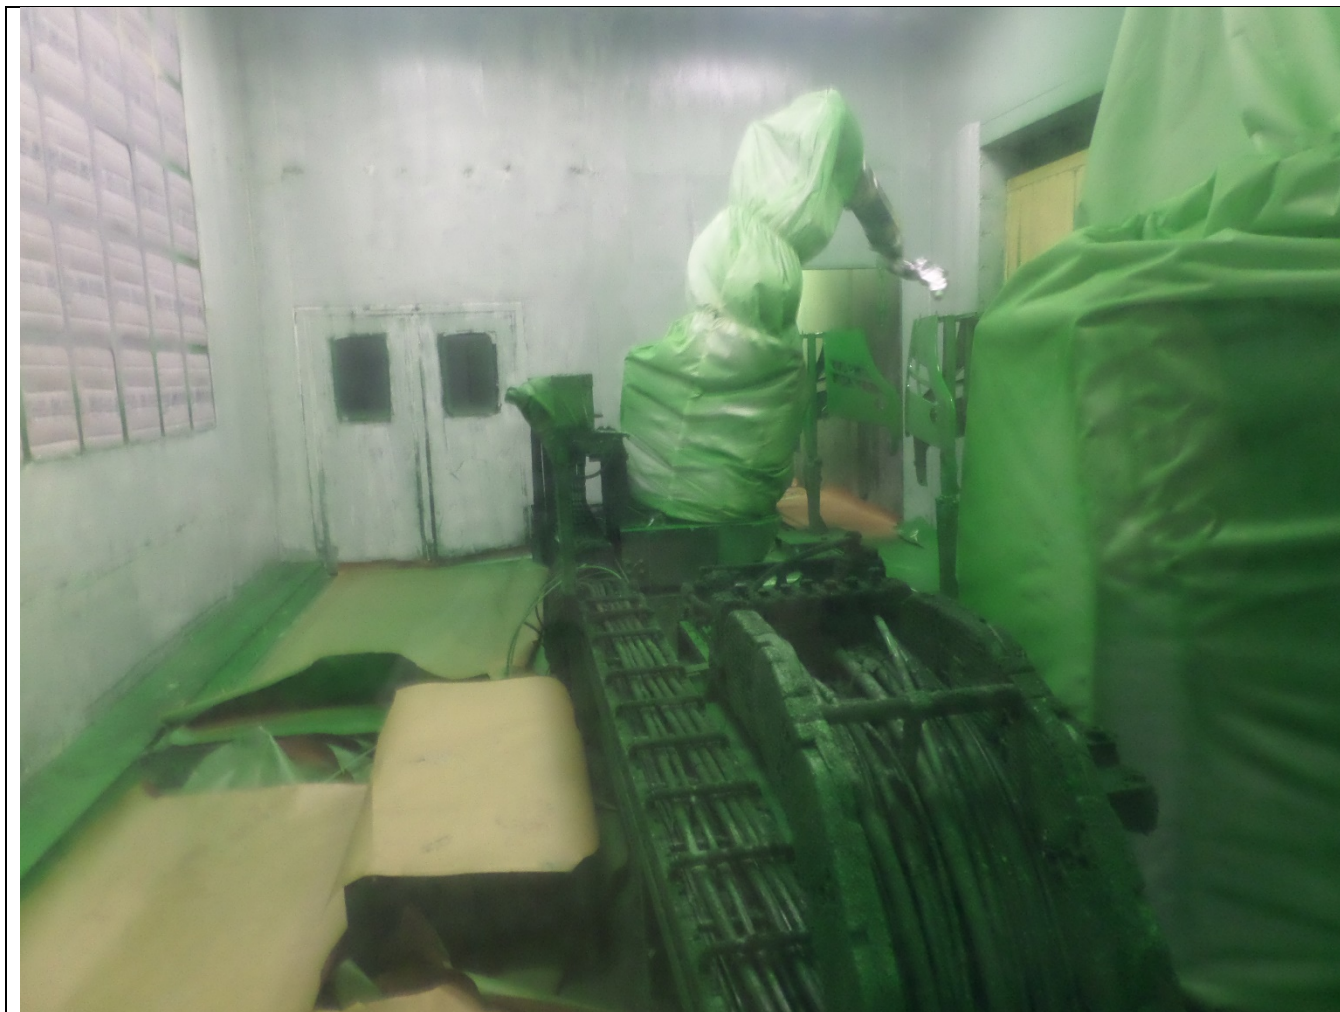
The inspectors observed the booth was in operation at the time of the inspection. A waterfall curtain is used to capture emissions. Wilbert manages a hazardous waste SAA at the Robotic Primer Paint Booth. The inspectors observed two 5-gallon containers accumulating hazardous waste paint and solvent from the painting process in this SAA. The containers were covered with over sprayed paint and were not marked or labeled with the words hazardous waste and were not marked or labeled with a hazard indicator (Photograph 4).

Wilbert. Paint Department. Robotic Primer Paint Booth. Observed container not labeled with the words hazardous waste and no hazard indicator. Photograph 4 taken at 11:07 a.m.

**Pursuant to 25 S.C. Code Ann. Regs. 61-79.262.15(a)(5)(i) [40 C.F.R. § 262.15(a)(5)(i)], which is a condition of the SAA Permit Exemption, A generator must mark or label its container with the following: (i) The words “Hazardous Waste.”**

**Pursuant to 25 S.C. Code Ann. Regs. 61-79.262.15(a)(5)(ii) [40 C.F.R. § 262.15(a)(5)(ii)], which is a condition of the SAA Permit Exemption, An indication of the hazards of the**

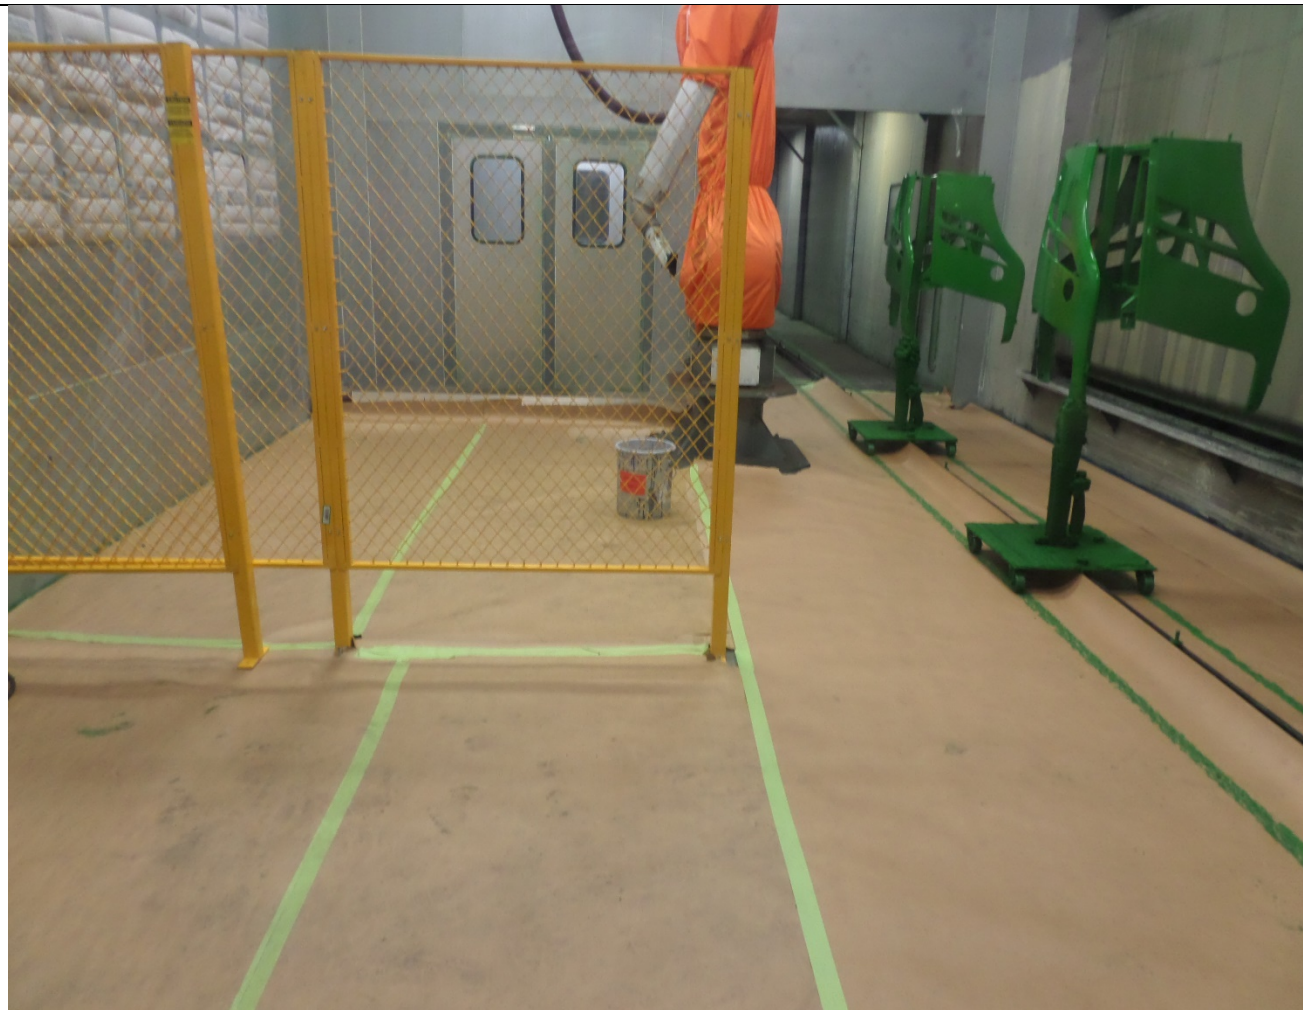
The inspectors observed the Robotic Clear Coat Booth, which is used to robotically apply a clear coat to parts, was not in operation at the time of the inspection. Wilbert manages a hazardous waste SAA at this booth. The inspectors observed one open and empty 5-gallon container labeled with the words “In Process Purge Solvent” (Photograph 5) in this SAA. Mr. Risner indicated to inspectors that these words are labeled on containers in the SAAs. The inspectors advised the facility to properly label container(s) in SAAs prior to accumulating any hazardous waste.

Wilbert. Paint Department. Robotic Clear Coat Paint Booth. Observed container labeled with the words "In Process Purge Solvent". Container was empty. Photograph 5 taken at 11:12 a.m.

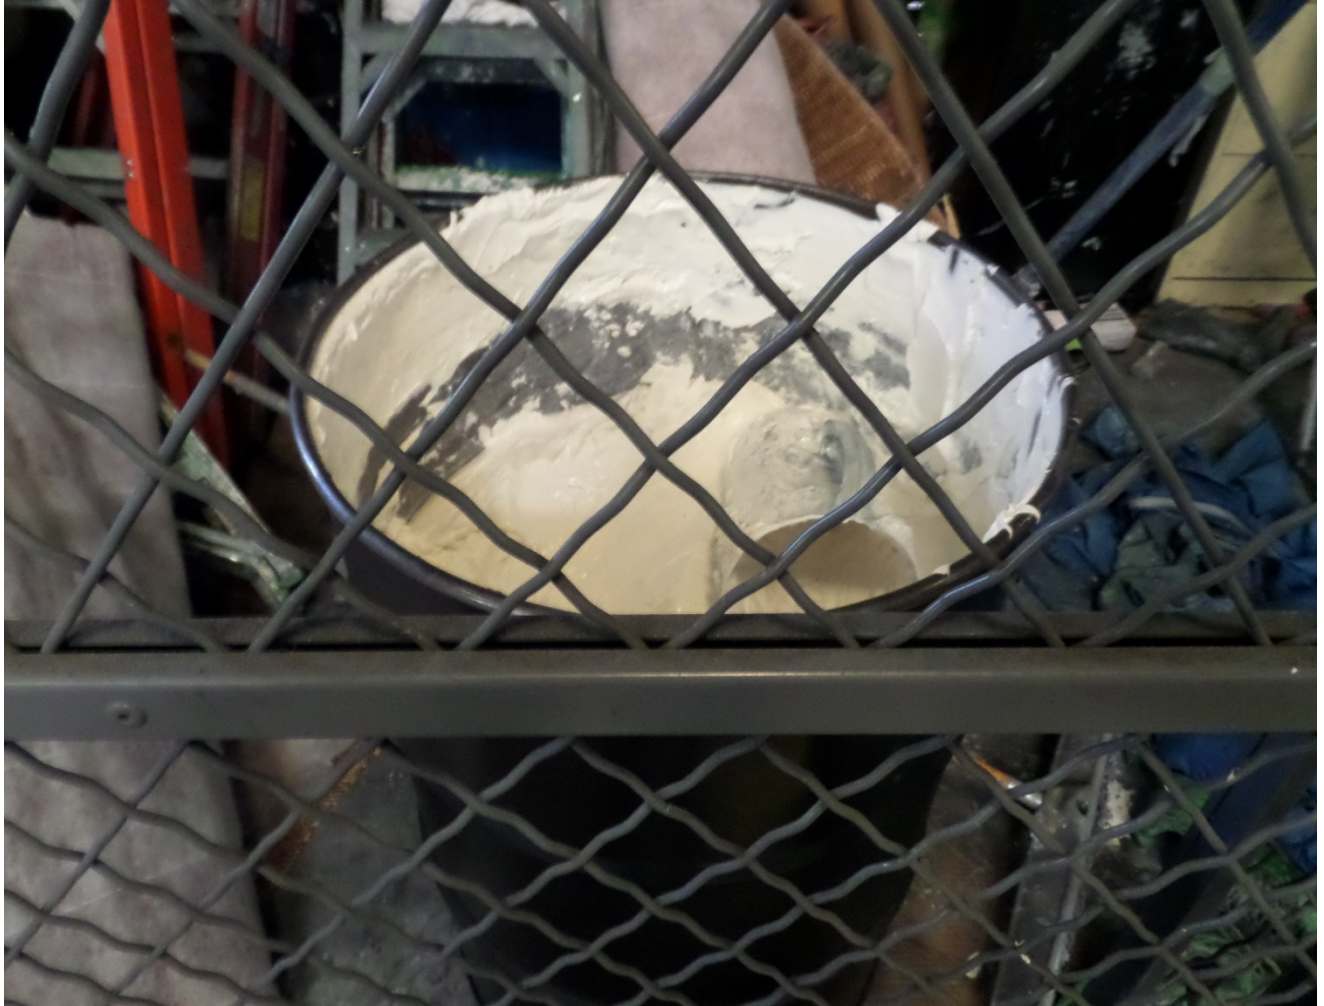
Across from the Robotic Primer Coat Booth Water Wash Area inspectors observed a locked chain-link cage. The inspector observed an open 55-gallon container storing a white material. The facility explained the white material was Chemico 8011 booth grease which is applied in the manual paint booths to prevent the paint from adhering to the walls (Photograph 7). Mr. Putman explained the process of scraping the paint booth walls is done by a contractor. The waste paint and grease scraped from the sides of the paint booths are disposed of in the MSW stream. Documentation that an accurate waste determination was performed on the waste paint and grease was not observed in the record review.

Wilbert. Paint Department Cage. White Booth Grease. Photograph 7 taken at 11:30 a.m.

**§ 262.11] to make an accurate determination as to whether that waste is a hazardous waste in order to ensure wastes are properly managed according to applicable RCRA regulations.**

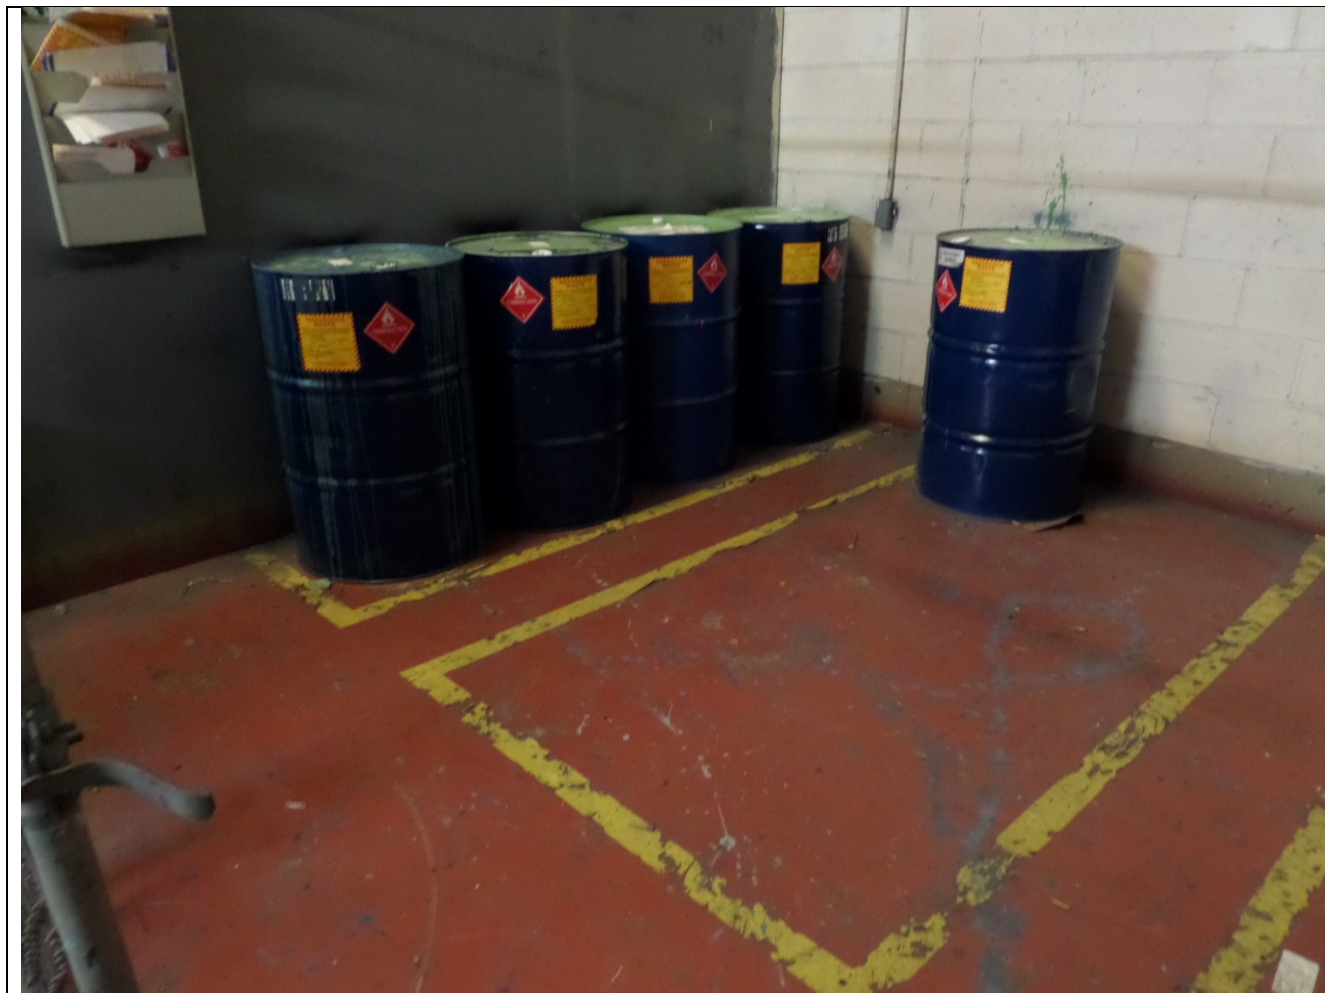
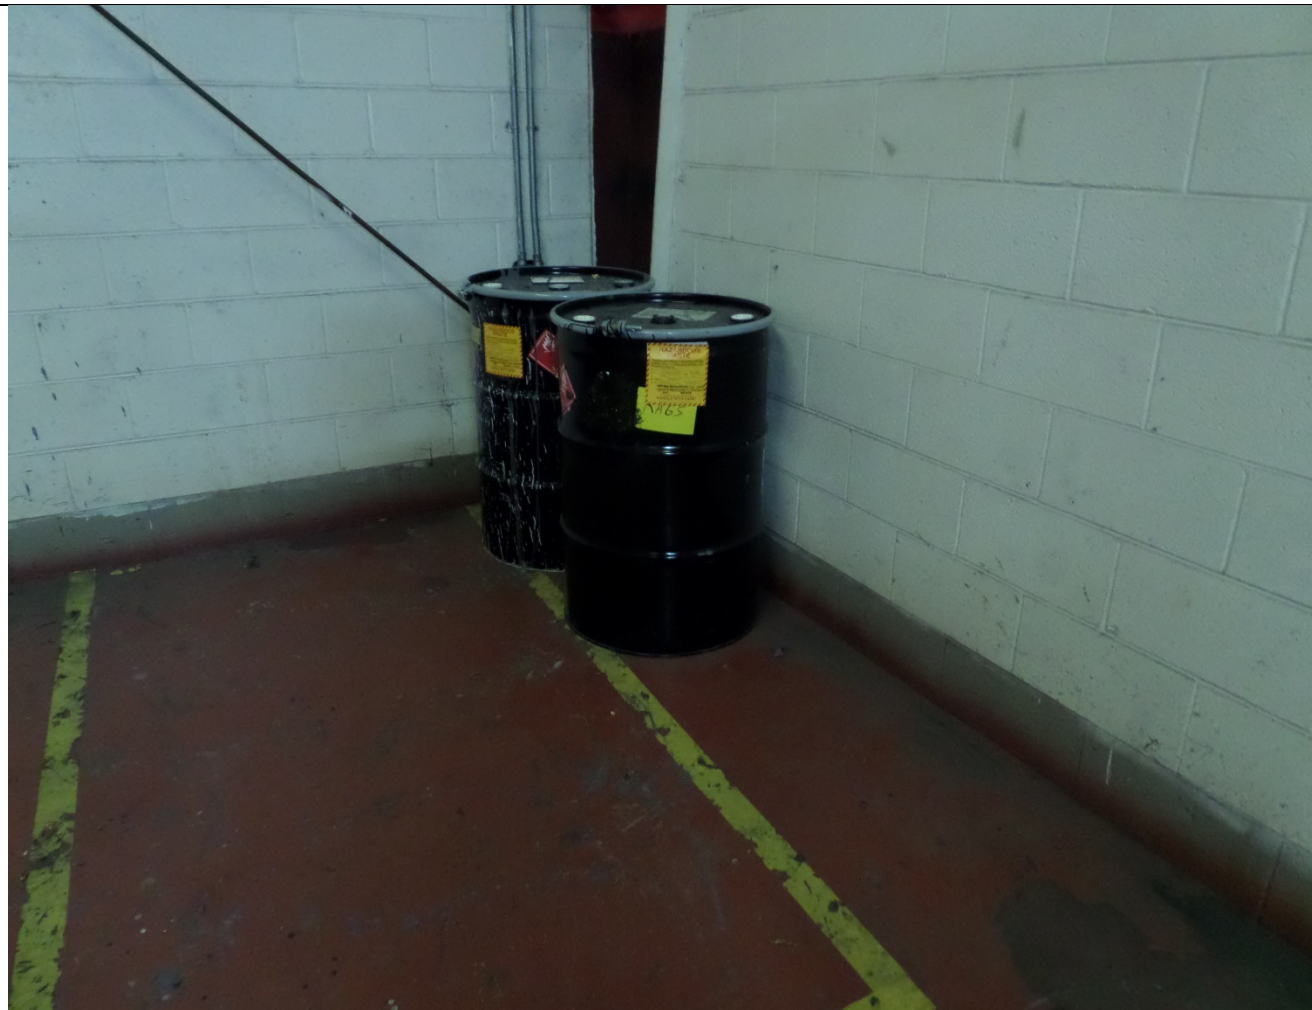
The 90-Day Area is constructed of concrete walls and a concrete floor sealed with an epoxy. The 90-Day Area is secured with a locked chain-link gate and inspectors observed posted signage designating the area as a hazardous waste storage area. The epoxy coating on the floor of the 90-Day Area appeared deteriorating in many areas. The concrete floor should be resealed.

Inspectors observed five 55-gallon containers accumulating hazardous waste positioned along the wall of the 90-Day Area. The inspectors observed the containers were closed, in good condition with aisle space, labeled with the words hazardous waste, marked with a flammable hazard indicator, and marked with dates in May or June 2021. The earliest date observed was May 11, 2021 (Photographs 8 and 9).

Wilbert. CAA/90-Day or Less Accumulation Area. Observed containers accumulating hazardous waste. Observed the floor epoxy appeared to be deteriorating. Photograph 8 taken at 11:39 a.m.

Wilbert. CAA/90-Day or Less Accumulation Area. Observed containers accumulating hazardous waste. Observed the floor epoxy appeared to be deteriorating. Photograph 9 taken at 11:39 a.m.

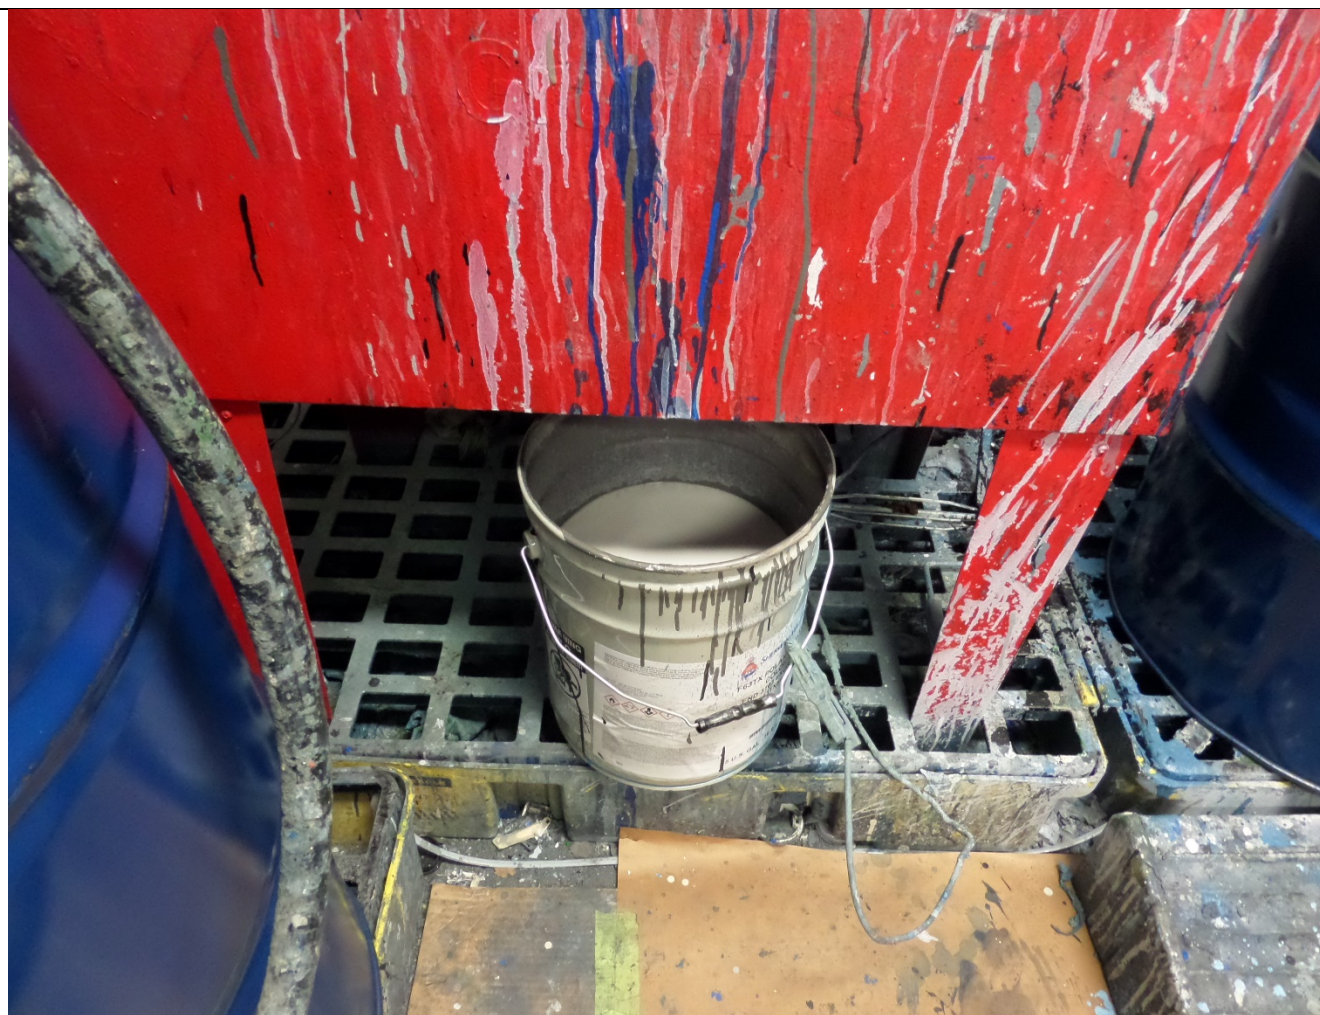
Wilbert manages another hazardous waste SAA under a part washer for accumulating hazardous waste solvent (acetone) used to clean the paint equipment. Spent solvent flows through a bottom drain into a 5-gallon container observed in this SAA. The part washer was not in operation. The inspectors observed the 5-gallon container was not closed, was not marked or labeled with the

words hazardous waste, and was not marked or labeled with a hazard indicator (Photograph 10).

Wilbert. Paint Mix Room. Observed a container under a part washer. Observed the container was not closed, not marked/labeled with the words hazardous waste and no hazard indicator. Photograph 10 taken at 11:45 a.m.

**Pursuant to 25 S.C. Code Ann. Regs. 61-79.262.15(a)(4) [40 C.F.R. § 262.15(a)(4)], which is a condition of the SAA Permit Exemption, A container holding hazardous waste must be closed at all times during accumulation.**

**Pursuant to 25 S.C. Code Ann. Regs. 61-79.262.15(a)(5)(i) [40 C.F.R. § 262.15(a)(5)(i)], which is a condition of the SAA Permit Exemption, A generator must mark or label its container with the following: (i) The words “Hazardous Waste”.**

**Pursuant to 25 S.C. Code Ann. Regs. 61-79.262.15(a)(5)(ii) [40 C.F.R. § 262.15(a)(5)(ii)], which is a condition of the SAA Permit Exemption, An indication of the hazards of the contents (examples include, but are not limited to, the applicable hazardous waste characteristic(s) (i.e., ignitable, corrosive, reactive, toxic); hazard communication consistent with the Department of Transportation requirements at 49 CFR part 172 subpart E (labeling) or subpart F (placarding); a hazard statement or pictogram consistent with the Occupational Safety and Health Administration Hazard Communication Standard at 29 CFR 1910.1200; or a chemical hazard label consistent with the National Fire Protection Association code 704).**

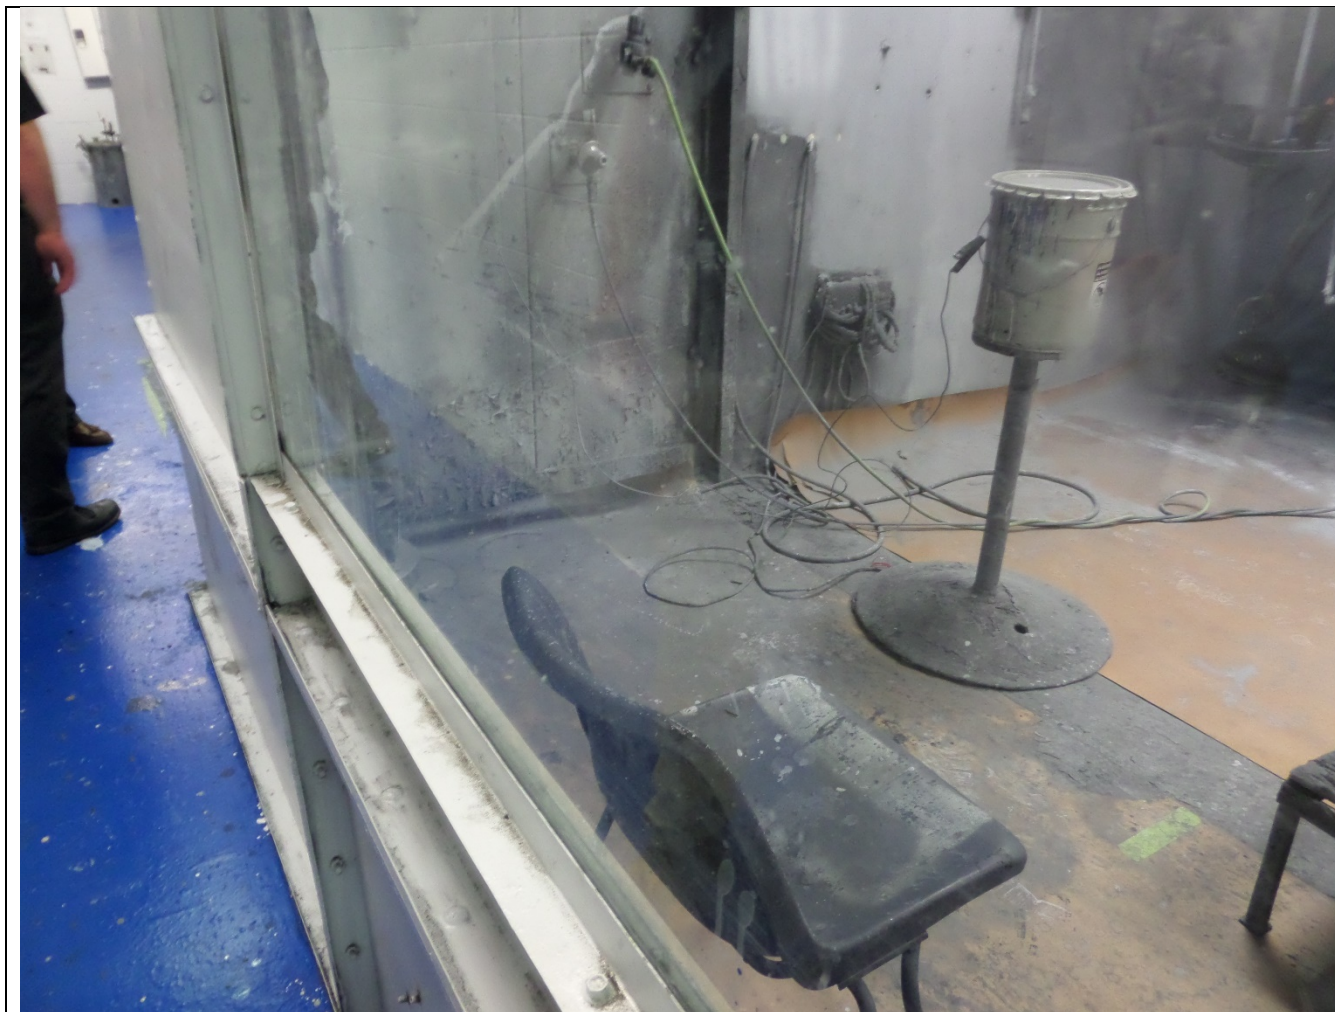
Wilbert. Paint Department. Manual Paint Booth 2. Observed a container was not marked/labeled with the words hazardous waste and no hazard indicator. Photograph 11 taken at 11:52 a.m.

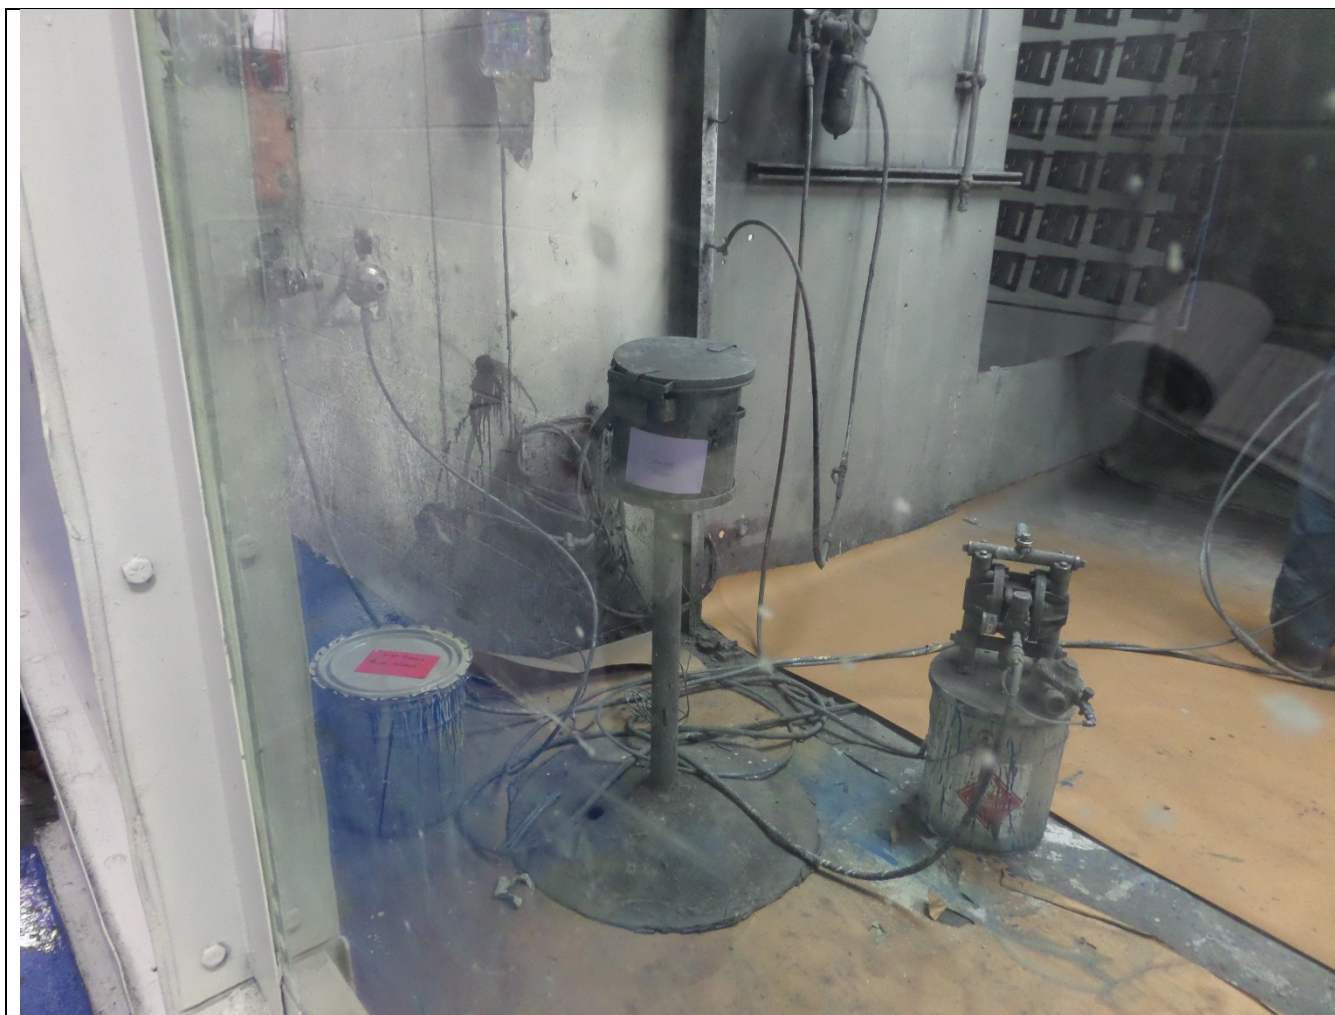
Wilbert. Paint Department. Manual Paint Booth 4. Observed a container was not marked/labeled with the words hazardous waste and no hazard indicator. Photograph 12 taken at 11:55 a.m.

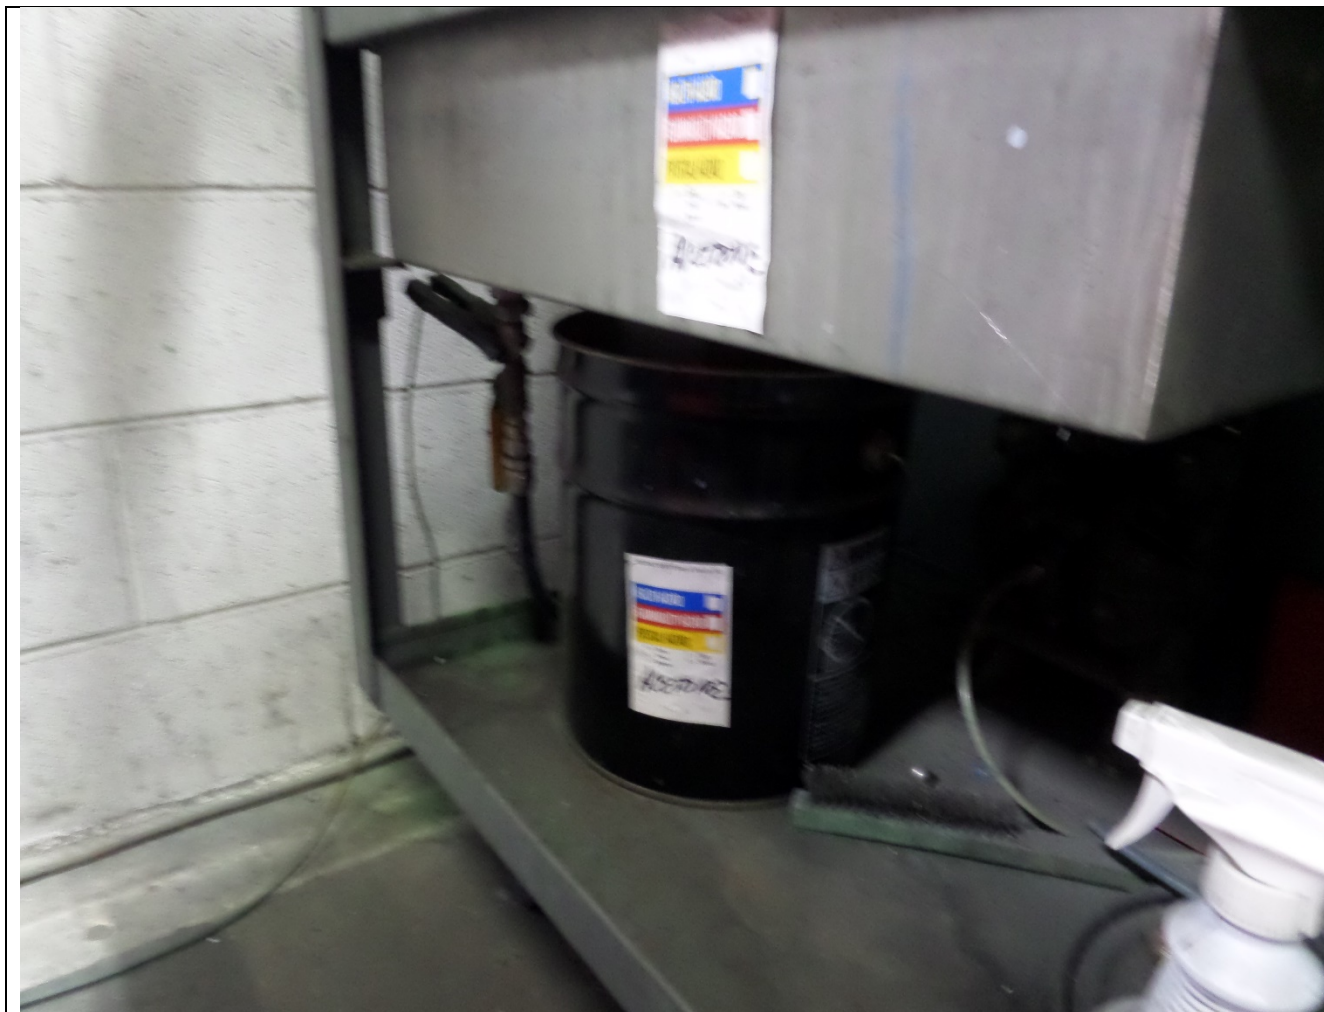
Wilbert. Paint Department. Paint Maintenance. Observed a container not kept closed and was not marked/labeled with the words hazardous waste. Photograph 13 taken at 11:58 a.m.

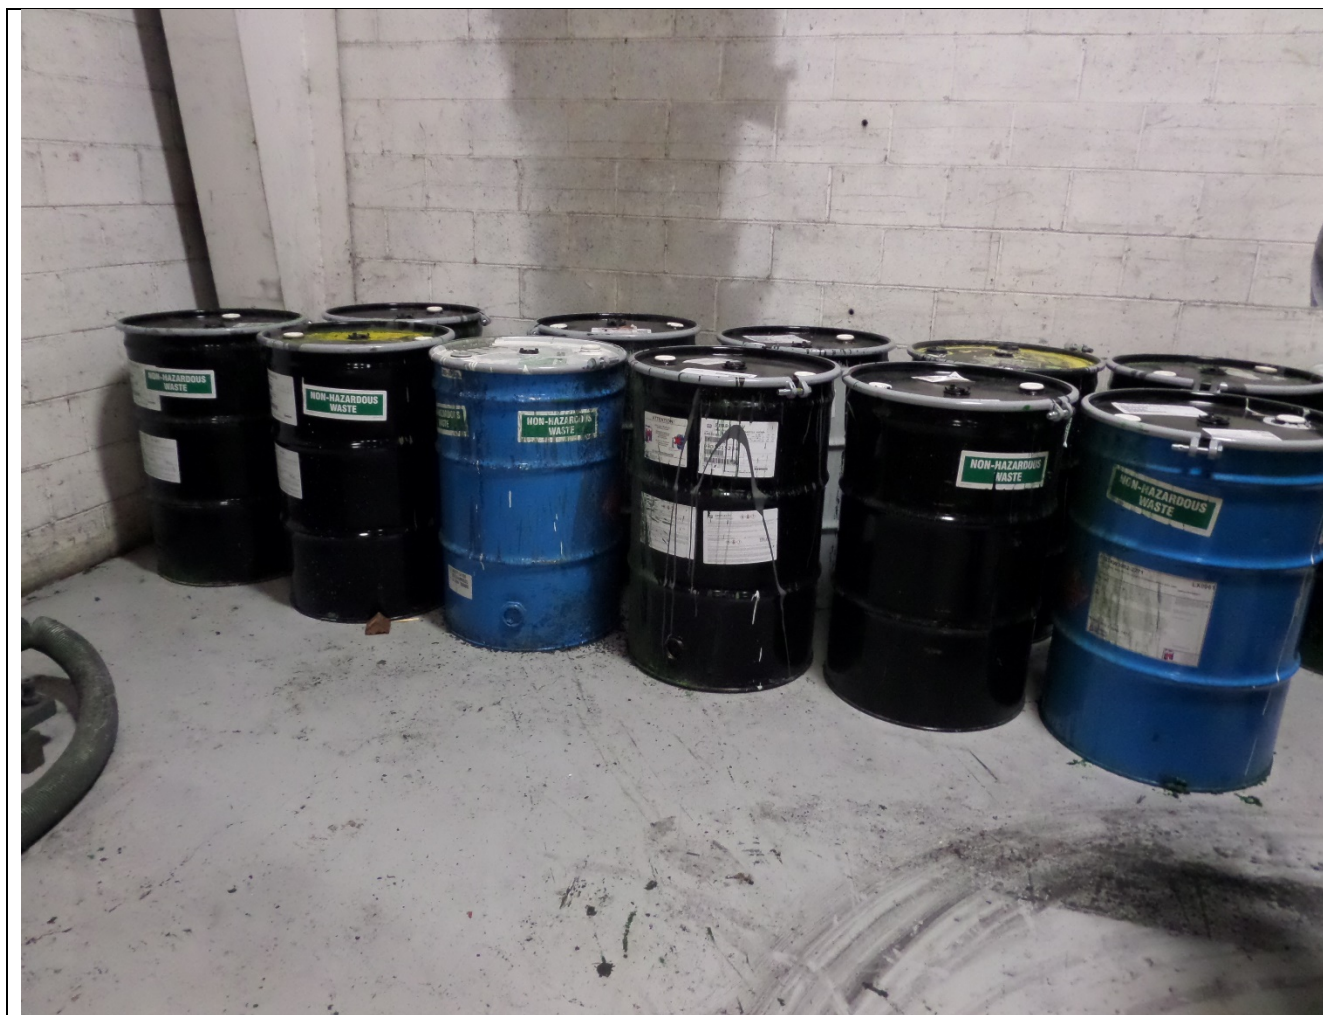
Wilbert. Non-hazardous Waste Accumulation Area. Observed twelve 55-gallon containers accumulating paint solids from water wash booth. Observed a hazard indicator on two containers. Photograph 14 taken at 12:02 p.m.

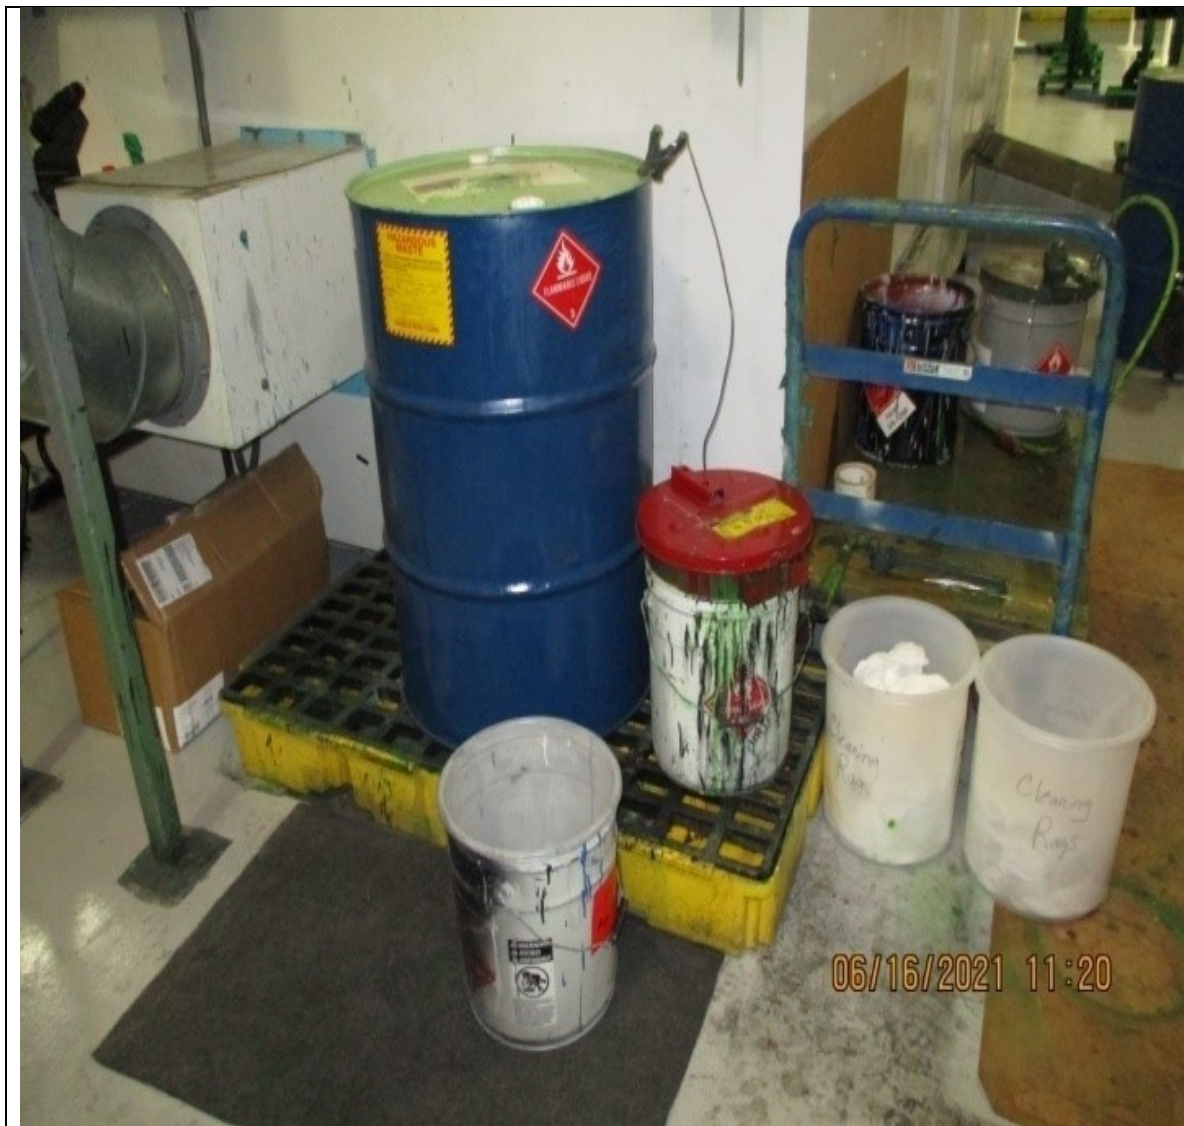
Wilbert. Robotic Paint SAA. The inspectors observed a 5-gallon container with a funnel accumulating hazardous waste. Photograph 14 taken by SCDHEC at 11:20 a.m. The SCDHEC Photographs in this report document the Photograph number used in the State of South Carolina report.
